# Ultrasonic Quality Assurance at Magnesia Shotcrete Sealing Structures

Vera Lay <sup>1,†</sup>, Ute Effner <sup>1,†</sup>, Ernst Niederleithinger <sup>1,\*</sup>, Jennifer Arendt <sup>2</sup>, Martin Hofmann <sup>2</sup> and Wolfram Kudla <sup>2</sup>

Keywords: ultrasonics; imaging; engineered barrier; underground; shotcrete; magnesia concrete

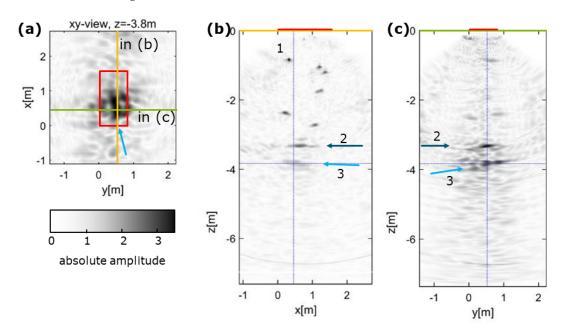
**Figure 4.** LAUS ultrasonic imaging results at area 2 at large scale shotcrete construction. (a) xy–slice at a depth of z = -3.8 m with measurement area (red) and corresponding slices marked. (b) yz–slice and (c) xz–slice.

The exemplary ultrasonic images in Figure 4 show the capacity of the LAUS when analysing the engineered barrier system from the side (area 2 in Figure 3a–c). Although the opposite side of the sealing structure is expected at  $z\approx-3.5$  m, data was recorded for the full length of the A–scans, also providing deeper information from within the salt rock environment. Although the self-healing nature of salt rock makes additional larger cracks unlikely, potential excavation-induced flaws can be monitored, particularly before the healing could take place. Distinct individual reflectors are clearly identified (number 1

in Figure 4b). The deepest reflector is identified at a depth of z = -3.8 m (light blue arrow, 3) with a slightly shallower reflector located at z = -3.4 m (dark blue arrow, 2). The reflectors 2 and 3 can be attributed to the bearing of the barrier system in the rock mass and the opposite wall of the structure.

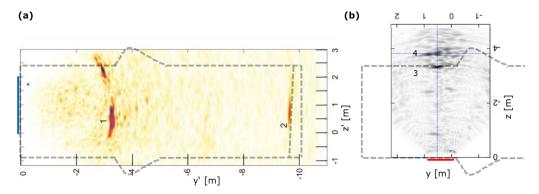
Figure 5 combines the previous results, measuring with the LAUS from the front ([16], Figure 5a), and the results presented here ([22], Figure 5b). The geometry of the sealing structure is indicated as a grey dashed line according to the sketch provided in Figure 3. In Figure 5a, reflector 1 is associated with the bearing at y' = -3.3 m and reflector 2 can be associated with the location (y' = -9.6 m) of a pressure chamber at the end of the sealing structure. Consistently, the backwall (i.e., the opposite side of the sealing structure) can be identified as a reflector when measuring from the side (number 3 in Figure 5b). Due to the self-healing nature of salt rock, additional cracks are unlikely to explain the deeper reflector marked with 4. Potentially, 3D effects of the bearing might explain this reflector.

**Figure 5.** LAUS GV2 ultrasonic images (after [16]) and comparison to engineered barrier (grey dashed line, details in Figure 3a): (a) Ultrasonic imaging from the front (LAUS area 1, blue), results from [16] and (b) ultrasonic imaging from the side (LAUS area 2, red), equivalent to Figure 4c.

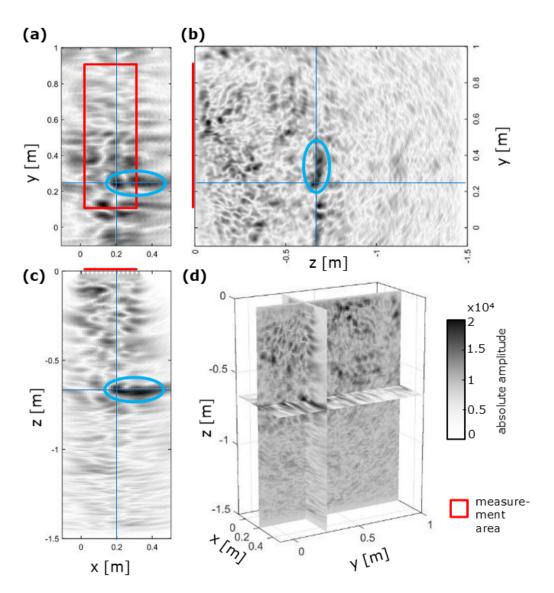
For the shotcrete box experiment GSBV3, ultrasonic images showed several reflectors within the concrete body (Figure 6). Generally, the final images showed inhomogeneous structures that might have been associated with the characteristics of the shotcrete material and the higher frequency conventional ultrasonic measurement device. Nevertheless, prominent reflectors, such as the elongated reflector at z=-0.7 m in Figure 6, were clearly identified. Concreting sections were not systematically imaged so that a successful concreting was assumed as also indicated by observed low permeabilities measured on core samples in the laboratory. Moreover, no clear reflection of the backwall (at  $z\approx-1$  m) was visible due to either higher general reflectivity of the shotcrete or very similar characteristics between the shotcrete and the salt rock, resulting in a low impedance contrast not causing a significant reflection.

**Figure 6.** Ultrasonic imaging results of GSBV3 (after [22]) showing a distinct reflector (blue ellipse): (a) xy-slice (parallel to measurement surface), (b) corresponding yz-slice, (c) corresponding xz-slice, and (d) 3D overview of the presented slices.

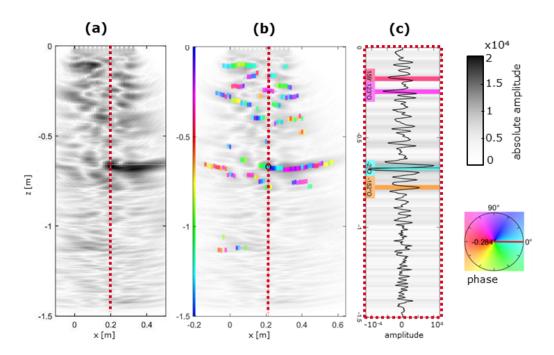
As a detailed phase analysis of prominent reflectors may provide insight into the nature of the reflector, it was carried out for prominent reflectors here. Thus, their origin may be determined. At the experimental shotcrete box GSBV3, the results of the phase analysis are summarised in Figure 7. The analysed xz–trace (marked in Figure 7a) coincided with the significant reflector from Figure 6. Associated phases after analysis, according to [20], are plotted in Figure 7b, with details of the exact location (red dotted line) extracted in Figure 7c. The specific reflector at z=-0.7 m had a phase close to  $0^{\circ}$  and was associated with a negative impedance contrast.

Thus, the origin of the reflector was a weaker structure with an acoustic impedance lower than that of the surrounding magnesia shotcrete being caused by, e.g., cavities, cracks, or delamination. Later drilling showed a well-manufactured shotcrete, with some minor irregular cavities (opening 0.1–0.5 mm, length 1–5 cm) also at the respective depth that also caused the core to break at exactly that depth.

**Figure 7.** Phase analysis at GSBV3: (a) Ultrasonic image, as shown in Figure 6c, (b) overlain by phase analysis results; (c) individual analysed trace at central location (red dashed line) with determined phases of major reflectors.

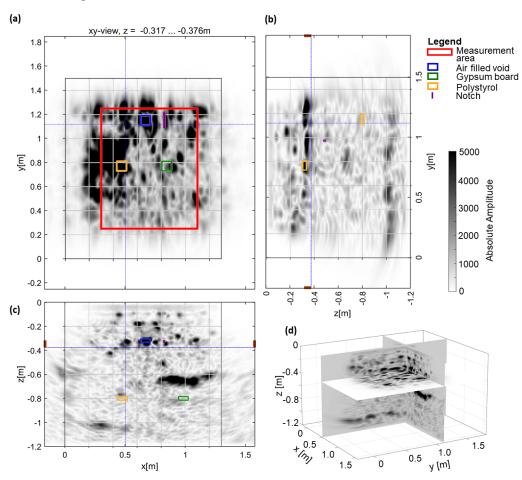
In a first step, the ultrasonic data was analysed as a blind test without any prior information about the location, depth, or nature of the artefacts. A standard measurement layout with a linear array instrument was used with the standard procedures, concerning, for example, grid line distance. The results of the depth layer shown in detail for the experimental setup in Figure 8 are summarised in Figure 9a, with corresponding xz–and yz–slices.

The ultrasonic imaging result shows that many reflectors are imaged that hint to varying material characteristics. Without prior knowledge, structures not artificially incorporated are clearly identified, but not all artificial flaws introduced in the experiment are detected, as shown by the overlay with the actual locations of the artificial defects in Figure 9. During this analysis, a few indications were identified. The expected backwall (at  $z \approx -1$  m) is partly visible in Figure 9, where the echo is not shadowed by shallower reflectors. Due to the generally inhomogeneous reflectivity of the shotcrete, some indications could later be correlated with the defects; but particularly, the deeper test flaws with lower contrast (e.g., gypsum board imitating a concrete with lower density) could not be seen, even when their location was known. Shallower artificial flaws and particularly the air-filled voids can be associated with reflectors. To verify the most significant reflectors, such as the strong reflector at z=-0.64 m between x-locations 0.75 m and 1.25 m, in Figure 9c, detailed phase analysis and subsequent drilling were undertaken.

**Figure 9.** Ultrasonic imaging results of GSBV4 overlain by expected location of artificial defects (compare Figure 8): (a) xy–slice at z = -0.32 m, (b) yz–slice, (c) xz–slice, and (d) 3D view at marked slices.

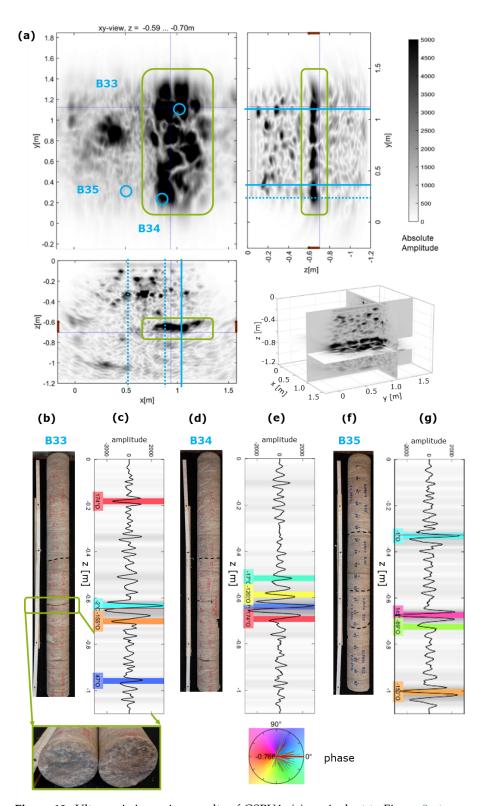
During the previous experiments, no extensional reflectors were identified that were directly imaged at the known concreting boundaries. However, for GSBV4, the analysis of the ultrasonic imaging shows a major reflector that covers nearly half of the investigated area, as shown in Figure 10. Corresponding xz– and yz–slices also show the extent of

The depth slice, shown in Figure 10a, is summed over a range of  $z=-0.59...-0.7\,\mathrm{m}$  to enhance the reflector, being most prominent at depths between  $z=-0.62...-0.66\,\mathrm{m}$ . This depth correlates well with a concreting boundary between the second and third 16 cm thick concrete layers, i.e., at  $z=-0.64\,\mathrm{m}$ . Most of the energy is reflected at this depth so that no imaging of deeper structures is possible at this location. Due to the strong appearance of the reflector, ground truthing was done through phase analysis and drilled boreholes with cores taken (see core photos in Figure 10b,d,f). The borehole diameter was 107 mm. The taken core samples were located within the large ultrasonic anomaly (B33, B34) and one outside (B35) and helped to confirm and understand ultrasonic signals. Partly, failure caused by the drilling occurred and is marked by dashed lines. Most interestingly, the core B33 in Figure 10b shows a clear delamination (green rectangle) at a depth of  $z=-0.63\,\mathrm{m}$  (also see detailed photo of the fracture surface) and is also visible in a camera analysis of the borehole. Although the core B34 (Figure 10d) was also broken at  $z=-0.61\,\mathrm{m}$ , respectively, there was no widespread delamination detected but several smaller inhomogeneities.

At the locations of the boreholes, phase analysis after [20] was done equivalently to results discussed in Figure 7, with the ultrasonic measurements recorded before drilling. Here, Figure 10c,e,g each show the trace with determined phases at the location of the boreholes. The phases are colour-coded, with blue colours associated with negative impedance contrasts, i.e., sound weaker material, such as air, and red colours associated with positive impedance contrasts, i.e., sound stronger material, such as denser concrete.

For major reflectors in the phase analysis, there was a good correlation to the structures identified at the cores, although not all individual structures were assignable. A detailed analysis of the drilled boreholes by [24] shows a set of defects in the cores that can only partly be related to clear reflectors identified in the ultrasonic images. However, the determined phase associated with potentially air-filled voids coincides with the visible delamination (B33, Figure 10b,c). The coincidence of the analysed phases with drilled results was particularly strong for large reflectors with relatively high amplitudes and showed the value of the phase analysis.

**Figure 10.** Ultrasonic imaging results of GSBV4: (a) equivalent to Figure 9 at a summed depth interval of z = 0.59-0.7 m. Note the location of drilled boreholes (blue) and large reflector (green rectangle). (b,d,f) taken cores with (c,e,g) corresponding phase analysis at the same location.
