DOCUMENTATION

Summer School 2022 | Kukaldosh Madrasah Bukhara Uzbekistan

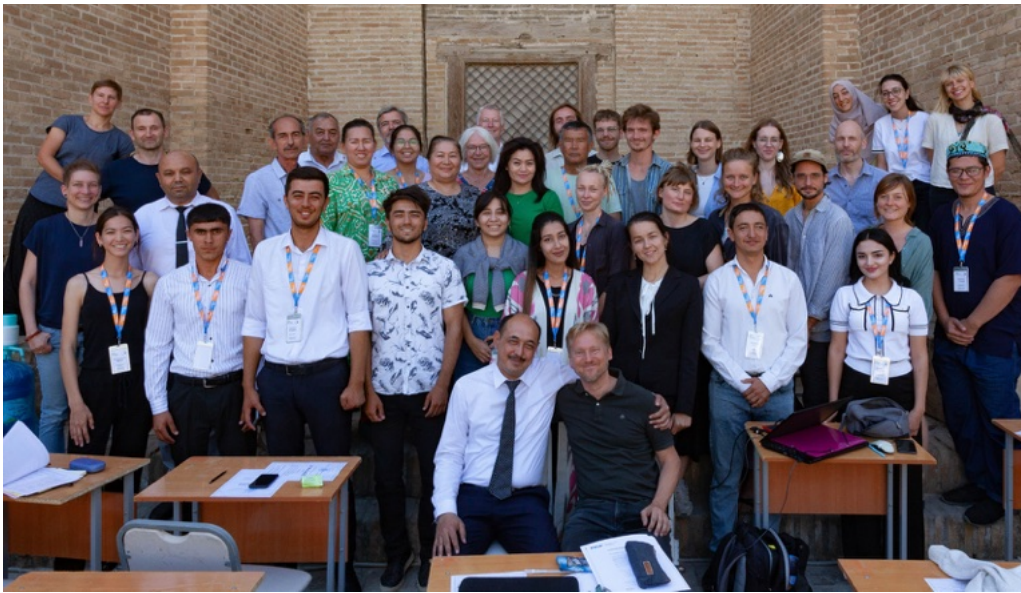
Political and financial frame:

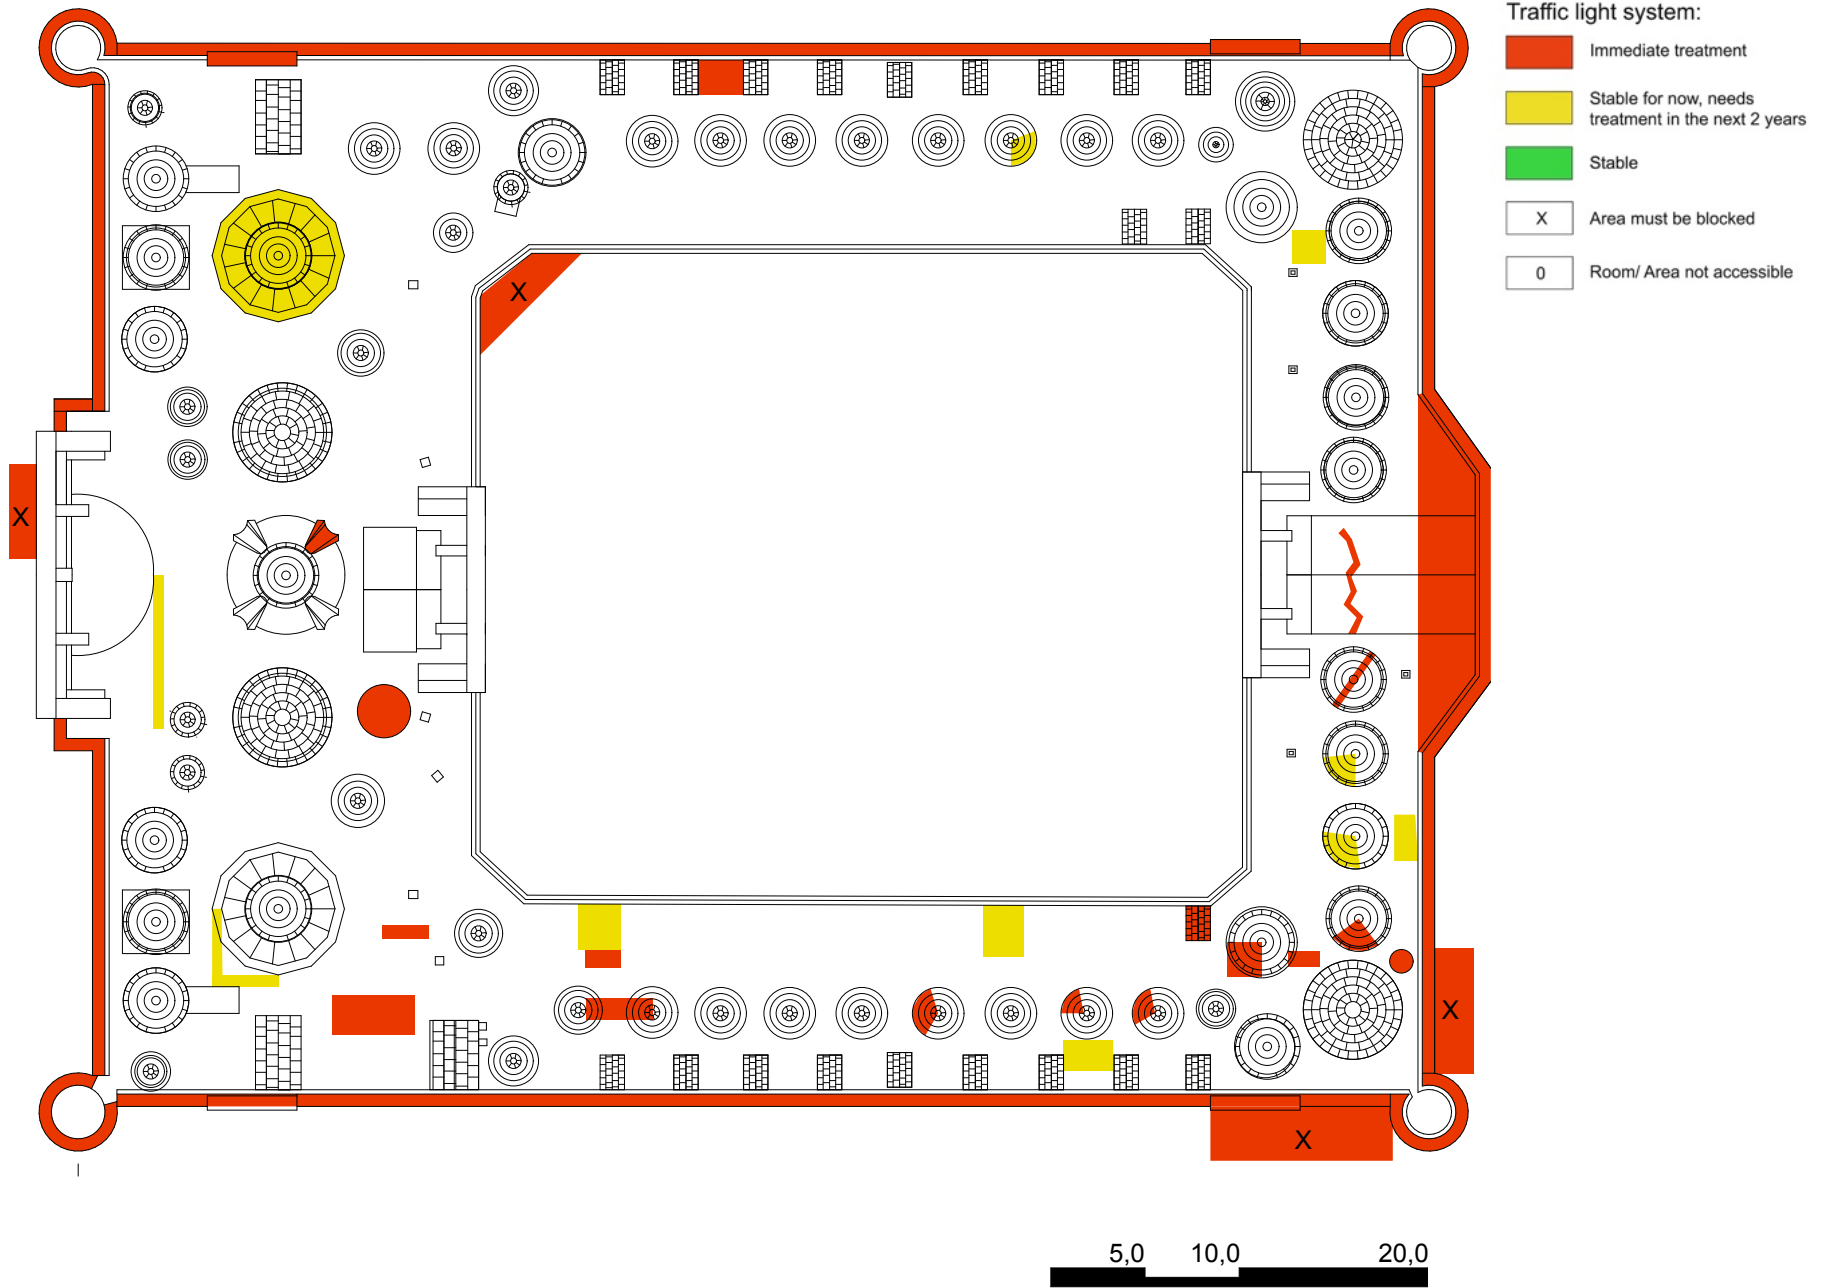
Apart from the measures to ensure stability, cleaning should generally be carried out on the roof and the overgrowth removed. To prevent further damage, a functioning roof drainage system must be ensured.

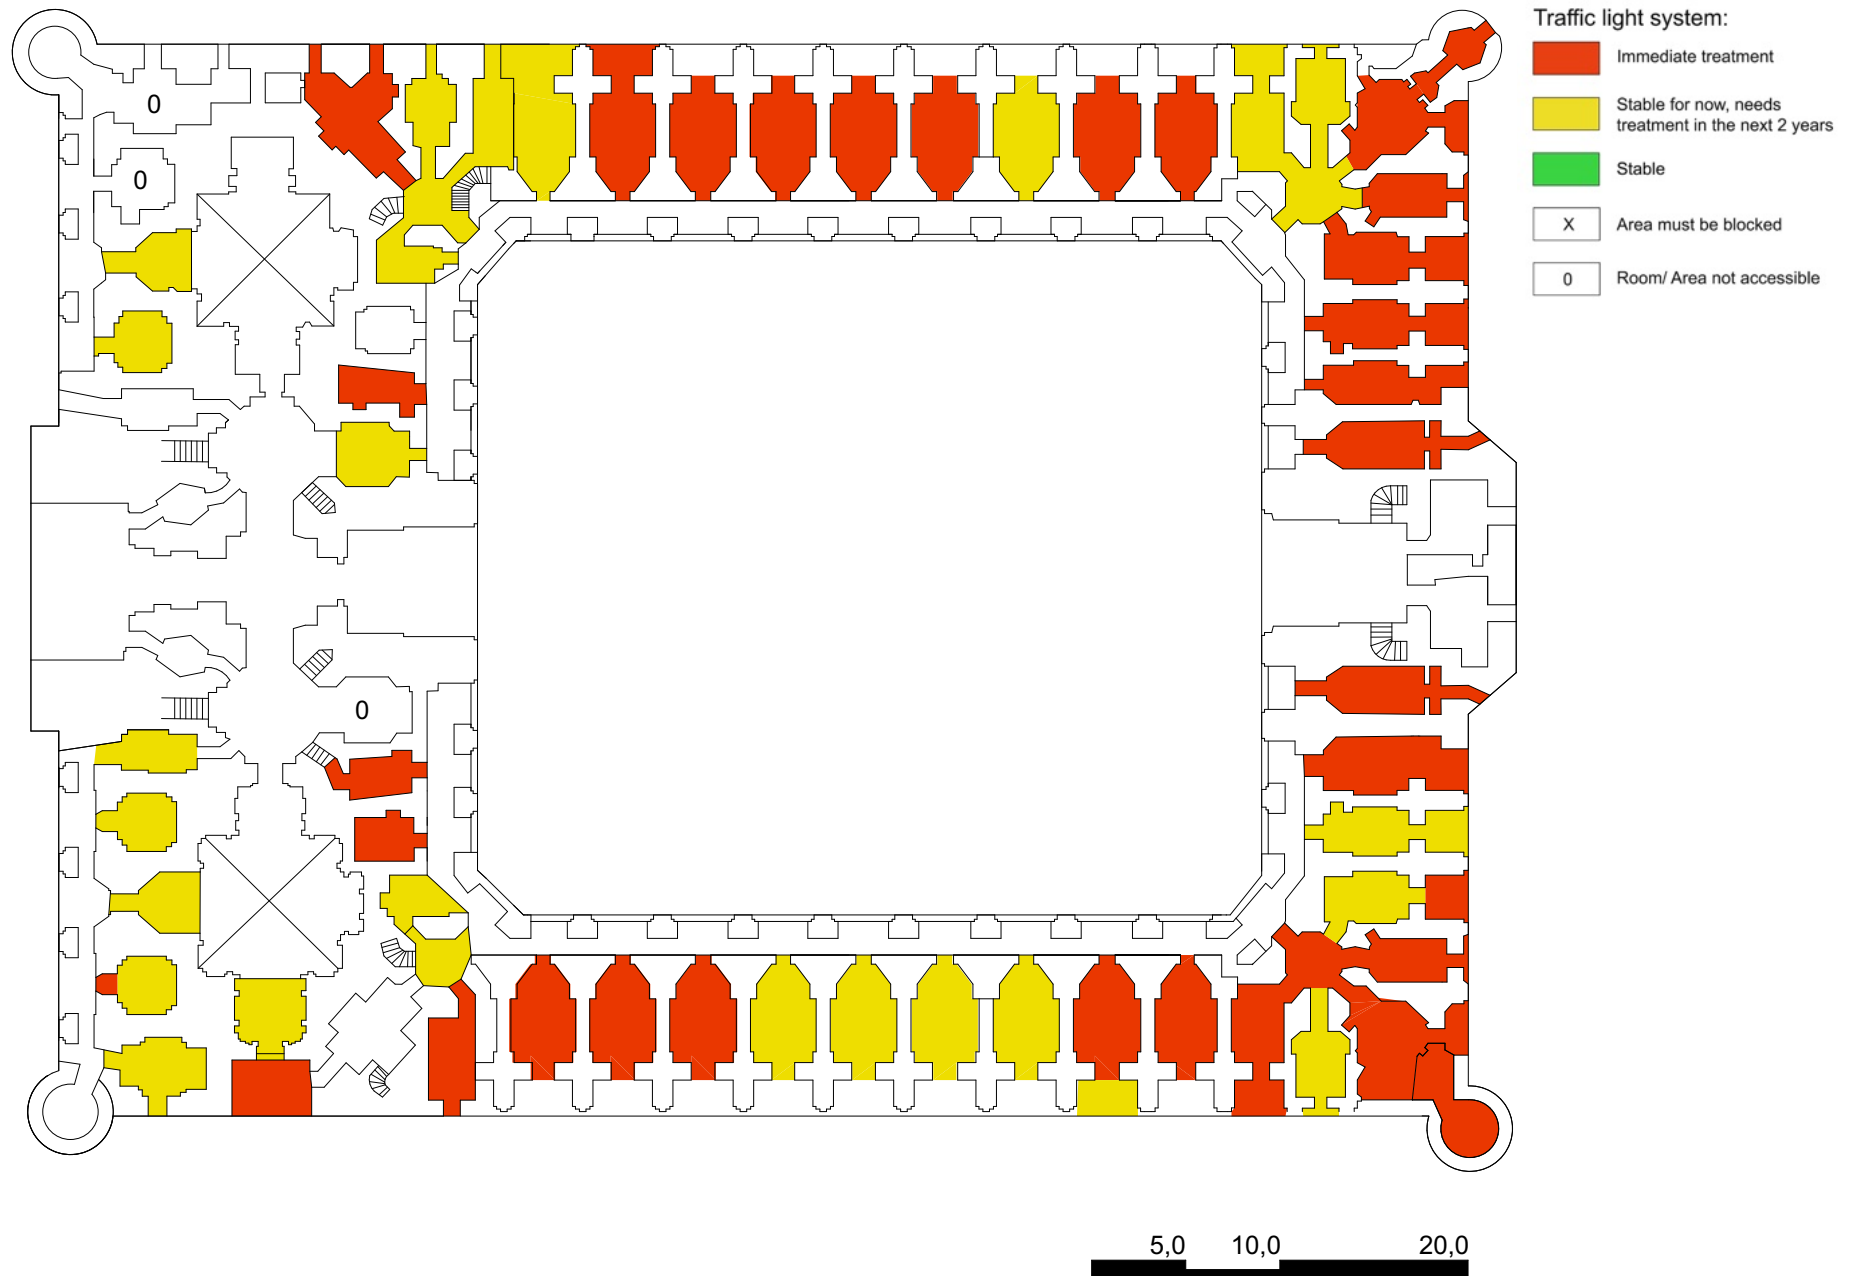
Traffic light system:

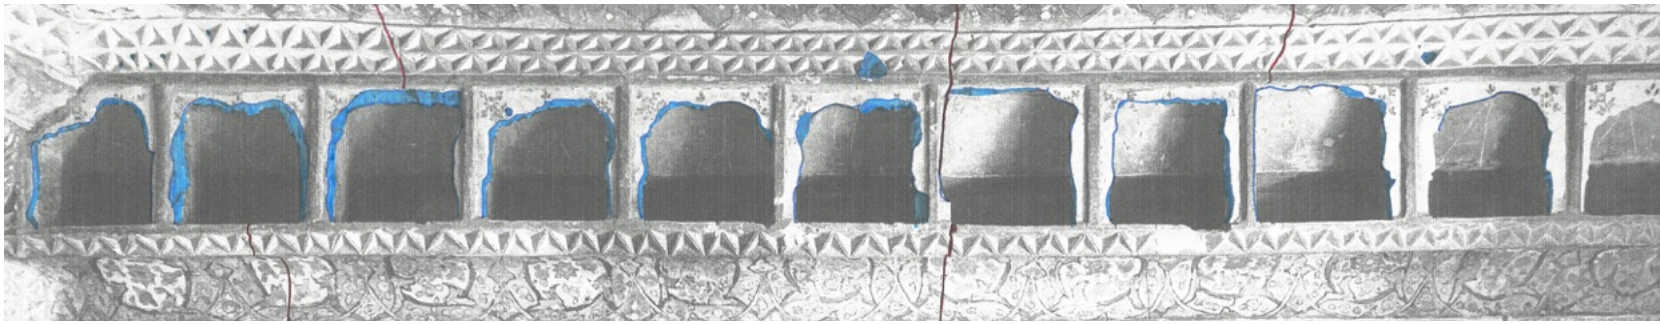
In some areas of the walls, losses of the paint layers can be seen. Abrasion on the stucco elements is also visible in some places. Another damage, probably one of the most visible, is missing spots/laccunae, on the stucco elements with broken edges. Overall, the lower main room is in good condition.

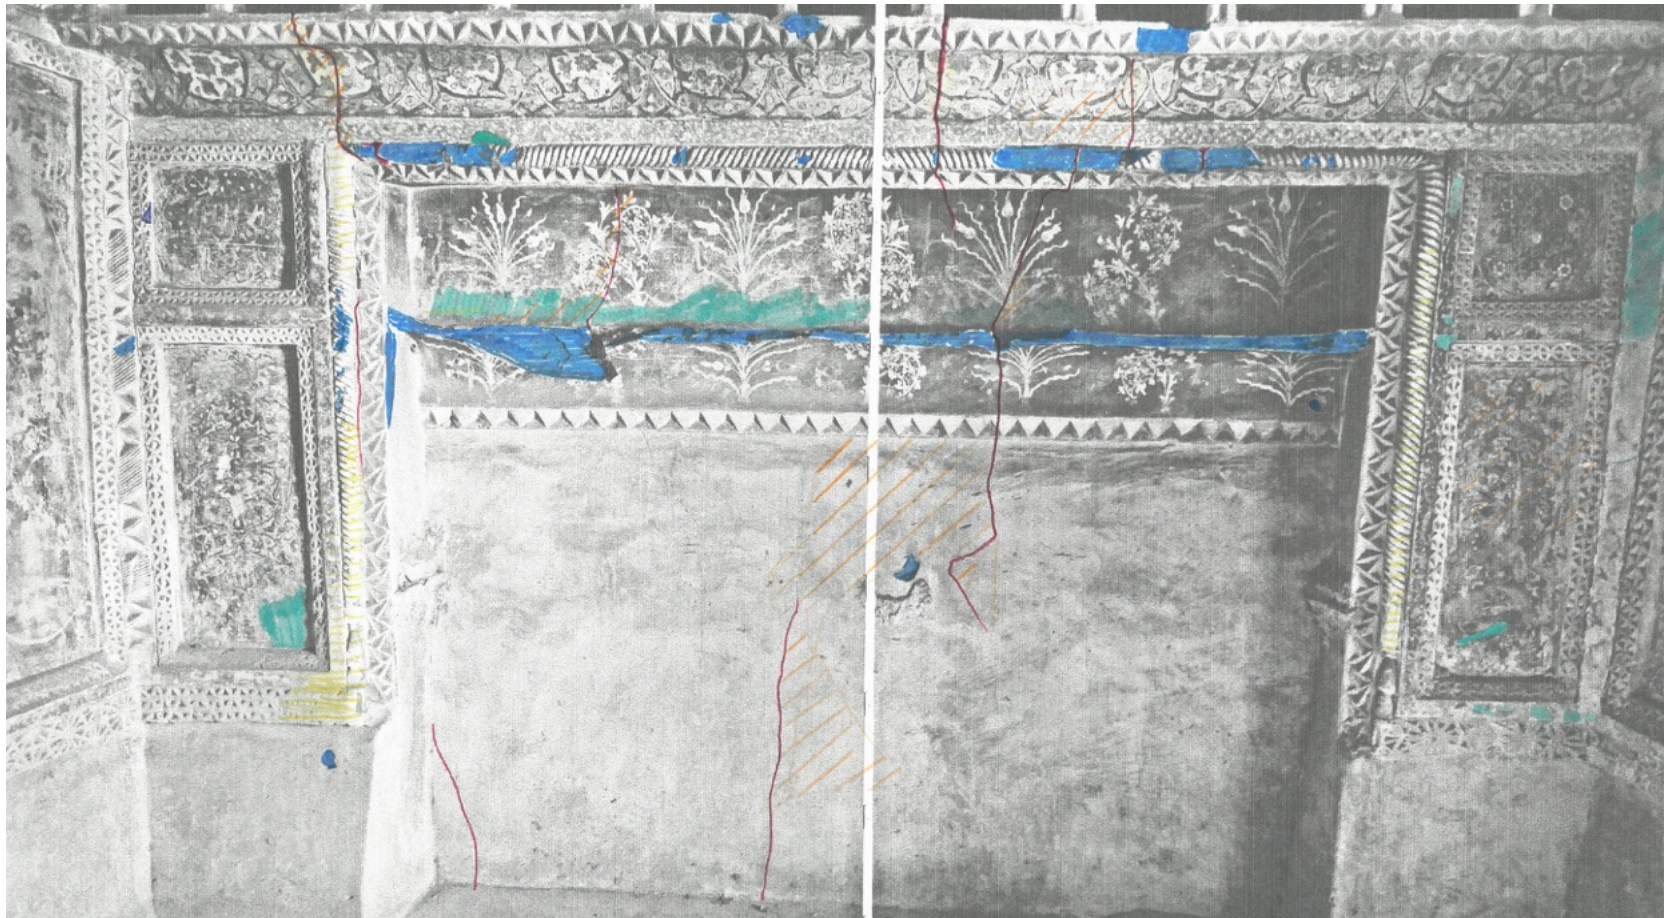
- Lacuna/ Missing parts
- Loss of paint layer
- Crumbling
- Peeling
- Crack
- Scaling
- Salt
- Biological growth
- Corrosion
- Burrow
- Water traces

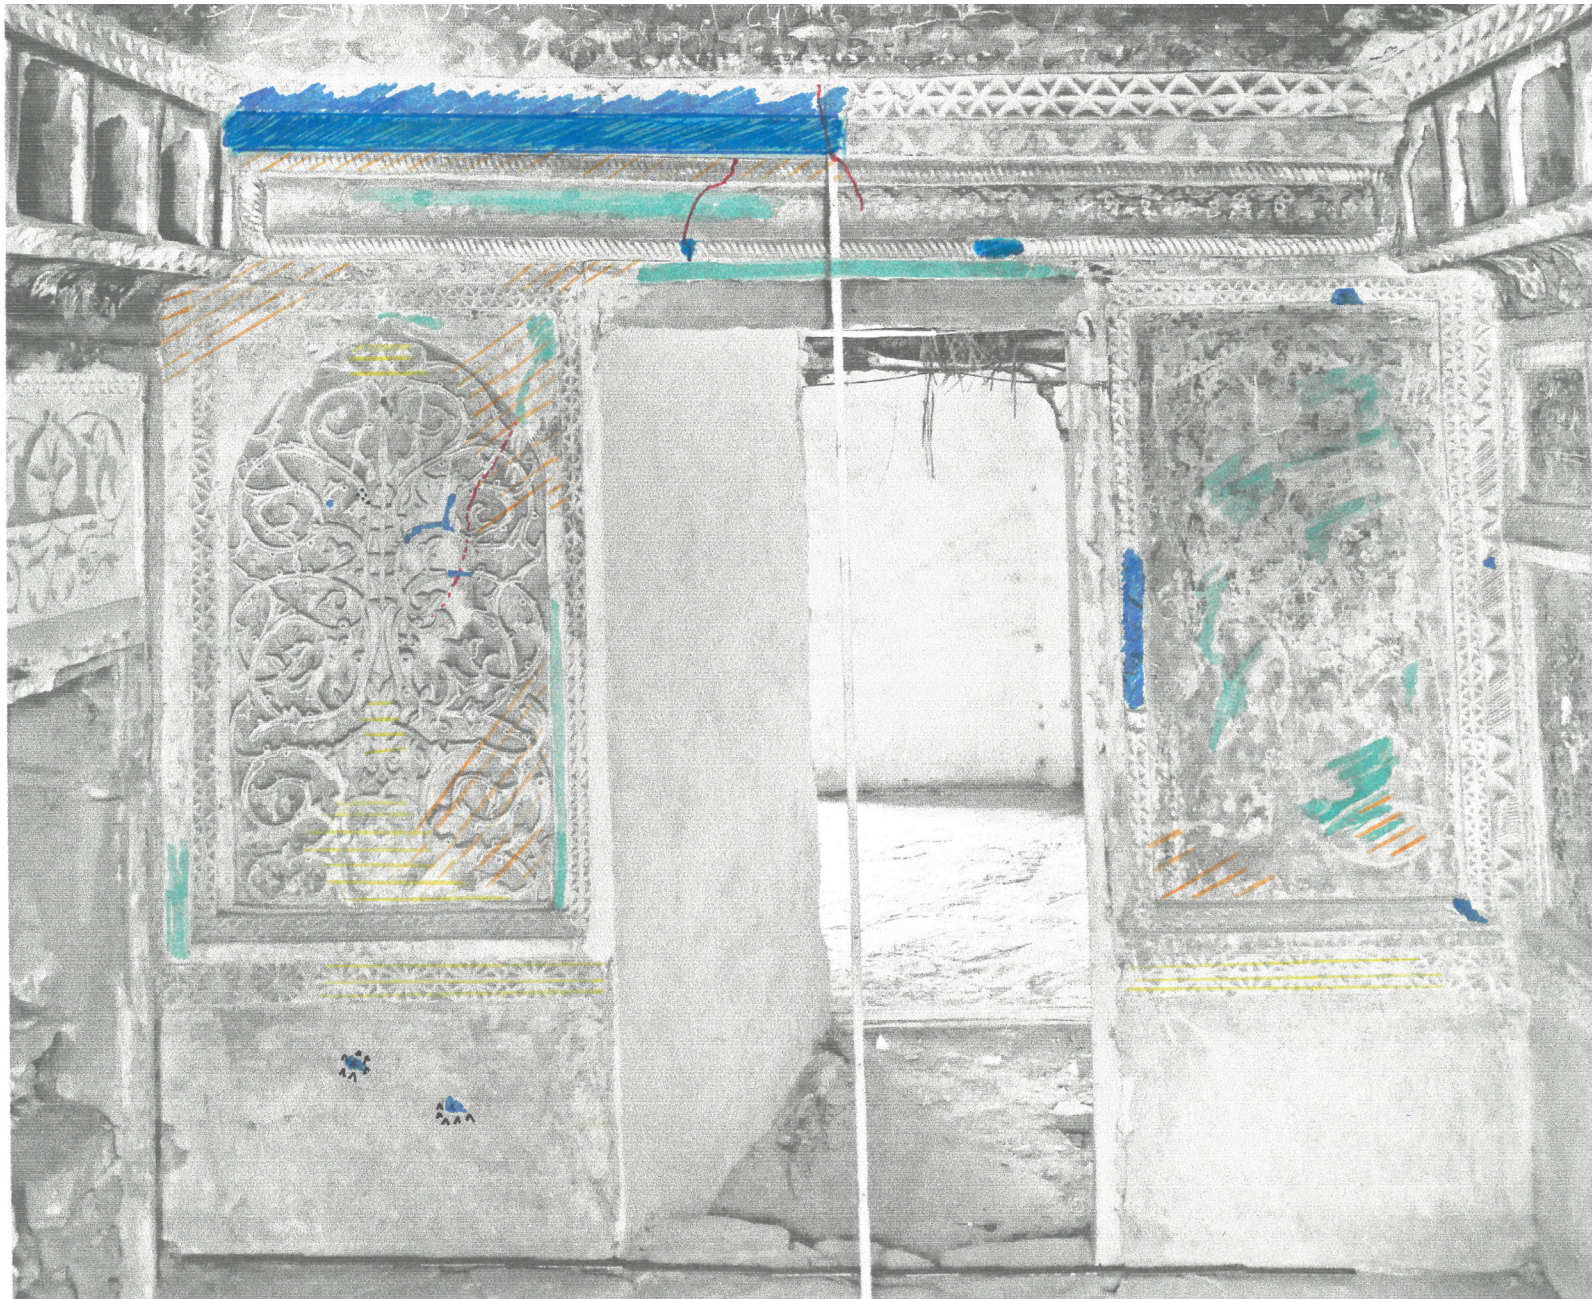
- Lacuna/ Missing parts
- Loss of paint layer
- Crumbling
- Peeling
- Crack
- Scaling
- Salt
- Biological growth
- Corrosion
- Burrow
- Water traces

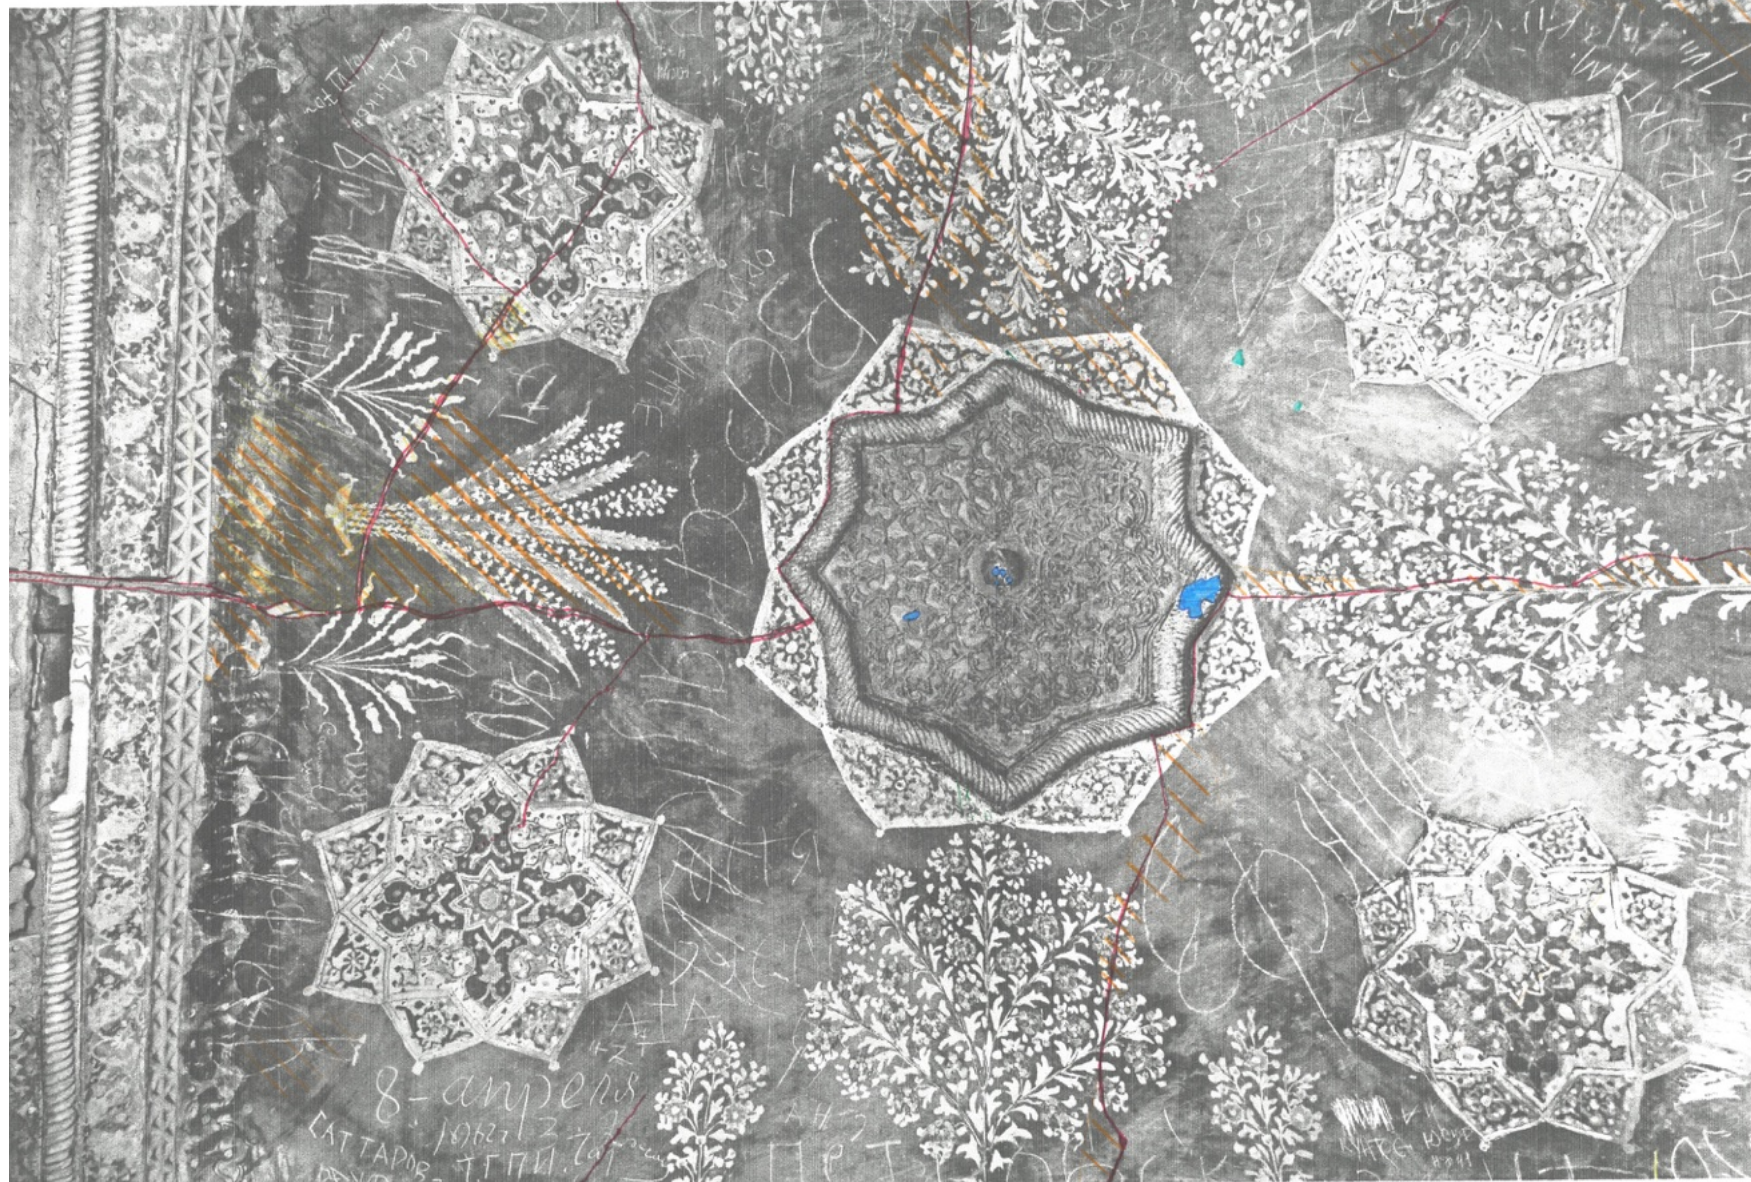
- Lacuna/ Missing parts
- Loss of paint layer
- Crumbling
- Peeling
- Crack
- Scaling
- Salt
- Biological growth
- Corrosion
- Burrow
- Water traces

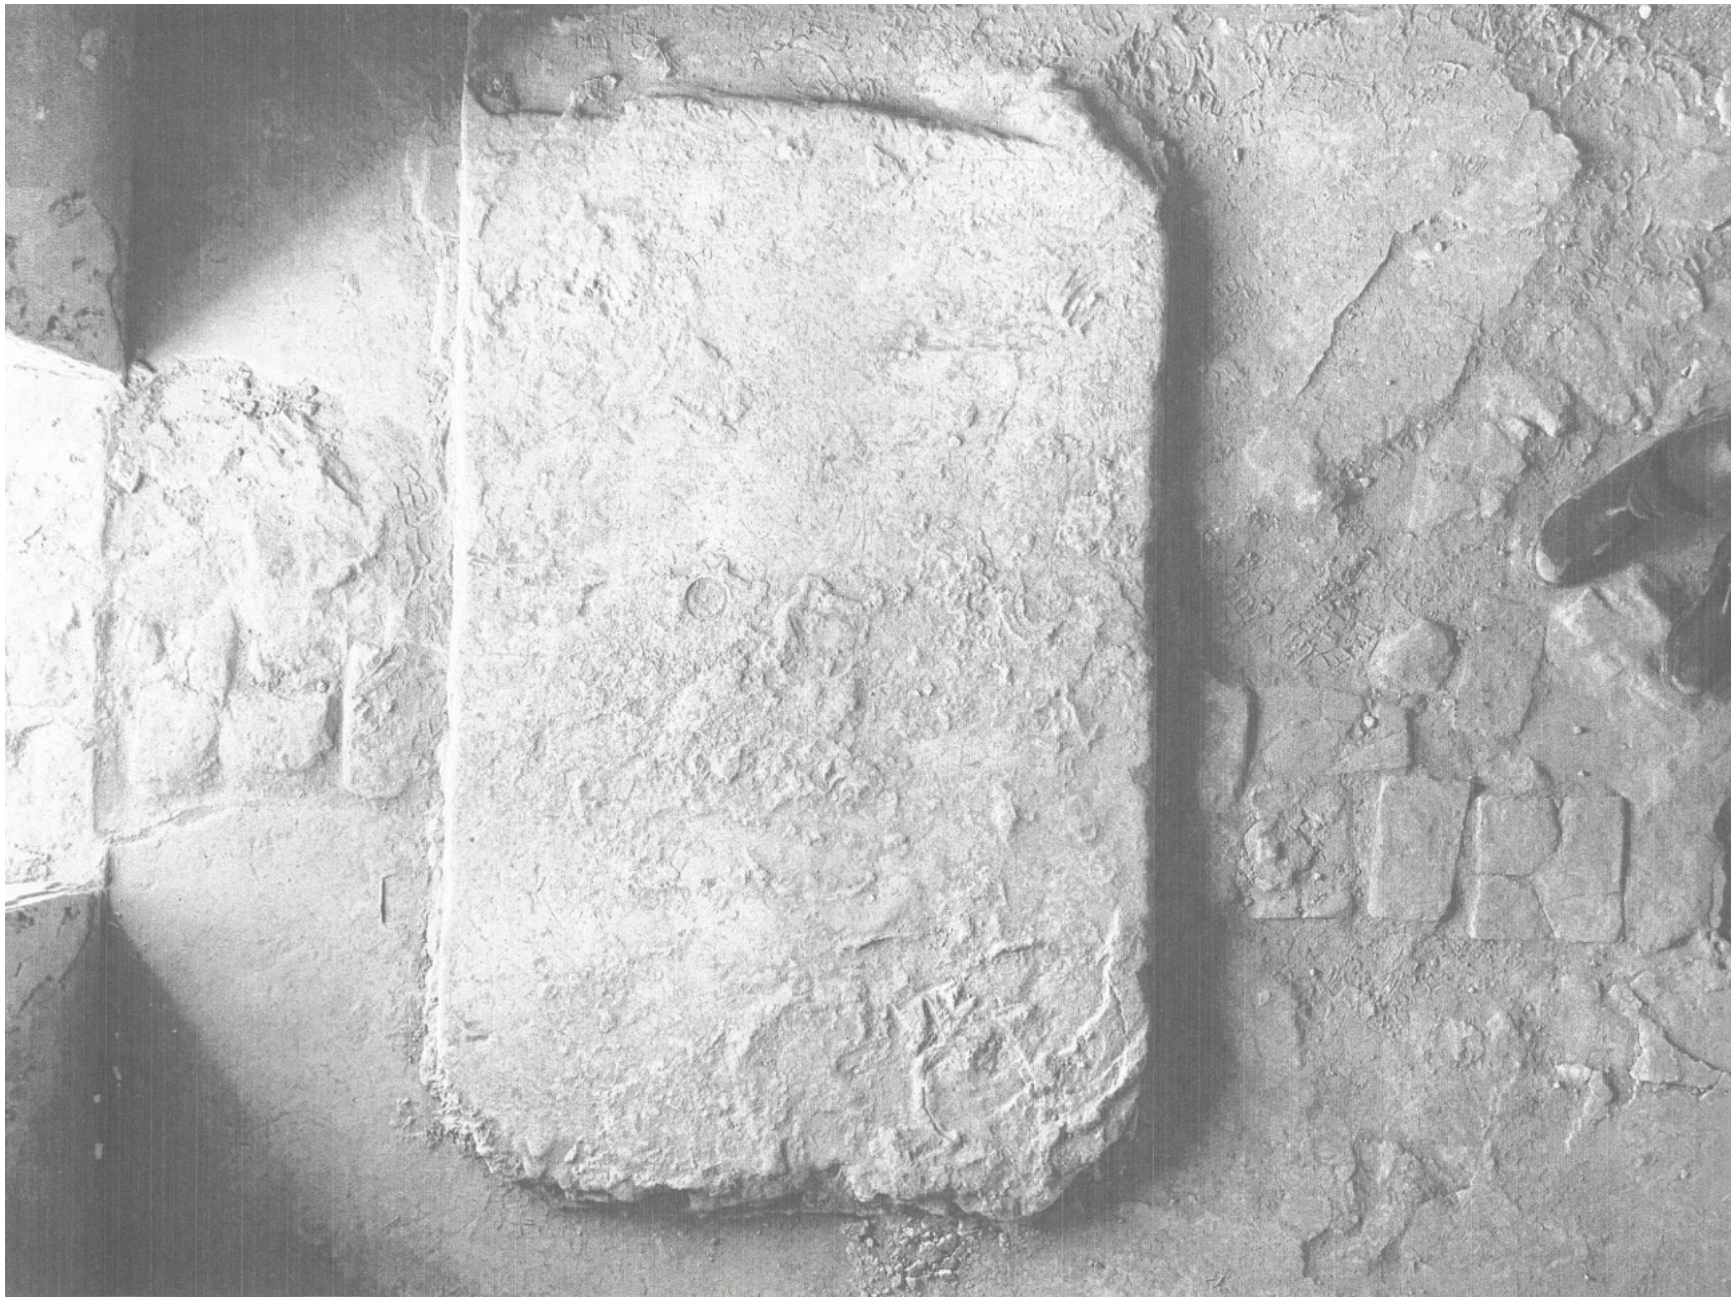
- Lacuna/ Missing parts
- Loss of paint layer
- Crumbling
- Peeling
- Crack
- Scaling
- Salt
- Biological growth
- Corrosion
- Burrow
- Water traces

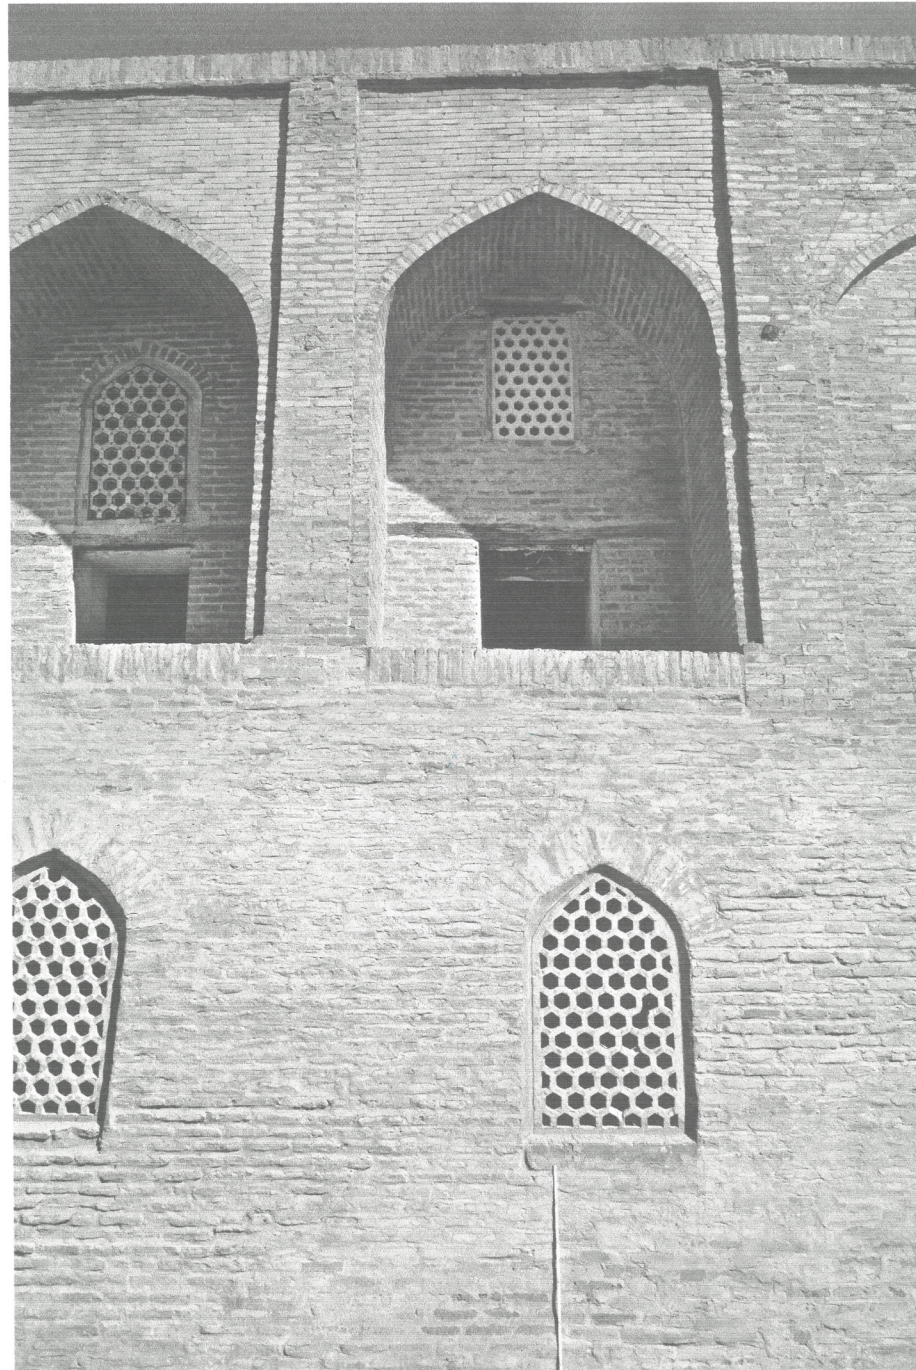
- Lacuna/ Missing parts
- Loss of paint layer
- Crumbling
- Peeling
- Crack
- Scaling
- Salt
- Biological growth
- Corrosion
- Burrow
- Water traces

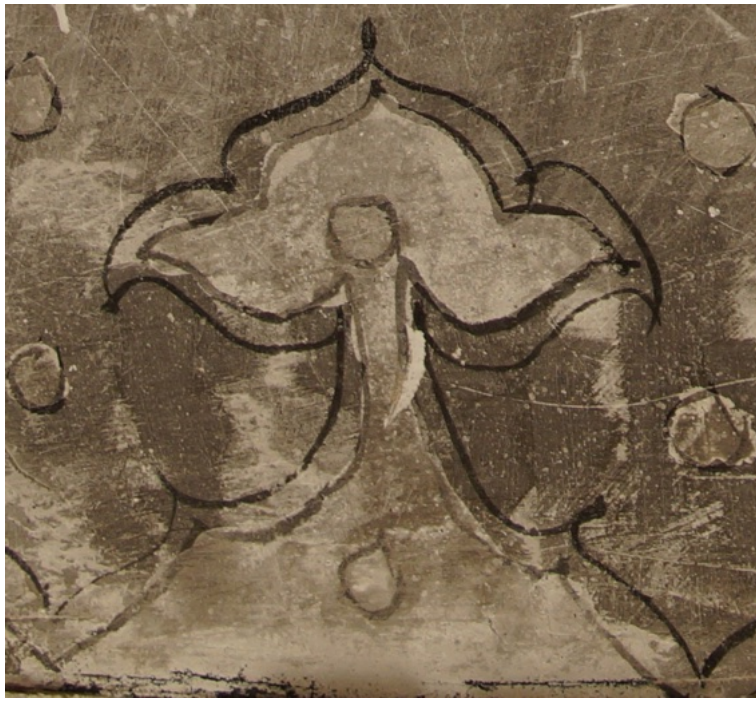
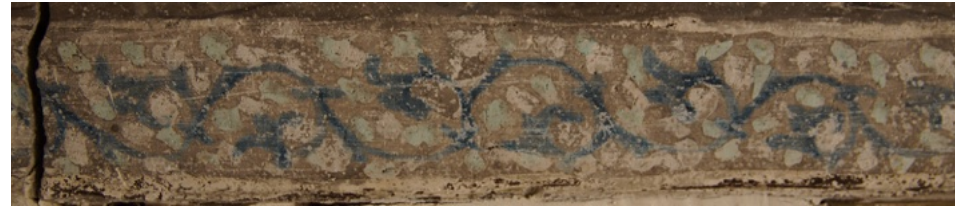
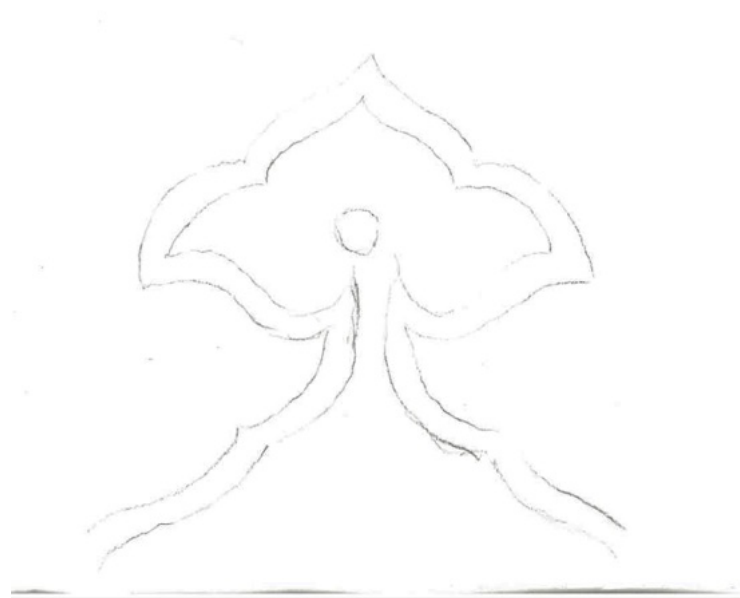
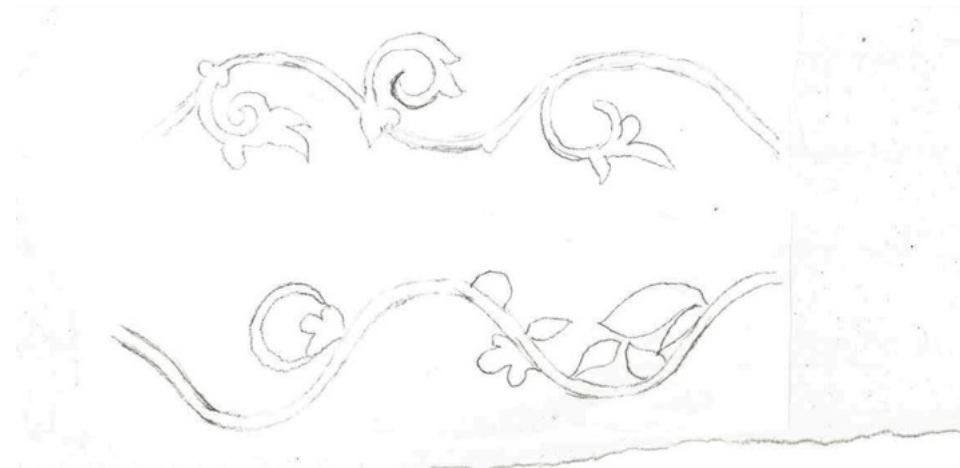
Photo- documen- tation

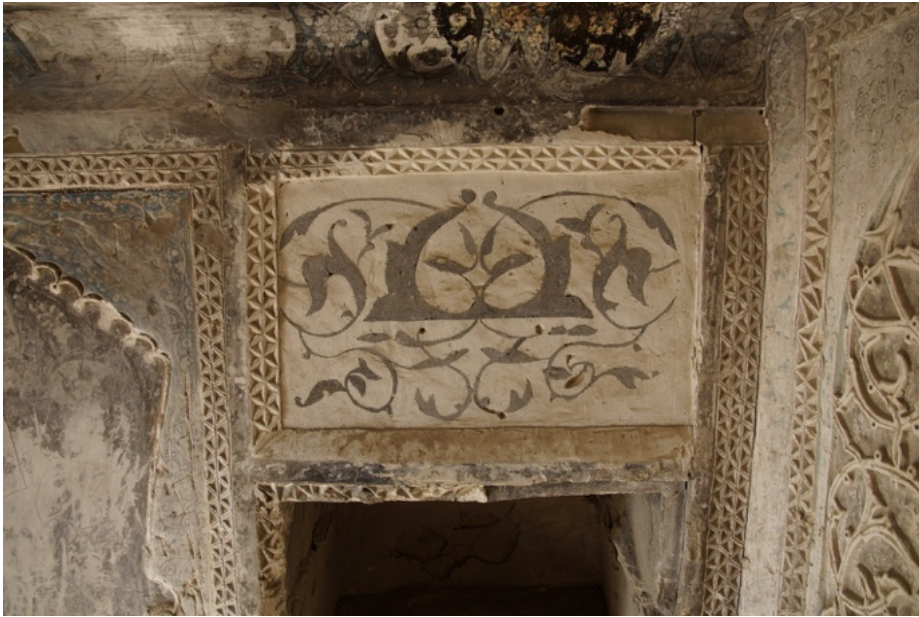
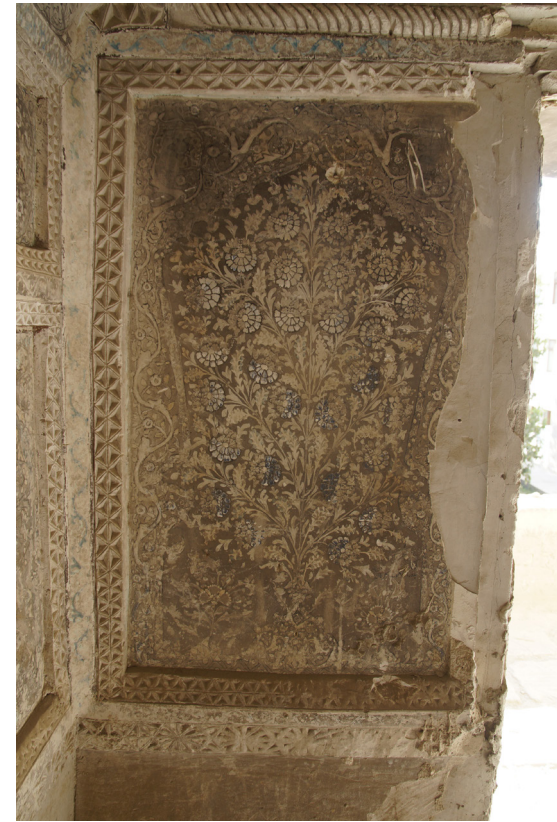
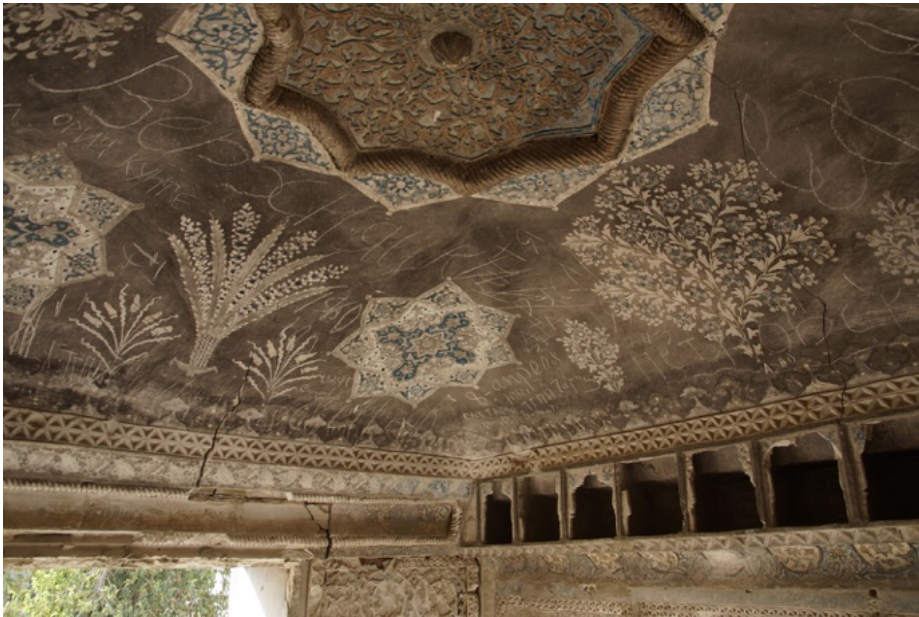
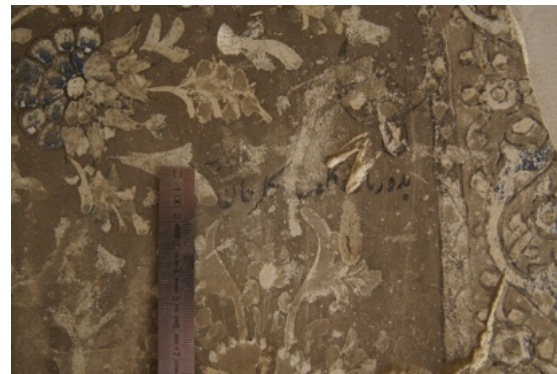
kyrma above the hearth, mural with lettering and ceiling painting with stucco mouldings in the wall transition and centre

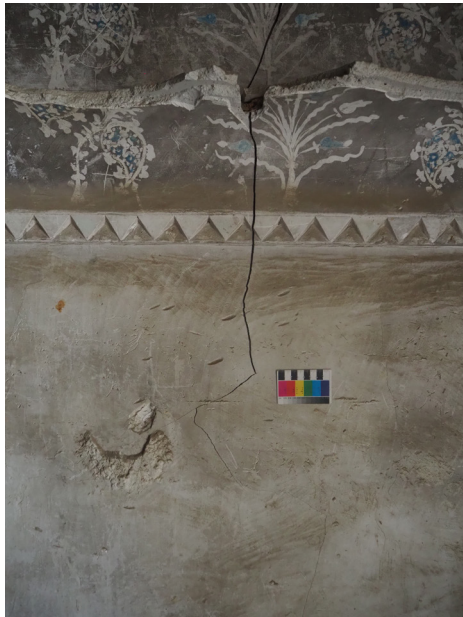
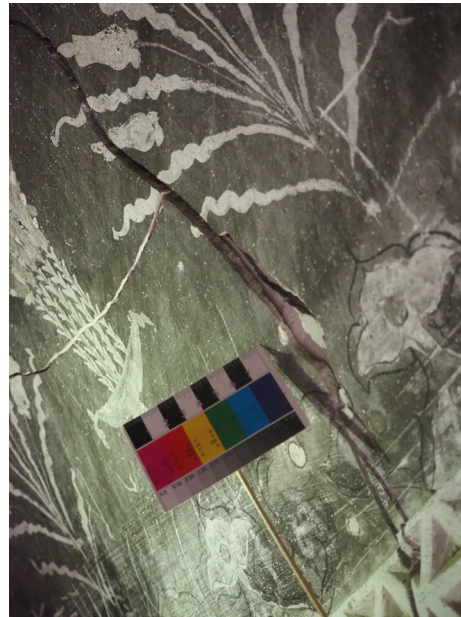
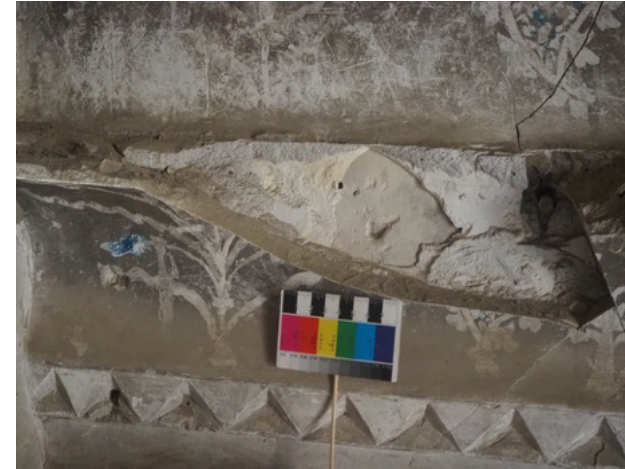
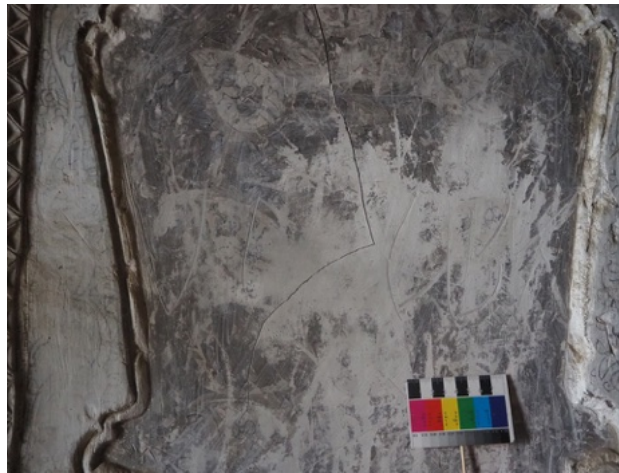
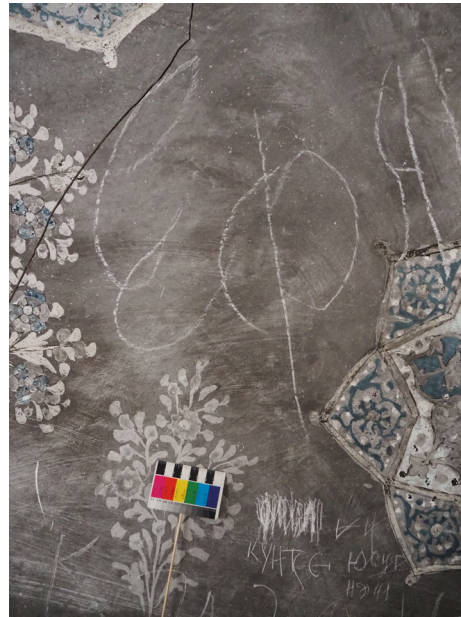
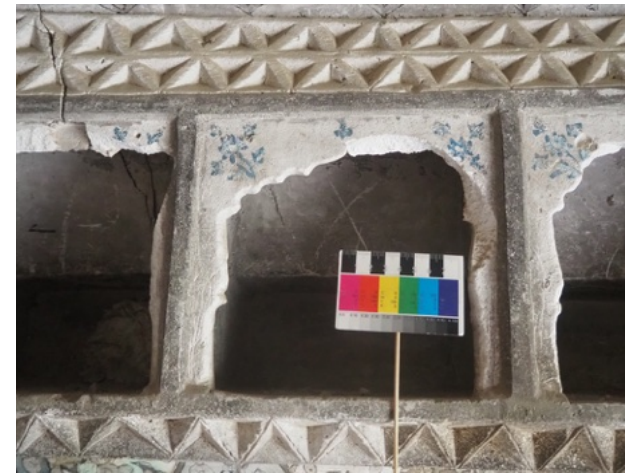
Close-up of individual damage patterns

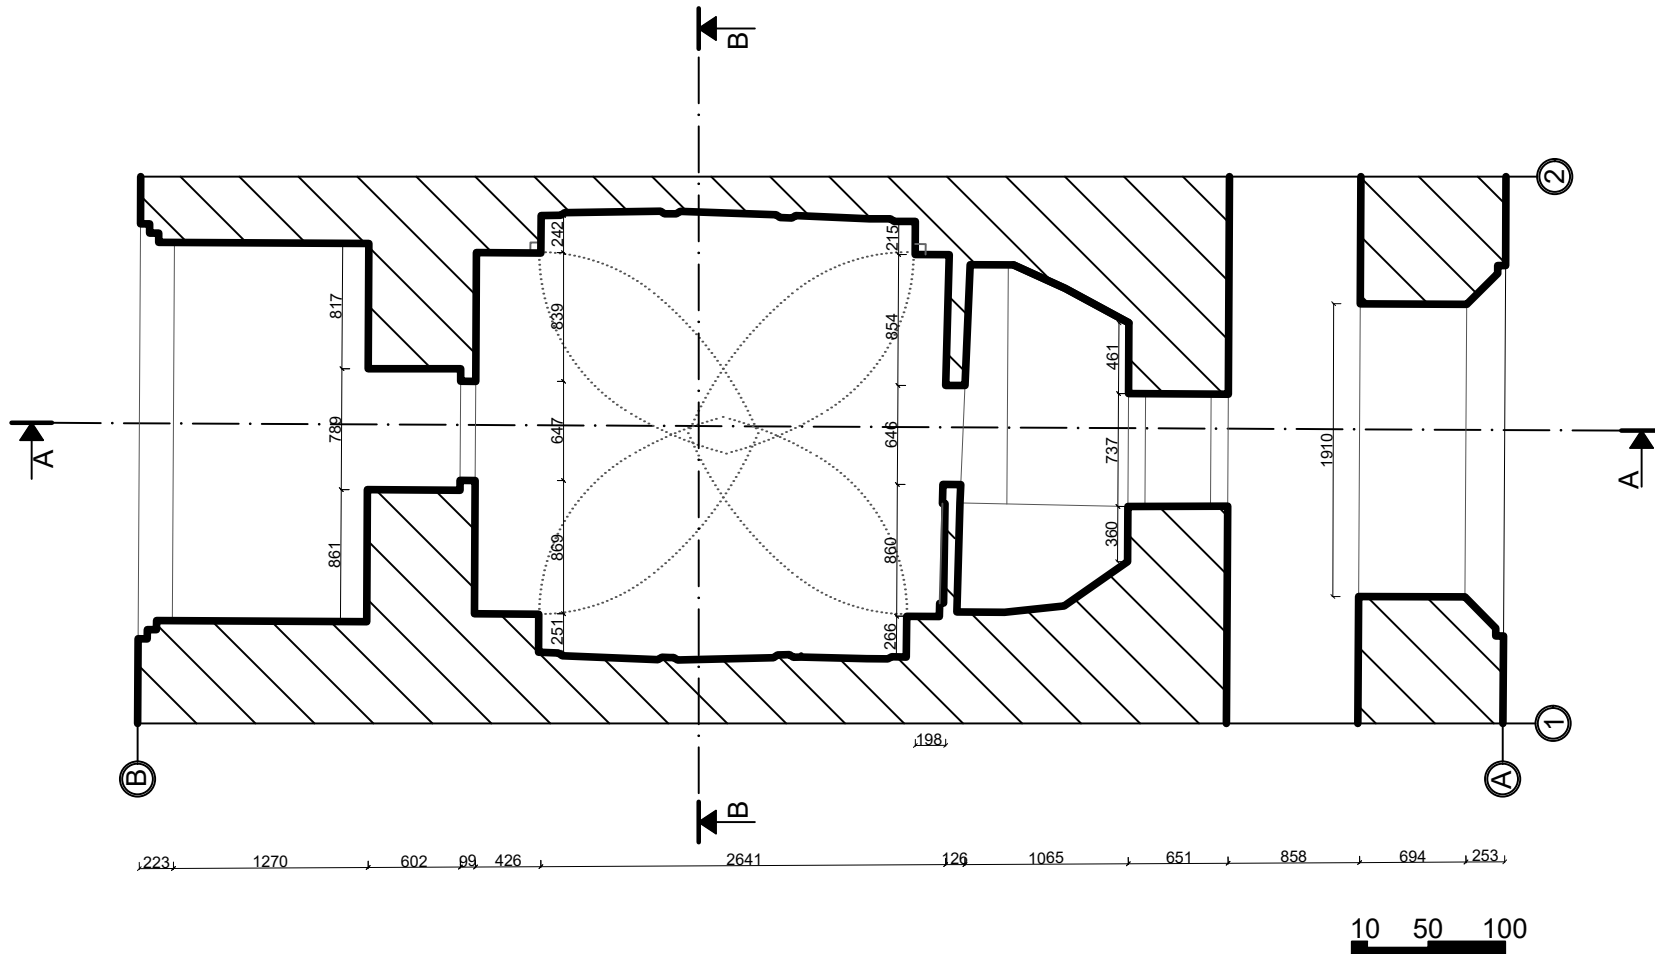
Aside of the floor plan, the documentation includes two sections which give an impression of the shape of the ceiling of the room. The main room is covered by a cupola on pendentives and is visible due to the loss of the intermediated level which once was located at a height of 3,00 m. The entrance room is topped by a semi cupola, which connects to the cupola of the main room.
