DOCUMENTATION

Summer School 2022 | Kukaldosh Madrasah Bukhara Uzbekistan

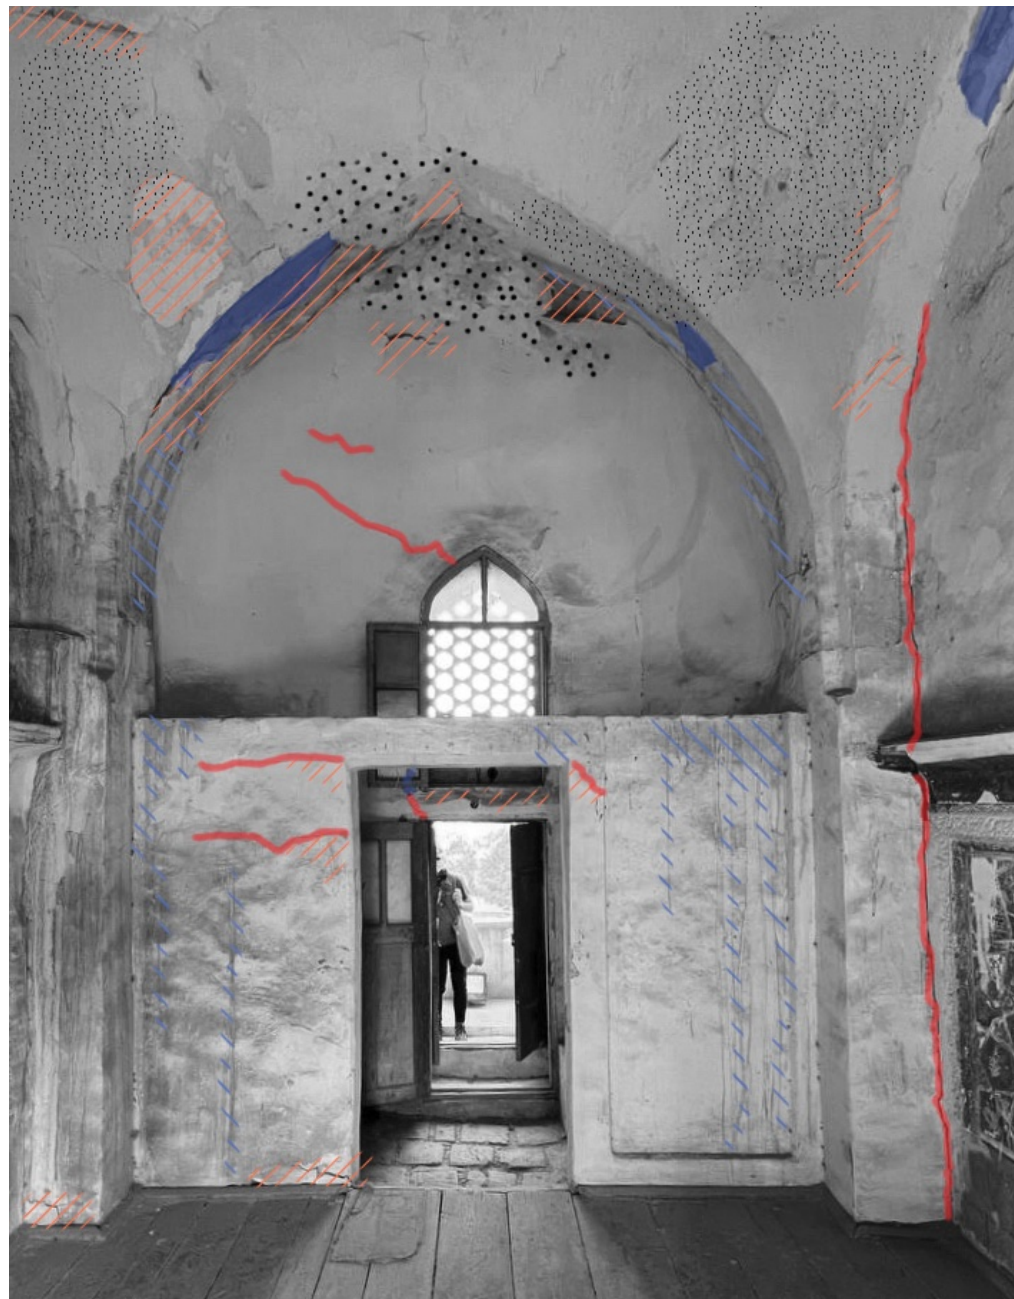
Altogether the room is in a bad condition and deterioration and damages are found in every part of the room with an exception of the floor which is mostly intact.

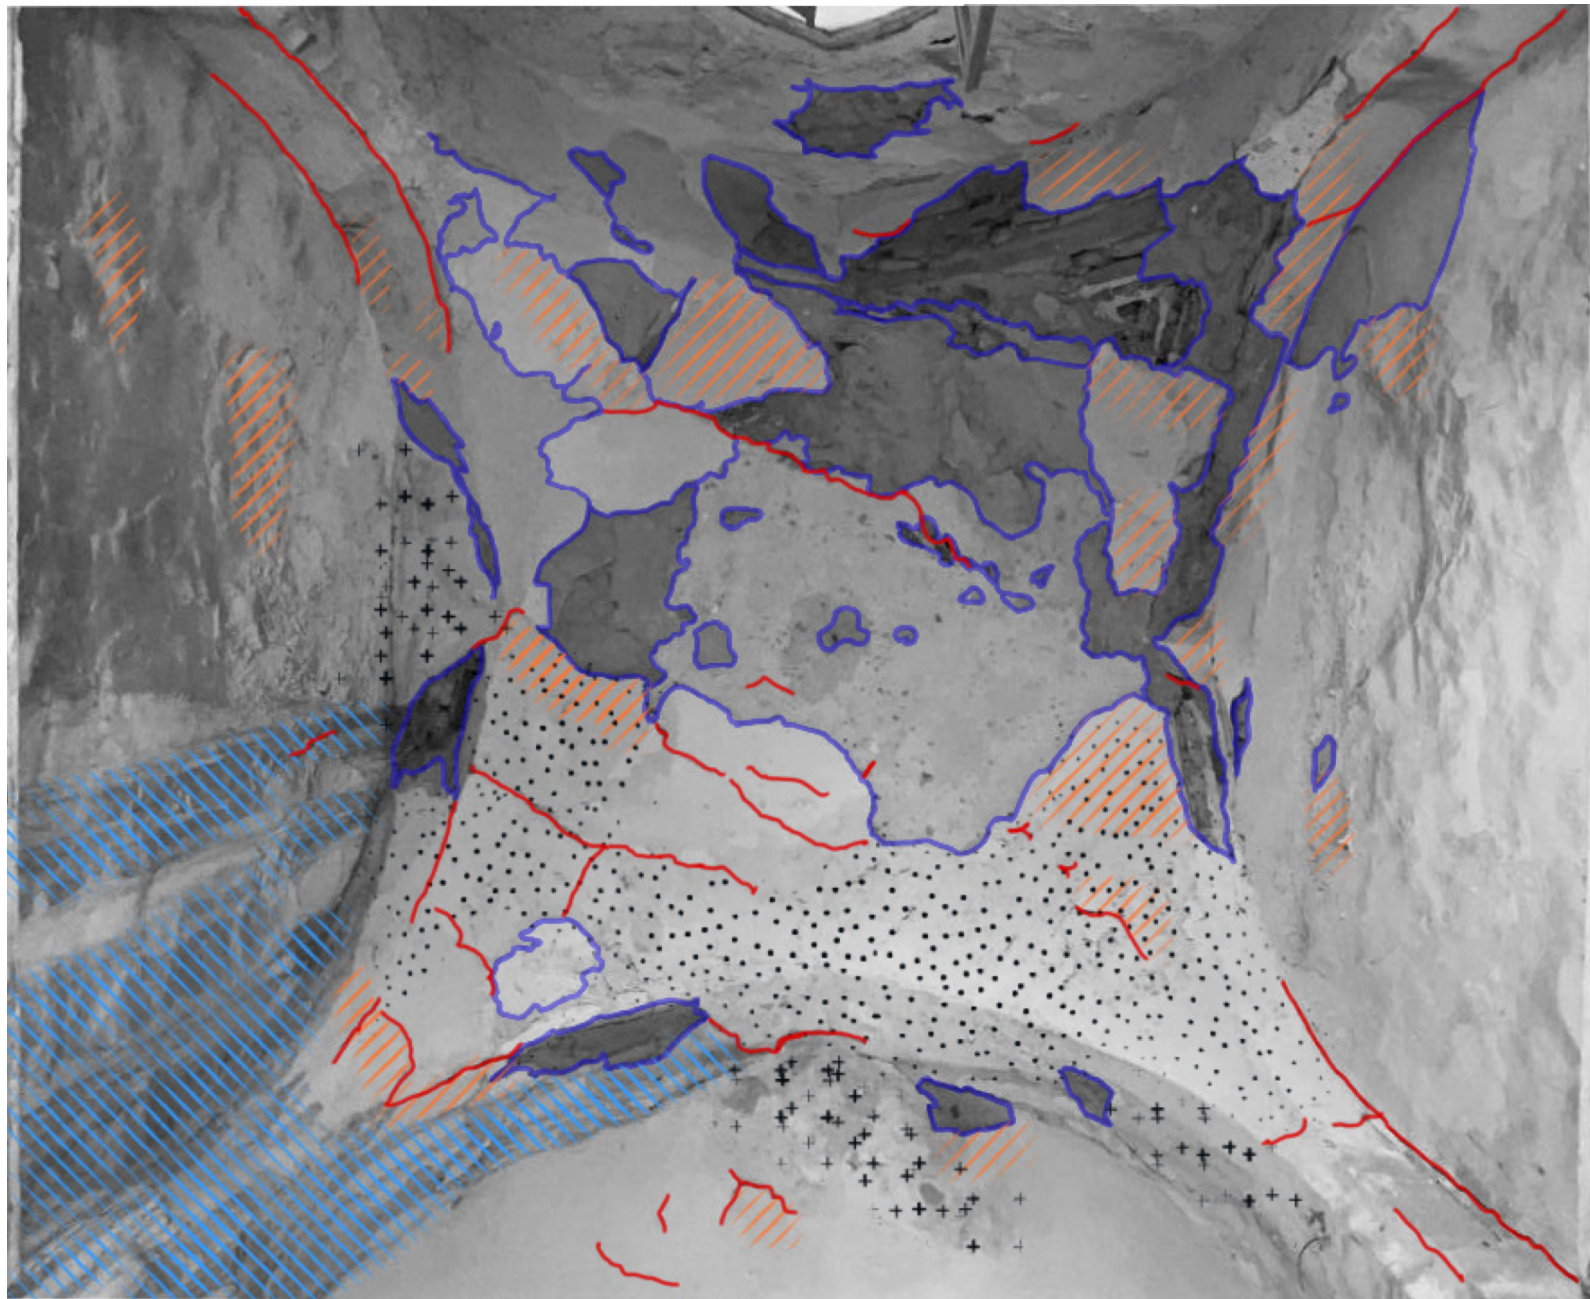
- Legend of damages:
- Lacuna/ Missing parts
 - Loss of paint layer
 - Crumbling
 - Peeling
 - Crack
 - Scaling
 - Salt
 - Biological growth
 - Corrosion
 - Burrow
 - Water traces

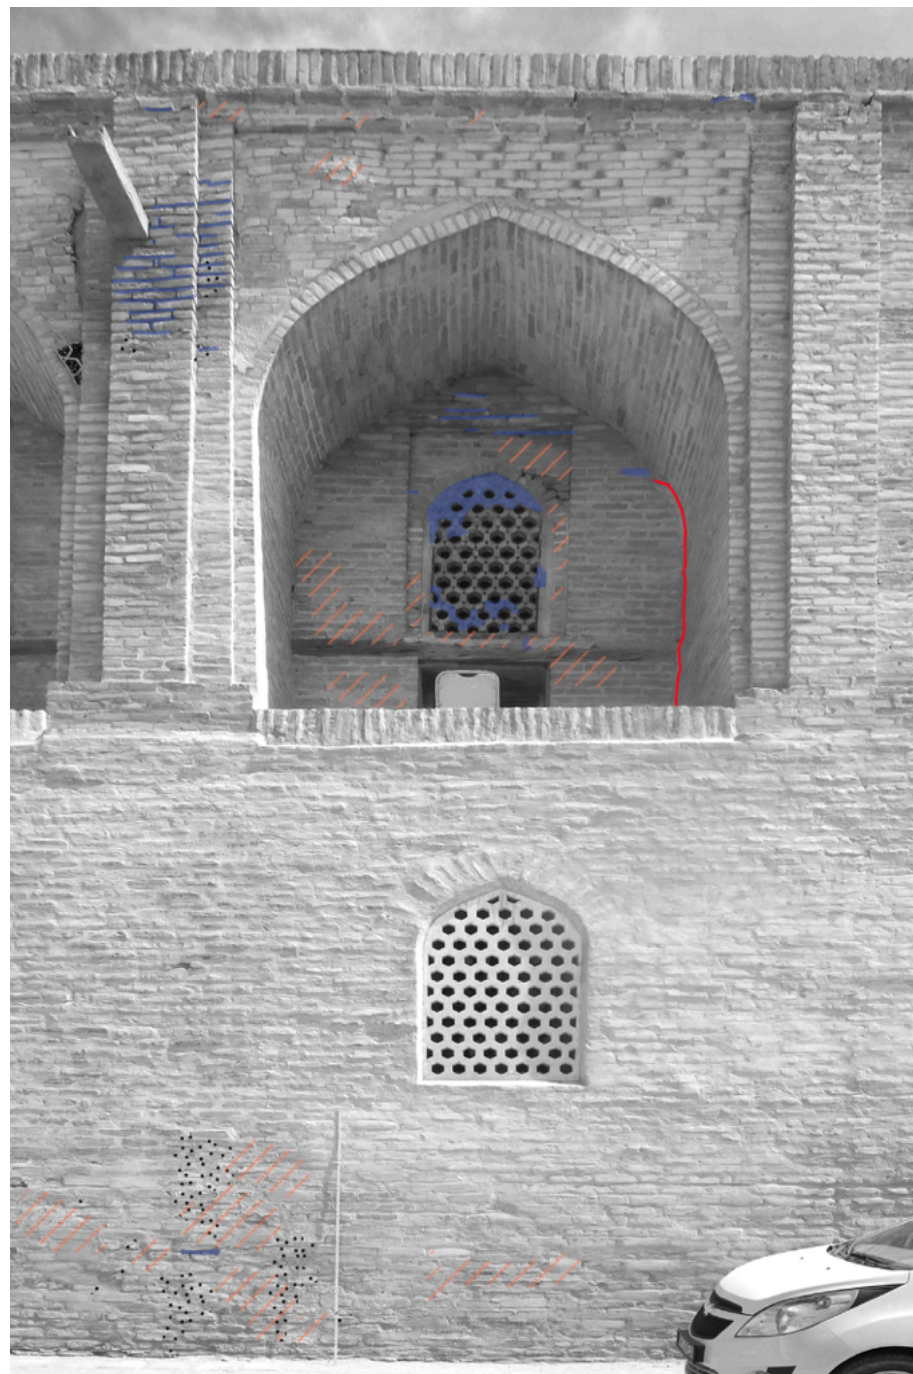
- Legend of damages:
- Lacuna/ Missing parts
 - Loss of paint layer
 - Crumbling
 - Peeling
 - Crack
 - Scaling
 - Salt
 - Biological growth
 - Corrosion
 - Burrow
 - Water traces

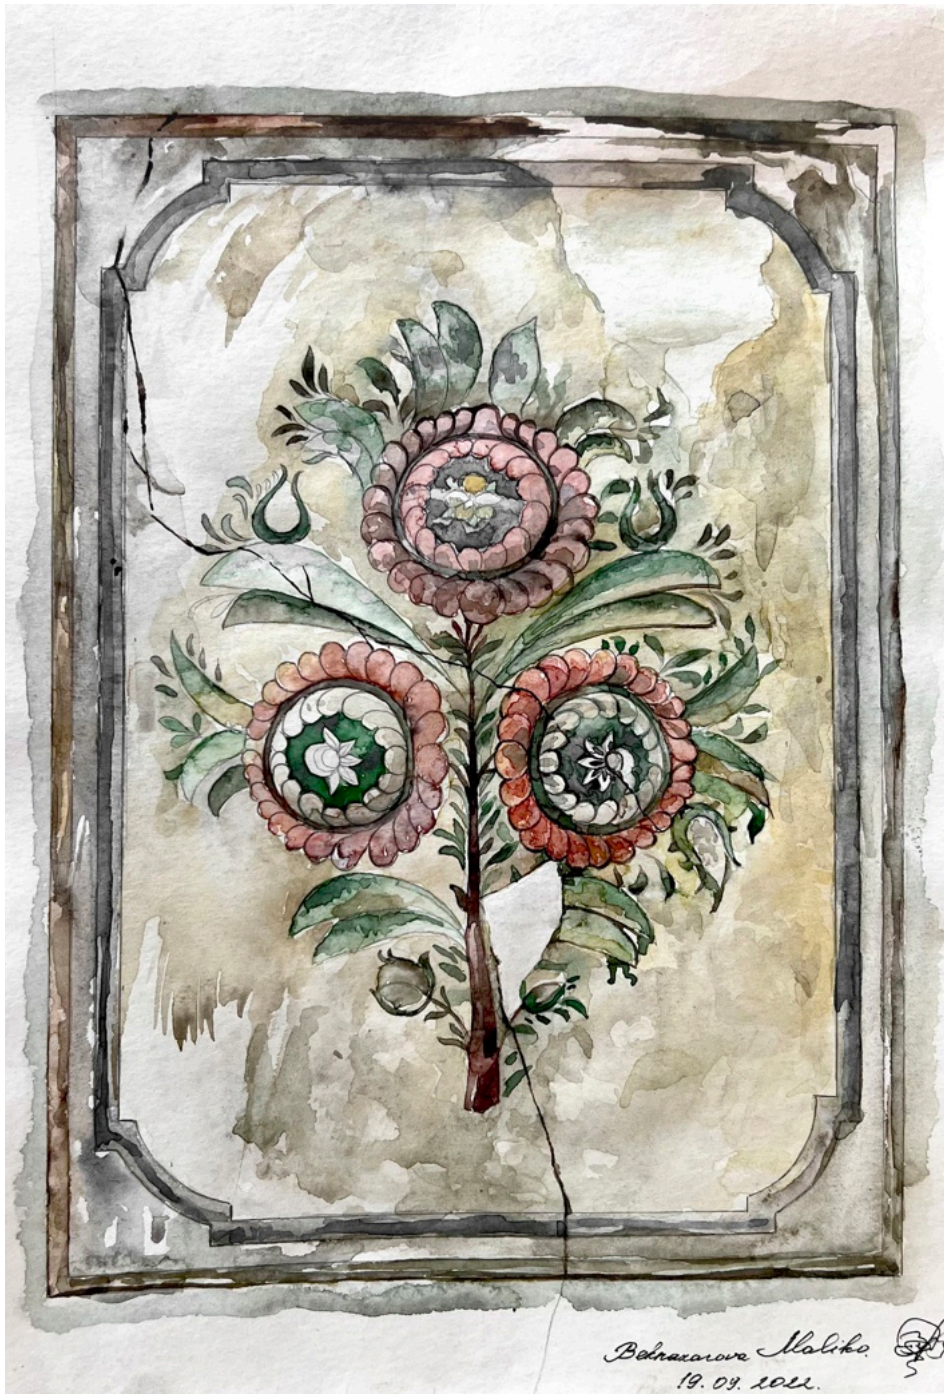
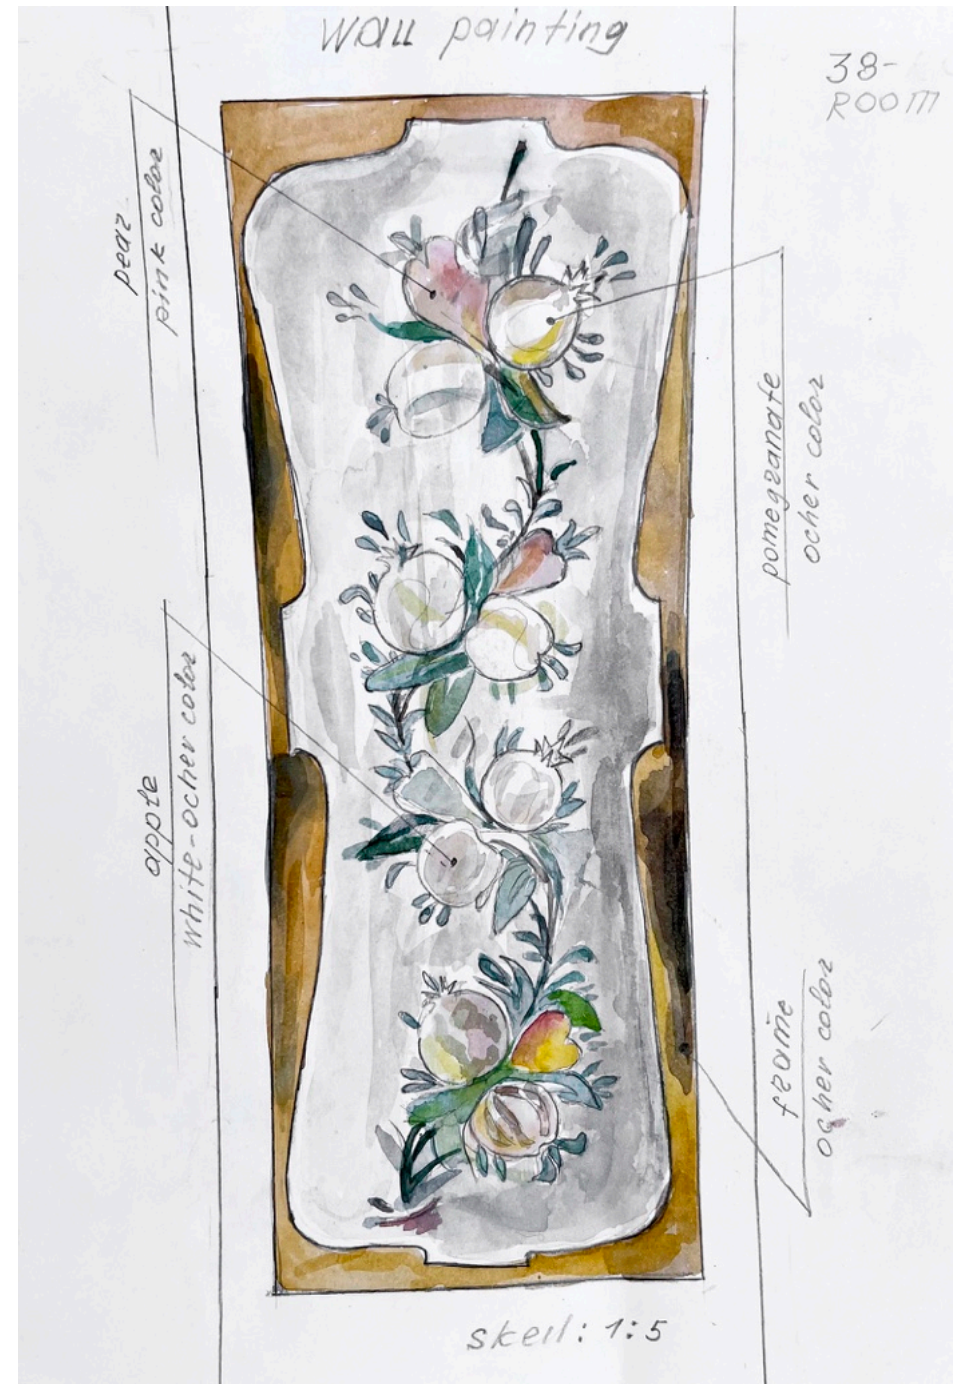
As part of the interdisciplinary work process Dilshoda Sultanova and Malika Beknazarova, a student of Fine Arts at the University in Bukhara, produced a number of paintings from some of the decorative elements that were found on the walls in the main room. To do this, they analysed the paintings and reconstructed selected parts but also gave an artistic impression for the potential color of its design to give a glimpse of a possible display in the future.

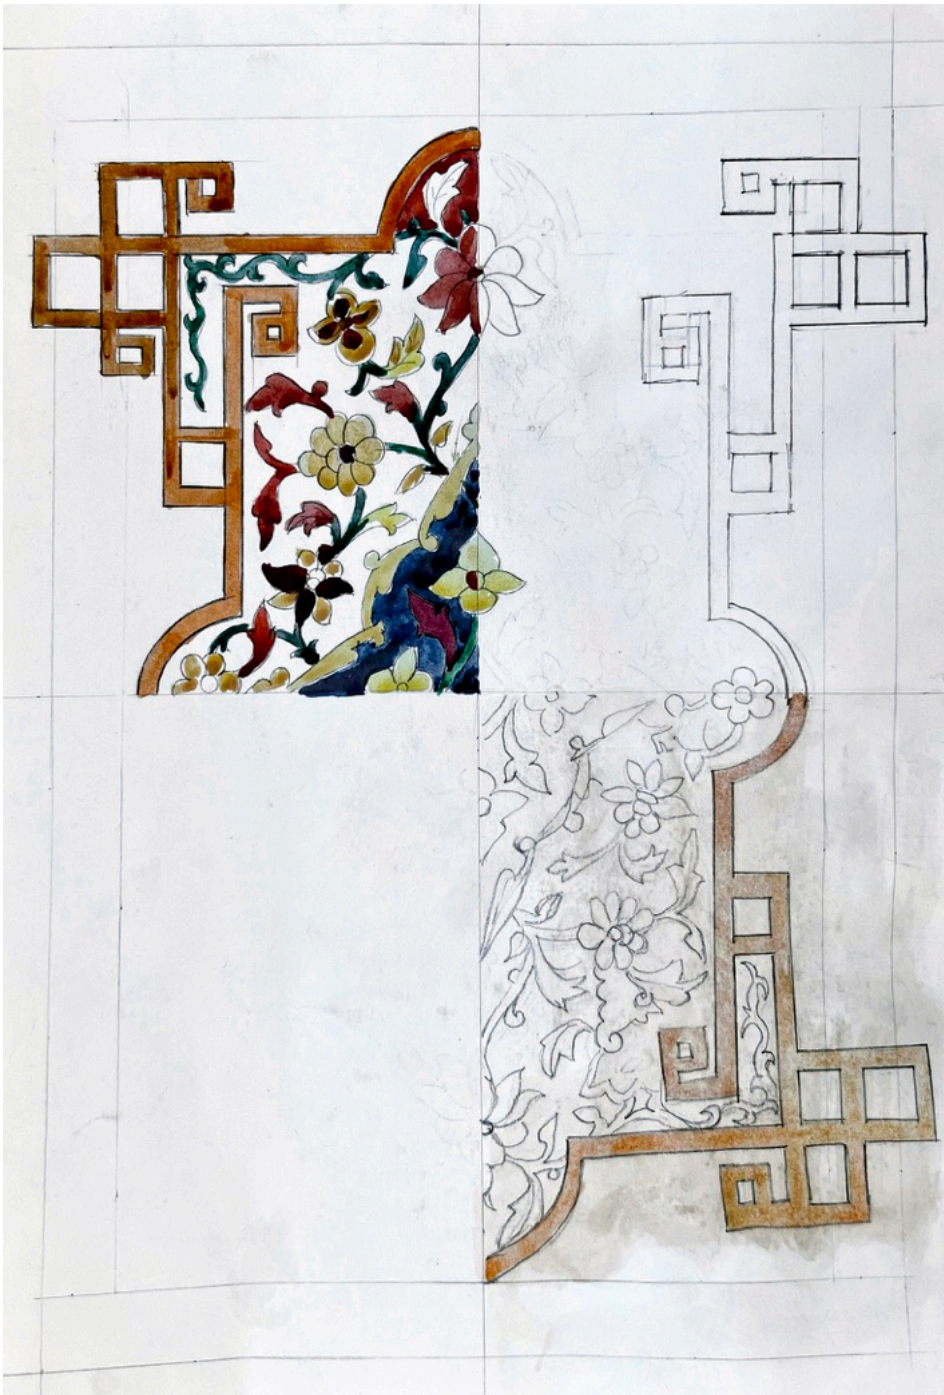
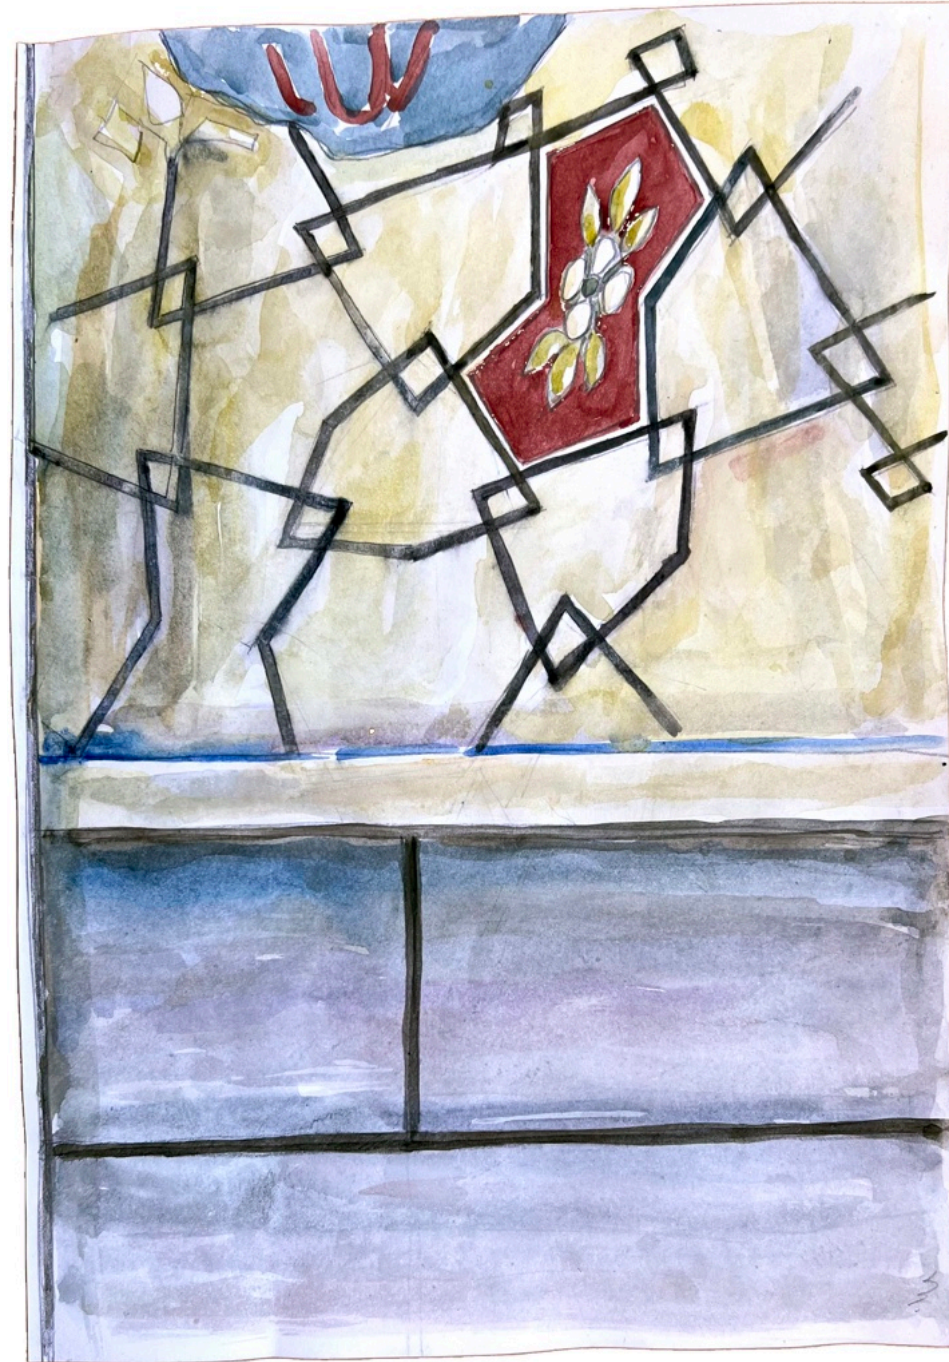
Traffic Light System

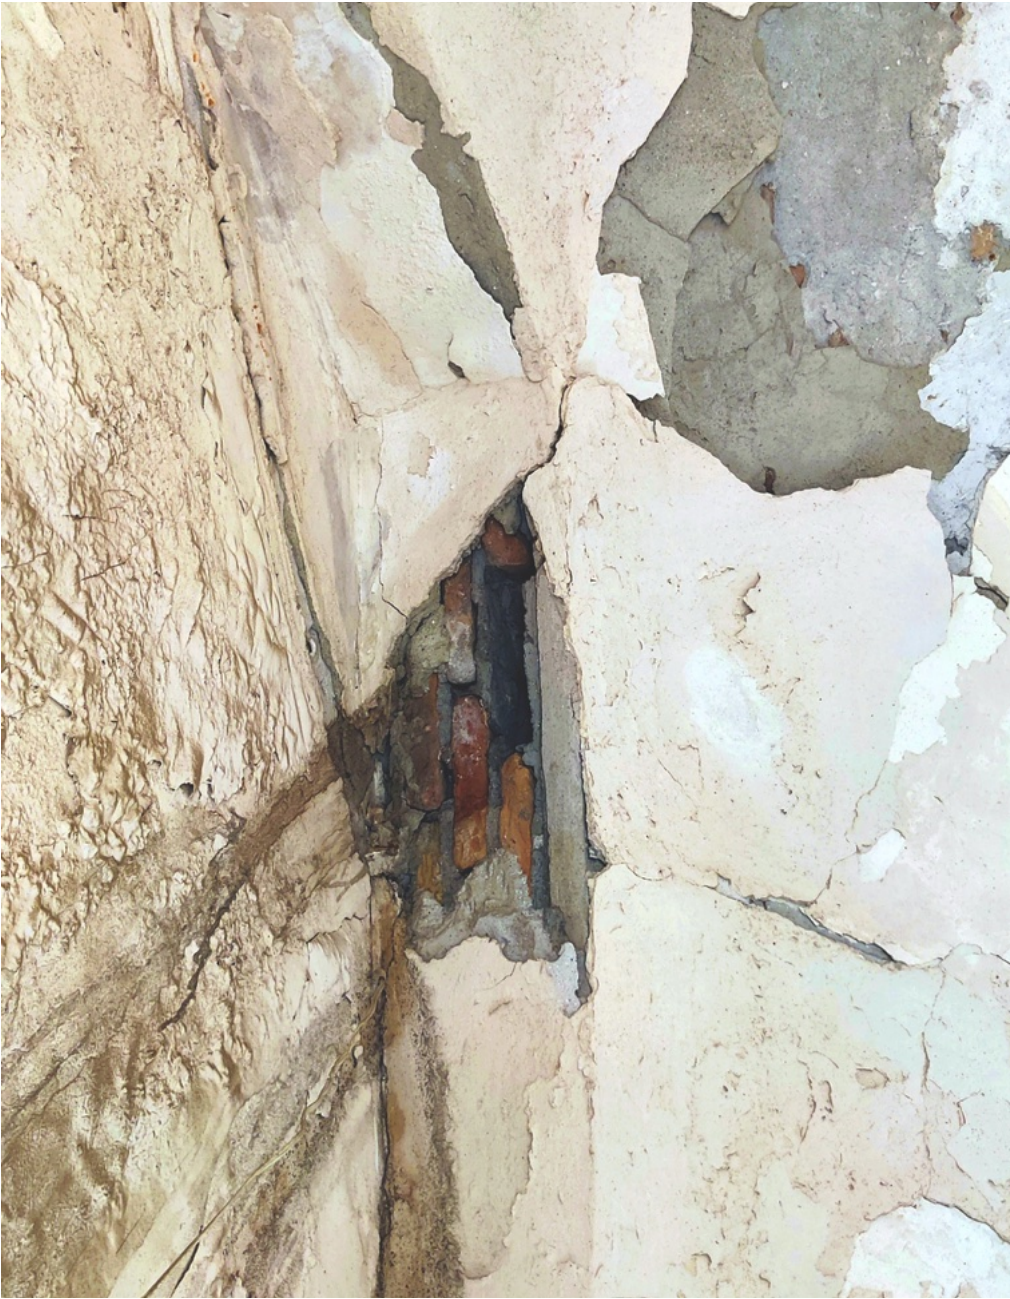
Water intrusion source in in northern corner of the cupola

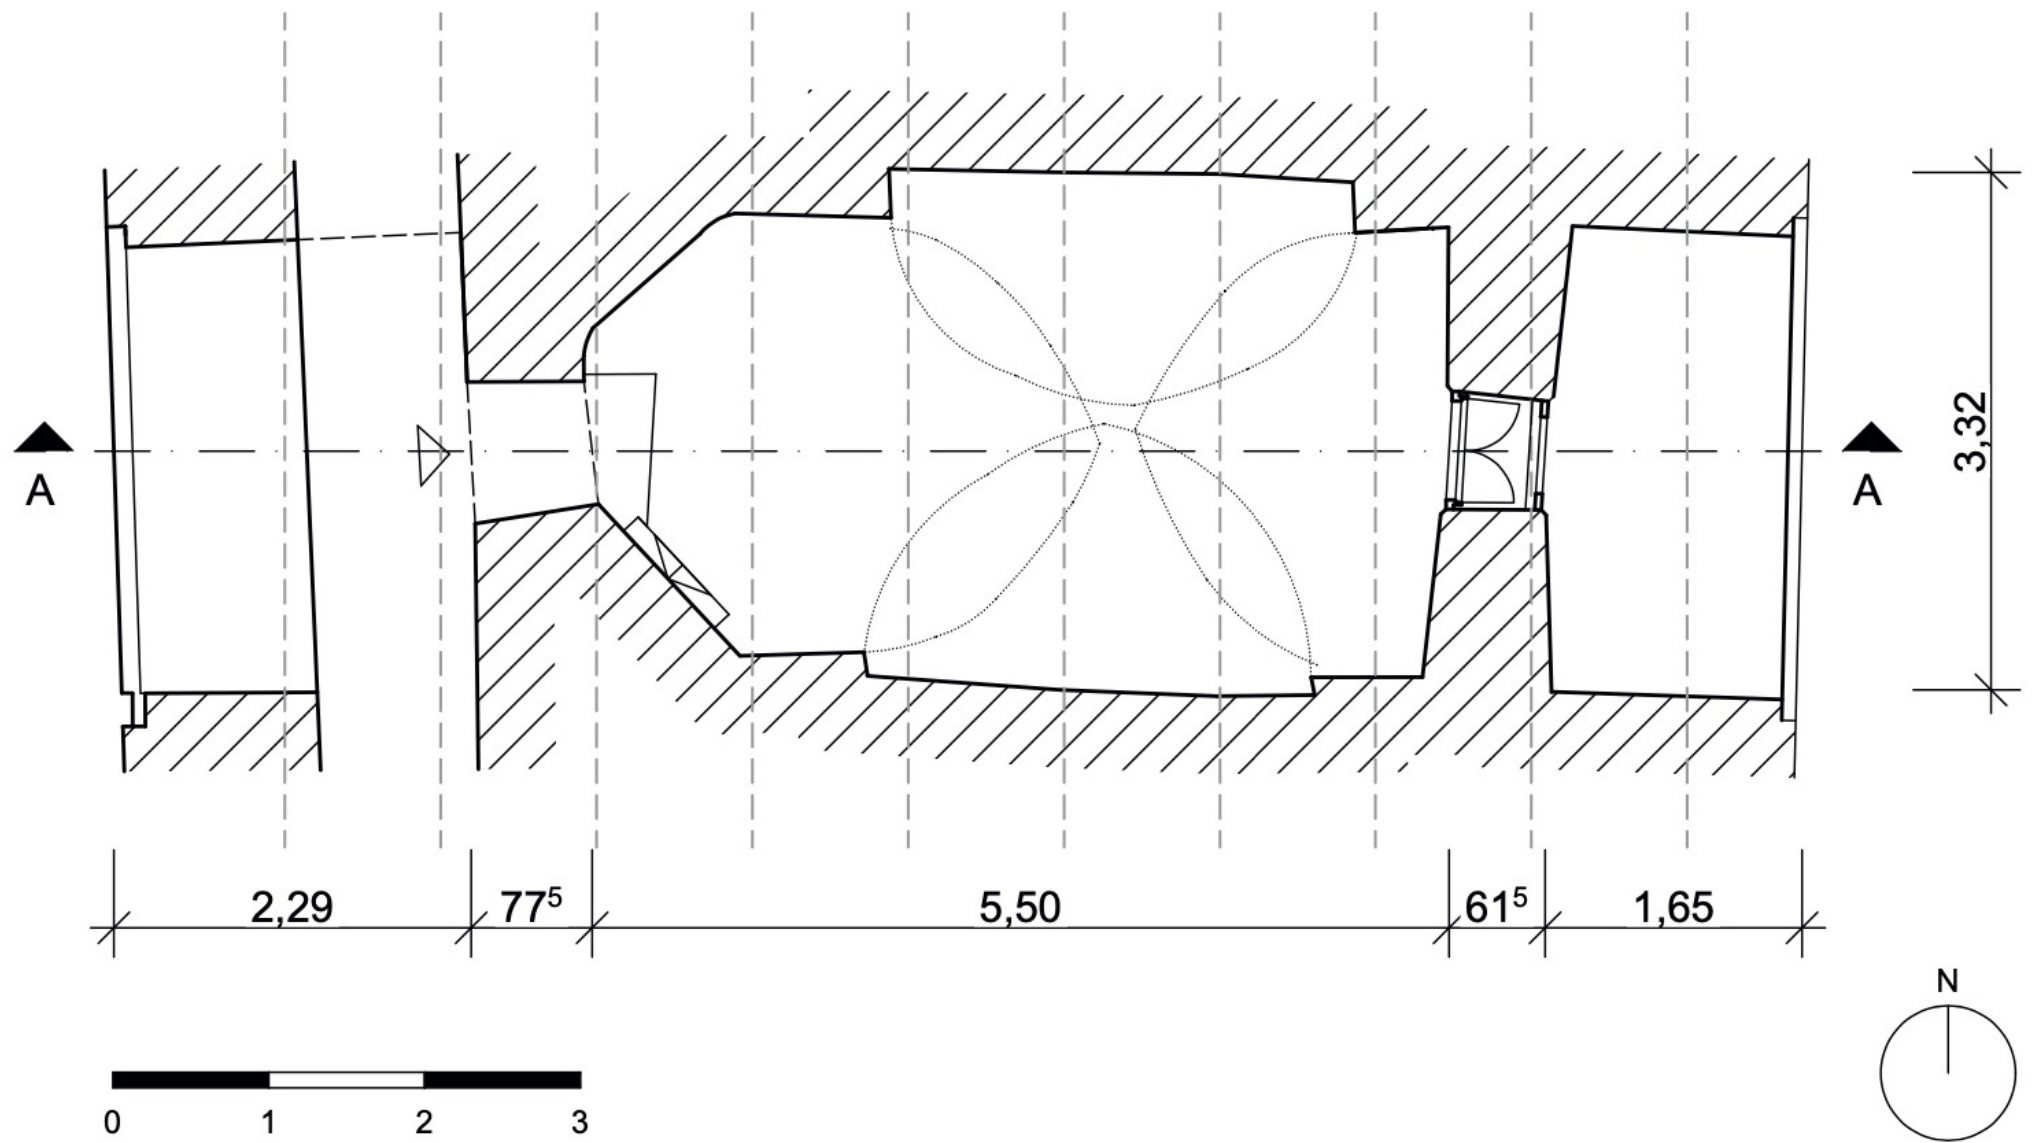
In the following chapter you can find a floor plan and section of room 1 as well as a photographic documentation of the interior and exterior condition of the rooms.

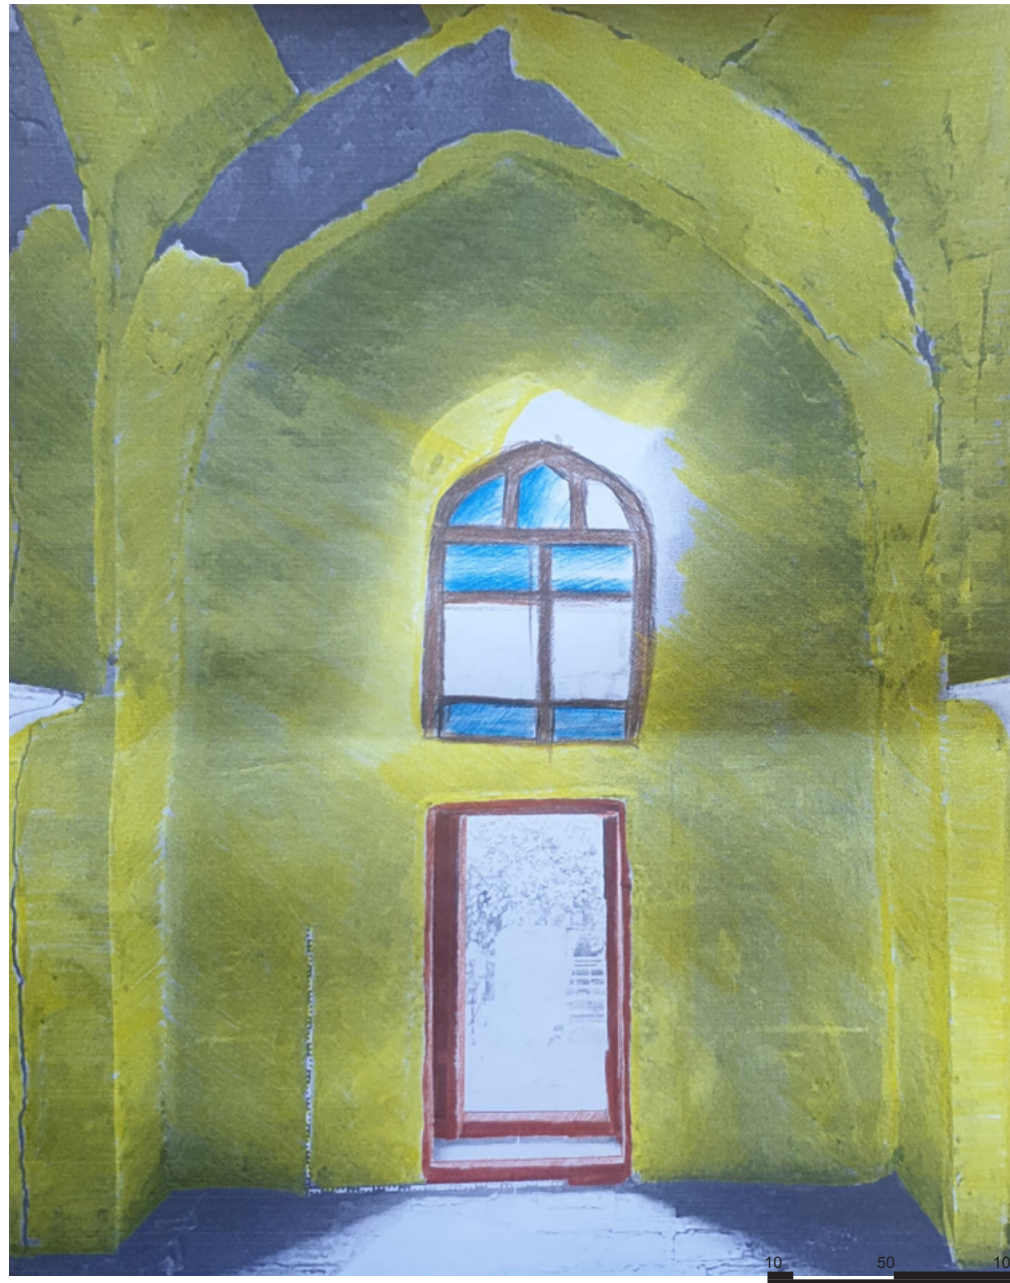
- Legend of materials:
-

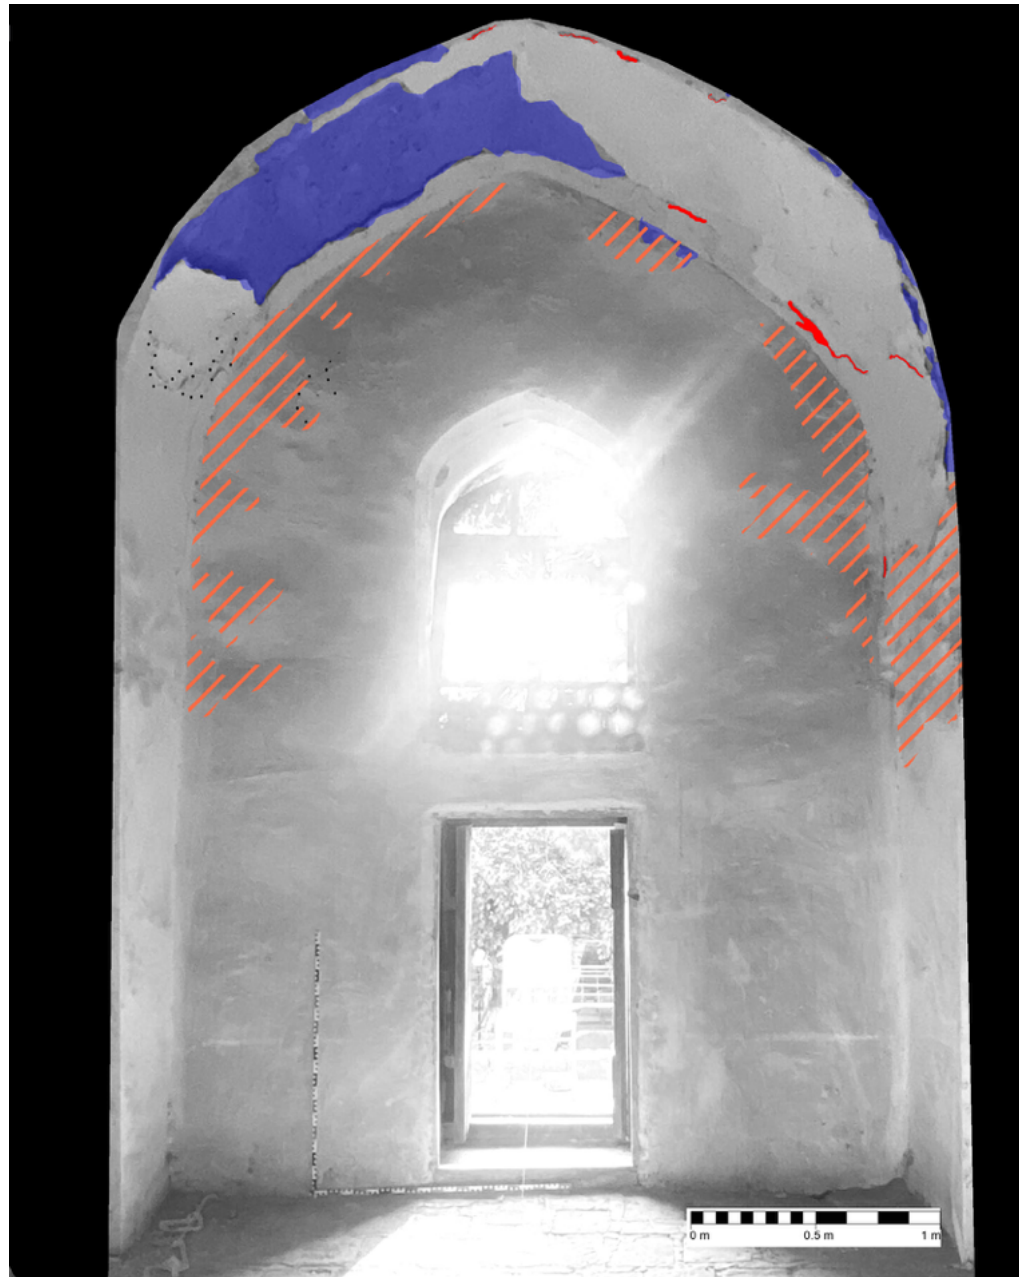
The necessary measures and their prioritisation can be seen in the table and mapping of the traffic light system in the second part of this chapter.

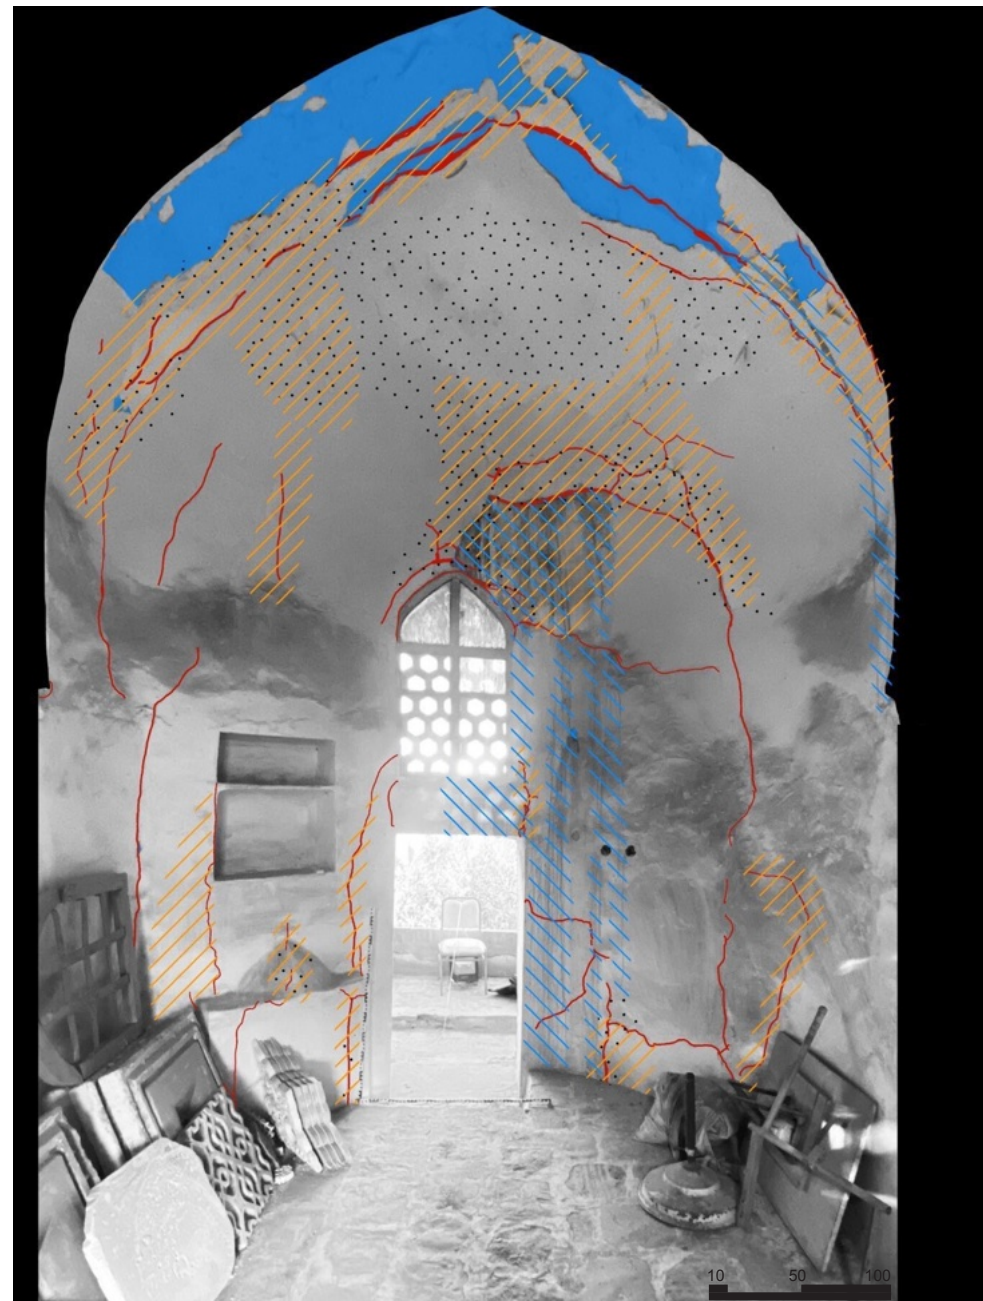
- Legend of damages:
- Lacuna/ Missing parts
 - Loss of paint layer
 - Crumbling
 - Peeling
 - Crack
 - Scaling
 - Salt
 - Biological growth
 - Corrosion
 - Burrow
 - Water traces

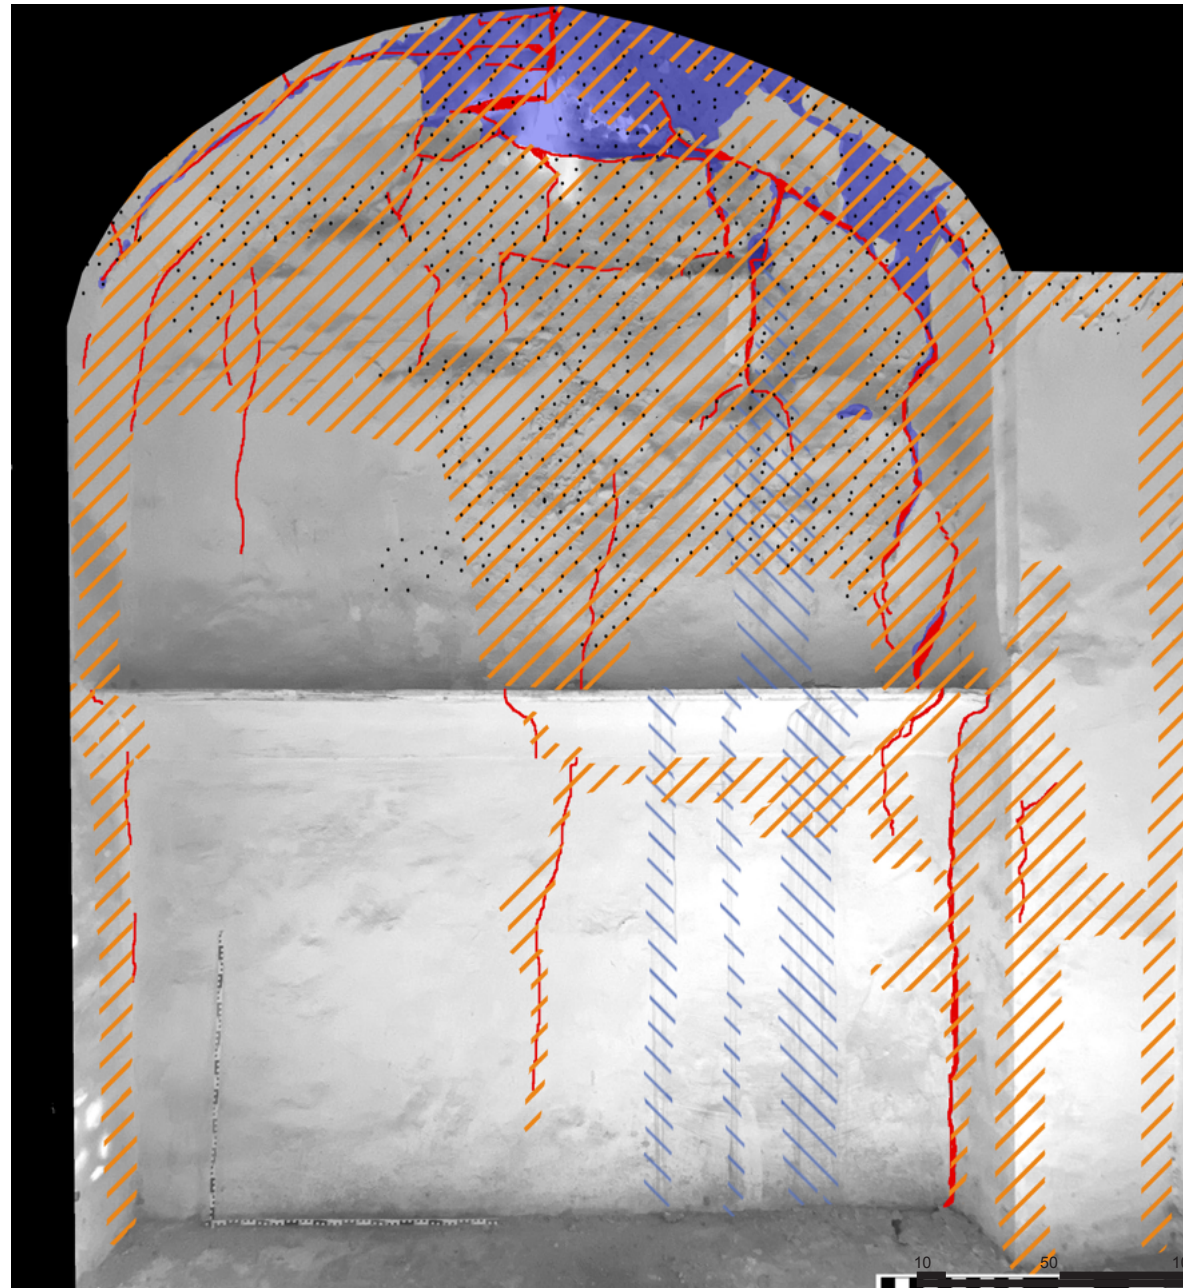
- Legend of damages:
- Lacuna/ Missing parts
 - Loss of paint layer
 - Crumbling
 - Peeling
 - Crack
 - Scaling
 - Salt
 - Biological growth
 - Corrosion
 - Burrow
 - Water traces

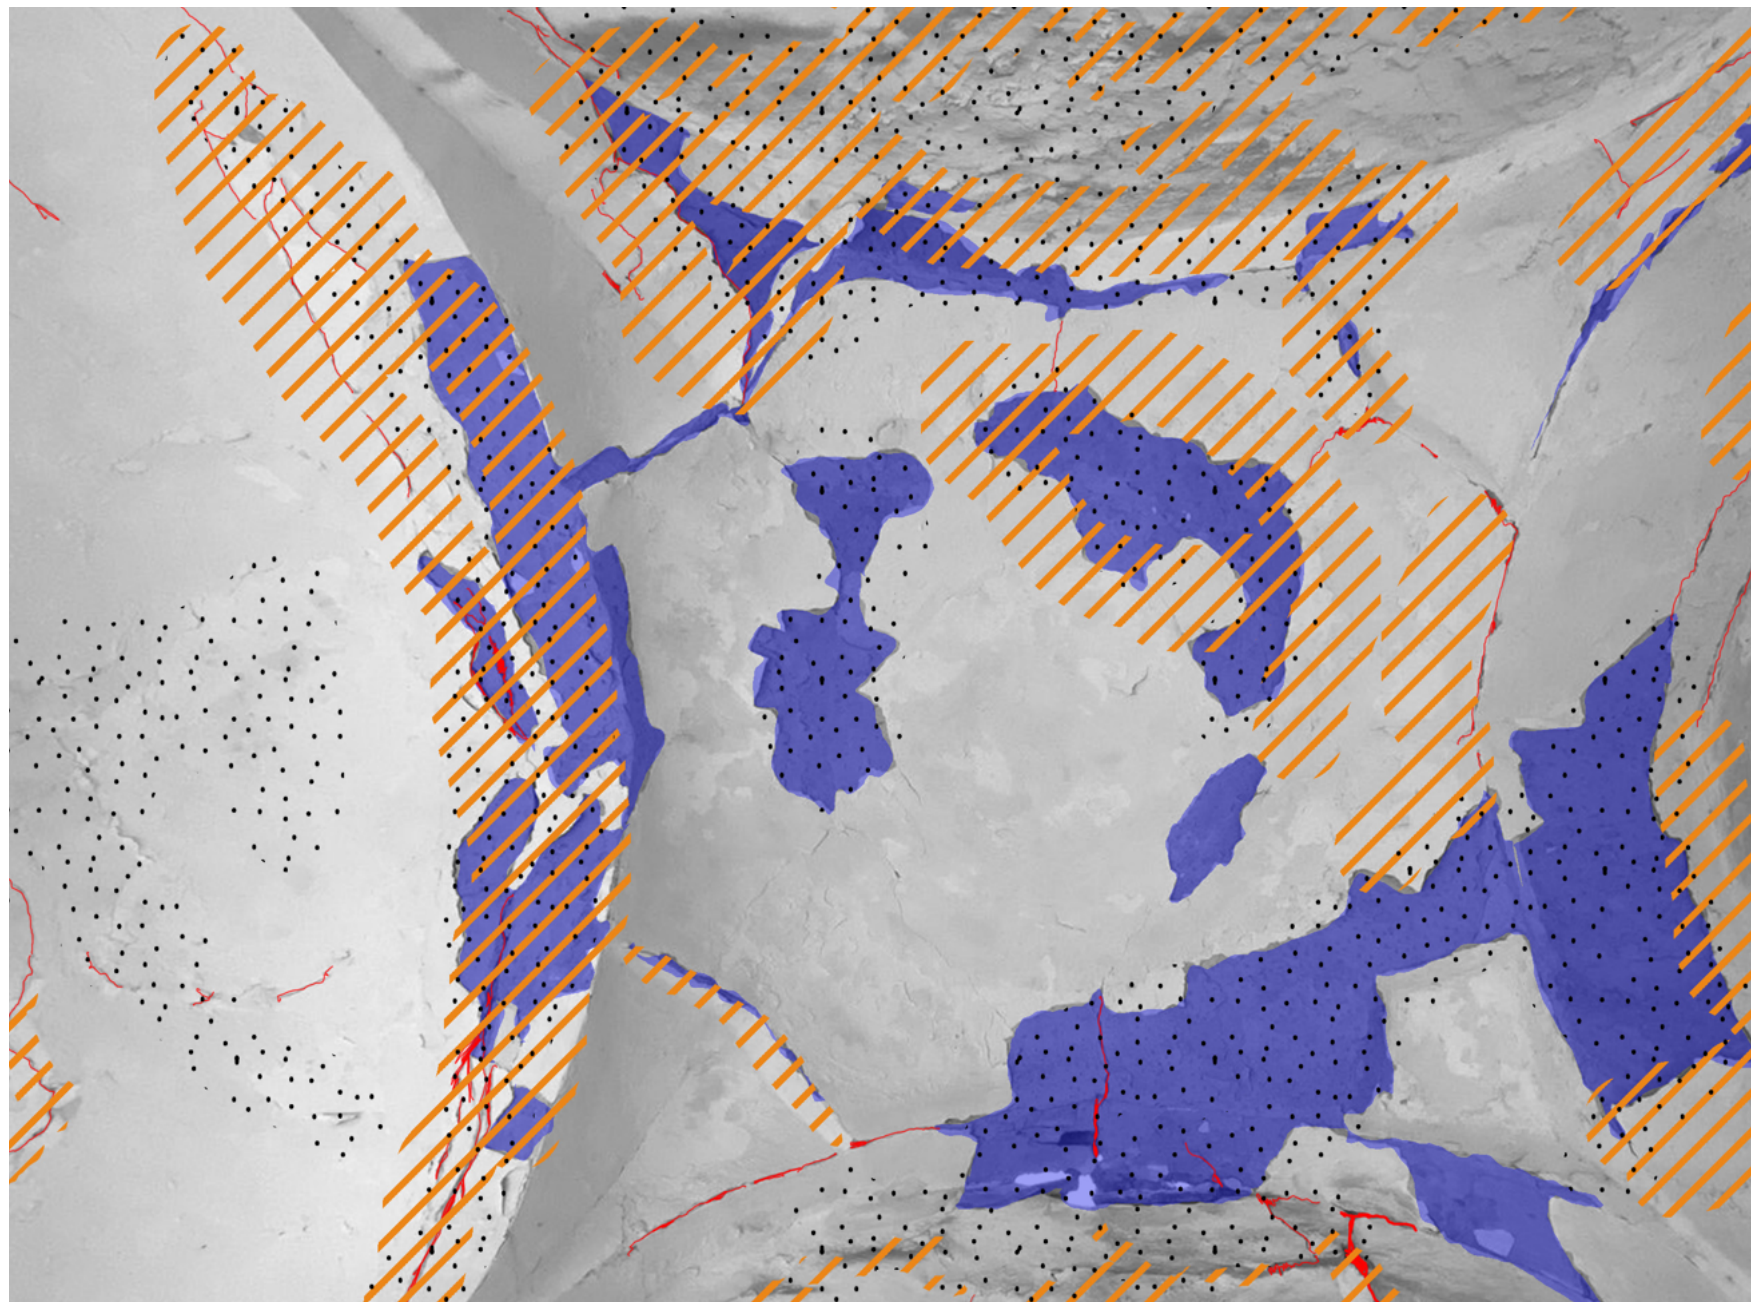
- Legend of damages:
- Lacuna/ Missing parts
 - Loss of paint layer
 - Crumbling
 - Peeling
 - Crack
 - Scaling
 - Salt
 - Biological growth
 - Corrosion
 - Burrow
 - Water traces

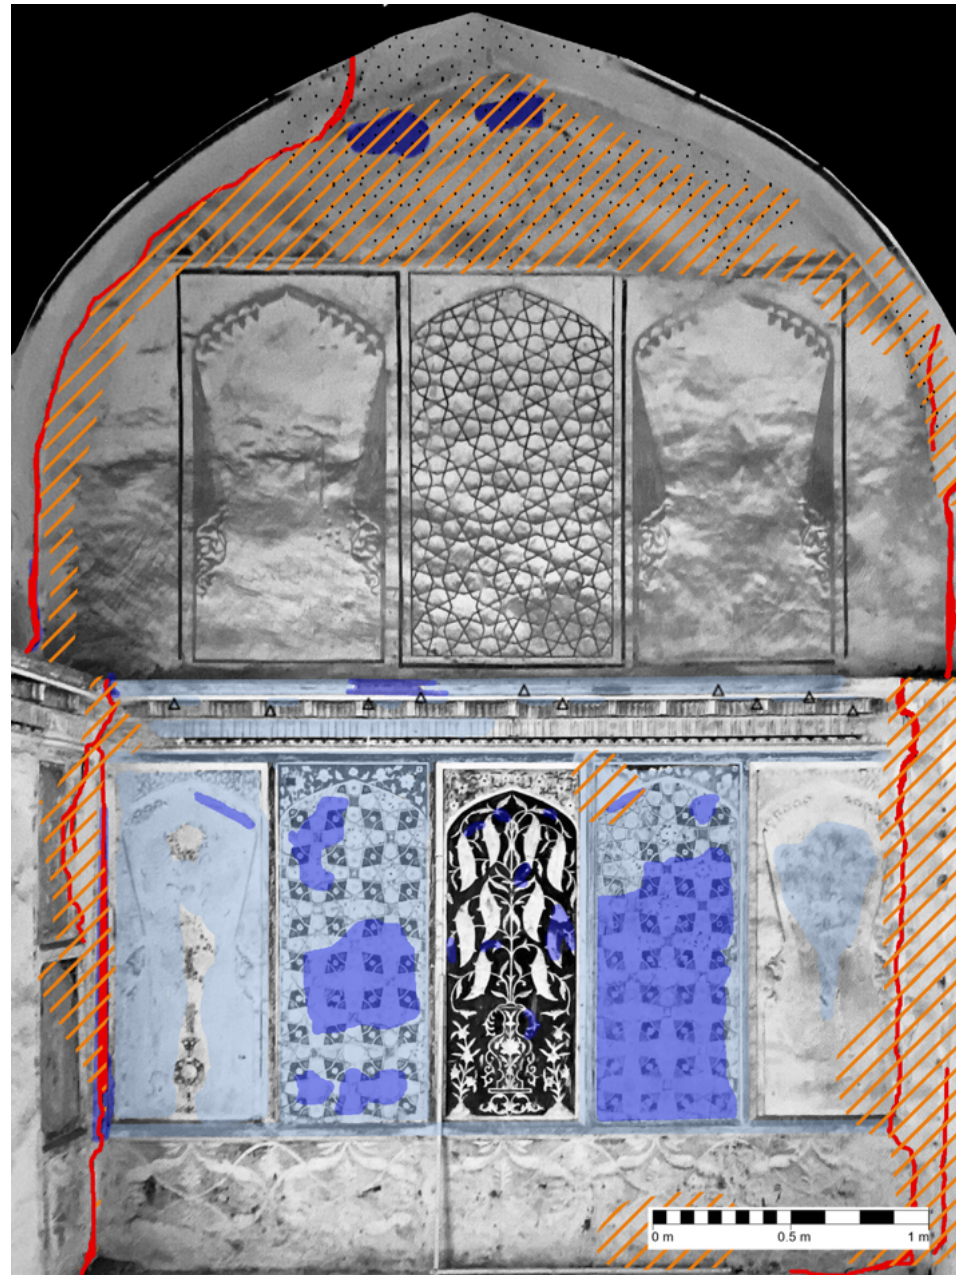
- Legend of damages:
- Lacuna/ Missing parts
 - Loss of paint layer
 - Crumbling
 - Peeling
 - Crack
 - Scaling
 - Salt
 - Biological growth
 - Corrosion
 - Burrow
 - Water traces
