DOCUMENTATION

Summer School 2022 | Kukaldosh Madrasah Bukhara Uzbekistan

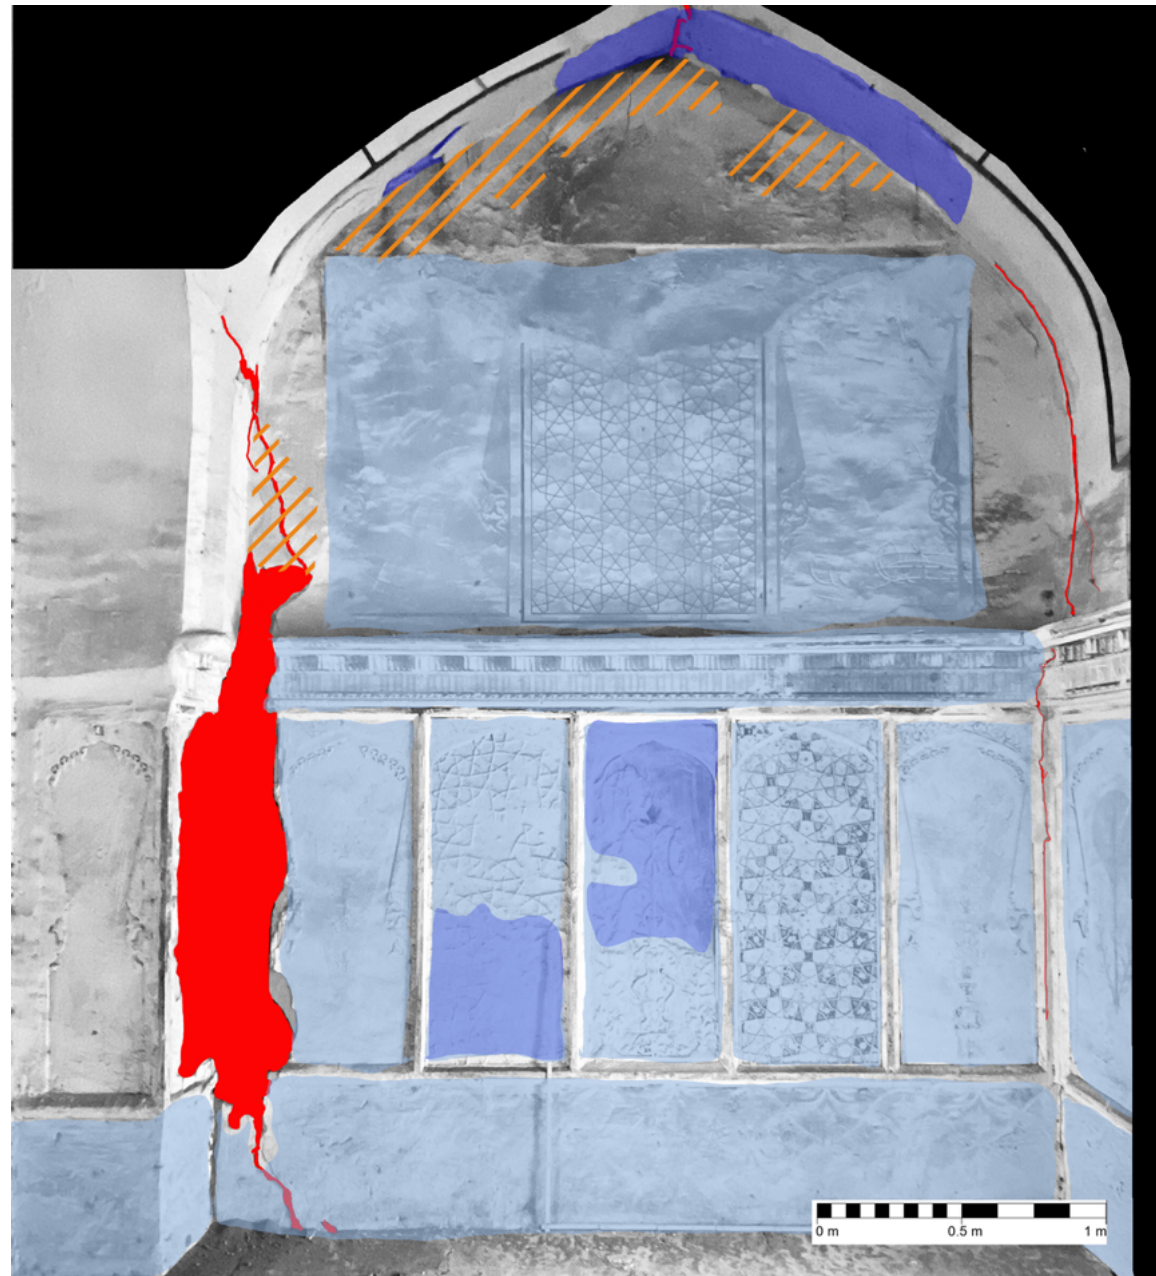
- Legend of damages:
- Lacuna/ Missing parts
 - Loss of paint layer
 - Crumbling
 - Peeling
 - Crack
 - Scaling
 - Salt
 - Biological growth
 - Corrosion
 - Burrow
 - Water traces

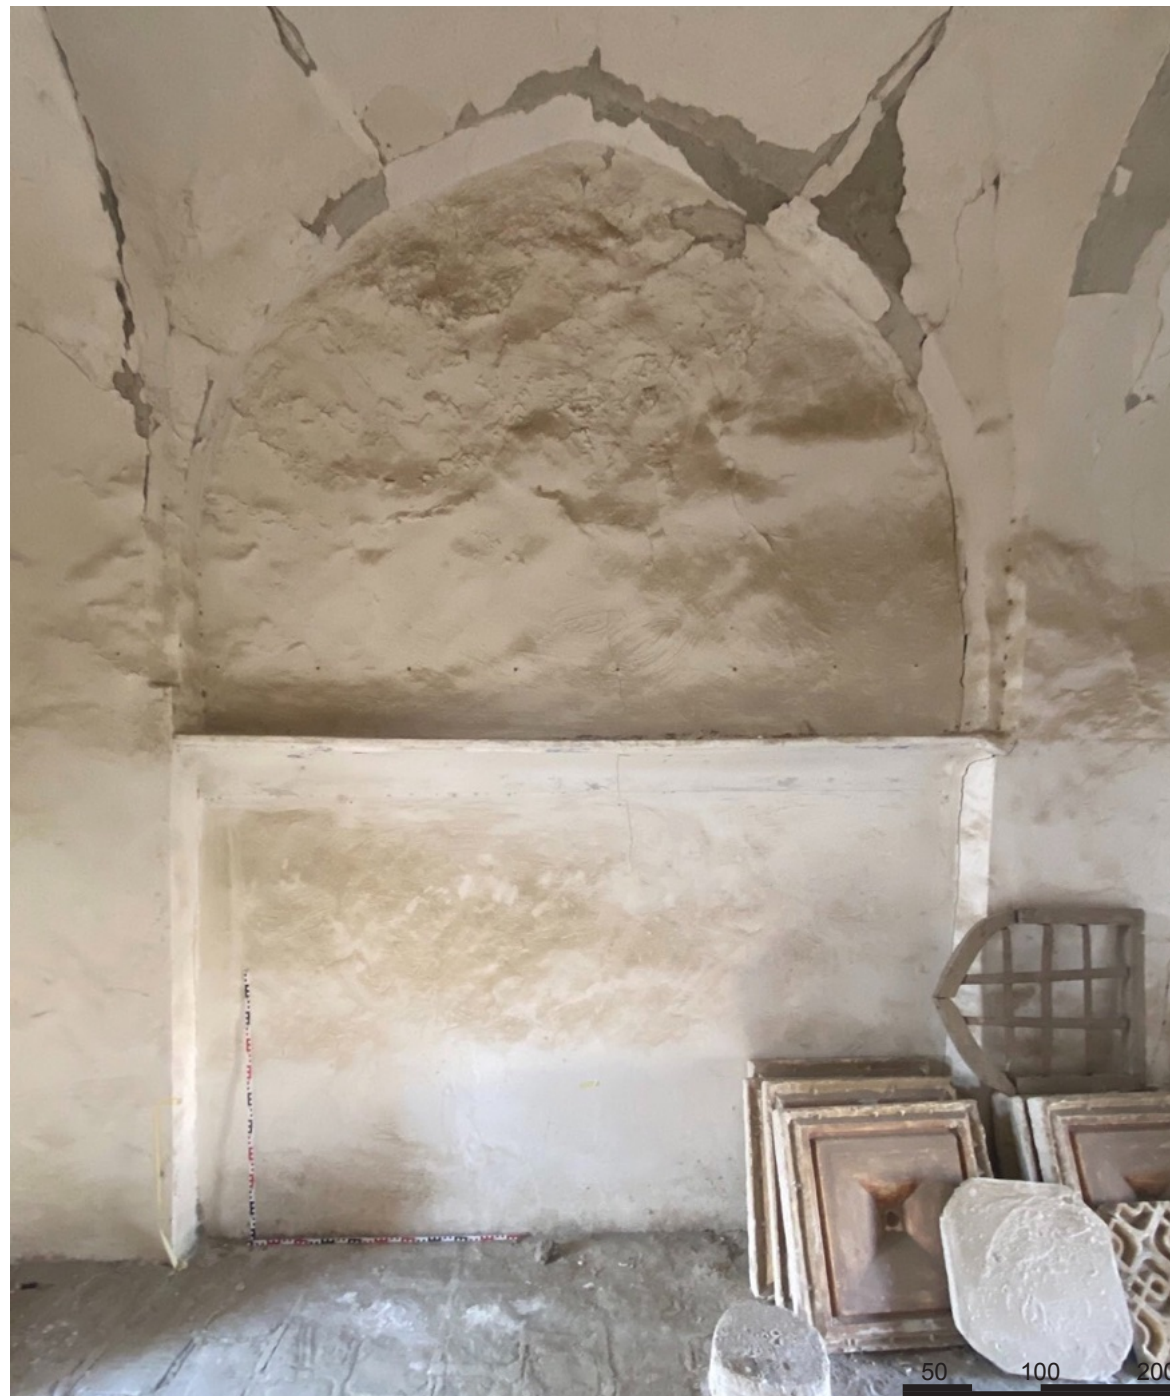
- Lacuna/ Missing parts
- Loss of paint layer
- Crumbling
- Peeling
- Crack
- Scaling
- Salt
- Biological growth
- Corrosion
- Burrow
- Water traces

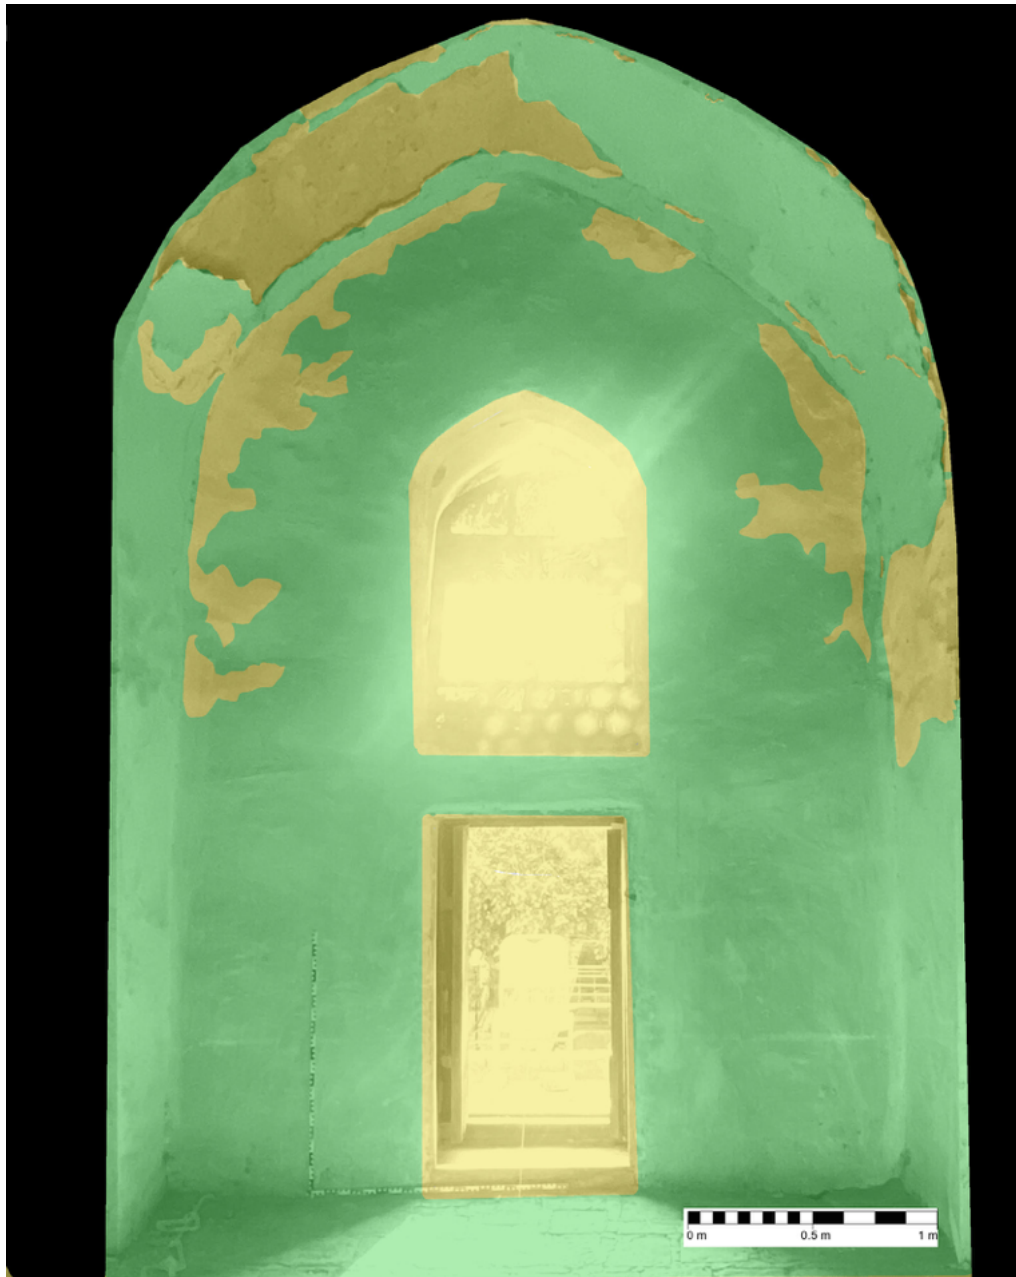
Traffic light system:

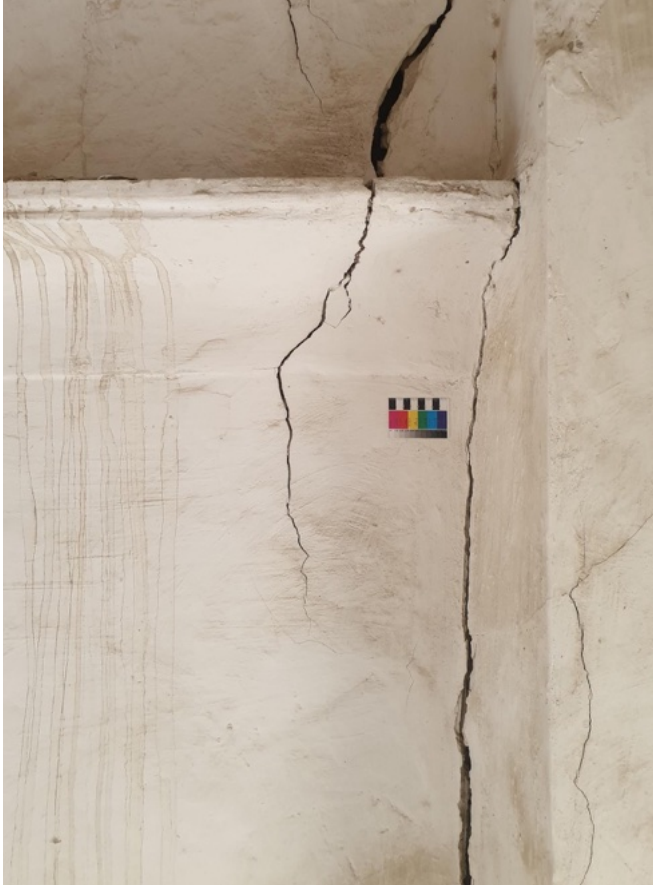
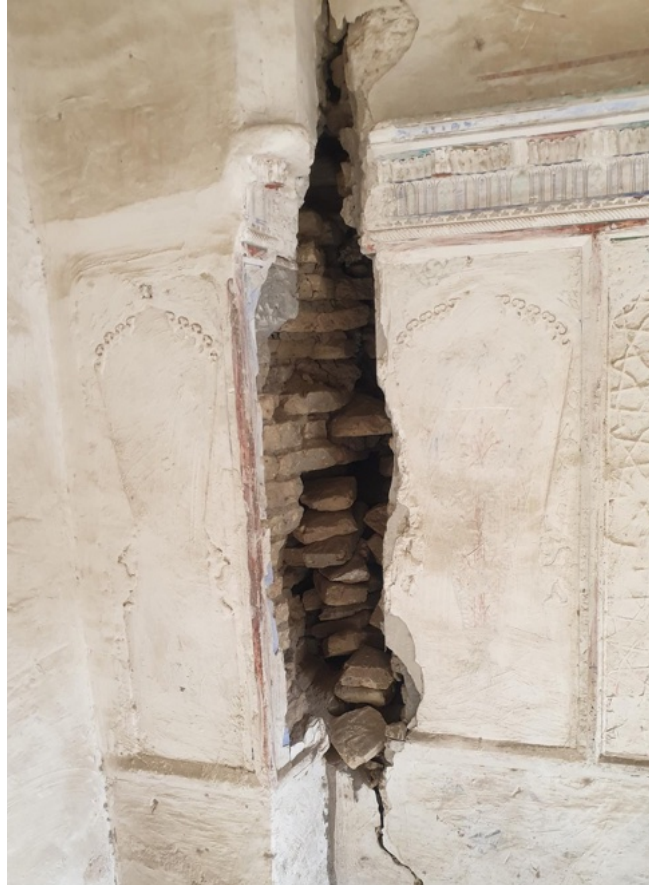
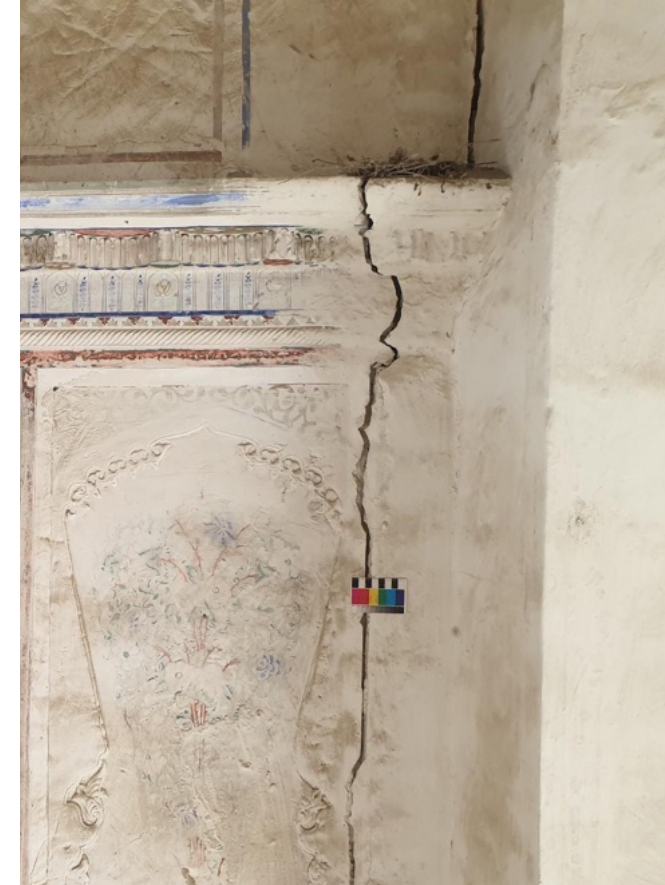
The severe crack between room 1/2/3.

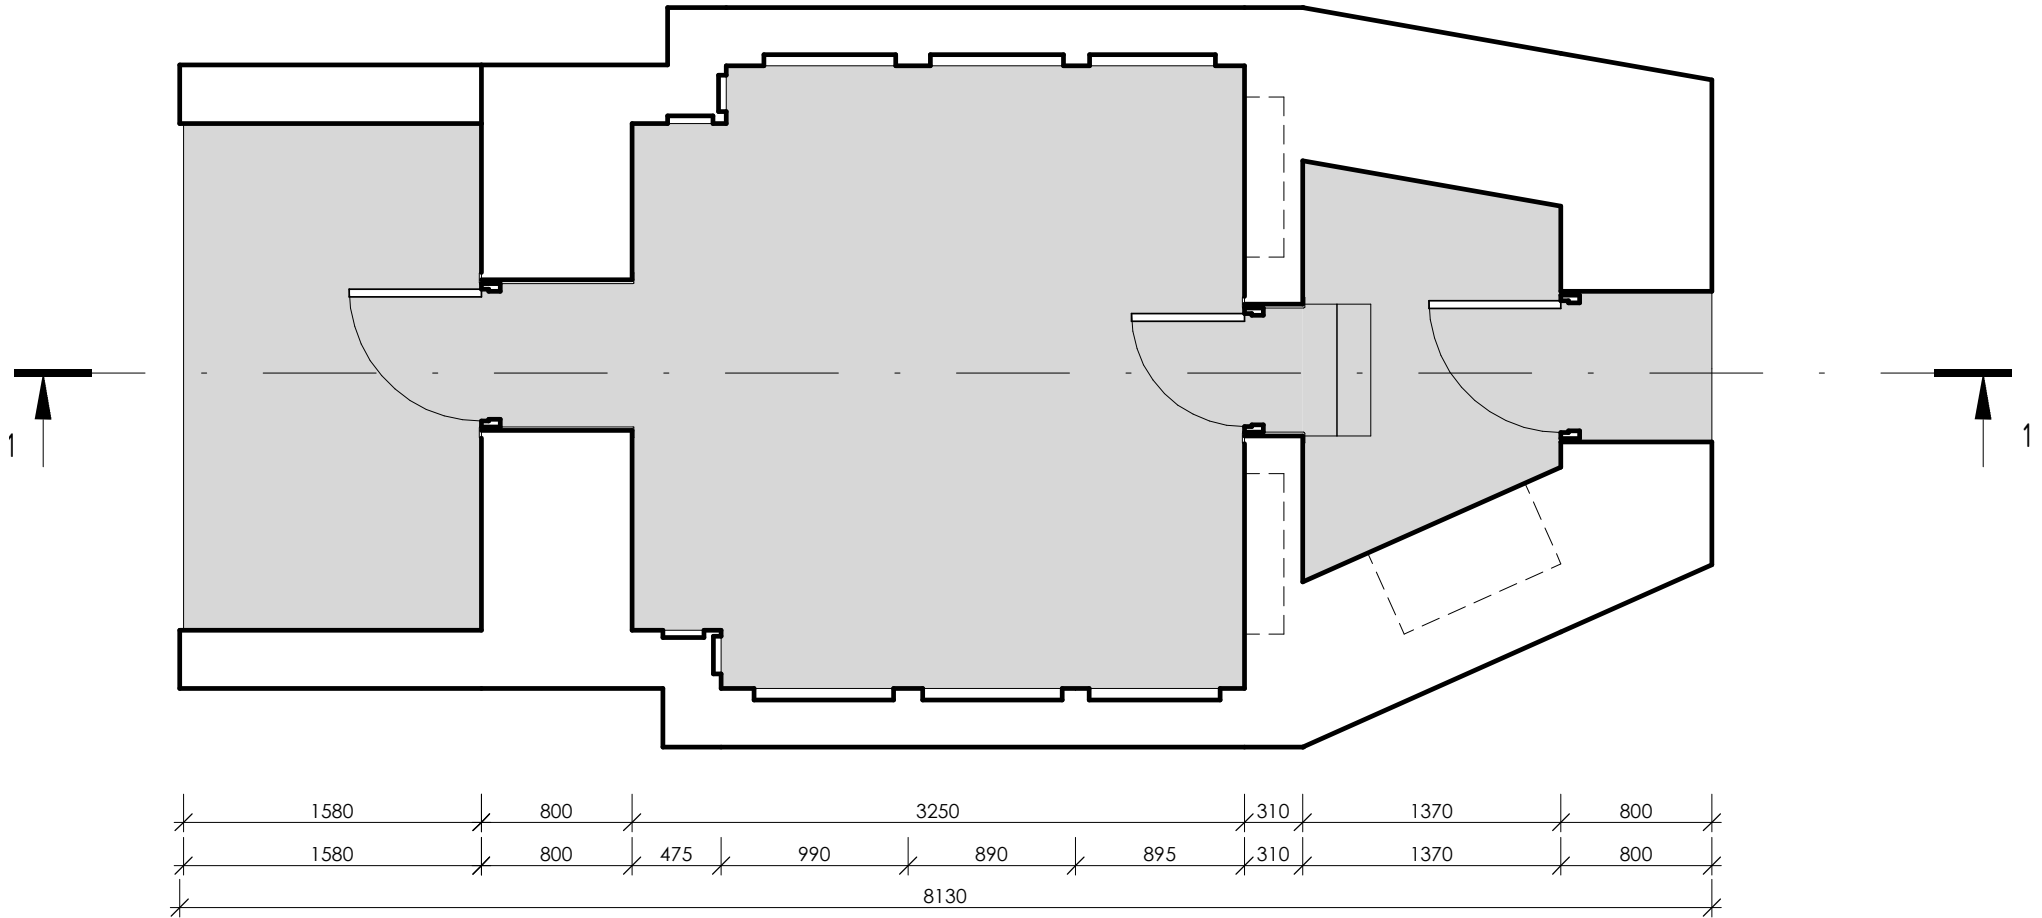
Inner and external facade have a similar layout. Both levels of the inlaying facade contain a pointed barrel vault. Crossing a small paved square on the ground level, one can reach the winding staircase through a wooden door on the left side that leads to the upper level of the Madrasah. Straight ahead, a wooden door is crowned by an ornamented open window. This layout can also be found on the upper level. The entrance to room number 64 opens off to the inner hallway that winds around the inner courtyard and interconnects the rooms on the upper level of the western wing, as well as parts of the southern and northern wing. The lower level of the external facade only contains an ornamented window. On the upper level, a similar layout to the inner upper level can be found. Instead of the hallway, the outer facade shows the loggia with its low railing.

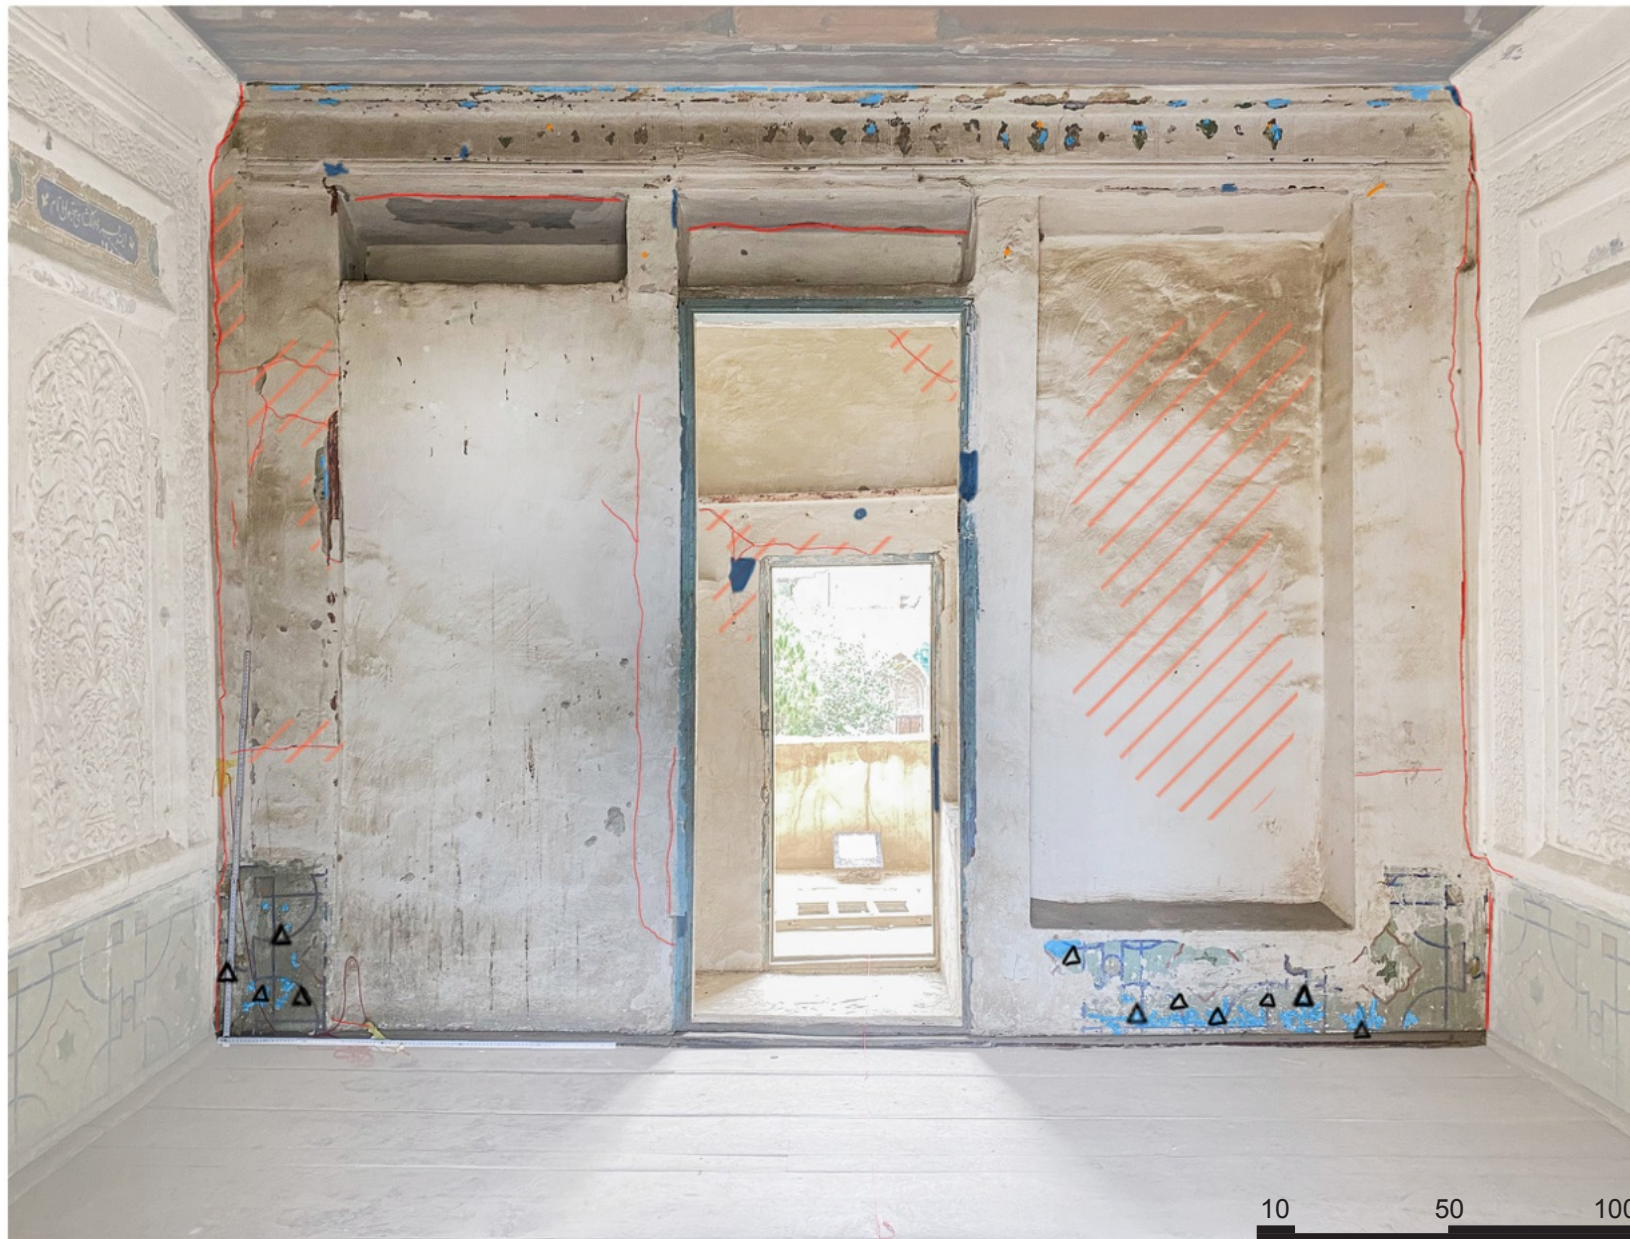
Missing parts, cracks, scaling as well as crumbling can be found on both external and inner facade. The outer facade additionally shows some salt damages on the base.

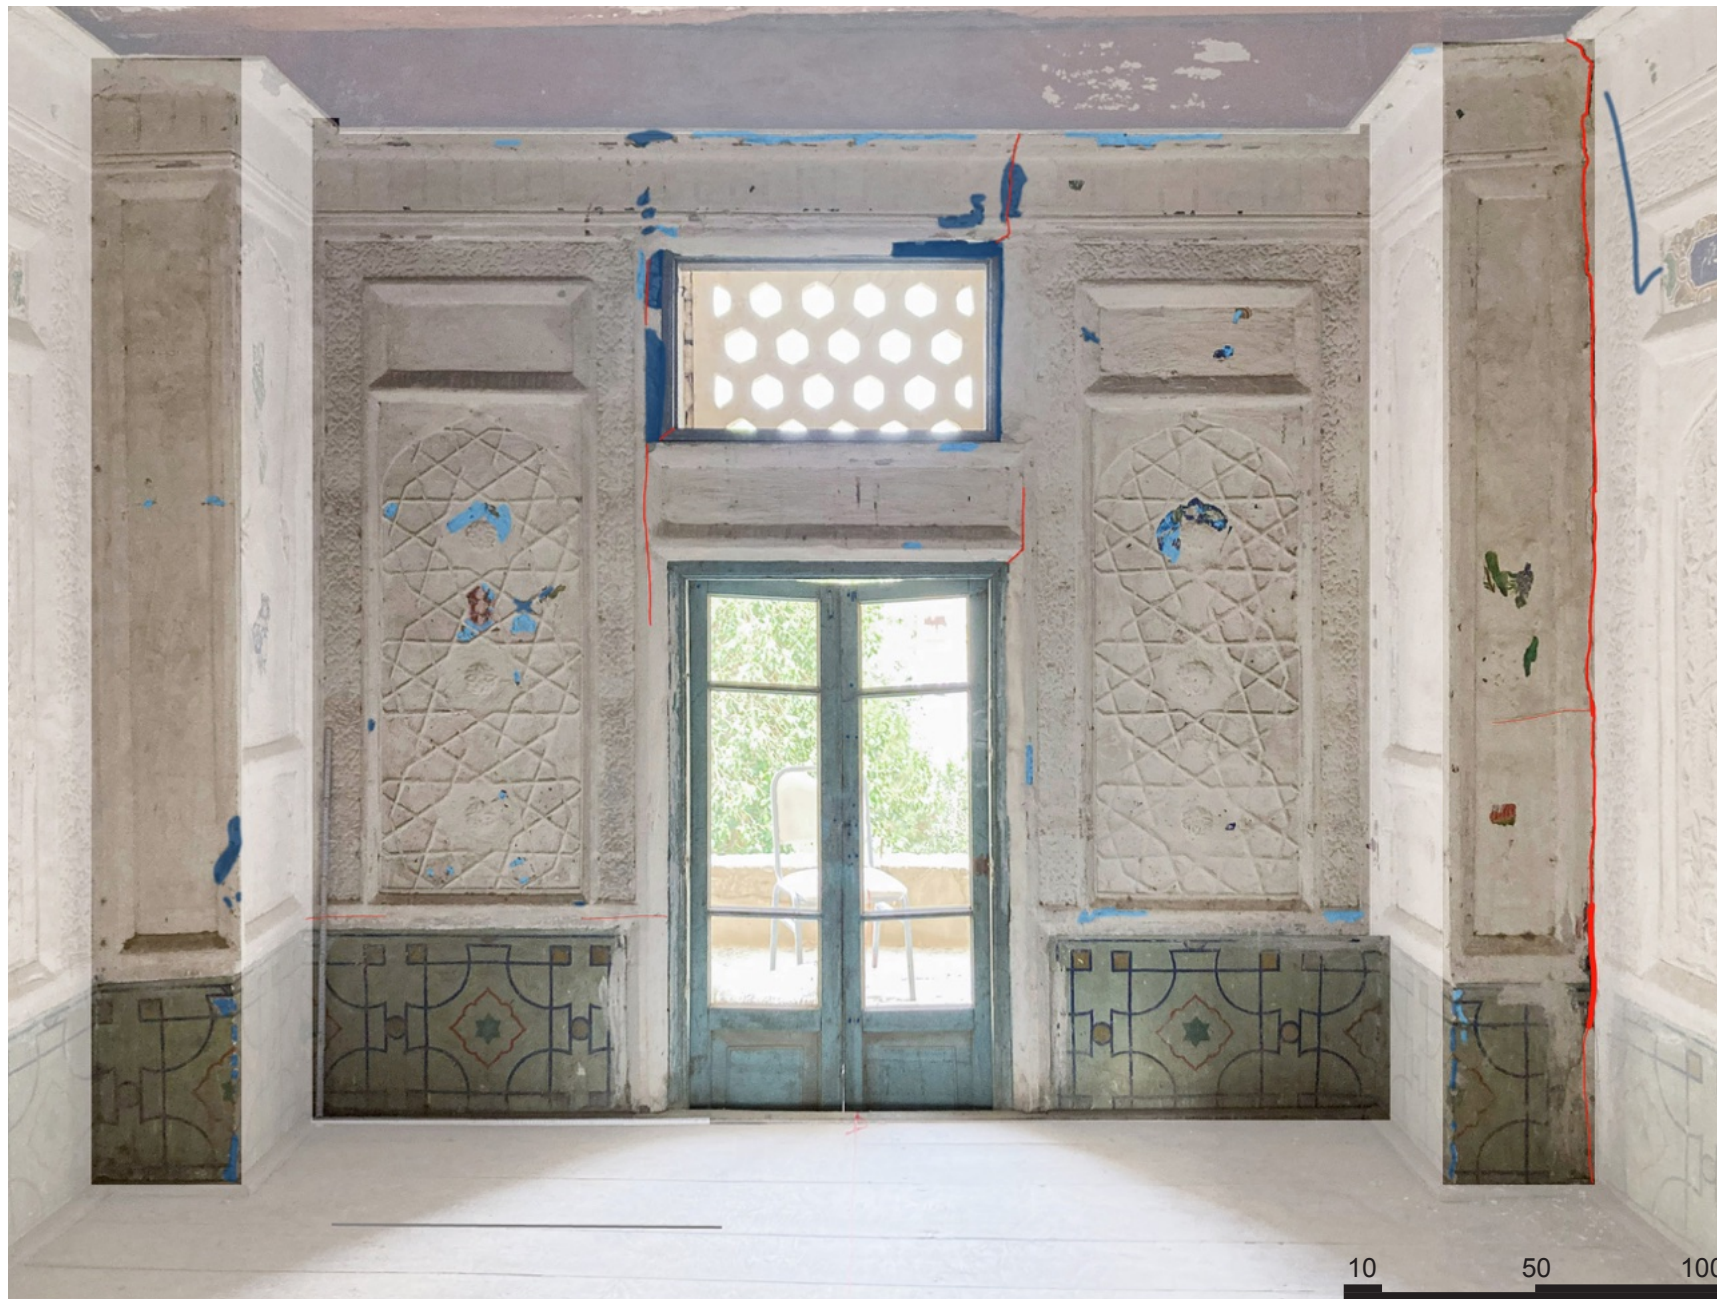
- Legend of damages:
- Lacuna/ Missing parts
 - Loss of paint layer
 - Crumbling
 - Peeling
 - Crack
 - Scaling
 - Salt
 - Biological growth
 - Corrosion
 - Burrow
 - Water traces

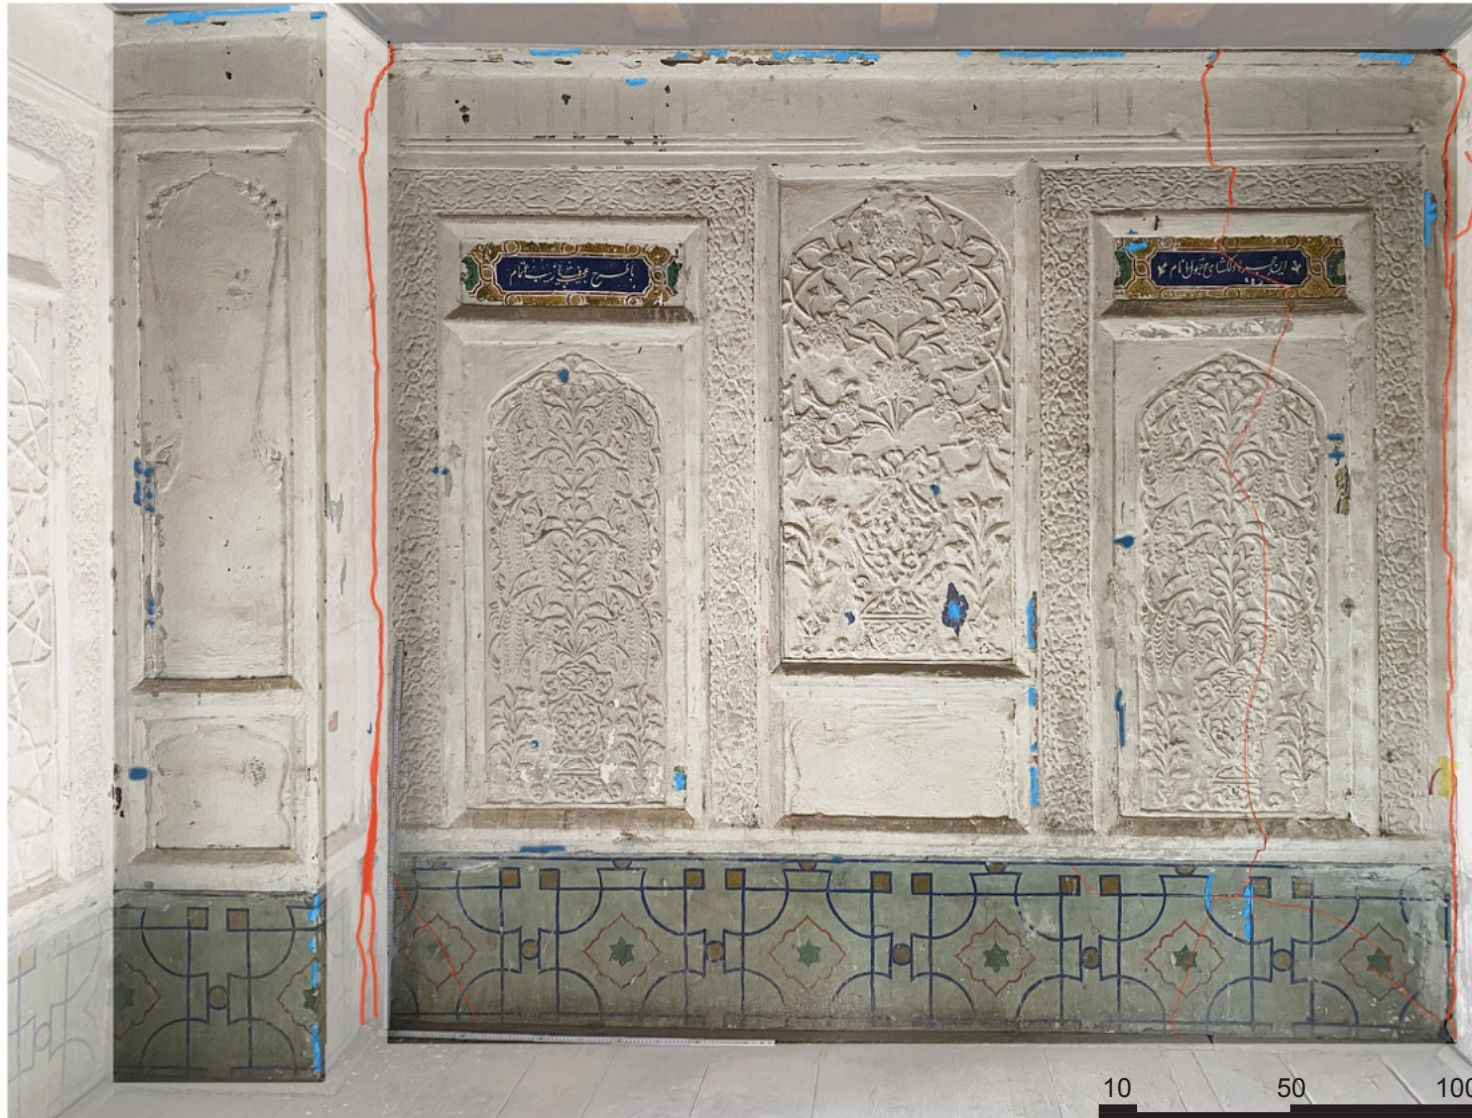
- Lacuna/ Missing parts
- Loss of paint layer
- Crumbling
- Peeling
- Crack
- Scaling
- Salt
- Biological growth
- Corrosion
- Burrow
- Water traces

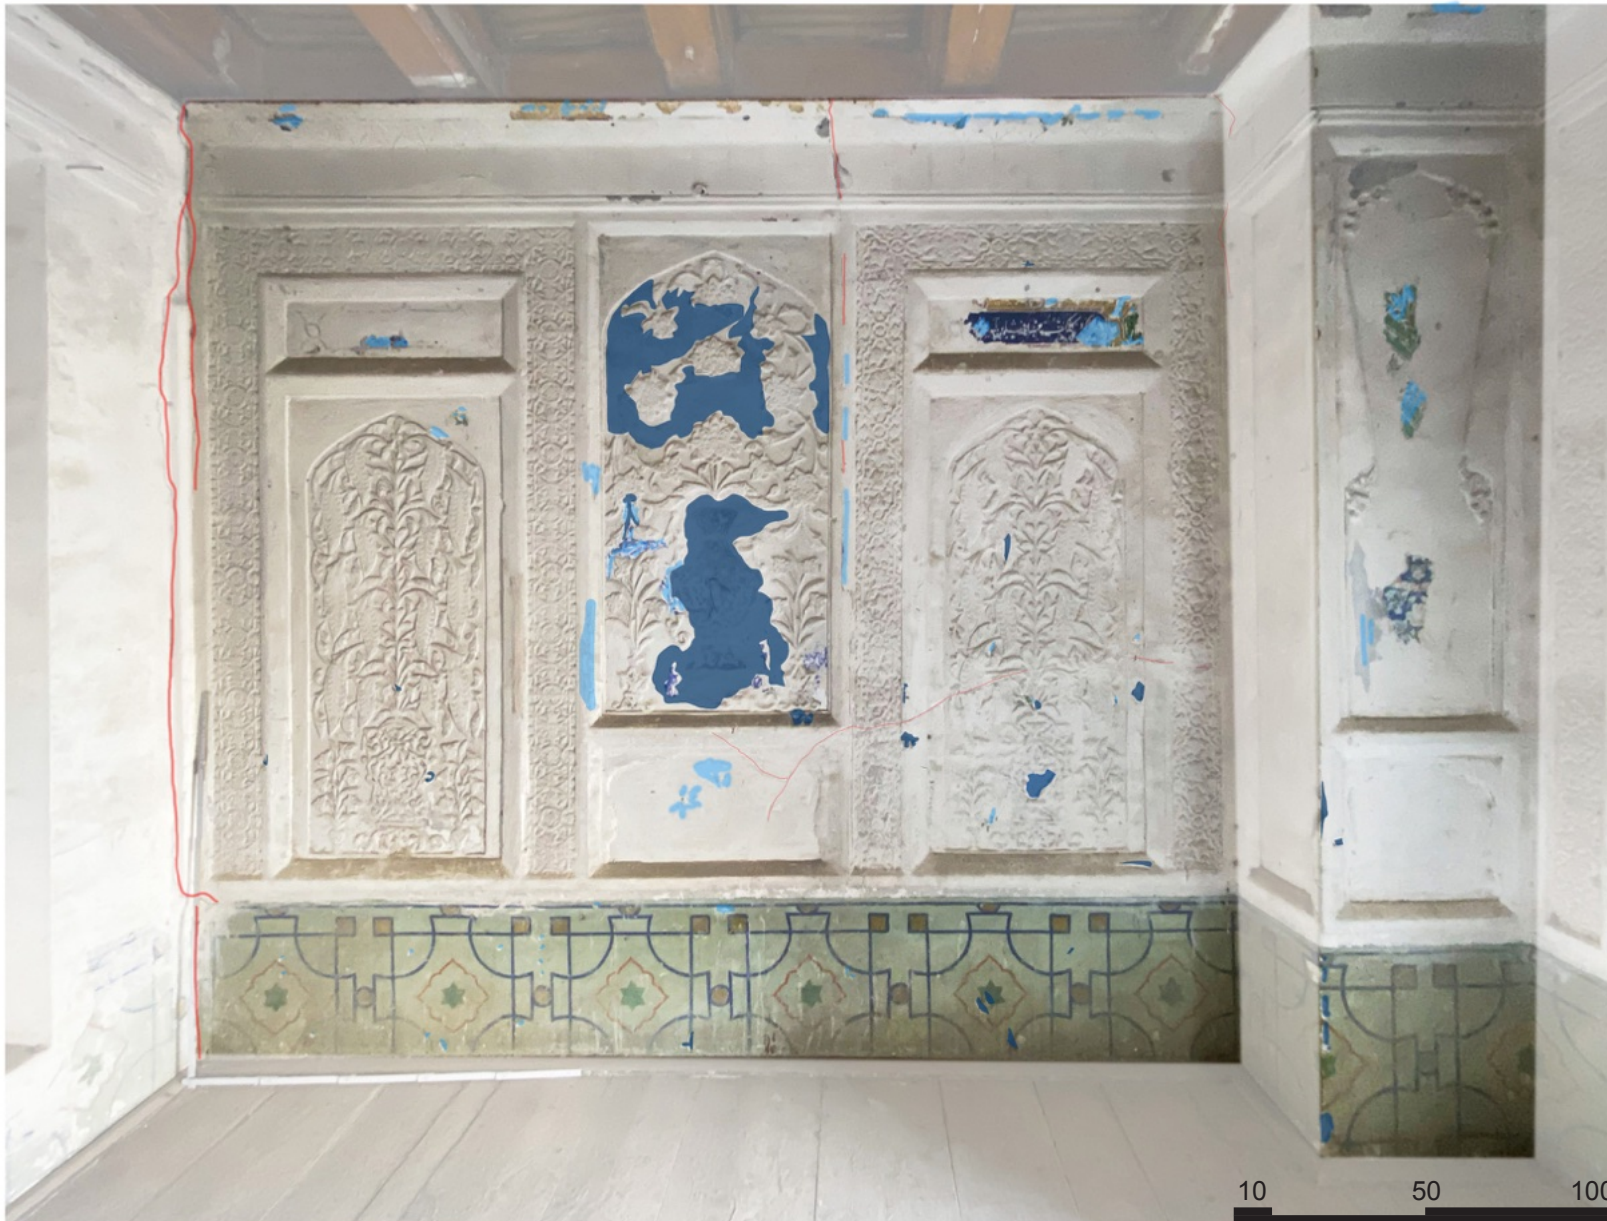
- Lacuna/ Missing parts
- Loss of paint layer
- Crumbling
- Peeling
- Crack
- Scaling
- Salt
- Biological growth
- Corrosion
- Burrow
- Water traces

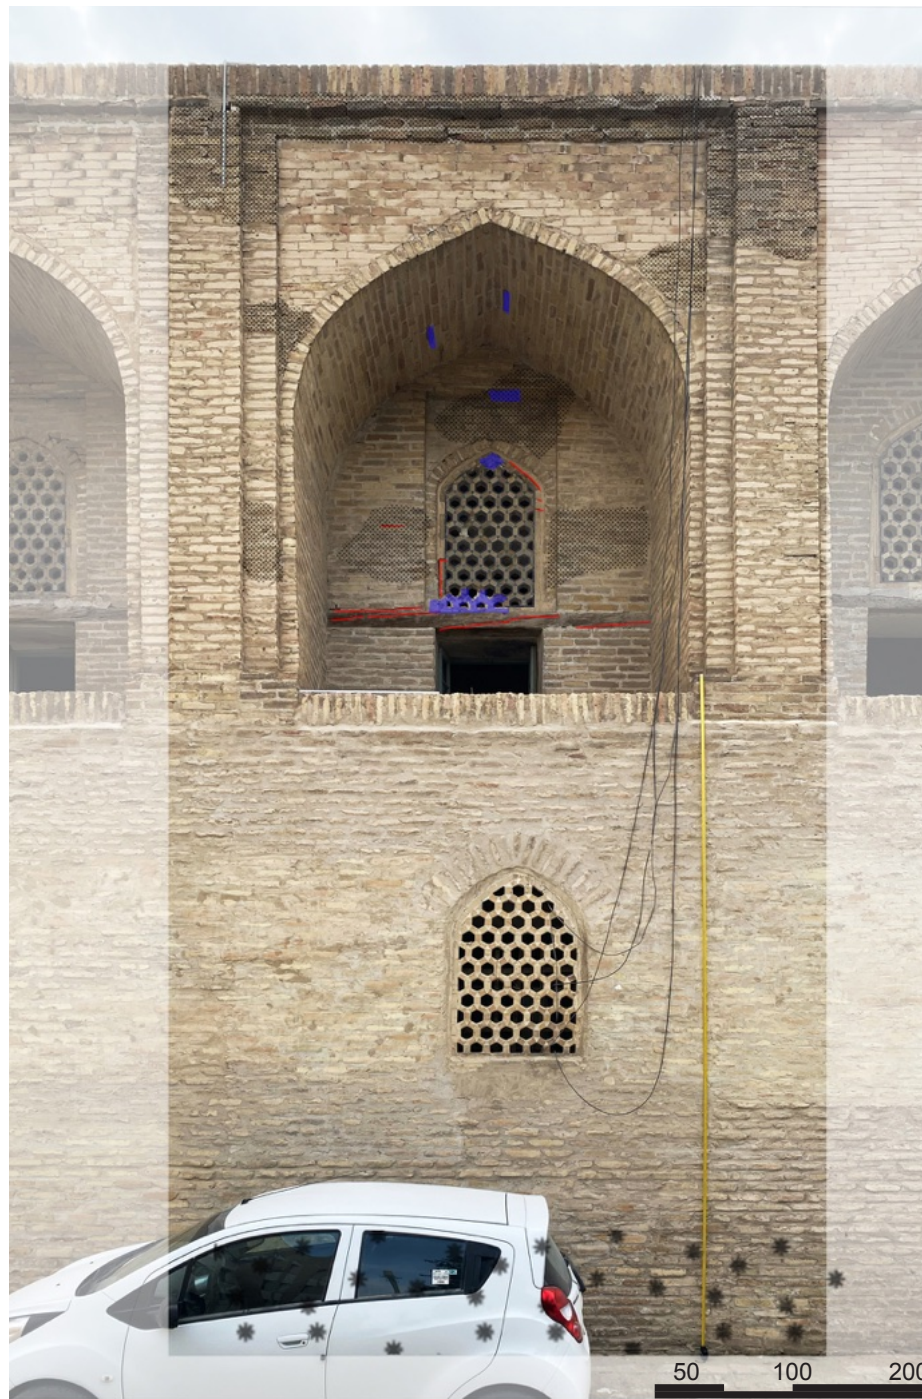
- Legend of damages:
- Lacuna/ Missing parts
 - Loss of paint layer
 - Crumbling
 - Peeling
 - Crack
 - Scaling
 - Salt
 - Biological growth
 - Corrosion
 - Burrow
 - Water traces

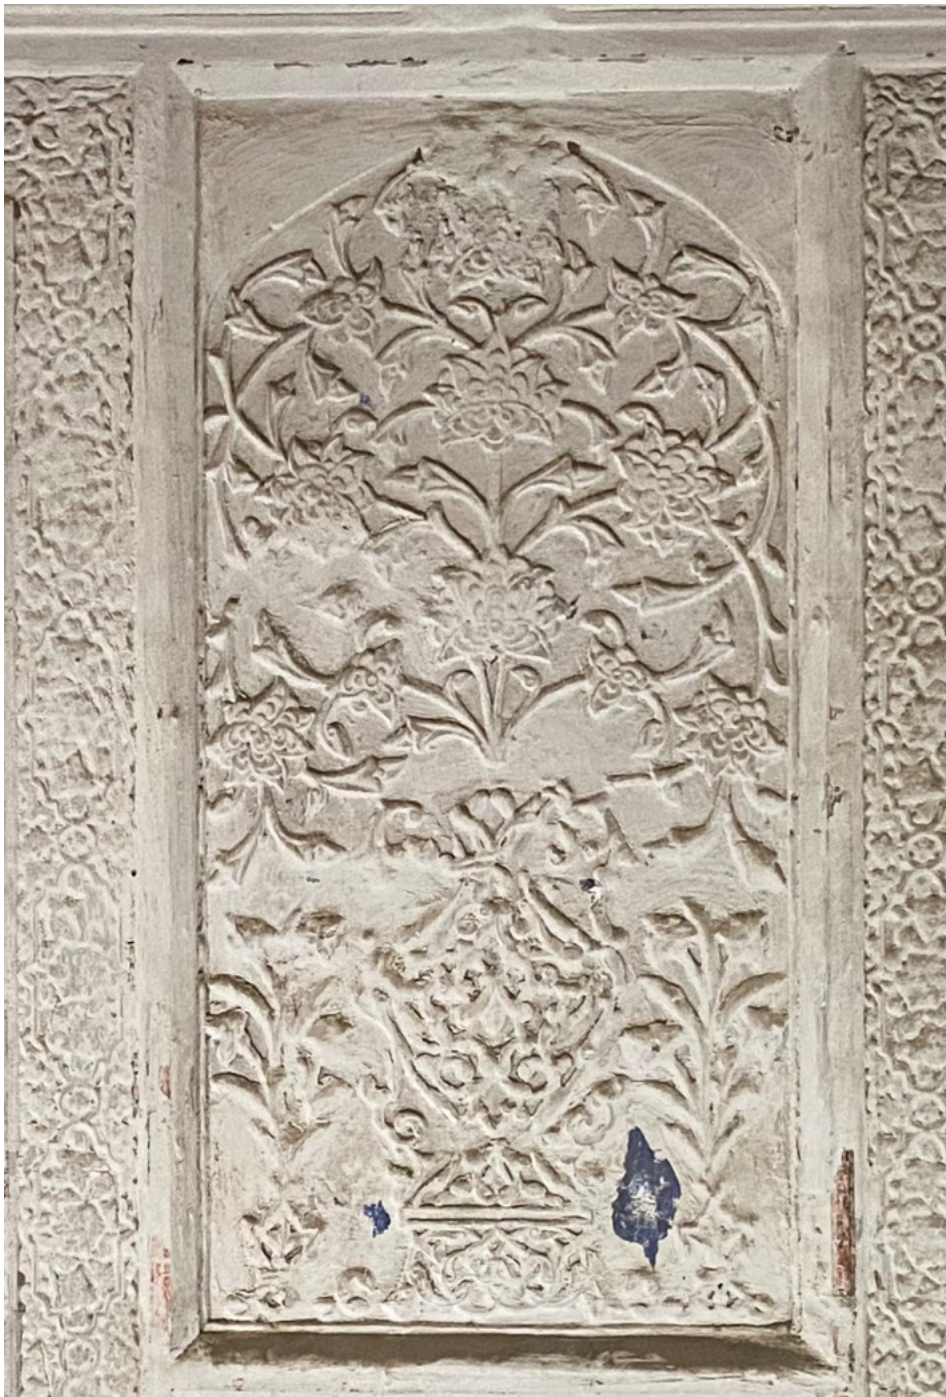
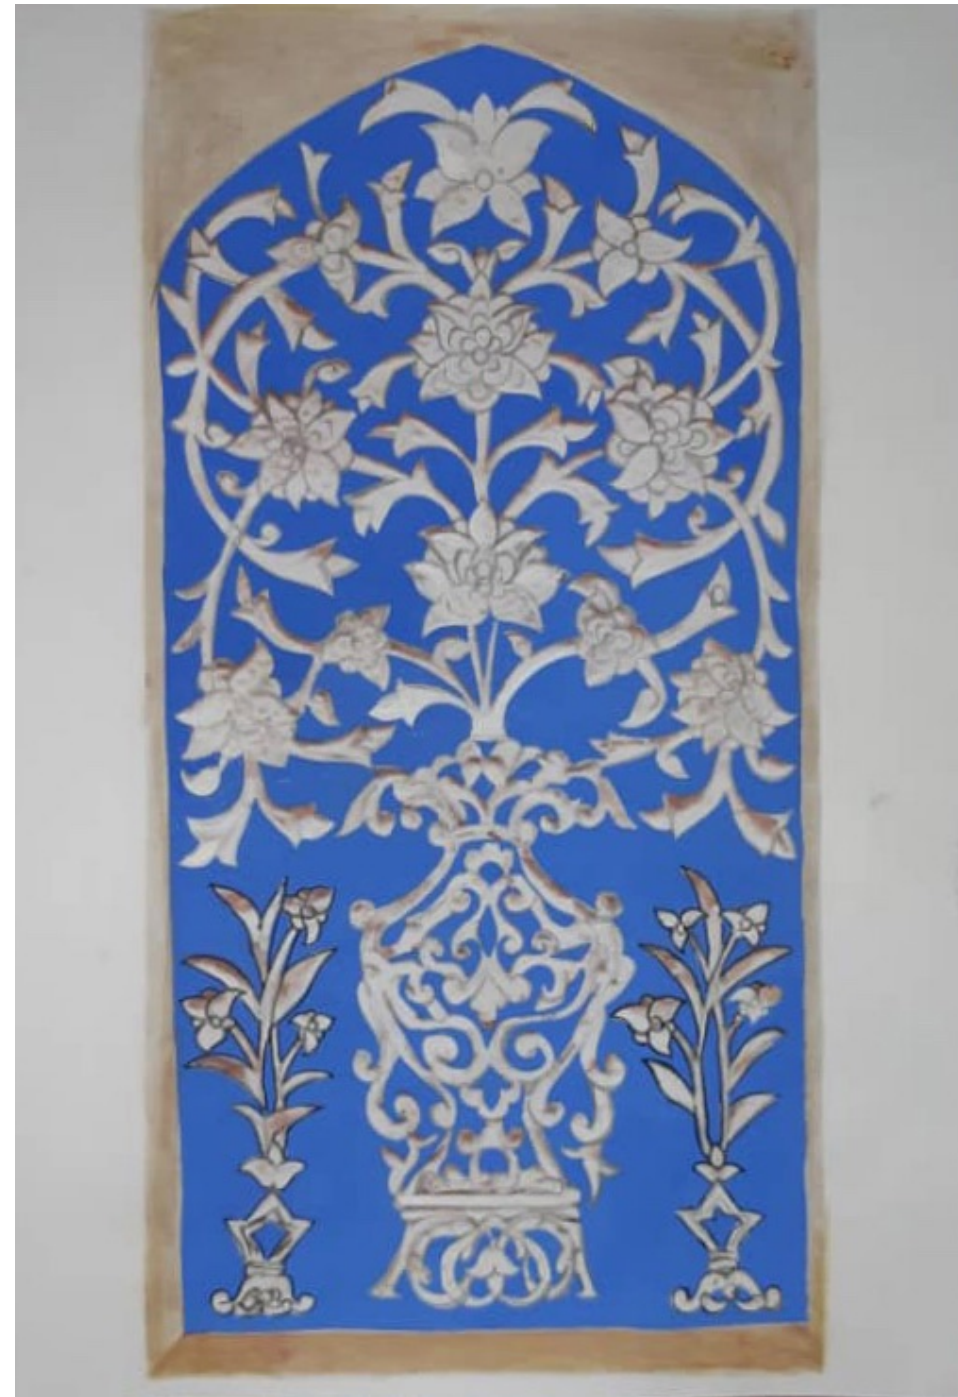
Traffic Light System

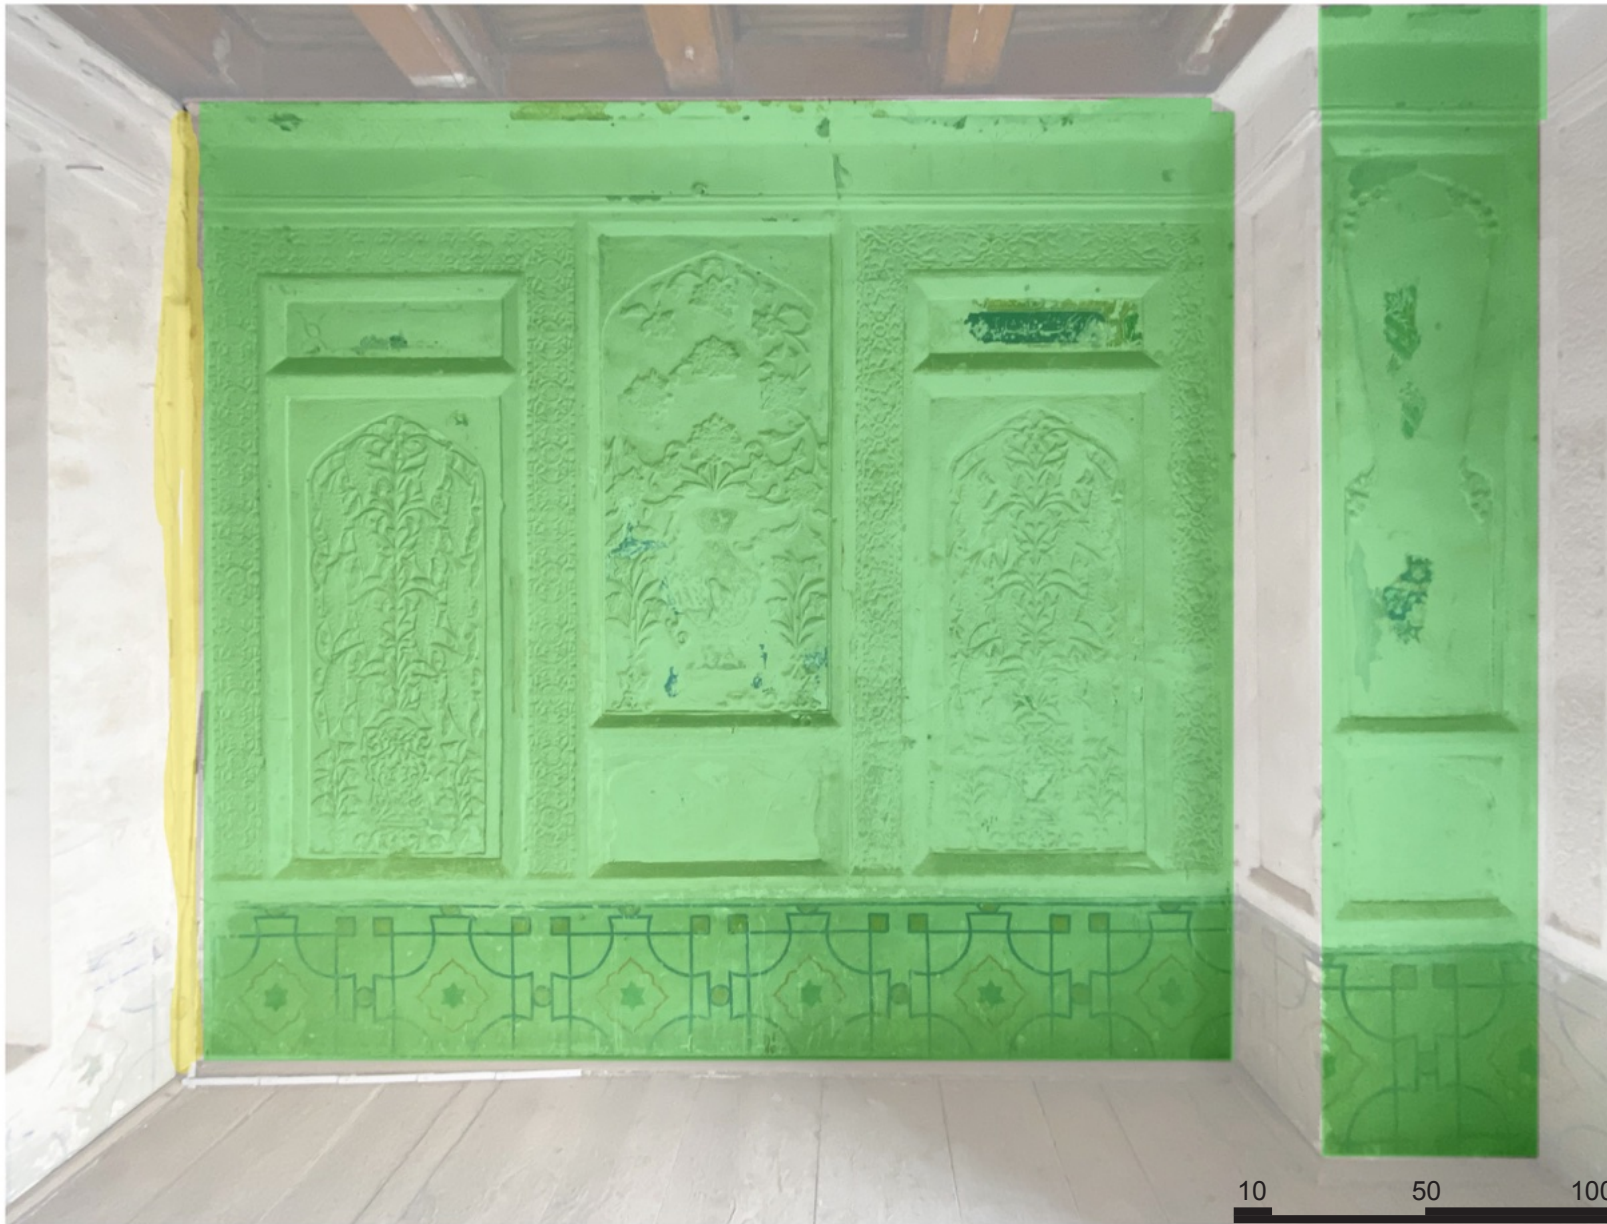
Photo- documen- tation
