DOCUMENTATION

Summer School 2022 | Kukaldosh Madrasah Bukhara Uzbekistan

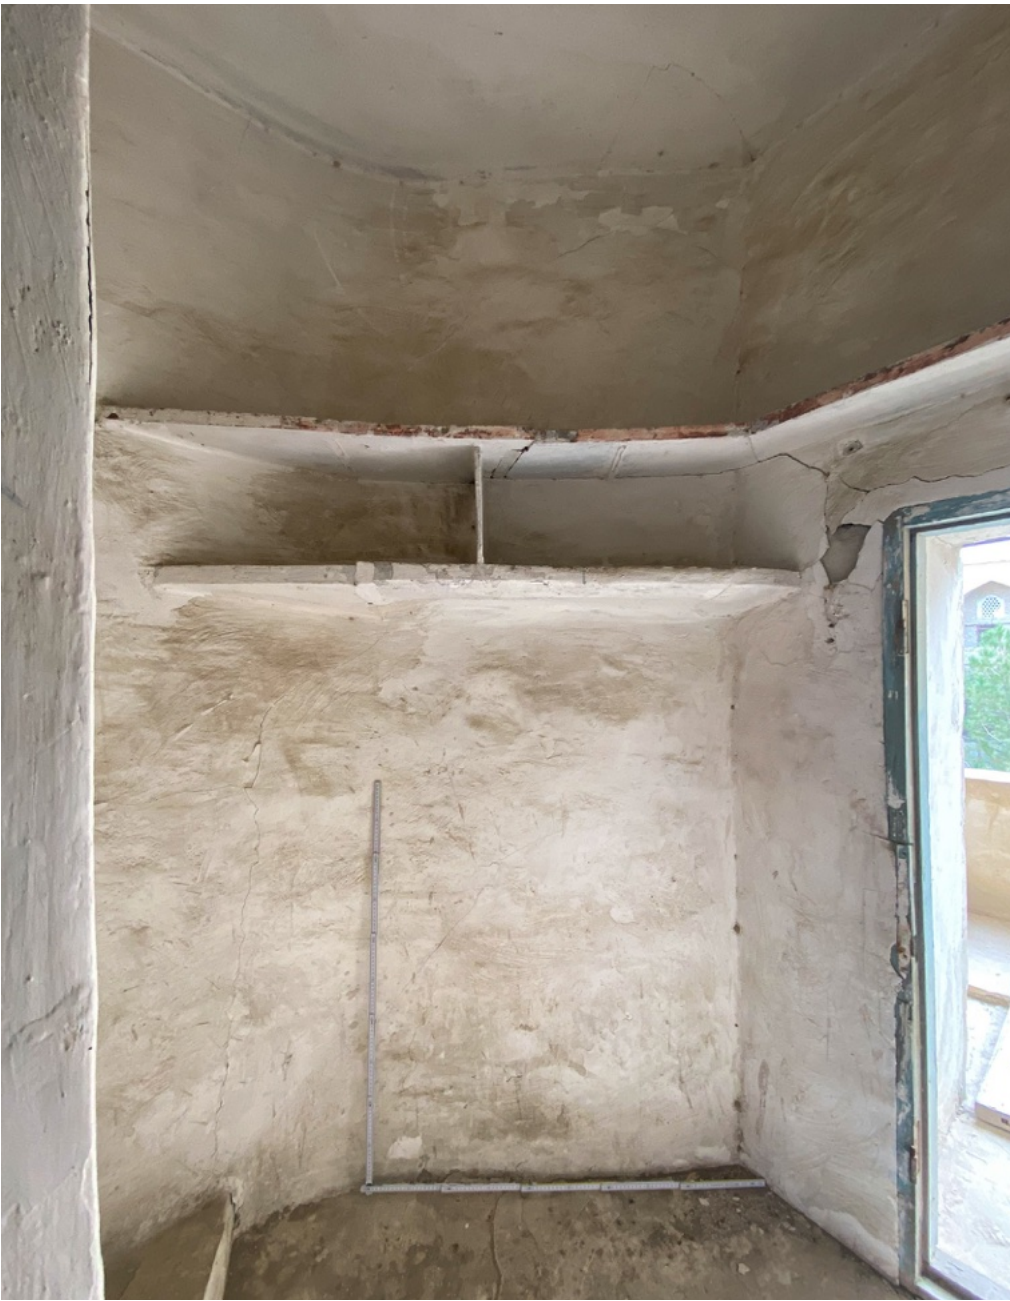
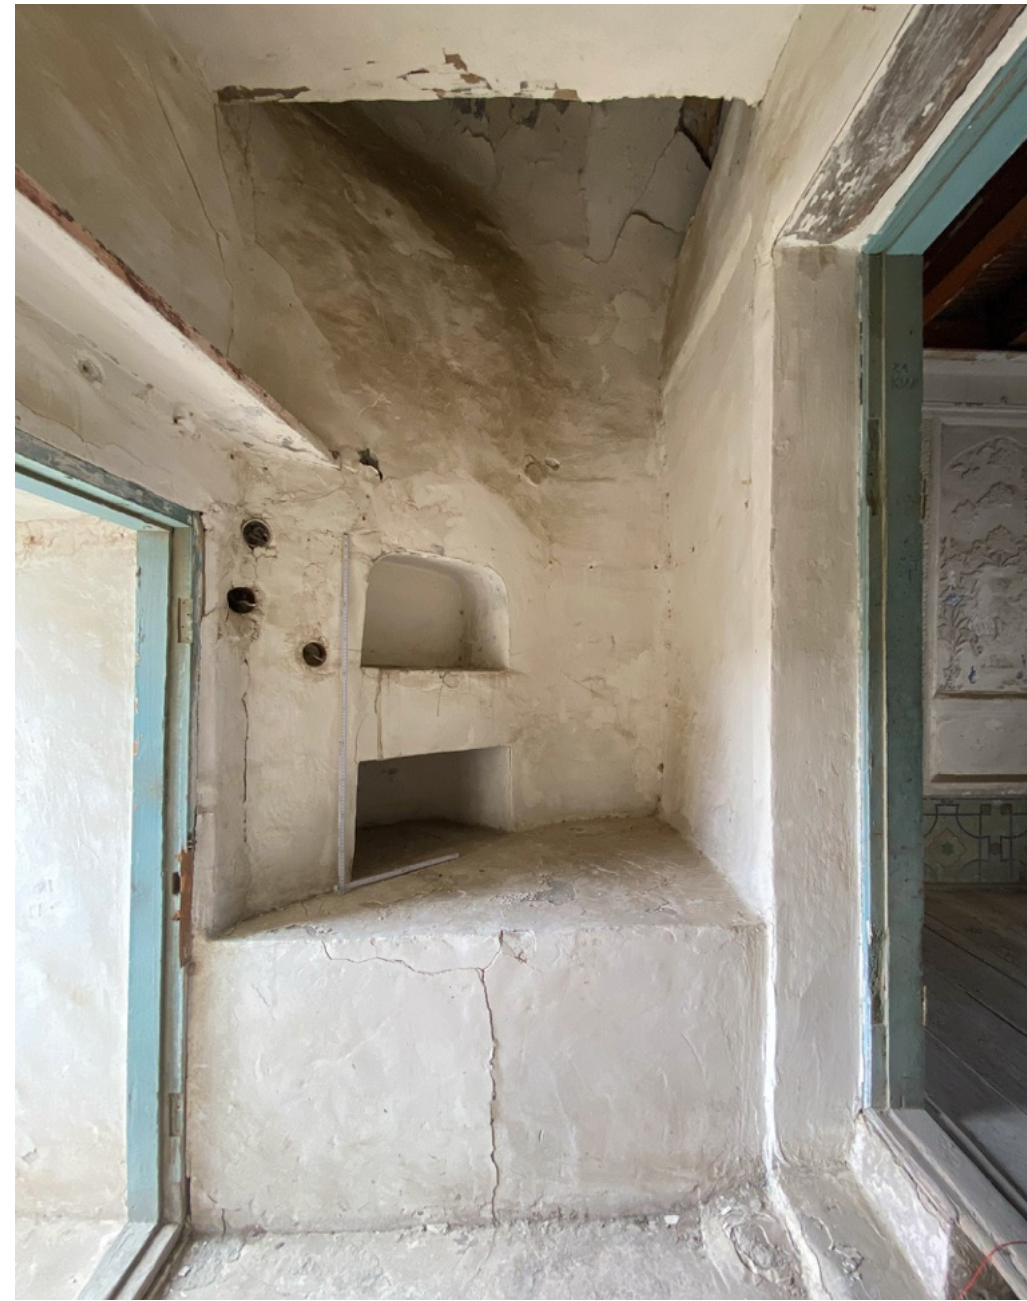
The antechamber, with a shelf and a small platform that might have been the access point to the upper level of the room

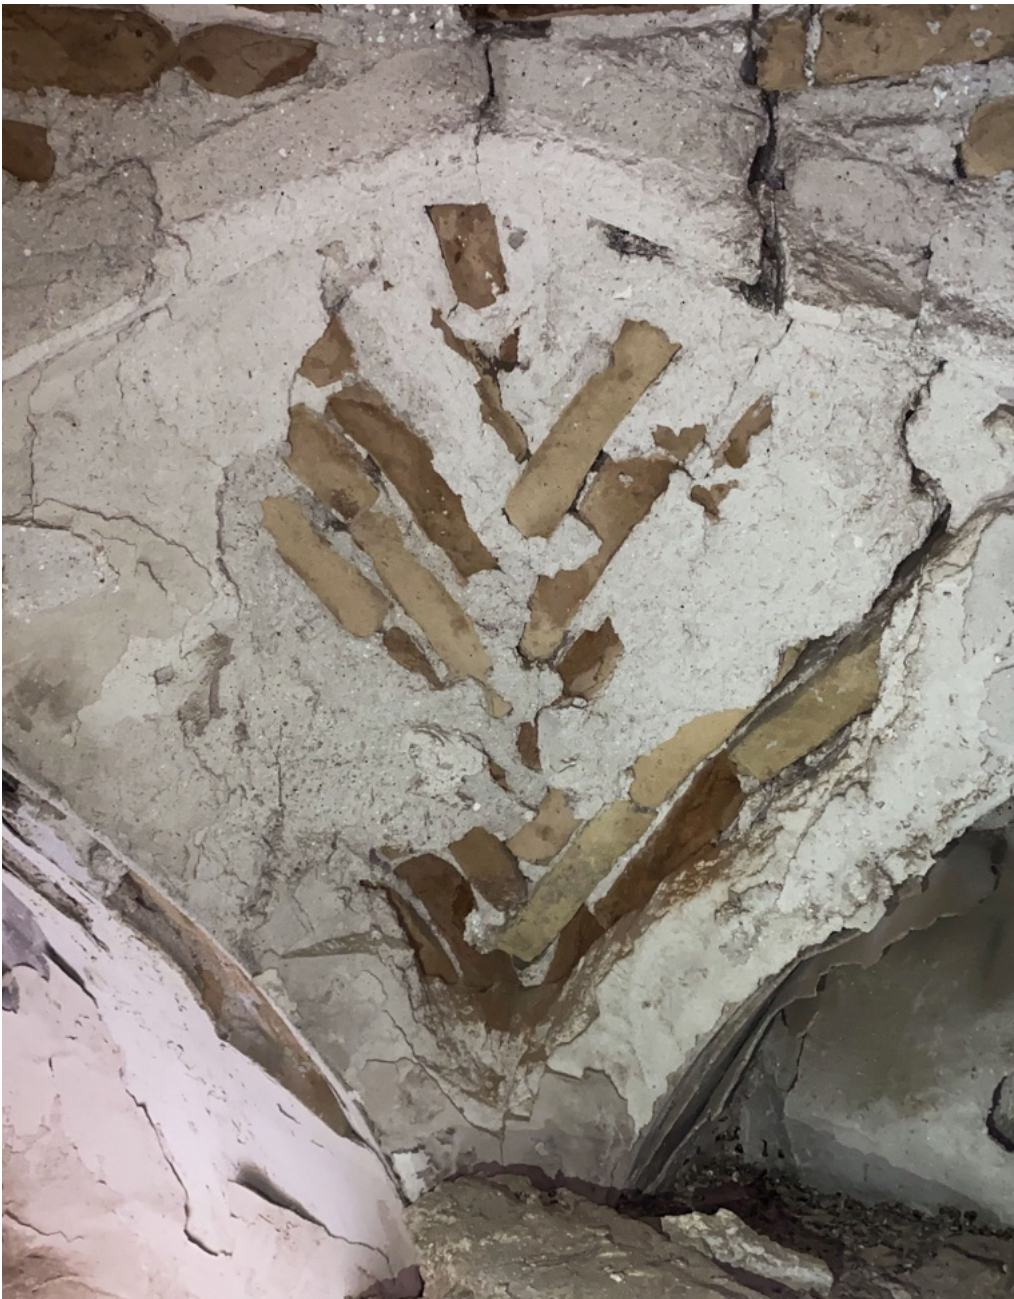
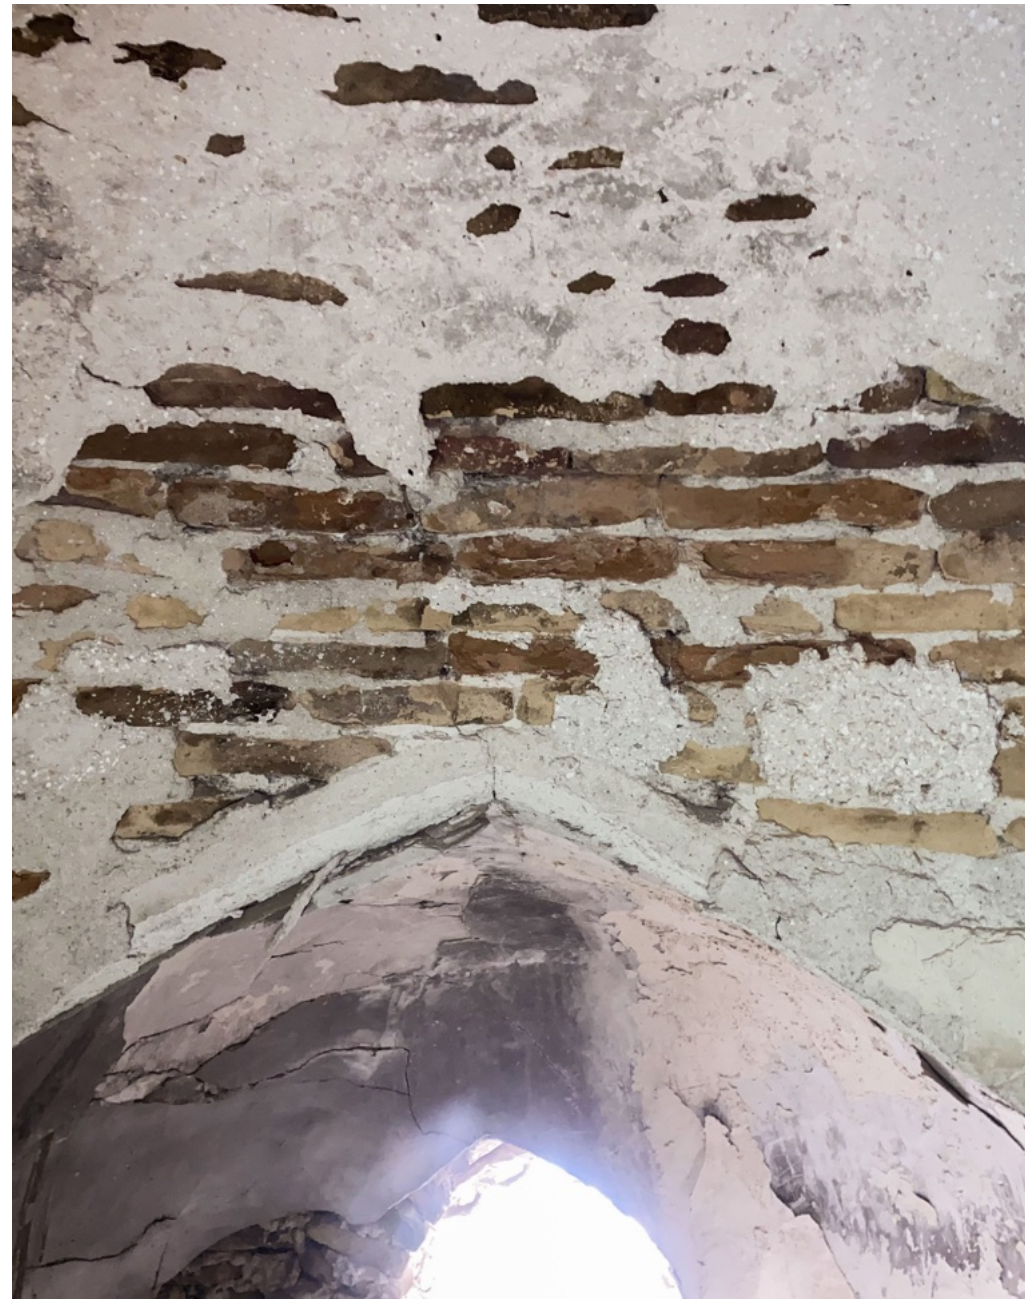
Damages at the inside of the cupola

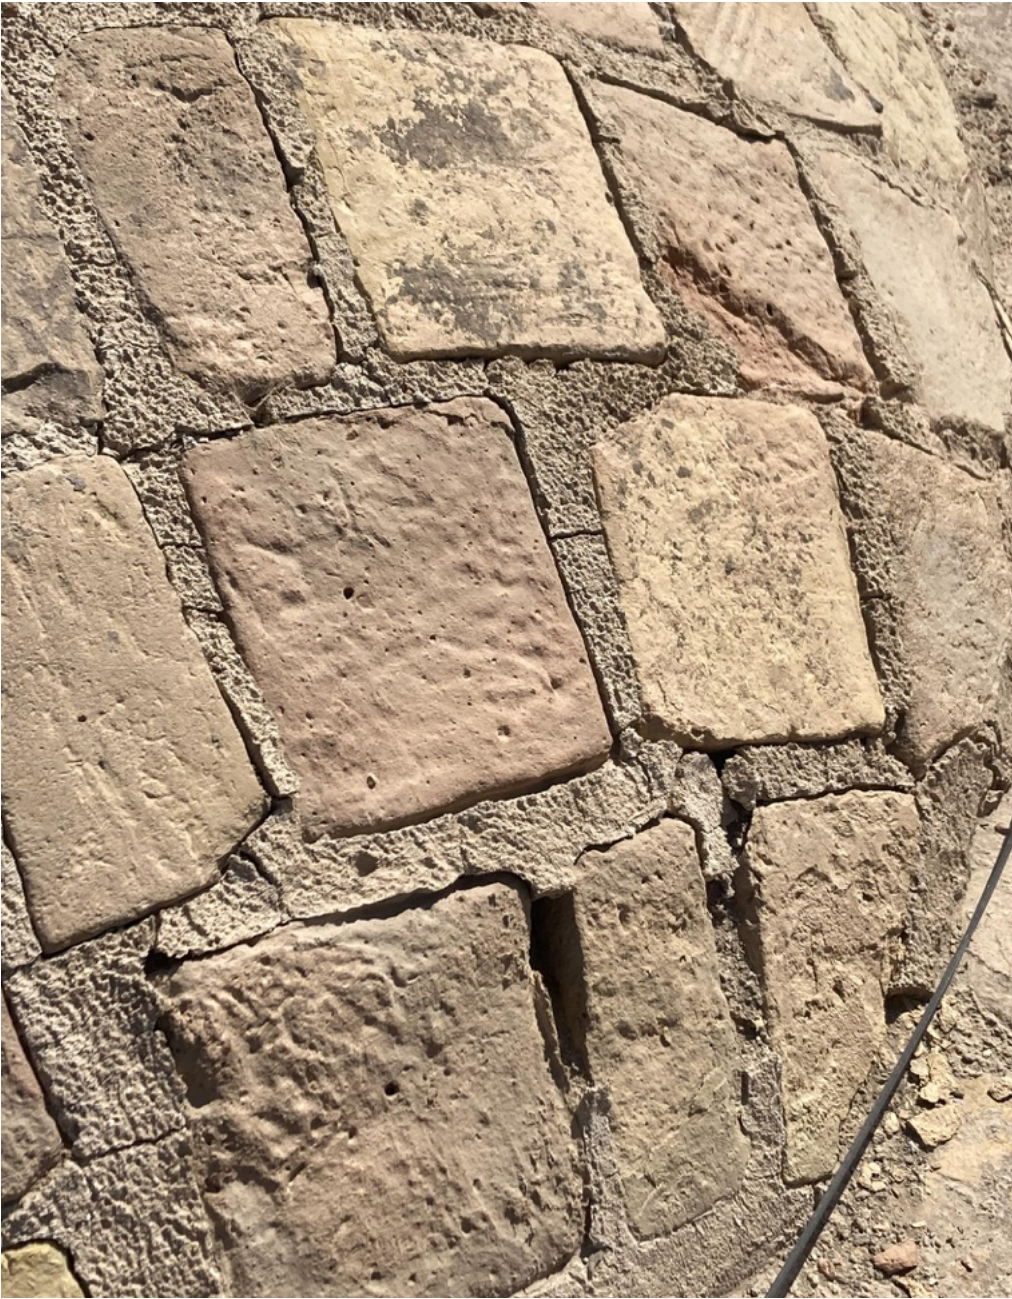
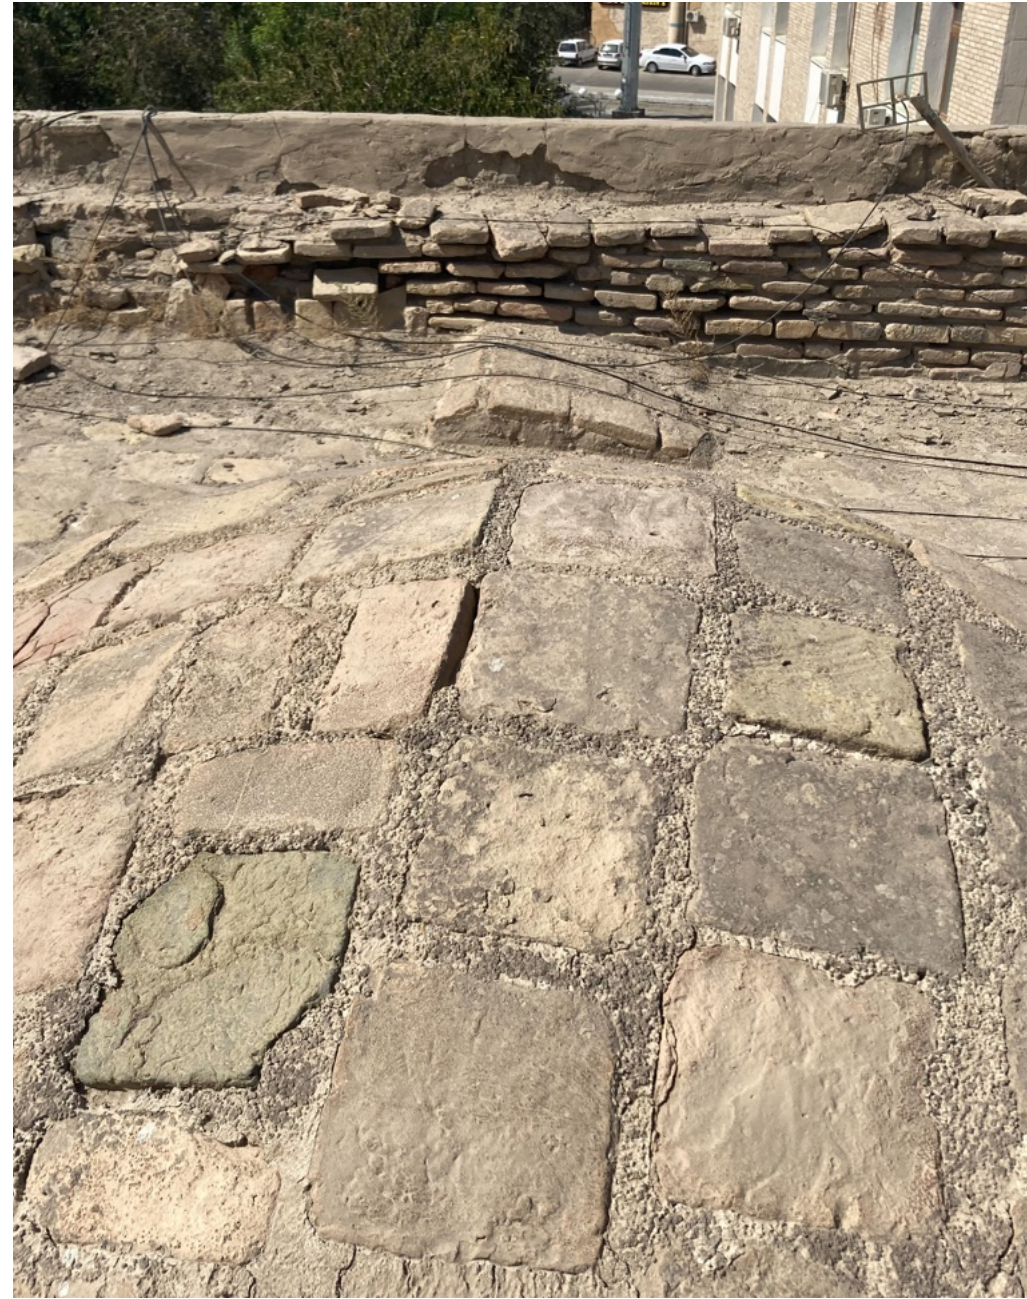
The roof above the Room 64

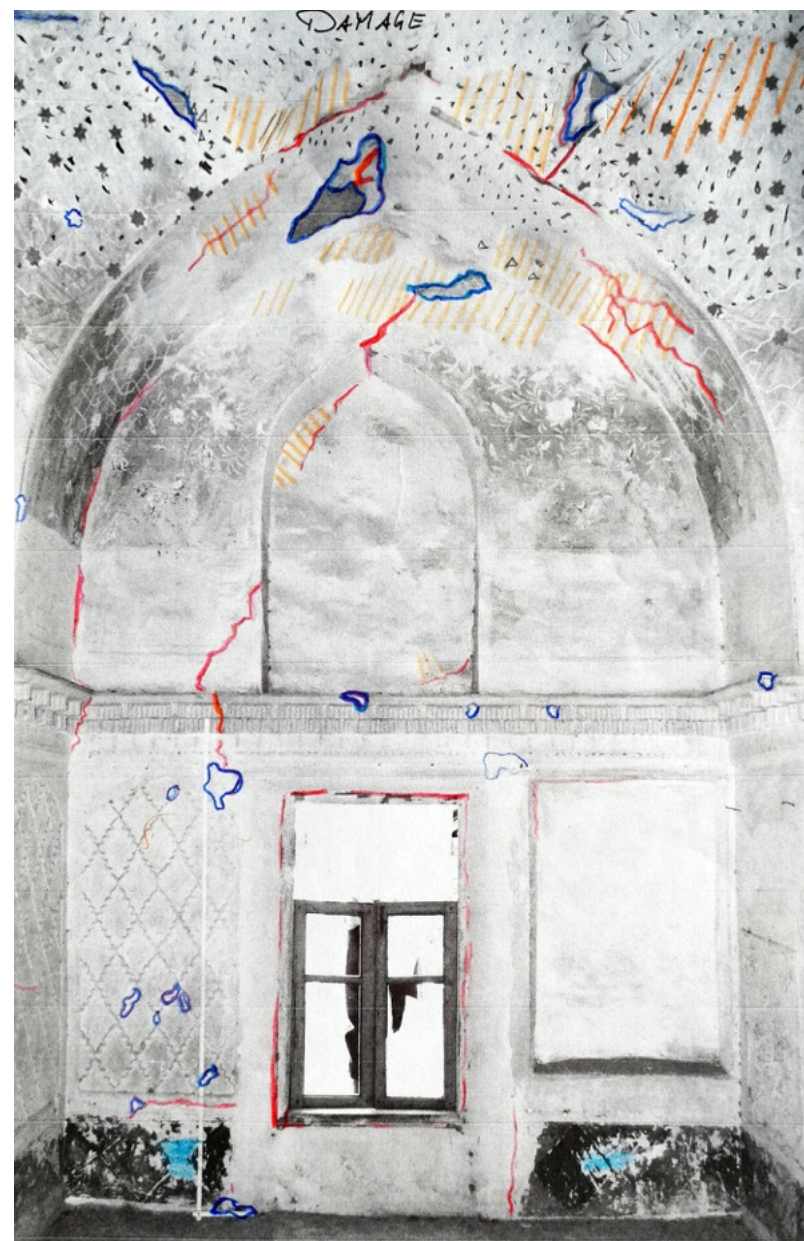
- Lacuna/ Missing parts
- Loss of paint layer
- Crumbling
- Peeling
- Crack
- Scaling
- Salt
- Biological growth
- Corrosion
- Burrow
- Water traces

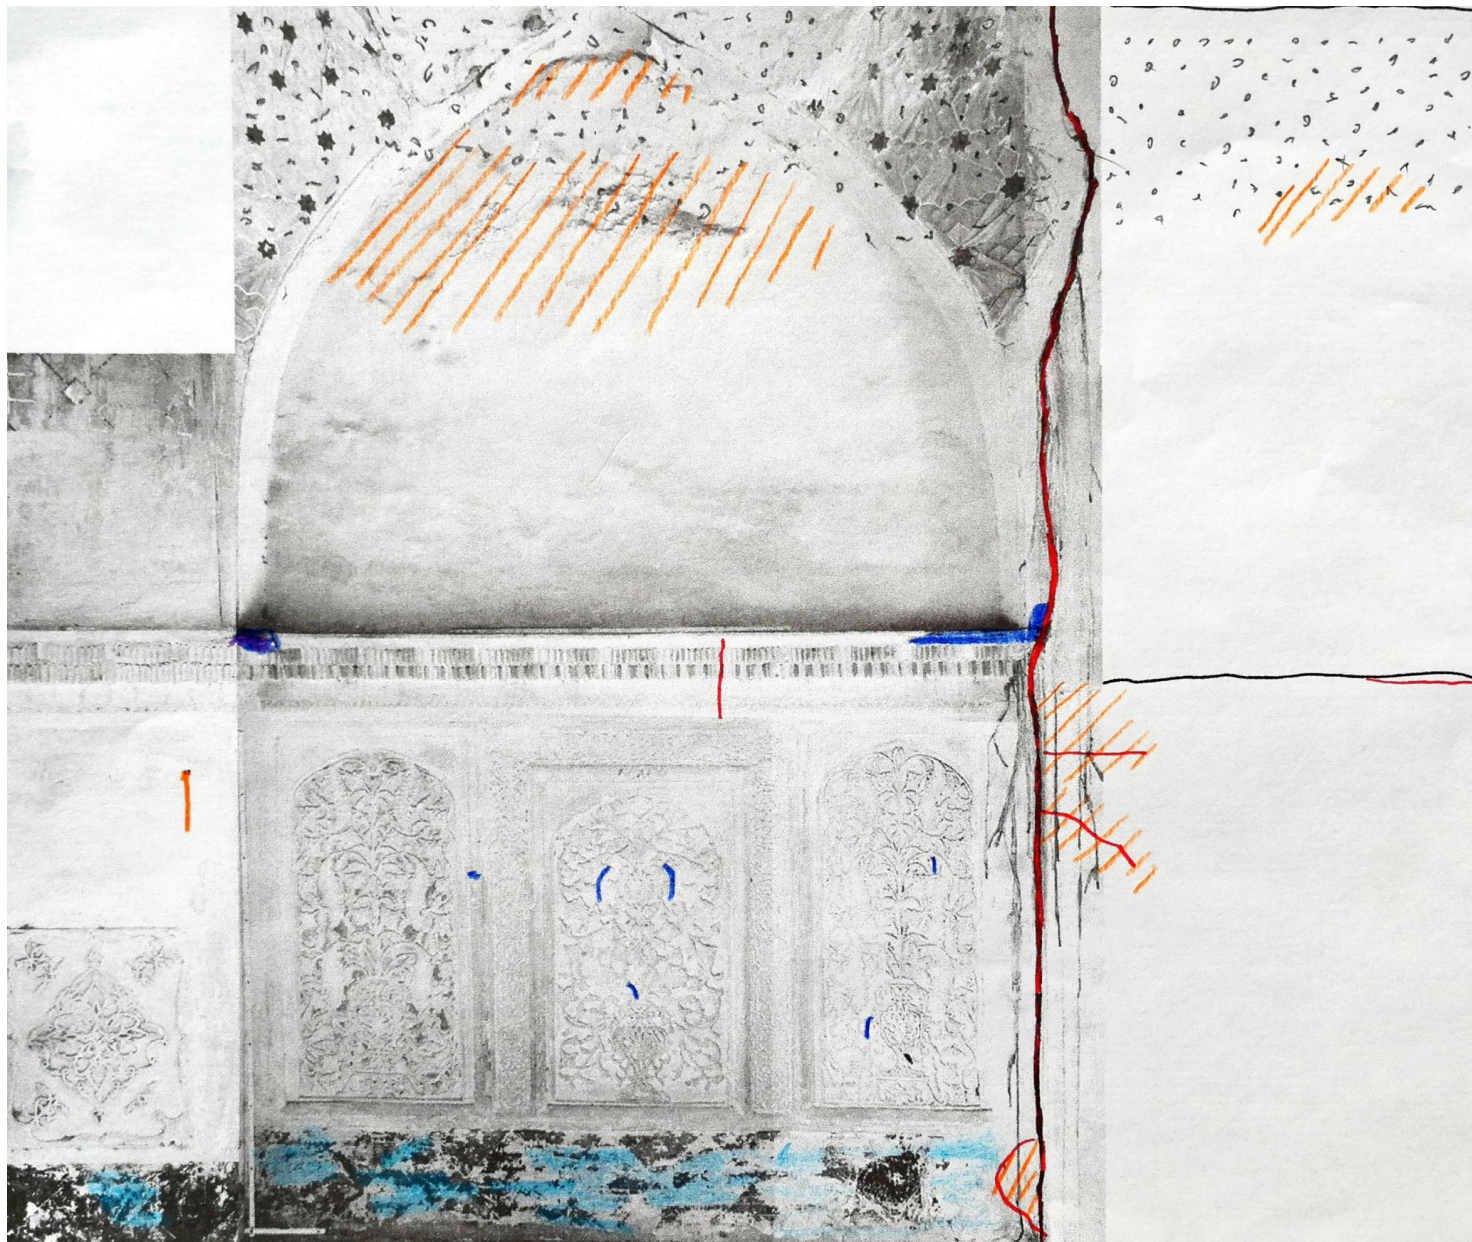
- Legend of damages:
- Lacuna/ Missing parts
 - Loss of paint layer
 - Crumbling
 - Peeling
 - Crack
 - Scaling
 - Salt
 - Biological growth
 - Corrosion
 - Burrow
 - Water traces

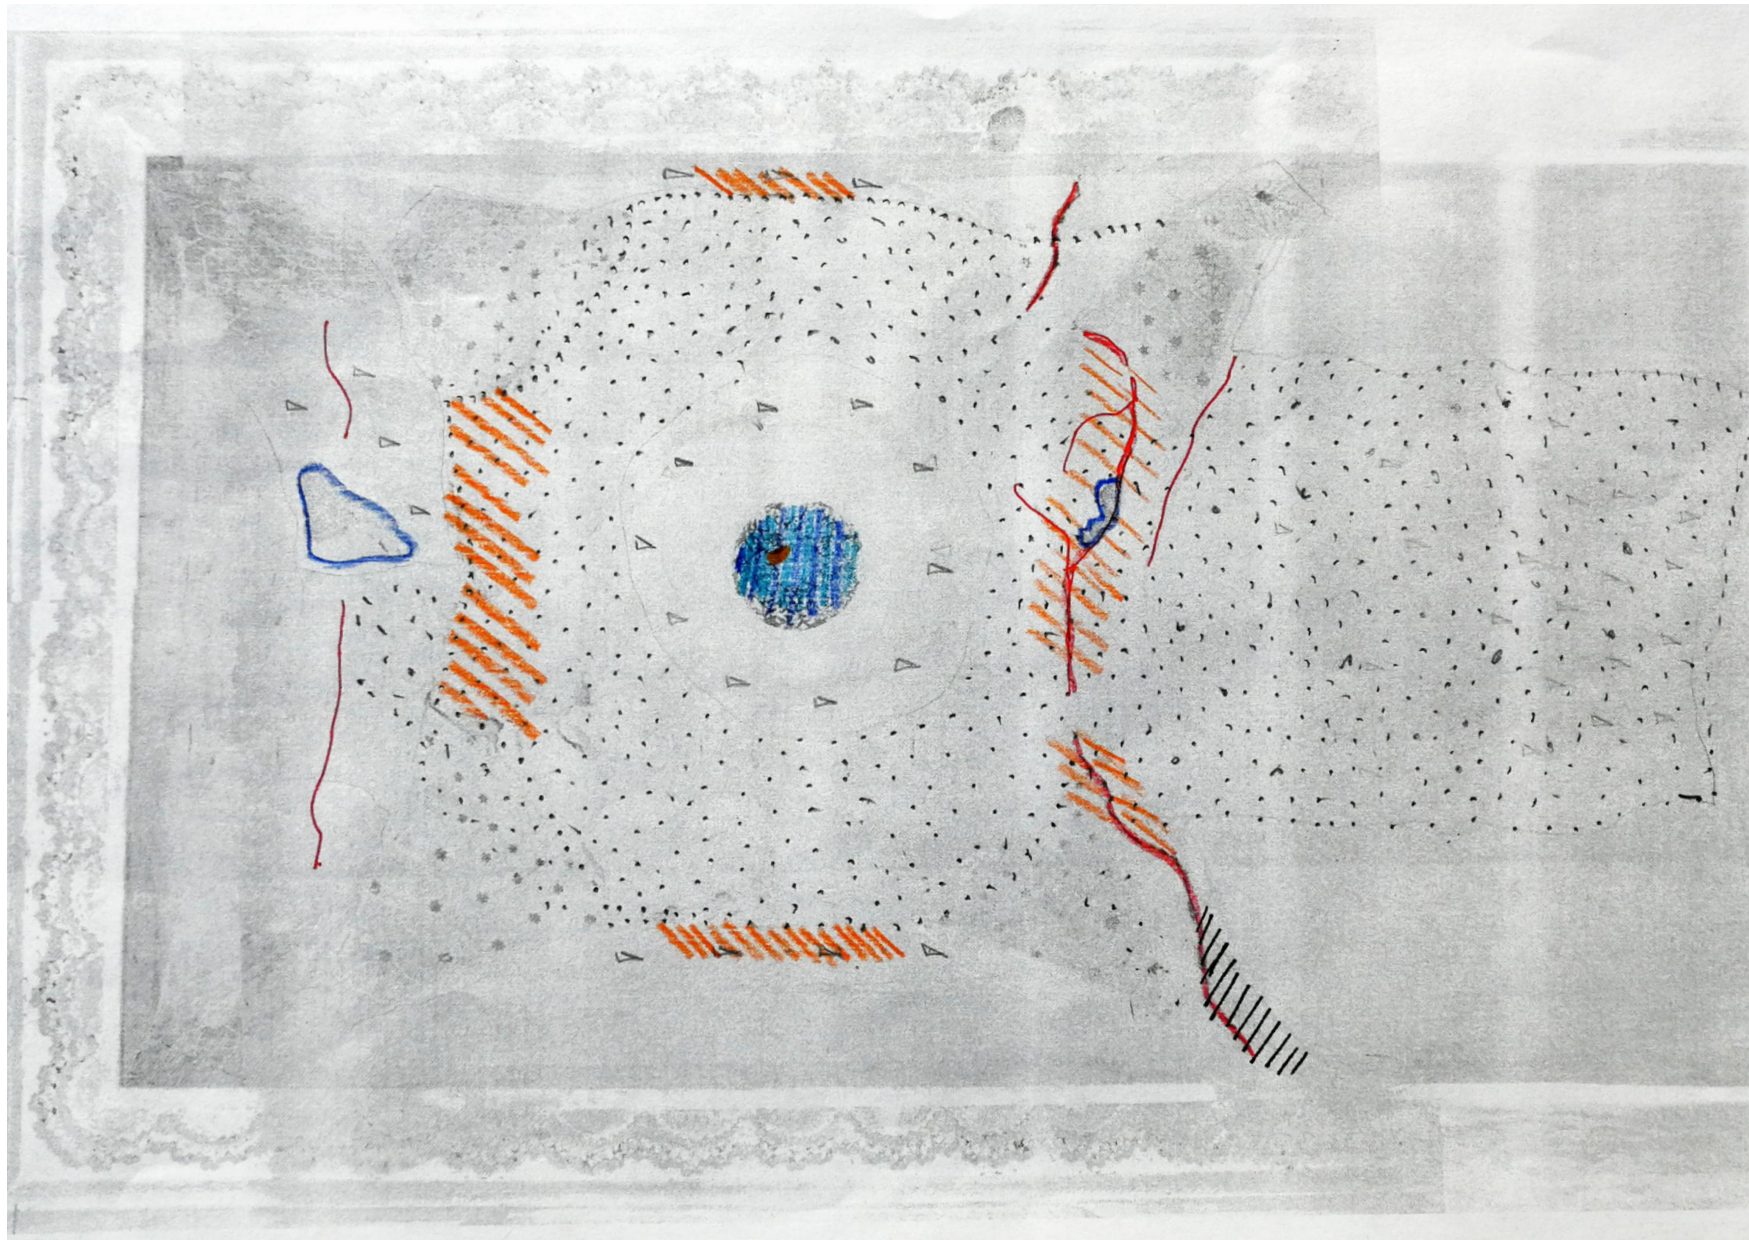
- Legend of damages:
- Lacuna/ Missing parts
 - Loss of paint layer
 - Crumbling
 - Peeling
 - Crack
 - Scaling
 - Salt
 - Biological growth
 - Corrosion
 - Burrow
 - Water traces

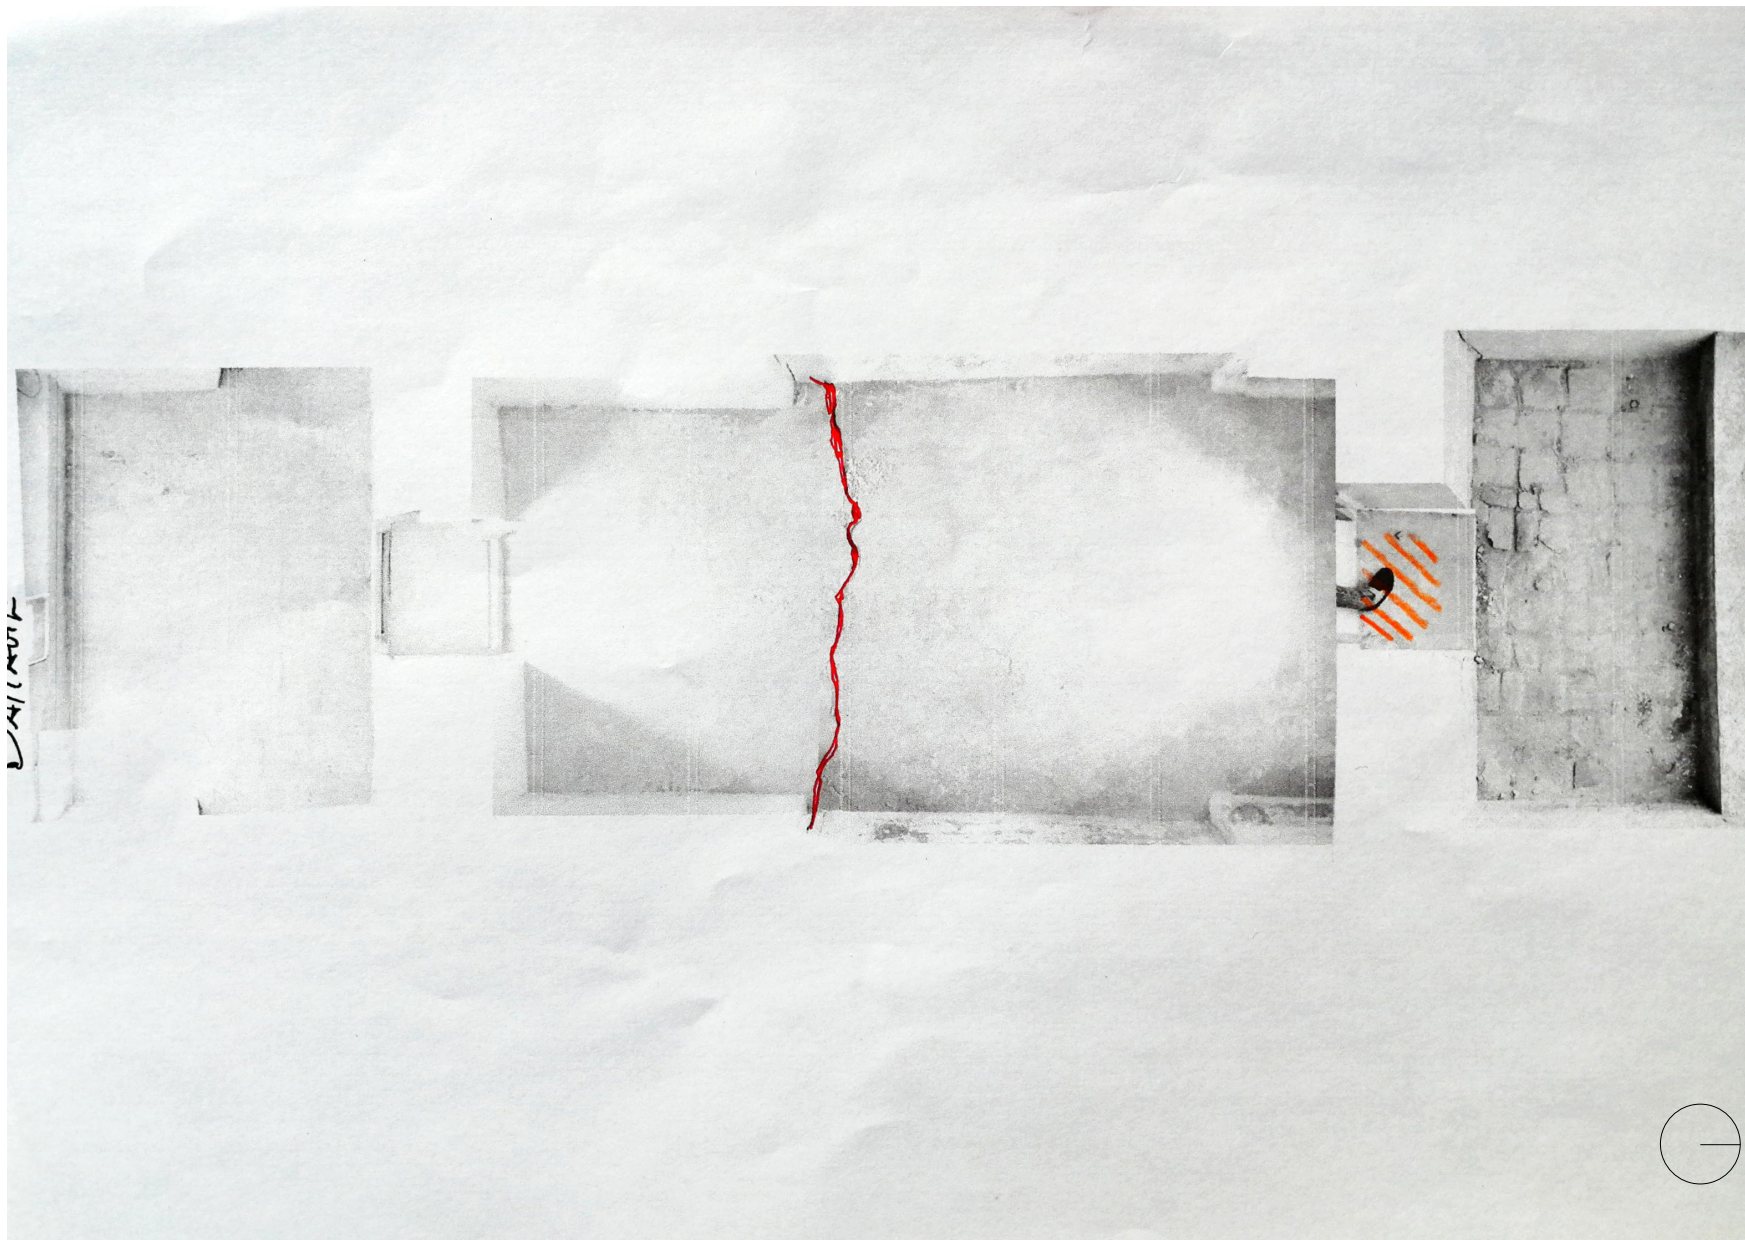
Traffic Light System

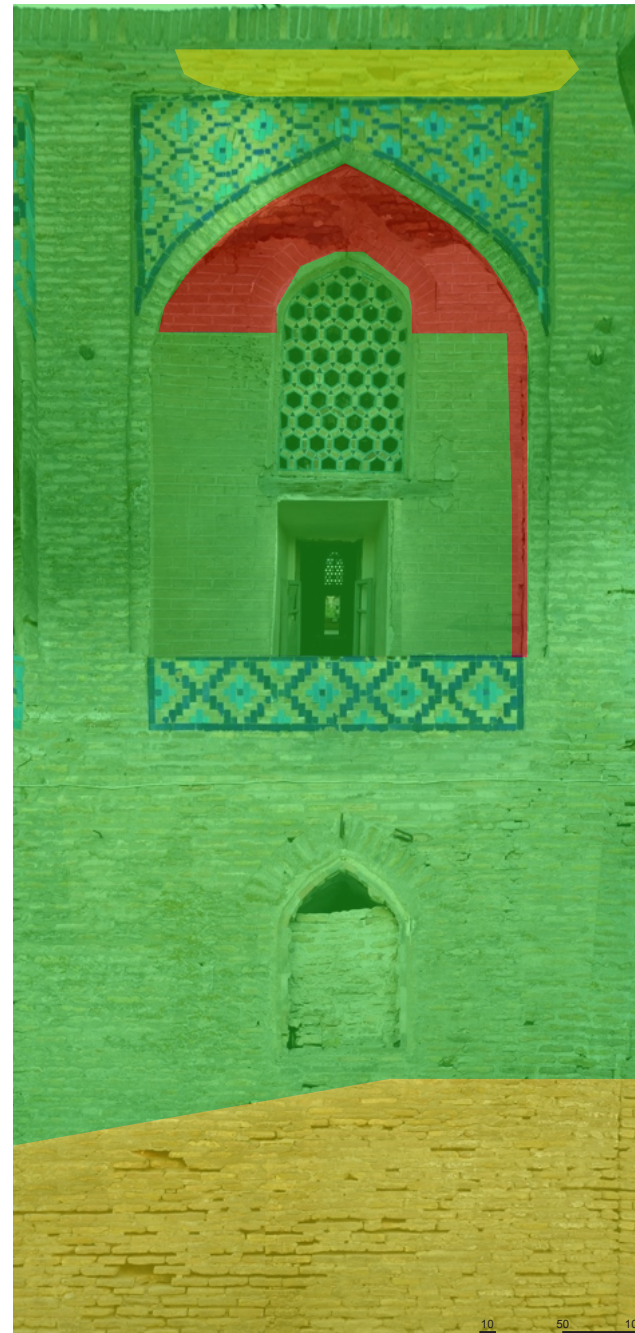
Photo- documen- tation

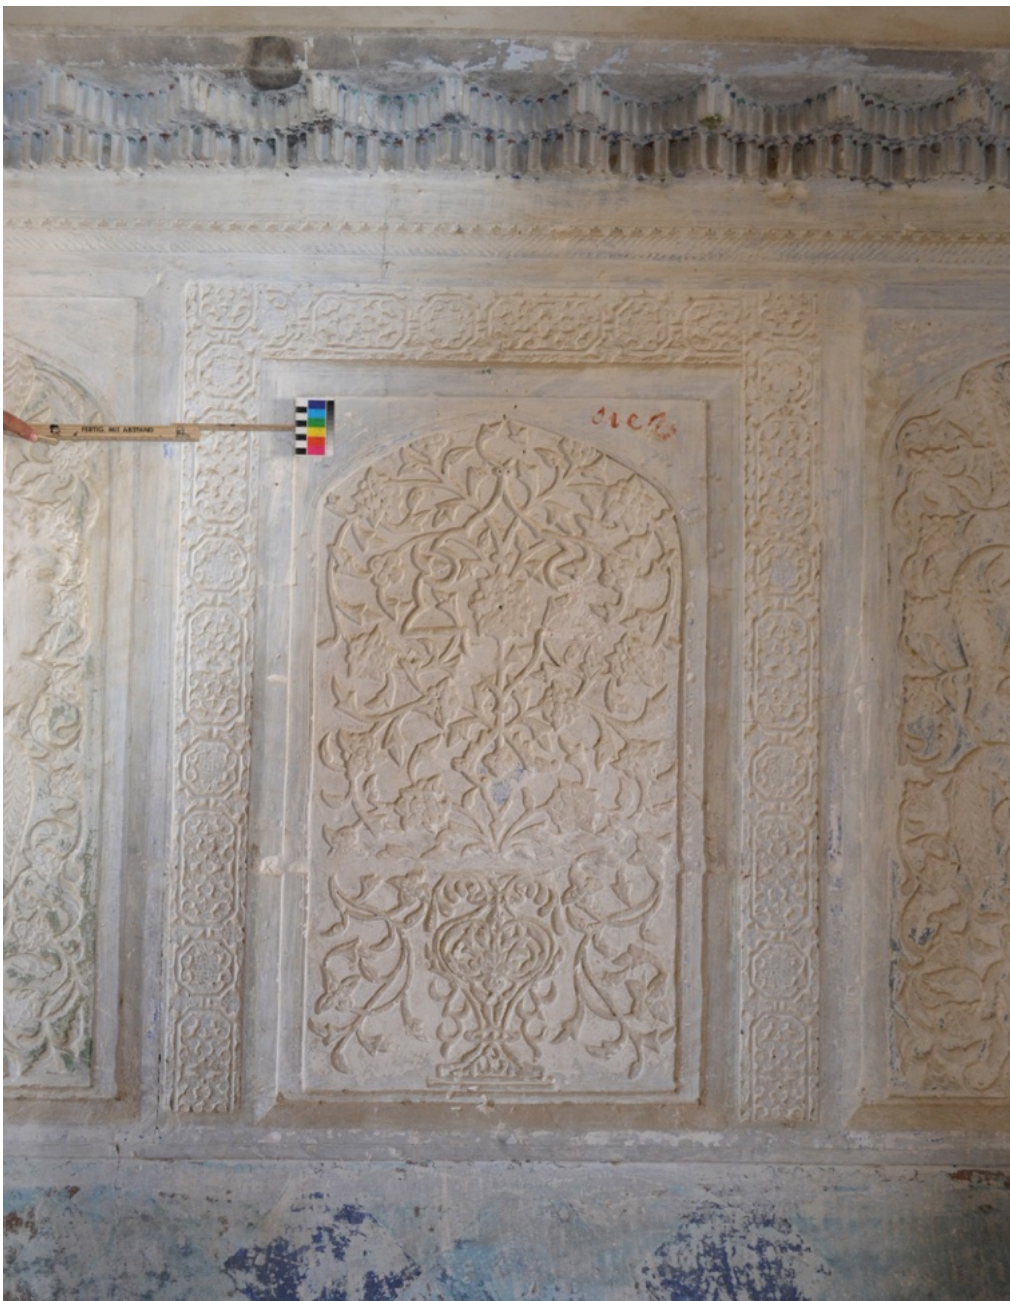
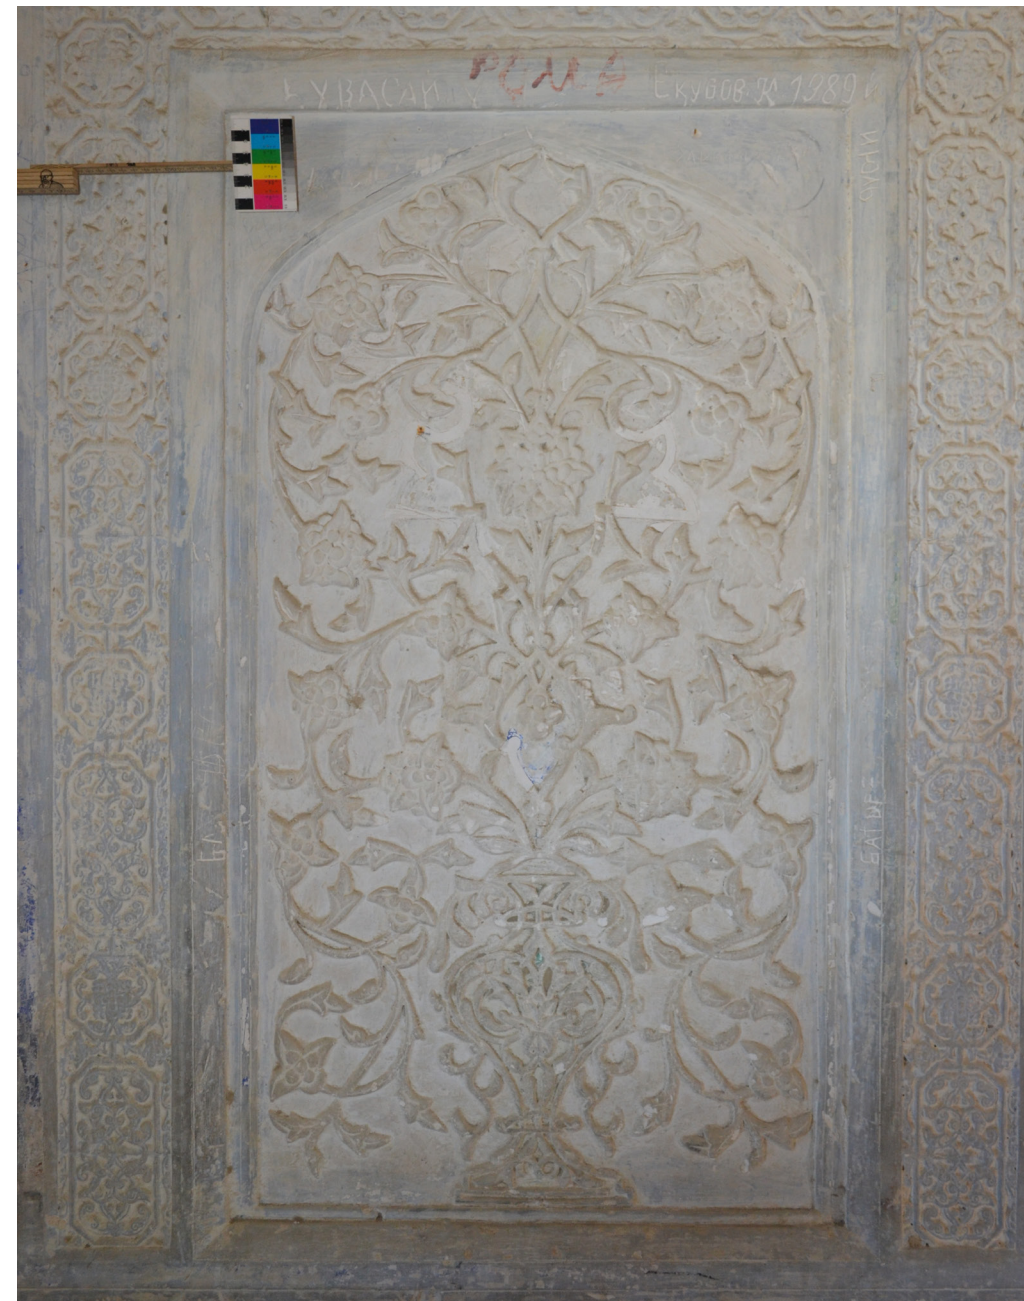
Rectangular frames on the west wall (fig. on the left) and the east wall (fig. on the right) made out of stucco, with different white floral ornaments

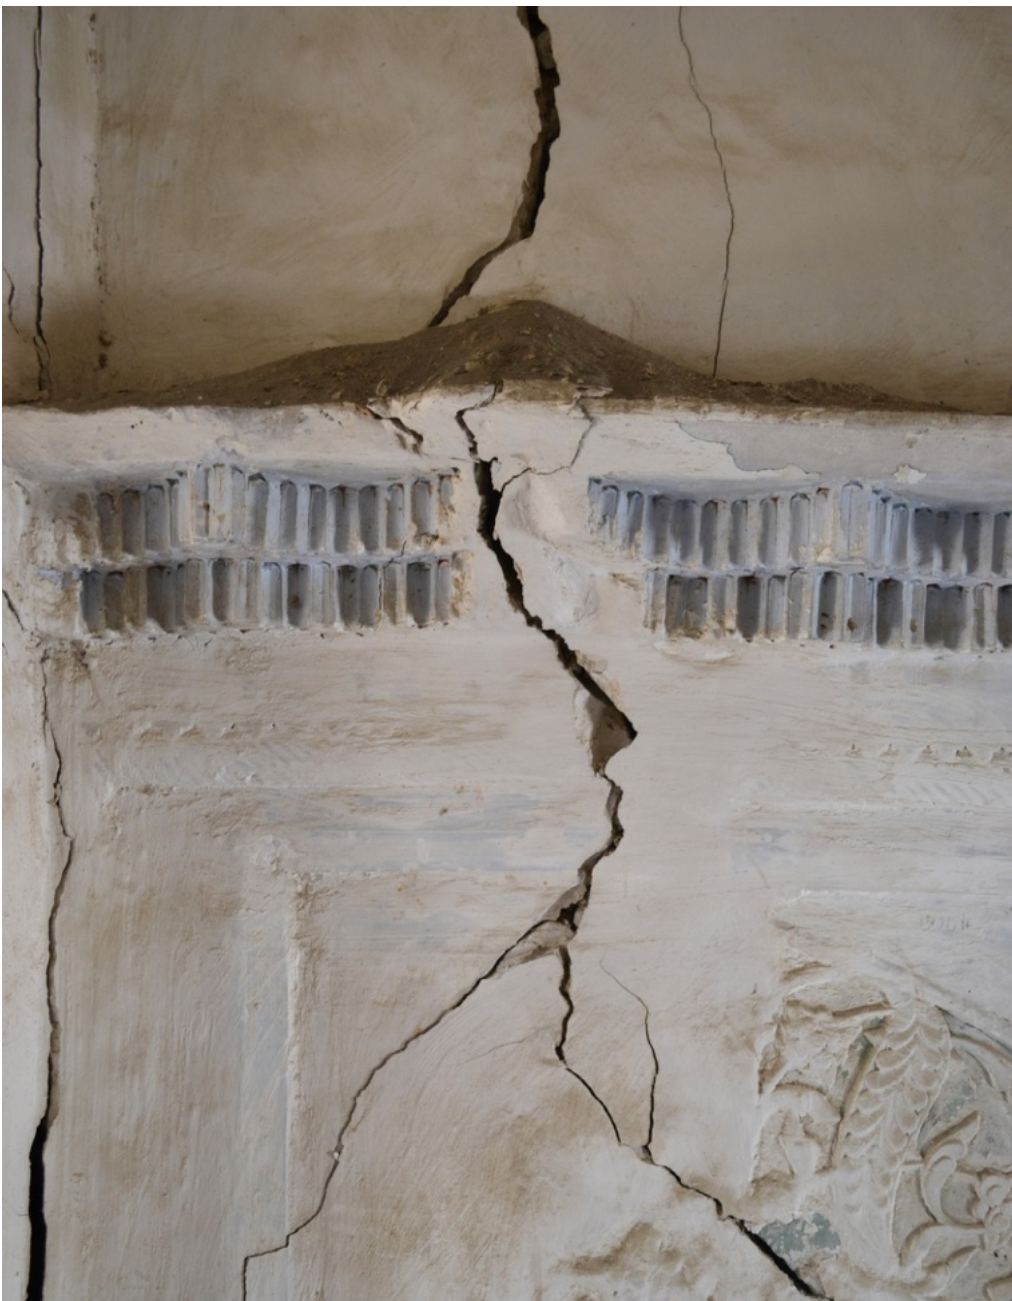
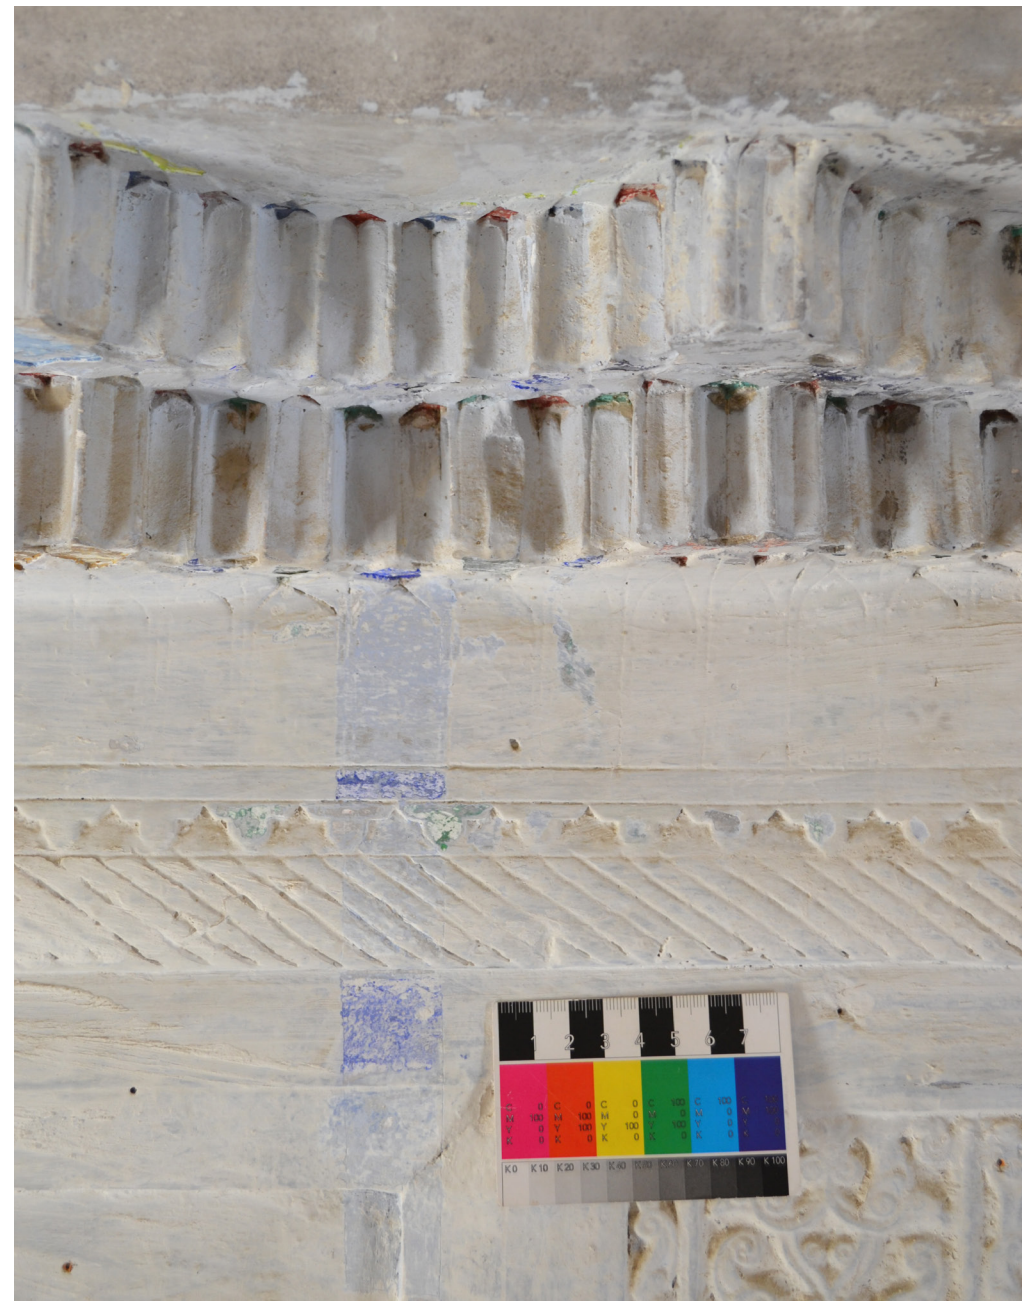
West wall: Analysis of the former colours on the elements of stucco (fig. on the right) and the sharafat with the crossing crack (fig. on the left)
