DOCUMENTATION

Summer School 2022 | Kukaldosh Madrasah Bukhara Uzbekistan

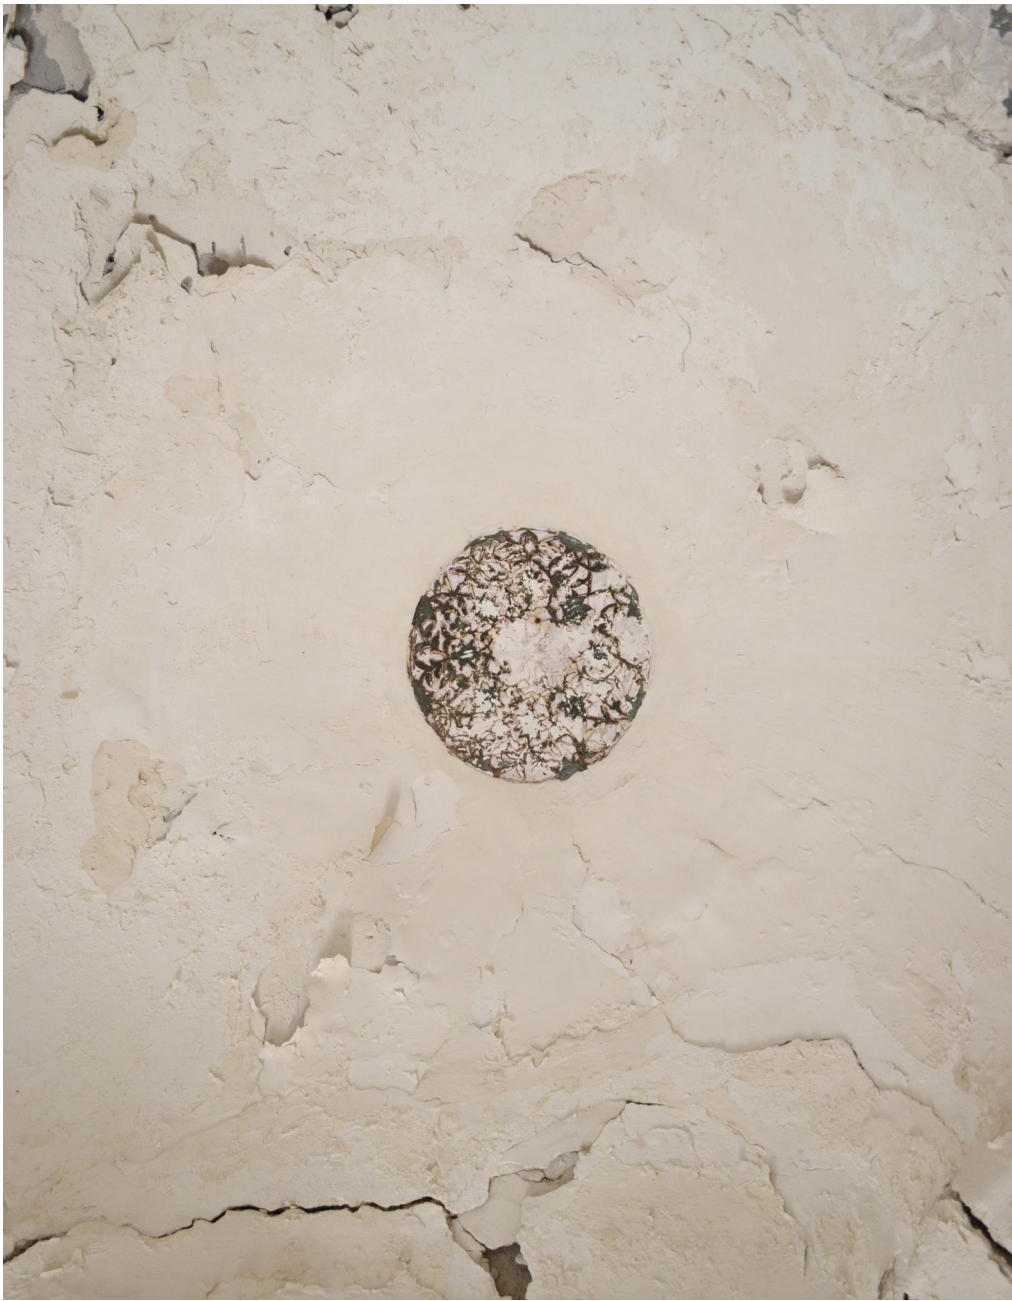
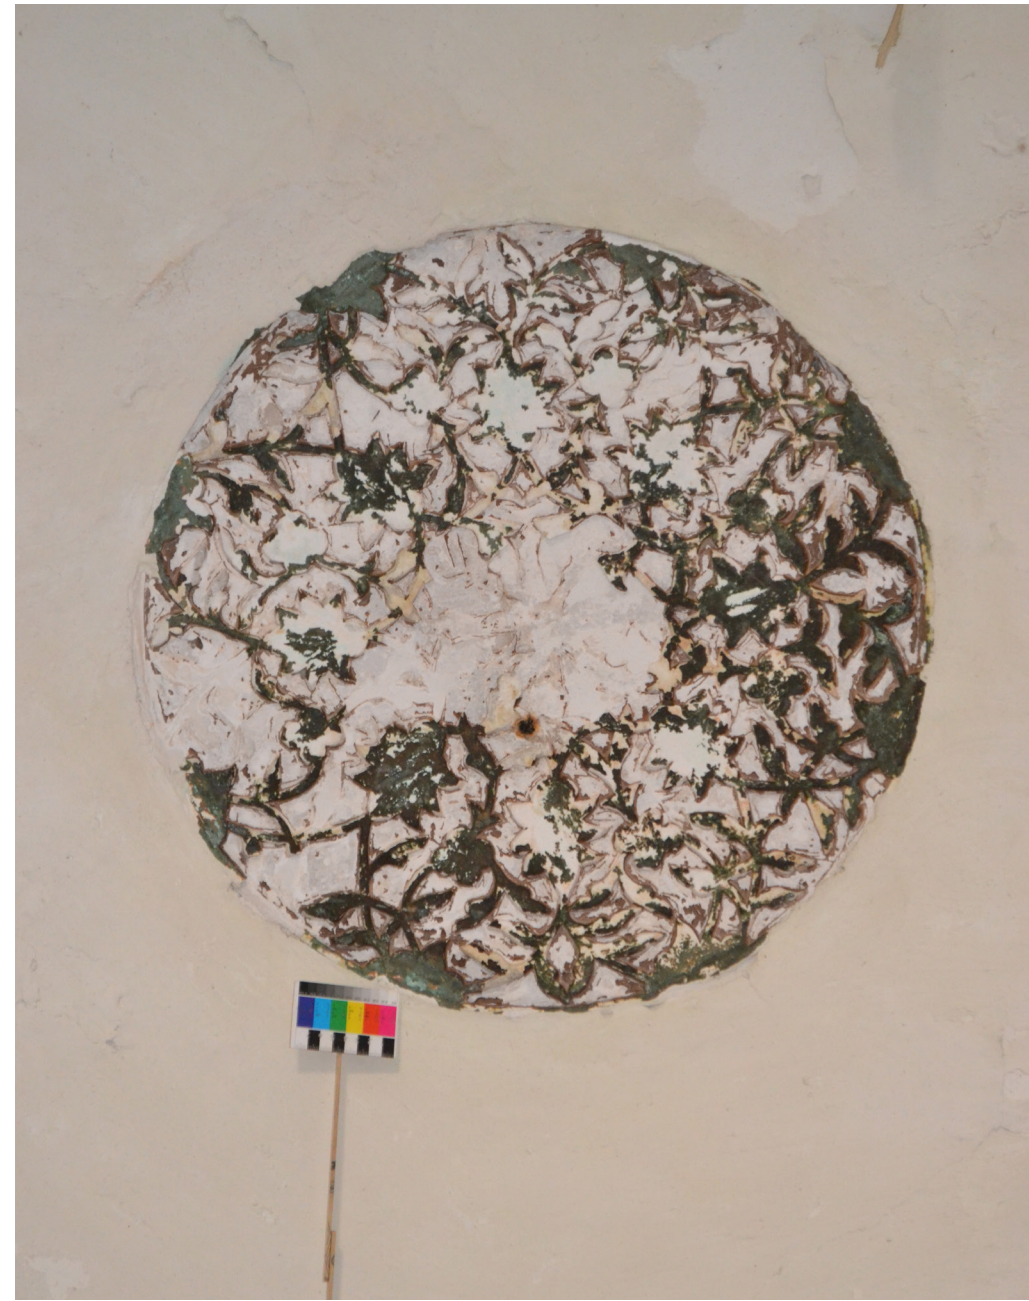
The figures show the circular floral Ornament in the peak of the cupola

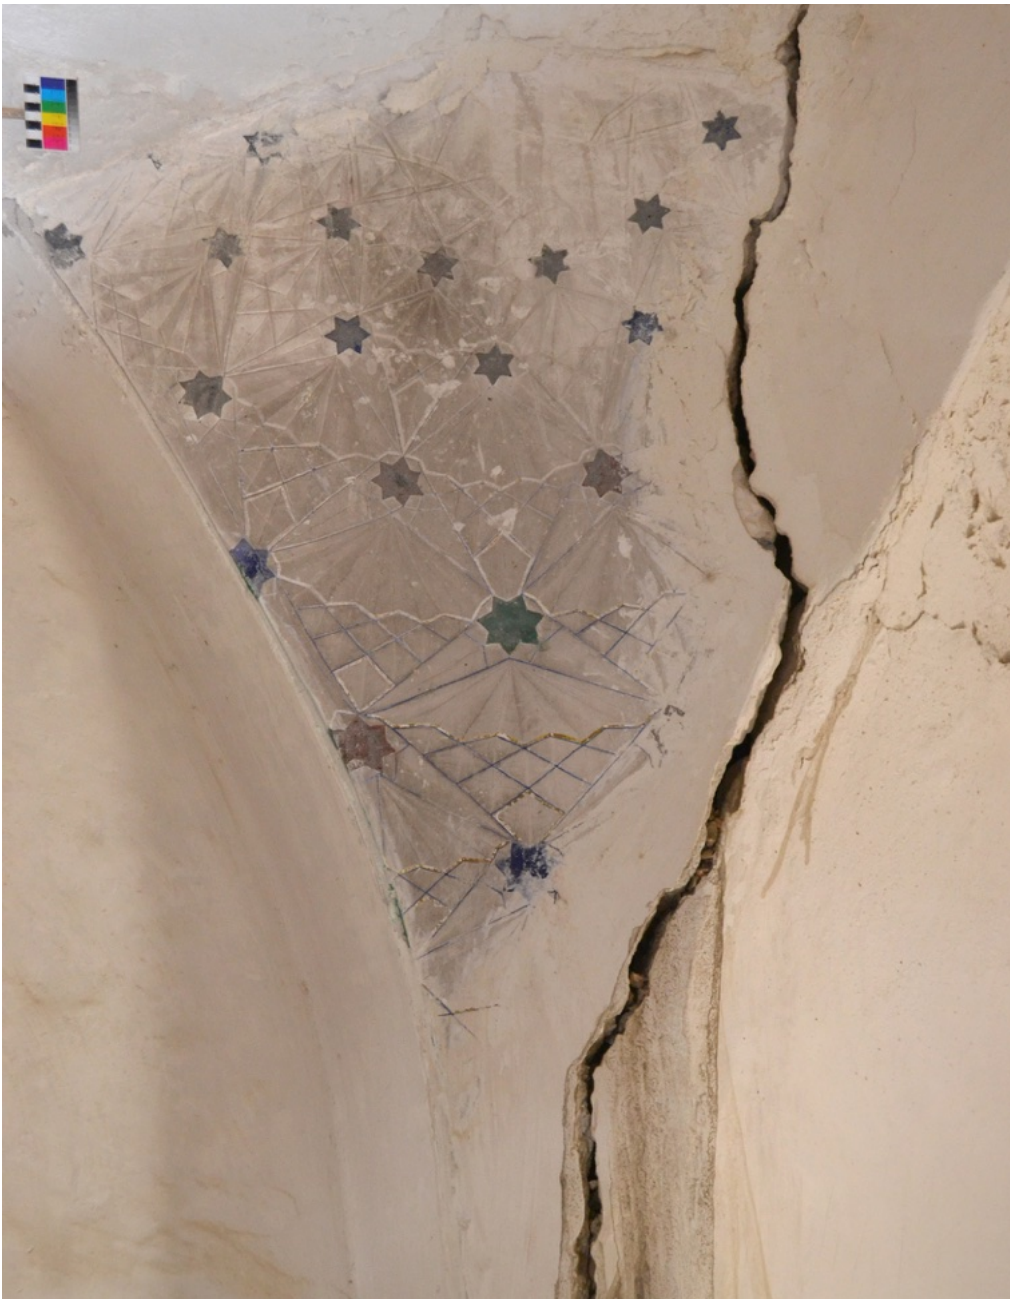
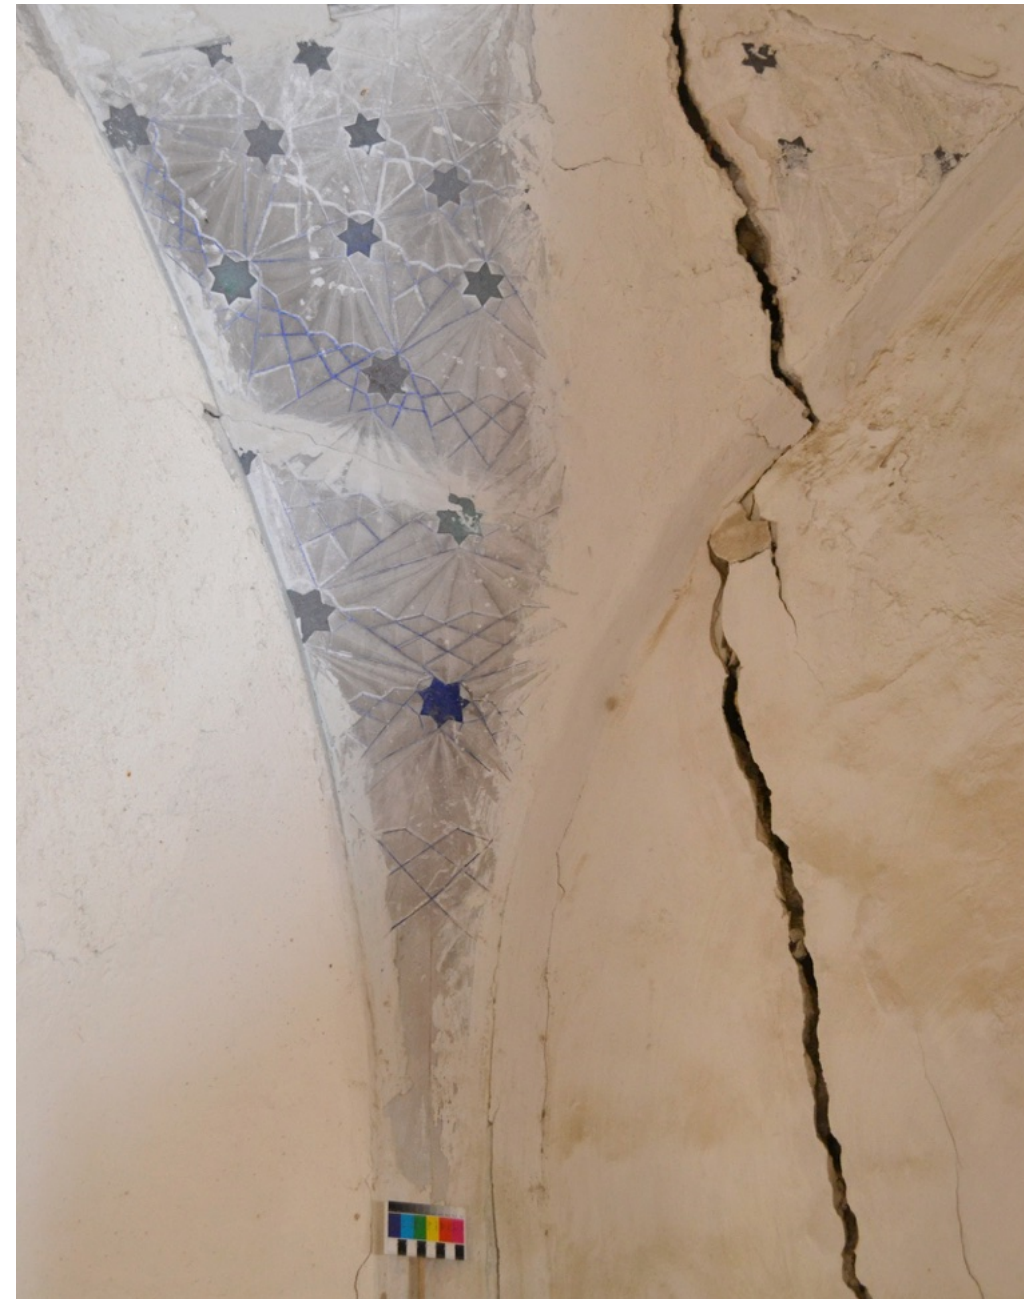
Looking south, to the pendants in the south-east corner and (fig. on the left) and the south-west corner (fig. on the right) with the immense crack

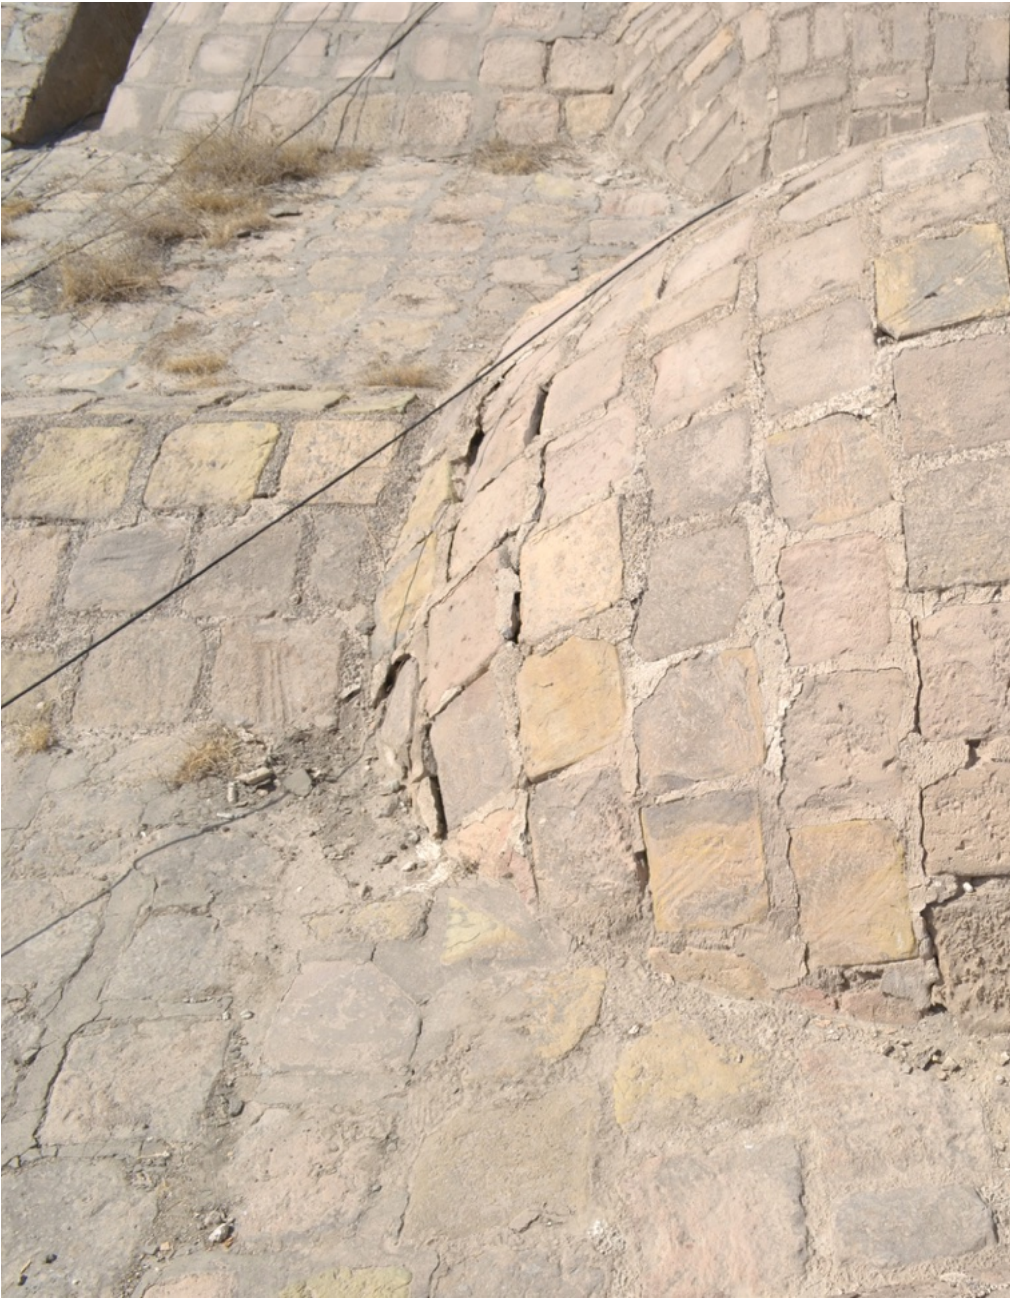
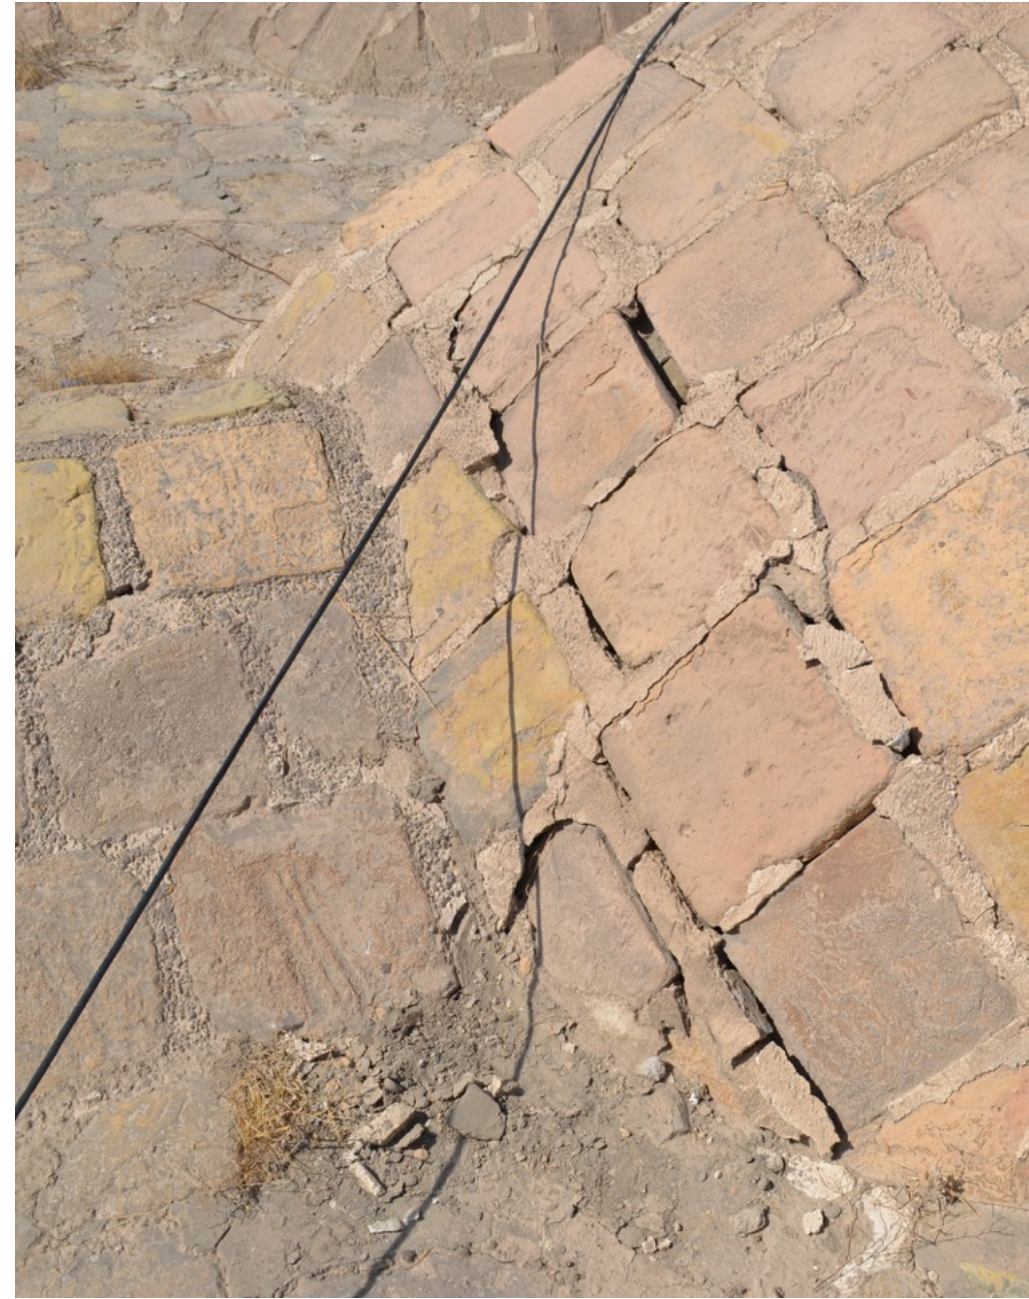
Roof of the cupola: Huge parts of the grouting mortar is missing, allowing the water to enter unhindered, which causes the crumbling plaster and stucco at the ceiling

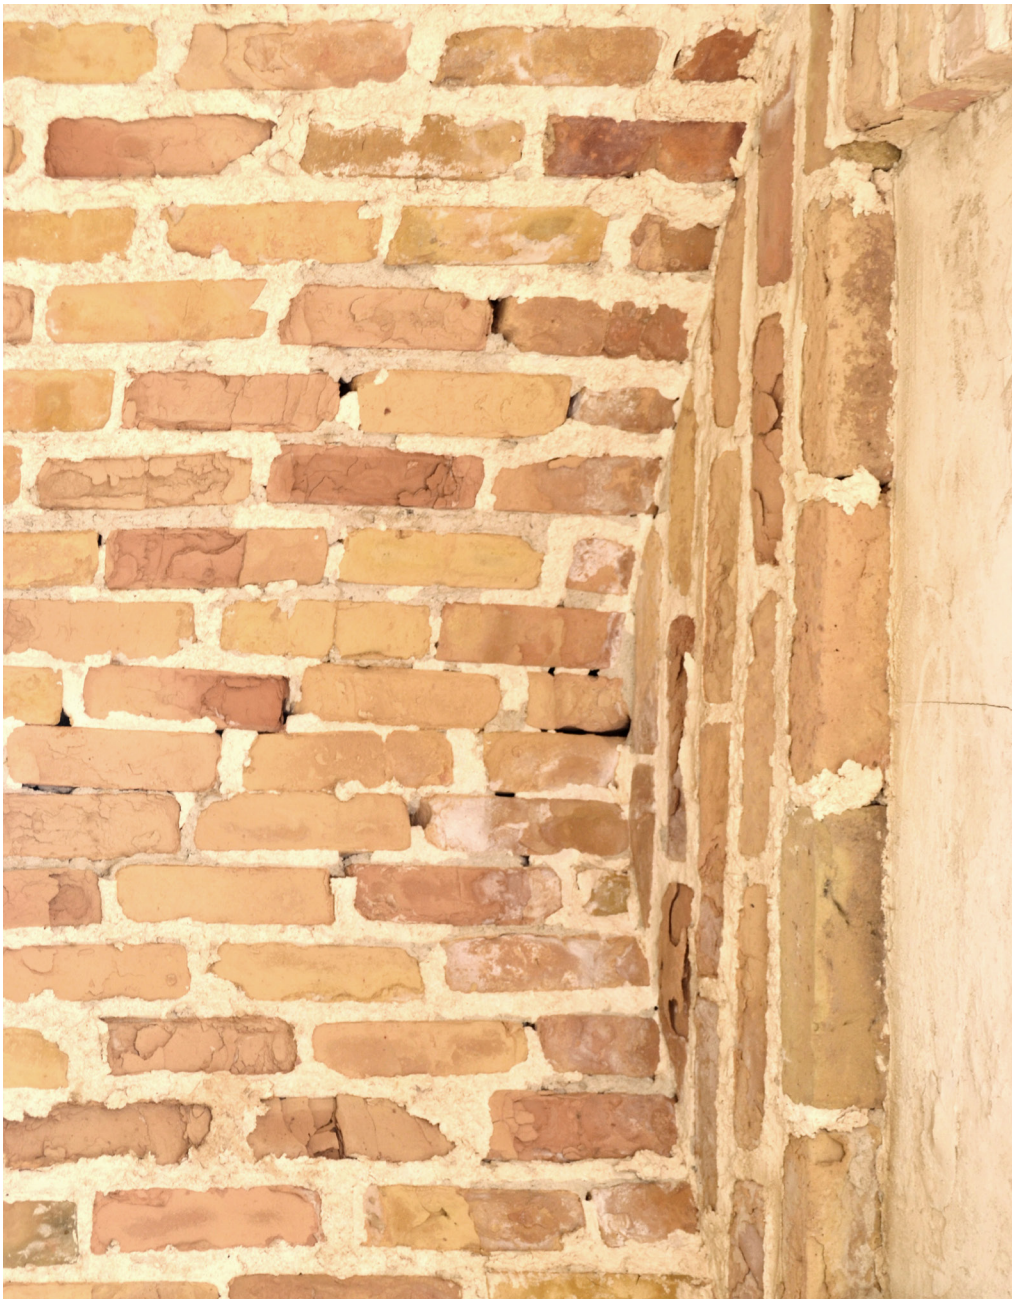
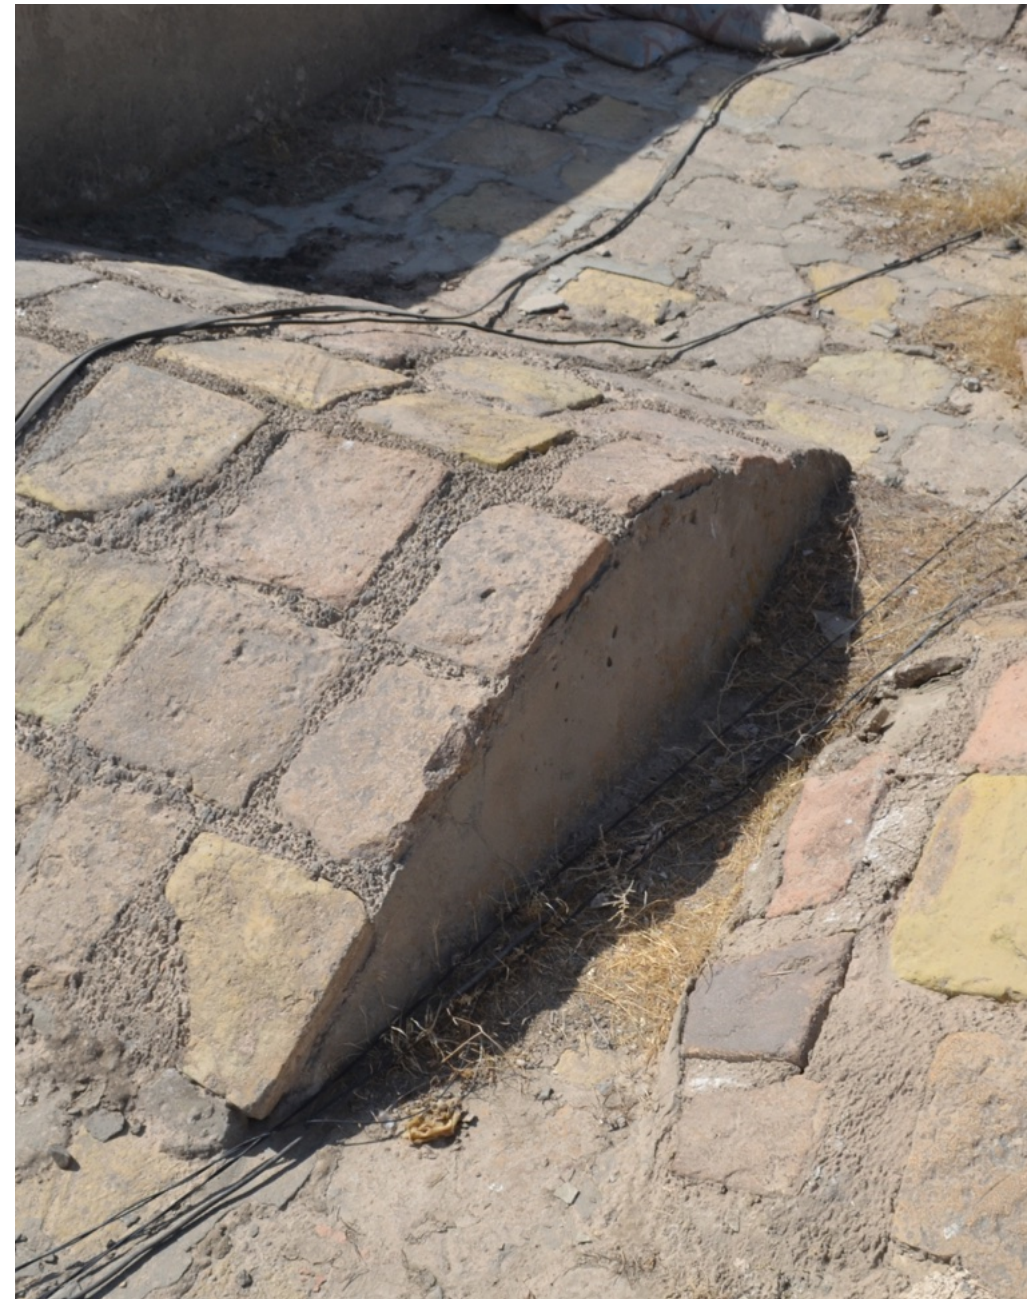
Arcade in the south: salt evaporation at the peak of the pointed barrel vault (fig. in the left), caused by a bad water supply system on the roof (fig. on the right)

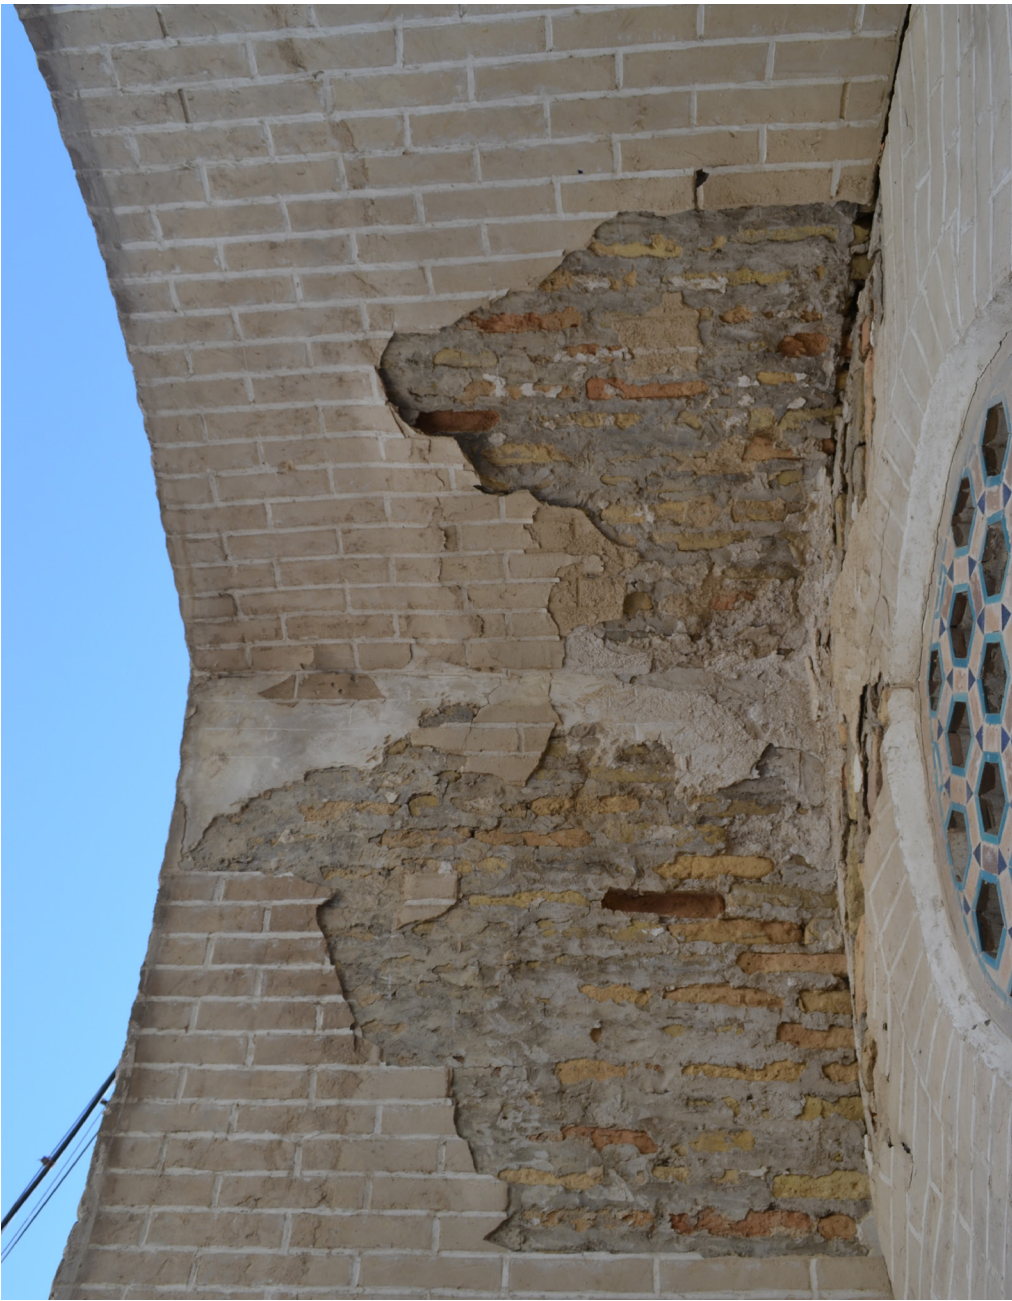
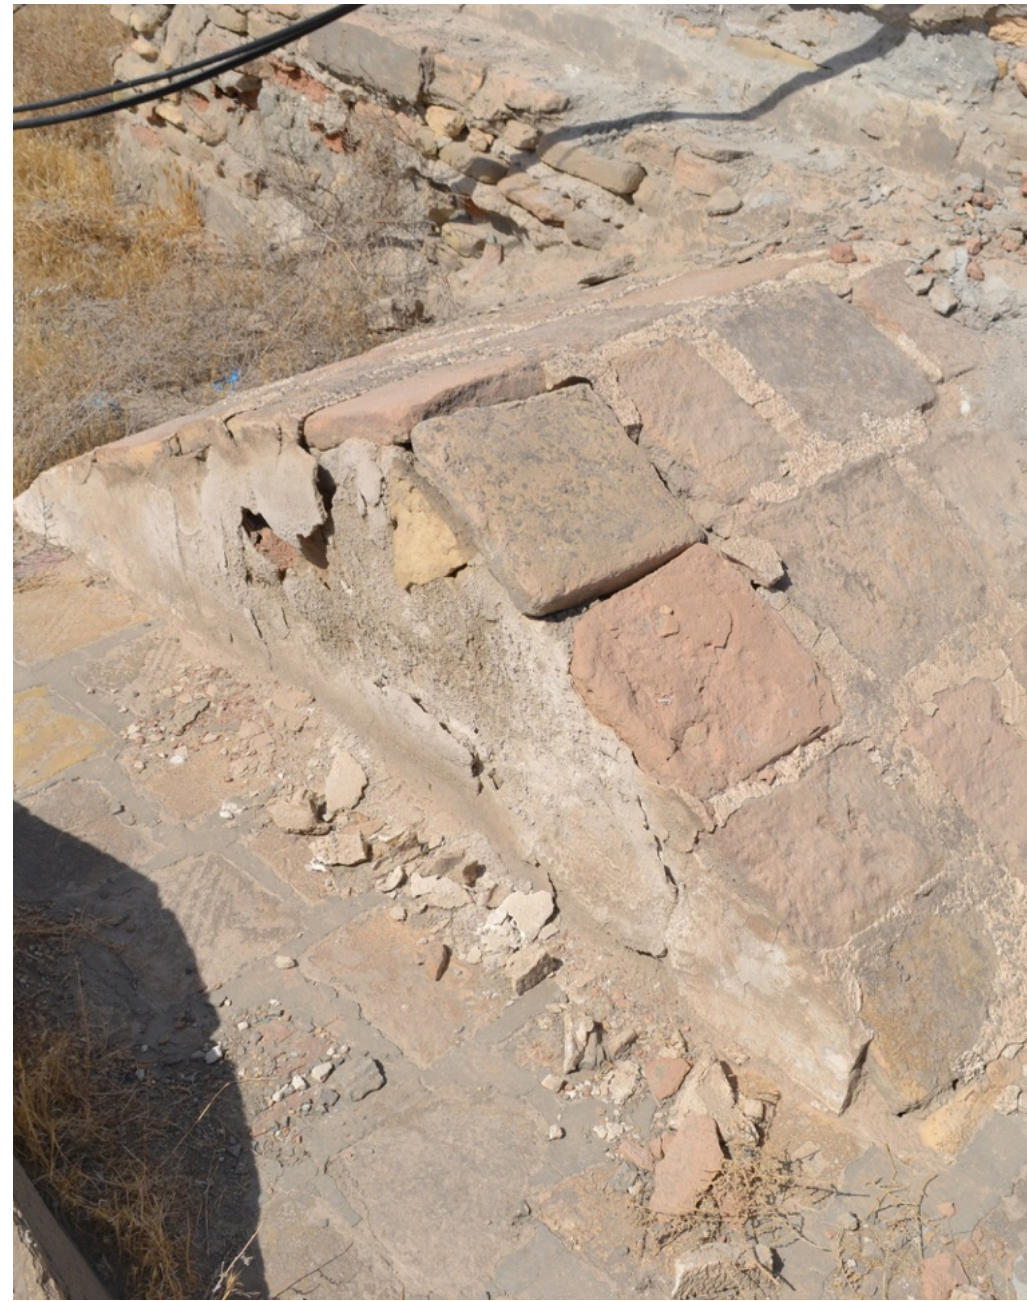
Loggia in the north (left): Parts of the plaster at the ceiling are missing, while the surrounding plaster is scaling heavily

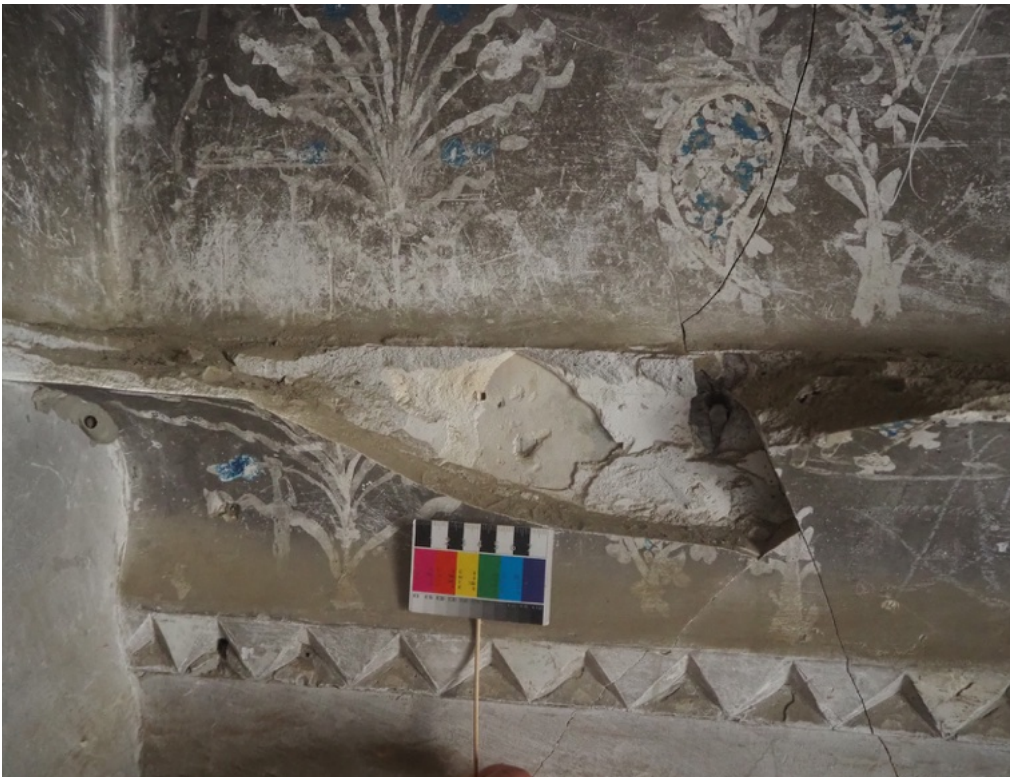
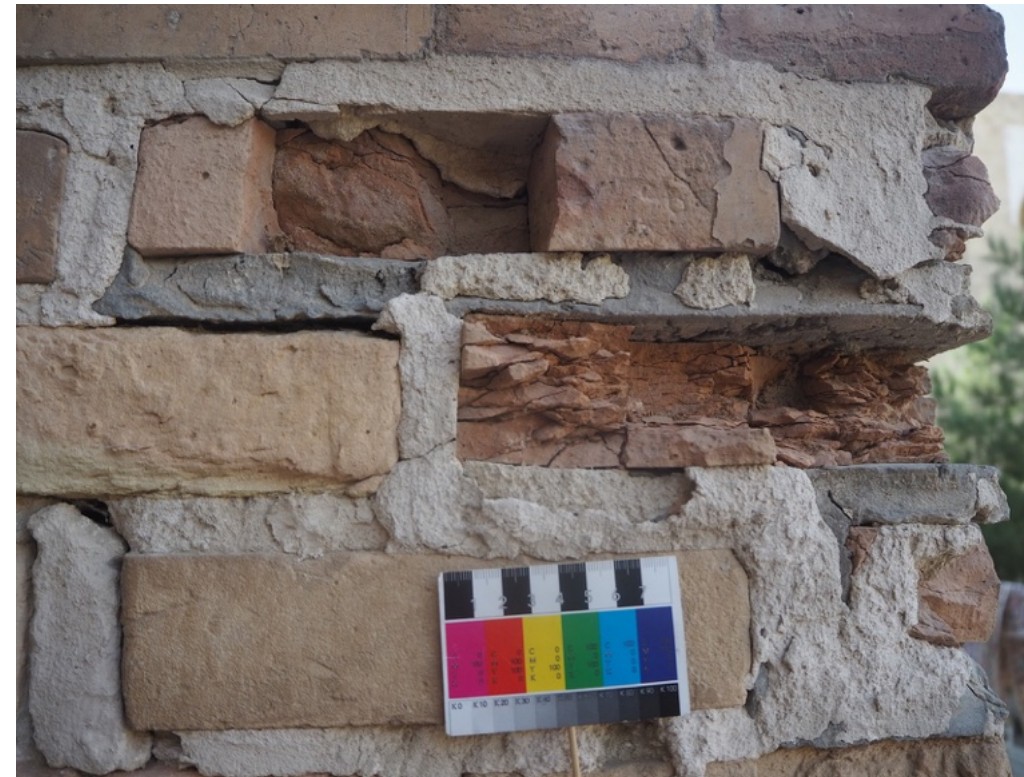
Loss of paint layer
Fehlende Malschicht
Отсутствует слой краски

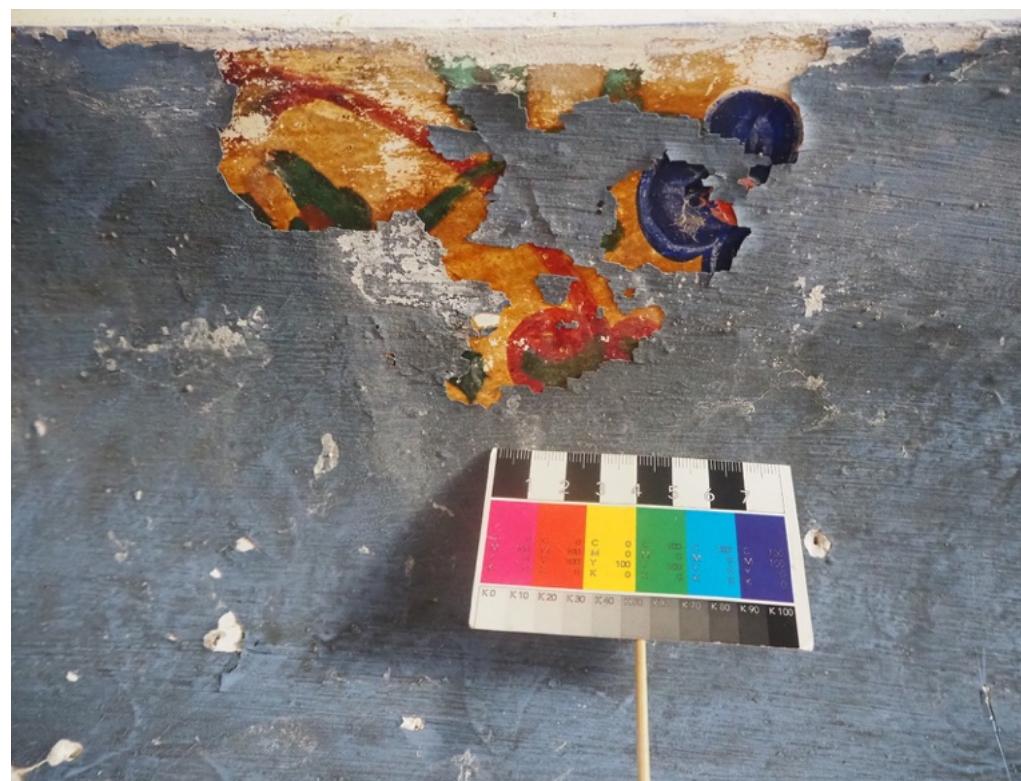
Auf Malschicht bezogen! Referring to paint layers! Относится только к слоям краски!

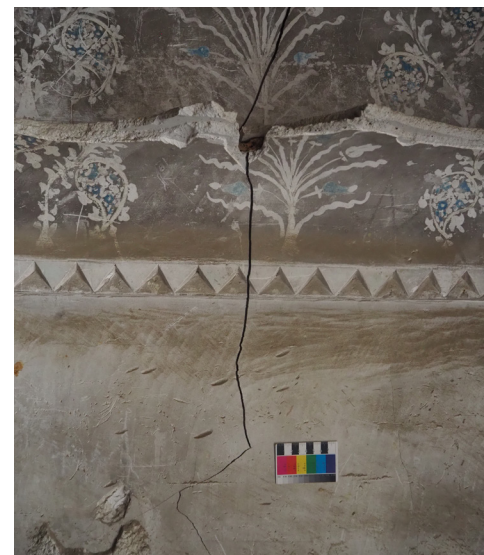
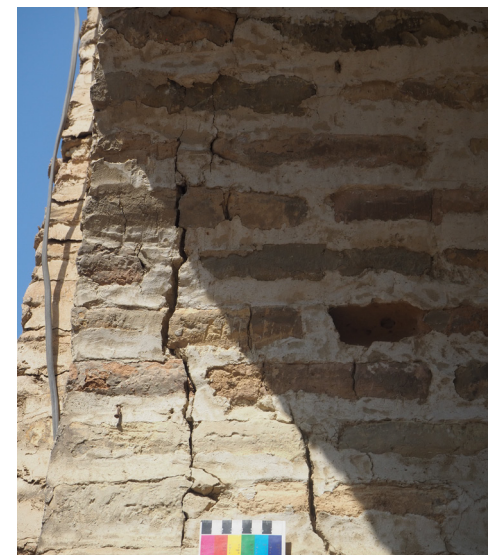
Scaling
Schalenbildung, Hohlstellen
Осыпание

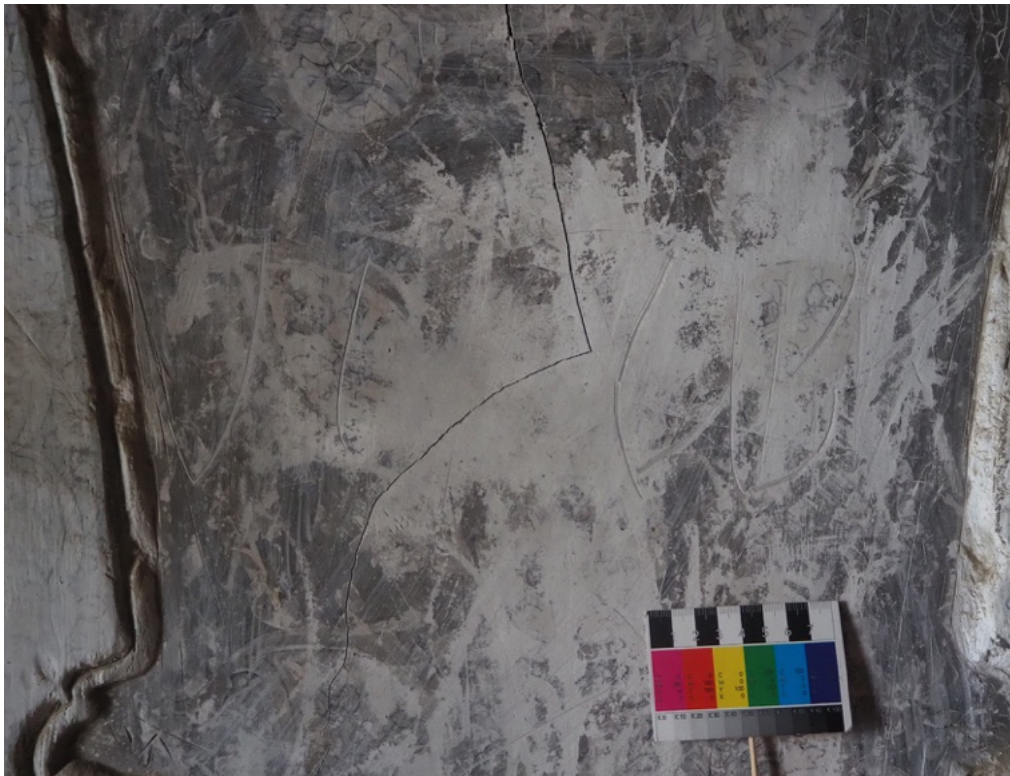
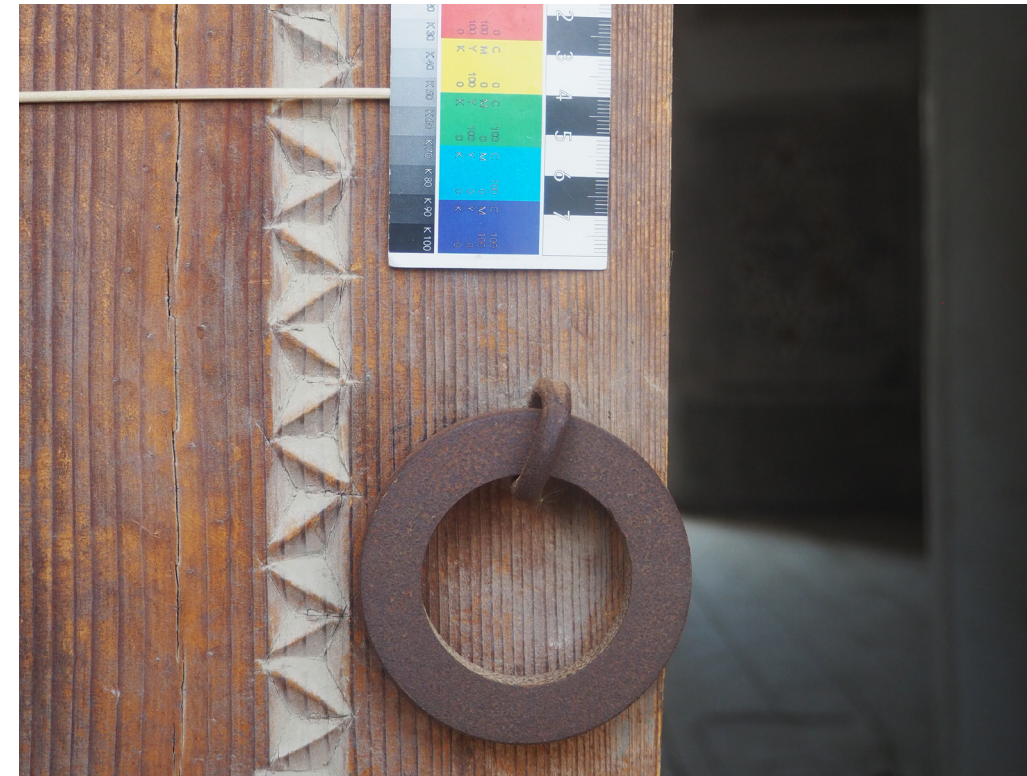
Graffiti
Graffiti
графические рисунки

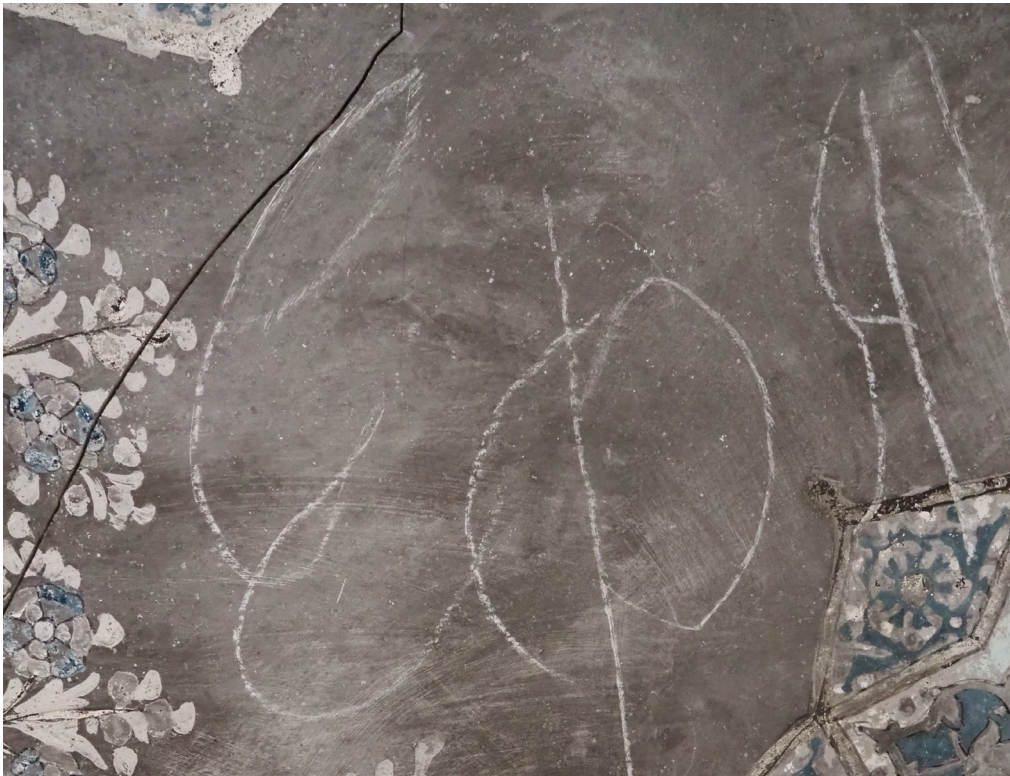
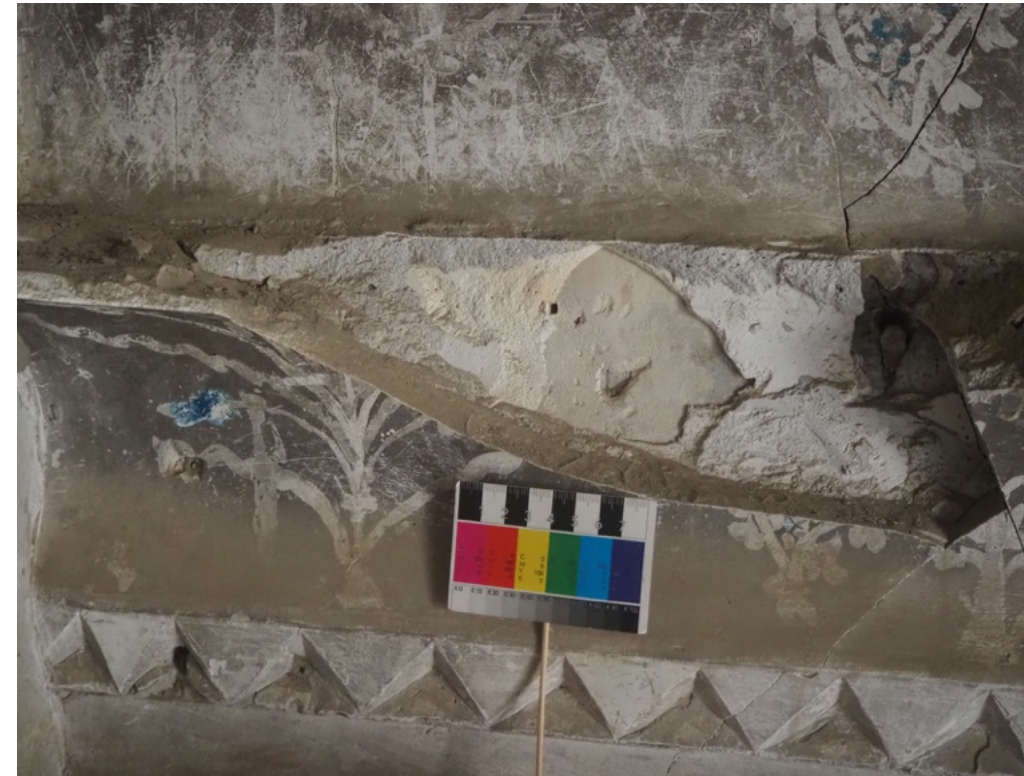
Die ganze Fläche wird kartiert, nicht jedes einzelne Loch. Single burrows will not be mapped. The hatching will be applied to the whole area. Поверхность полностью будет зафиксирована, не каждая дырка в отдельности. Штриховка применяется ко всей поверхности.
