**On the risks of transporting
liquid and gaseous fuels in pipelines**

Research report 289

Berlin 2009

BAM Federal Institute for Materials Research and Testing

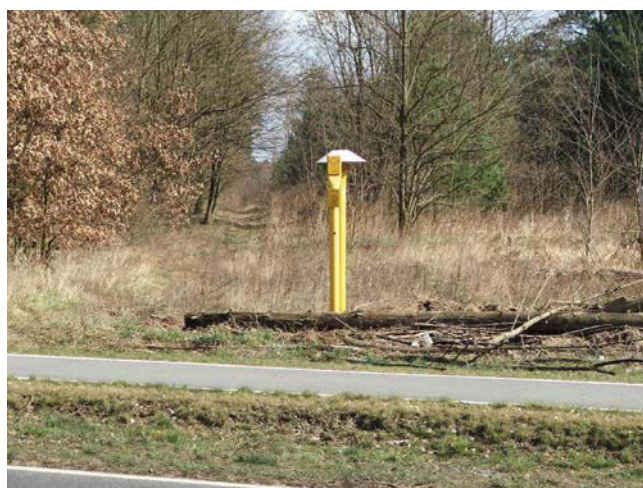
Figure 2 shows a route post in a mixed forest area. If the forest path becomes overgrown, the pipeline may easily be damaged in the course of earthworks, especially if firms who do not know the local area carry out such work and no information on possible pipeline routes has been obtained.

Figure 2: Route post in a wooded area.

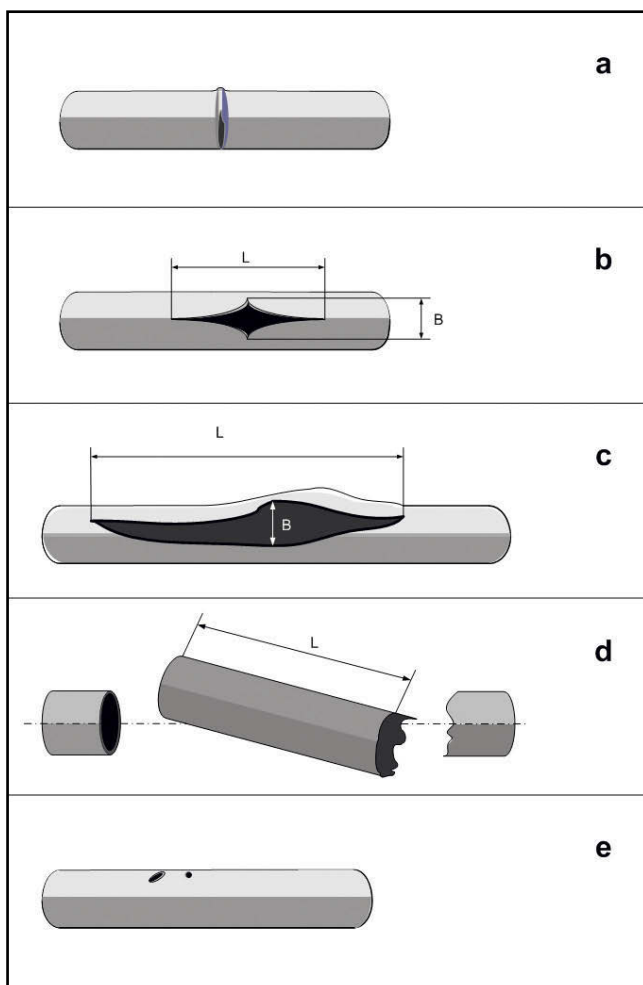
- a) Splitting of the pipeline in a tangential direction, mostly caused by earth movements (landslide) or by being passed over by heavy construction equipment or similar machines,
- b) Splitting of the pipeline in an axial direction over a relatively short section with simultaneous widening crosswise to the pipe axis (fish mouth rupture),
- c) Splitting of the pipeline in the upper vertex over several metres,
- d) A pipe segment bursts out, i.e. the entire pipe cross-section is exposed (guillotine break) and
- e) An oval or circular penetration of the pipeline caused by excavator shovels or earth borers, see figure 7.

Figure 7: Typical types of leaks in high pressure pipelines

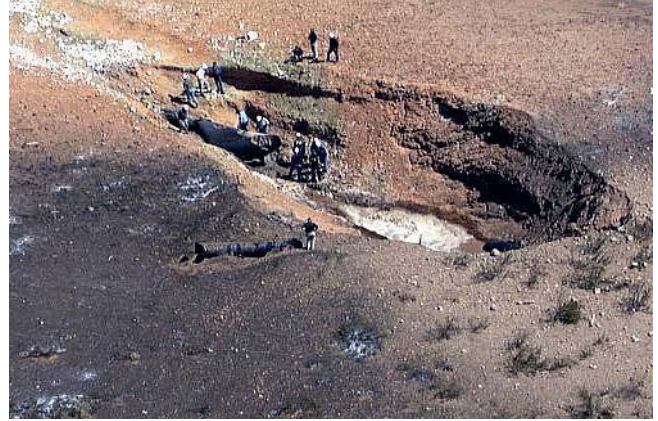
A guillotine break (figure 3, case d)) occurred on 19 August 2000 in Carlsbad (New Mexico, USA). A section of pipe around 15 m long was blasted out of the explosion crater from a 762 mm natural gas pipeline which, at the time of the accident, had an internal pressure of 47 bar, figure 8. The gas ignited and the flare burnt for around 55 minutes.

Figure 8: Carlsbad explosion crater 19 August 2000 (source: NTSB/PAR-03/01)

In the “guillotine-type” pipeline failure that occurred on 19 August 2000 in Carlsbad, 12 people were fatally injured by the thermal radiation 205 m away from the explosion crater.
