Characterisation of Historic Façades using Active Thermography with Solar Heating and Optical Methods

Abstract. Active thermography is well suited for the detection of delaminations and cracks in façade elements like plaster and tiles. Not only artificial heating but also solar heating can be used if the adjustment of the façade and the weather conditions are suitable. Optical methods like laser scanners, photogrammetric methods and crack tracking sensors are providing geometrical 3D data which can be used for a 3D mapping of thermograms and for providing data with higher geometrical resolution. Thus, by the combination and fusion of these data, a comprehensive mapping and monitoring of damages of façade systems is possible.

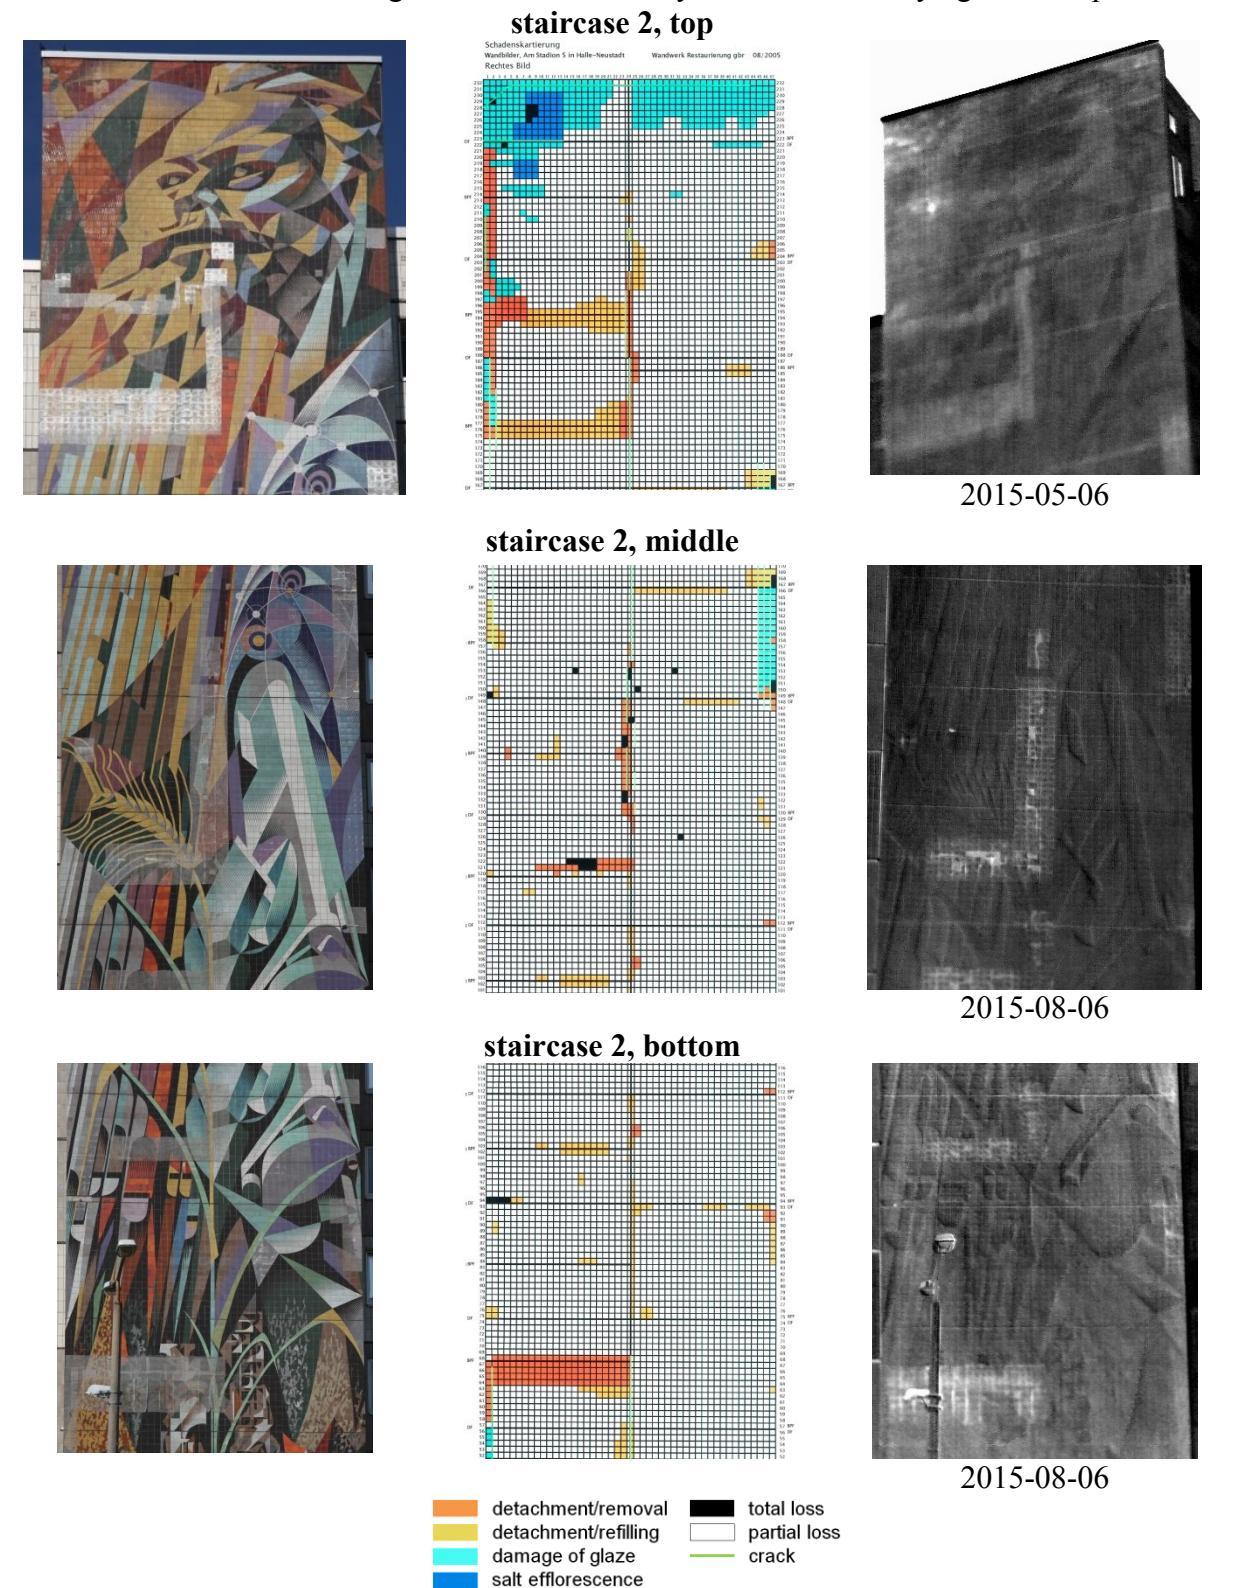
Fig. 1 shows a collection of photos, damage mapping and selected difference thermograms of three stacked sections of staircase 2. From comparison, the following observations could be summarized:

- In the photos, the fixed nets used for protecting the tiles against falling down could be recognized easily.
- In the top part, the tiles in the top left corner with salt efflorescence and with damage of glaze could be detected as warmer (lighter) areas. Few of the warm single spots could be related to missing tiles, which are not registered in the damage mapping.
- In the middle part, the areas which are marked as total loss in the damage mapping are appearing as warm (light) areas in the thermograms.
- In the bottom part, especially the area with the large net is appearing relatively warm, which could be explained by detachment of the tiles protected by the net. But it has to be considered that all areas with a net are appearing slightly warmer.

Fig. 1. Sections of the tile picture of staircase 2, selected from top to bottom. The left row shows the photos of the sections, the middle row the results of damage mapping (source: Fa. Wandwerk, Berlin) and the right row selected difference thermograms.

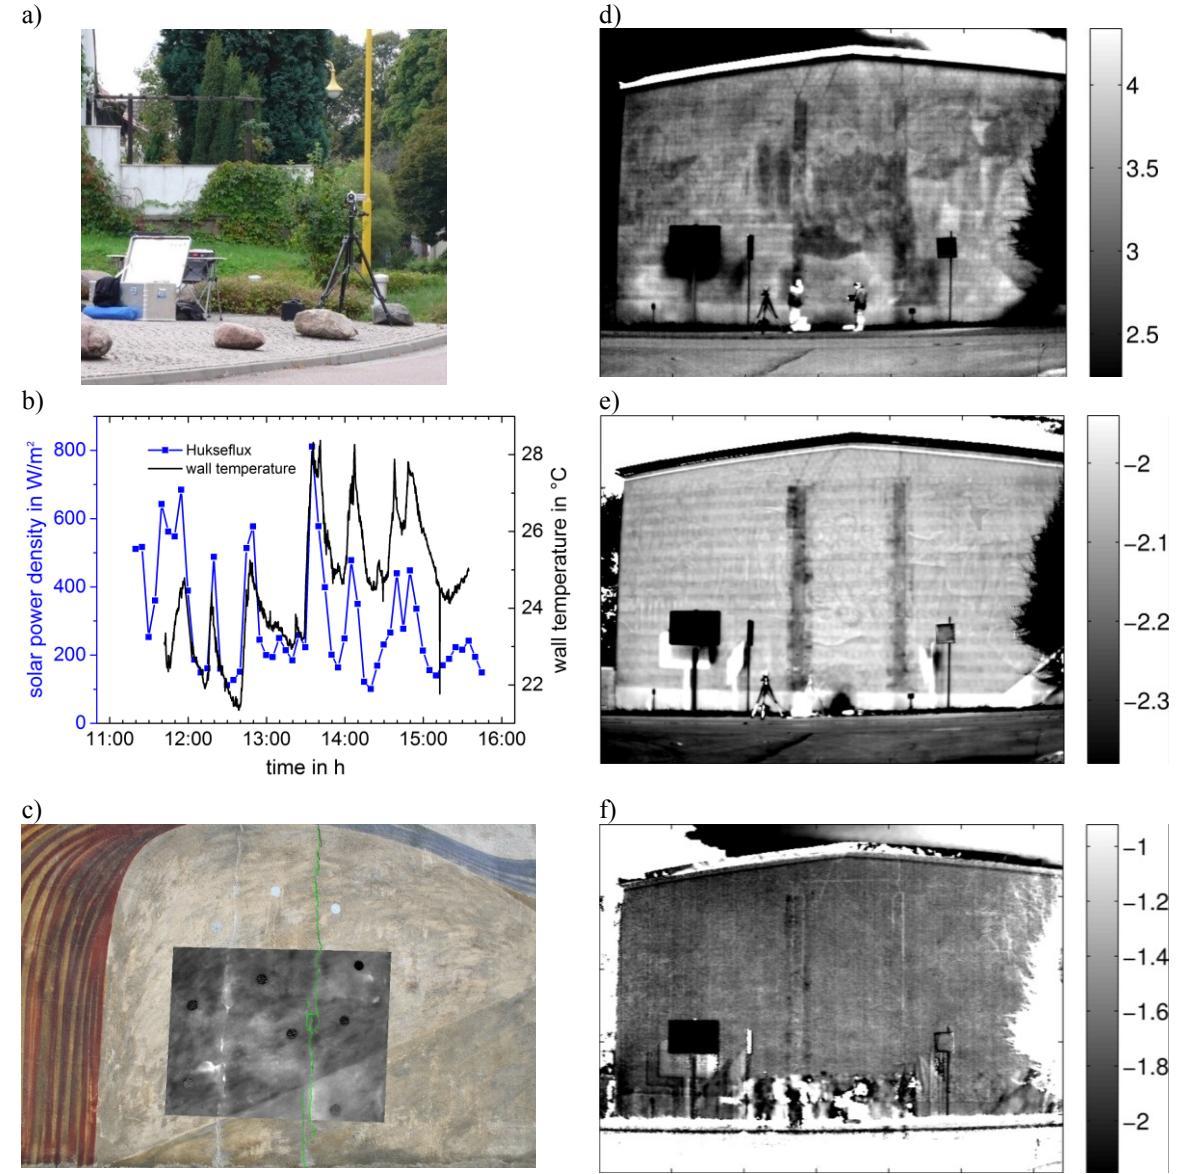
A thermogram was selected from the sequence at 01.56 p. m. directly after the maximum radiation and is shown in figure 2.d. From this thermogram, the temperature distribution recorded directly at the beginning of the measurement was subtracted. Thus, only temperature changes due to solar heating from the beginning of the measurements are shown. First of all, it can be noticed that some of the thermal structures are related to the

drawing in the picture and thus to different degrees of emissivity at the surface. Below the roof, thermal features related to cracks can be detected. In the middle of the wall, two vertical bars related to the pillars can be seen. These structures appear colder, which might be related on the one hand to a view directly into the cracks, where the structure is cooler, and on the other hand to a higher thermal diffusivity due to the underlying metallic pillars.

Additionally to these signatures, also features related to joints and bricks are visible. In addition to the thermogram, two phase images calculated by pulse phase thermography from the recorded thermal sequence are displayed in figure 2.e and f. Figure 2.e shows the 2^{nd} phase image of the sequence, thus it is belonging to lower frequencies of the temporal behaviour of the surface temperature. Here, the two steel pillars could be clearly detected as darker areas. In figure 2.f, phase image no. 10 is shown, thus it is belonging to a higher frequency. Cracks below the roof and at the edges of the vertical pillars are visible.

In the bottom left corner of the wall, cracks were recorded with the 3D crack tracking system. Figure 2.c shows a data fusion of these 3D crack data, a photo and a thermogram of this area. The thermogram was recorded from a closer distance. Markers stuck to the wall were used as reference points in order to find correspondences in the different data domains. Although the crack could already be detected well in the thermogram, the crack tracking sensor enabled a more detailed 3D recording of the crack position with both higher accuracy and resolution.

Fig. 2. Results of investigations at the mural painting in Cobbelsdorf. a) Set-up of the IR-camera in front of the painting. b) Solar power density and wall temperature during the measurements on 2014-09-09. c) Fusion of 3D data of the cracks, photo and thermograms of a section of the painting (bottom left corner).

d) Difference thermogram recorded at 01.56 p.m. on 2014-09-09. The values of the grey scale are given in K.
e) Phase image no. 2 of the whole sequence. The values of the grey scale are given in rad. f) Phase image no. 10 of the whole sequence. The values of the grey scale are given in rad.

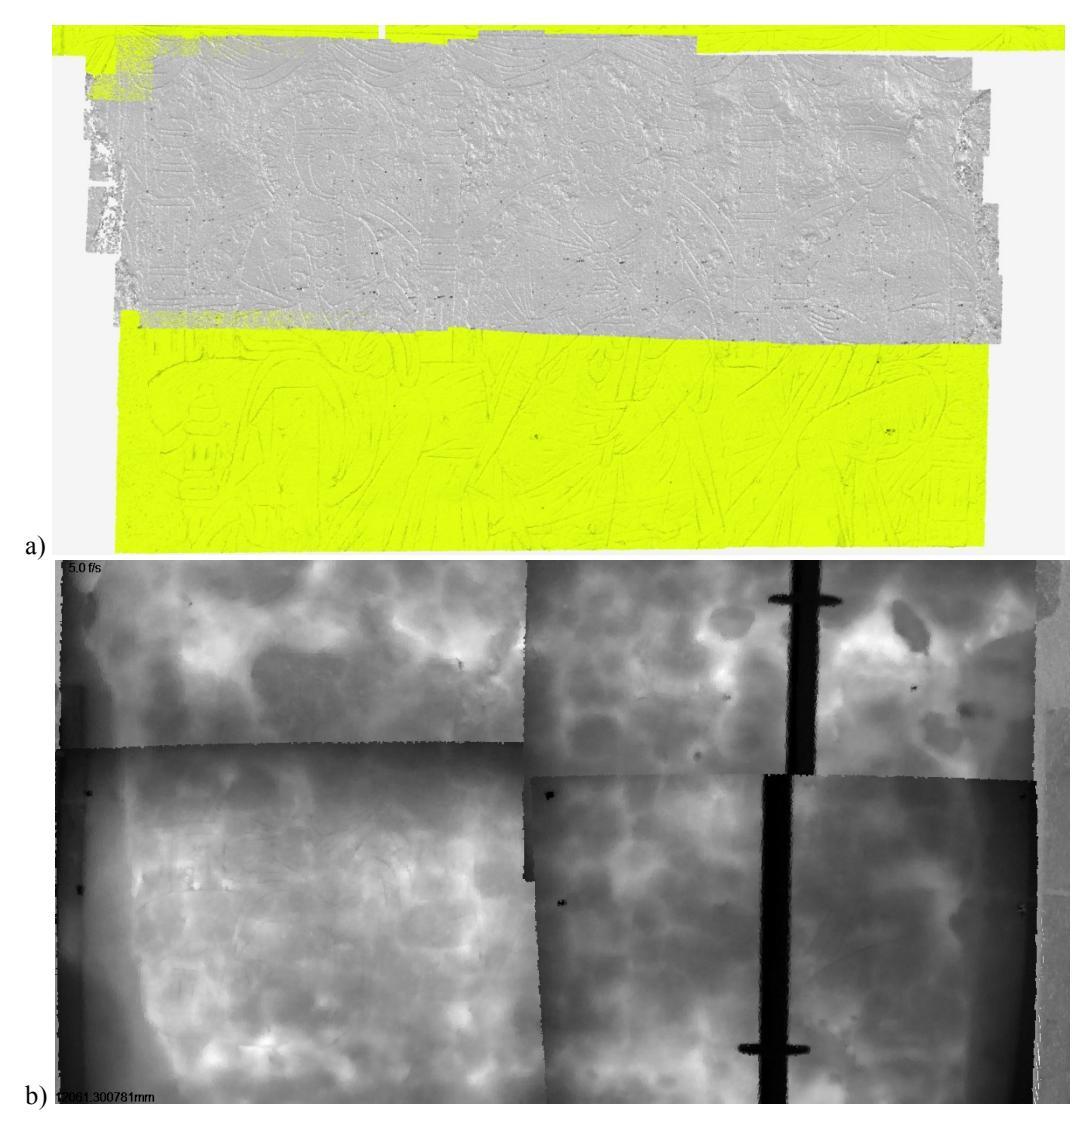
Fig. 3. Results of investigations of the central picture of the plaster scratches. a) Combined 3D data recorded with the photogrammetric stereo sensor (grey: 2012-07-24, yellow: 2014-09-12). b) 3D mapping of the recorded thermograms after 5 min heating with an infrared radiator.

With the photogrammetric stereo sensor system, the central picture was first recorded in 2012. This area was enhanced in 2014, thus an area with a total size of $2.3 \times 2.1 \text{ m}^2$ was captured and is shown in figure 3.a. For the recording of the whole area, in total 12 h were needed. Thus, the 3D data acquisition and recording took much longer for the stereo sensor in comparison to the laser scanner, but a significant higher spatial resolution of sub millimetres was gained.

The 3D data recorded with the laser scanner and the four thermograms taken directly after the heating were fused. For both methods, six corresponding point pairs were selected, which was repeated for each thermogram. The resulting image is shown in figure 3.b. In this thermogram of the whole central picture, first of all the structure of the underlying masonry becomes visible. Lighter and thus warmer areas are hints to joints between the single bricks and stones, while these areas with much higher temperatures are an indication for plaster delaminations.
