Failure Mechanisms of GFRP Scarf Joints under Tensile Load

Federal Institute for Materials Research and Testing (BAM), Unter den Eichen 87, 12205 Berlin, Germany; carineh.ghafafian@bam.de (C.G.); bpopiela999@gmail.com (B.P.)

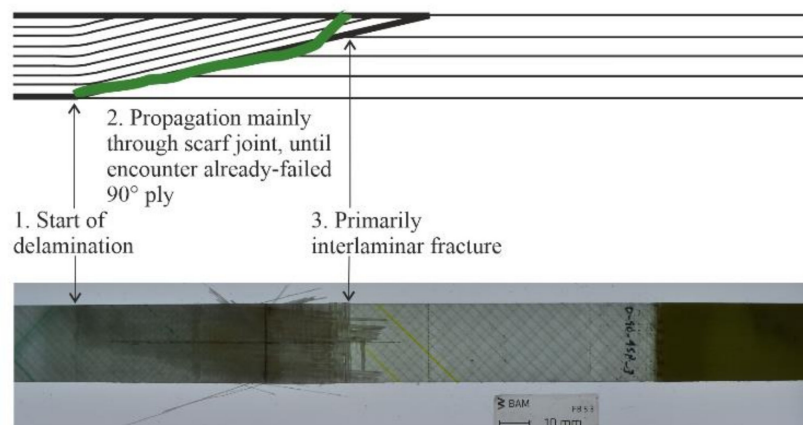
The damage initiation for the $0/90^\circ$ repaired specimens began at the edge of the scarf joint, on the side with more repair material, shown in Figure 12. At this point is a resin fillet caused by a slight jump (0.1 mm) in material caused by the joining of the repair material with the original parent structure. As opposed to the other side of the scarf joint, where there is more parent material, this side's surface profile is not restored after repair layers are applied. This side is representative of the back side of a wind turbine blade shell face sheet which is repaired, the side in contact with the core material of the sandwich structure, illustrated schematically in Figure 18 of Section 4, and plays a more significant role in the failure of the $0/90^\circ$ repaired specimens due to the role of the 0° layers influencing the specimen strength and stiffness.

Figure 12. Step-by-step fracture path of $0/90^\circ$ repaired specimens under tensile load, portrayed as the top view of a real tested specimen (**bottom**) and side view of a schematic illustration (**top**).

After failure initiates at this point, there is a competition of interlaminar strength versus fiber strength at play when it comes to the propagation path. Unlike the control $0/90^\circ$ specimens, there are no longer continuous 0° fibers running along the entire specimen length in the load direction that are able to carry the load. Here, the interlaminar strength is significantly lower than the fiber strength in the load direction, leading to interlaminar propagation of the failure path along the scarf joint, shown in Figure 12. Additionally, the peak shear stresses in the structure are lower with the presence of 0° plies [17]. This propagation in the interface between parent and repair material continues in this way until an already failed 90° layer in the repair is reached, after which the failure propagates for the last small portion toward the surface of the specimen through the repair material.

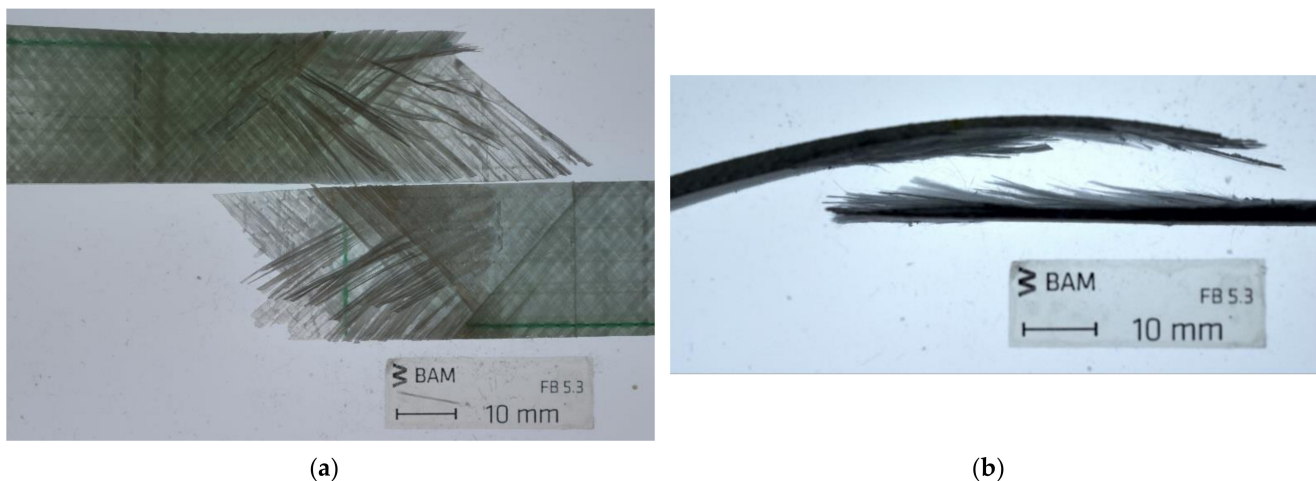
Figure 15. (a) Fractured surfaces and (b) side view of $\pm 45^\circ$ scarf joint specimen under tensile load, showing fibrous remnants as a result of the intralaminar fracture path.

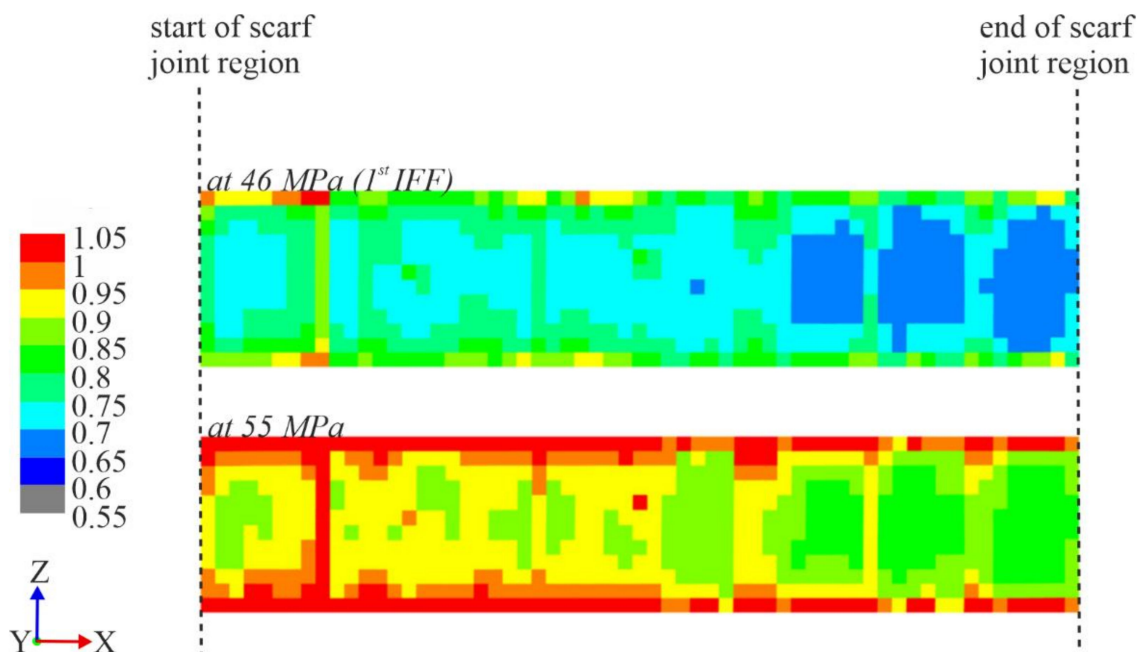
Looking at the IRF values of the scarf joint specimens in the $\pm 45^\circ$ orientation in Figure 16, it can be seen that the critical regions were concentrated mostly along the edges of the specimen, as is the case for control $\pm 45^\circ$ specimens under tensile load. In contrast to the $0/90^\circ$ repaired specimen, which showed higher IRF values in the repair layers than parent material, and especially at the points which mapped to damage initiation and damage path changes, the $\pm 45^\circ$ stress exposure seems uninfluenced by the presence of a

Figure 16. IRF values of $\pm 45^\circ$ scarf joint region, showing the development of the critical regions under tensile load, viewed from the specimen top. The scale begins at a value of 0.55 for clarity.

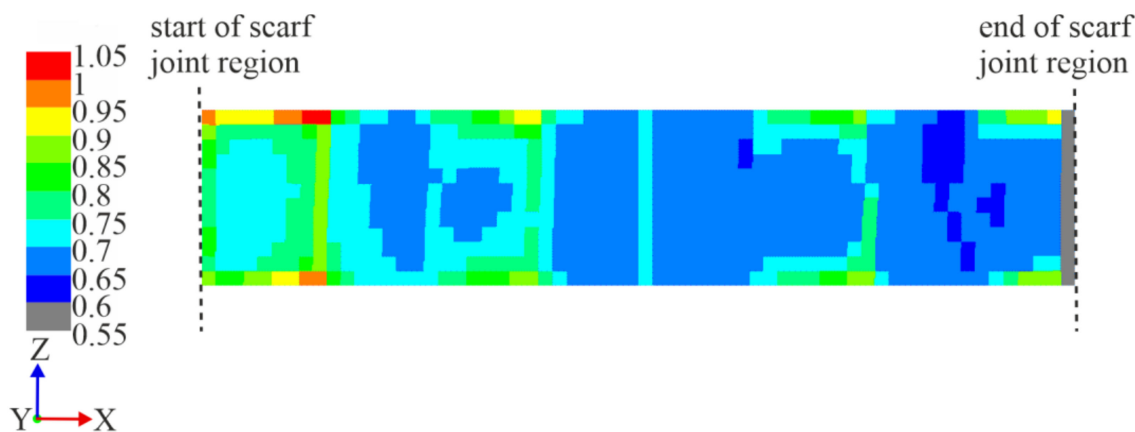
Figure 17. IRF values of the bottom-most repair layer of a simulated $\pm 45^\circ$ scarf joint specimen under tensile load from the top view, shown to be the most critical layer under tensile load, where the first IFF occurs at $\sigma_x = 46$ MPa. The scale begins at a value of 0.55 for clarity.
