**Study of the failure limits of a railway tank car filled
with liquefied petroleum gas subjected to an open
poolfire test.**

Final report

"Study of the failure limits of an undergrate-fired railway tank car filled with liquefied petroleum gas"

Federal Institute of Material Research and Testing (BAM)

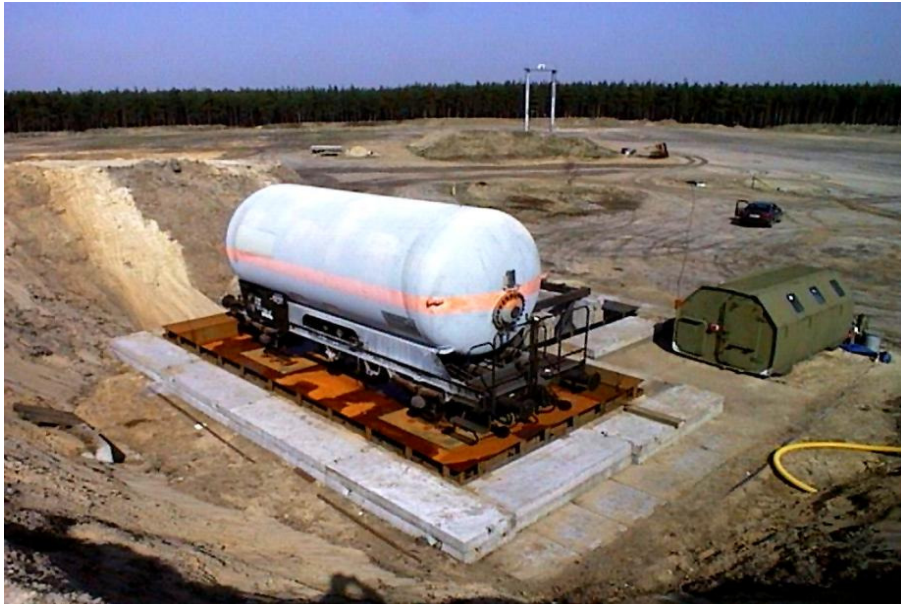
Fig. 3.1: View of the fire stand under construction; the drop tower is seen at the back

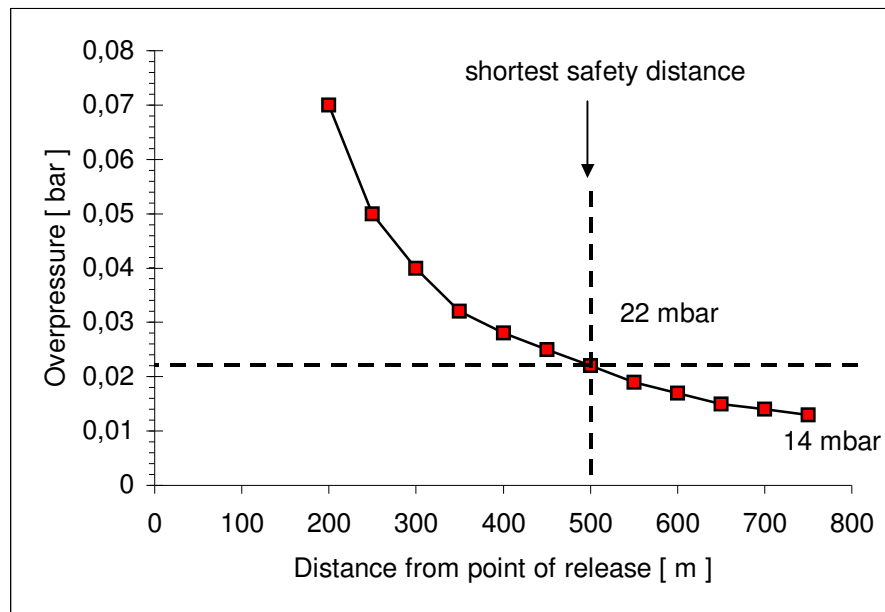
An estimate of the action radii based on a TNT-equivalent model (also for VCE) shows that with an energy input of 5 t of propane overpressures of 14-22 mbar can be expected at distances between 500 and 700 m.

Fig 4.1: Overpressure in dependence of the mass of gas; TNT-equivalent model

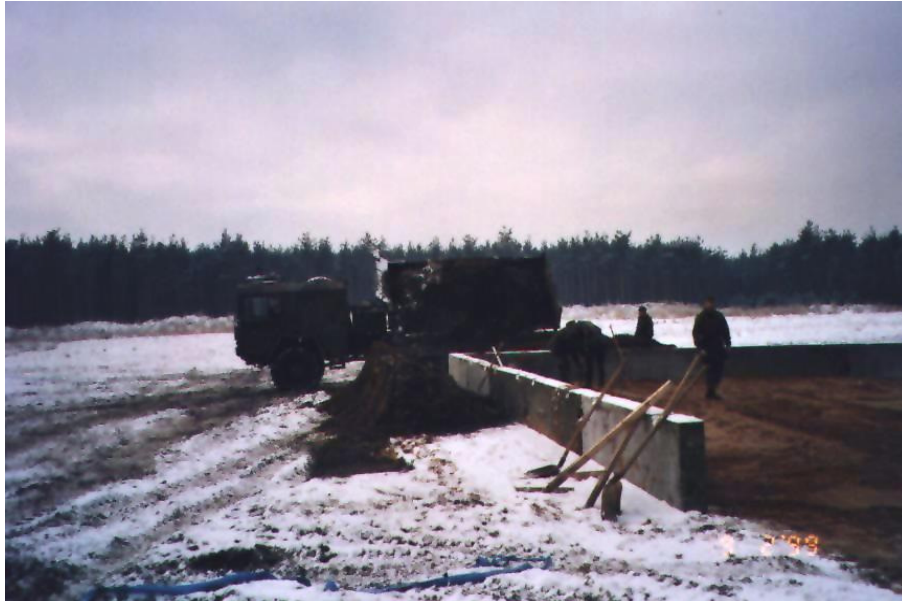
Work was commenced by installing the slab foundations. For this purpose concrete slabs measuring 3 x 1 x 0.2 m were placed on-end in a 0.2 m deep trench, so that initially a U-shaped semi-enclosure measuring 15 x 15 m by 0.8 m high was formed (see Fig. 5.1).

Fig 5.1: Setting up the external sidewalls

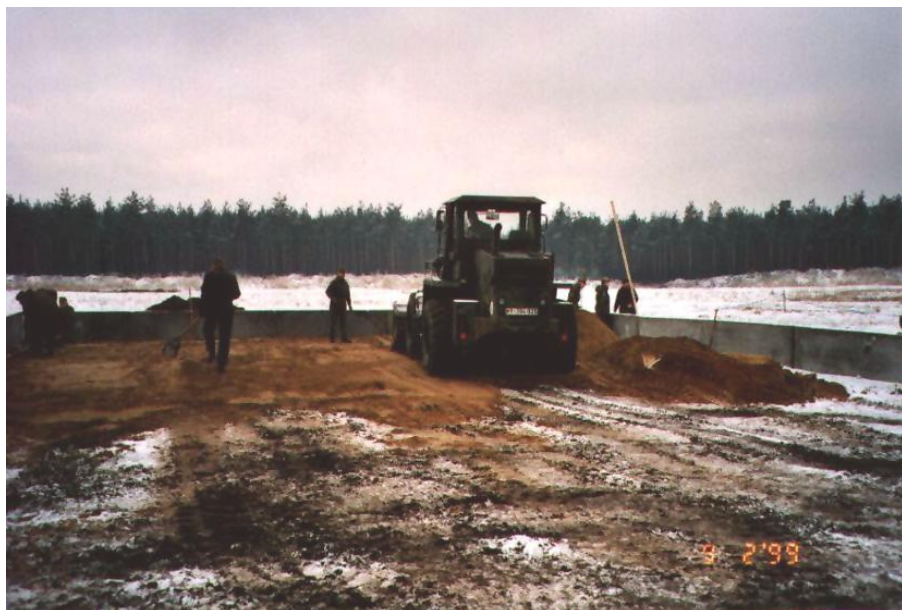
It was necessary to ensure that the gravel used for this purpose was free of larger stones or other contamination, so that the sheet to be installed in the following step was not damaged. Figure 5.2 shows the building of the plane prior to installing the sheet.

Fig. 5.2: The first layer of gravel is installed

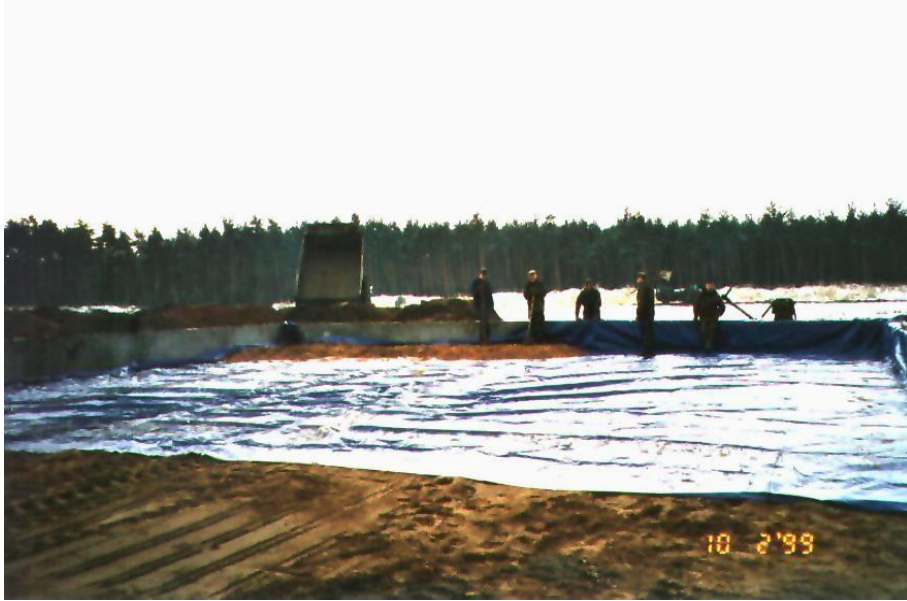
To protect the ground water against contamination, an oil-resistant sheet was laid out on this flat and slightly inclined plane (see Fig. 5.3).

Fig. 5.3: Installing the oil-resistant sheet

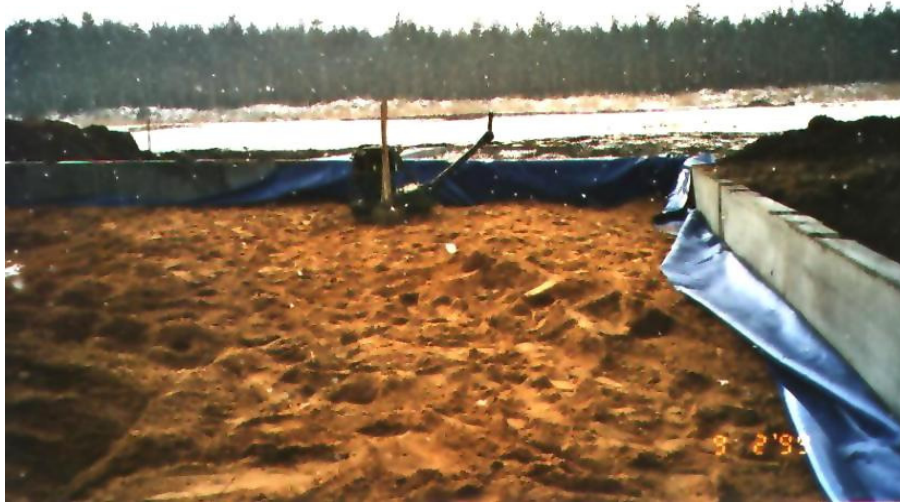
Next, a 0.6 m thick layer of gravel was placed over the sheet and then compacted (Fig. 5.4).

Fig. 5.4: Applying the layer of gravel

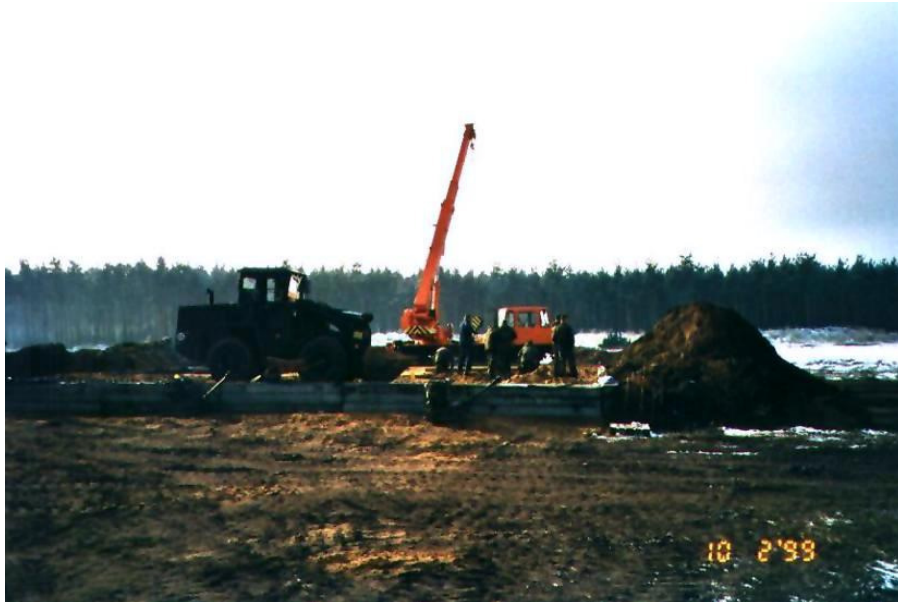
After the gravel material had been introduced for the rear area, the still open forward side was closed with three layers of concrete slabs until a height of 0.6 m was reached. The sheet was folded up so that a closed tanking was formed. Now the drainage pipes could be placed and the remaining gravel for the forward area was introduced (see Fig. 5.5).

Fig 5.5: The tanking is closed; the remaining gravel is introduced via a ramp using a wheeled loader.

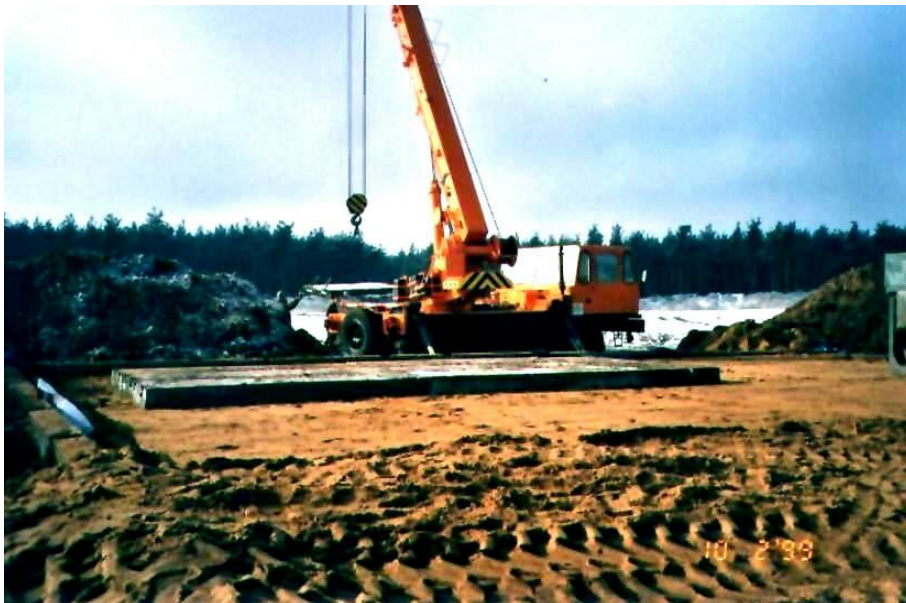
Concrete slabs 3000 x 1000 x 200 were laid out on this gravel bed as a foundation for the fire troughs for the railway tank car and the CASTOR container (see Fig. 5.6).

Fig 5.6: Laying down the cover slabs

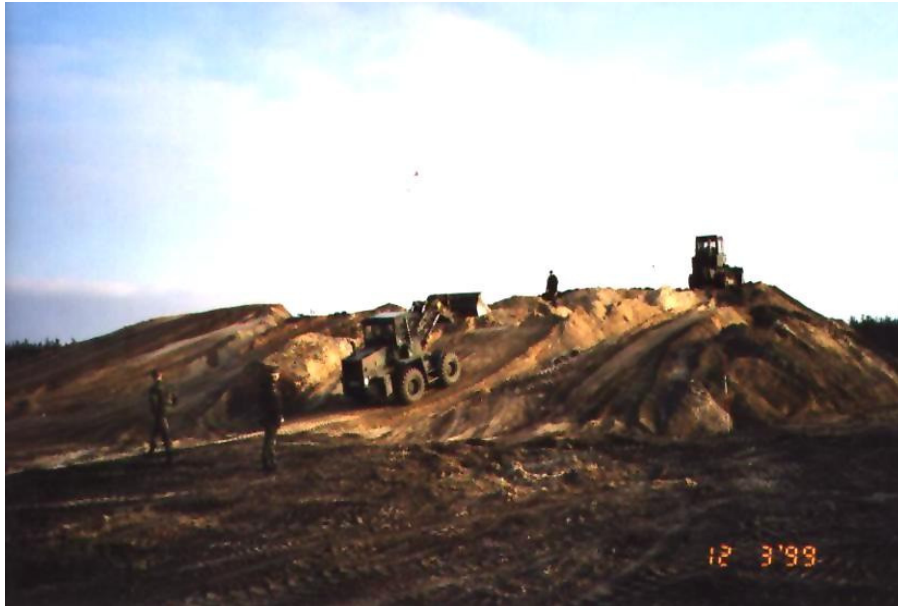
After the cover slabs had been laid out, the approx. 6 m high, surrounding U-shaped earth embankment was completed (see Fig. 5.7). The purpose of this earth embankment was to prevent parts of the railway tank car from being hurled into the surrounding forest area after a BLEVE and possibly causing fires.

Fig 5.7: Building the earth embankment for the fire stand.

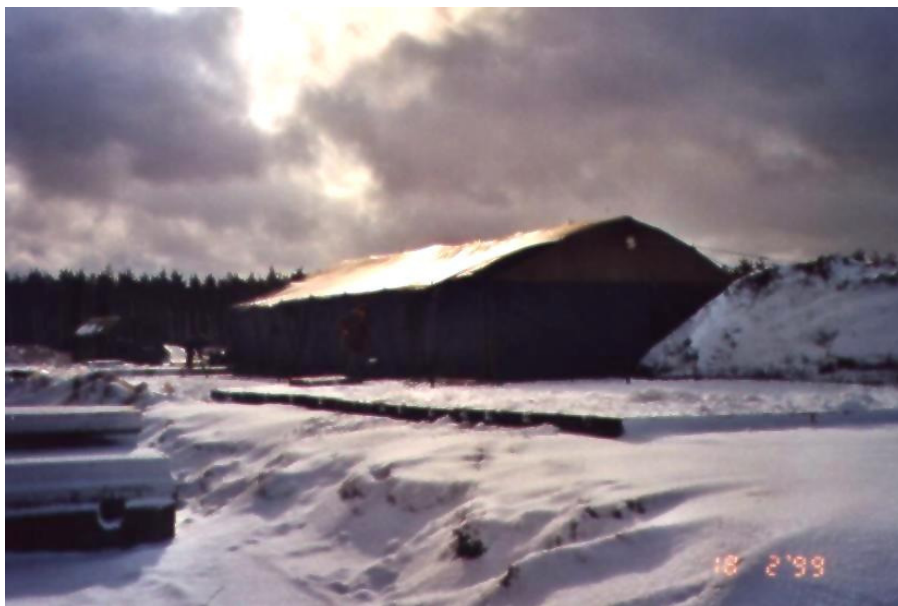
After the rear part of the earth embankment had been completed, the fire trough for the railway tank car was constructed. For this purpose, a welding tent (see Fig 5.8) was set up on site on the cover slabs; protected against the weather by this tent, welding work was then continued to construct the 5 x 10 m fire trough for the railway tank car using 2.5 mm sheet steel.

Fig 5.8: The welding site for the fire trough for the RTC

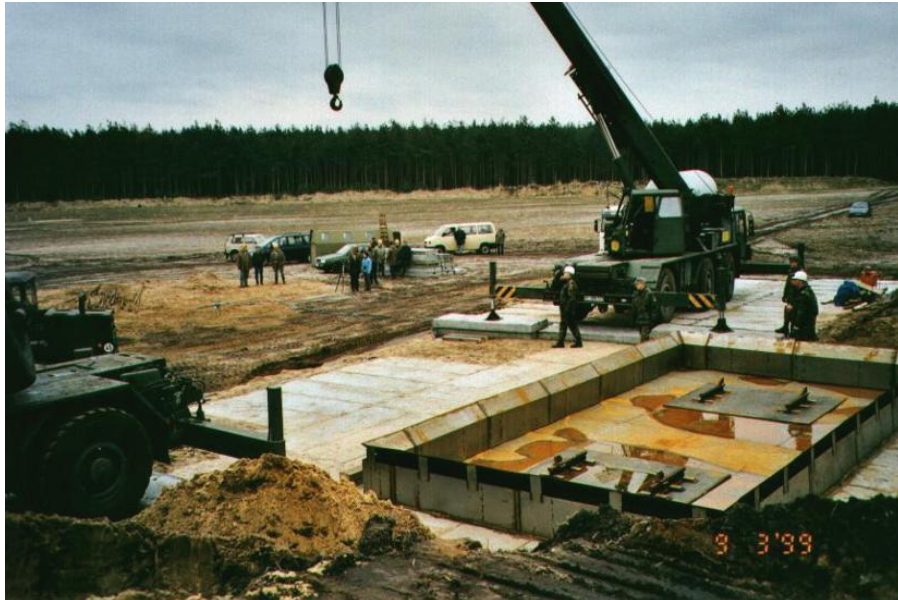
The tanking was constructed to a height of 500 mm. The side panels were made double walled so that water-cooling could take place in these areas. Fig. 5.9 shows the completed tanking for the RTC shortly before the railway tank car was placed inside.

Fig 5.9: The fire trough for the railway tank car

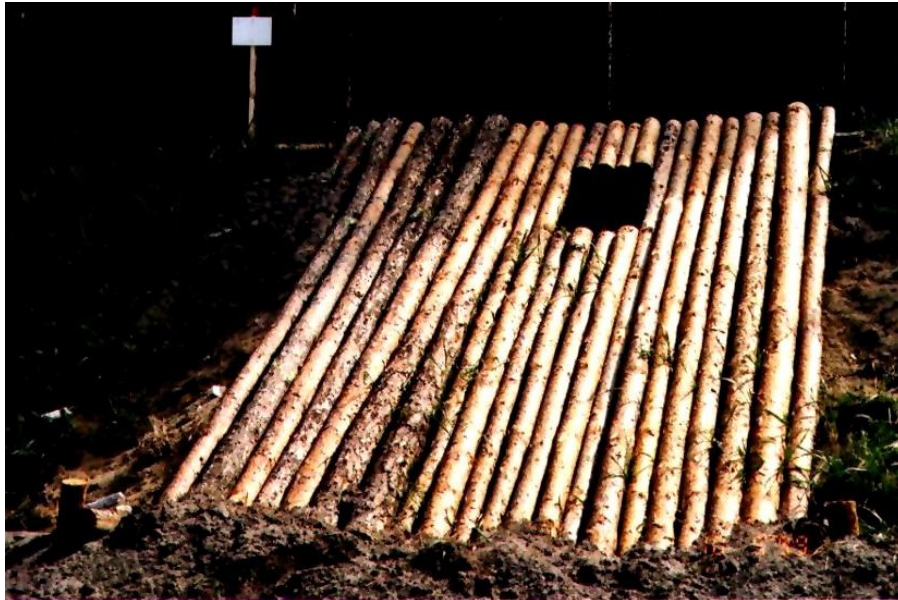
To provide adequate test documentation, it was necessary to set up camera locations positioned as close to the fire stand as possible. As a means of protection against flying debris and the expected blast wave, the earth embankment was opened at points and covered with wooden palisades (see Fig. 5.11).

Fig. 5.11: Camera at the earth embankment; distance to the fire stand approx. 200 m

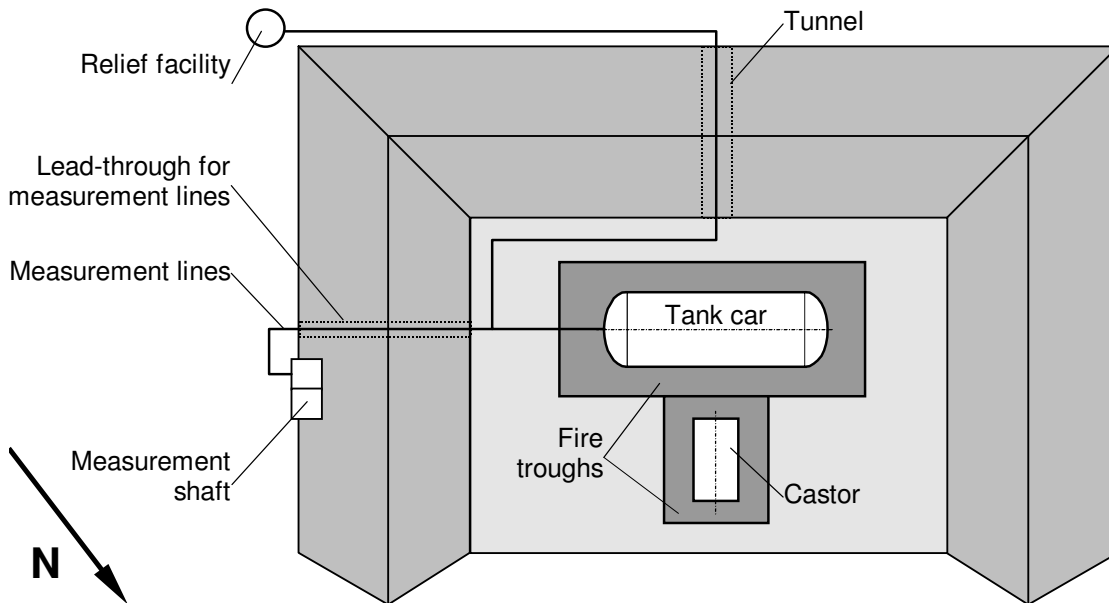
Located approximately in the centre of this open space, there was a U-shaped protective embankment approx. 42 x 55 m in extent and 6 m high; it served primarily to restrict the blast wave and the flight of debris.

Fig. 2: Protective embankment with fire troughs

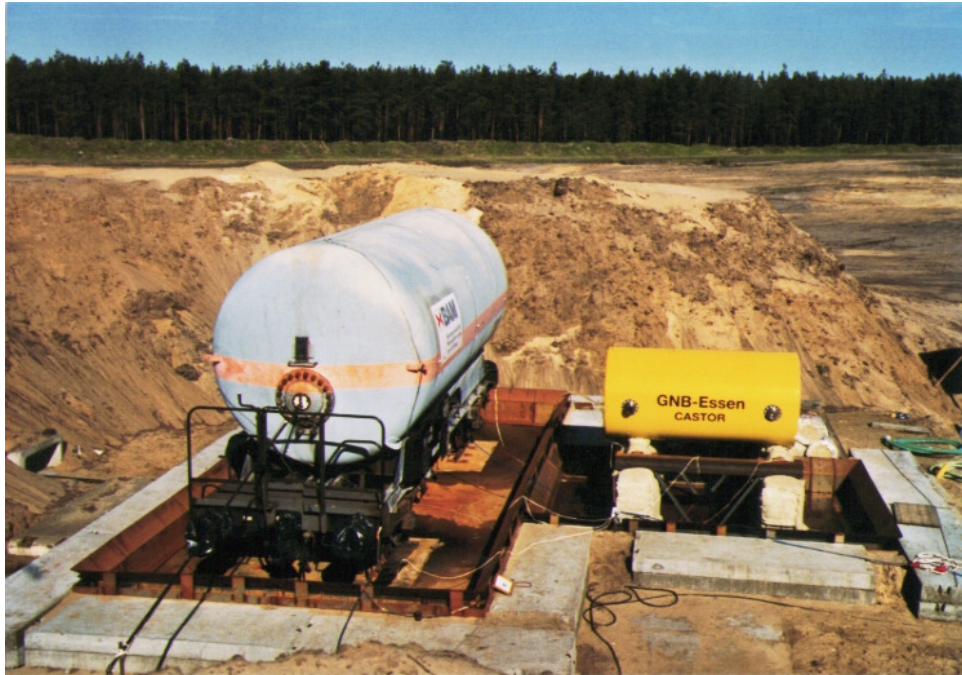
Fig. 3 shows the test setup during instrumentation.

Fig. 3: Test stand within the protective embankment

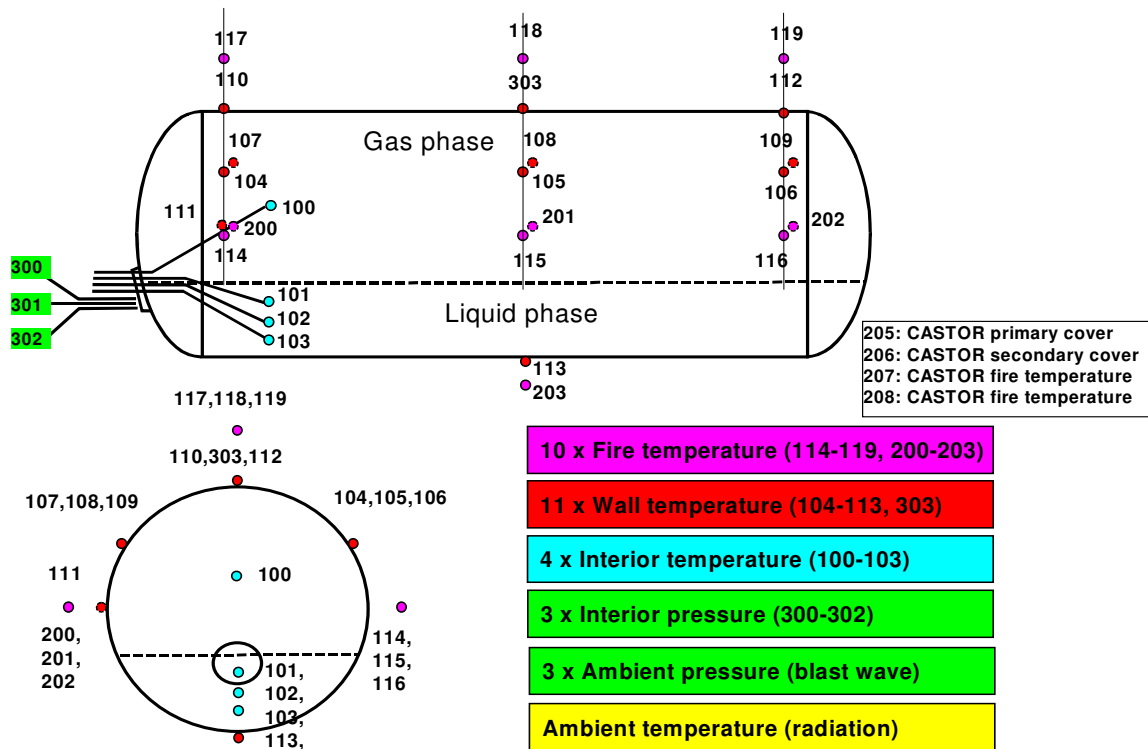
With help of the 11 wall temperatures in conjunction with the 3 internal pressure sensors (P8AP 100 bar by HBM), it was possible to determine the drop in wall strength so that the point of bursting could be estimated. Using the 4 internal temperatures it was possible to determine whether and how much liquid state had already vaporized at the respective time (temperature difference between liquid phase and gaseous phase).

Fig. 4: Measurement points for instrumenting the tank car and the CASTOR

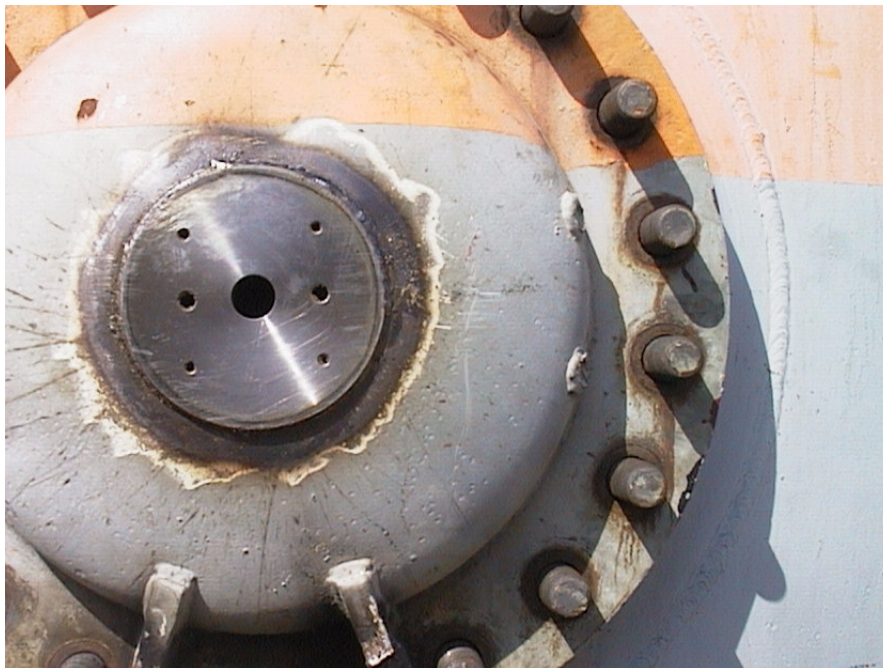
To lead out the internal measurement points, the cover of the inspection opening was provided with a centrally positioned reinforcement plate into which lead-throughs for the thermocouples and threaded connections for the pressure lines were screw-fastened (see Fig. 5).

Fig. 5: Reinforcement plate in the cover of the inspection opening

This relief facility, which could be remotely operated via cables (see Fig. 6) and which was located outside of the protective embankment, consisted of a ring nozzle as well as 3 propane burners installed above it and fed from one cylinder; the propane burners were equipped with a permanent ignition facility. The connection to the fuel tank was provided by a relief line (NW 18), which ended in the bottom of the tank, from where it passed centrally out of the reinforcement plate (Fig. 5) into which it was welded.

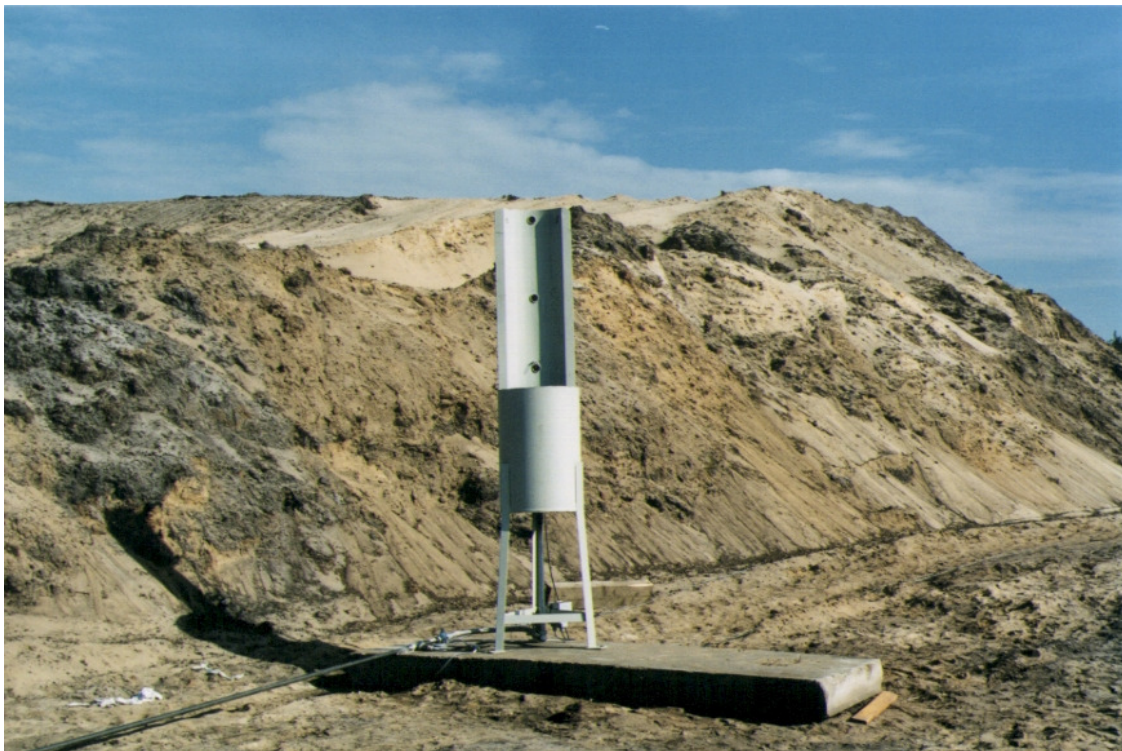
Fig. 6: Relief facility outside the protective embankment

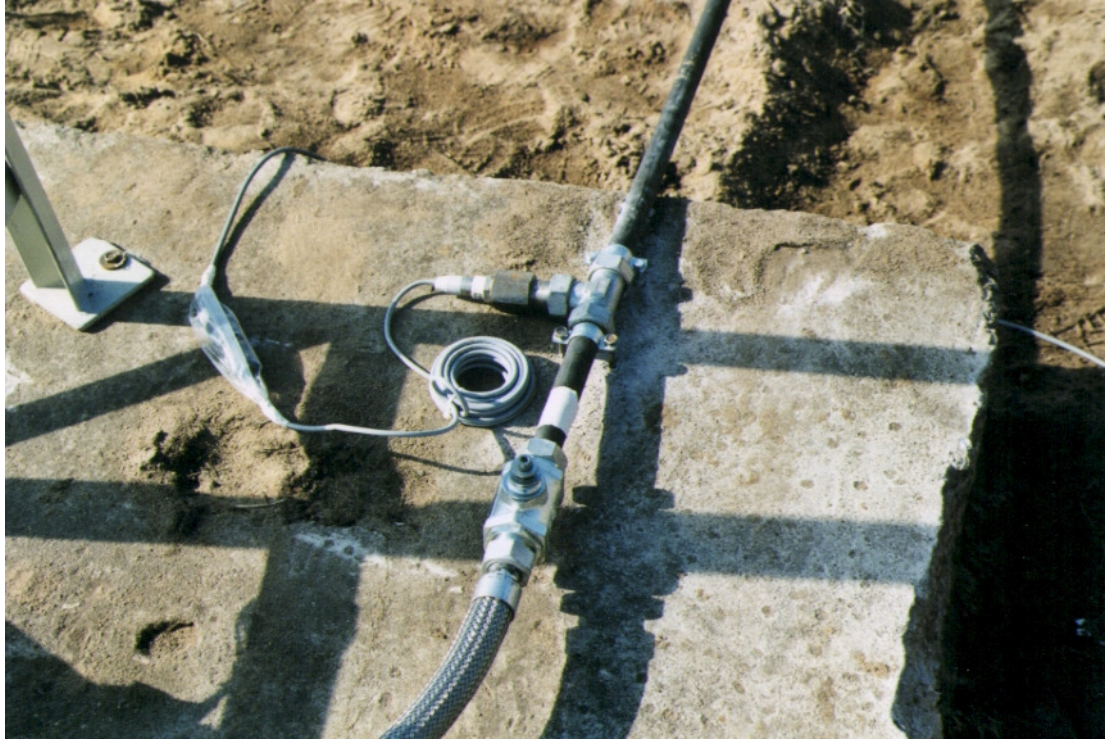
At the foot of the relief facility, in front of the ball valve (shown here without a lever) there was one of the three pressure recorders used for measuring and recording pressure. The remaining 3 pressure-measurement lines could also be turned off by one ball valve each in the proximity of the fire trough.

Fig. 7: Pressure recorder and ball valve (without actuating lever) in the relief line

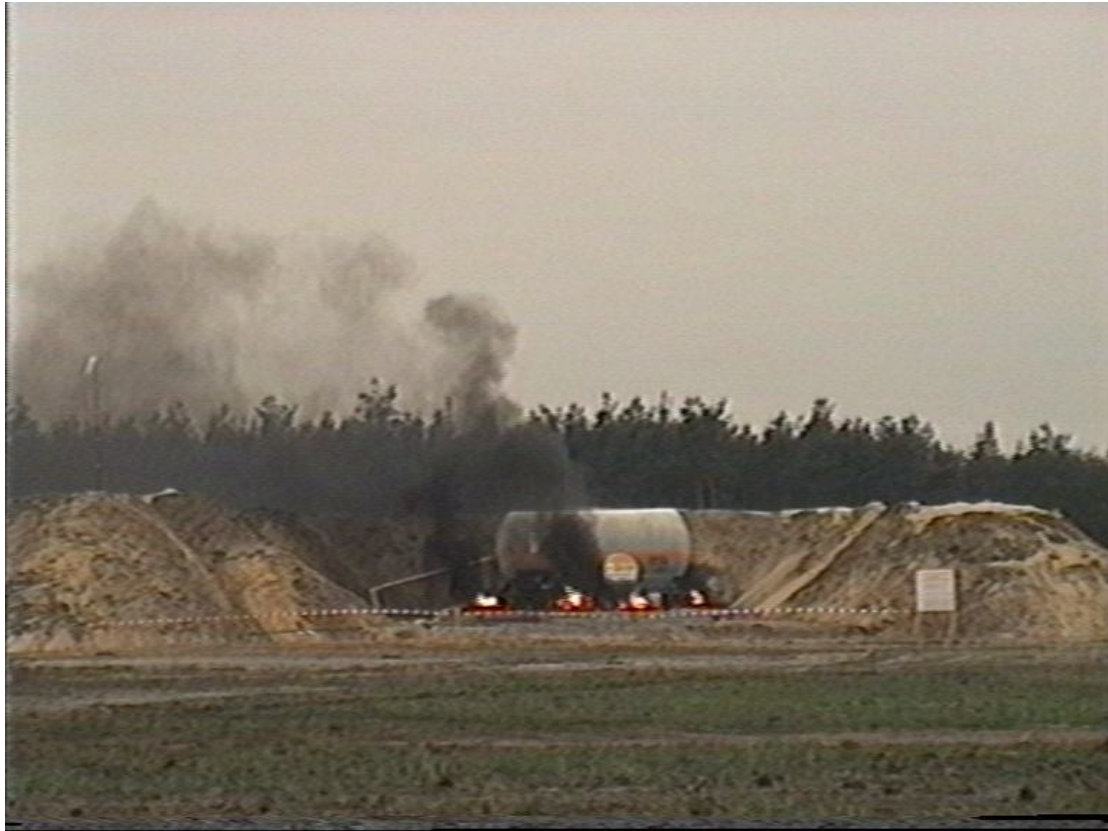
The plastic bowls were destroyed after about 100 seconds so that the burning gasoline poured out on to the fuel oil which then ignited. After a relatively short time the troughs were burning completely.

Fig. 8: Triggering the ignition devices

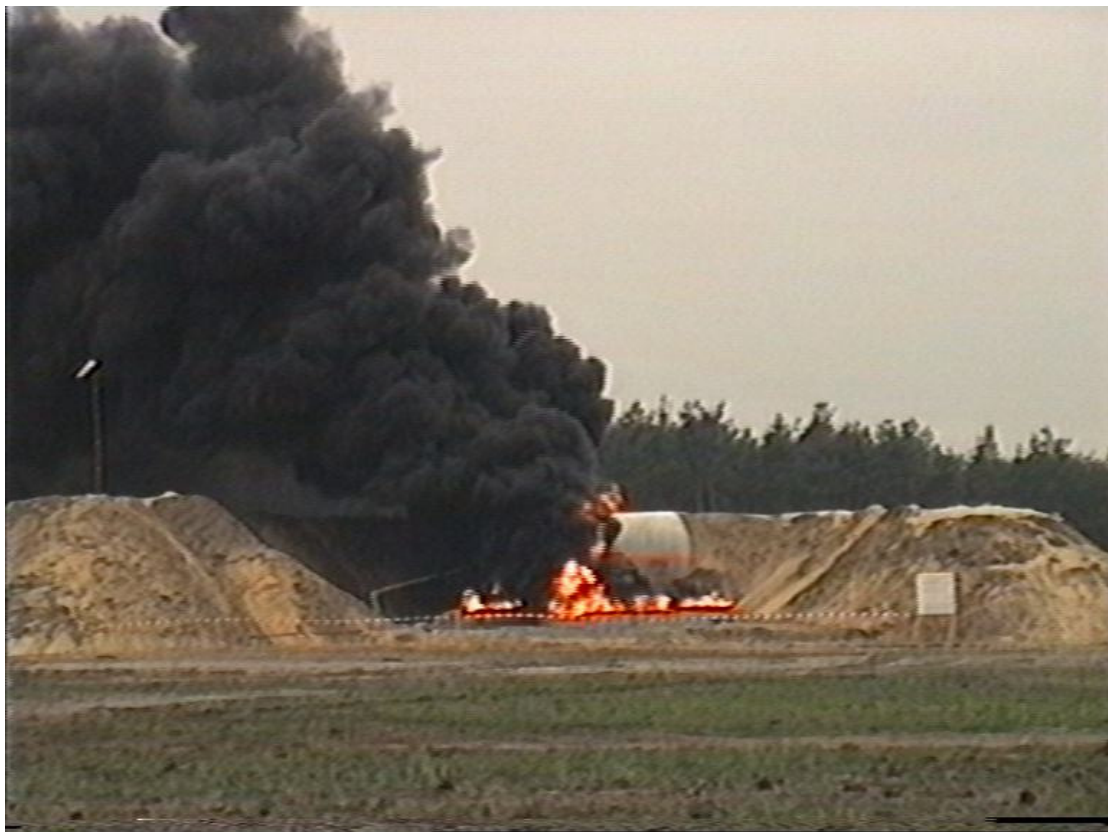
Fig. 9: Flame appearance at the beginning of the test

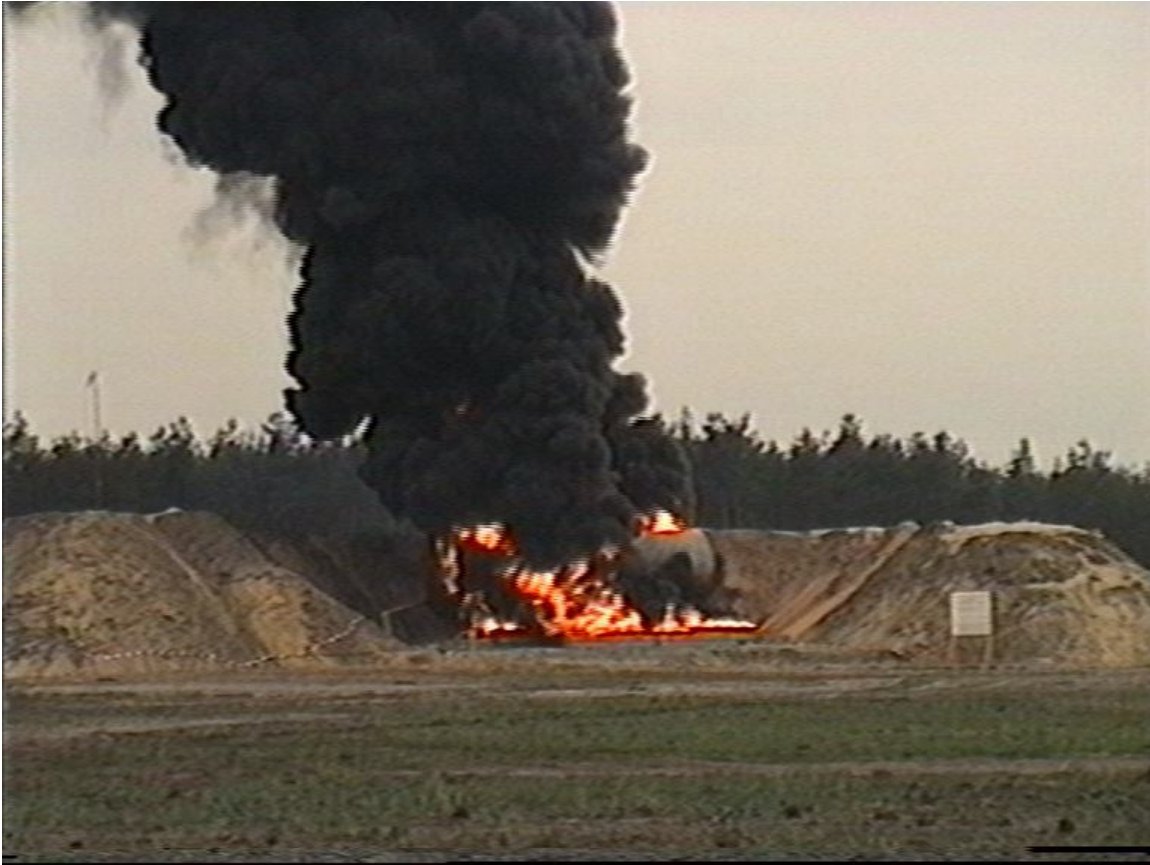
As the test progressed, the wind decreased.

Fig. 10: Improved flame envelopment towards the end of the test

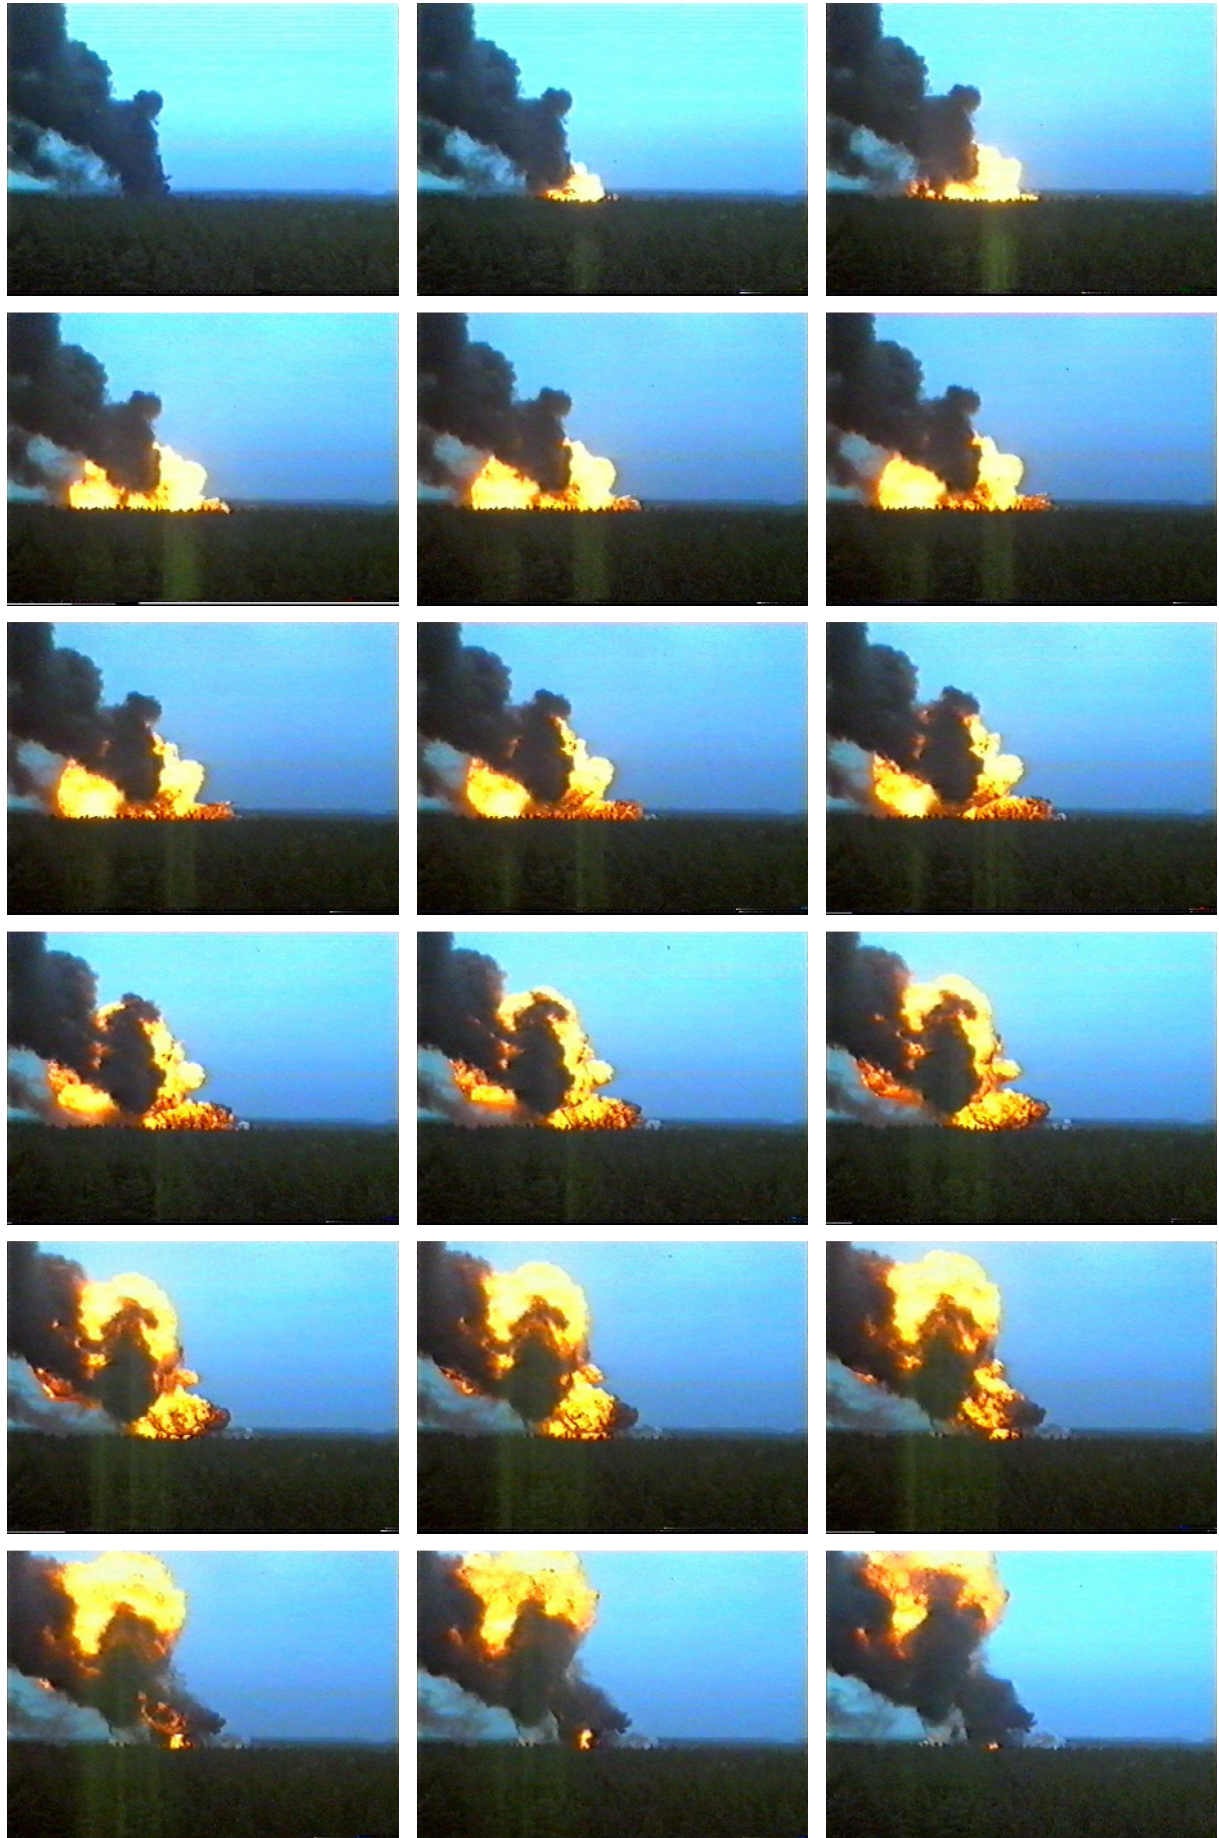
The following sequence shows the fireball from a distance of approx. 750 m. The photographs are spaced 0.4 seconds apart. From this sequence, the duration of the fireball is calculated to be 7.2 seconds.

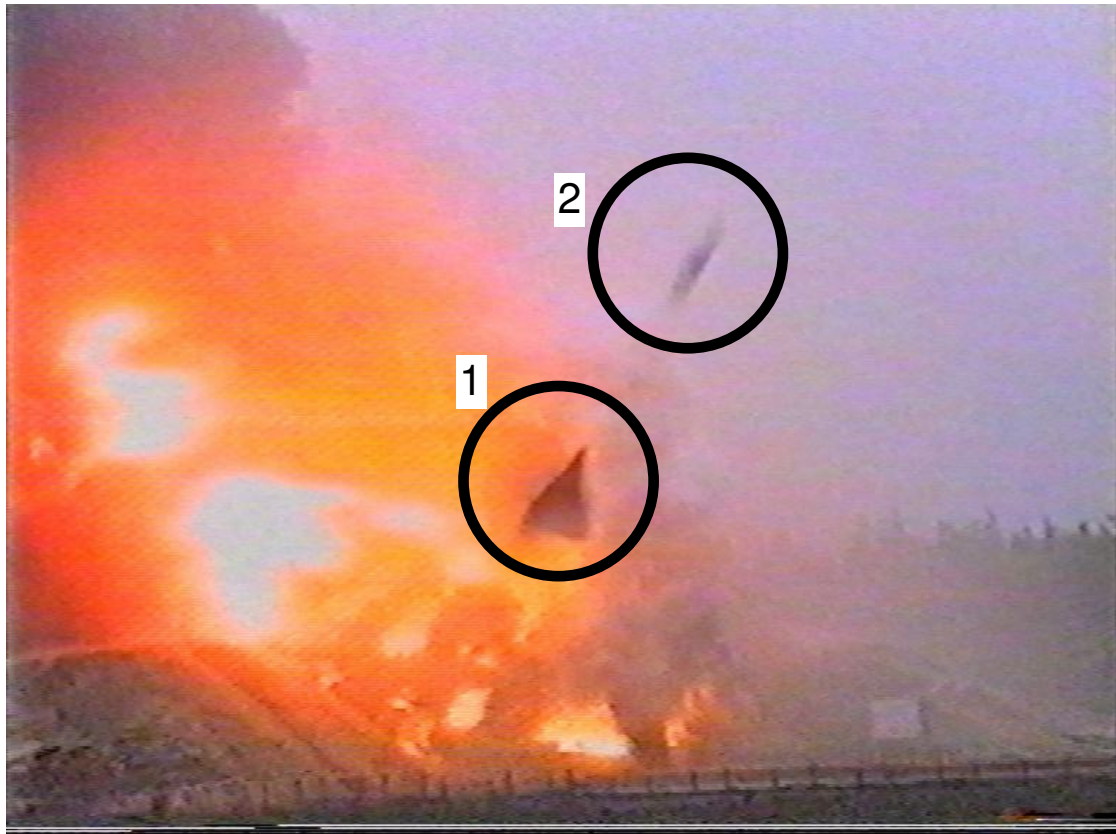
Due to the sudden release of liquefied gas and its resulting expansion, the tank jacket was unravelled and accelerated forwards. Starting from the back, the cylinder bottoms were ripped away from the cylindrical part and thus also propelled forwards. While ripping open, a triangular part (part 1 in Fig. 11) became detached from the left rear part of the jacket.

Fig. 11: Part of the jacket (1) and the baffle plate (2) flying off (left camera position (0.32 seconds))

Apparently the baffle plate (part 2 in Fig. 11) initially separated from the forward part of the jacket and then, due to a whiplash effect caused by the unravelling of the jacket, it was hurled up to a height of approx. 200 m (see Fig. 12).

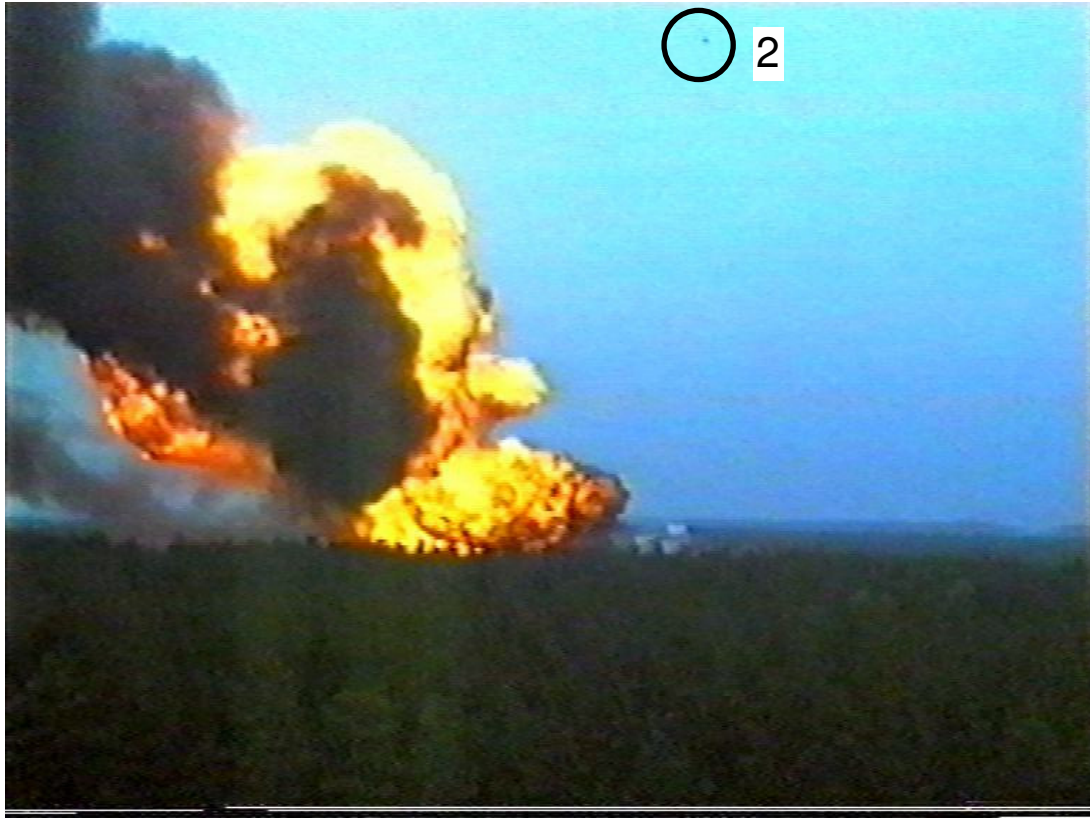
Fig. 12: Baffle plate at highest point after approx. 4.6 seconds

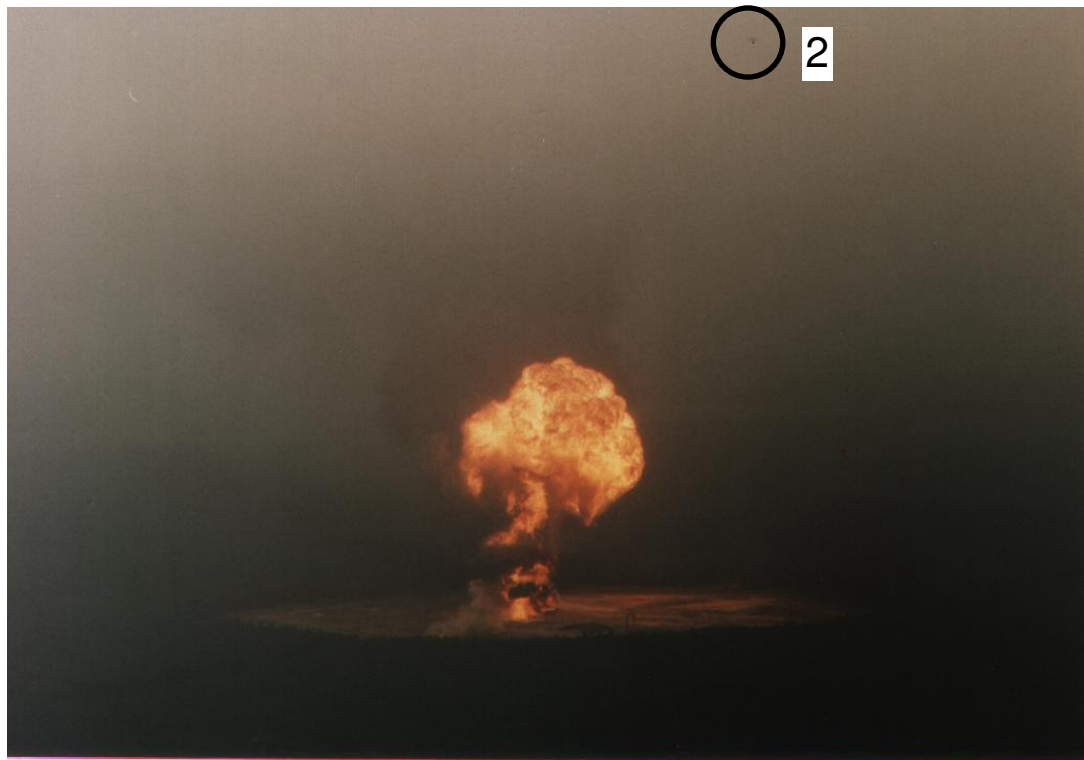
Fig. 13 shows the fireball in its maximum extension

Fig. 13: Fireball seen from a north-easterly direction

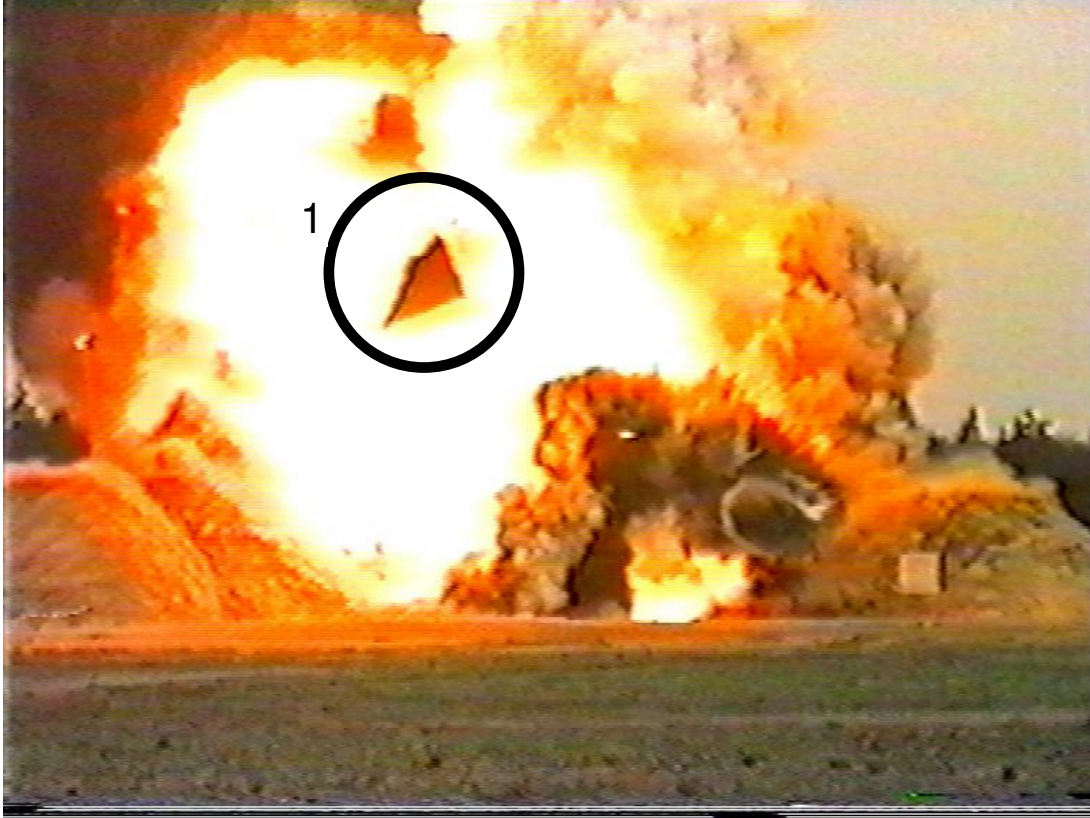
Fig. 14: Part of the tank jacket (1) flying off (central camera position)

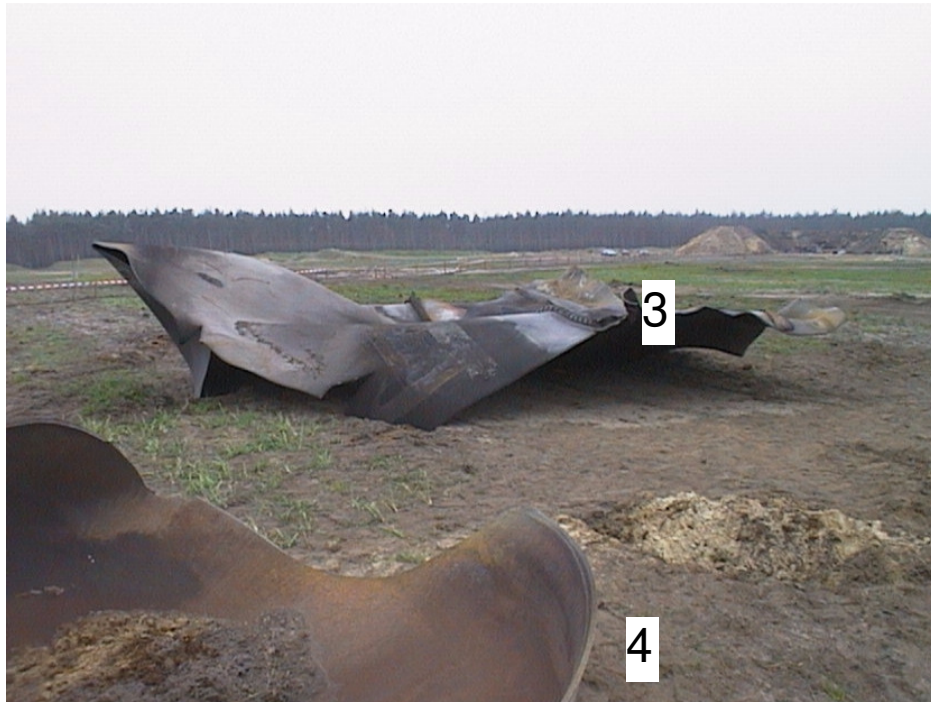
The jacket section (3) repeatedly struck the ground and came to rest in a partially folded state approx. 150 m away. The right bottom (4) was found approx. 155 m away (see Fig. 15).

Fig. 15: Jacket (3) and right bottom (4)

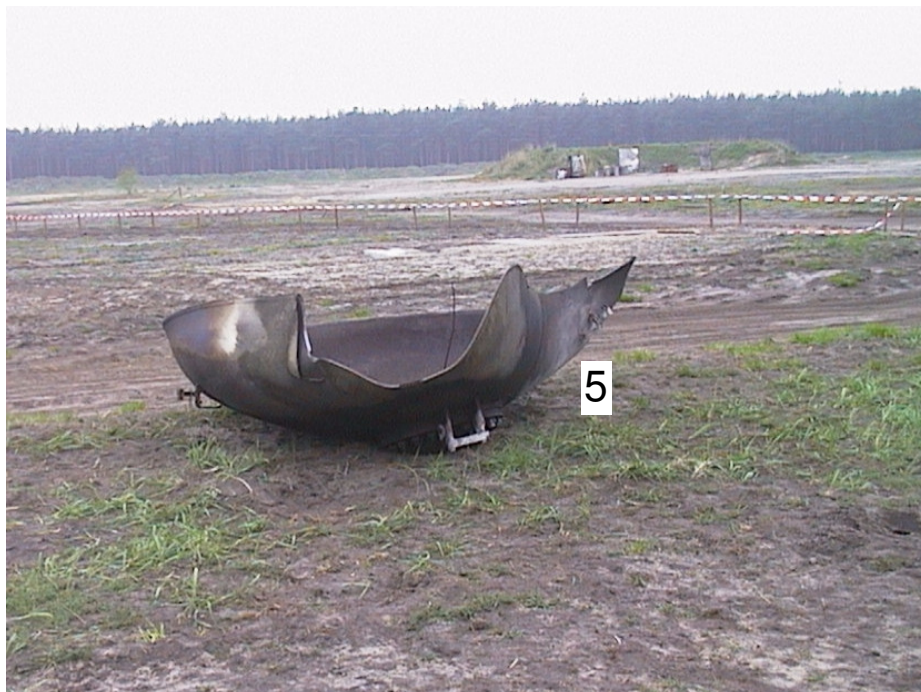
Der linke Boden (5) befand sich nach dem Versuch ca. 130 m vom Zentrum des Versuchsplatzes entfernt.

Fig. 16: Left bottom (5)
