**Study of the failure limits of a railway tank car filled
with liquefied petroleum gas subjected to an open
poolfire test.**

Final report

"Study of the failure limits of an undergrate-fired railway tank car filled with liquefied petroleum gas"

Federal Institute of Material Research and Testing (BAM)

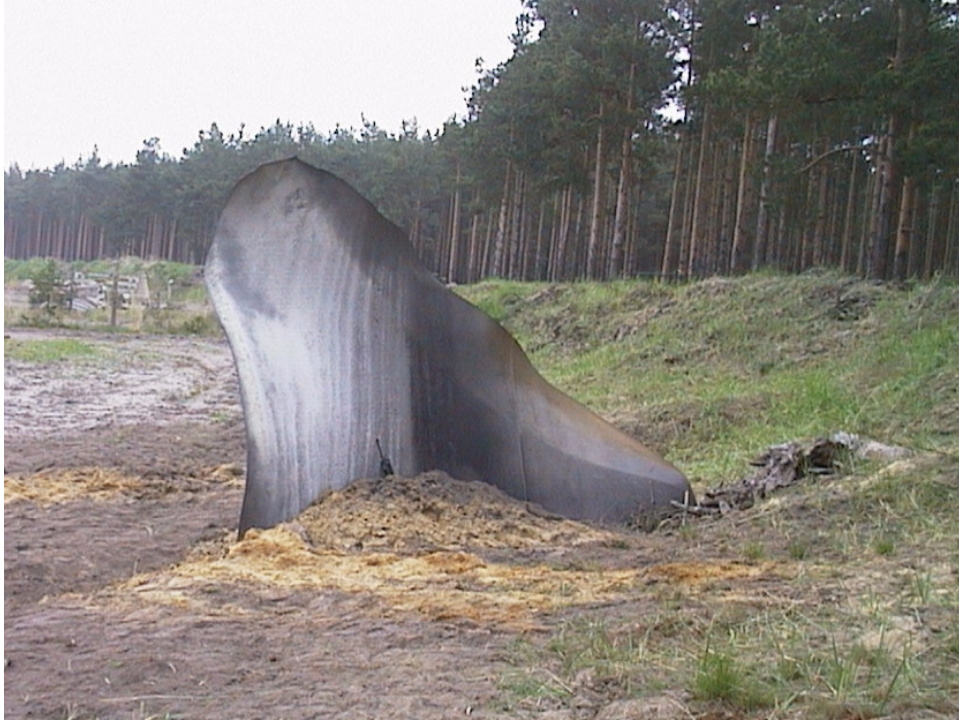
The jacket section (1) was found vertically slammed into the embankment surrounding the test grounds, approximately 200 m away from the latter.

Fig. 17: Position of the jacket section (1) after the test

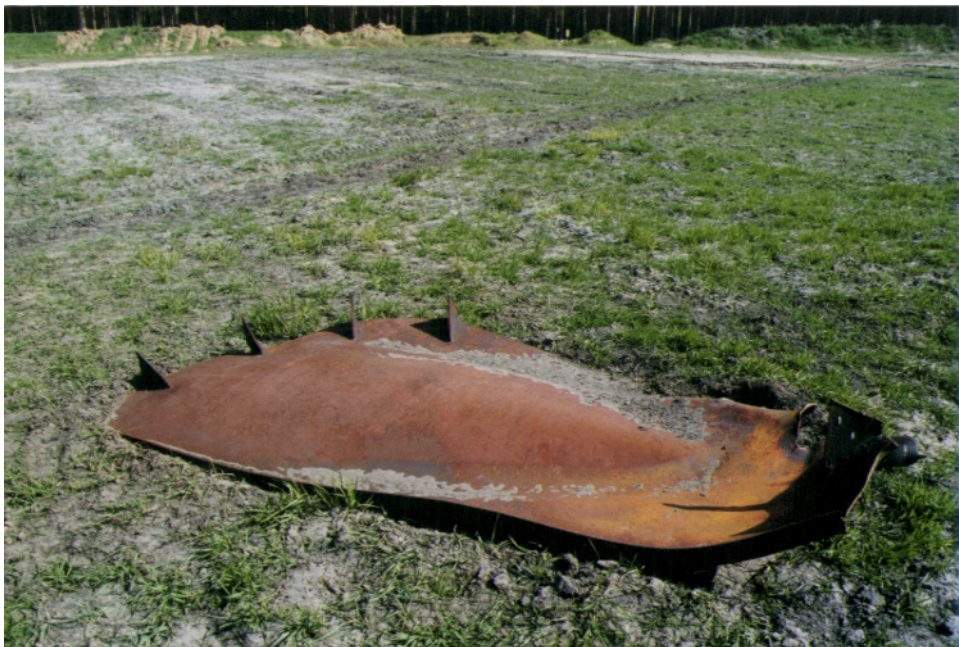
The baffle plate (2) was found a distance of approx. 145 m from the test grounds.

Fig. 18: Baffle plate (2)

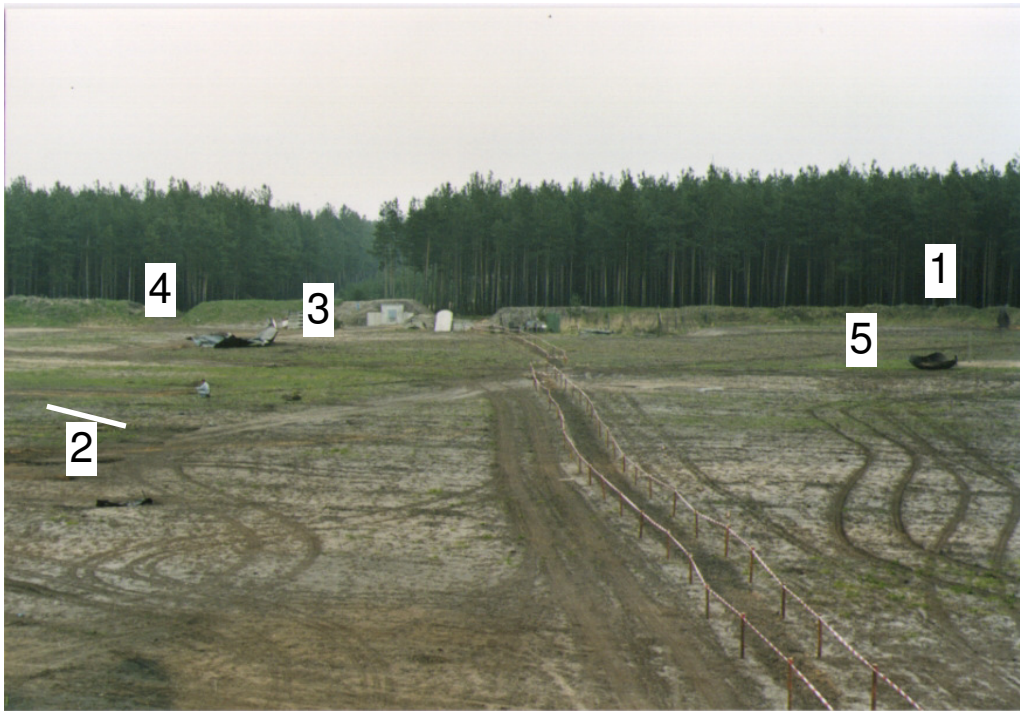
Figure 19 provides an overview of the positions of the different tank parts and debris:

Fig. 19: Positions of the jacket sections and bottoms

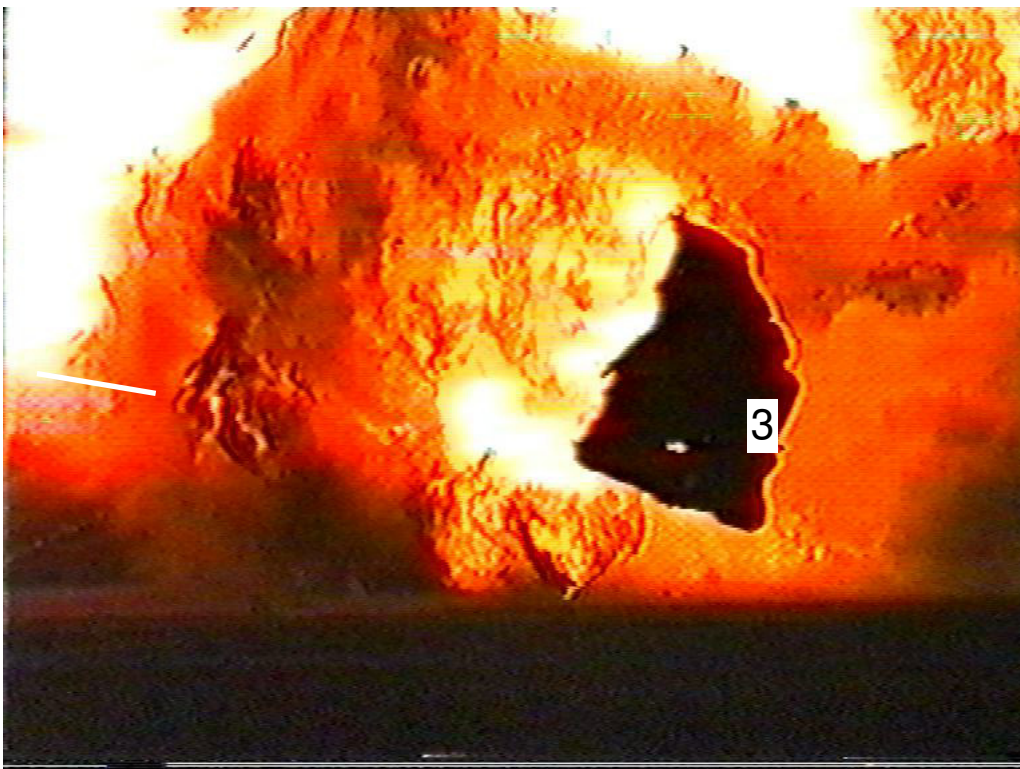
Fig. 20 reveals the form of the jacket section. However, the follow-up examination revealed, that at this point in time the jacket was wrapped around its vertical axis.

Fig. 20: Remaining part of the tank jacket

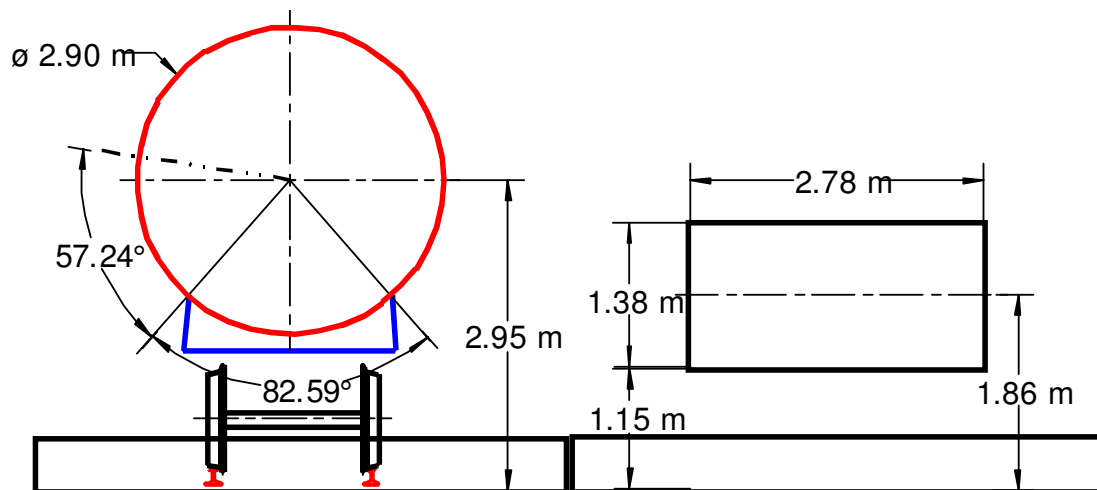
The following drawing shows the geometric arrangements of the tank car and the Castor in the fire troughs as well as the angles derived by measuring the arc lengths.

Fig. 21: Arrangement of the tank car and the Castor and the position of the rupture line

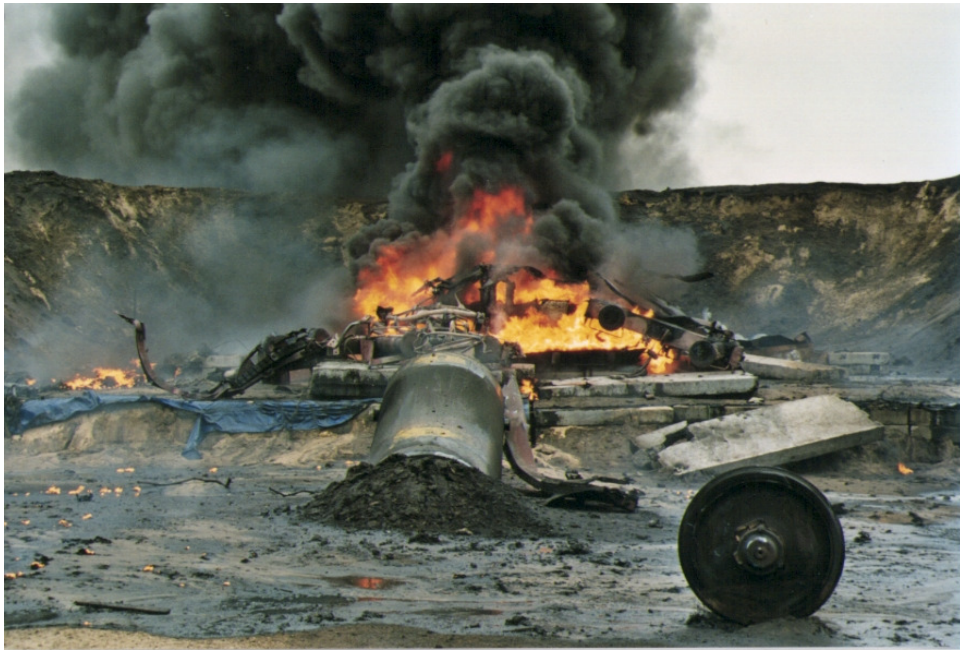
The buildings in the immediate vicinity of the test explosion as well as the measuring devices and the video equipment including cables all remained intact.

Fig. 22: Test stand immediately following the test

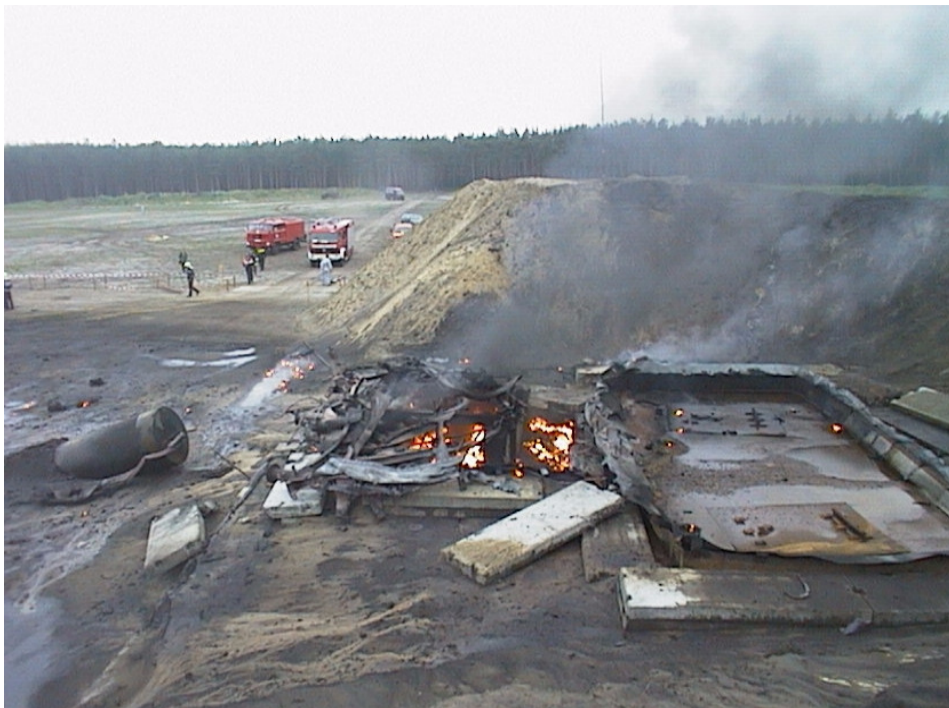
Only a smaller secondary fire, due apparently to flying sparks caused by the burning information signpost on the right next to the test site, had to be put out by the fire department.

Fig. 23: Test site seen from the right after the test

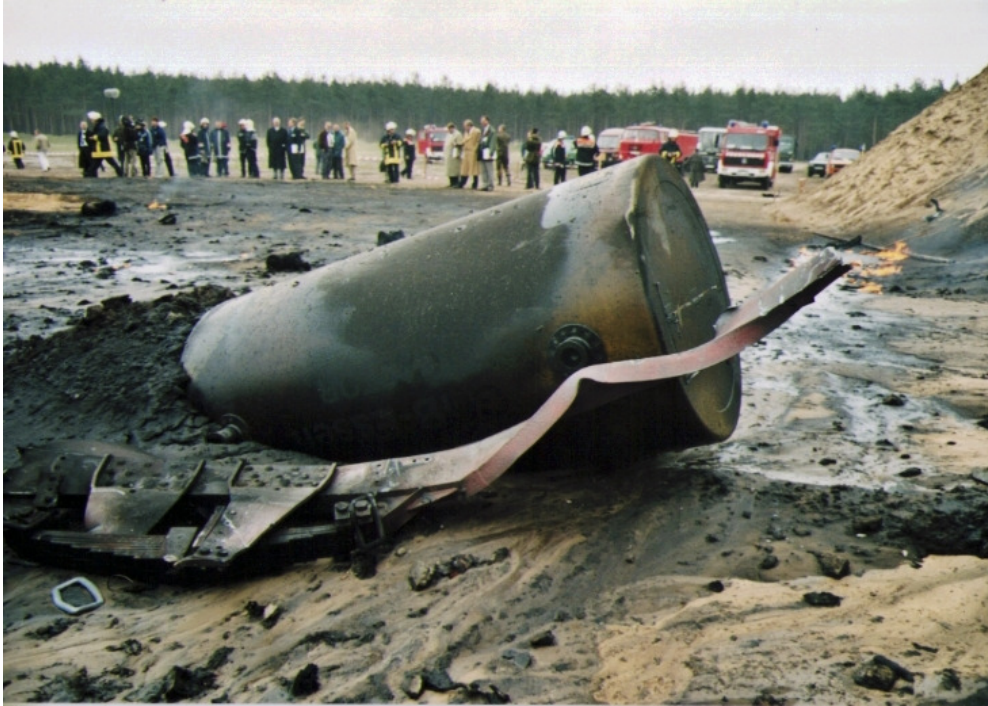
The Castor container was found tilted at an angle of approx. 20° with the cover downwards and approx. 7 m away (Fig. 24), after it had already moved 3.1 m from its original mid-point and had impacted the concrete elements with its bottom edge (see Fig. 25).

Fig. 24: Position of the Castor container after the test

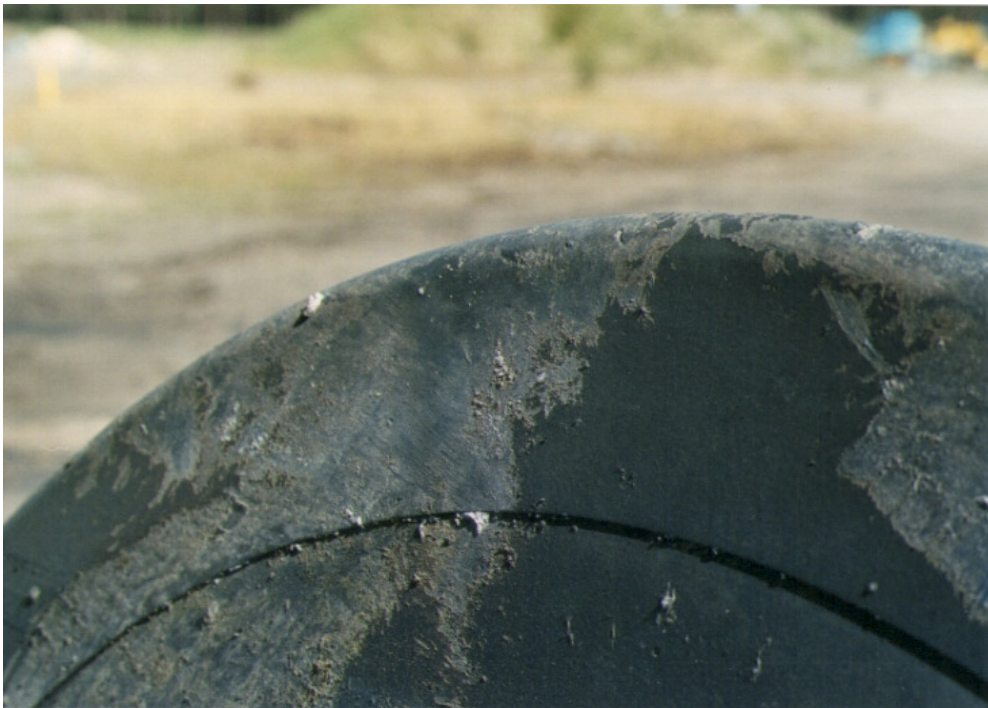
Fig. 25: Traces of concrete on the bottom edge of the Castor

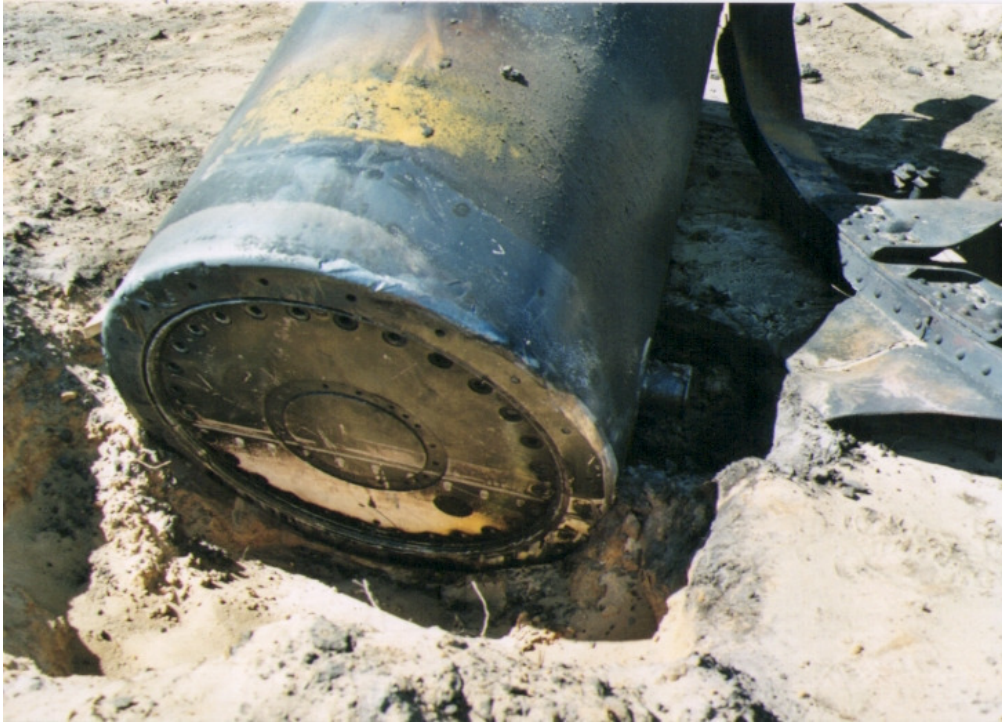
Fig. 26: Traces of the tank car on the Castor container

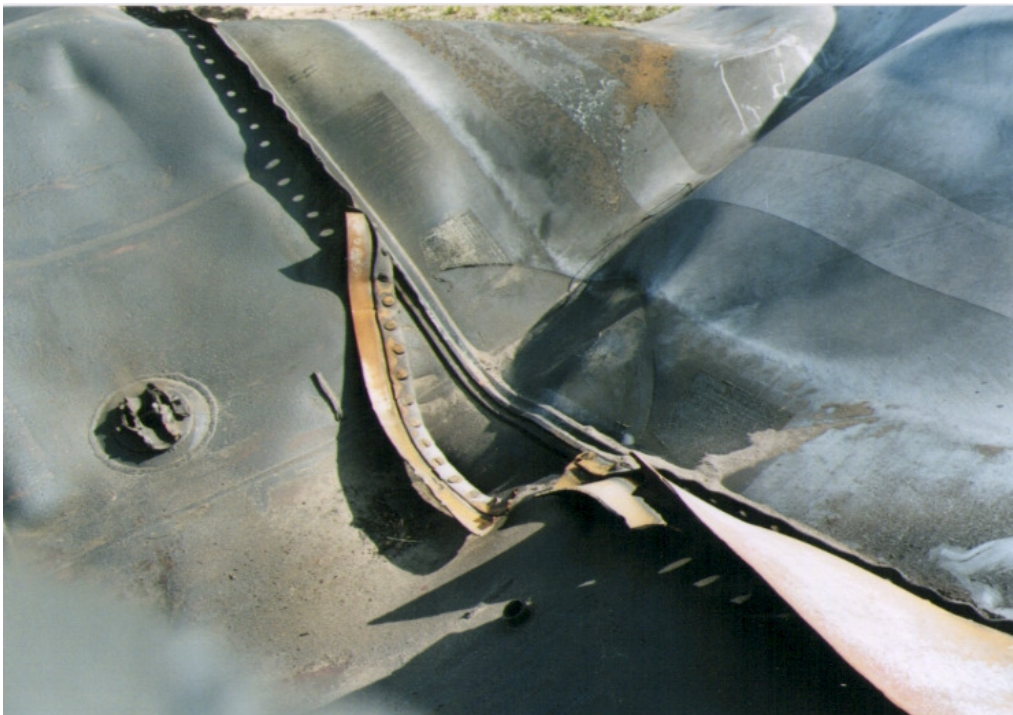
Fig 27: Dent in tank car's jacket, the point at which it came into contact with the Castor

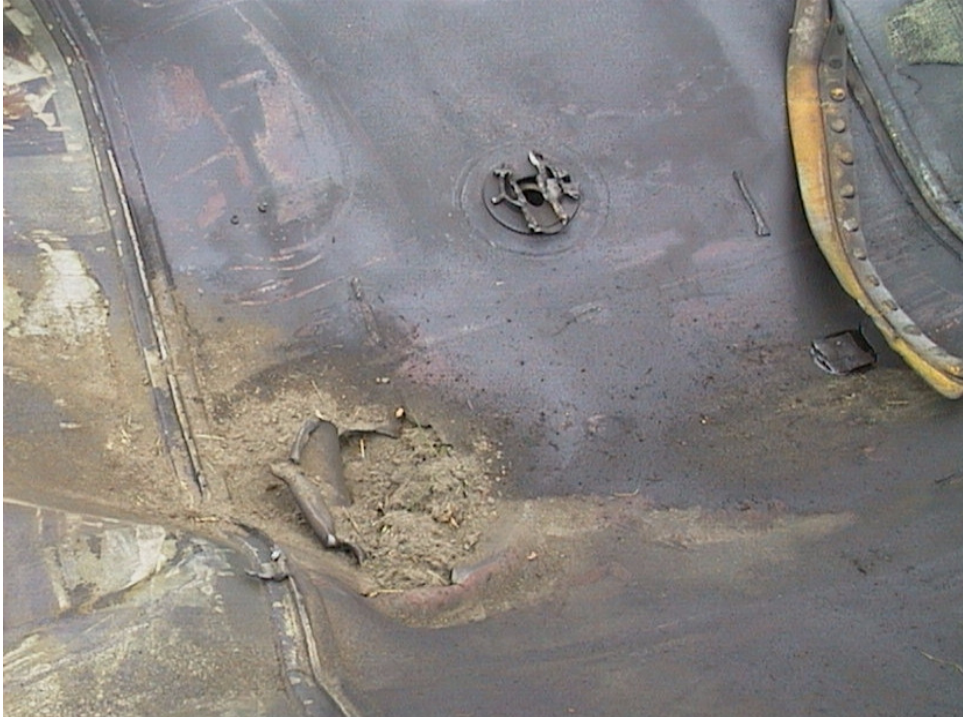
Fig. 28: Opening in the jacket due to contact with Castor's support

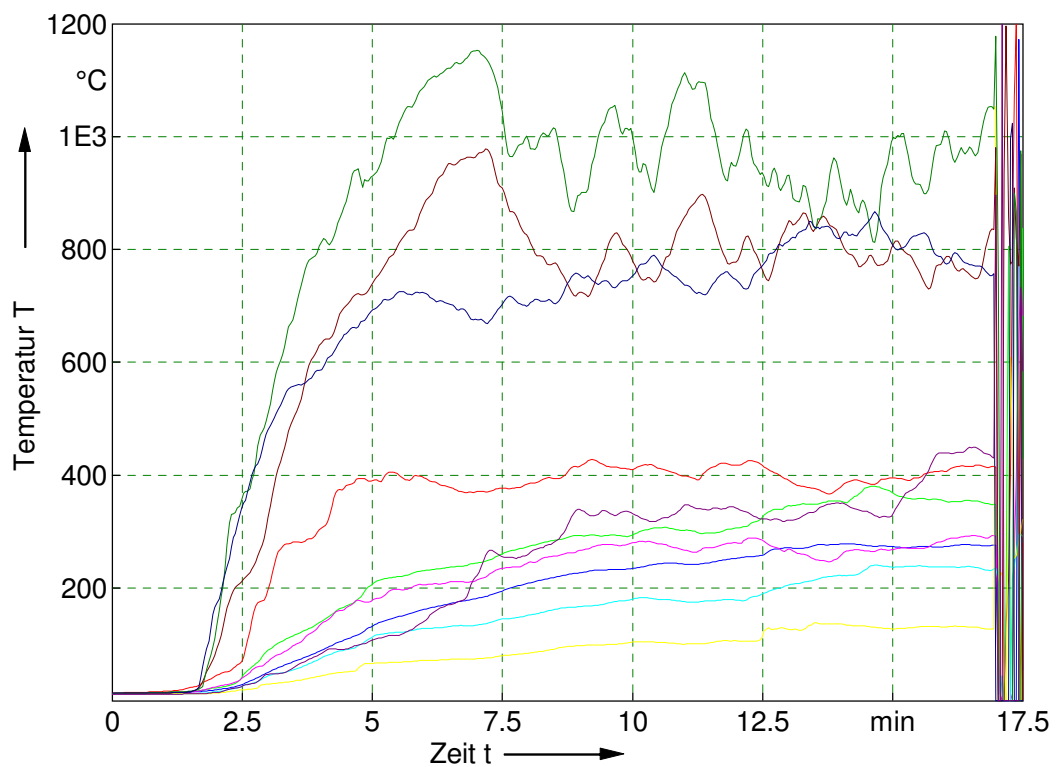
Fig. 29: Fire temperatures

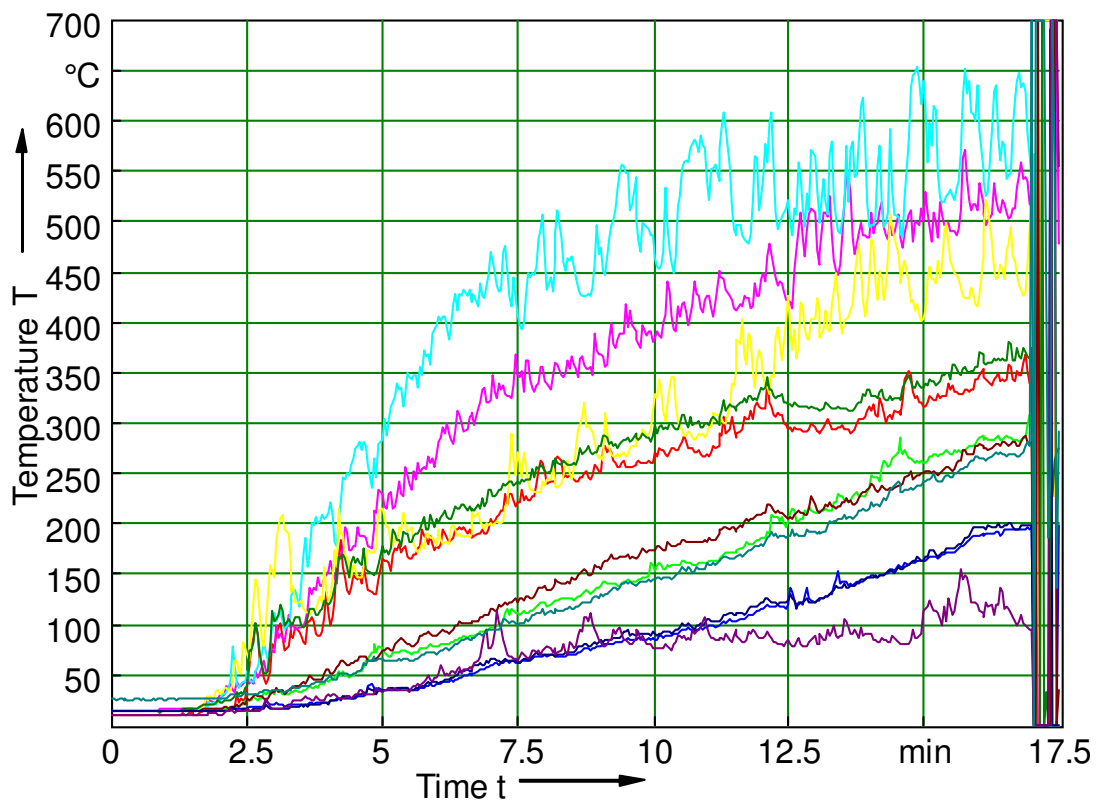
Fig. 30: Wall temperatures

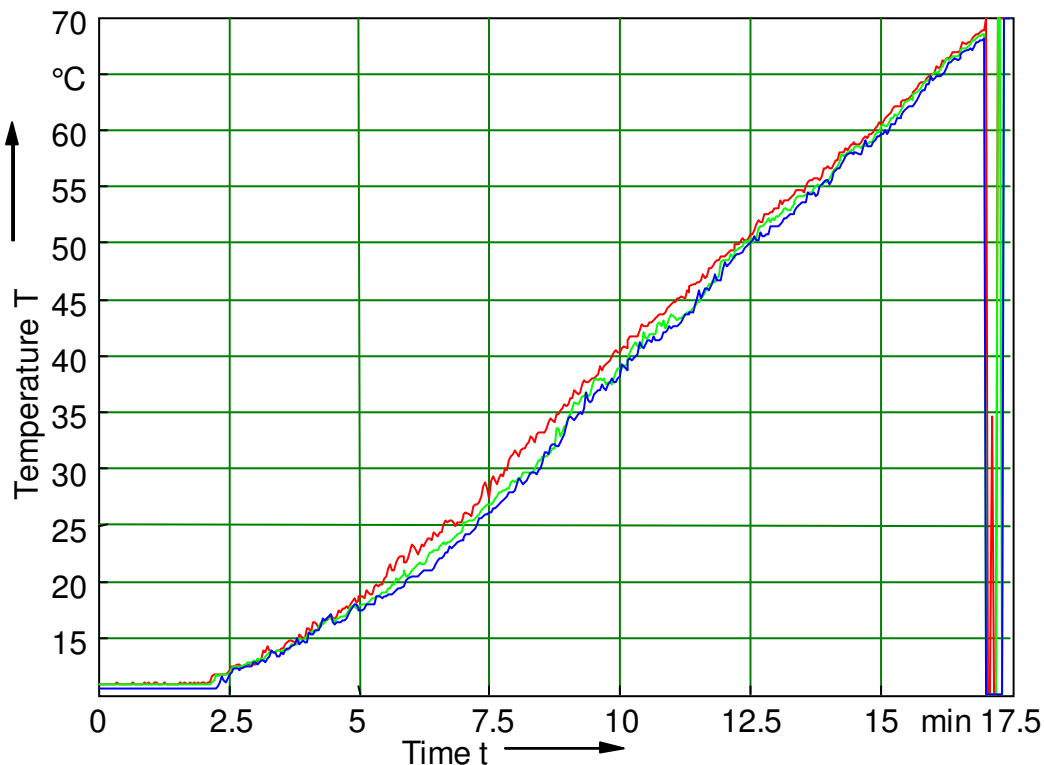
Fig. 31: Temperatures in the liquid phase

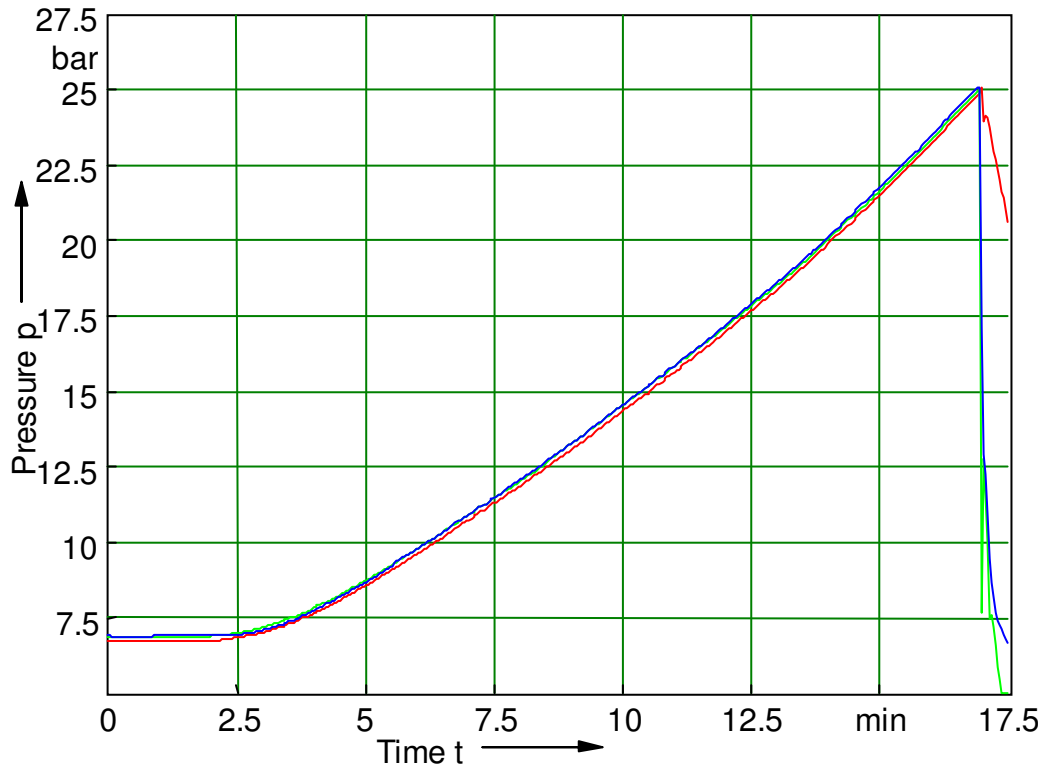
Fig. 32: Internal pressure of the tank during the course of the fire

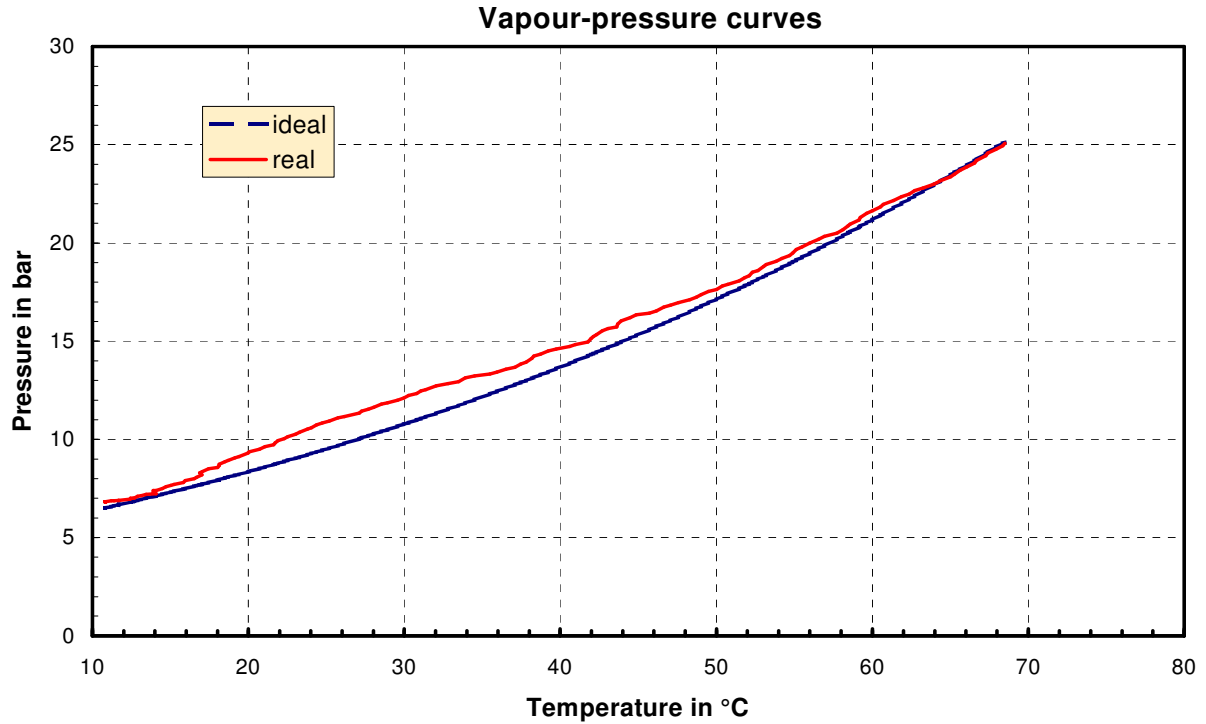
Fig. 33: Internal pressure of the tank as a function of the temperature of the liquid phase
 The fire temperatures measured around the Castor container are shown in Figure 34. Figure 35 shows the temperatures at the cover gaskets.

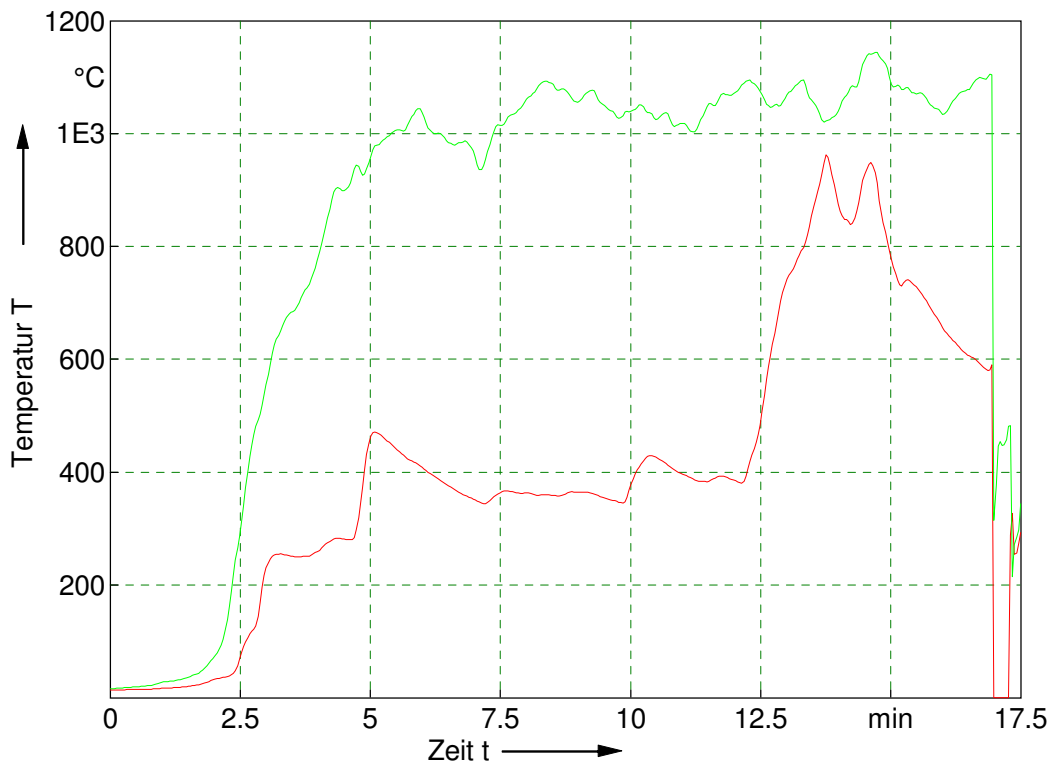
Fig. 34: Fire temperatures in the cover area of the Castor container

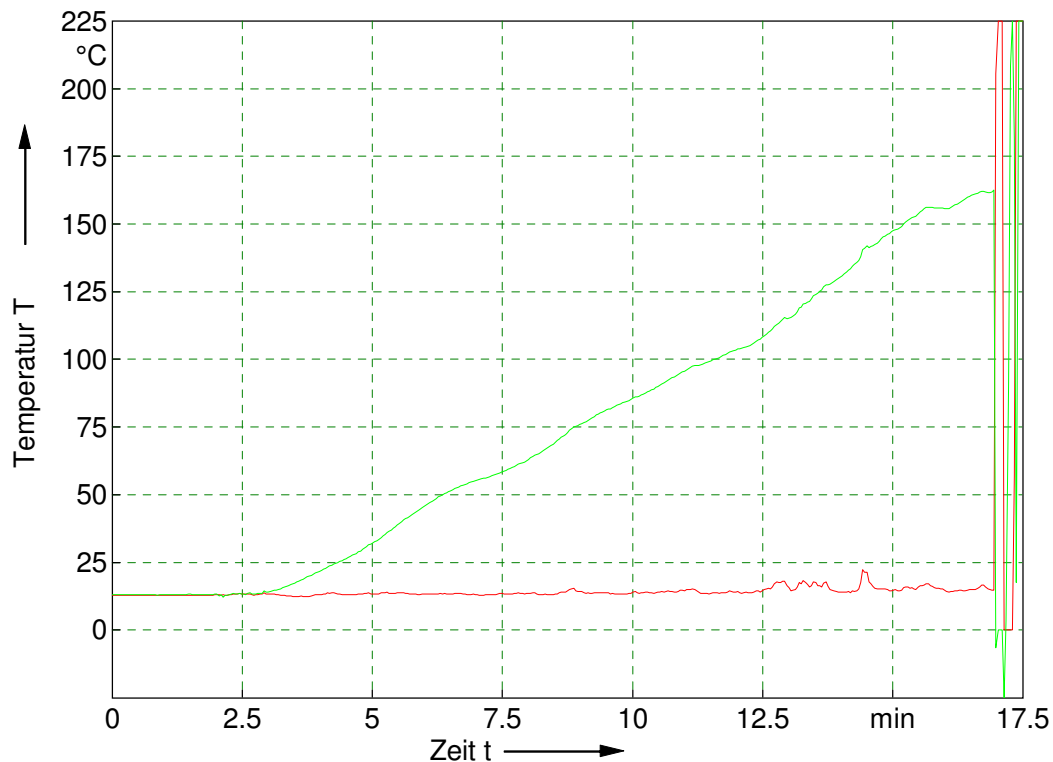
Fig. 35: Temperatures in the area of the primary and secondary cover gasket of the Castor

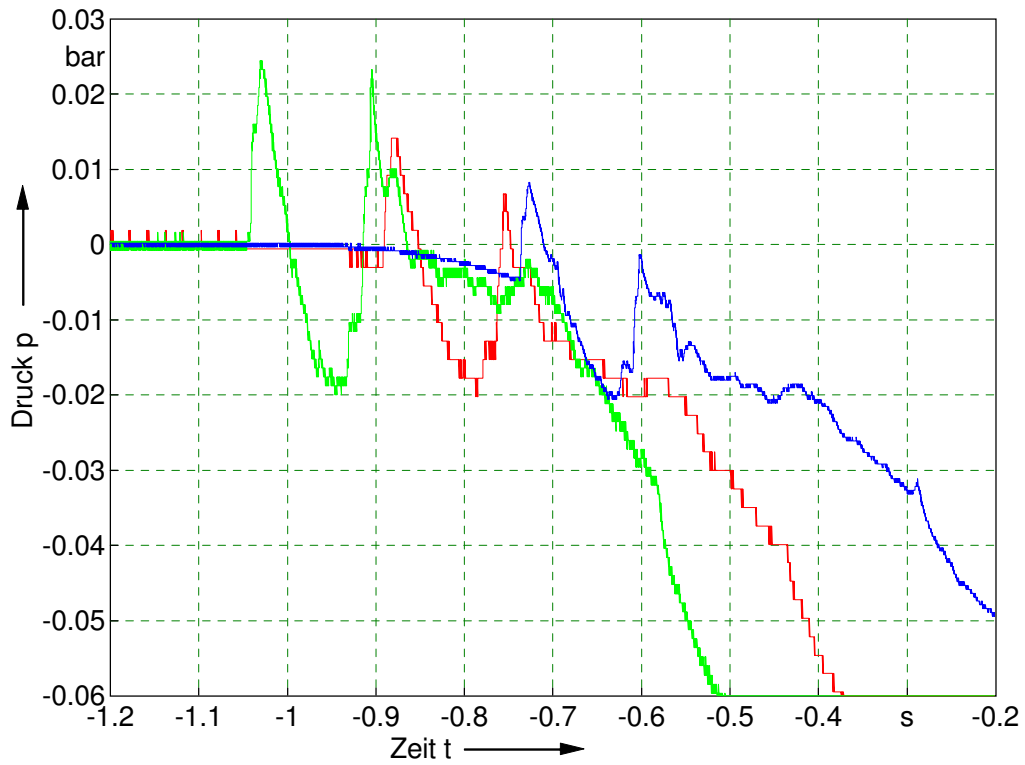
Fig. 36: Ambient pressures at 100 m, 150 m and 200 m from the test stand

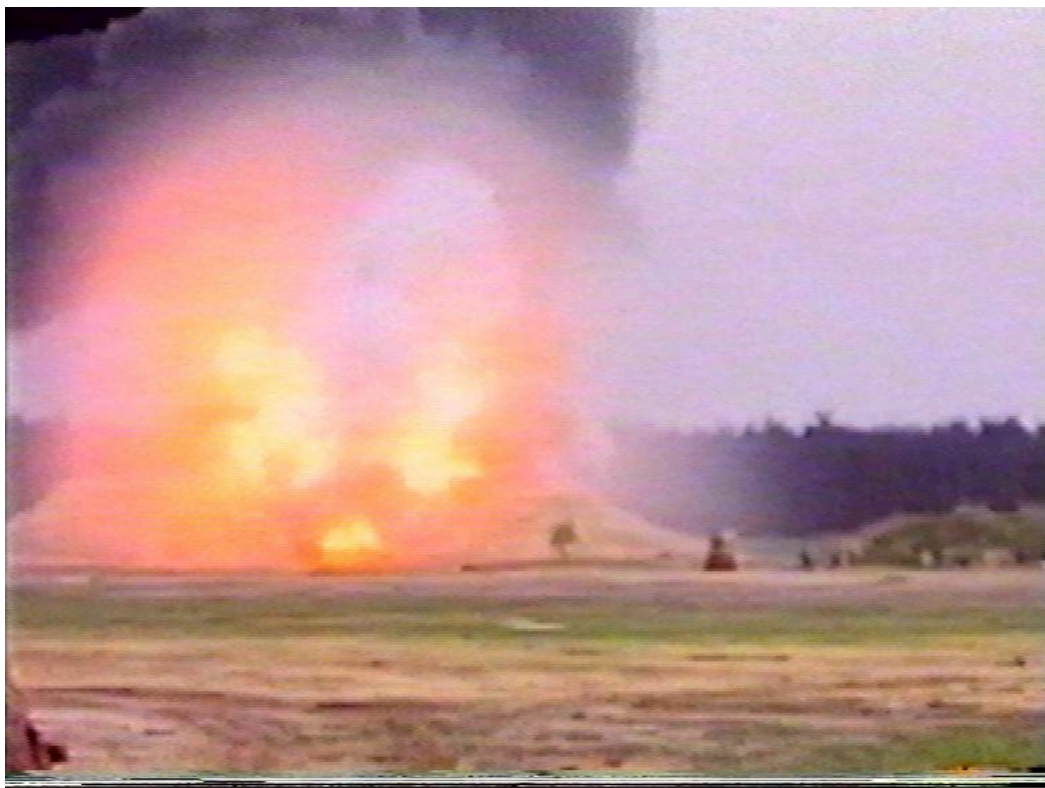
Fig. 37: Condensation of air (approx. 200 ms after the rupture)

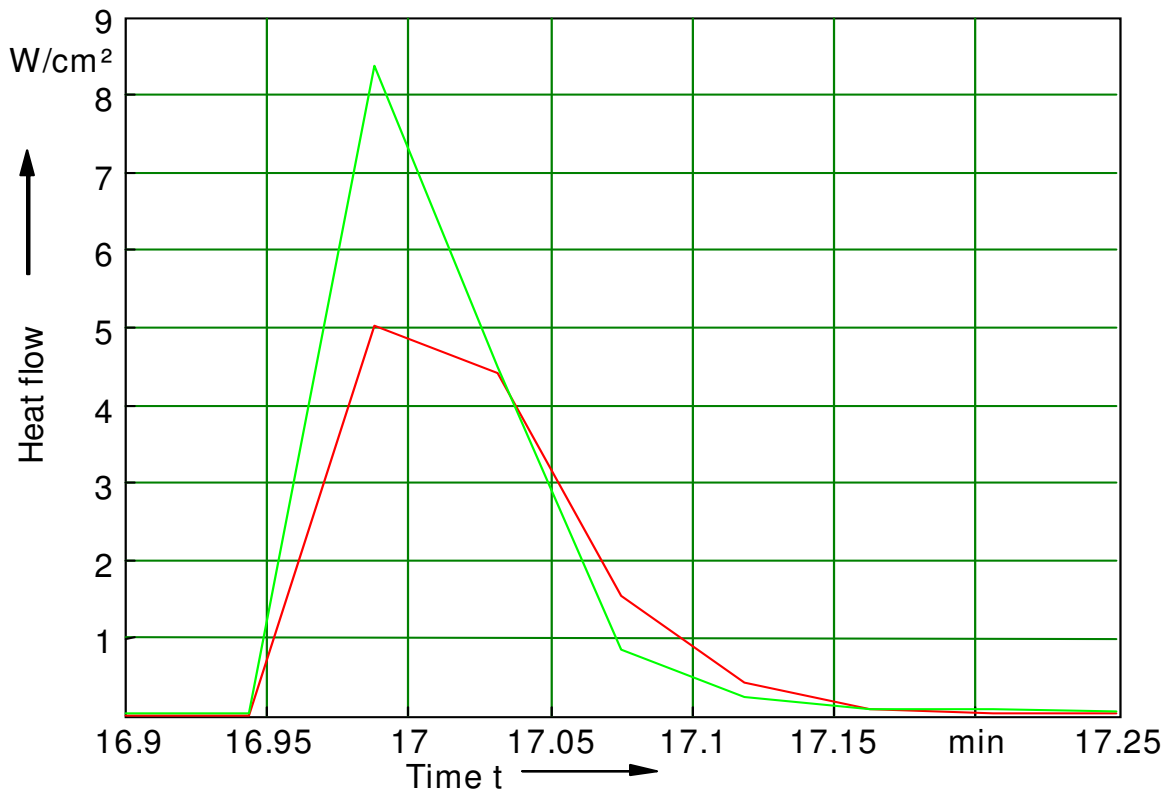
Fig. 38: Heat flow determined for the fireball

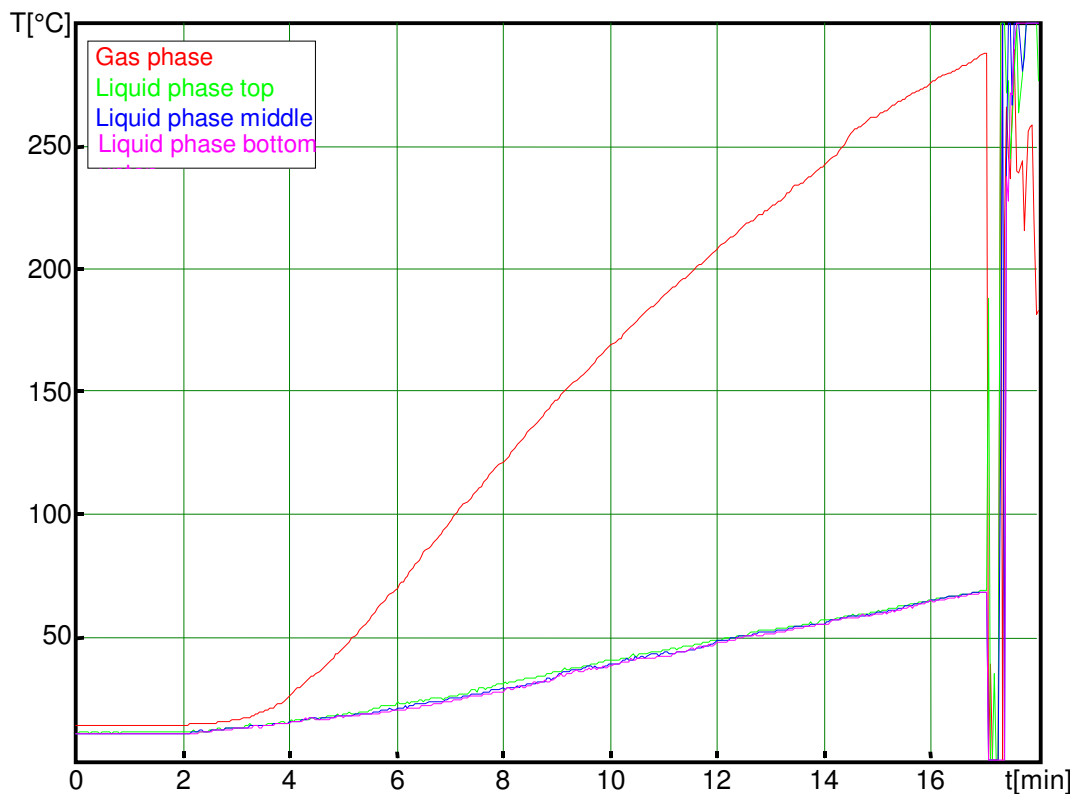
Time characteristic of the inner temperatures (gas and liquid phase)

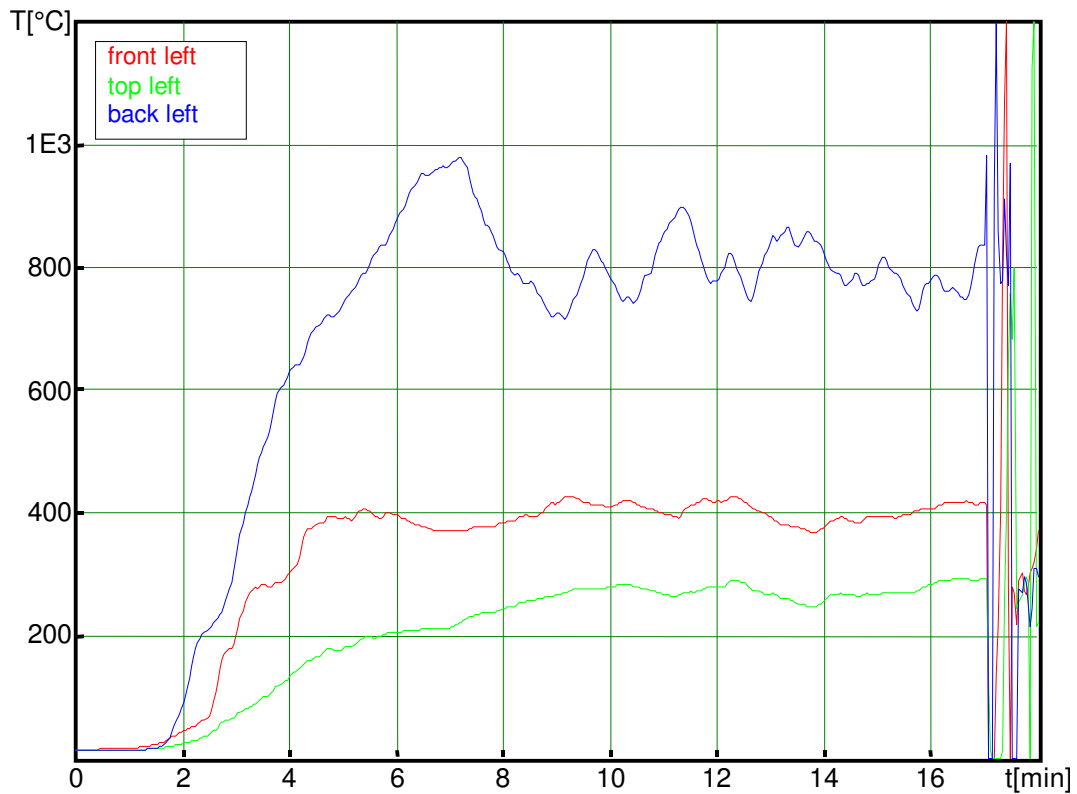
Time characteristic of the fire temperatures in the left plane

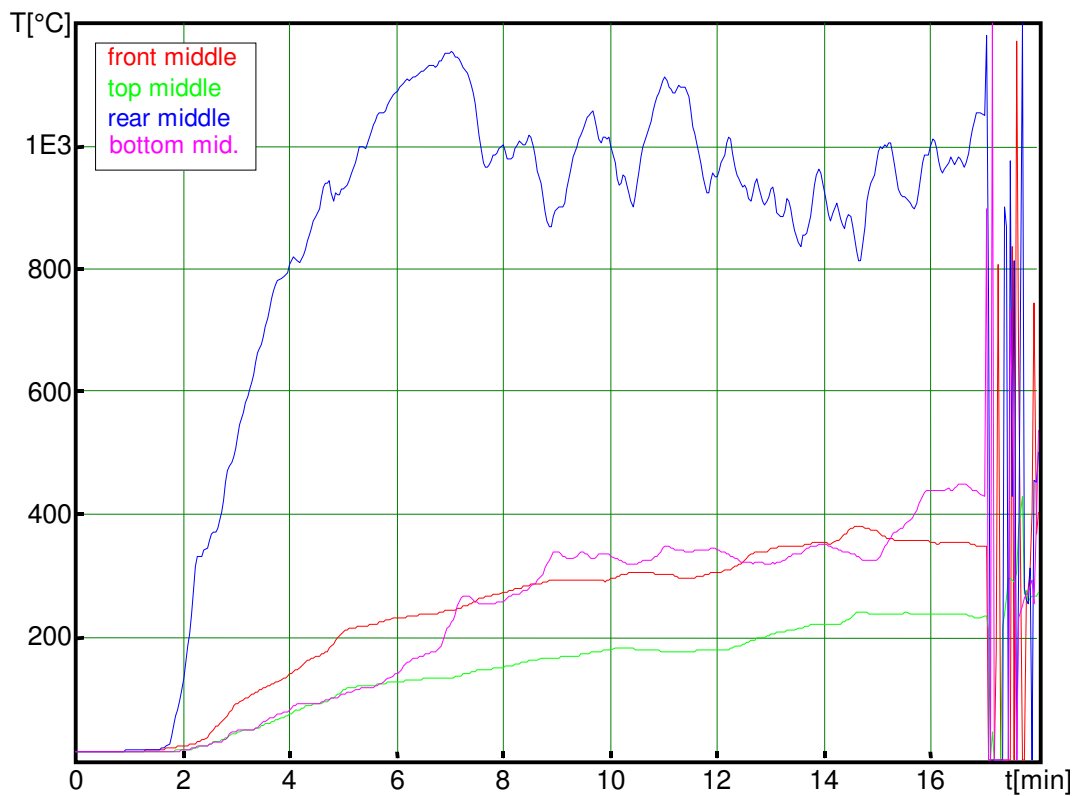
Time characteristic of the fire temperatures in the middle plane

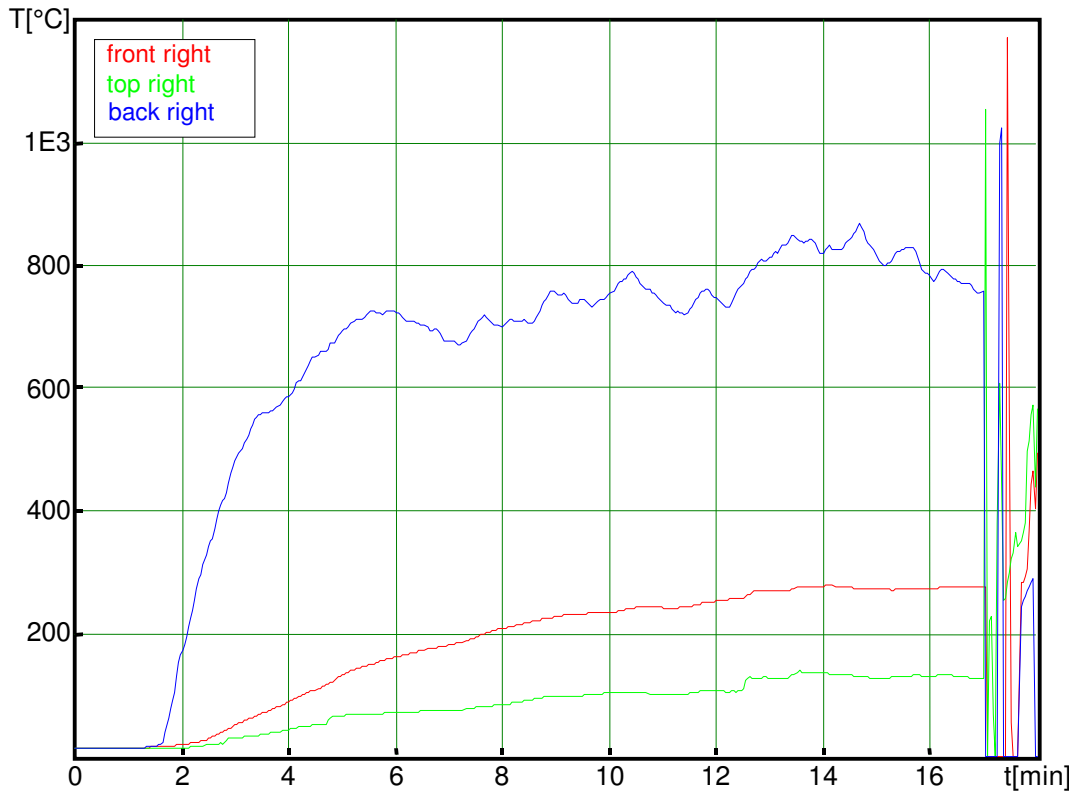
Time characteristic of the fire temperatures in the right plane

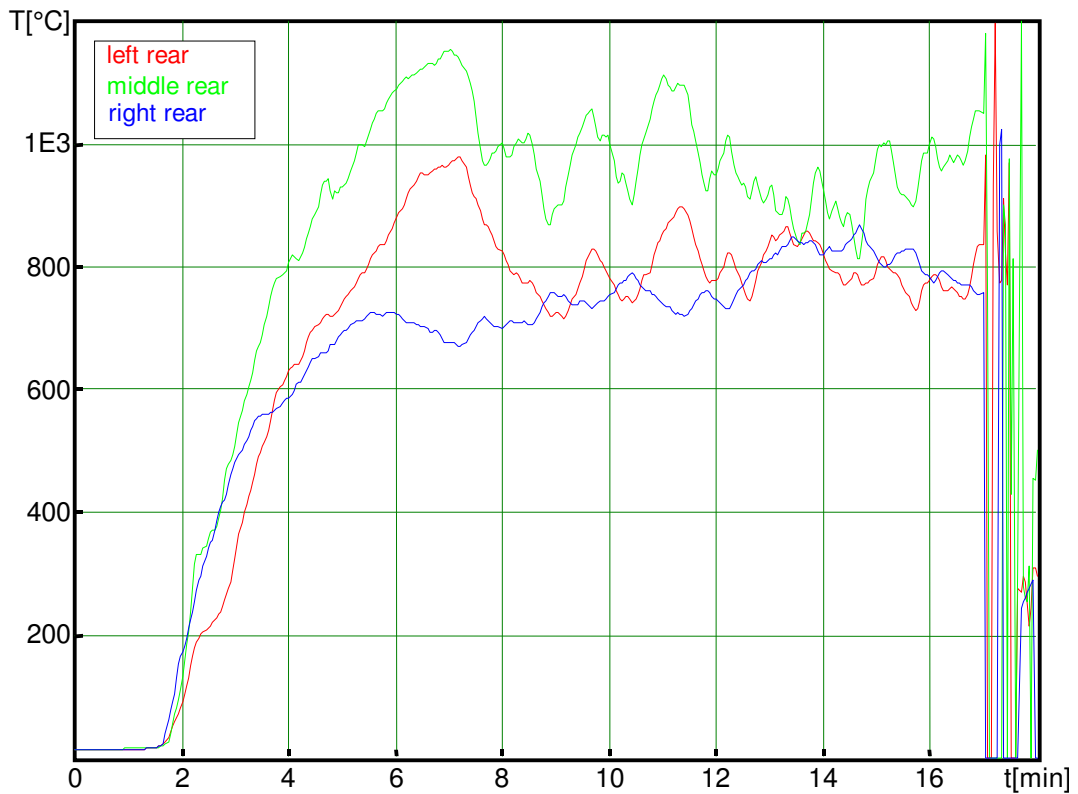
Time characteristic of the fire temperatures in the rear area

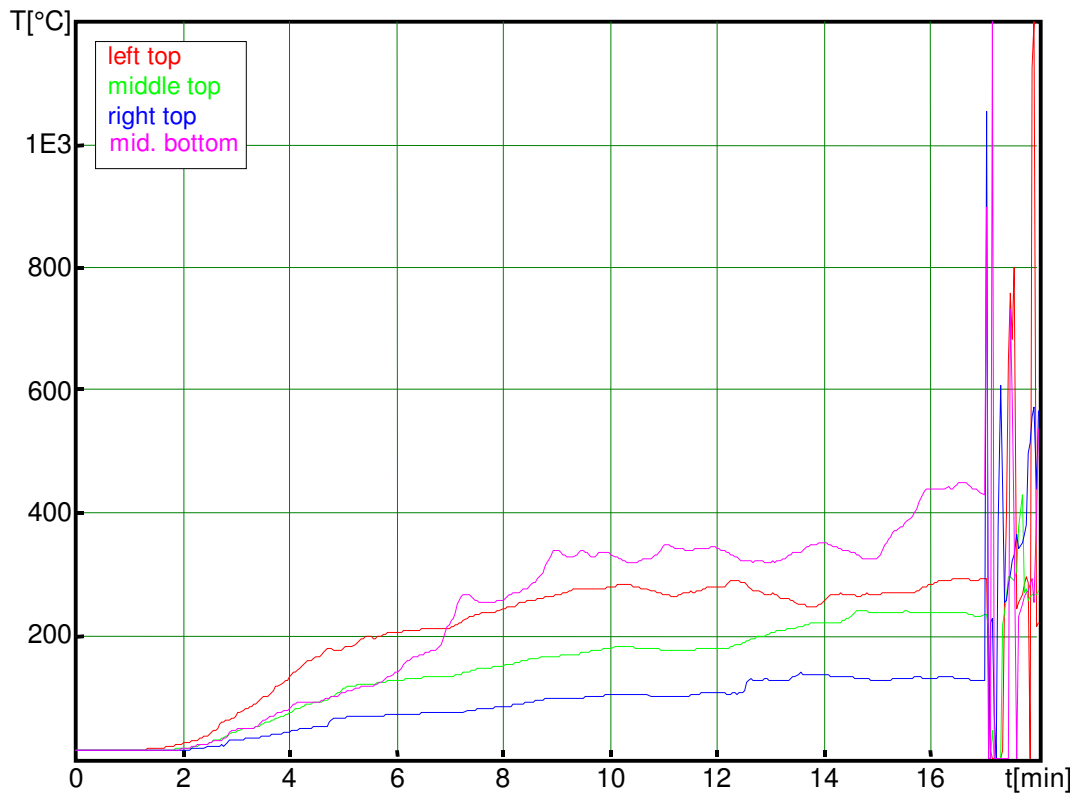
Time characteristic of the fire temperatures in the upper and lower area
