**Study of the failure limits of a railway tank car filled
with liquefied petroleum gas subjected to an open
poolfire test.**

Final report

"Study of the failure limits of an undergrate-fired railway tank car filled with liquefied petroleum gas"

Federal Institute of Material Research and Testing (BAM)

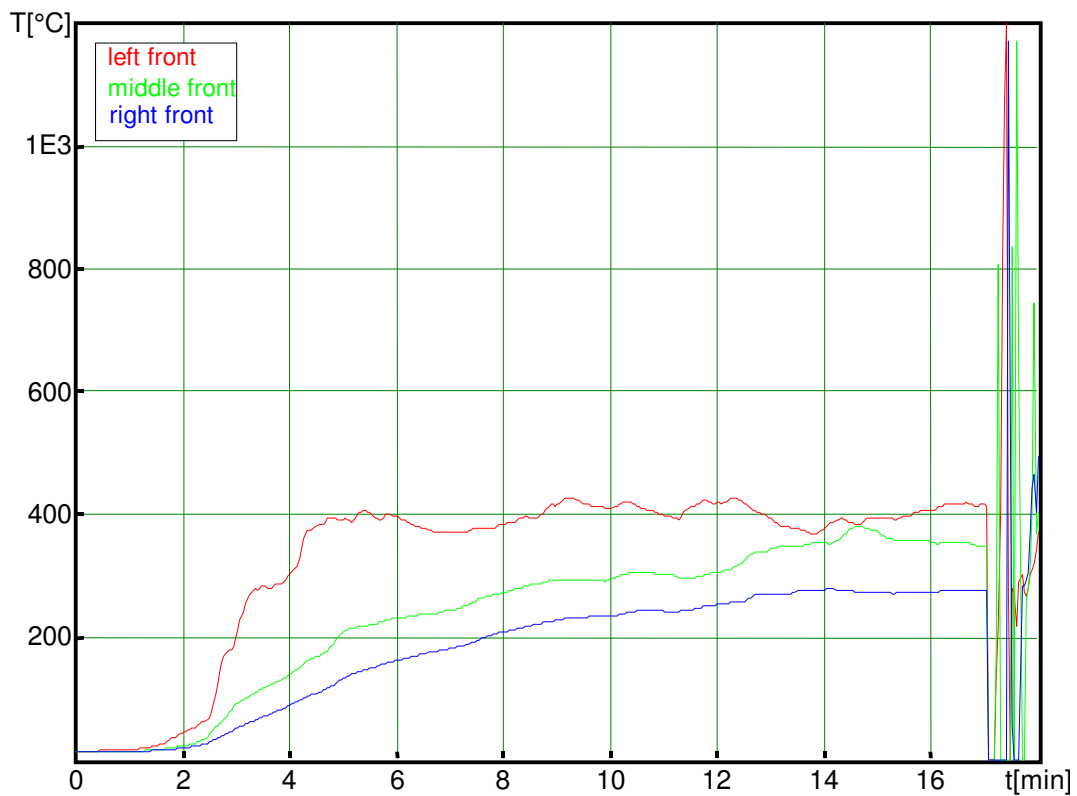
Time characteristic of the fire temperatures front area

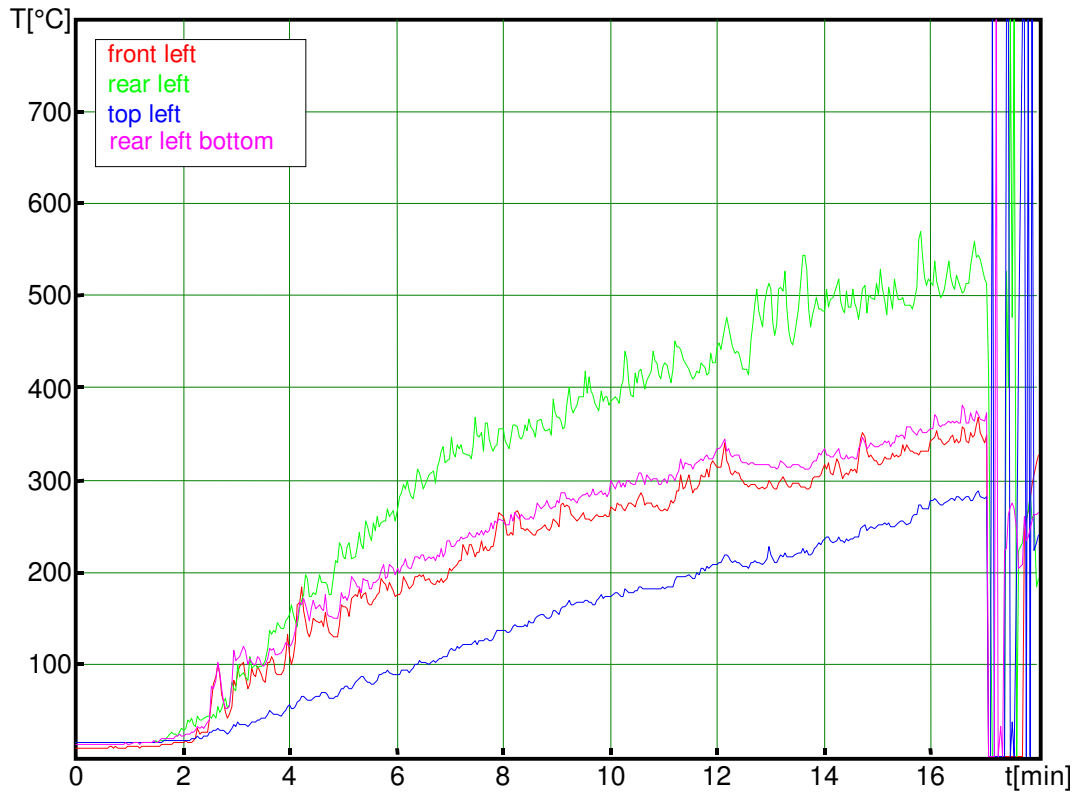
Time characteristic of the wall temperatures in the left plane

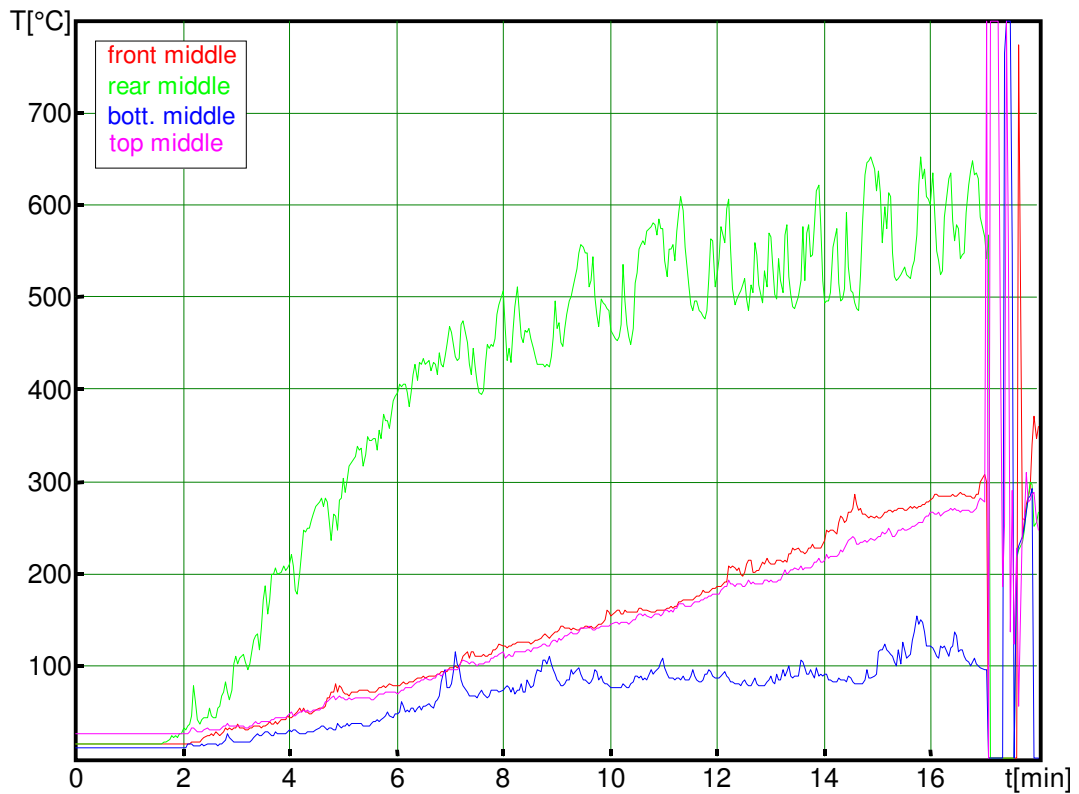
Time characteristic of the wall temperatures in the middle plane

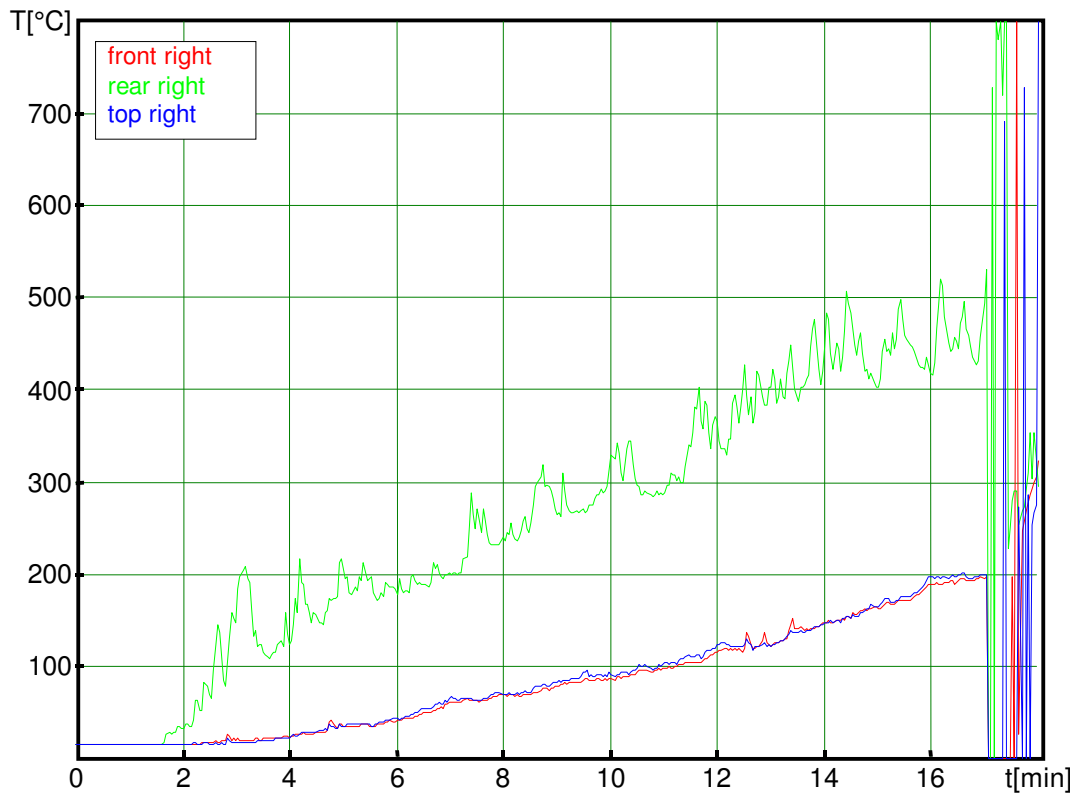
Time characteristic of the wall temperatures in the right plane

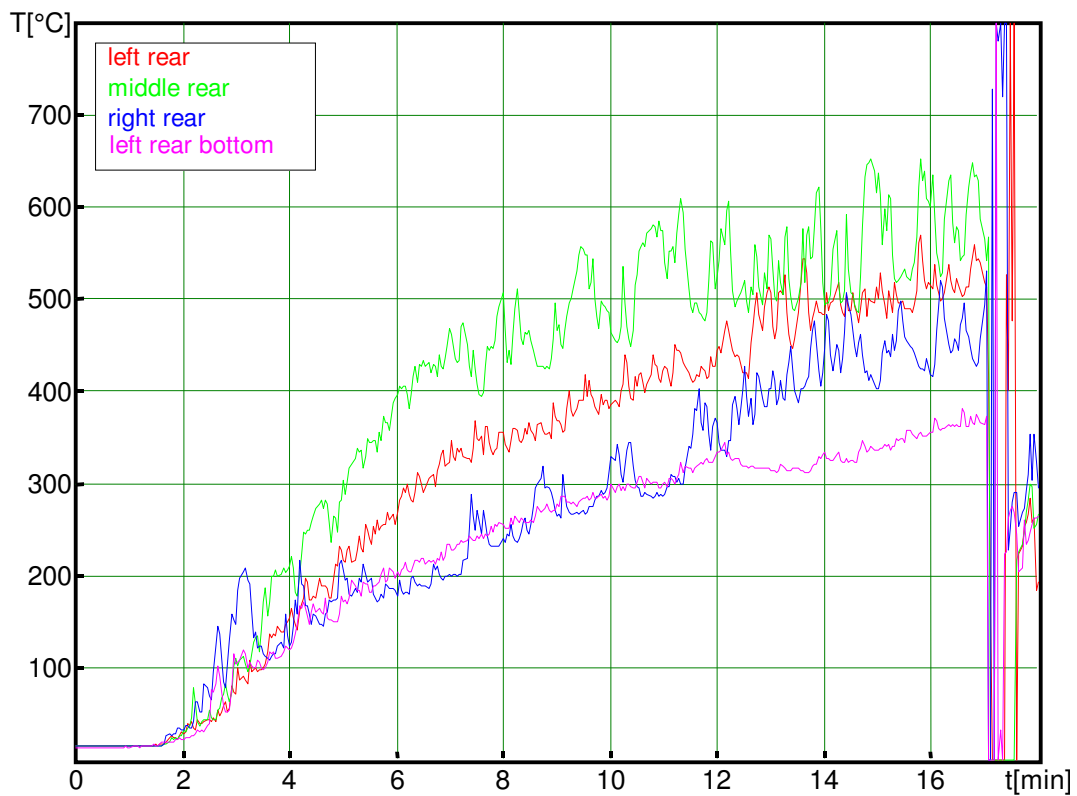
Time characteristic of the wall temperatures in the rear area

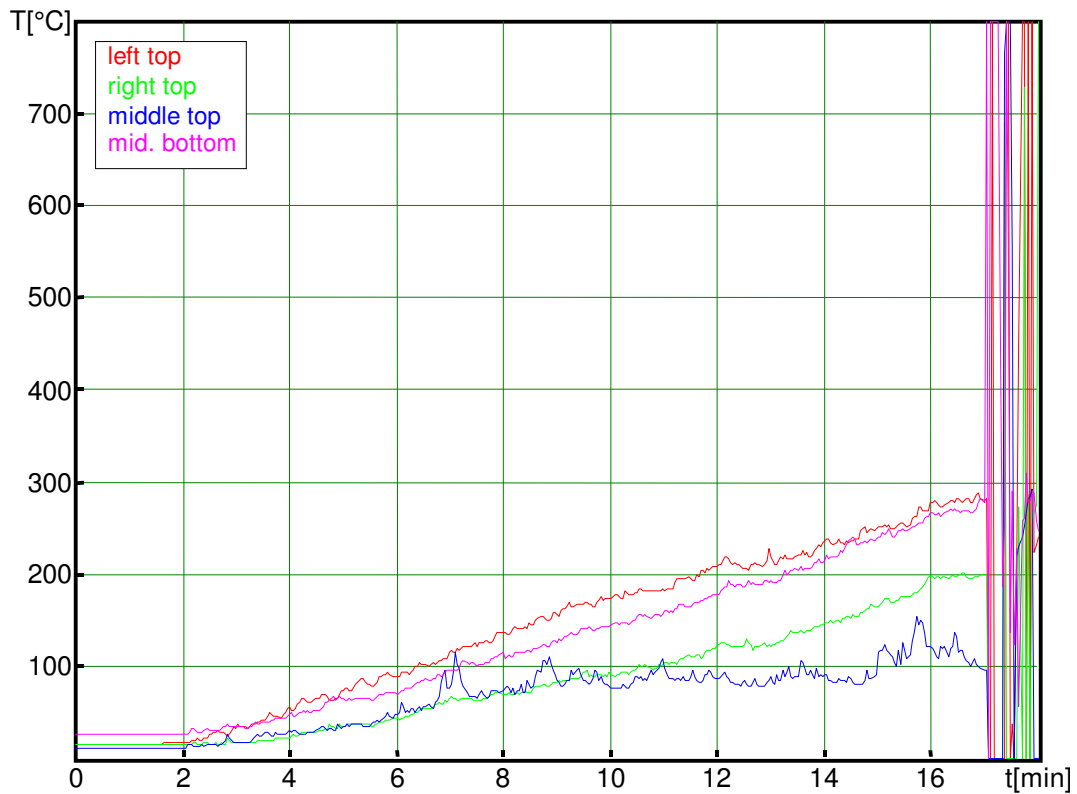
Time characteristic of the wall temperatures in the upper and lower area

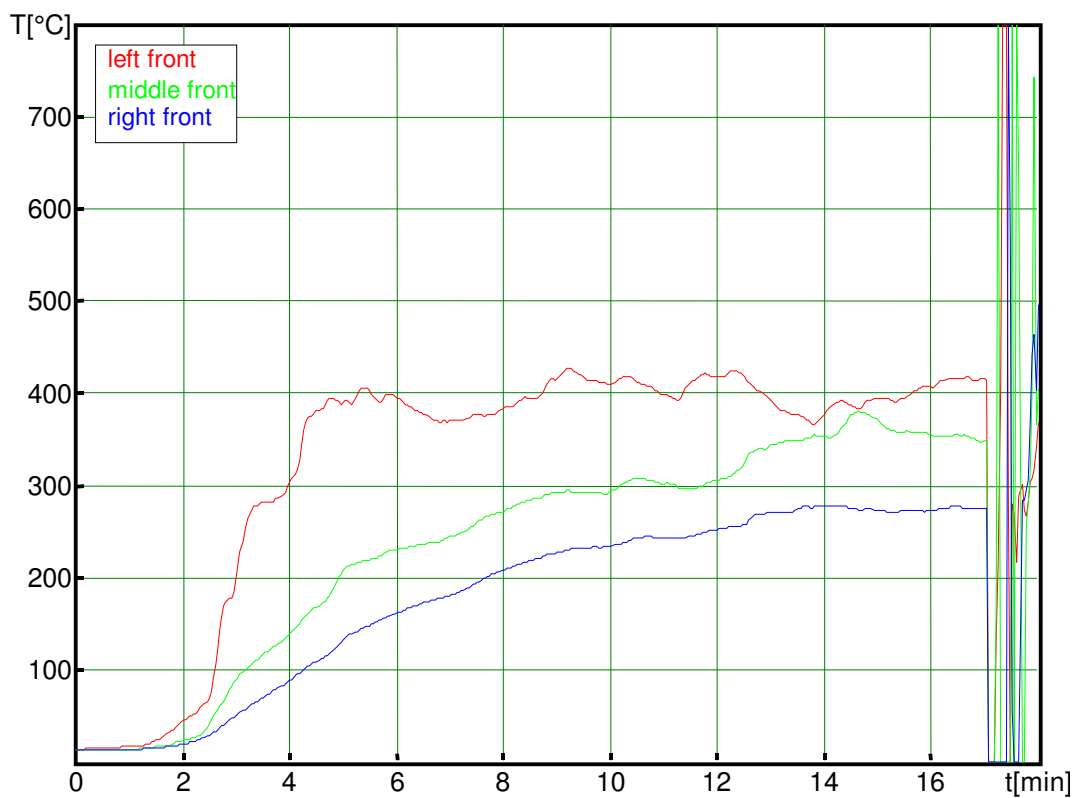
Time characteristic of the wall temperatures in the front area
