Thermographic rotor blade inspection from larger distances – a promising tool for the maintenance of wind turbines

Rainer KRANKENHAGEN, Mathias RÖLLIG, Tamara WORZEWSKI, Manoucher DOROSHTNASIR

Federal Institute for Materials Research and Testing (BAM), Berlin, Germany

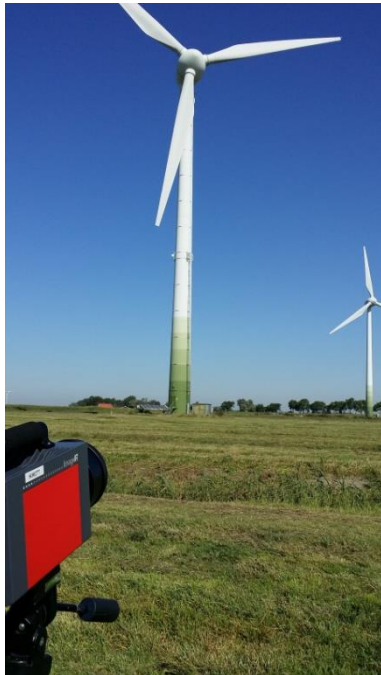
Fig. 1: onsite investigation of a rotating wind turbine at sunny weather, distance of about 250 m to the hub

Outdoor measurements were conducted in onshore wind farms by courtesy of the owner More energy GmbH. The IR camera was located at the ground in different distances to the particular wind turbine (as shown in Fig. 1). Usual distances to the rotor blades were between 150 and 300 m leading to geometrical resolutions between 2.5 cm and 5 cm per pixel. In order to avoid motion blurring effects at rotating blades only cooled infrared cameras with a snapshot mode and short integration times were applied. The following results were recorded with the ImageIR 8300, equipped with an objective of 100 mm focal length. In the following, some results are discussed for the case of rotating blades of an operating wind turbine, and for the case of inactive blades of a turbine that was switched off.

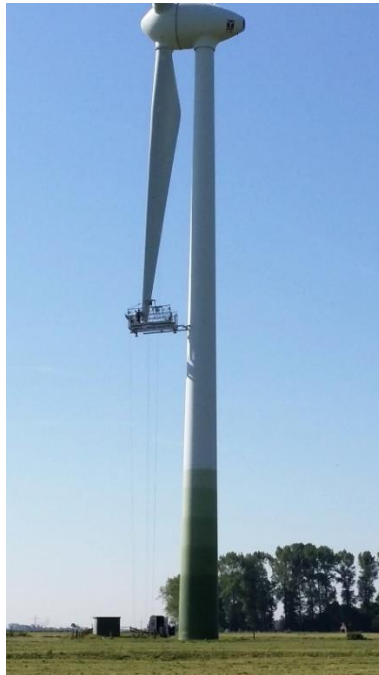
Fig. 2: stopped wind turbine during maintenance inspection using a special platform

Alternatively, thermal rotor blade inspection can be carried out when the turbine is in shut down modus as shown in Fig. 2 (where no turbulence wedges should appear)

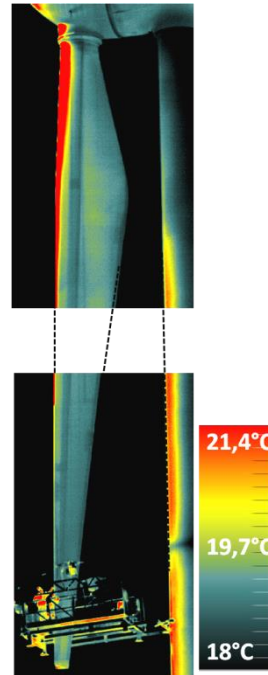
Fig. 3: thermograms of the lower rotor blade shown in fig. 2, recorded with an Infratec 8300 camera (see following section Experimental details)

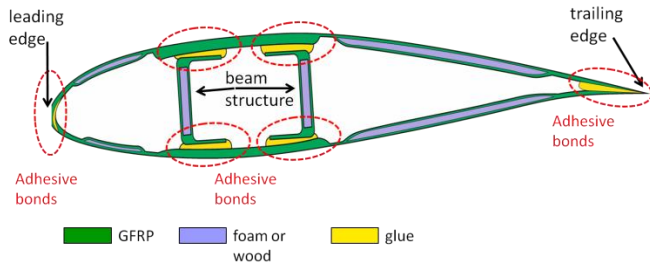
The following Fig. 4 displays the principal structure of a rotor blade in cross section view. Mostly, the blade consists of two half shells connected by adhesive bonds at the leading edge and the trailing edge. The inner beam structure strongly enhances the mechanical strength. It is also fixed by adhesive bonds. Both kinds of adhesive bonds (red highlighted in Fig. 4) are essential for function and durability of the rotor blade. Possible detachments

Fig. 4: scheme of the cross section of a rotor blade, different materials are displayed with colors

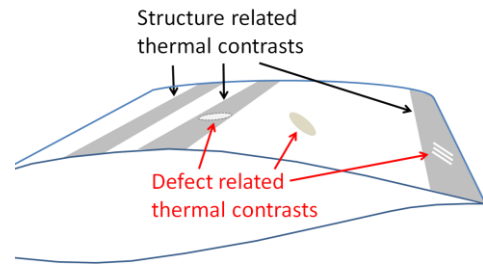
Fig. 5: thermal contrasts to be expected at a rotor blade after external heating or cooling

Those parts of the outer shell, which are in contact to backside glue layers, behave thermally like parts of larger thicknesses (i.e. like regions with enlarged thermal capacity) leading to the formation of thermal contrasts after external heating or cooling. Fig. 5 shows the corresponding thermal contrasts as grey colored stripes, indicating how thermograms of a rotor blade usually look like. If inner defects existed they would cause additional thermal contrasts overlaying the thermal signature of an undamaged blade. Some examples are drawn in Fig. 5 (red arrows and text). Careful inspection of Fig. 3 reveals stripe-shaped thermal contrasts comparable to the drawing in Fig. 5. Another example is shown here in Fig. 7:

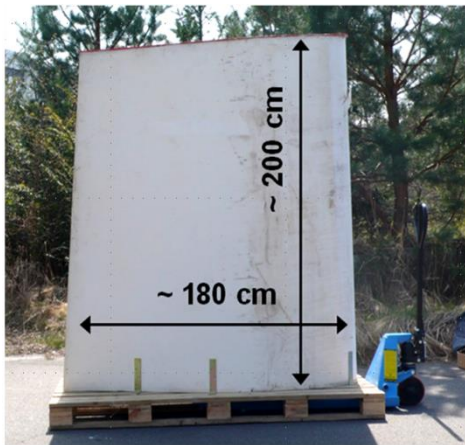
Fig. 6: separated part of an used rejected wind turbine rotor blade mounted on a pallet for outdoor measurements

In this case, a separated part of a rejected wind turbine rotor blade (shown in Fig. 6) was observed with an infrared camera under different weather conditions from a larger distance [6]. Stripe shaped contrasts associated with the beam were clearly detectable but the temperature contrasts were weak, i.e. below 1 K. These examples shall only demonstrate how a thermographic inspection method could work.

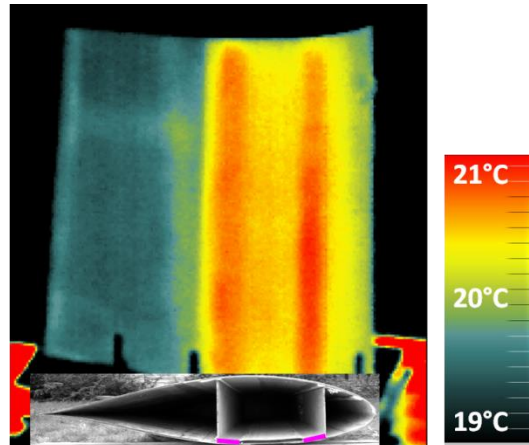
Fig. 7: thermogram of the blade part recorded in a distance of 34 m after a sunny summer day (for details see [6]), adhesive bonds corresponding to the recorded surface are magenta highlighted in the photo of the cross section below

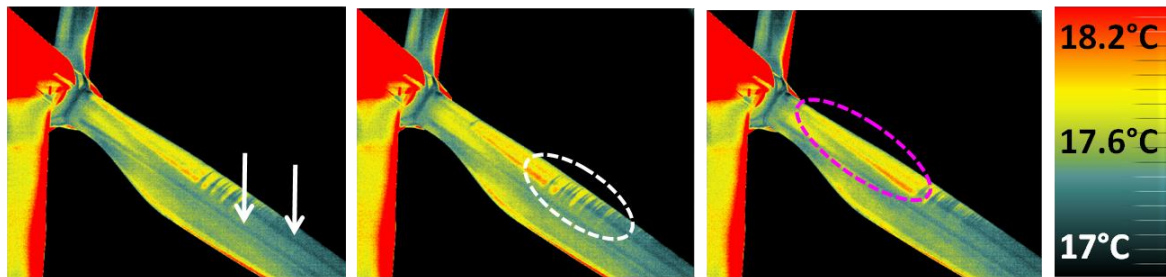
The following figure 8 contains thermograms of all three blades of a turbine during operation, which was running with 15 rotations per minute. Here, the suction sides were observed while the sun was shining mostly on the pressure sides. The accurate sun position can be approximated by considering the location of the heated parts of the wind turbine (strong red regions in the thermograms).

Fig. 8: thermograms of all three rotor blades of a rotating wind turbine in the morning, temperature scale is optimized for the blade regions, arrows mark stripe-shaped contrasts correlated to an inner structural feature, the white ellipse includes an uneven stripe pattern due to the occurrence of turbulent wedges at the surface, the magenta ellipse includes a moderate heated region caused by laterally incident sun rays

- Two long parallel cooler stripes (white arrows pointing to dark blue stripes) probably due to interior belts or adhesive bonds
- Uneven stripe pattern at the leading edge due to the occurrence of turbulent wedges at irregularities on the surface i.e. bumps or open cracks [7]
- Partly warmer region at the leading edge near the hub, probably caused by partly incident rays of the sun which is located laterally with respect to the curved shape of the blade

Since there was no direct sun exposure, the parallel cool stripes must have been generated by a former increase of the air temperature during the morning (about 3 K within 3 h). Faced with a variety of thermal contrasts with different causes, it becomes difficult to identify contrasts which are related to internal defects. Furthermore, detecting small thermal contrasts of relevant defects can be hindered when they are masked by greater thermal contrasts of disturbing reflections/radiation. However, one gains more clarity on the interpretation of thermal contrasts by comparing the particular thermograms with each other. Within the project IKARUS, a simple difference method was considered in more detail [8]. In

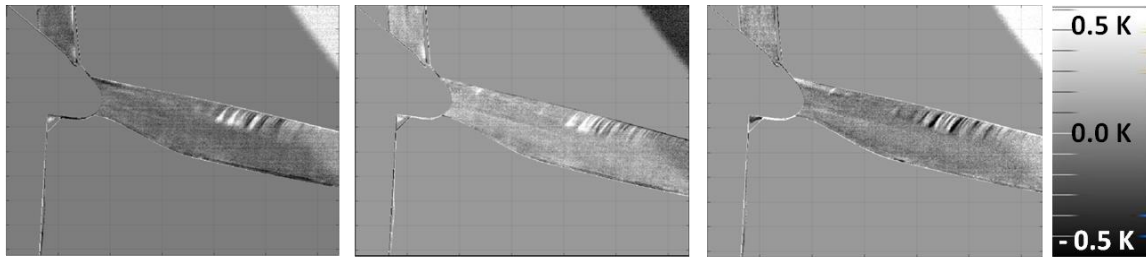
Fig. 9: difference thermograms of the rotor blades shown in Fig. 8, every thermogram represents the spatial distribution of thermal differences of two different blades (left: blade 1 - blade 3, centre: blade 1 - blade 2, right: blade 3 - blade 2)

As to be expected, the structural related parallel stripes and also the (disturbing) warmer region at the leading edge disappeared in the difference thermogram, because the geometrical shape is more or less equal in all blades. Only the turbulence wedges remain and actually increase in number, because the difference thermogram contains thermal signatures of two blades with each particular turbulence patterns. Depending on whatever is minuend or subtrahend within the calculation of the difference thermogram, the thermal contrasts associated with turbulence wedges appear with different signs.

Summarizing, difference thermograms can facilitate the detection of thermal irregularities in rotor blades by minimizing/eliminating disturbingly masking features such as inner structures or radiated regions. Yet, in regions where turbulence wedges evolve (in case of rotating blades), the detection of possible inner damages is hindered. The investigated wind turbine, here, has no known damages which could be presented in Fig. 9.

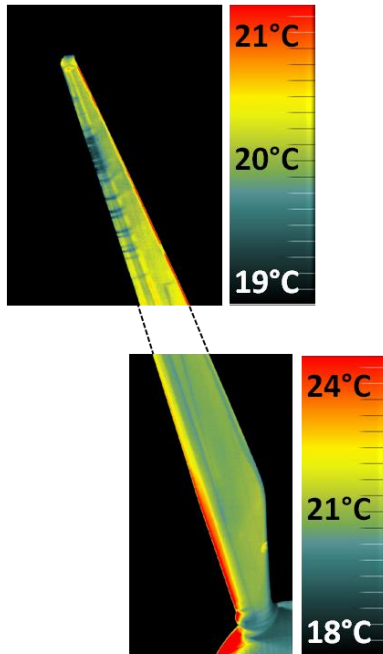
Fig. 10 and Fig. 11 display again thermographic results obtained at the wind turbine shown in Fig. 2. The different temperature scales indicate a typical problem of non-rotating blades: inhomogeneous heating of the very uneven-shaped blade surface leads to high temperature contrasts that are much stronger than possible defect related contrasts.

Fig. 10: thermograms of the upper rotor blade above the nacelle (not shown in Fig. 2) with adapted temperature scales

However, blade regions with nearly homogeneous surface heating exhibit very clearly structure correlated contrasts. Interestingly, turbulent wedges appeared also in this case at the upper half of the upper rotor blade resulting from the actual wind flowing around the resting blade. Concerning convection effects, it must be generally noted that the strength of the particular thermal contrasts depends not only of the velocity difference between air and blade surface, but also from the temperature difference (sign and magnitude) between air and blade and the actual exposure to sunlight. Of course, the probability of thermal active turbulent wedges is strongly reduced for non- rotating blades. Furthermore, the probability increases with a higher rotation speed. In fact, there are always turbulence wedges near the blade tip of rotating blades due to the high tangential velocity in this blade sector, even at low rotating frequencies.

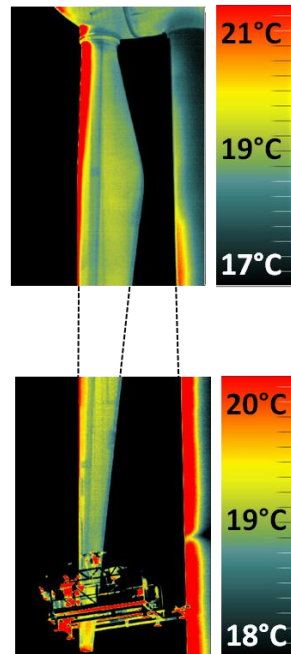
Fig. 11: thermograms of the lower rotor blade below the nacelle (as shown in Fig. 2) with adapted temperature scales
