Infinite Life of CFRP Evaluated Non-Destructively with X-Ray-Refraction Topography In-Situ Mechanical Loading

Volker TRAPPE¹, Alexander MÜLLER¹, Stefan HICKMANN¹

¹ BAM Bundesanstalt für Materialforschung und -prüfung,
Unter den Eichen 87, 12205 Berlin, Germany

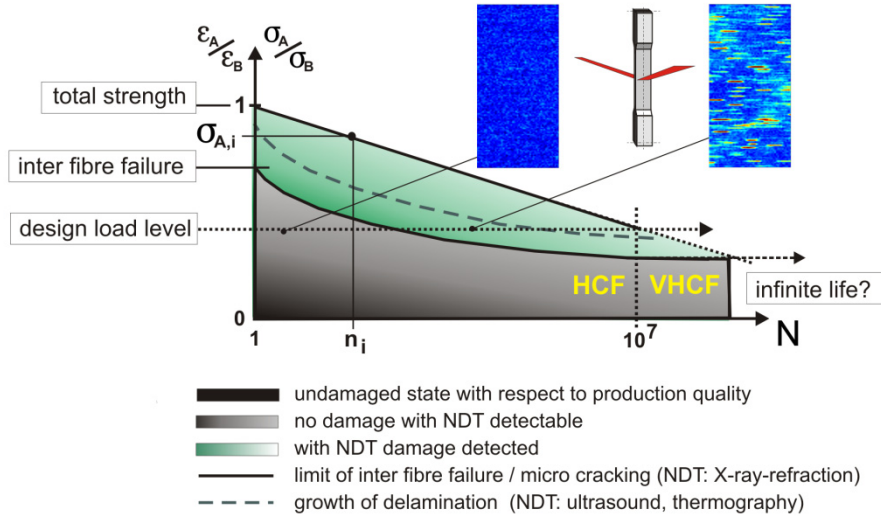
Fig. 1: Basic idea of investigation – characterisation of the damage state of CFRP due to fatigue loading before the S-N curve.

determine the boundary to “infinite life”. The basic idea of the investigation is represented in Fig. 1. Accompanying non-destructive testing (NDT) is mandatory to achieve information about the damage state of the material since at low load levels the total failure of the samples will not be reached.

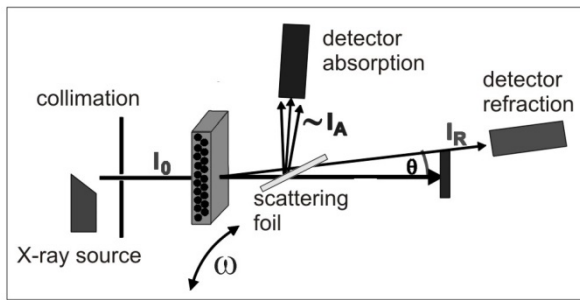
Fig. 2: Experimental setup of the X-ray-refraction technique

With DEI the refracted light at cracks or pores is discriminated with an analyser crystal (Fig. 5), in contrast to the Small Angle X-ray Scanning (SAXS) technique (Fig. 2). Therefore a parallel beam of monochromatic X-ray light is mandatory which can be generated with synchrotron radiation and a double-crystal monochromator. The analyser crystal can be rotated precisely. If the Bragg-angle is adjusted to the maximum intensity only the unrefracted light complies with the Bragg condition and refracted light is missing. Thus, the cracks are imaged dark. If the Bragg-angle is adjusted to the edge of the rocking

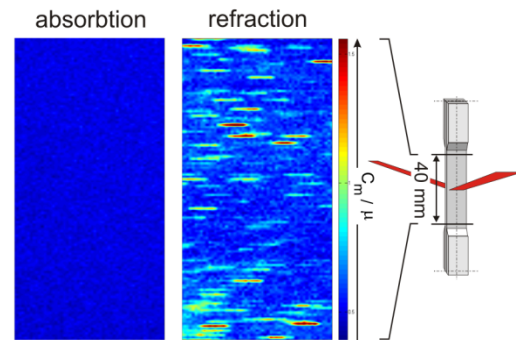
Fig. 3: The absorption and refraction signal are measured at the same position on the sample. Only in consideration of the refraction signal the cracks could be visualised.

The intensity of the refracted beam will increase if a difference of the refractive index occurs at the observed interfaces. Hence, the intensity will be higher for materials with de-bonded fibres or pores than without (Fig. 3). By calibration the absolute as well as the relative inner surfaces C are measured. In most cases the relative increase is sufficient and used in the further investigations. Scanning the whole area of the sample gives a topographic map of inner surfaces (Fig. 3 and 5). According to Lambert-Beer's law the absorption is a function of the density-proportional linear absorption coefficient μ and the thickness d of the sample:

The density itself contains no information about inner surfaces. In the experimental setup of the refraction technique the absorption and the refraction signals are measured independently in one shot. In Fig. 3 the absorption and refraction mapping of a CFRP sample made of a twill fabric are compared. The absorption (Fig. 3, left) maps only slight differences of the density. Instead, the refraction-signal (Fig. 3, right) maps the micro-cracks due to inter fibre failure caused by the cyclic fatigue loading. Thus, if there is no significant change of the density it is impossible to detect any fibre matrix de-bonding with the classical X-ray radiography which only uses the absorption proportional to mass.

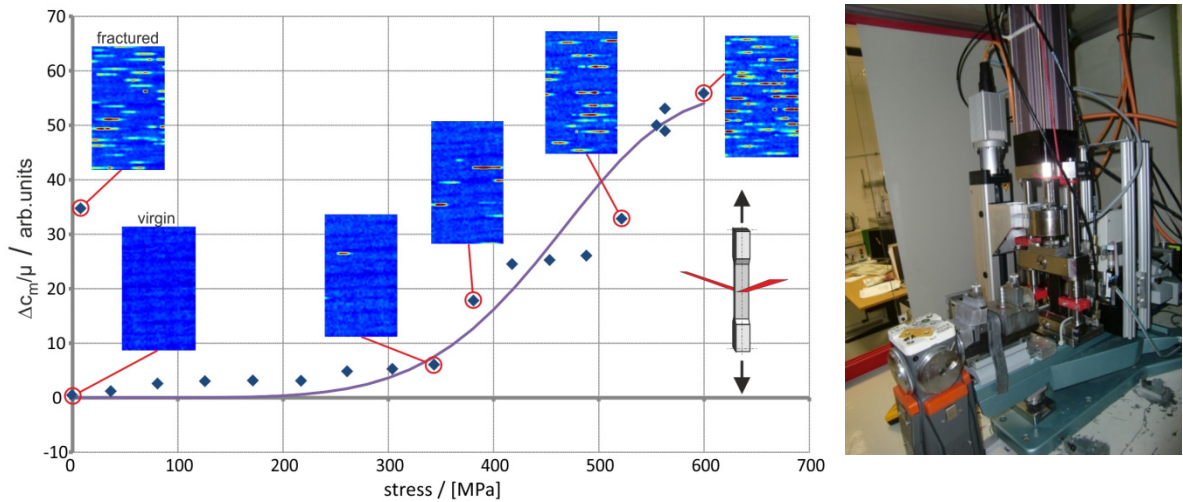
Fig. 4: left - 0°/90°-CFRP-sample of non-crimp fabric, tensile loaded and in-situ X-ray-refraction testing. right - 15kN-elektro-mechanical tensile testing machine integrated in the X-ray scanner.

A tensile testing machine was integrated in a small angle X-ray scattering (SAXS) setup (Fig. 4, right). X-ray refraction topography [1, 2] was performed while the CFRP-samples were tensile loaded (Fig. 4, left). This non-destructive technique enables the detection of micro-cracking and inter-fibre failure especially important for CFRP. For GFRP X-ray-refraction and in-situ loading has already been successfully used [2, 3]. The increase of inner surfaces due to inter-fibre failure was measured as a function of the stress state. For $0^\circ/90^\circ$ -laminate made of non-crimp fabrics the first inter-fibre failure occur at a stress level of approximately 350 to 400MPa. In steps of about 1kN (approx. 40MPa) the load was increased until the total failure of the sample. For $0^\circ/90^\circ$ -laminate made of twill style textile the first cracks occur above 300MPa. Since the first inter-fibre failure was detected at a certain stress level, it is assumed to reach the very high cycle (VHCF) range (Fig. 1) for the $0^\circ/90^\circ$ -laminate below this value.

Due to the 0°/90°-fibre orientation the inter fibre failures occur perpendicular to the load direction. Beside the phenomenological degradation process of increasing inner surfaces measured and visualised with the refraction technique [2] described above (Fig. 4), the proper shape of the micro cracks is of high interest for physical interpretation. Therefore a comparative investigation was done at the Berlin synchrotron BESSY with Diffraction Enhanced Imaging (DEI) [4, 5, 6].

The fractured specimen shown in Fig. 4 was investigated with DEI. The DEI images are shown comparative to the SAXS topography in Fig. 6. The DEI images are area-wide and contain 520 vs 800 pixel with a pixel-size of 28.8 μ m vs 28.8 μ m. The SAXS images are non-area-wide with a step size of 0.3mm each in x- and y- direction (horizontal and vertical) and contain 40 vs 67 pixel of 2000 μ m vs 50 μ m. The marginal values were omitted in the images due to the width of the X-ray beam of the Kratky collimation. The DEI images have a much higher resolution and visualise that the inter fibre cracks mostly pass the hole width of the specimen. Additionally the cracks are not straight but rather follow the waviness of the 90°-fibre bundles. With this finding all crack indications in the SAXS-topography can be assumed as one crack over the whole width of the specimen. The result is a crack density of approximately 1/mm. Counting the cracks of the DEI images gives the same result. For further SAXS investigations the scanning grid was optimised. Finally the specimens were scanned in 7 steps over the width and 100 steps of each 0.2mm in fly by technique over a length of 20mm.

The $0^\circ/90^\circ$ -CFRP specimen of non-crimp fabric do not fail at and below a stress level of 500MPa ($R=0.1$) up to 10^8 load cycles, even though the first inter fibre failure occur at the first load cycle (Fig. 4 and 7). The maximum crack density is doubled to approx. 2/mm compared to the static strength test with ca. 1/mm at fracture. In the fatigue tests the maximum crack density decreases with stress level. Below 200MPa there is no micro cracking detected up to 10^6 load cycles. Thus technically infinite life could be assumed at this load level in respect to the laminate, the load ratio and the taken material concerning fibre, fabric and matrix.

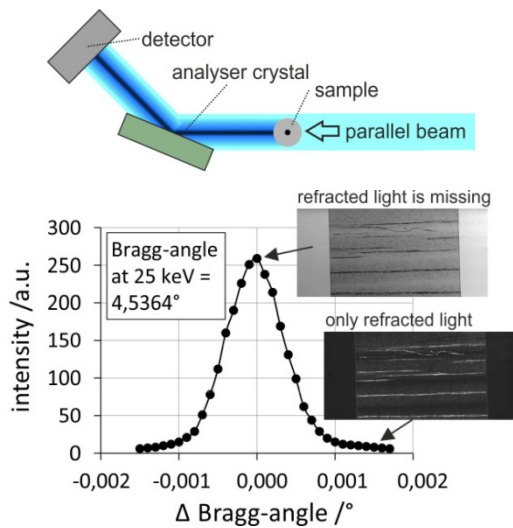
Fig. 5: Principle of Diffraction Enhanced Imaging (DEI) – refracted light is discriminated with the rocking curve of an analyser crystal.

curve, only refracted light passes the analyser crystal and the cracks are imaged bright (Fig. 5 and 6).

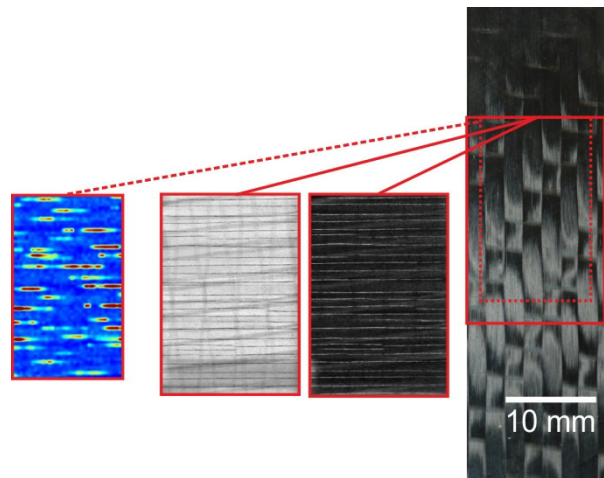
Fig. 6: Imaging transverse cracks in a CFRP-sample – from right to left: 0°/90°-CFRP, DEI at the edge and in the middle of the rocking curve, SAXS-technique.

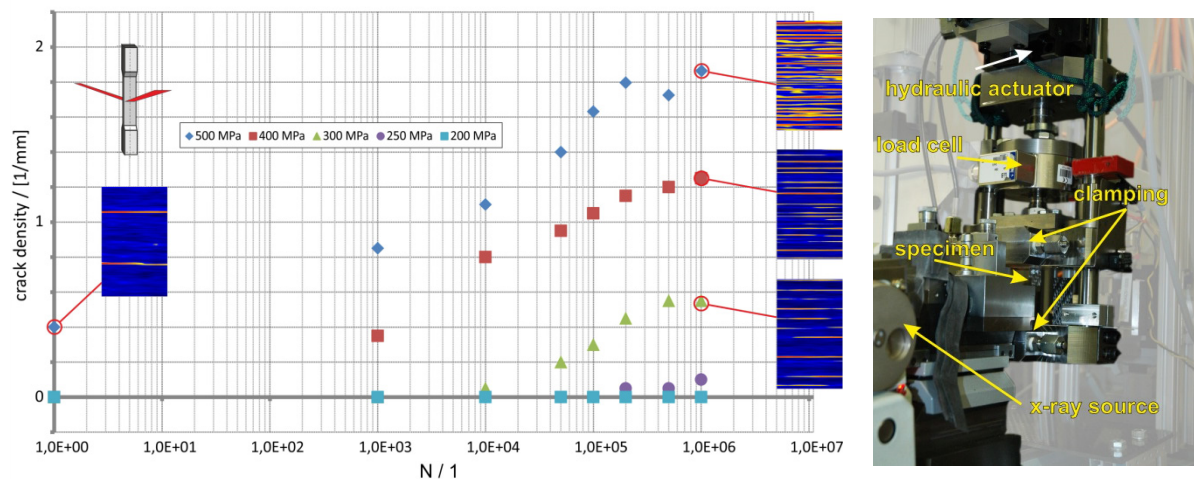
Fig. 7: left - 0°/90°-CFRP-sample of non-crimp fabric, tensile cyclic (fatigue) loaded and in-situ X-ray-refraction testing. right - 10kN servo-hydraulic tensile testing machine integrated in the X-ray scanner.

Two test rigs of servo-hydraulic tensile testing machines were built-on with a load capacity of max. 10kN. One load frame was integrated in the SAXS scanner (Fig. 7, right) instead of the electro-mechanical tensile testing machine (Fig. 4, left). The specimens were scanned after a certain number of load cycles (Fig. 7, left) and the crack density was measured while

a preload was applied to open the cracks. These in-situ measurements were done up to 10^6 load-cycles at different load levels (Fig. 7, 8 and 10). In a second load frame the very high cycle fatigue tests were performed up to 10^8 load-cycles. After a certain number of load cycles the fatigue experiments were stopped and the specimens were scanned in a second SAXS scanner unloaded. All results are summarised in the Figures 9 and 11.

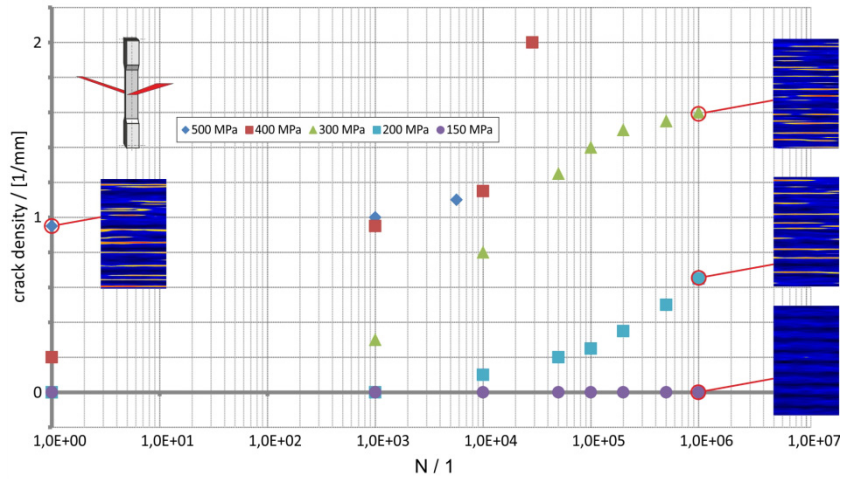
Fig. 8: $0^\circ/90^\circ$ -CFRP-sample of twill style textile, tensile cyclic (fatigue) loaded and in-situ X-ray-refraction testing. Load ratio $R=0.1$.

An overview of the fatigue tests on $0^\circ/90^\circ$ -CFRP specimen of twill style textile is summarised in Fig. 8 and 9. The total failure of the samples emerged in the fatigue tests at and above 400MPa upper limit, load ratio $R=0.1$. Above 300MPa inter-fibre failure occurs at the first

Below a stress level of 150MPa no increase of micro cracking could be observed up to 10^7 load cycles (Fig. 9). This is approximately 50% of the inter-fibre failure stress in static loading. Again technically infinite life could be assumed at this load level in respect to the laminate, the load ratio and the taken material concerning fibre, fabric and matrix. There is a transition region from undamaged to damaged state between 150 and 300 MPa upper limit stress. X-ray refraction enables to show an increasing crack density with the stress amplitude (Fig. 8).

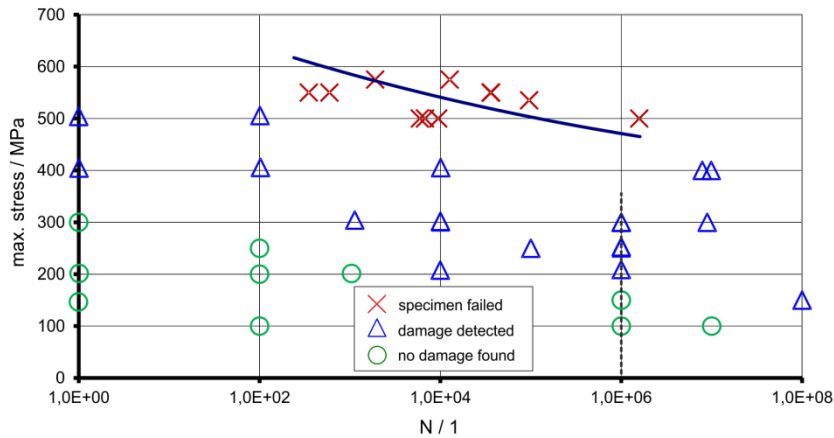
Fig. 9: S-N-curve of $0^\circ/90^\circ$ -CFRP of twill style textile – failed, damaged and no detectable damage. Load ratio $R=0,1$

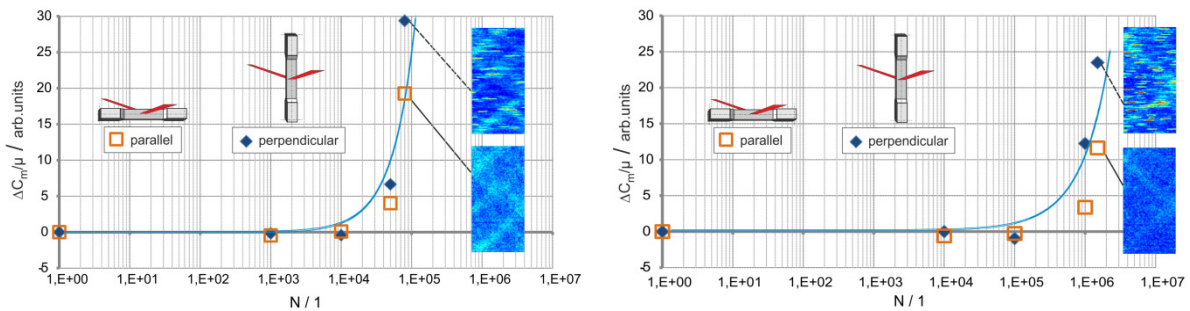
Fig. 10: +/-45°-CFRP-samples of twill style textile, tensile cyclic (fatigue) loaded and in-situ X-ray-refraction testing parallel and perpendicular to the samples length direction. Load ratio R=0.1.
left: maximum stress 75MPa, right: maximum stress 60MPa

The overview of the fatigue tests on +/-45°-laminate is summarised in Fig. 10 and 11. The failure in fatigue loading is found at and above a maximum stress of 70MPa up to 10^6 load cycles. The region of no damage is below 50MPa. That's also approximately 50% of inter-fibre shear strength. The VHCF region could be reached at an upper stress limit of 60MPa. Fortunately the scatter of number of load cycles to failure of the S-N-curve is much lower compared to the 0°/90°-laminate. Figure 10 depicts the transition from undamaged to damaged state by fatigue tests on constant stress levels at 75 and 60MPa. Due to the +/-45°-fibre orientation two perpendicular oriented X-ray refraction measurements have to be done [2, 3]. Two different failure mechanisms occur. First perpendicular to the specimen length direction matrix cracks appear in the crossings of the fibre bundles and subsequent intralaminar fibre matrix debonding occurs due to the inter-fibre shear loading. Both effects

can be distinguished by the perpendicular measurements. In parallel configuration only the fibre matrix de-bonding is visualised. In perpendicular configuration both – the fibre matrix debonding and the matrix cracks become visible. The scattering orientation function is proportional to $\cos^2\omega$ [2, 3]. Hence both the $\pm 45^\circ$ -fibres and/or the fibre-matrix de-bonding contribute to the parallel and perpendicular scans. In contrast the matrix cracks contribute only to the perpendicular scanning configuration. Neither the matrix cracks nor the fibre-matrix-debonding travel over the whole width of the sample rather distribute statistically over the specimen. Due to this micro crack behaviour no crack density could be defined as for the $0^\circ/90^\circ$ -laminates. Therefore the normalised refraction value was plotted vs. the number of load cycles to characterise the damage state.

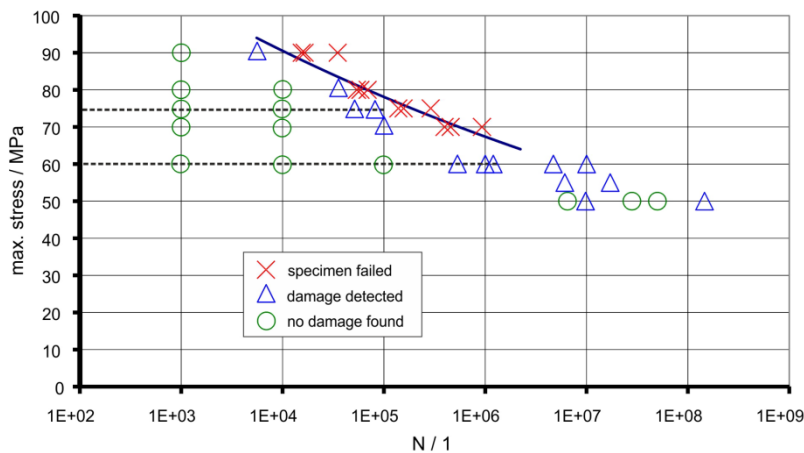
Fig. 11: S-N-curve of +/-45°-CFRP of twill style textile – failed, damaged and no detectable damage.
Load ratio R=0,1
