Smart electronic helper for long-term monitoring of bridges and building structures

Sergej JOHANN¹, Christoph STRANGFELD¹, David ZIMMEK¹, Matthias BARTHOLMAI¹
¹ Bundesanstalt für Materialforschung und -prüfung (BAM), Berlin, Germany

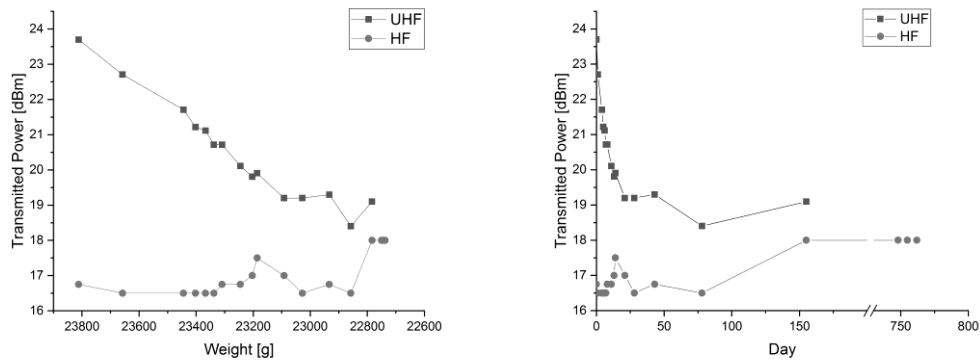
Figure 6. Measurement results of more than two-year measurement test, left: transfer power as a function of weight, right: transfer power as a function of the drying process

Using the PVC encapsulated systems, the following measurement results were obtained after more than 2 years and are shown in Figure 6. It can be seen that the presumed increase of the measurement signals occurred as a function of the hydration process. After reduction of liquid water due to hydration and evaporation, the signals gradually stabilize.

Due to an unknown event, the UHF sensor system can no longer be addressed. Thus the measurement was aborted at this point. However, the HF sensor system still shows a stabilized course. The results of the Bluetooth system were no longer recorded because the system was no longer responsive after a few weeks, probably due to the decreasing battery power. After a while, the measurements of the Bluetooth module became no longer relevant for this investigation. Therefore the method of an active system was successfully implemented in another project, Adao et al (2017). A possible cause for the failure of the systems is the capillary formation, as shown in Figure 7, which drew the water into the interior of the housing during the preparation of the test specimens and thus put the system into full saturation or destroyed individual components after some time.

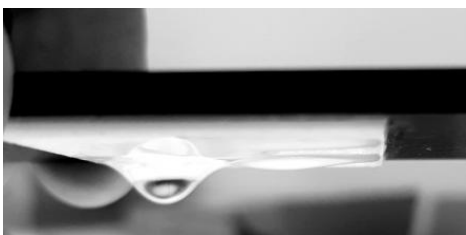
Figure 7. Capillary formation in the housing of the sensor system.
