Supporting Information

Chloride-induced steel corrosion in alkali-activated fly ash mortar: increased propensity for corrosion initiation at defects

Gregor J. G. Gluth*, Gino Ebell, Petr Hlaváček, Jürgen Mietz

Bundesanstalt für Materialforschung und -prüfung (BAM), Berlin, Germany

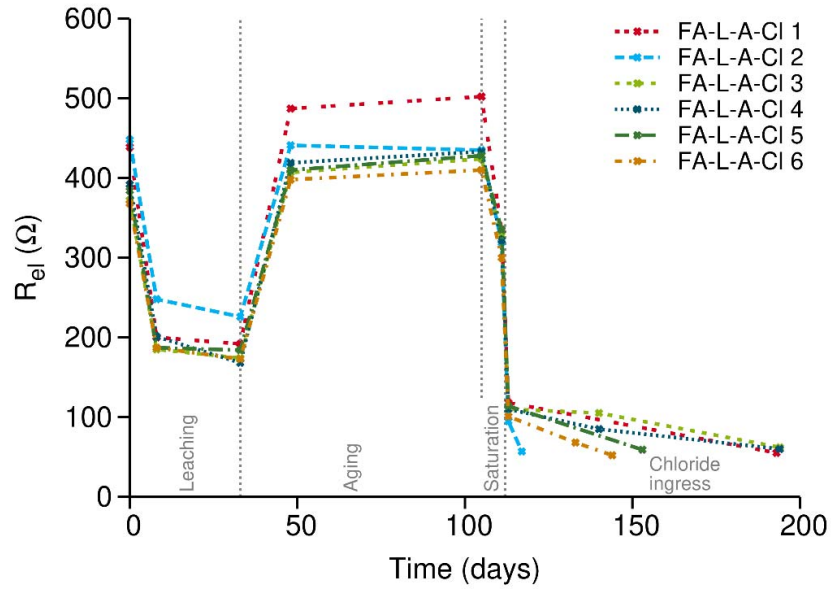
Figure S3. Evolution of the ohmic resistance (R_{el}) of the alkali-activated fly ash mortar exposed to leaching, aging and chloride (“L-A-CI”).

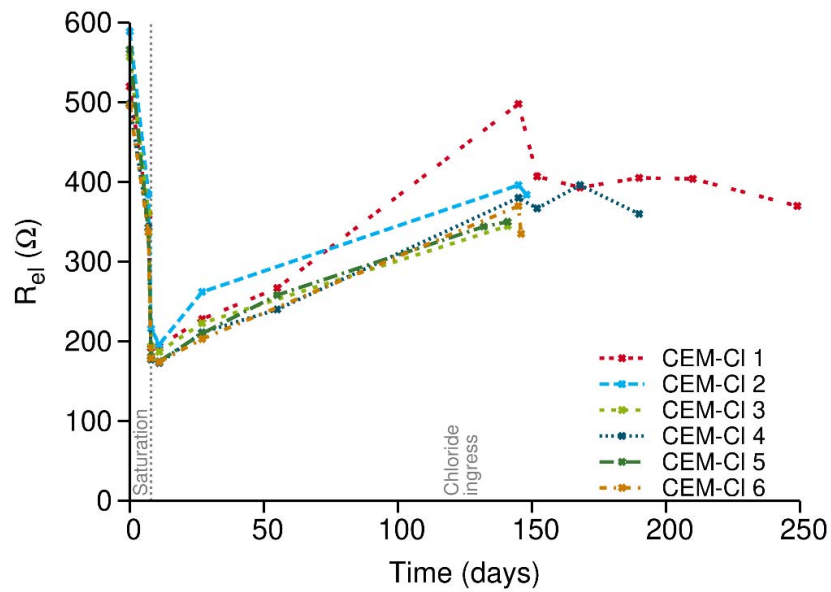
Figure S4. Evolution of the ohmic resistance (R_{el}) of the Portland cement mortar exposed to chloride (“CI”).

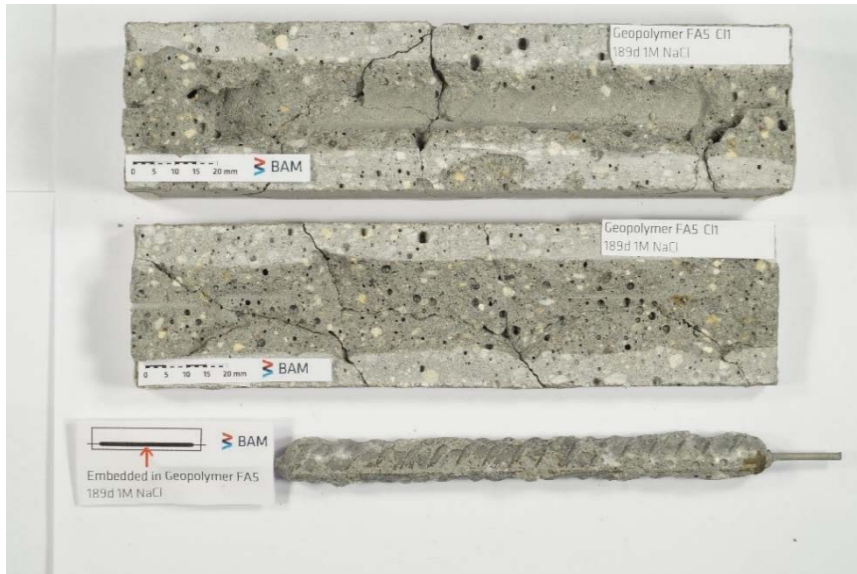
Figure S5. Mortar specimen FA-Cl 1 and embedded steel rebar split after depassivation of the steel was detected.

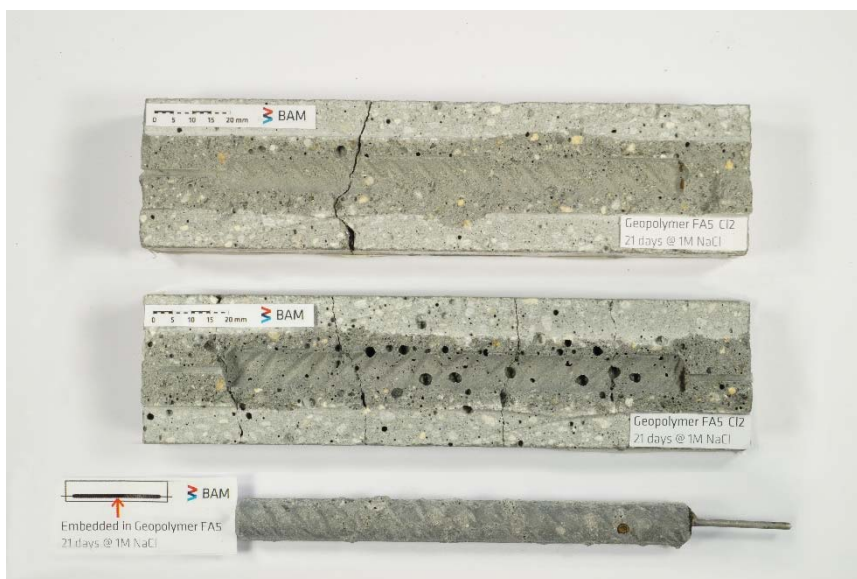
Figure S6. Mortar specimen FA-Cl 2 and embedded steel rebar split after depassivation of the steel was detected.

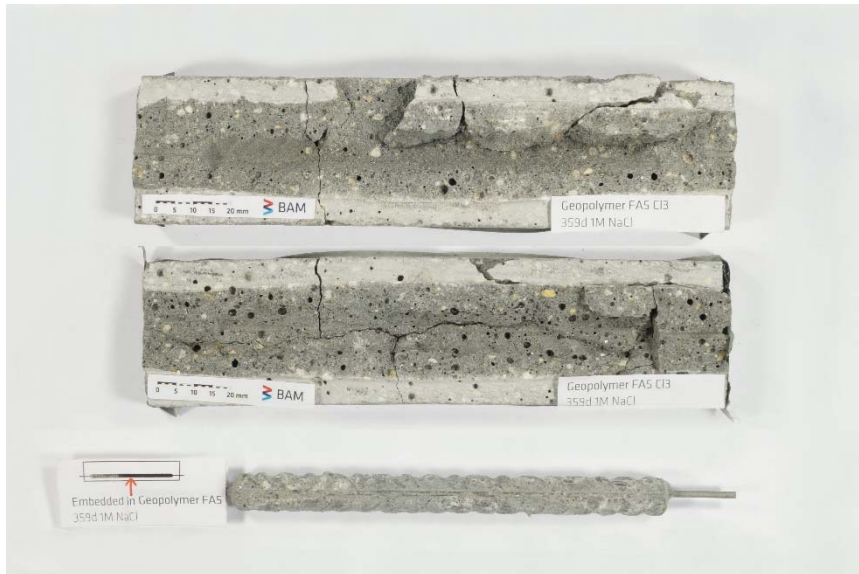
Figure S7. Mortar specimen FA-Cl 3 and embedded steel rebar split after depassivation of the steel was detected.

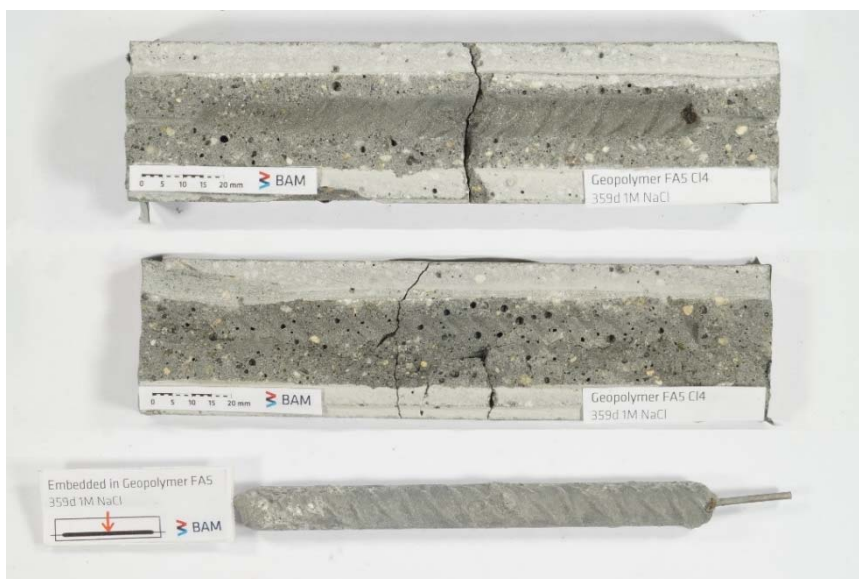
Figure S8. Mortar specimen FA-Cl 4 and embedded steel rebar split after depassivation of the steel was detected.

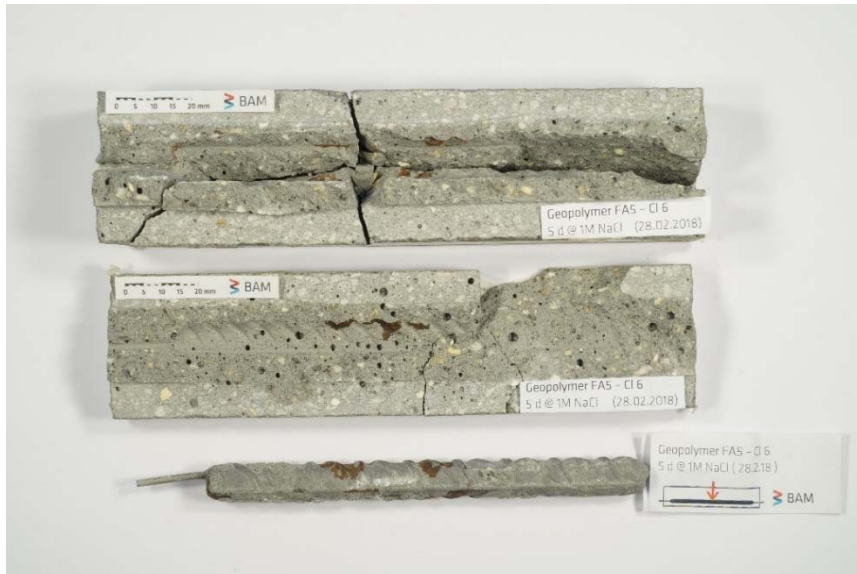
Figure S9. Mortar specimen FA-Cl 6 and embedded steel rebar split after depassivation of the steel was detected.

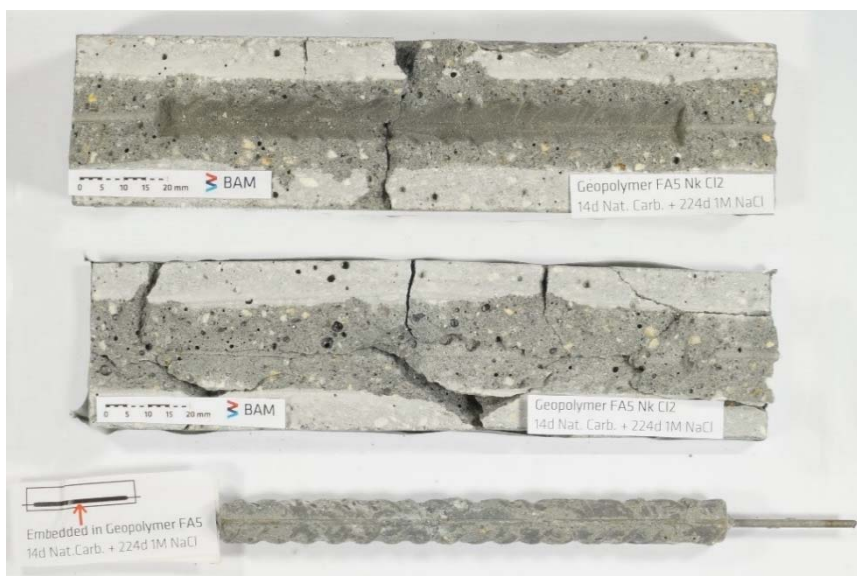
Figure S10. Mortar specimen FA-Cl 8 and embedded steel rebar split after depassivation of the steel was detected.

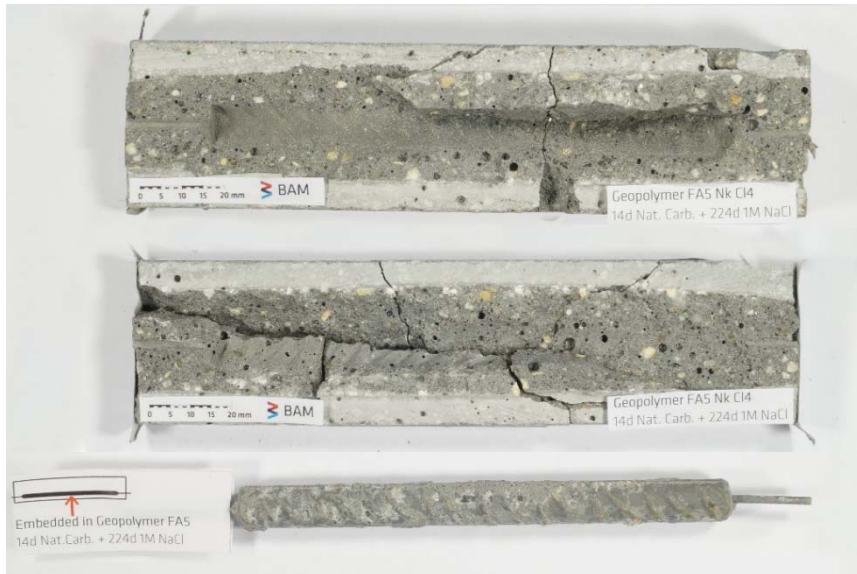
Figure S11. Mortar specimen FA-Cl 10 and embedded steel rebar split after depassivation of the steel was detected.

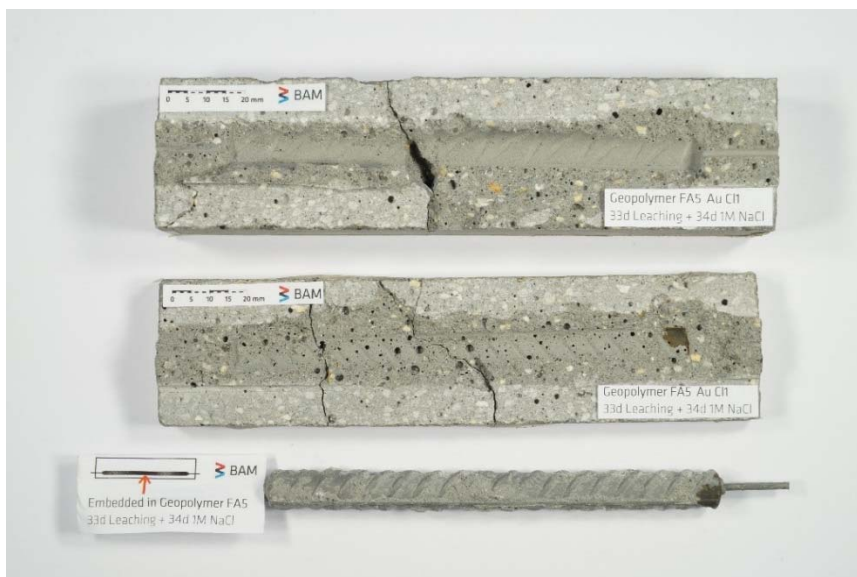
Figure S12. Mortar specimen FA-L-Cl 1 and embedded steel rebar split after depassivation of the steel was detected.

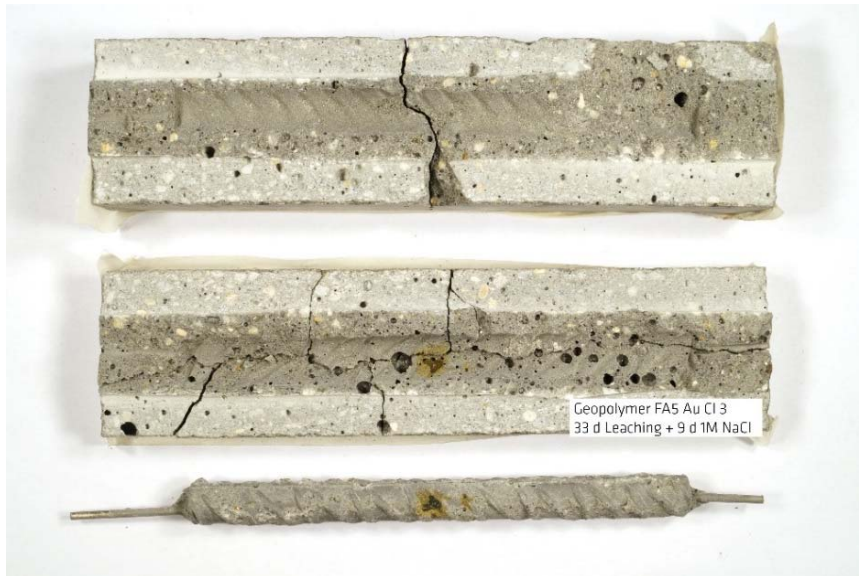
Figure S13. Mortar specimen FA-L-CI 3 and embedded steel rebar split after depassivation of the steel was detected.

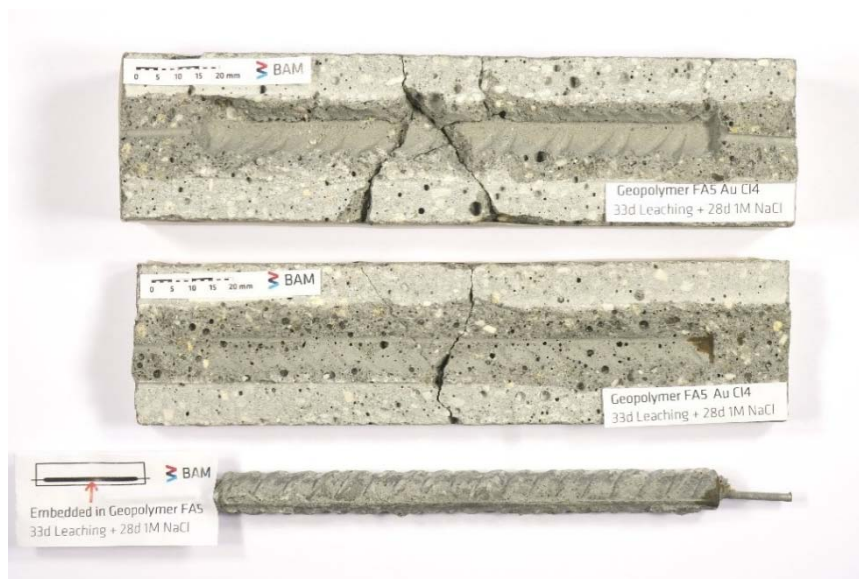
Figure S14. Mortar specimen FA-L-CI 4 and embedded steel rebar split after depassivation of the steel was detected.

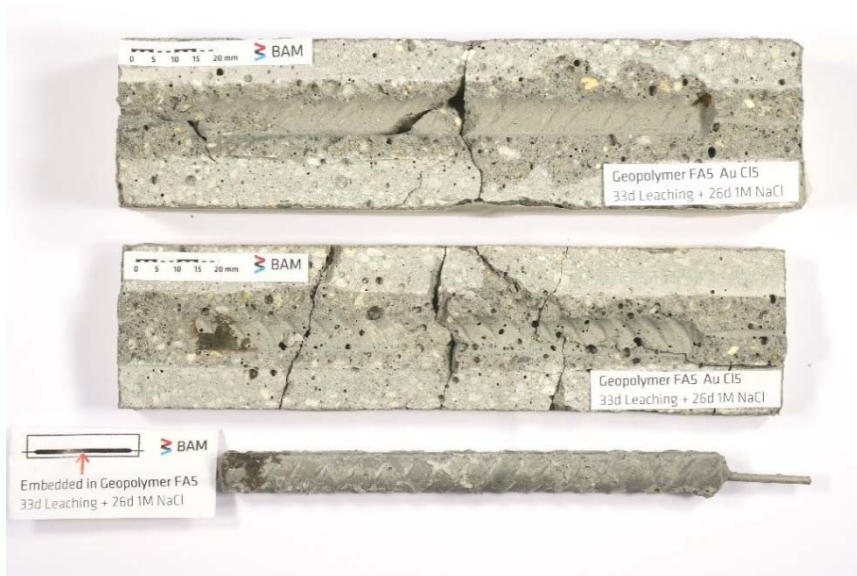
Figure S15. Mortar specimen FA-L-Cl 5 and embedded steel rebar split after depassivation of the steel was detected.

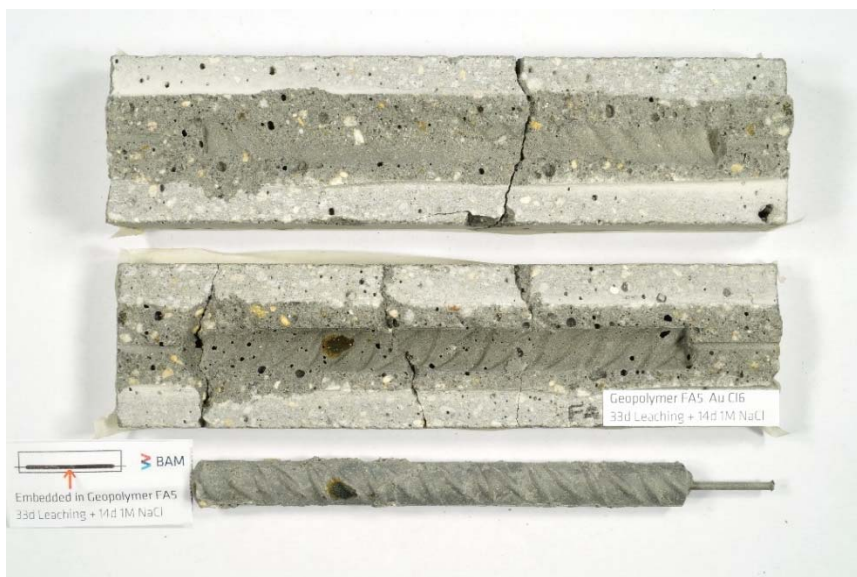
Figure S16. Mortar specimen FA-L-Cl 6 and embedded steel rebar split after depassivation of the steel was detected.

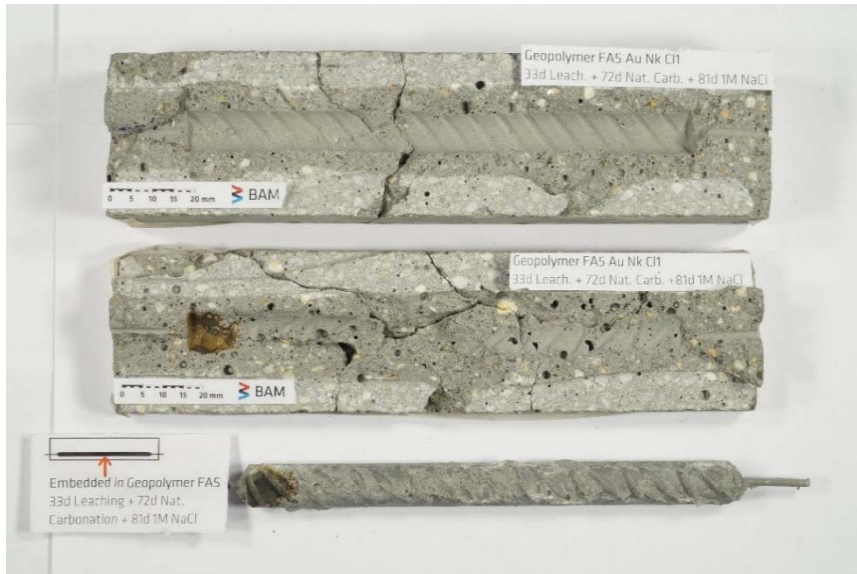
Figure S17. Mortar specimen FA-L-A-Cl 1 and embedded steel rebar split after depassivation of the steel was detected.

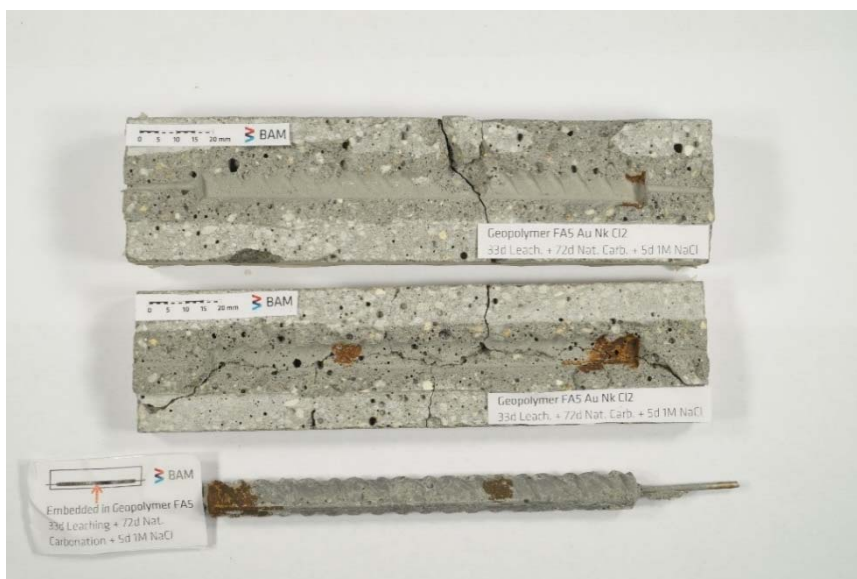
Figure S18. Mortar specimen FA-L-A-Cl 2 and embedded steel rebar split after depassivation of the steel was detected.

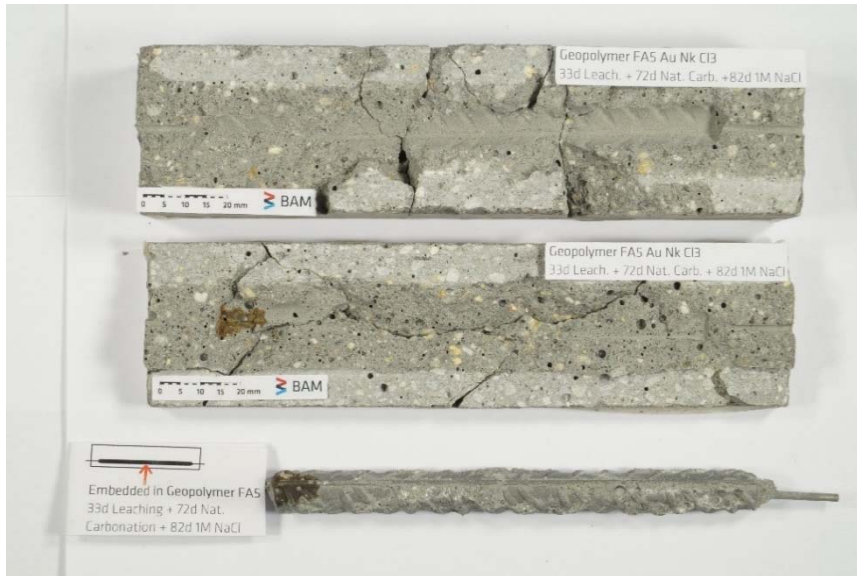
Figure S19. Mortar specimen FA-L-A-Cl 3 and embedded steel rebar split after depassivation of the steel was detected.

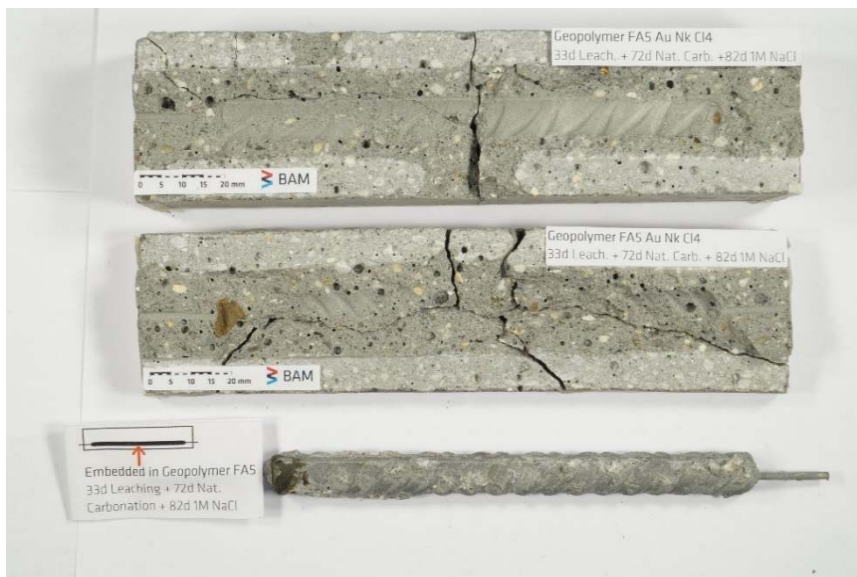
Figure S20. Mortar specimen FA-L-A-Cl 4 and embedded steel rebar split after depassivation of the steel was detected.

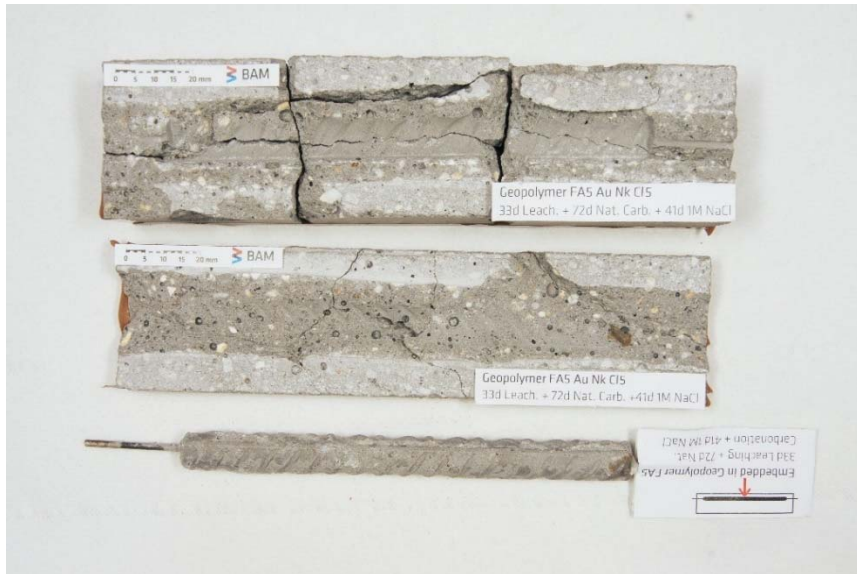
Figure S21. Mortar specimen FA-L-A-Cl 5 and embedded steel rebar split after depassivation of the steel was detected.

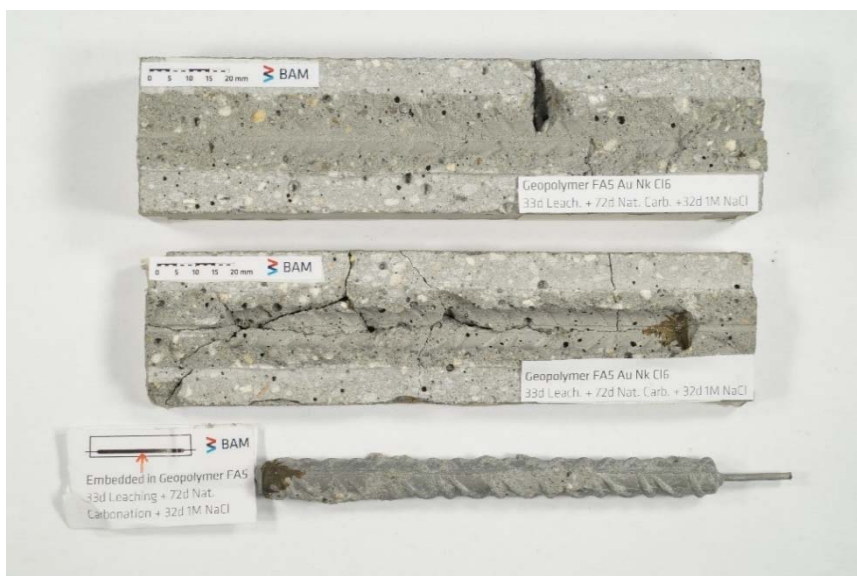
Figure S22. Mortar specimen FA-L-A-Cl 6 and embedded steel rebar split after depassivation of the steel was detected.

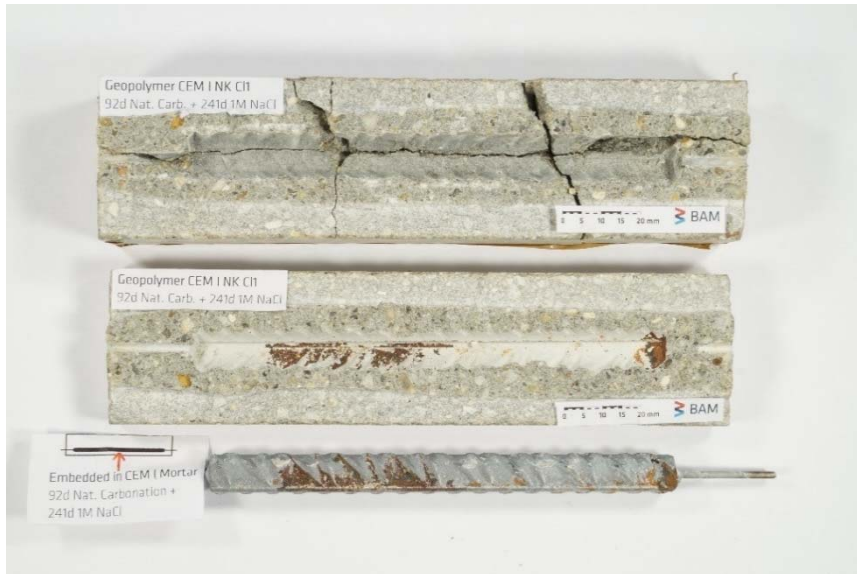
Figure S23. Mortar specimen CEM-CI 1 and embedded steel rebar split after depassivation of the steel was detected.

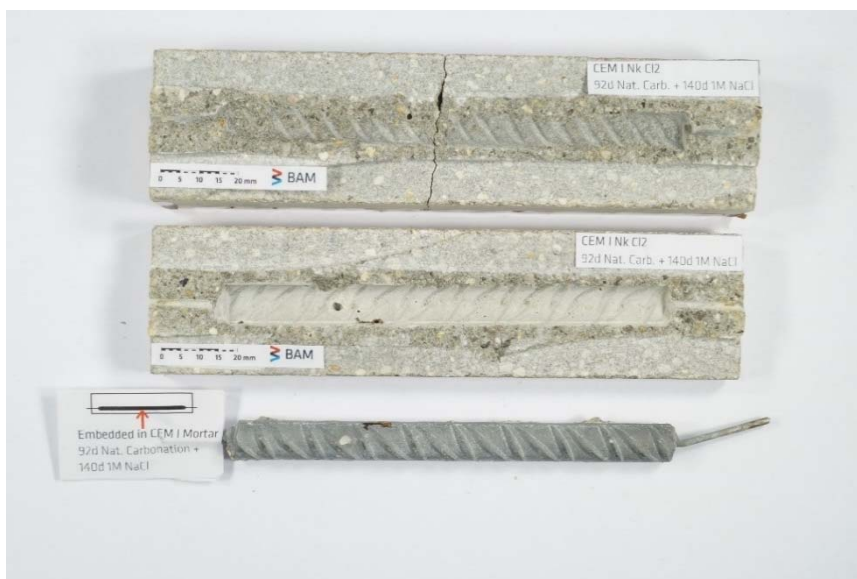
Figure S24. Mortar specimen CEM-CI 2 and embedded steel rebar split after depassivation of the steel was detected.

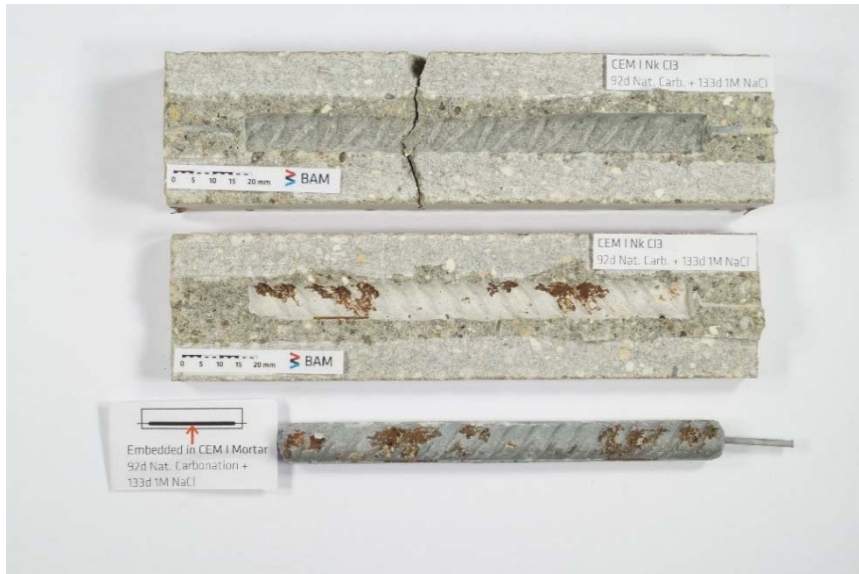
Figure S25. Mortar specimen CEM-Cl 3 and embedded steel rebar split after depassivation of the steel was detected.

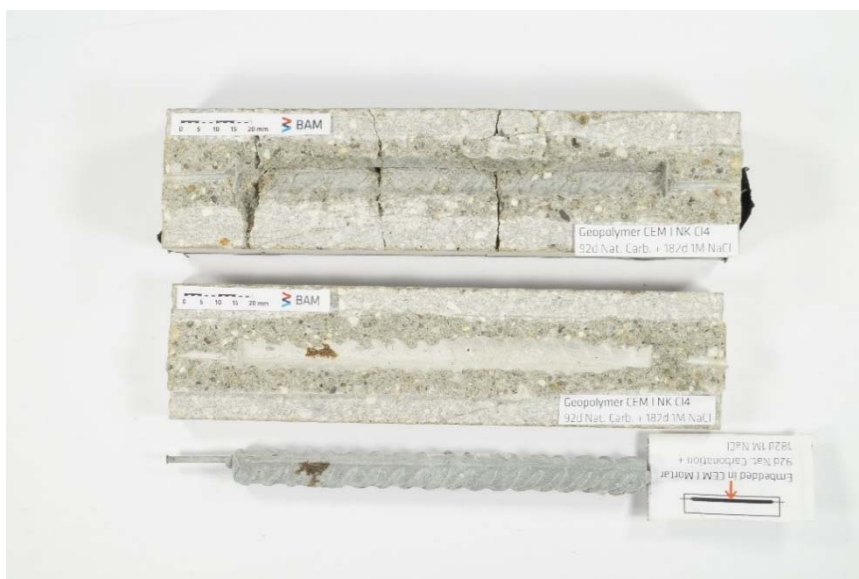
Figure S26. Mortar specimen CEM-Cl 4 and embedded steel rebar split after depassivation of the steel was detected.

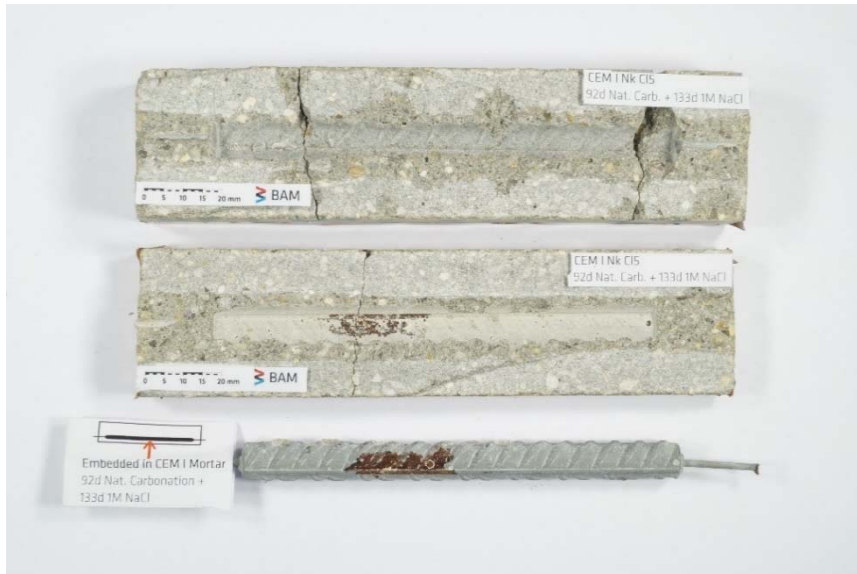
Figure S27. Mortar specimen CEM-CI 5 and embedded steel rebar split after depassivation of the steel was detected.

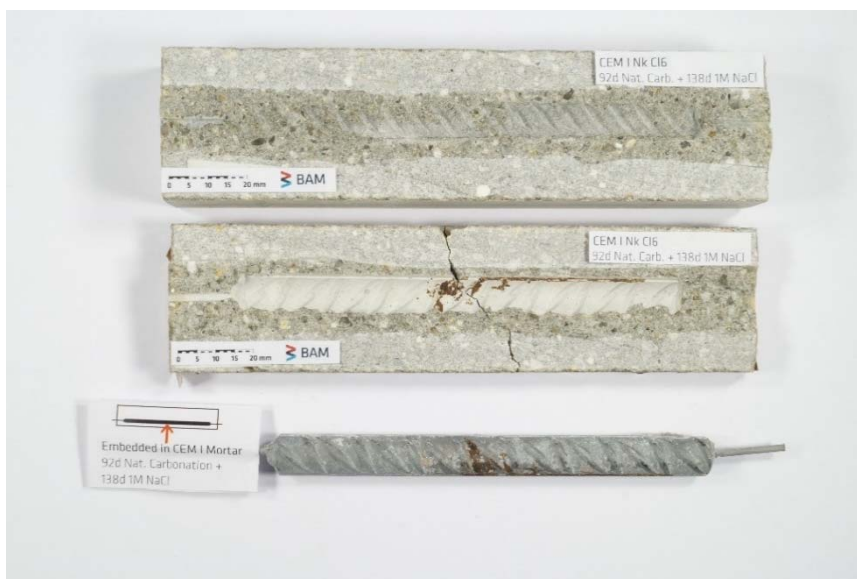
Figure S28. Mortar specimen CEM-A-CI 6 and embedded steel rebar split after depassivation of the steel was detected.
