Fibre reinforced AlSi12CuMgNi alloy under compression

Franziska BAENSCH¹, Sergej EVSEVLEEV¹

¹ Bundesanstalt für Materialforschung und -prüfung, Berlin

ACOUSTIC EMISSION OF FIBRE REINFORCED AISi12CuMgNi ALLOY UNDER COMPRESSION

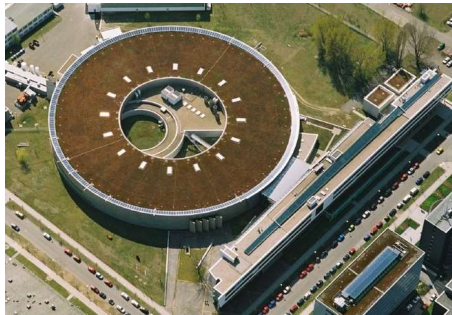
Synchrotron BESSY II, Berlin

BAMline

- Sample diameter: 1mm
- Effective pixel size: 0.44 μ m
- Spatial resolution: <1 μ m

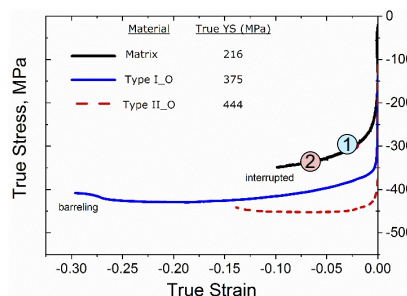
Micro-Tomographic analysis Damage accumulation within AlSi12CuMgNi alloy

- Microcracks: Intermetallic (IM), Silicon (Si)
- No damage observed: Aluminium (Al)

Intermetallics

Eutectic Si

$VF_{\text{cracks}} = 1.6 \pm 0.1\%$

$VF_{\text{cracks}} = 3.4 \pm 0.1\%$

Crack volume
Intermetallic

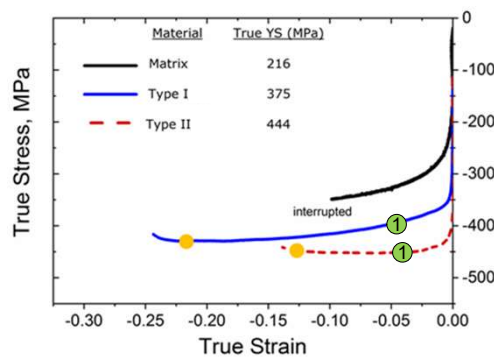
Micro-Tomographic analysis Damage accumulation within type I and II

- Type II generated less crack volume at low plastic strain than Type I
- No damage in Al of I & II

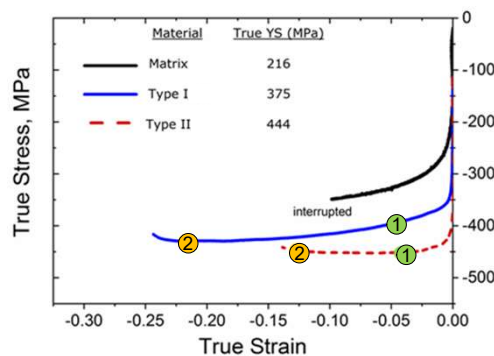
Micro-Tomographic analysis Damage accumulation within type I and II

- A more catastrophic damage development in Type II due cracking in SiC clusters
- No damage in Al of I & II

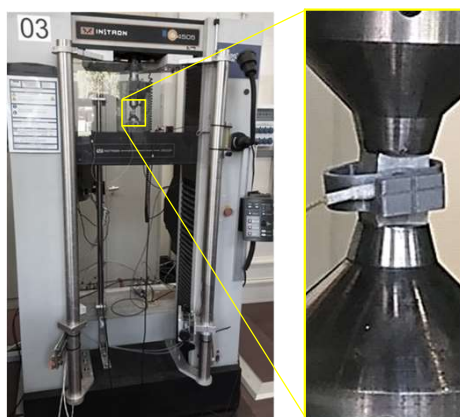
Test setup AE measurement during compression test

- 2 specimens of each type (8 x 8 x 16 [mm³])
- Test with/without Teflon sheets btw. sample and holding device
- Testing device Instron 4505, compression with 100μm/min traverse speed
- AE sensor PICO S/N 5259 (PAC, Ø 5 mm x H 4 mm)
- AMSY6, continuous mode, threshold-free, sampling rate 5 MHz, digital Filter: 120 kHz ... 1 MHz

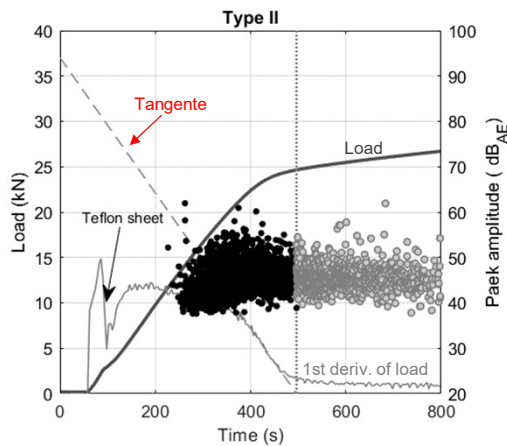
Acoustic emission analysis Definition of 2 testing states

Test states 1 and 2:

- Tangent along the decrease in load
- Intersection of x-axis with tangente

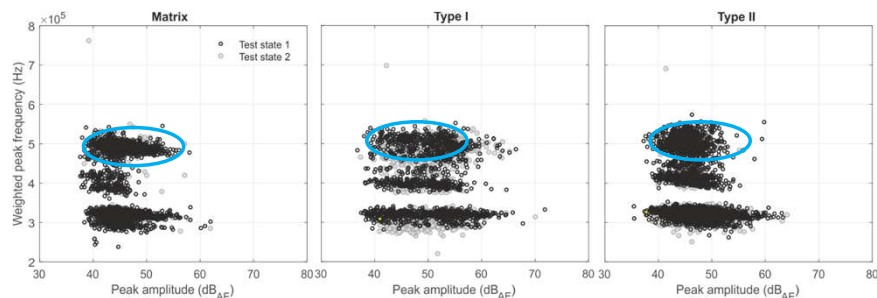
Weighted peak frequency

- Detected signals range from 300 kHz to 550 kHz
- 3(4) clusters are formed in weighted peak frequency (WPF) vs. Peak amplitude for each material
- Differences in the scatters for each material, f.e. above 450 kHz (WPF)
