# Conservation of the Shaft #1 Headgear at the Tsumeb Mine, Namibia: Corrosion Protection

Thomas Boellinghaus, Eva Wentland, Ronny Jassmann, Ruth Keller & Anne Wolfrum

<sup>1</sup>Department of Component Safety, Federal Institute for Materials Research and Testing – BAM, Berlin, Germany; <sup>2</sup>Conservation of Modern Materials and Industrial Heritage, University of Applied Sciences – HTW, Berlin, Germany

### ABSTRACT

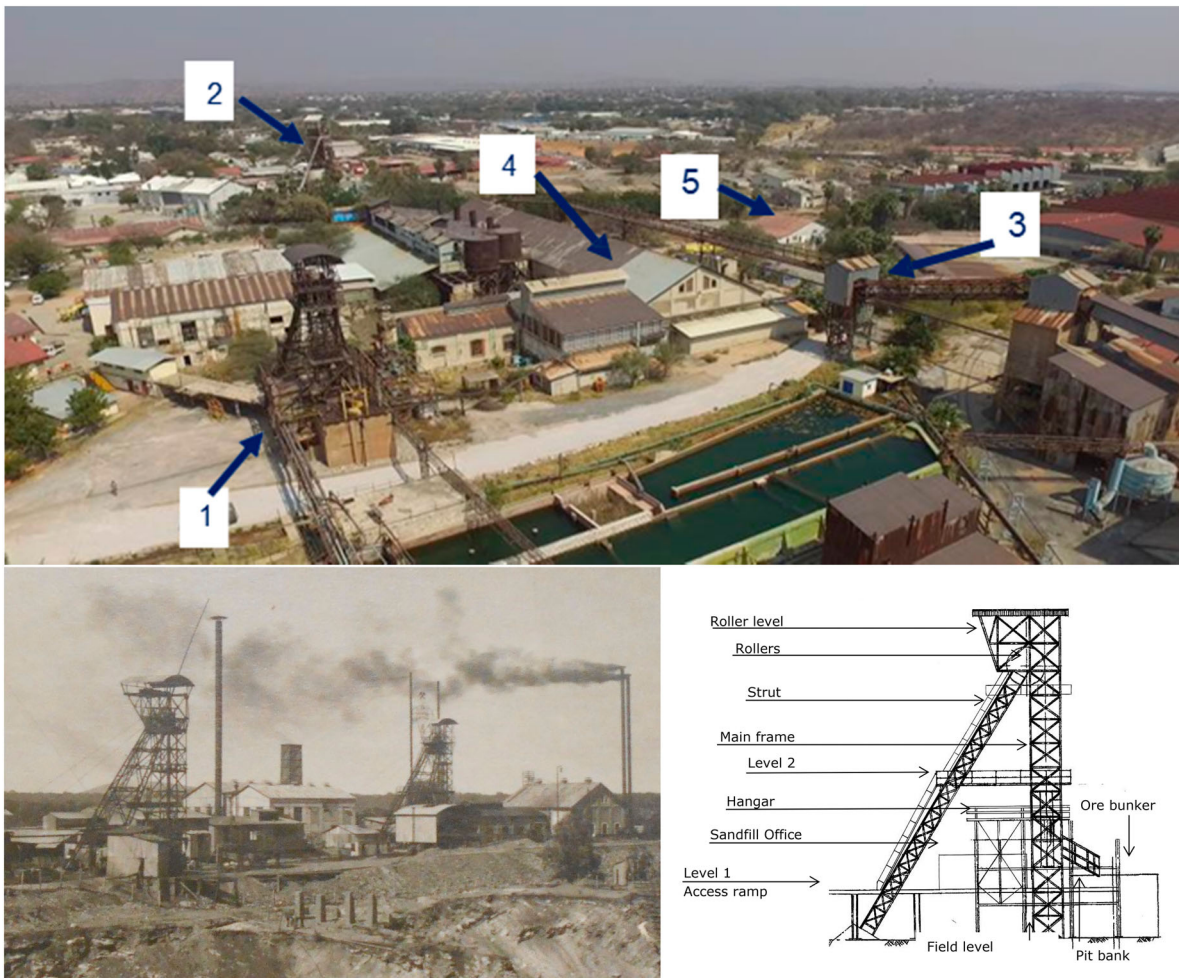
**Figure 1.** Shaft #1 headgear. Upper: Relevant objects for development of the Tsumeb mining site as a national heritage site (Scholz and Frautschy 2019, 2020). 1, new (Friedrich-Wilhelm) Shaft #1 headgear; 2, DeWet Shaft headgear; 3, main ore conveyer; 4, power plant hall; and 5, mineralogy building. Lower: left, photograph of the old (left) headgear from 1908 and the new (right) Shaft #1 headgear from 1925 (Scholz and Frautschy 2019, 2020; Jassmann 2020); right, Engineering illustration of the new Shaft #1 headgear (Jassmann 2020).

Designed and mounted between 1922 and 1924, the Shaft #1 headgear represents one of the oldest riveted steel mining headgears of the Promnitz design (Fait 2017; Jassmann 2020). This type of headgear was developed as early as 1874. Earlier steel headframes suffered frequently from fatigue fracture caused by rapid load changes and thus could only gradually replace the older wooden or stone-walled structures in the mining industry. As a pioneer of steel headgears, Promnitz continuously improved his design by application of respectively innovative and much more fatigue-resistant steels developed over the decades. The Promnitz steel headgear, also named German strut framework, does not have additional upright supports as typically seen in previous designs (Schönberg 1997). The main framework carries the vertical loads and is connected to the struts via girders that also carry the main loads of the cable sheaves (Figure 1 lower right). Further advantages of this headframe type include easy adaptability to the local environment as well as much improved shipping requirements and the simplicity of on-site assembly eliminating the requirement for trained staff being present. When these features are considered alongside its extended lifespan of up to 50 years, Promnitz headgears developed into a global export hit (Fait 2017, 2019). The Shaft #1 headgear in Tsumeb, Namibia represents probably the last existing system on the African continent.

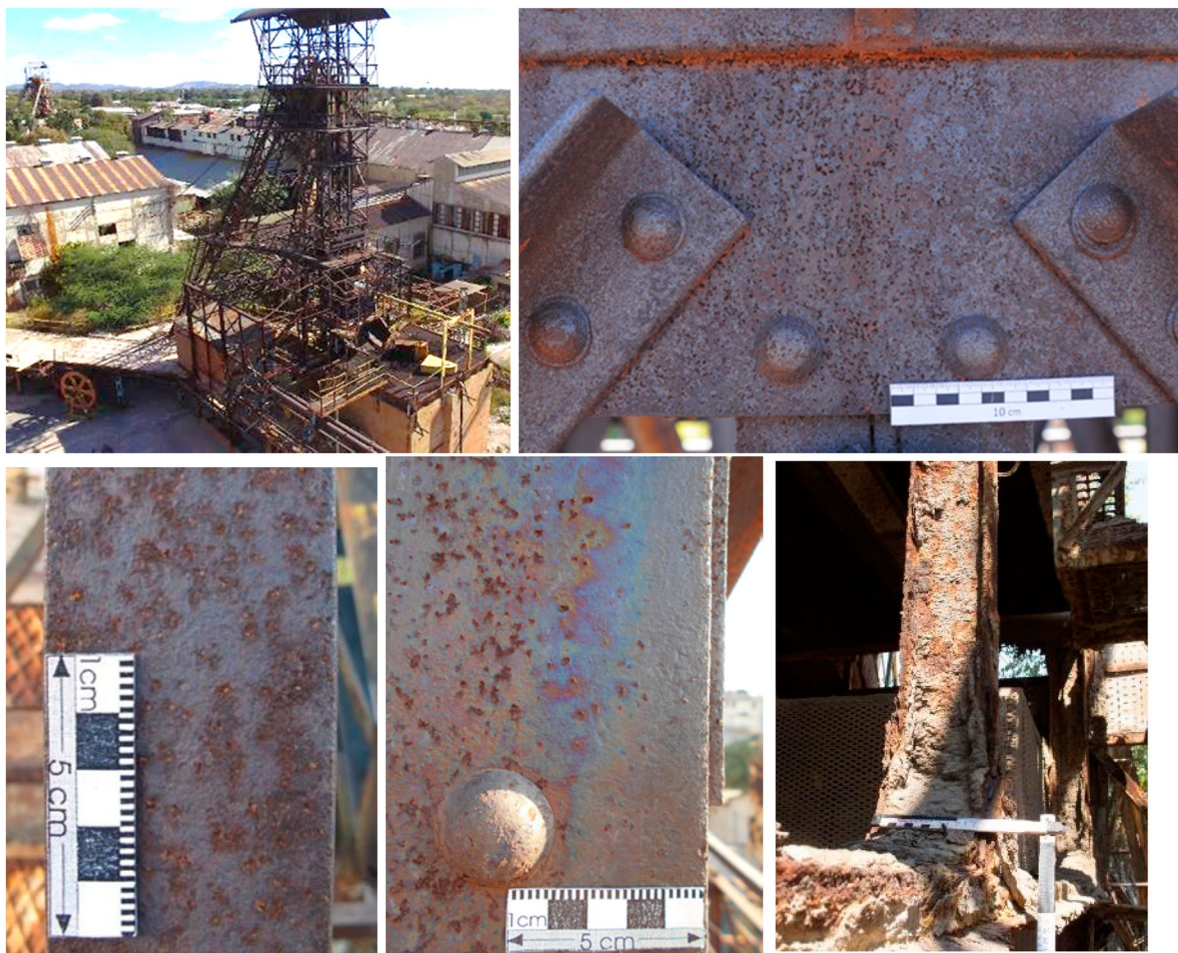
**Figure 2.** Corrosion phenomena on the steel surface at various regions of the headgear. Upper left: Shaft #1 headgear, overview. Upper right: gusset plate at center main column of Level 2 (south). Lower left: shallow pitting corrosion at a handrail. Lower center: main column at Level 2 (east side) with coating remains. Lower right: ore dust accumulation at the lower column parts.

Depending on the location and exposure, different states of preservation were determined (Figure 2). The upper levels of the headgear (Figure 2 upper left) are in good condition with remains of the original coating on a large area (Figure 2 upper right and lower). It is anticipated that the surface of the original steel parts was either protected by oil-flaming or by tar-coating. Both practices were common during the first quarter of the twentieth century.

The lower levels of the headgear are in significantly worse condition. A reason for this is the microclimate in combination with the coverage of the steel parts with blown debris composed of sand and ore dust. On the lower levels, many spots are not reached by wind and sunlight. Several centimeter-thick ore dust deposits have been observed that are also clogging the drainage of the construction (Figure 2 lower

right). The ores hoisted at the Shaft #1 at Tsumeb were extremely rich in copper, zinc, and lead. The tough ore dust/sand coverage of the steel not only retains moisture, but also has a high content of metals much more noble than the low-carbon steel underneath. It represents a well-known fact that aqueous electrolytes in such crevices are extremely acidic, due to pH, oxygen, and potential depletion. Due to the more noble metal contents of the ore dust/sand coverage, corrosion of the steel surface inside such crevices is additionally enhanced by galvanic effects that cause anodization and metal dissolution at the steel surface. Associated with the higher corrosion rates, extensive metal dissolution has been observed at such parts. Especially at these locations of the structure, removal of the sand/ore dust coverage and application of a protective coating is essential to prevent further corrosion.

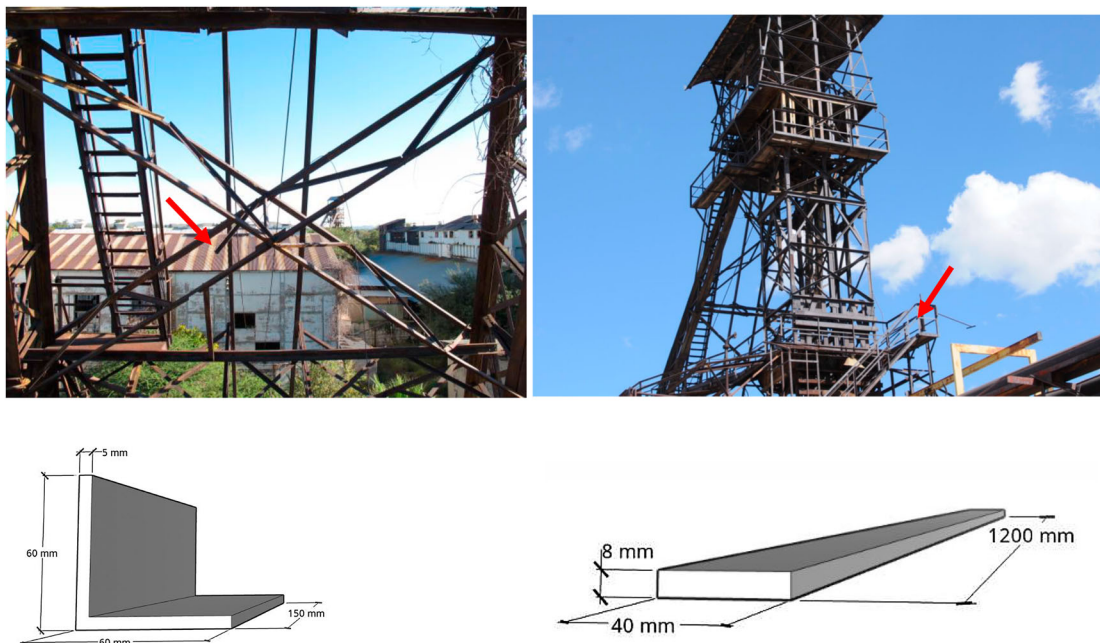
**Figure 3.** Locations of the specimens taken from the Shaft #1 headgear. Upper left: location of the angular profile. Upper right: location of the flat profile. Lower left: dimensions of the angular profile 60 × 60 × 5 mm. Lower right: dimensions of the flat profile 40 × 8 mm.

Subsequent to the on-site studies, two representative mild steel samples were taken from the Tsumeb Shaft #1 headframe and were subjected to laboratory tests. The specimens originate from the locations as shown in Figure 3 and have the dimensions shown. The angular profile represents a part of the original steel frame structure erected in 1925. It is assumed to be flame cut from the location shown in Figure 3 (upper left) at a time when one of the two cable sheaves was replaced, and it was salvaged from a location on the Level 2 platform directly underneath. This specimen was taken to compare the long-term corrosion products formed on the surface for about 35 years longer than those on the second specimen.

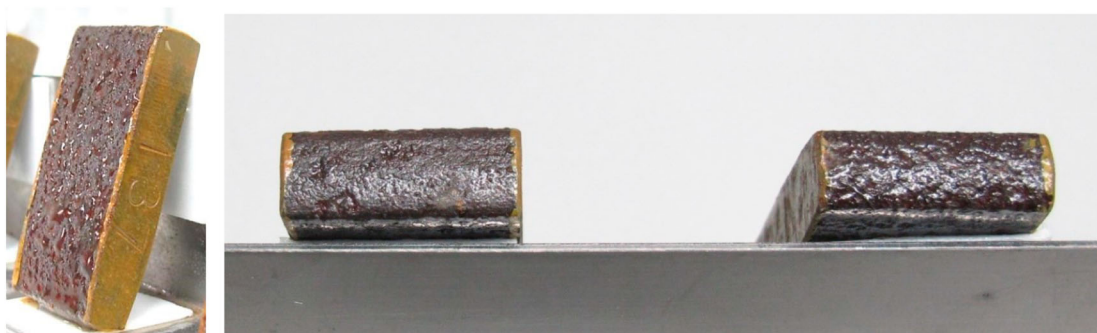
**Figure 4.** Test coupons after climate chamber testing. Left: test coupon with alkyd resin-based coating at 201 h exposure. Right: coated with alkyd resin-based substance with UV-blocker addition (left) and without (right) – all specimens coated with the UV blocking additive lost luster in the coating after the climate test chamber exposure.

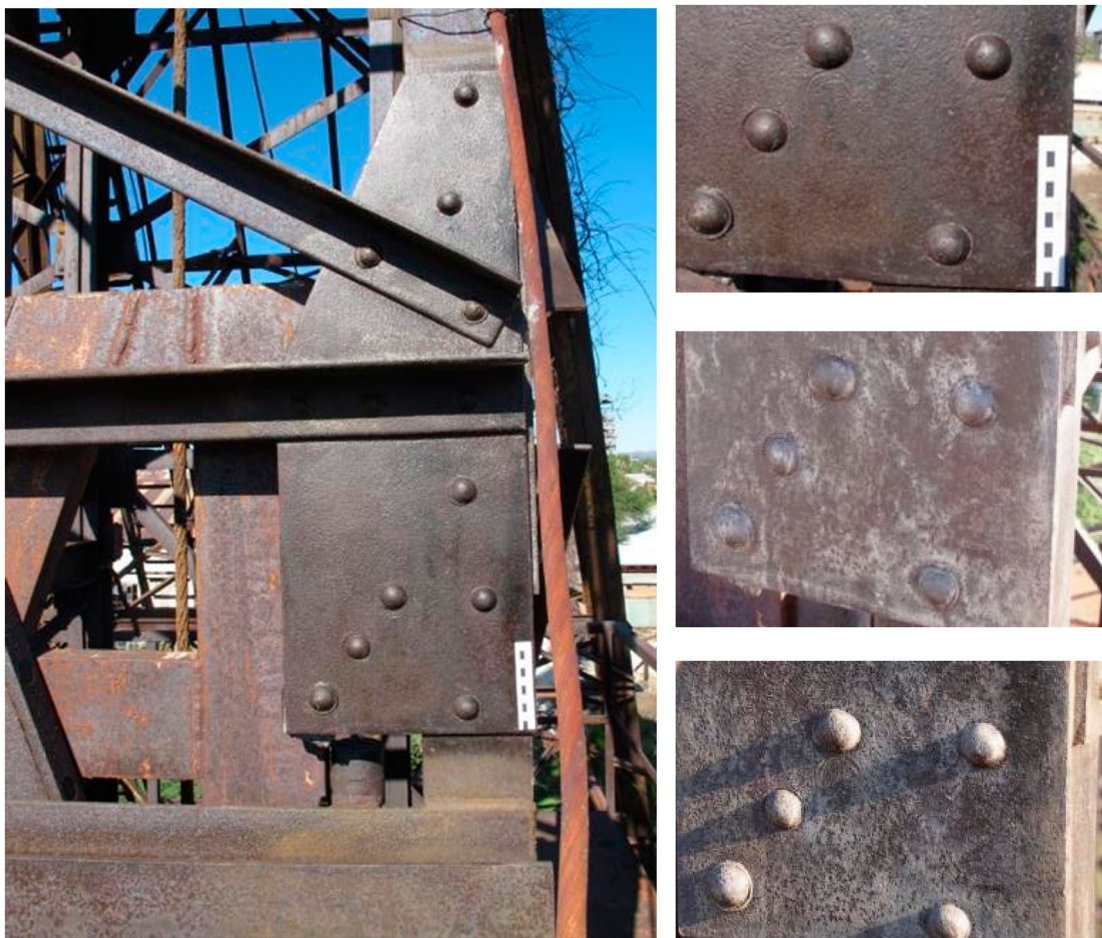
**Figure 5.** Samples of Tecero® Wax coating. The right images show the condition on May 2018 (top), November 2018 (middle), and October 2019 (below), respectively.

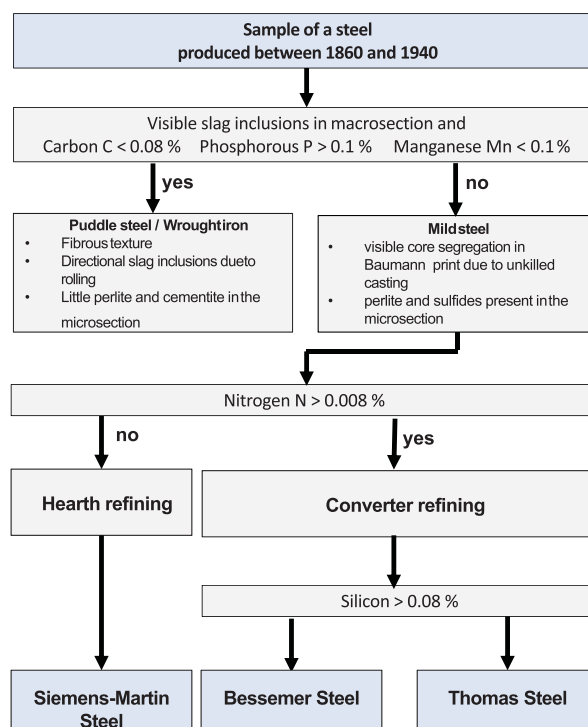
Figure 6. Flowchart for the classification of old steels as puddle or mild steels according to Langenberg (Langenberg 1995).

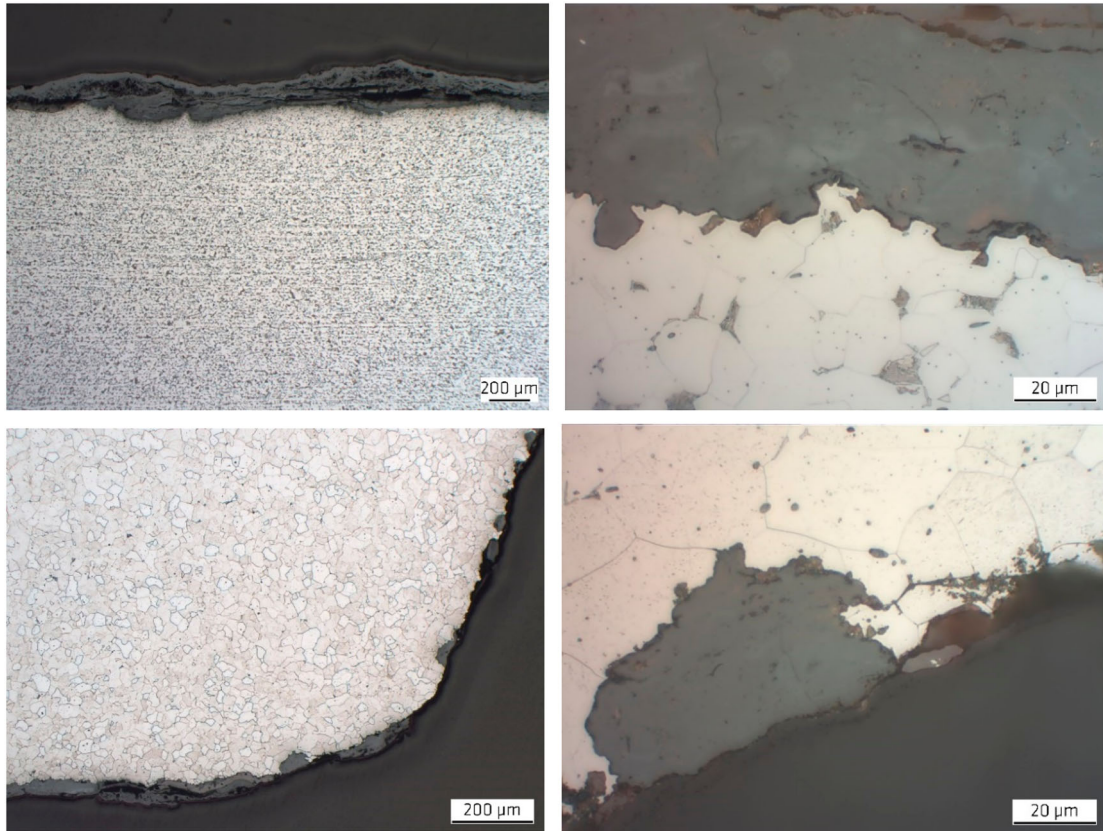
**Figure 7.** Microstructure of the two steel profiles investigated with scanning electron microscopy (SEM). Upper left: flat profile – cross-section in rolling direction with corrosion layer, low magnification. Upper right: flat profile – cross-section in rolling direction with corrosion layer, high magnification. Lower left: angular profile – cross-section perpendicular to rolling direction with corrosion layer, low magnification. Lower right: angular profile – cross-section perpendicular to rolling direction with corrosion layer, high magnification.

The microstructure of both steel profiles can be seen in Figure 7. At lower magnification, both steels show typical sulfide lines (Figure 7 upper and lower left). Obviously, the higher Mn content in both steels accomplished sufficient binding of S to MnS which might also be the reason that both profiles did not exhibit any pronounced core segregations. In the close-ups (Figure 7 upper and lower right) both steels exhibit some small pearlite islands, which can readily be identified by their laminar structure.

Cross-sections in and perpendicular to the rolling direction showed that both steels developed significant corrosion layers on the surface (Figure 7 upper and lower left). The close-ups in Figure 7 upper and lower right show dissolutions at the interface between the steel and the respective corrosion layer which have the characteristic circular shape and size of total grains. Such a region is magnified in Figure 7 lower right and it becomes evident that the margins of the dissolved grains are surrounded by pearlite islands. The reason for this is that the pearlite is more corrosion resistant in mild steels, due to the higher C content. Such regions with their ferrite cementite lamellae act as local cathodic sites, locally enhancing the anodic reaction and the dissolution of iron in the ferrite grains with their much higher purity of iron. A closer look at the micro-scale, as suggested also by Notis (2002), for instance, thus reveals that the phenomena of atmospheric corrosion of mild steel industrial heritage structures, as exhibited by the two typical examples here, are obviously much more diverse than generally anticipated.

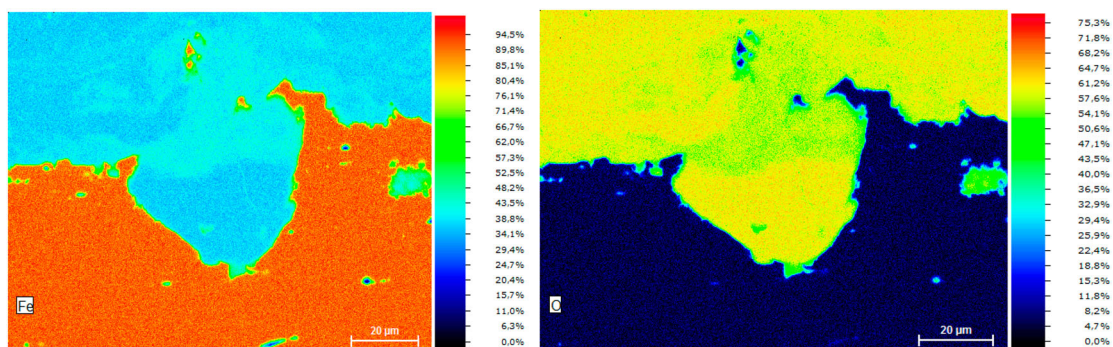
**Figure 8.** Energy-dispersive X-ray (EDX) mapping of iron and oxygen at region of selective ferrite grain corrosion on the mild steel profile surface. Left: iron content (at.%). Right: oxygen content (at. %).

To gain closer insights, Figure 8 shows high-magnification EDX maps of the iron and oxygen content (at.%) of the flat profile at a spot where selective corrosion of the ferrite has occurred. Figure 8 left shows that the average iron concentration in the steel is higher than 90 at.%, while it ranges at around 40 at.% in the corrosion layer. Interestingly, it ranges at about 60 at.% at the interface between the steel and the corrosion layer and thus at the same level as in other islands in the steel that obviously represent pearlite regions where nearly no oxygen is present. Tentatively it can thus be concluded that the circular margins are pearlitic and that the dissolved area represented a ferrite grain. Expectedly, the oxygen content in the steel is considerably low, but ranges slightly above 60 at.% in the corrosion layer. Inside the region of the dissolved ferrite grain and at the outer margins, the atomic distribution in the corrosion layer has an Fe:O ratio of 1:2 (ca. 33 at.% Fe and ca. 66 at.% O). This indicates an iron oxyhydroxide (FeOOH)

or the hydroxide  $\text{Fe}(\text{OH})_2$ . More concentrated towards the base steel, ratios of 2:3 (ca. 40 at.% Fe and ca. 60 at.% O) and even 3:4 (ca. 43 and 57 at.%) can be detected, which are indications for the oxides hematite  $\text{Fe}_2\text{O}_3$  and magnetite  $\text{Fe}_3\text{O}_4$ , respectively. The hydroxide  $\text{Fe}(\text{OH})_3$  can probably be ruled out, since this would require a Fe:O ratio of 1:3 (25 at.% Fe and 75 at.% O) which has not been observed.

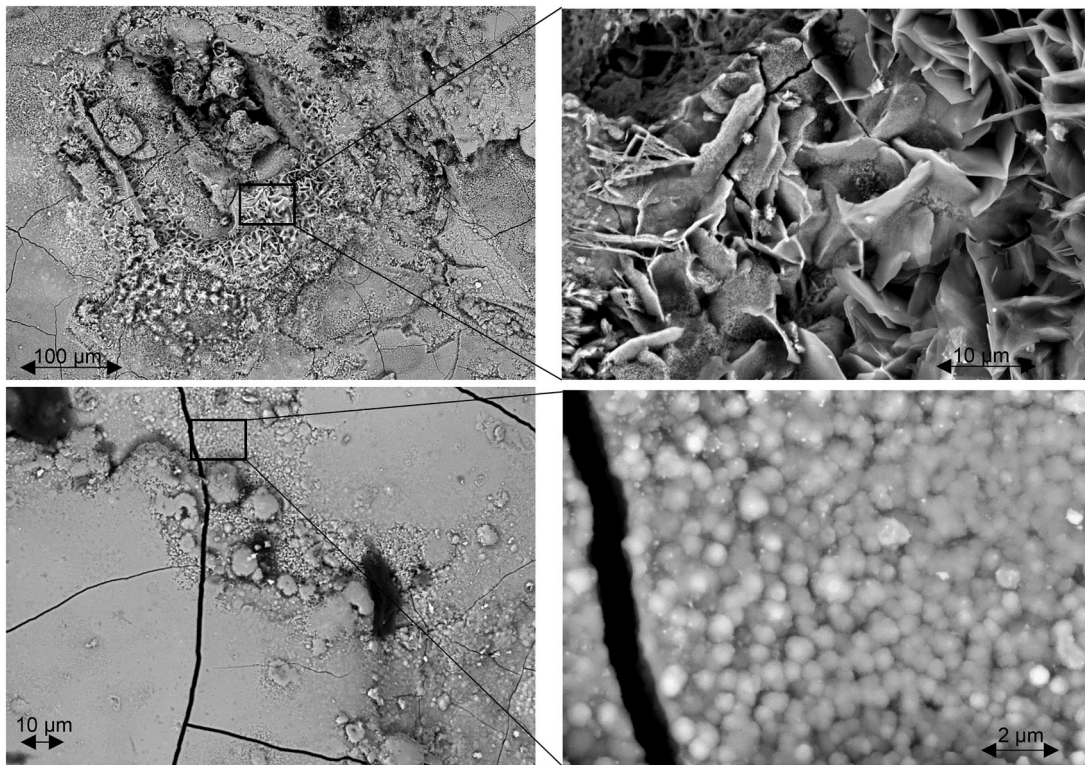
**Figure 9.** High resolution (HR) SEM images of the corroded flat steel profile surface. Upper: overview of an extensively corroded region (left); close-up exhibiting lamellar lepidocrocite (right). Lower: close-up of a less corroded region (left); close-up exhibiting rosette-like goethite (right).

Figure 9 shows the HR-SEM images of the corroded surface of the flat steel profile surface typical for most of the headgear's surface appearance. Figure 9 upper left provides an overview of a region severely affected by pitting corrosion. As shown in the close-up (Figure 9 upper right), the corrosion products at the pit margins exhibit a laminar structure. This was found to be typical for lepidocrocite ( $\gamma\text{-FeOOH}$ ) (Morcillo et al. 2011, 2013; Montoya et al. 2013; Tewari et al. 2016). A close-up of a smooth surface area in the vicinity of the pit in Figure 9 lower left shows a spheric, rosette-like, structure of the corrosion products (Figure 9 lower right). These can be assigned to goethite ( $\alpha\text{-FeOOH}$ ) (Morcillo et al. 2011, 2013; Montoya et al. 2013; Tewari et al. 2016). In general, lepidocrocite was found in the more corroded areas of this sample, while goethite was always associated with smoother surfaces.

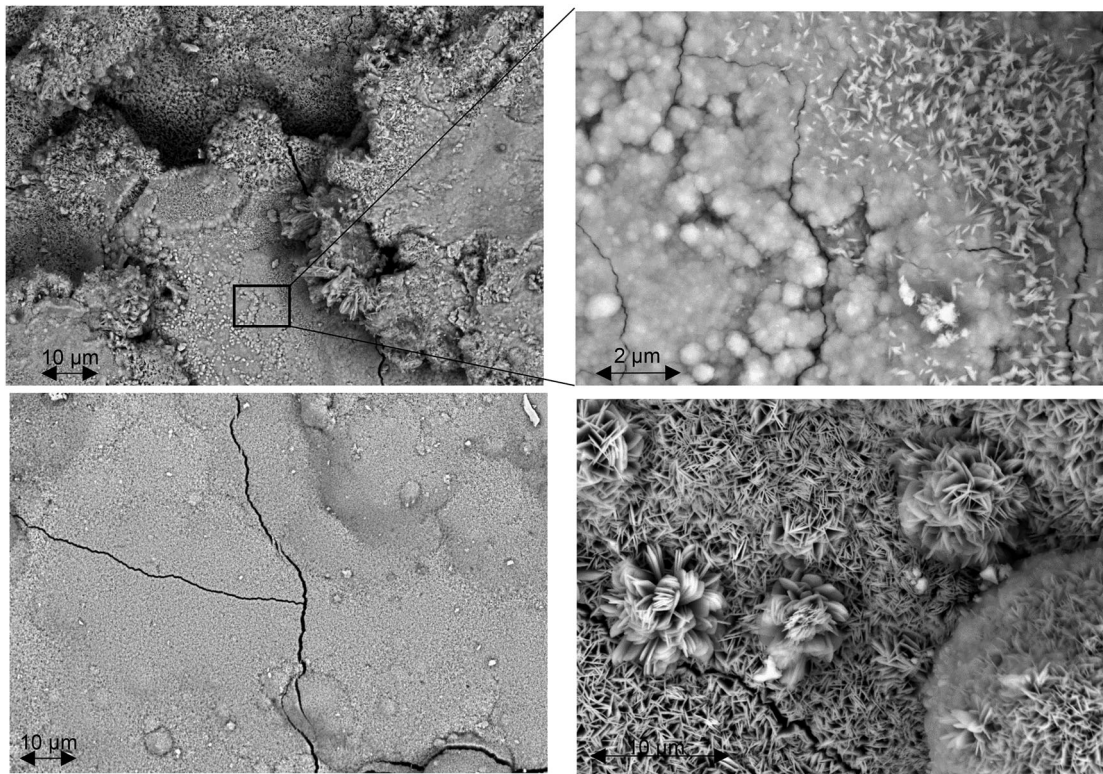
**Figure 10.** HR-SEM images of the corroded angular steel profile surface. Upper: overview of extensively corroded region (left); close-up exhibiting lamellar lepidocrocite on top of rosette-like goethite (right). Lower: close-up of a less corroded region (left); close-up exhibiting goethite transformed from a rosette-like structure to a more crystalline structure (right).

HR-SEM images of the angular steel profile surface are shown in Figure 10. A close-up of a more severely corroded region is shown in Figure 10 upper left. At even higher magnification (Figure 10 upper right), it can be seen that the major part of this region consists of rosette-like goethite. Small sections also show a lamellar corrosion product on top of goethite. Considering the literature (Morcillo et al. 2011, 2013; Montoya et al. 2013; Tewari et al. 2016), it is likely that this represents freshly formed lepidocrocite not yet transformed to goethite. It should be noted that this steel profile has been exposed for 90 years to atmospheric corrosion in the semi-arid climate of the Otavi Mountain Land and thus 35 years longer than the above discussed flat profile. This might be an indication that the transformation from lepidocrocite into goethite under these atmospheric corrosion conditions might require

much longer than 60 years of exposure. A close-up of a smoother surface region of the angular steel profile exhibiting less severe corrosion is shown in Figure 10 lower left. Interestingly, the higher magnification in Figure 10 lower right shows a lamellar fine-crystalline structure of such regions. Consistent with the existing literature, this structure represents a very stable goethite formed after very long exposure times (Morcillo et al. 2011, 2013; Montoya et al. 2013; Tewari et al. 2016).

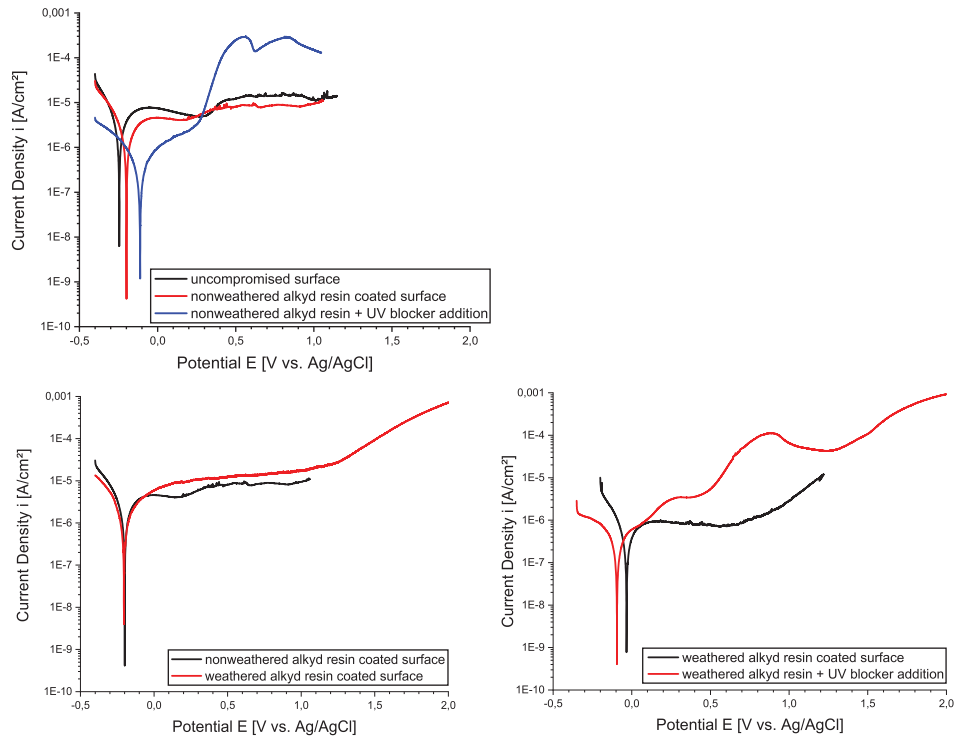
**Figure 11.** Potentiodynamic diagrams (E–I curves) of the flat profile mild steel surface. Upper: potentiodynamic diagrams of the flat profile mild steel surface in the non-weathered condition. Lower left: I–E curves of weathered (red line) and the non-weathered (black line) alkyd resin coated surface. Lower right: I–E curves of the weathered alkyd resin coated surface and that coated with UV-blocker addition.

For a closer insight into the protective effect of the Owatrol Oil® coating with and without UV-blocker additions versus the already existing corrosion layers the respective scans of the potentiodynamic measurements are summarized in Figure 11.

The comparison of the corrosion behavior of the non-weathered sample to the samples with different coatings is compared in Figure 11 (upper). In contrast to polarization diagrams of mild steel surfaces published elsewhere (Nujoma 2009), the non-weathered and non-coated surface (black line) exhibits a significantly flattened anodic branch indicating that there is some semi-passive behavior over a quite large potential range. A first, but still minor potential increase can be identified at about 300 mV. However,

In comparison, the sample coated with Owatrol Oil® (red line) exhibits a slightly higher equilibrium potential and a slightly lower anodic current density over the entire potential range. The corrosion resistance of the surface seems thus to be slightly improved by the Owatrol Oil® coating.

However, the Owatrol Oil® + UV stabilizer coating system (blue line) reveals a completely different potentiodynamic behavior. While the equilibrium potential is slightly increased, significant activation of the steel surface occurs already at around 300 mV. Such behavior has been confirmed by several tests and it indicates that the UV stabilizers used in this study counteract the corrosion protection provided by both the long-term corrosion products and the Owatrol Oil® coating.

Figure 11 (lower) summarizes the potentiodynamic tests for the long-term corroded mild steel surface preserved with Owatrol Oil® with and without UV-blocker additives after accelerated aging for two weeks in the climate chamber. Figure 11 lower left shows the potentiodynamic response of a sample coated with Owatrol Oil® after artificial weathering (red line) versus a sample in the non-weathered condition (black line). The curves show the same equilibrium potentials and the current density–potential curve also have a very similar shape. This shows that the weathering does not affect the corrosion protection achieved by the Owatrol Oil®

Figure 11 lower right shows a comparison of samples coated with Owatrol Oil® (black line) and Owatrol Oil® + UV stabilizers (red line) after two weeks of artificial weathering. As without weathering, the surface coated with added UV stabilizers shows a significant increase in anodic current density without any signs of semi-passive behavior. In addition, the equilibrium potential of this surface decreased by about 50 mV. Even after exposure to the high UV-radiation in the climate chamber selected for this study, the UV-stabilizing additives simply show no positive effect and, even worse, cause a significant decline in semi-passive behavior in both the non-weathered and the weathered condition.
