Data Article

Dataset on geosynthetic material debris contamination of the South-East Baltic shore

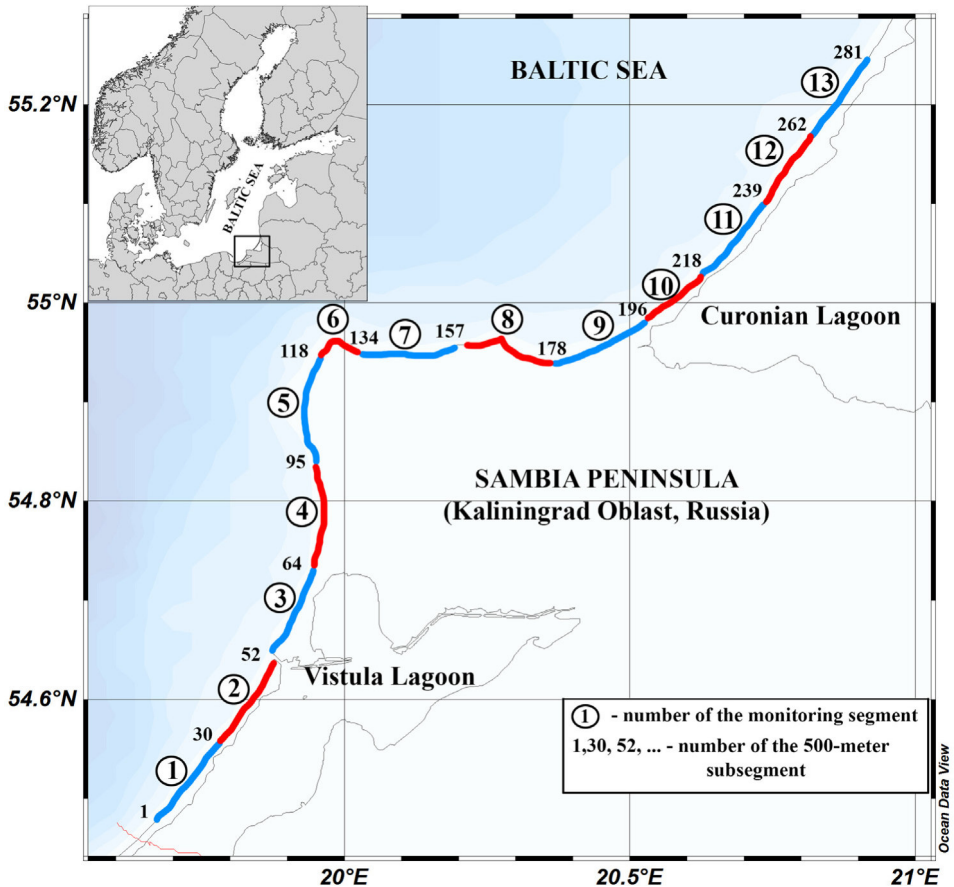
Fig. 1. Monitoring field design in the South-Eastern Baltic. The numbers of the monitoring shore segments are in circles. The numbers of reference points mark the end of the monitoring segment.

- The number of the 500 m coastline subsegment (column “№ Subsegment”). The approximate position of the subsegments is shown in Fig. 1, which presents the segments monitored during one day. The numbers of the reference point marked the northern end of coastline subsegment (this number is also the number of coastline subsegment) are also indicated.
- Coordinates (WGS 84) of the center of the subsegment (columns “Latitude [degree]”, “Longitude [degree]”)
- Number of samples of geosynthetic material of different types (Geotextile, Gabion coating, Geocontainer, Geocell, Geomat) found on corresponding subsegment (columns “Geotextile [numbers]”, “Gabion coating [numbers]”, “Geocontainer [numbers]”, “Geocell [numbers]”, “Geomat [numbers]”).

The study area (Fig. 1) in the South-Eastern Baltic included the beaches of the Kaliningrad Oblast (Russia) and also contains the beach segments on the adjacent territories: the Polish shore from the Poland-Russia border on the Vistula Spit to the mouth of the Vistula River, the Lithuanian shore from the border Lithuania-Russia on the Curonian Spit to the border of Latvia-Lithuania. Therefore, the transboundary shores of the sandy barrier, the Vistula and Curonian spits were studied as a whole.

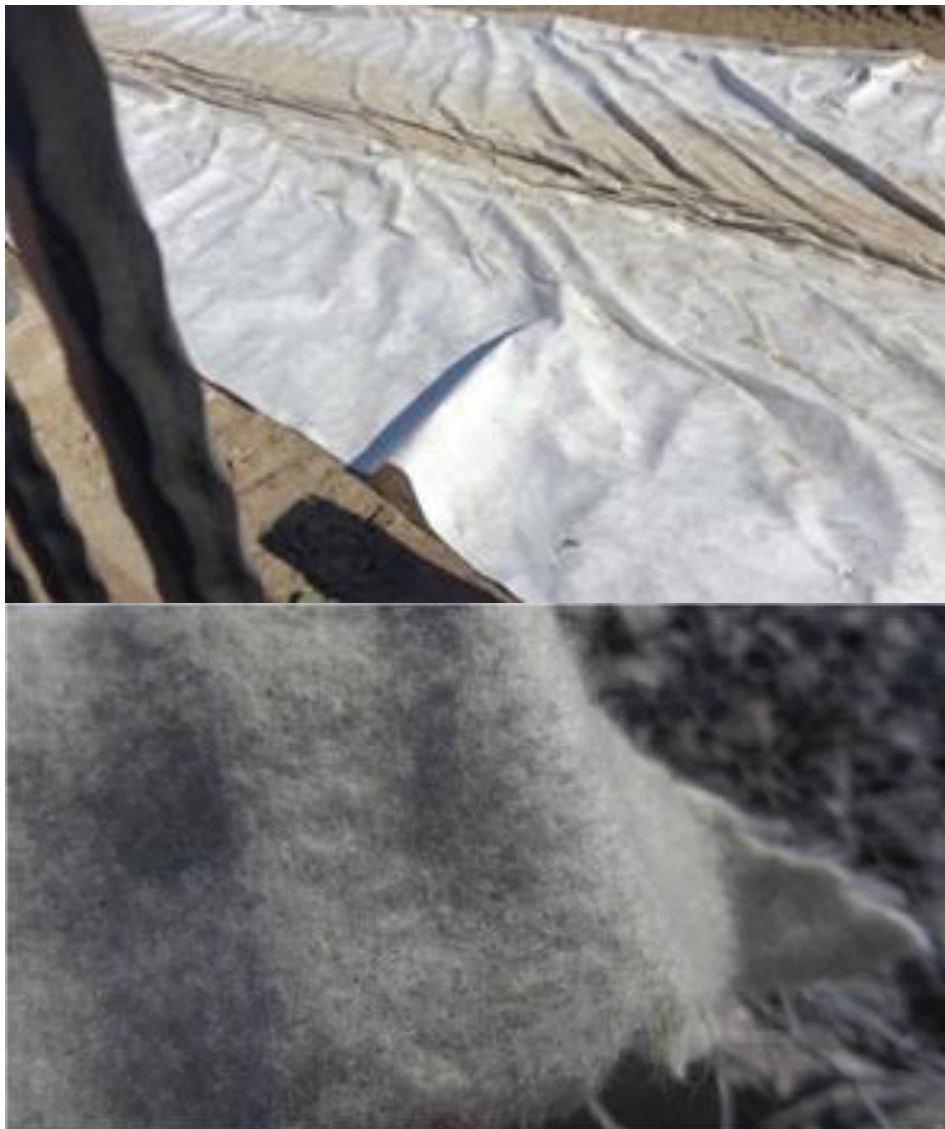
Figure 1.1. Nonwoven geotextile (PP, PET) is used in coastal protection constructions.

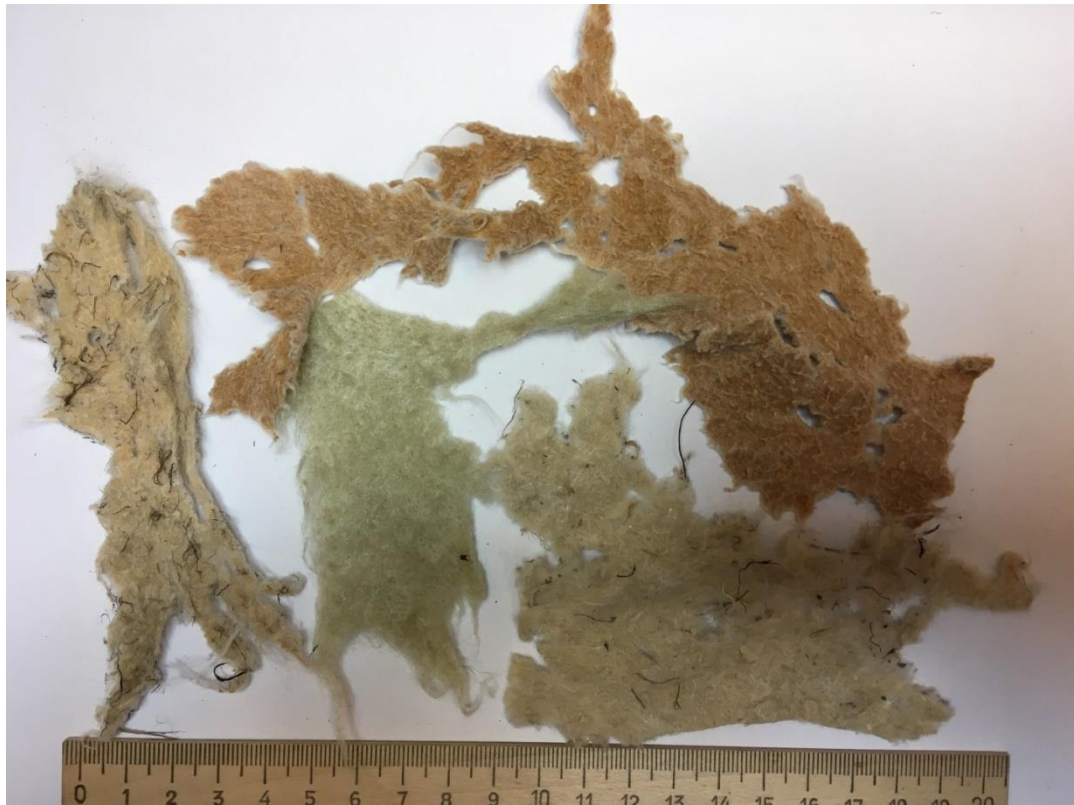
Figure 1.2. Fragments of nonwoven geotextile (PP, PET). All pieces are not fresh; they were a long time in natural conditions.

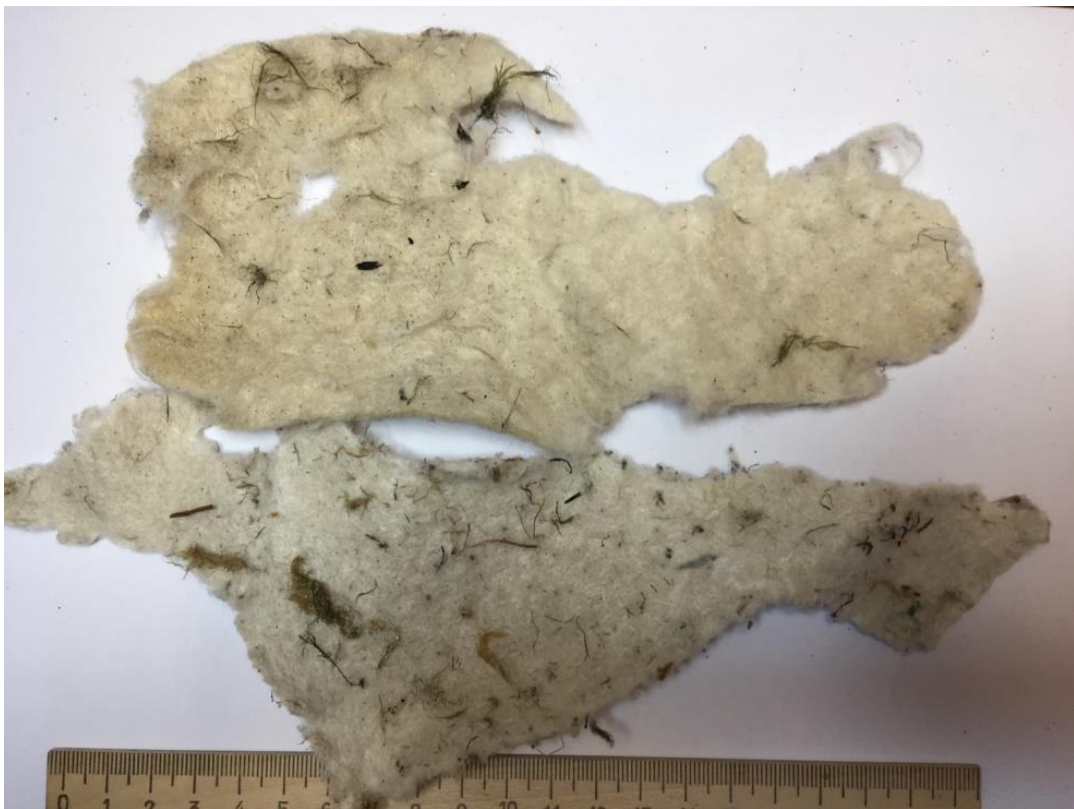
Figure 1.3. Fragments of white nonwoven geotextile (PP, PET). Pieces are not fresh; they were a long time in natural conditions.

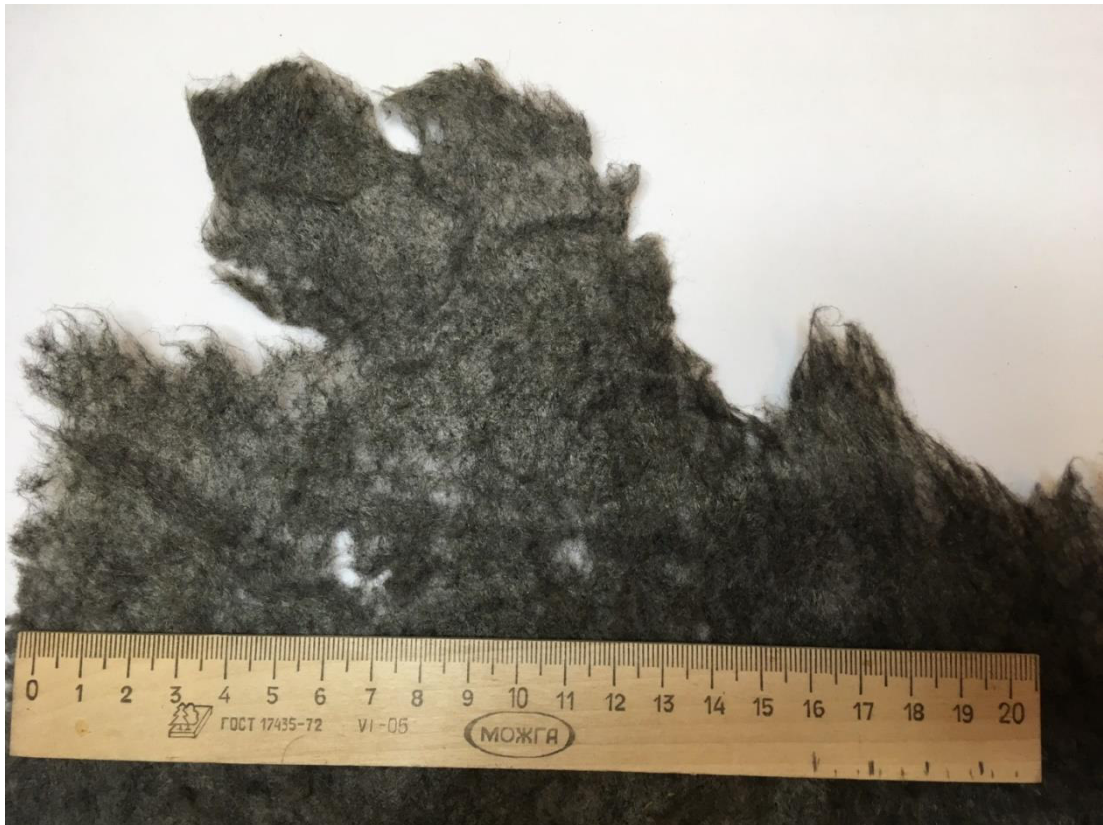
Figure 1.4. The Fragment of black nonwoven geotextile (PP, PET)). Pieces are not fresh; they were a long time in natural conditions.

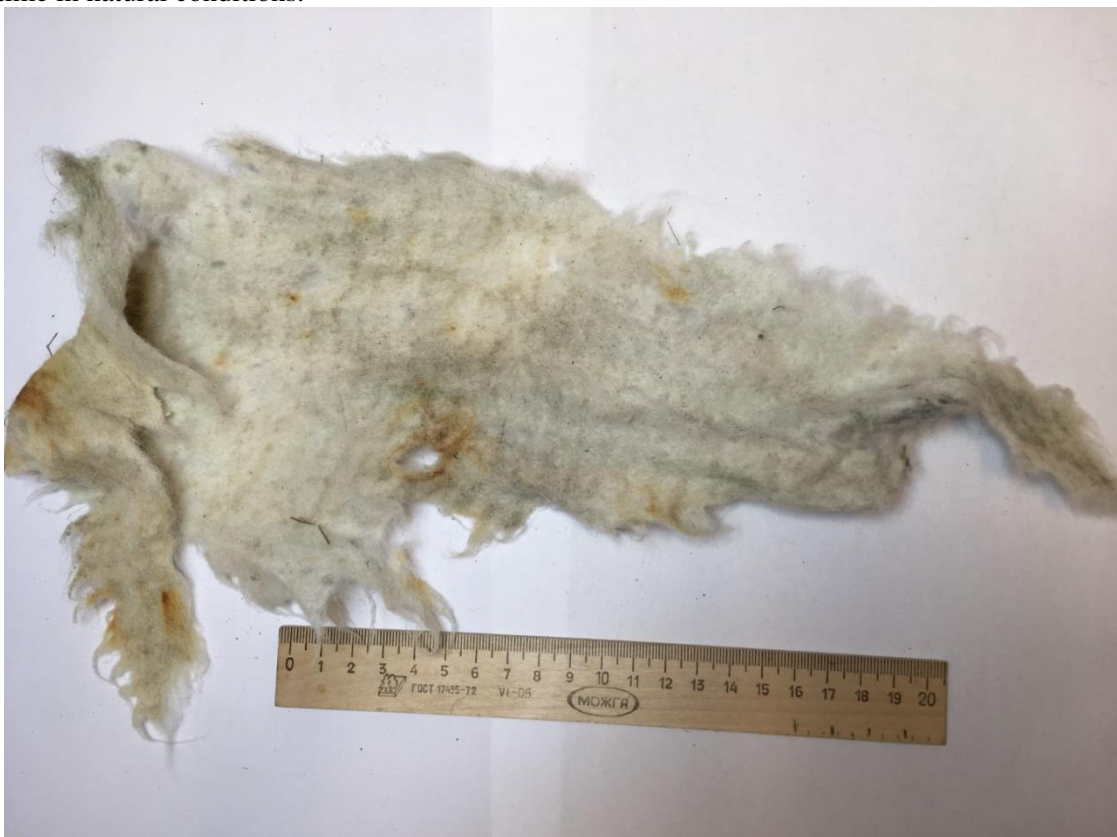
Figure 1.5. The Fragment of white nonwoven geotextile (PP, PET) with reinforcing stitching. The pieces is not fresh; it was a long time in nature.

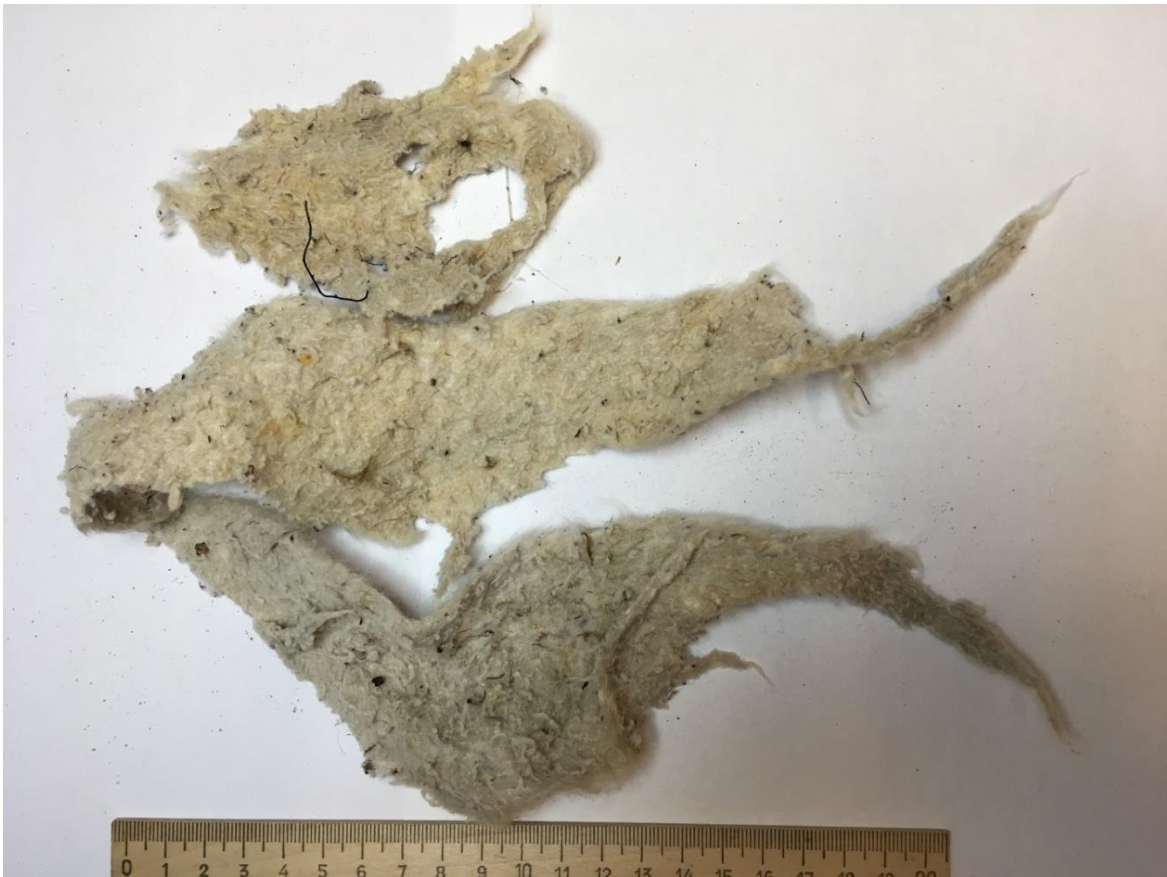
Figure 1.6. The Fragment of white nonwoven geotextile (PP, PET)). Pieces are not fresh; they were a long time in natural conditions.

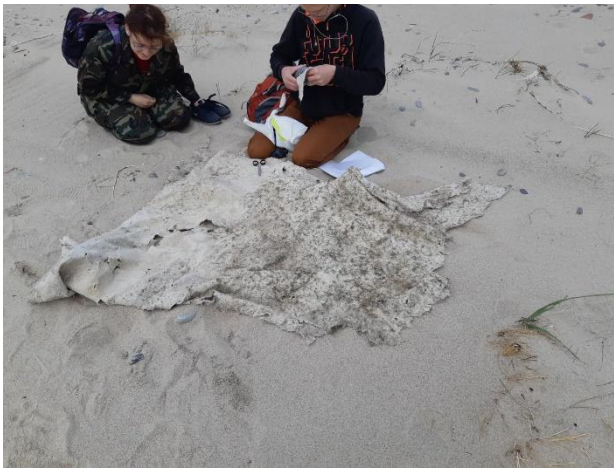
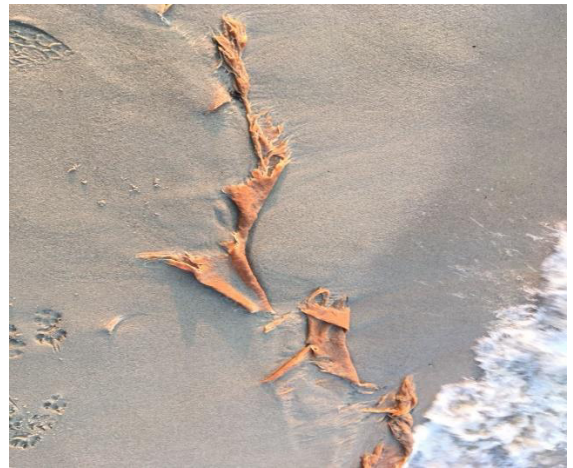
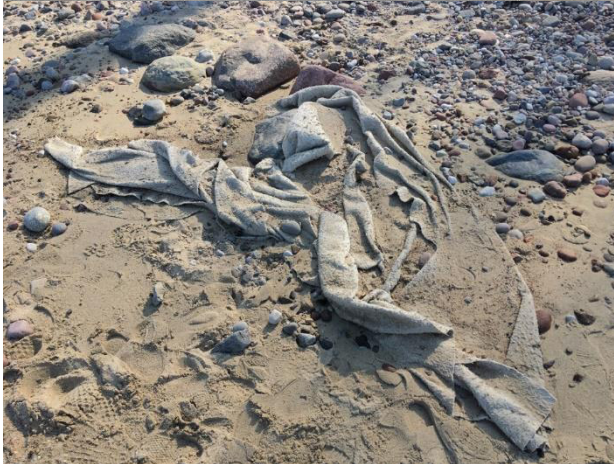
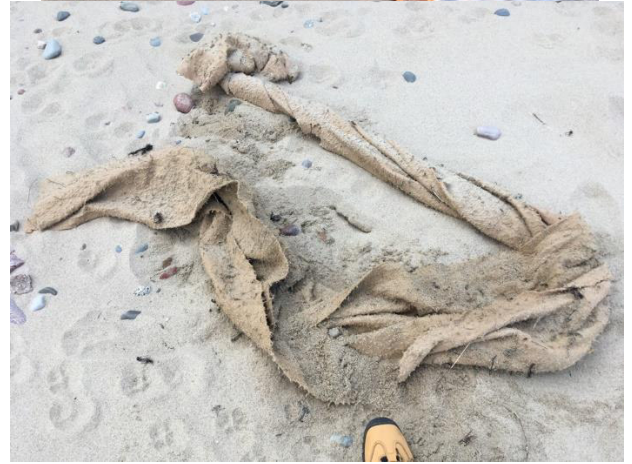
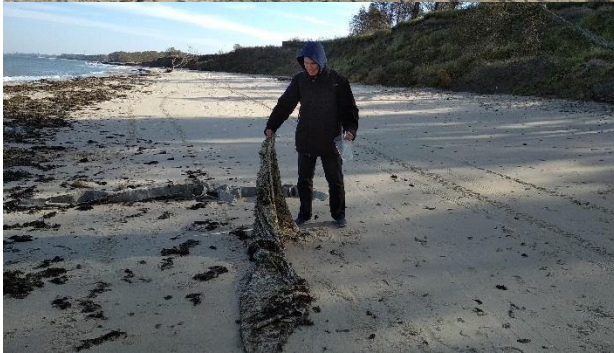
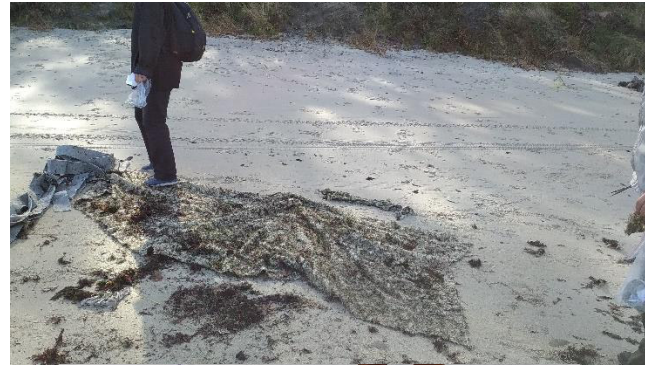
Figure 1.7. Examples of the geotextile debris on the beaches of the Kaliningrad Oblast, Russia.

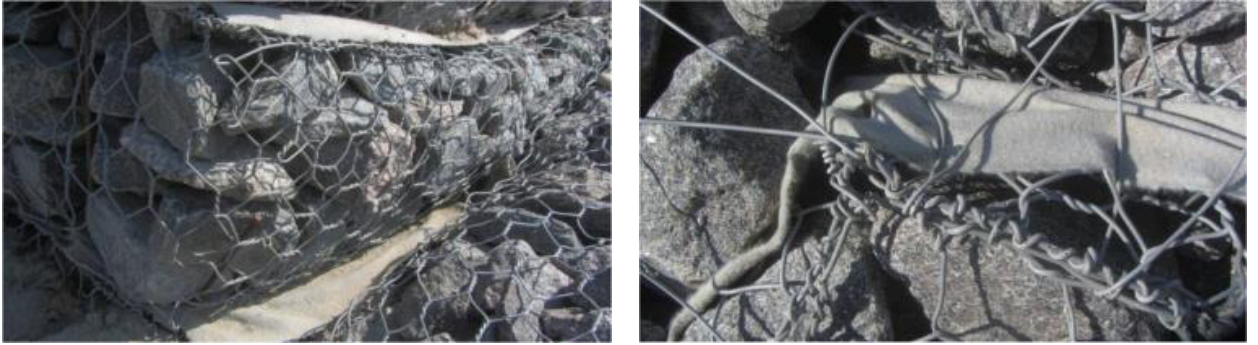
Figure 1.8. Gabion wire braid.

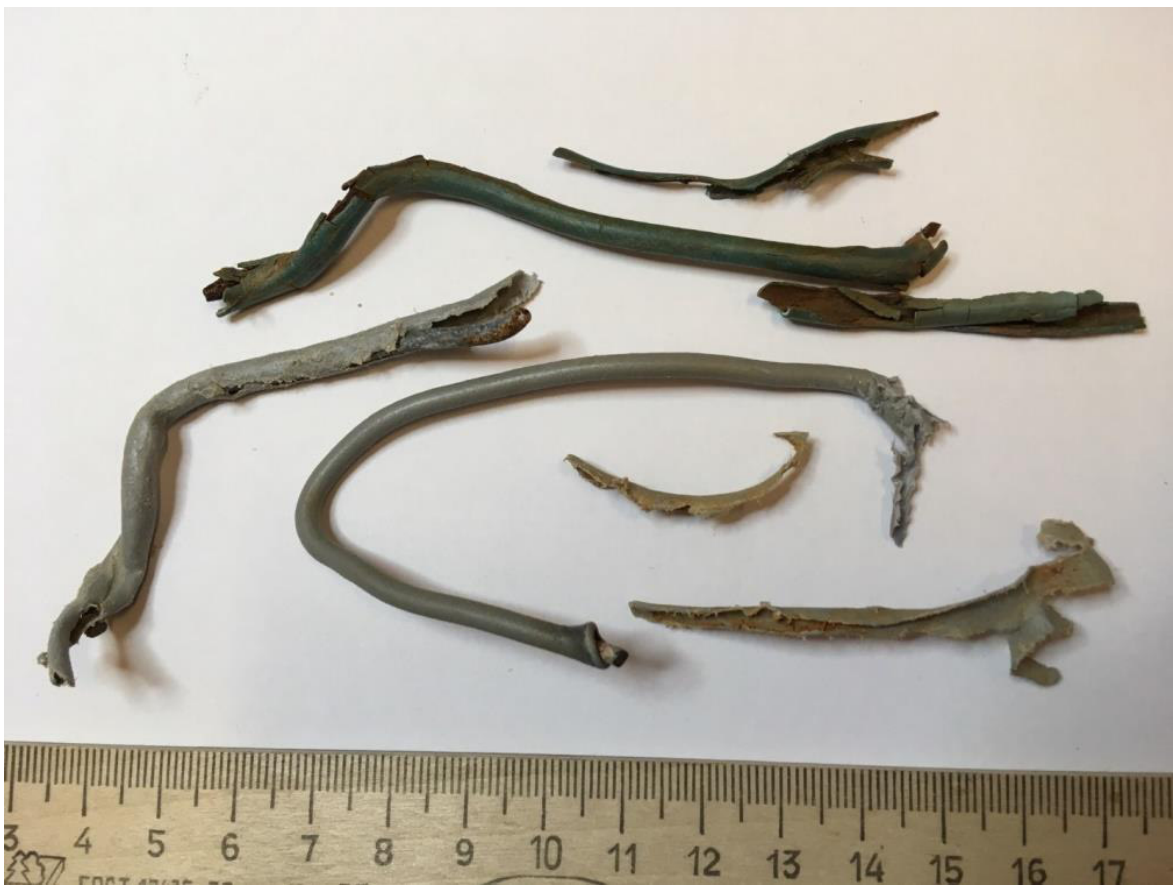
Figure 1.9. Usually, only fragments of plastic coating for gabion wire are present on the beach, but sometimes the pieces contain the wire (two pieces in the figure).

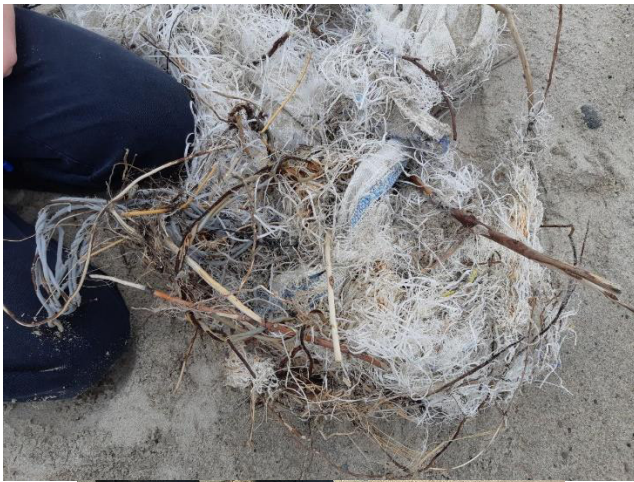
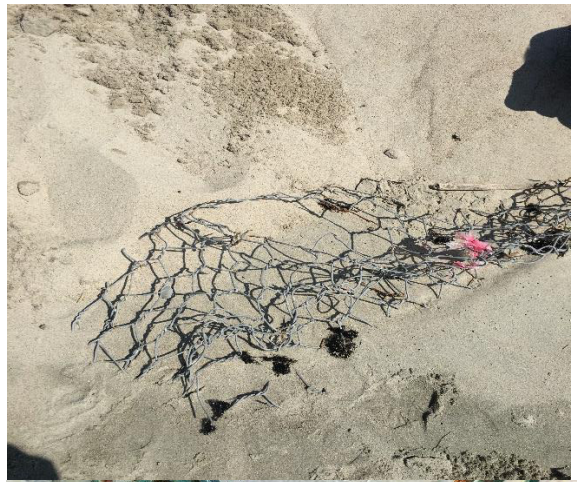
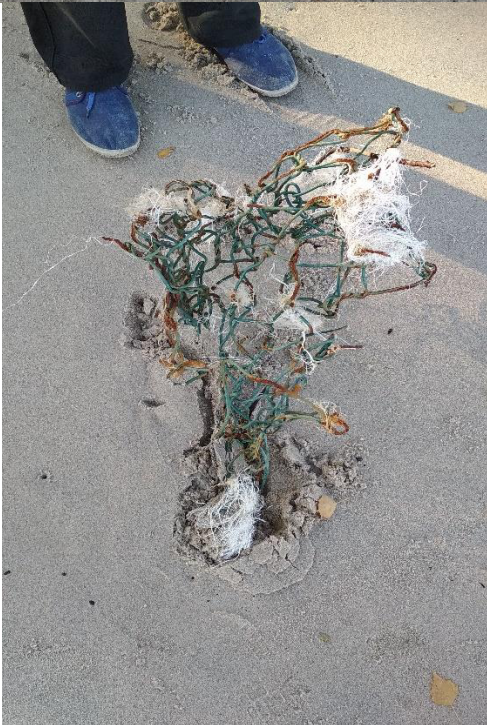
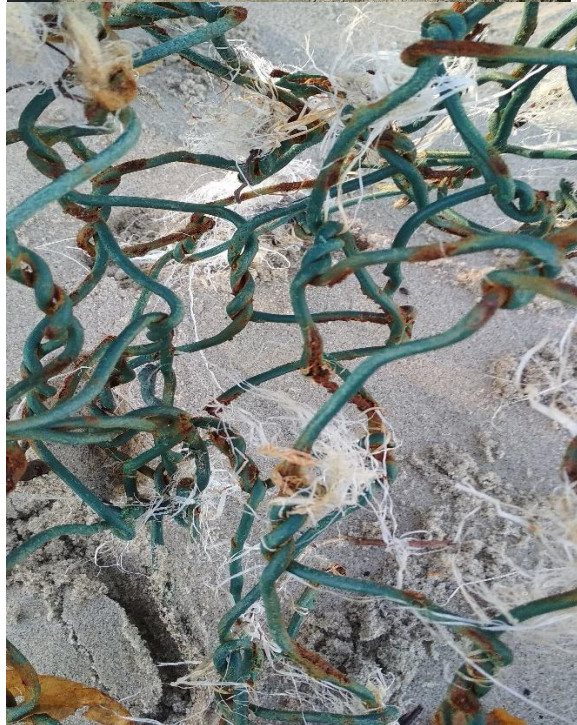
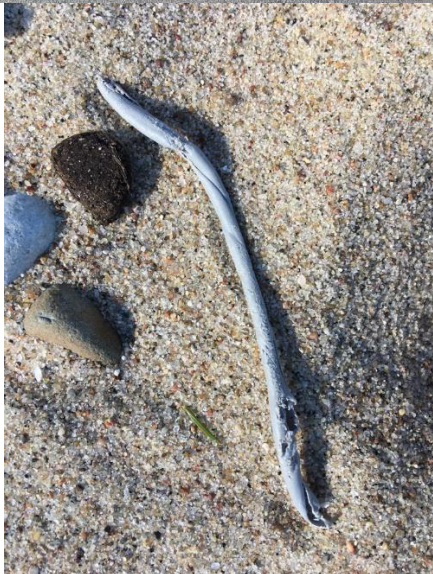
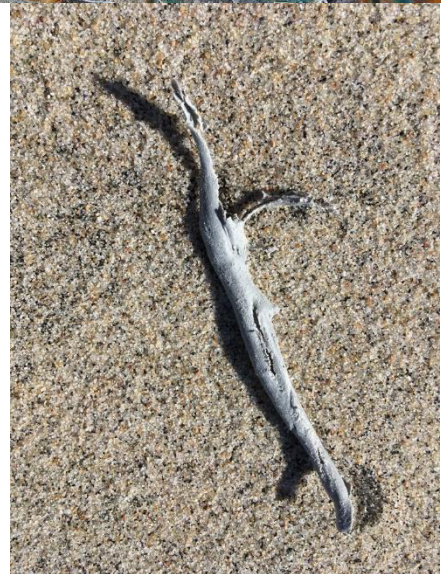
Figure 1.10. Examples of the gabion fragments on the beaches of the Kaliningrad Oblast, Russia.

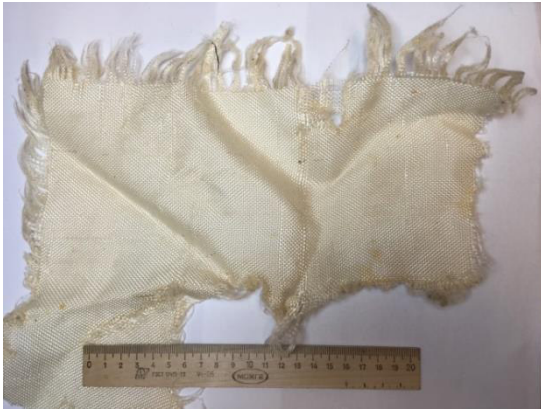
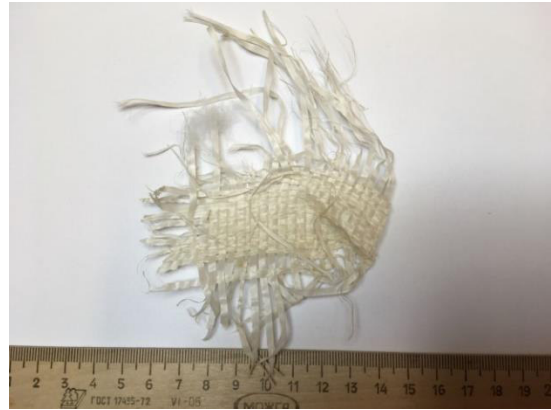
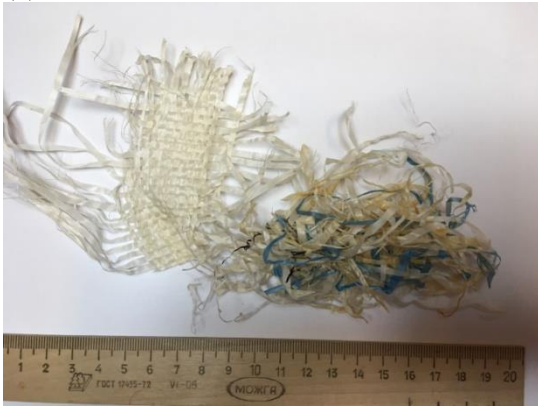
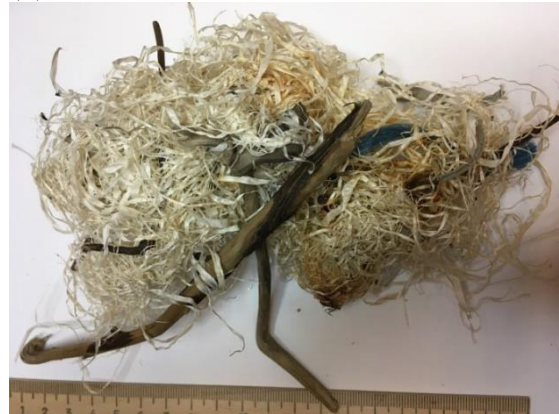
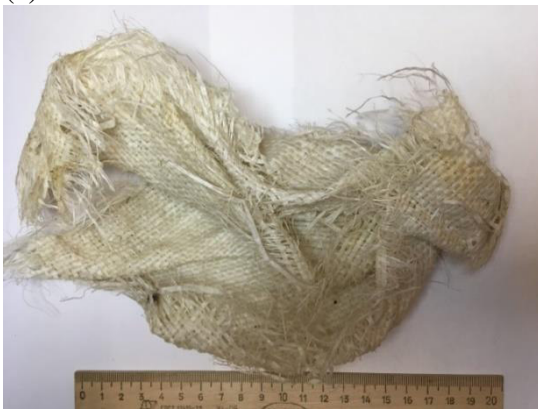
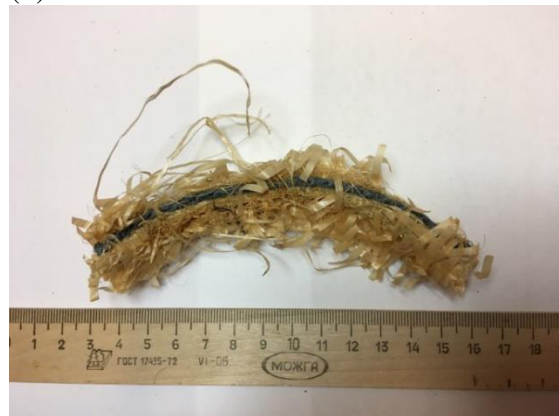
Figure 1.11. Fragments of woven material.

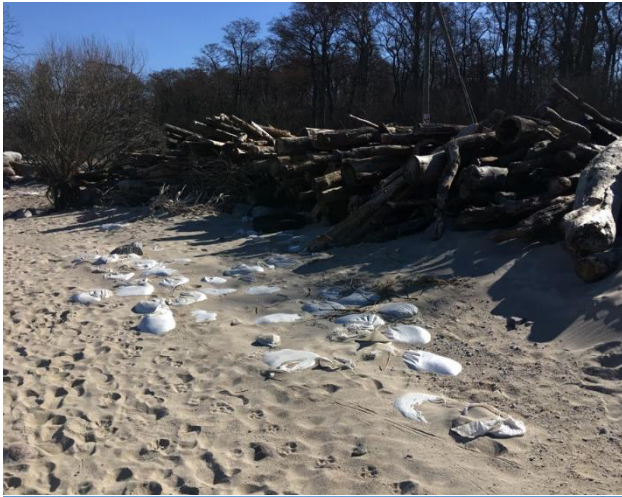
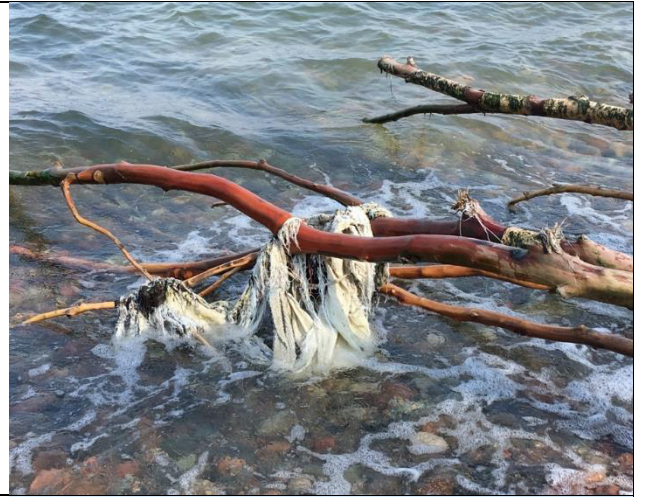
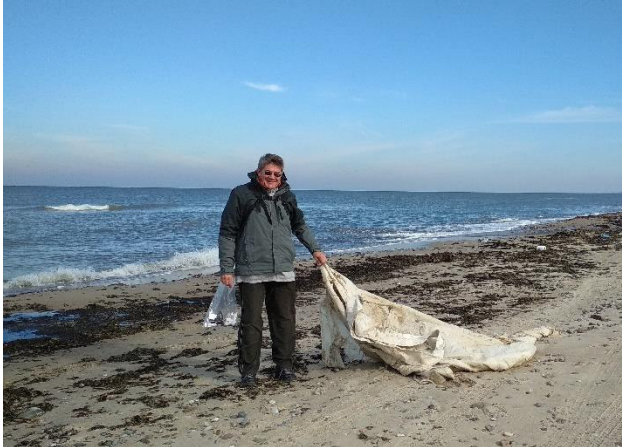
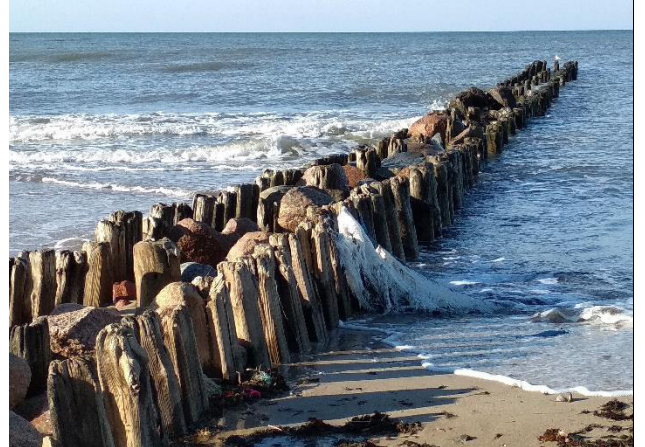
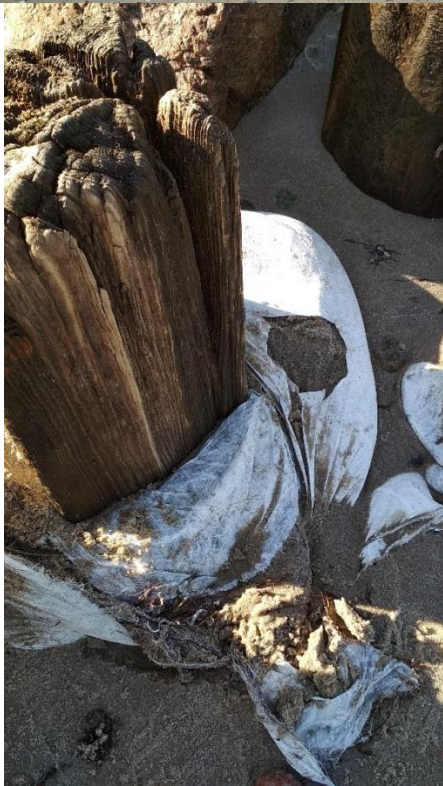
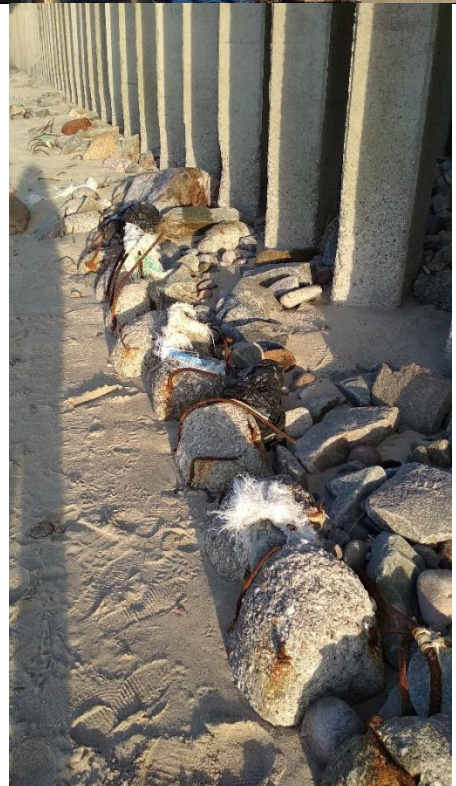
Figure 1.12. Examples of the geocontainer fragments on the beaches of the Kaliningrad Oblast, Russia.

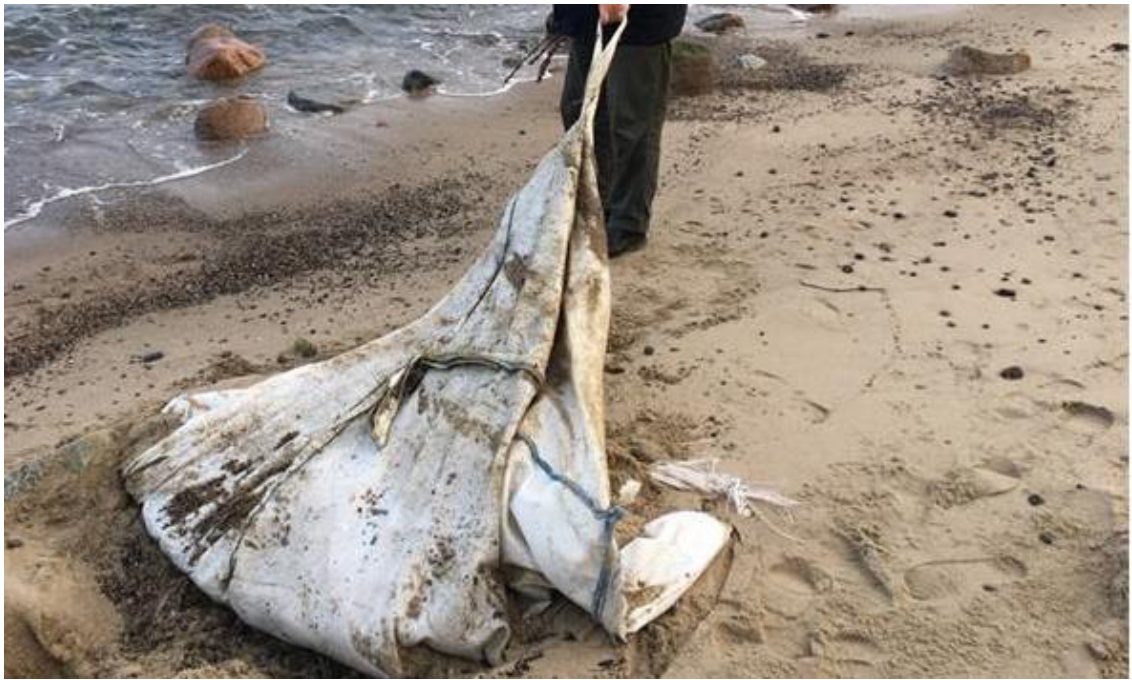
Figure 1.13. Used geotainer (a woven bag, HDPE, PP).

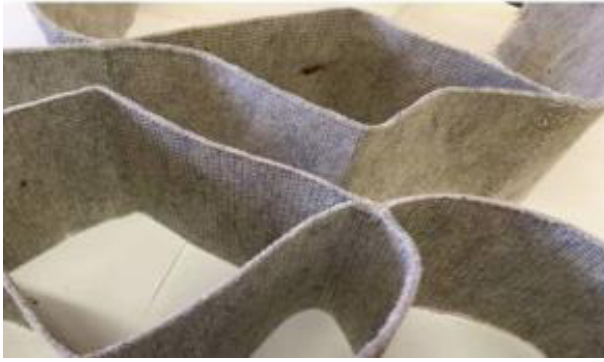
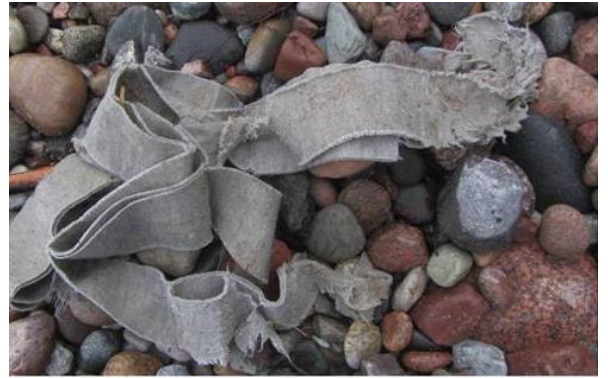
Figure 1.14. Geocells are made from PP, HDPE or PE fibres.

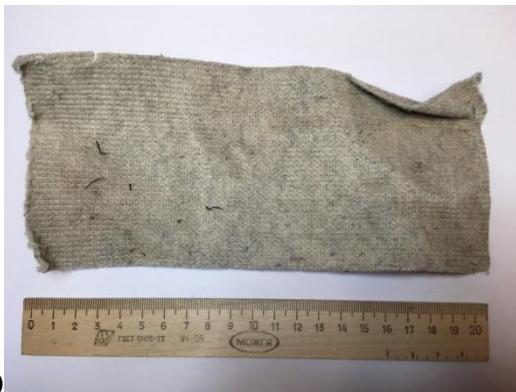
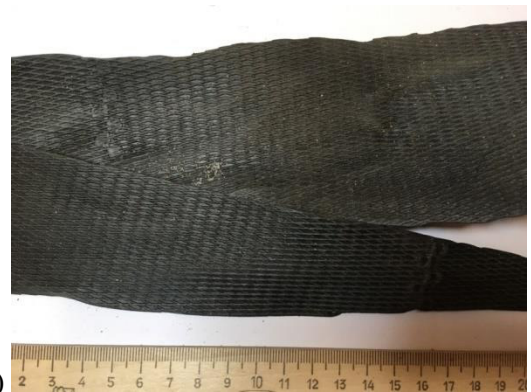
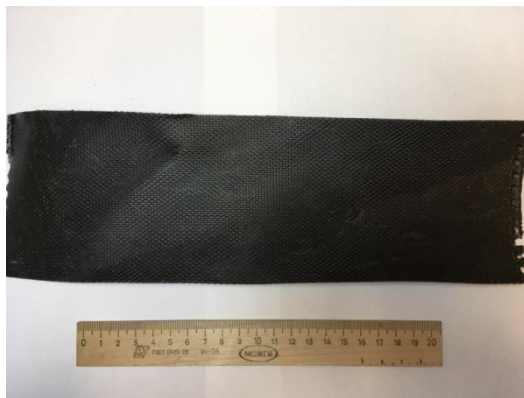
Figure 1.15. Fragments of the tape from which geocells are produced.

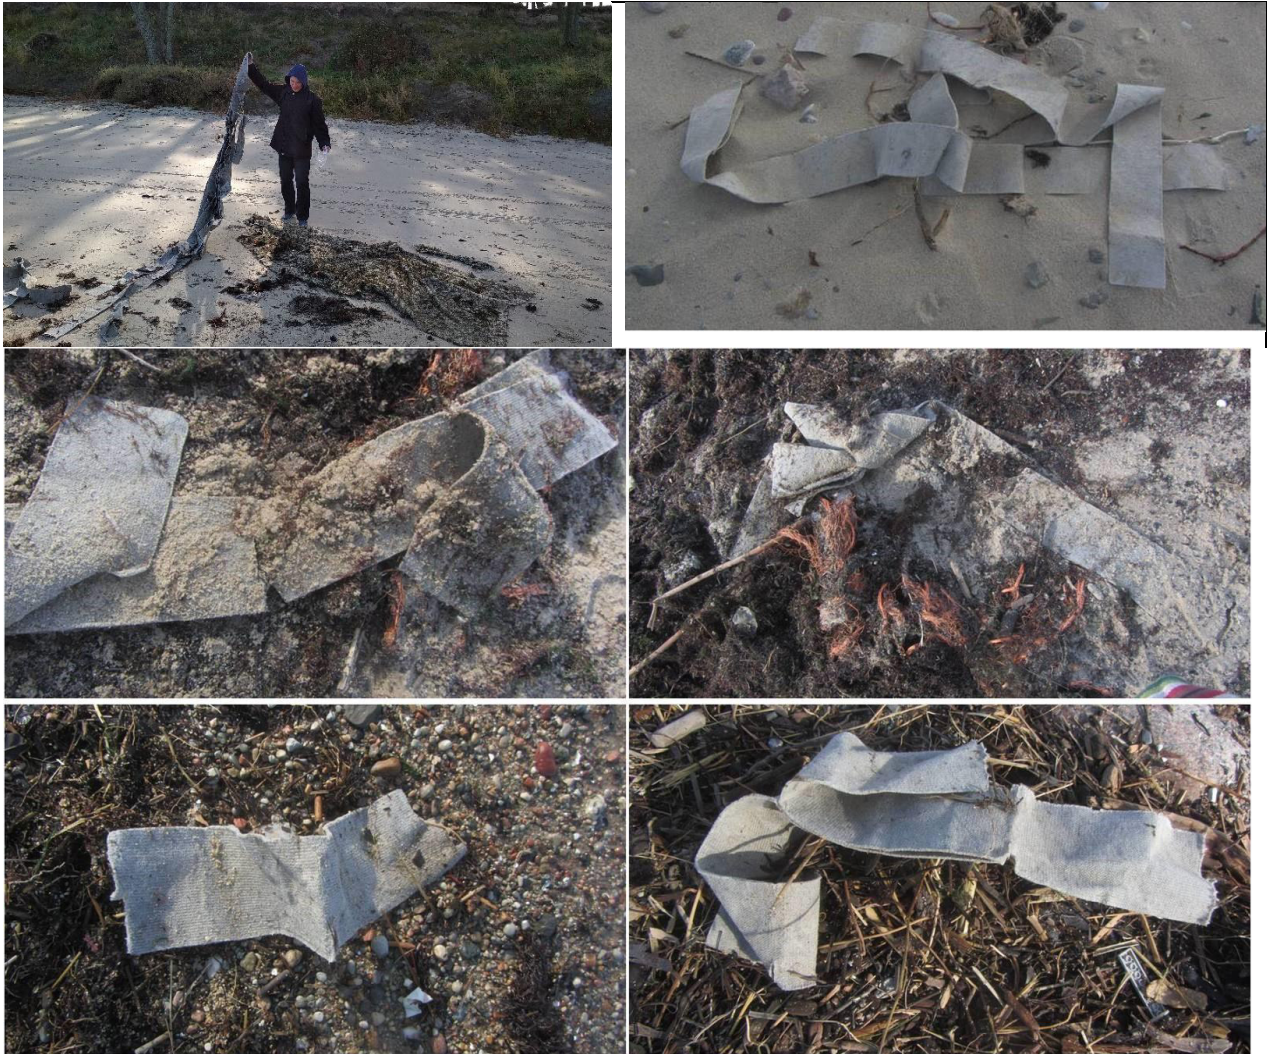
Figure 1.16. Examples of the geocell fragments on the beaches of the Kaliningrad Oblast, Russia.

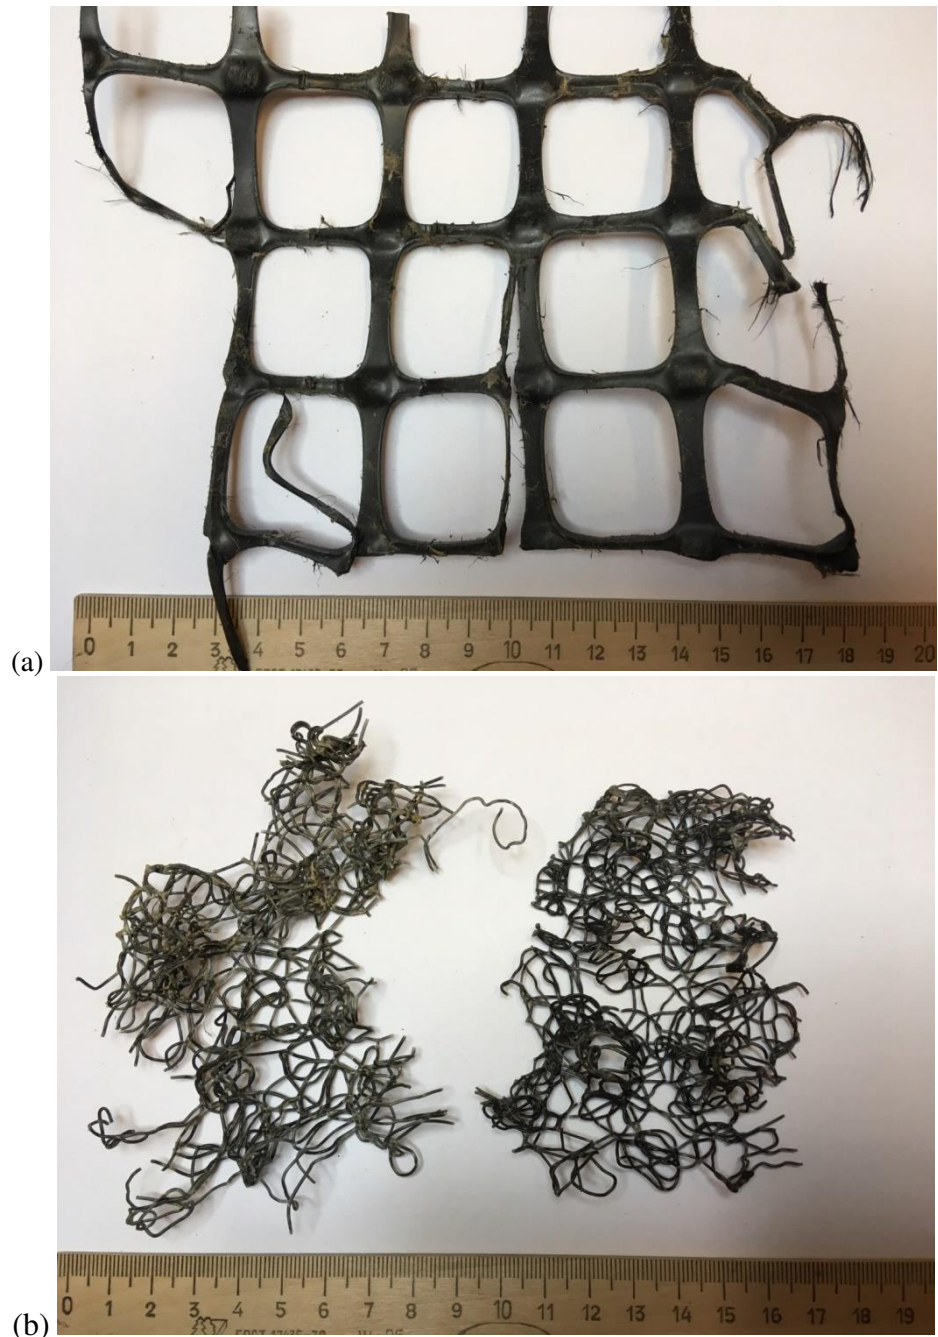
Figure 1.17. Fragments of the geomat.

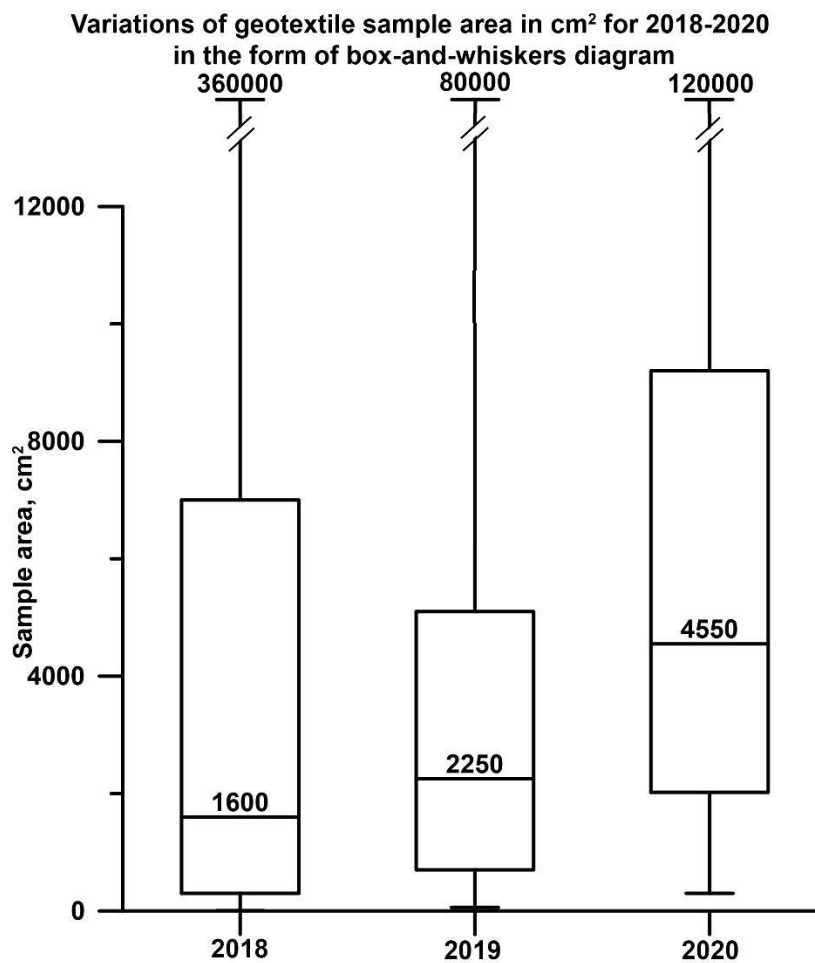
Figure 3.1. Variation of geotextile sample area in cm² for 2018-2020 in the form of a box-and-whiskers diagram. The label inside the box is the median value, the label above the upper whisker is the maximum value.

The statistics on sample size are presented in the form of a box-and-whisker diagram for debris of geotextile (Fig.3.1), geocontainer (Fig.3.2) and gabion plastic coating (Fig.3.3) for each monitoring year. For geotextile and geocontainer, variations of a sample area (cm²) are presented (Figs 3.1 and 3.2), while for gabions, the variations of a sample length (cm) are presented (Fig. 3.3).

On each box-and-whisker diagram, the label inside the box indicates the value of the median sample size. Upper and lower whiskers correspond to the maximum and minimum values. The upper whiskers are also labelled.

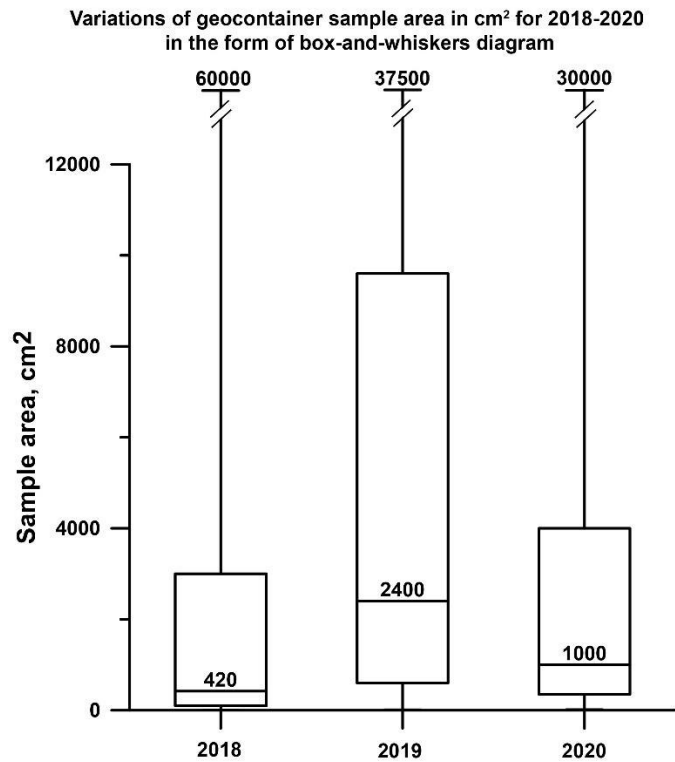
Figure 3.2. Variation of geocontainer sample area in cm² for 2018-2020 in the form of a box-and-whiskers diagram. The label inside the box is the median value, the label above the upper whisker is the maximum value.

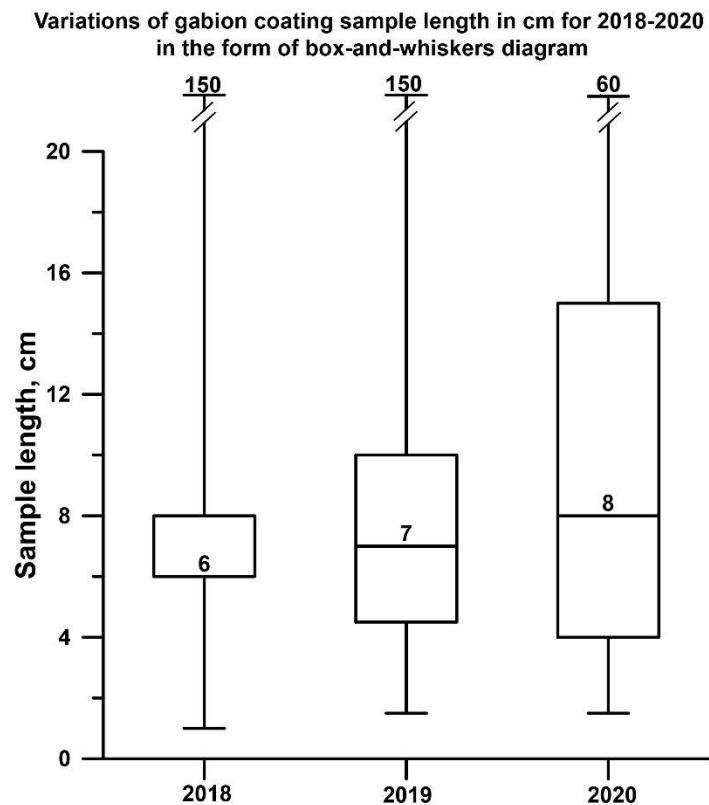
Figure 3.3. Variation of gabion plastic coating sample length in cm for 2018-2020 in the form of a box-and-whiskers diagram. The label inside the box is the median value, the label above the upper whisker is the maximum value.
