Data Article

Dataset on geosynthetic material debris contamination of the South-East Baltic shore

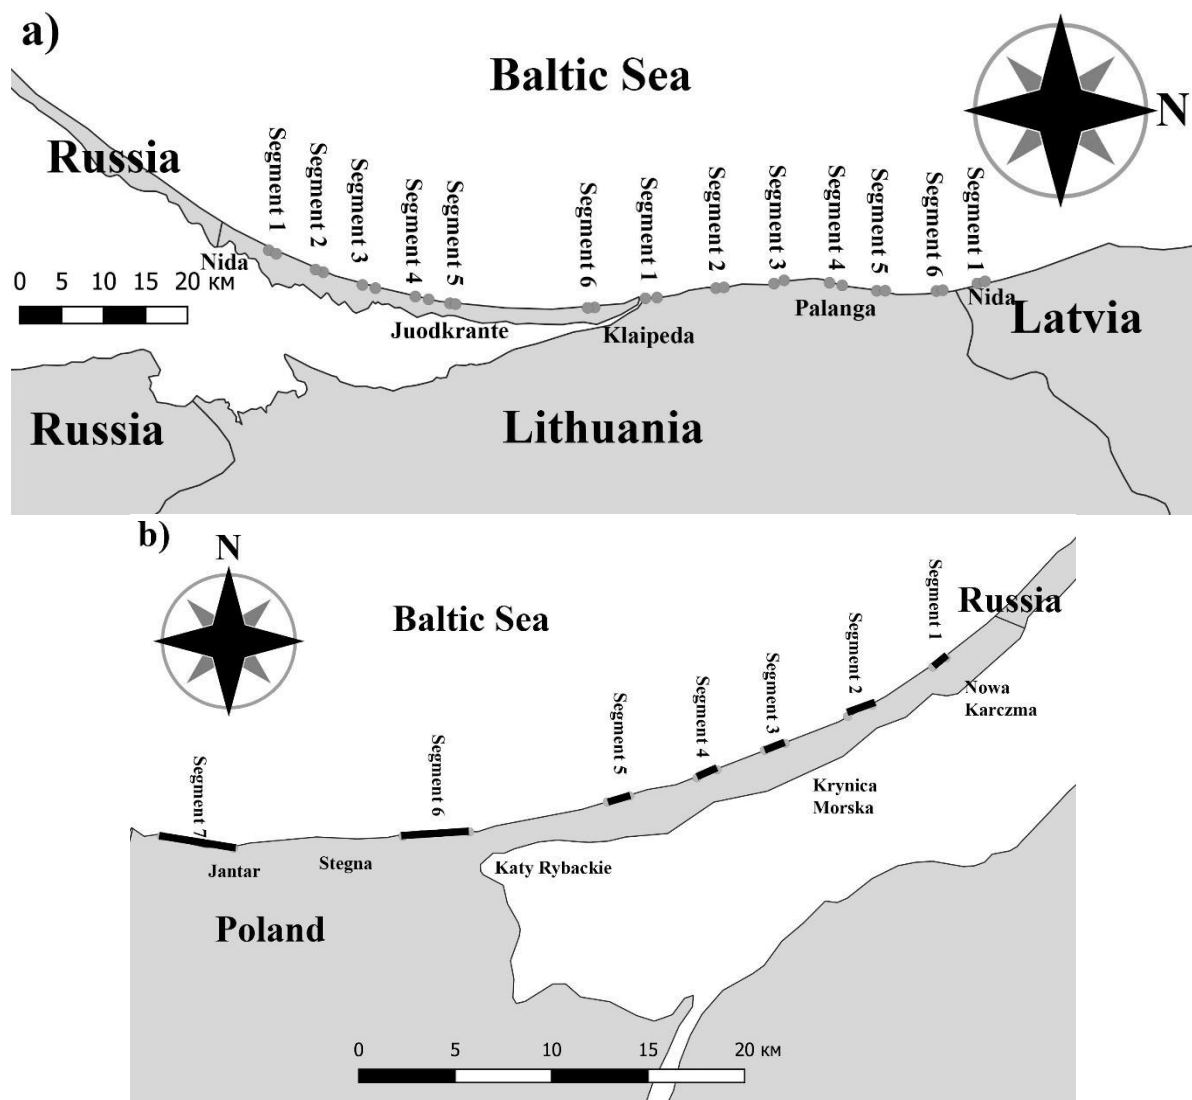
Figure 4.1. Positions of the monitoring segments on the Lithuanian (a) and Polish (b) shores.

There were twelve test 1-km segments at the Lithuanian part of the shore of the Southeastern Baltic (Fig. 4.1a): six 1-km segments on the Lithuanian part of the Curonian Spit (spit sector) and six segments on the mainland to the north towards the Latvian-Lithuanian border (mainland sector).

Seven test segments of various lengths were defined at the Polish part of the neighbouring shore - five segments on the Polish part of the Vistula Spit and two segments between the Vistula River mouth and the core of the Vistula spit (Fig.4.1b).
