## Detection of wire breaks in prestressed concrete bridges by Acoustic Emission analysis

Stephan Matthias Pirskawetz<sup>a,\*</sup>, Sebastian Schmidt<sup>b</sup>

<sup>a</sup> Bundesanstalt für Materialforschung und -prüfung (BAM), Unter den Eichen 87, 12205, Berlin, Germany

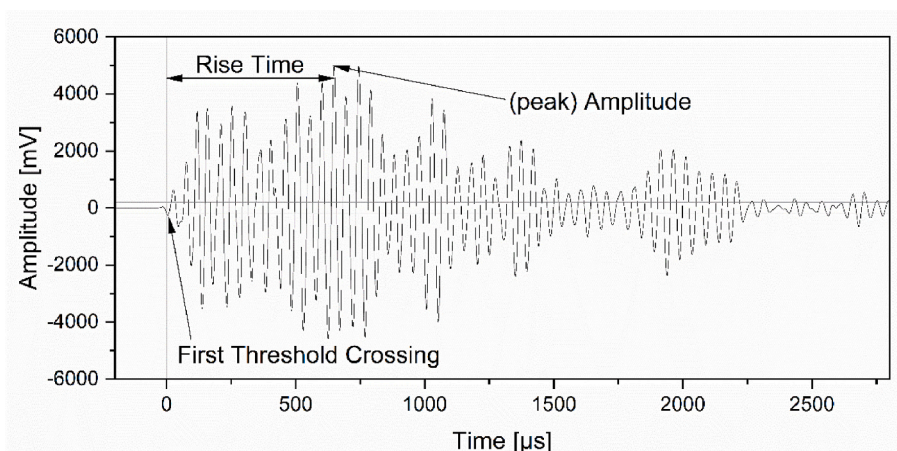
Fig. 1. AE signal of a wire break recorded on the “Altstadtbrücke Brandenburg”.

A part of the energy released during wire rupture propagates as elastic wave through the structure. The dynamic deformations of the surface caused by these so-called AE waves can be detected by piezoelectric AE sensors. An AE system detects an AE signal (output of the AE sensor) as a “Hit” if the signal amplitude crosses a predefined threshold, and AE signal features like Arrival Time (time of first threshold crossing), Rise Time, (peak) Amplitude, and Energy are extracted and

stored. The signal feature (peak) amplitude is usually quoted in  $\text{dB}_{\text{AE}}$ . It is defined by  $\text{dB}_{\text{AE}} = 20 \log (U/U_r)$ ; where  $U$  is the signal voltage referred to the preamplifier input and  $U_r = 1 \mu\text{V}$  is the reference voltage. For Energy calculation the AE signal voltage is squared and integrated within the signal duration. Further terms used specifically in AE testing are listed and defined in (EN 1330-9, 2009). Fig. 1 shows an AE signal of a wire break recorded on the bridge “Altstadtbrücke Brandenburg” during the destructive tests. An analysis of signal features allows to identify wire breaks and to separate such signals from noise. Sources of AE noise on bridges can be traffic, strong electromagnetic interference (e.g., from a pantograph of a train) or active cracks in concrete. Since wire breaks stimulate acoustic emissions of high energies and amplitudes, these signal features usually are the most important features for the identification of wire breaks. The analysis of arrival times is also a powerful tool for filtering of noise signals. Based on the arrival times of an AE waves from one source at different sensors, the location of the source can be calculated. Although AEs from concrete cracking near a sensor can result in high amplitude AE signals, they cannot be detected by distant sensors. Traffic can generate locatable signals that occur in the same place repeatedly. This is often caused by large joints or (loose) gully covers and must be considered when evaluating the data. Traffic also can generate noise that moves across the structure. This type of noise can usually be localized by arrival sequence zone location (EN 1330-9, 2009) and makes it possible to estimate the speed of the causing vehicle. Electromagnetic interference can be filtered out by too short arrival time differences at different sensors and by extraordinary high frequencies.

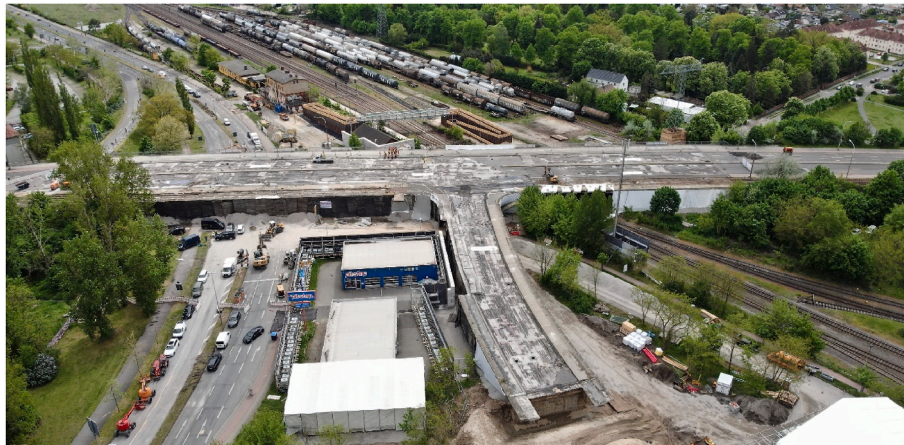
Fig. 2. Aerial photo of the “Altstadtbrücke Brandenburg” shortly before it was blasted. Viewer looks south.

The „Altstadtbrücke“ Brandenburg/Havel was a part of the federal road network in Germany. With a length of 180 m and a width of 37 m the bridge crossed a road and railway tracks of a steel works and of a regional train. It was designed to carry a four-lane road, two bicycle paths, two sideways, and two tramway tracks including tram stations. A distributor road on the north side connected the federal road B1 to the bridge. Fig. 2 shows an aerial photo of the bridge before it was blasted.

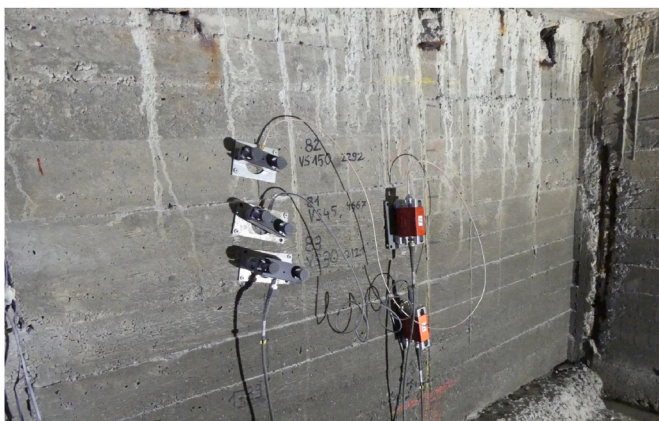
Fig. 6. Different types of AE sensors fixed with magnetic holders inside a box girder.

surface (Fig. 6). The quality of the acoustic coupling was tested by breaking pencil leads 50 mm away from the sensors (Hsu-Nielsen-Source 0.5 mm, 2H) according to ASTM E976 (ASTM E 976, 2015).

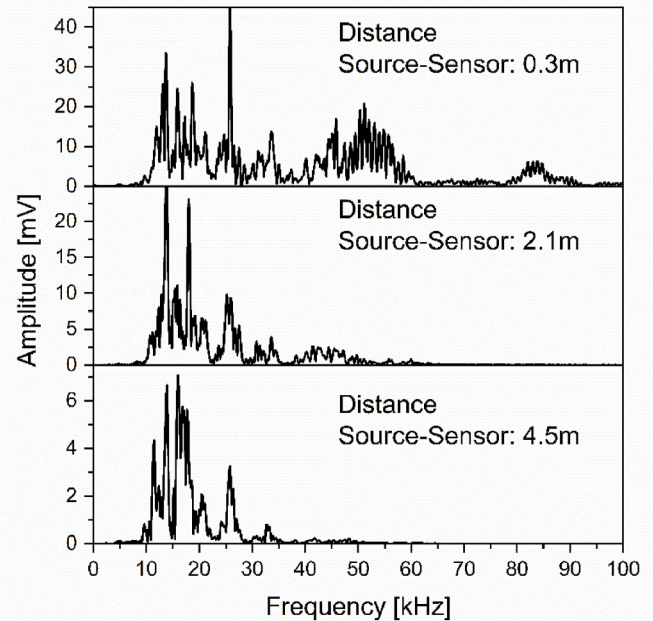
**Fig. 8.** Frequency spectrum of a Schmidt hammer impact detected by Sensor 82 (VS150) sensor in different distances to the source.

Fig. 8 shows the frequency spectra of a Schmidt hammer impact detected by a VS150 AE sensor in a distance of 0.3 m, 2.1 m, and 4.5 m. Even over the short distance of 0.3 m the eigenfrequency of the sensor around 150 kHz was not stimulated by the hammer impact. The source obviously doesn't stimulate frequencies higher than 90 kHz. Due to the described frequency dependent attenuation already from a distance of 3 m, frequencies above 50 kHz can no longer be detected.

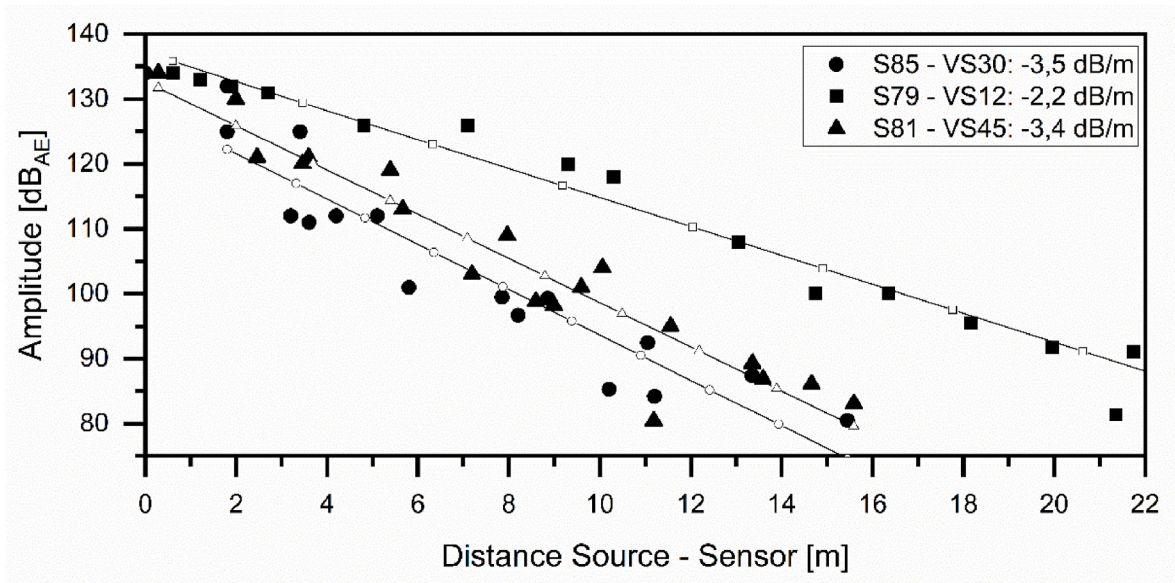
Fig. 9. Signal amplitudes of hammer impacts and attenuation curves as linear fits of the measured amplitudes for different types of sensors.

The pronounced attenuation of acoustic waves with wavelengths below 10 cm in concrete results in different detection ranges of different types of AE sensors. The higher the sensitivity in the lower frequency range, the larger is the range of detection. Fig. 9 shows a comparison of attenuation measurements with different types of sensors. Since the

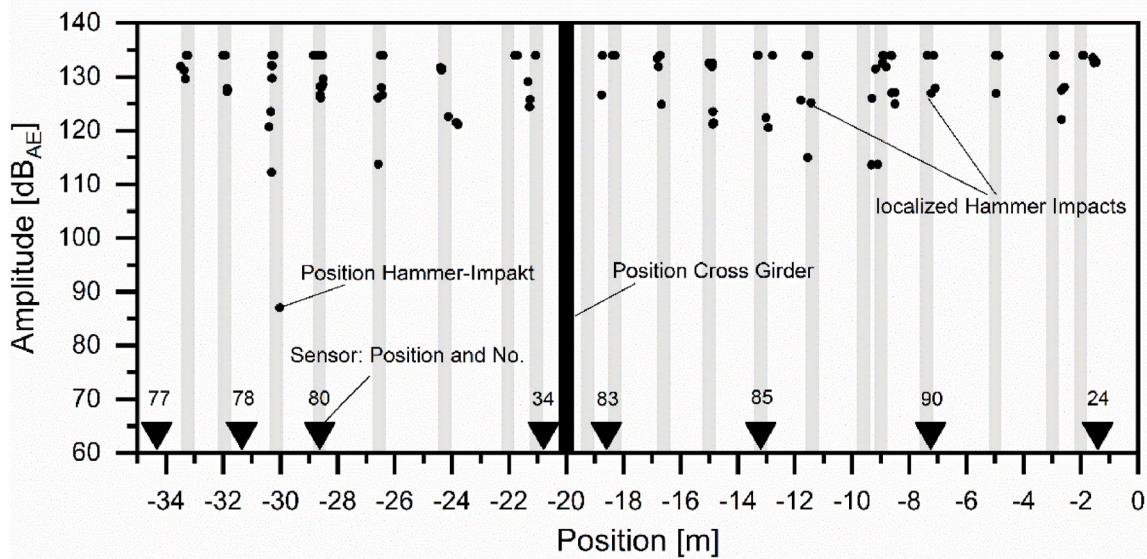
Fig. 10. Localization results for Schmidt hammer impacts on Girder 4.

Fig. 10 shows localization results of hammer impacts on Girder 4 of the bridge in Brandenburg in comparison to the known positions of the sources, marked by the grey vertical lines. The width of the lines corresponds to approximately 50 cm. The localization error for most of the impacts in this test with a dense sensor network is smaller than  $\pm 50$  cm. It is to point out, that the positioning of sensors is very irregular between the Sensors 80, 34 and 83 on Girder 4. This led to a higher location uncertainty in localization results between the Sensors 80 and 34. To avoid this effect, a variation of the sensor distance should be limited to a smaller than the presented factor. For practical applications a

localization error of around 10% of the span with of a girder seems acceptable. For the Altstadtbrücke Brandenburg this corresponds to a location uncertainty of 4 m. In most applications the detection range of the sensors requires sensor distances which result in location errors below  $\pm 1$  m.

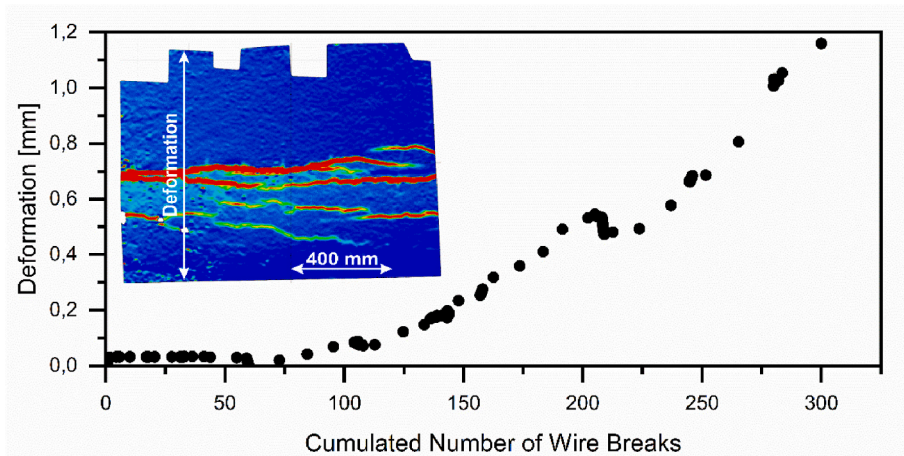
Fig. 11. Correlation between the Number of detected wire breaks and the vertical deformations measured with DIC about 1 m next to the cut on Girder 4. The graph inside the diagram shows the crack pattern visualized by DIC on the side of the girder after cutting. DIC data provided by (Steinbock and Bösche, 2021).

An important goal of the project was to assign the damage pattern of horizontal cracks in the concrete along the concentrated tendons to breaking of the prestressing wires. The development of such cracks during sawing could be visualized with DIC. Based on the DIC, the total crack width over the height of Girder 4 along a vertical line approximately 1 m from the cut. Fig. 11 shows the correlation between the measured deformation and the number of wire breaks detected with AE. Since the individual measurements points of the two techniques were not simultaneous, the respective time series were interpolated to

equidistant points in time. Before the destructive test Girder 4 showed no significant cracks in concrete or separation of concrete along the concentrated tendons. According to Fig. 11 cracking on the concrete surface started after about 125 wires were cut. This is about one third of the total numbers of wires in the tendon. After the first crack formation, the relationship between wire breaks and crack growth is almost linear. The decrease in total crack width after 200 wire breaks occurred during a night break and can probably be attributed to temperature changes. After the test, the crack pattern on the side of the girder corresponded to the expected pattern as sketched in Fig. 4. The appearance of such cracks depends on details of the construction, such as the number and cross section of the wires, quality of grouting and thickness of the concrete cover. However, such cracks are in any case an indicator of serious damage to the tendon, so that detailed inspections should be initiated immediately and securing measures considered.

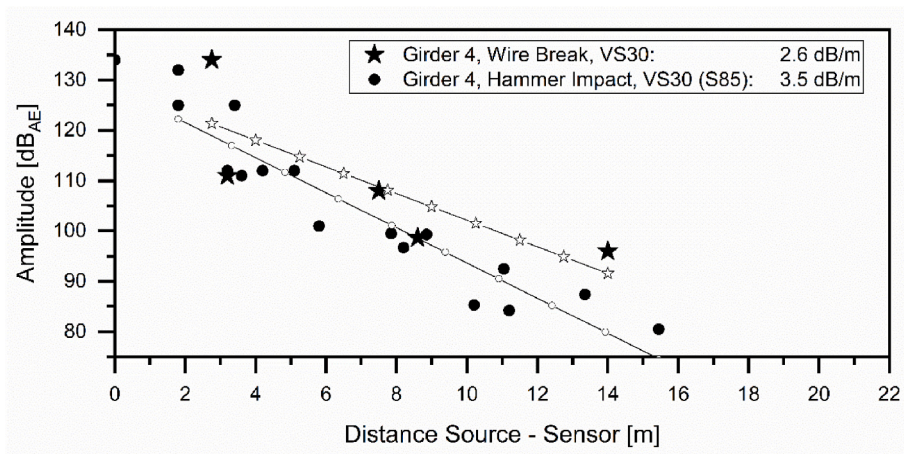
Fig. 12. Signal amplitudes of wire breaks and hammer impacts and attenuation curves as linear fits of the measured amplitudes.

By analyzing the signals at different sensors, the attenuation of a wave stimulated by a wire rupture can be estimated. Fig. 12 shows the attenuation curve measured by VS30 sensors at different positions compared to Schmidt hammer impacts. In general, the amplitudes of the wire rupture signals are higher than the hammer impacts and the attenuation is lower. The lower attenuation may be explained by direction of the impact. A Schmidt hammer impact stimulates a displacement perpendicular to the surface whereas a wire break stimulates a material displacement inside the tendon in direction of the girder.

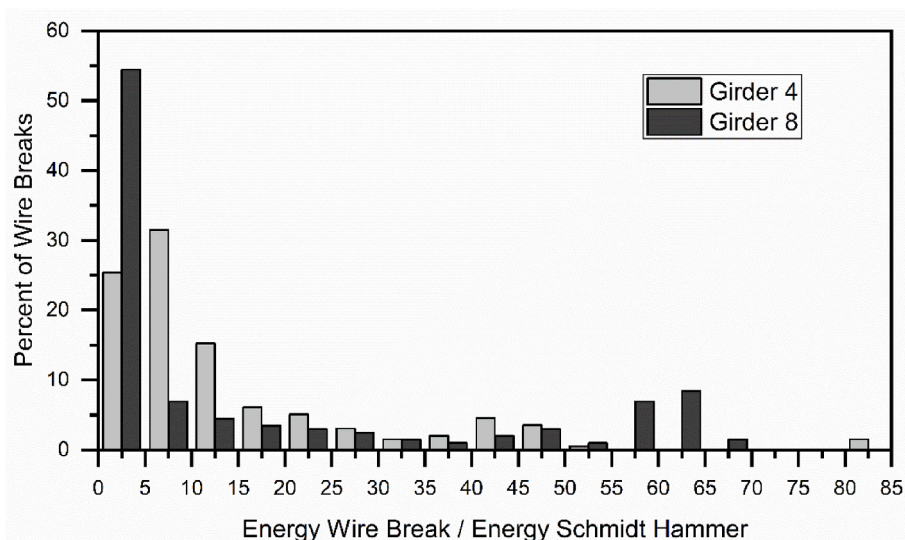
**Fig. 13.** Distribution of AE signal energies from wire breaks measured during sawing on the bridge “Altstadtbrücke Brandenburg”.

Taking into account the significant uncertainty the energy released by a wire break should be 7 to 80 times higher than the energy of a Schmidt hammer impact of 2.2 Nm. Fig. 13 shows a comparison of energies of AE signals of wire breaks in relation to hammer impacts in the same distance to the sensor 90 at Girder 4 and sensor 98 at Girder 8.

The lowest wire break energy was 0.8 times the energy of a hammer

impact. It was measured on Girder 8 and in total only 2% of the signals had an energy lower than the hammer impacts. On Girder 4 the lowest energy ratio wire break to hammer impact was 2.2. In general, the portion of low energy wire breaks is higher in Girder 8 than in Girder 4. This can possibly be attributed to the higher degree of damage of Girder 8 already before the destructive tests. The low energies here could be explained by low tensions in wires which were cut near preexisting ruptures.

Overall, most of the measured energies are at the lower end of the estimated range. Assuming that Girder 4 was in a comparatively good condition and most wires were under a tension between 680 N/mm<sup>2</sup> and 810 N/mm<sup>2</sup>, this leads to the conclusion that the transmission length in the compact, concentrated tendons is short. Local loss of prestress in single wires therefore leads to a stress redistribution into the surrounding wires. The growing local stress then increases the risk of additional wire breaks. This may explain the accumulation of wire breaks detected by AE monitoring in the one-year period before the destructive tests (Bösche et al., 2021).
