# Controlled Creating of Delaminations in Concrete for Nondestructive Testing

Locating and sizing delaminations is a common inspection task in the maintenance and quality control of construction and rehabilitation. Their detection is an important area of application of nondestructive testing in civil engineering (NDT-CE). To improve this application, NDT test systems and test solutions must be compared, for which specimens containing well-defined delaminations are needed to serve as a reference. Currently, there are no widely accepted procedures available for creating such flaws locally and reproducibly. This study presents procedures for creating artificial delaminations repeatably and as close as possible to natural delaminations. To produce the discontinuities only substances were used which can occur in concrete components and do not affect the application of NDT-CE methods. Ultrasonic pulse-echo (UPE) was used to test the flaws in the specimens. The delaminations were created by applying expansive mortar in prepared through holes. Three specimens with two delaminations each were built and tested using UPE.

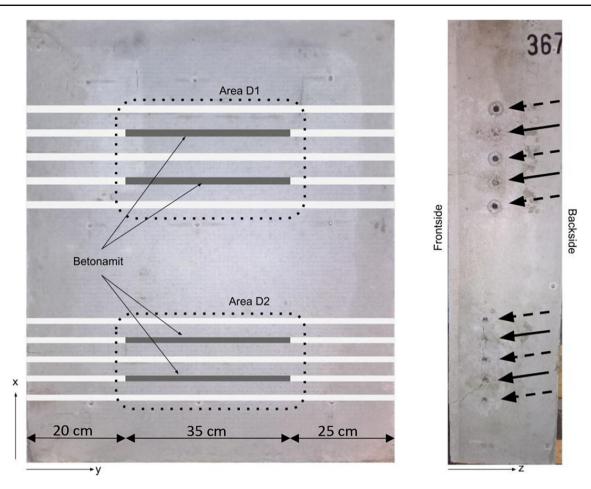
**Fig. 1** Photograph of specimen #1 shows delaminations. The solid/ thicker arrows point to the through holes which are aligned with the axis, parallel to the xy-surface. The continuous arrows (right) point to the holes which are partially filled with Betonamit and the dashed ones remain empty, as indicated by the dark grey area in the top view (left).

Only 2 of 5 holes were filled in order not to create too much expansion pressure, so that unwanted cracks in other directions occur. The delaminations should develop in the Areas D1 and D2. UPE measurements were carried out from the front- and backside. \*Copyright: Herbert Wiggenhauser, Juri Timofeev

As the specimens are dedicated to being used for NDT-CE, any specific requirements for standard NDT methods should be met. Pulse-echo methods, such as ultrasonic pulse-echo or impact-echo, are especially sensitive to edge effects and dead zones. Edge effects are caused by the diffraction of waves at the edges of the specimen and should be minimized to avoid interference with signals from the built test targets. Dead zones are depth ranges close to the scanning surface where the signals of the surface wave and the echoes from reflectors are included, so that the reflector of interest is not revealed here. Essentially, the delaminations should be placed in a reasonable spacing from edges of the specimens to distinguish the reflections from delaminations and the edges well during the evaluation of signals (Fig. 1).

created by embedded Polymethylmethacrylate tubes which were placed in the formwork before concrete pouring. The tubes served as markers and were stabilized with metal rods inside during the concreting process. After hardening of the concrete, the metal rods were pulled out of the tubes and the tubes were removed by drilling, creating the space through which the expansive mortar was later applied. Five parallel cavities were created parallel to the large surface of the specimen to define the plane of the delamination. The expansive mortar was filled only into the middle part of the holes where the delamination should be initiated. Each specimen has two such areas as depicted in Fig. 1.

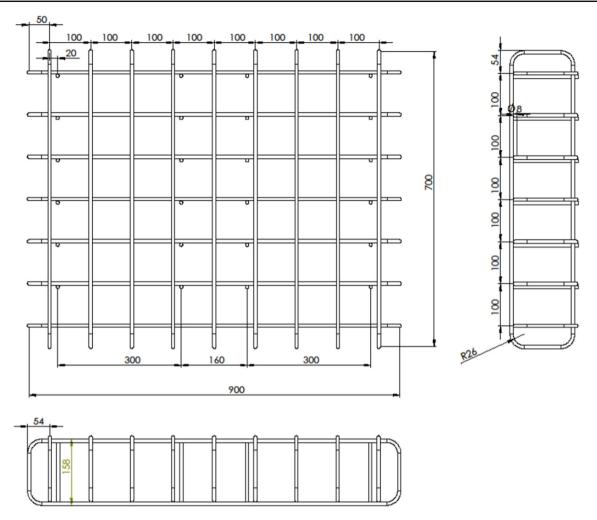
Fig. 2 Drawing of the reinforcement for the delamination specimen. The reinforcement includes the following parts: reinforcement basket consisting of stirrup reinforcement in x- and y-direction and bars perpendicular to larger surfaces. \*Copyright: Matthias Behrens, Juri Timofeev

Figure 2 shows the reinforcement plan of the specimen. The reinforcement for the delamination specimen consists of reinforcement cage, including reinforcement in x- and ydirection, and bars perpendicular to larger surfaces.

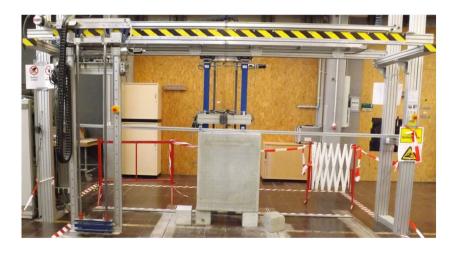
**Fig. 3** Photo of the mechanical scanner, which was used for UPE measurements

A mechanical scanner was used to take measurements in a predefined grid of 10 mm  $\times$  10 mm (center of the probe) in a meander pattern.

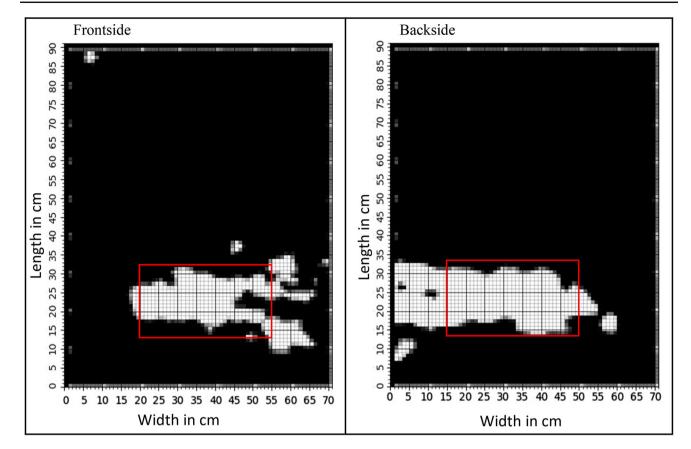
**Fig. 4** Result of the UPE measurements on specimen 1. Bright color indicates the delaminations. In area D2 both pictures show the delamination in the corresponding area. Regarding the width there is almost a continuous delamination, except about 10–15 cm on one side. Regarding the length, there is almost a continuous delamination at about 15–30

cm. In area D1 there is no delamination on both pictures and one possible reason is that Betonamit did not apply the required expansion pressure in this area. Both views are seen from above and are symmetrical to the y-axis, so they can be mentally folded/unfolded.

Figures 4, 5 and 6 present the result of the UPE measurements evaluated by applying the data evaluation criteria described above. In Fig. 5 frontside, delaminations are in pieces and not connected with each other, because here vertical cracks run from the area of delaminations to the closer concrete surface (frontside). The vertical cracks always take the shorter path or, more precisely, the path of lower resistance. This path leads to the closer concrete surface (frontside) since the concrete strength in the specimen is almost the same. Indicated areas at the left and bottom edges are probably caused by the edge effect. Thus, the backside provides better results. In Fig. 6 frontside, the delaminations are not visible because here larger and more vertical cracks run from the area of the delaminations to the closer concrete surface (frontside). The reason is that the diameter of the boreholes, thus the amount of betonamit and thus the expansion forces were larger. Here it is particularly useful to test from the backside. In Fig. 6 backside, real delaminations are on the left and bottom edges caused by the higher expansion force of betonamit.

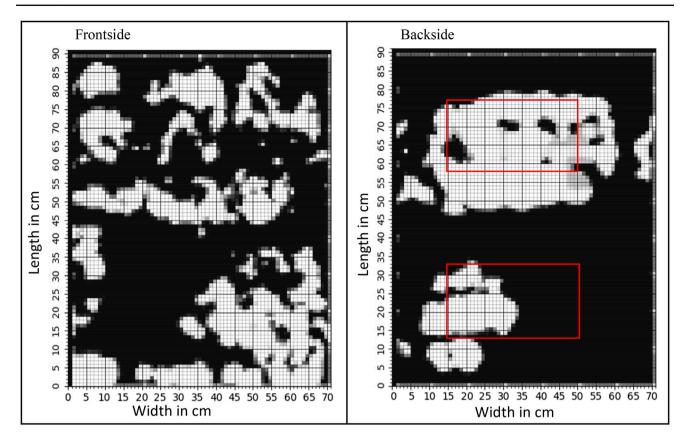
**Fig. 5** Result of the UPE measurements on specimen 2. Bright color indicates the delaminations. In area D1 is the larger delamination. Looking at the intersection of both images, it is between about 10–60 cm in width and between about 50–80 cm in length. The smaller delamination

in area D2 measures approx. 25 cm in width and length. This delamination has only about one half of the desired size. Possible reason is that Betonamit could not completely penetrate the two holes on one side. Both views are seen from above and are symmetrical to the y-axis, so they can be mentally folded/ unfolded

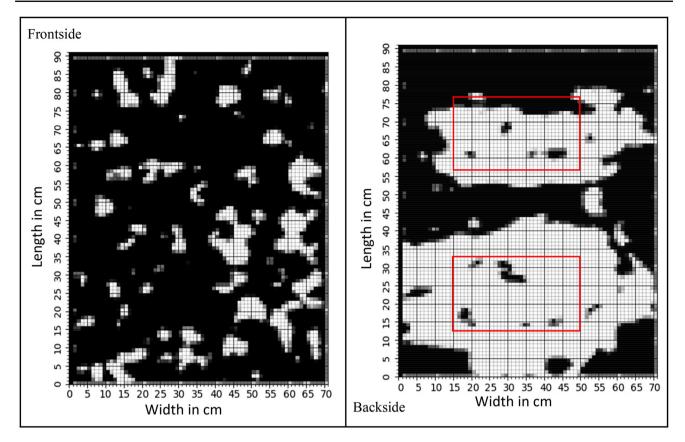
**Fig. 6** Result of the UPE measurements on specimen 3. Bright color indicates the delaminations. Only the backside shows delaminations. One possible reason are vertical cracks in case of the frontside, probably due to the larger hole diameter, 10 mm instead of 8 mm. The backside shows two delaminations. In area D1 the delamination is between about

10-65 cm in width and between about 55-75 cm in length. In area D2 the delamination is larger. The D2 delamination is in the complete width, i.e. 70 cm, and between about 0-40 cm in length. Both views are seen from above and are symmetrical to the y-axis, so they can be mentally folded/ unfolded

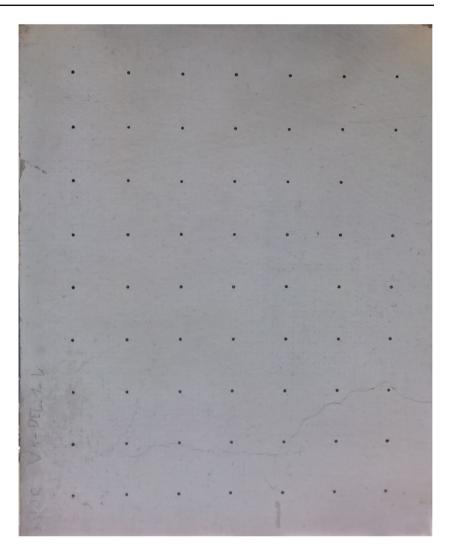
Despite the in-depth study of the direct and indirect indicators of delamination, some questions remained unanswered. Fig. 7 Frontside specimen 1: surface cracks. The surface cracks are visible in delamination 2. The dots on the surface are a 10 cm grid

Figures 7, 8 and 9 present the frontsides of the specimen 1, 2 and 3. These figures show surface cracks. In Fig. 9, no surface cracks are visible after the application of Betonamit, in contrast to Specimens 1 and 2.

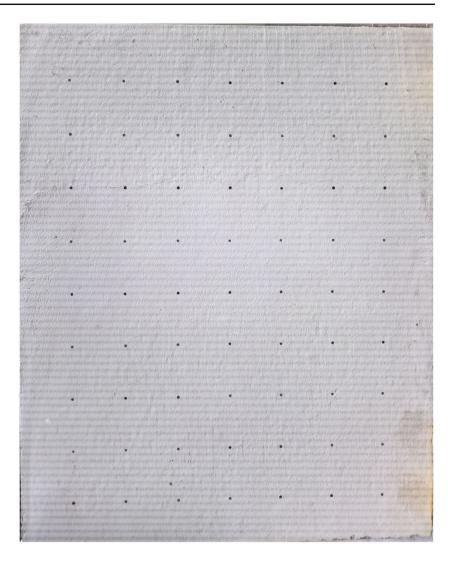
Fig. 8 Frontside specimen 2:
surface cracks. The surface
cracks are visible in delamination
1

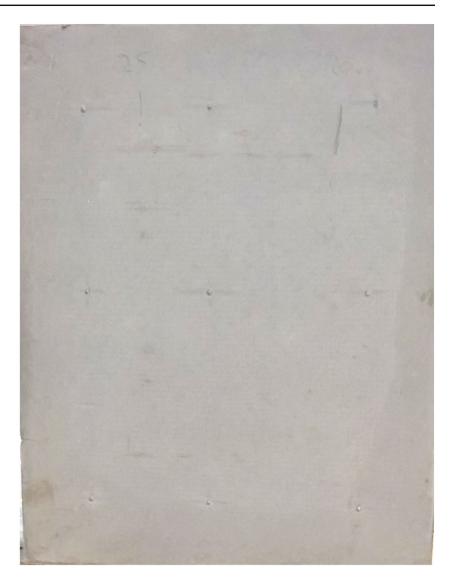
the preliminary studies: time of flight diffraction (TOFD), ground penetrating radar (GPR) and reverse time migration (RTM). These did not prove to be effective in detecting delaminations. The procedures developed here now make it possible to compare and improve NDT test systems regarding the testing task of delaminations. This serves NDT-CE in particular and quality assurance in CE in general. Improving NDT can, in turn, make infrastructure, such as bridges, safer. **Fig. 9** Frontside specimen 3. Unfortunately, no cracks are visible here. The cracks to the surface after the application of Betonamit were not visible, in contrast to specimen 1 and 2
