Electrochemical characterization of surfaces of galvanized steels under different exposure conditions using gel electrolytes

Abstract

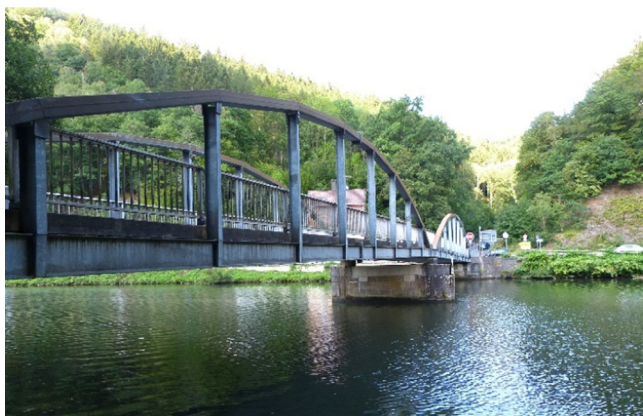
FIGURE 1 Measurement object “Lenne Bridge” made of galvanized steel over the Lenne river on the German federal highway B236. [Color figure can be viewed at [wileyonlinelibrary.com](https://onlinelibrary.wiley.com/terms-and-conditions)]

The “Lenne Bridge” measurement object is an HDG steel bridge that was 33 years old at the time of measurement in 2020. It is located on the German federal highway B236 in the area of the city of Werdohl and crosses the Lenne river. The average annual temperature here is 9.8°C, with a cumulative annual rainfall of 1008 mm recorded. Figure 1 shows a photo of the bridge. The GPS data set for this location is: 51°15′50.5″ N and 7°44′35.5″ E.

At this site, LPR measurements were conducted for 18 min, along with polarization curves and electrochemical impedance, at various spots one to three times. The horizontal measurement points were the top and bottom sides of HDG steel beams, which do not exhibit an undisturbed η layer (approximately 99% Zn) due to the presence of iron–zinc alloy phases from the ζ layer extending to the surface. A vertical measurement point involved an HDG post, which was measured both in its

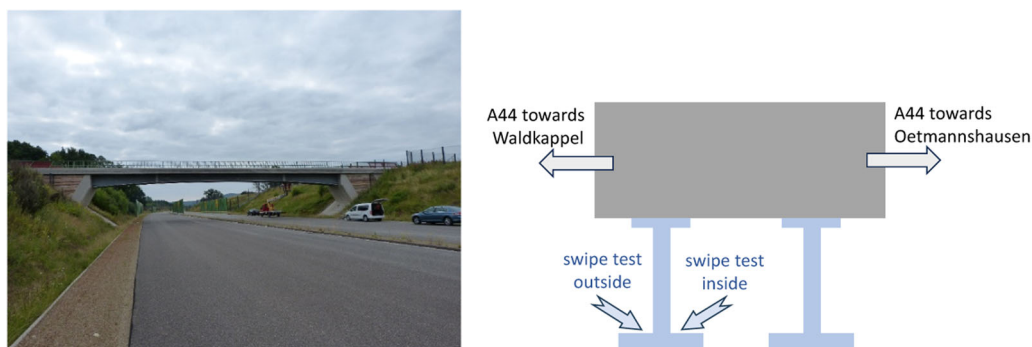
FIGURE 2 Measurement object “Waldkappel Motorway Bridge” near Waldkappel/Bischhausen, including a schematic drawing of the swab sampling locations on the outer and inner surfaces of a girder. [Color figure can be viewed at [wileyonlinelibrary.com](https://onlinelibrary.wiley.com/doi/10.1002/maco.202414389)]

The second measurement object is the Waldkappel/Bischhausen motorway bridge on the A44 motorway. Measurements were conducted on an HDG bridge girder. Due to the structural design of the bridge, the HDG girders are not classified as being freely rained upon. At the time of measurement in 2021, the motorway was not yet operational, but the bridge had already been completed for 5 years. The average annual temperature for Eschwege in 2021, located near the site, was 9.3°C, the cumulative annual rainfall was 572 mm, and the average annual relative humidity was 79%.

At this measurement object, swipe samples were taken from the inner and outer surfaces of the girders to determine the deposited levels of corrosion-relevant pollutants, as shown in Figure 2. Up to five individual LPR measurements were conducted at these points after a 10-min waiting period and one electrochemical impedance measurement per location. The GPS data set for this location is 51°08′36.6″ N and 9°56′11.6″ E.

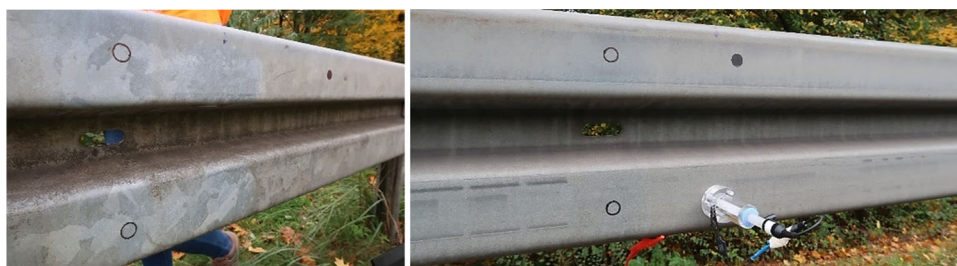
FIGURE 3 Measurement object 3 near Bergisch Gladbach: piece-galvanized guardrail on the left, continuous hot-dip galvanized guardrail on the right. [Color figure can be viewed at [wileyonlinelibrary.com](https://onlinelibrary.wiley.com/doi/10.1002/maco.202414389)]

The third measurement object is a galvanized motorway guardrail on a test track of the federal motorway “BAB” A4 near Bergisch Gladbach, maintained by the Federal Highway Research Institute (BASt). Two different guardrail beams were measured in 2019 after 17 years of service. Swipe samples were taken from both rails. One guardrail beam was piece-galvanized (Zn) and the other was continuous HDG (ZnAl). The GPS data set for this location is 50°57′00.8″ N and 7°08′43.7″ E. Figure 3 shows the measuring points on the two types of guardrails.

The measurement campaign on the guardrails involved two objects, a piece-galvanized and a continuous HDG guardrail with a zinc–aluminum coating (ZnAl). Analyses of the conducted swipe samples, presented in Table 4, showed that there is no high accumulation of corrosive components on the freely weathered surfaces, which would be expected due to the proximity to the motorway. Besides rainfall events, subsequent spray mist events also help wash off corrosive deposits. However, during the winter months with de-icing salt use, these will surely contribute to chloride loading.

The electrochemical results presented in Table 5, indicate an extremely high protective layer resistance, suggesting low corrosion activity due to the effective protection. The OCPs are nearly identical and can be attributed to the protective layer resistance of similar magnitude. Impedance values for 0.1 and 1000 Hz are also comparable.

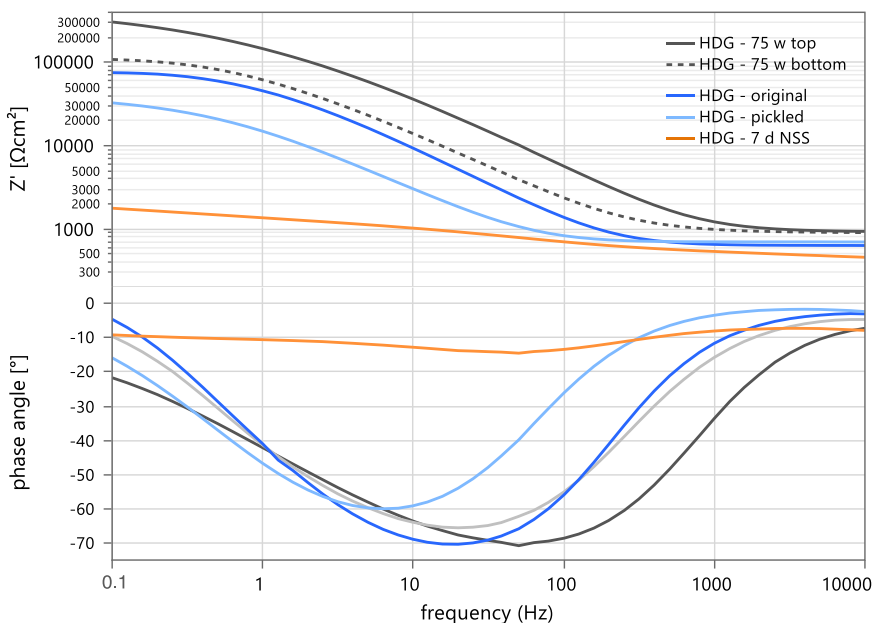
FIGURE 5 Electrochemical resistance Z' and phase angles of the investigated sample states after 20 min of electrolyte contact. [Color figure can be viewed at wileyonlinelibrary.com]

electrolyte resistance, as the sample is most active and residual soluble salts remain on the surface, which were not completely removed. The samples with stable protective layers exhibit the highest electrolyte resistances, as these layers are less soluble, thus inhibiting the formation of zinc ions from corrosion processes and protecting the zinc from corrosion.

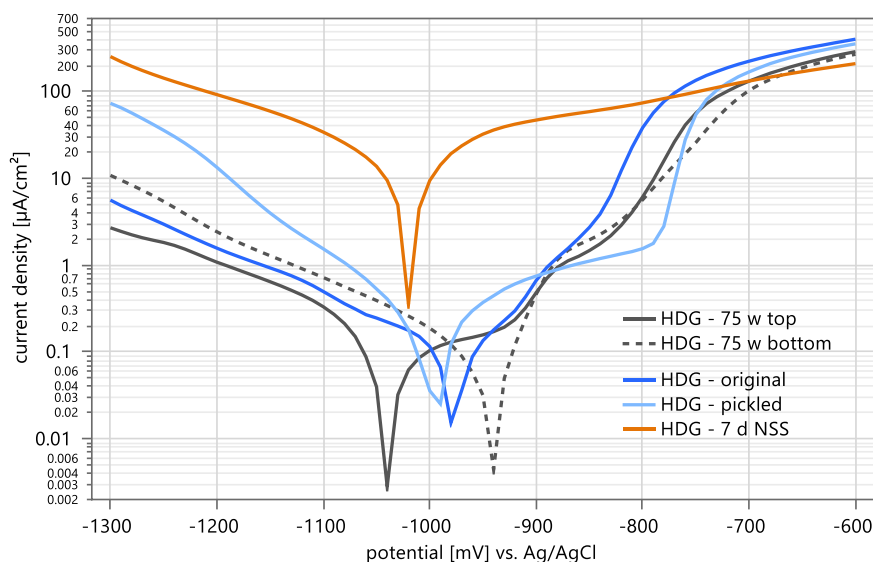
FIGURE 6 Polarization curves of the investigated sample states after approximately 40 min of electrolyte contact. [Color figure can be viewed at wileyonlinelibrary.com]

The polarization tests conducted following the EIS measurements provide insight into the cause of the reaction inhibition by the protective layers, as seen in Figure 6. In the samples after 7 days in the salt spray test, the current densities are the highest, that is, the least inhibited. The pickled sample and the one in its original state show significantly lower current densities and inhibition in both the anodic and cathodic regions. Particularly noticeable is the inhibition of the cathodic current densities in the weathered samples, which increases further with longer exposure. The significantly stronger inhibition of the cathodic partial reaction is responsible for the OCP values (compare Figure 4 and Table 1) being more negative in samples with protective layers, as the potential values in the equilibrium state shift more into the negative range.

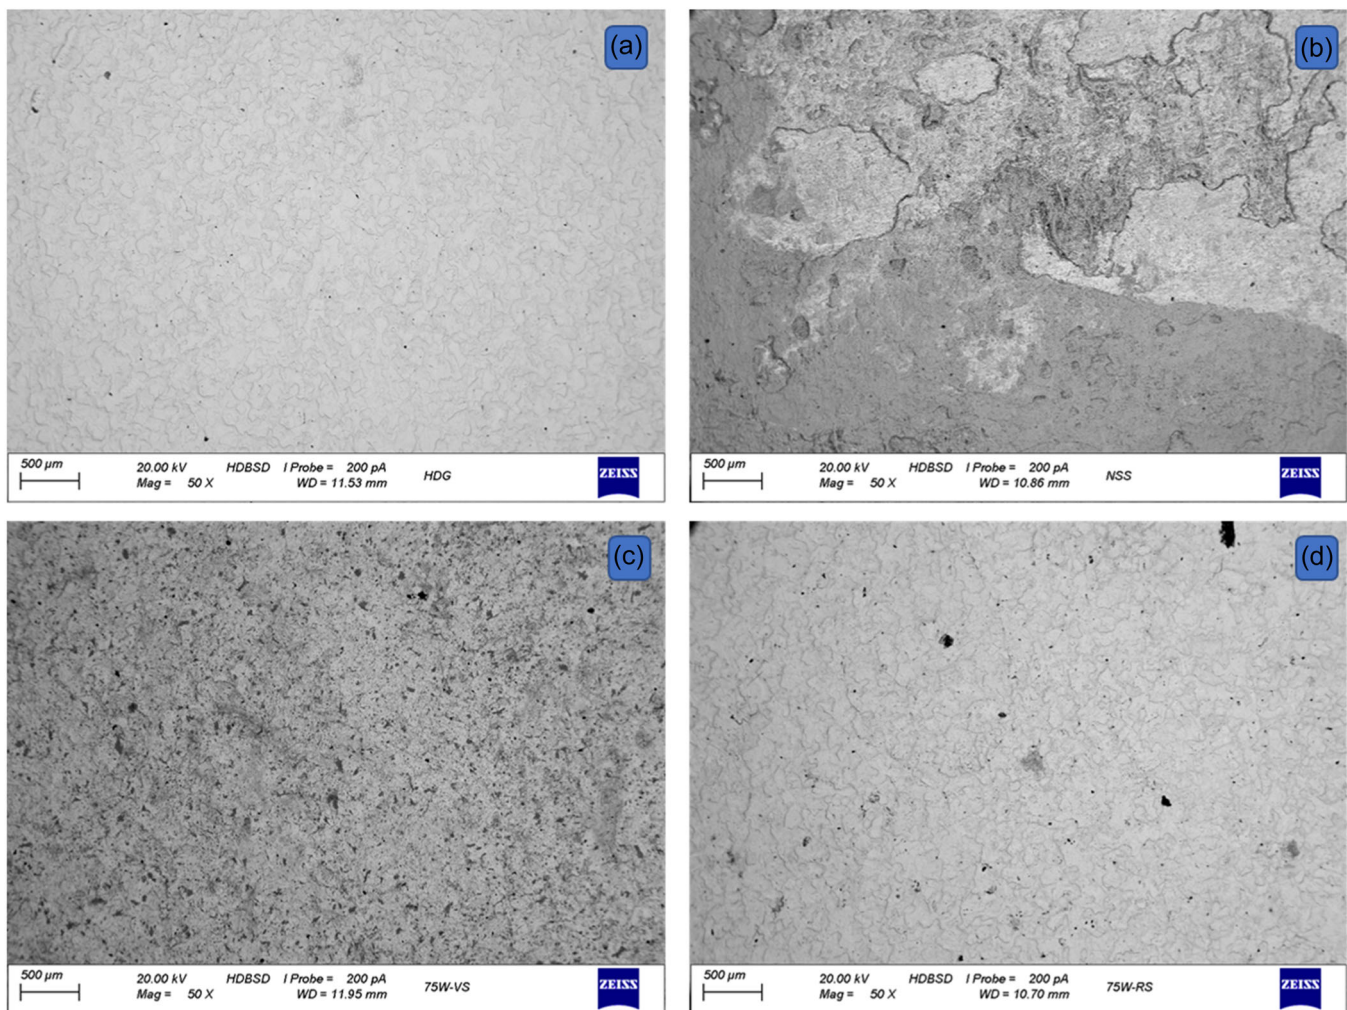
FIGURE 7 Comparative representation of the sample states: (a) HDG original, (b) HDG 7 days NSS, (c) HDG after 75 weeks exposure in C2 atmosphere top side, and (d) bottom side, at $\times 50$ magnification. [Color figure can be viewed at [wileyonlinelibrary.com](https://onlinelibrary.wiley.com/terms-and-conditions)]

Comparative SEM images confirm the visual appearance. Figure 7 compares the four examined states in BSE mode at $\times 50$ magnification.

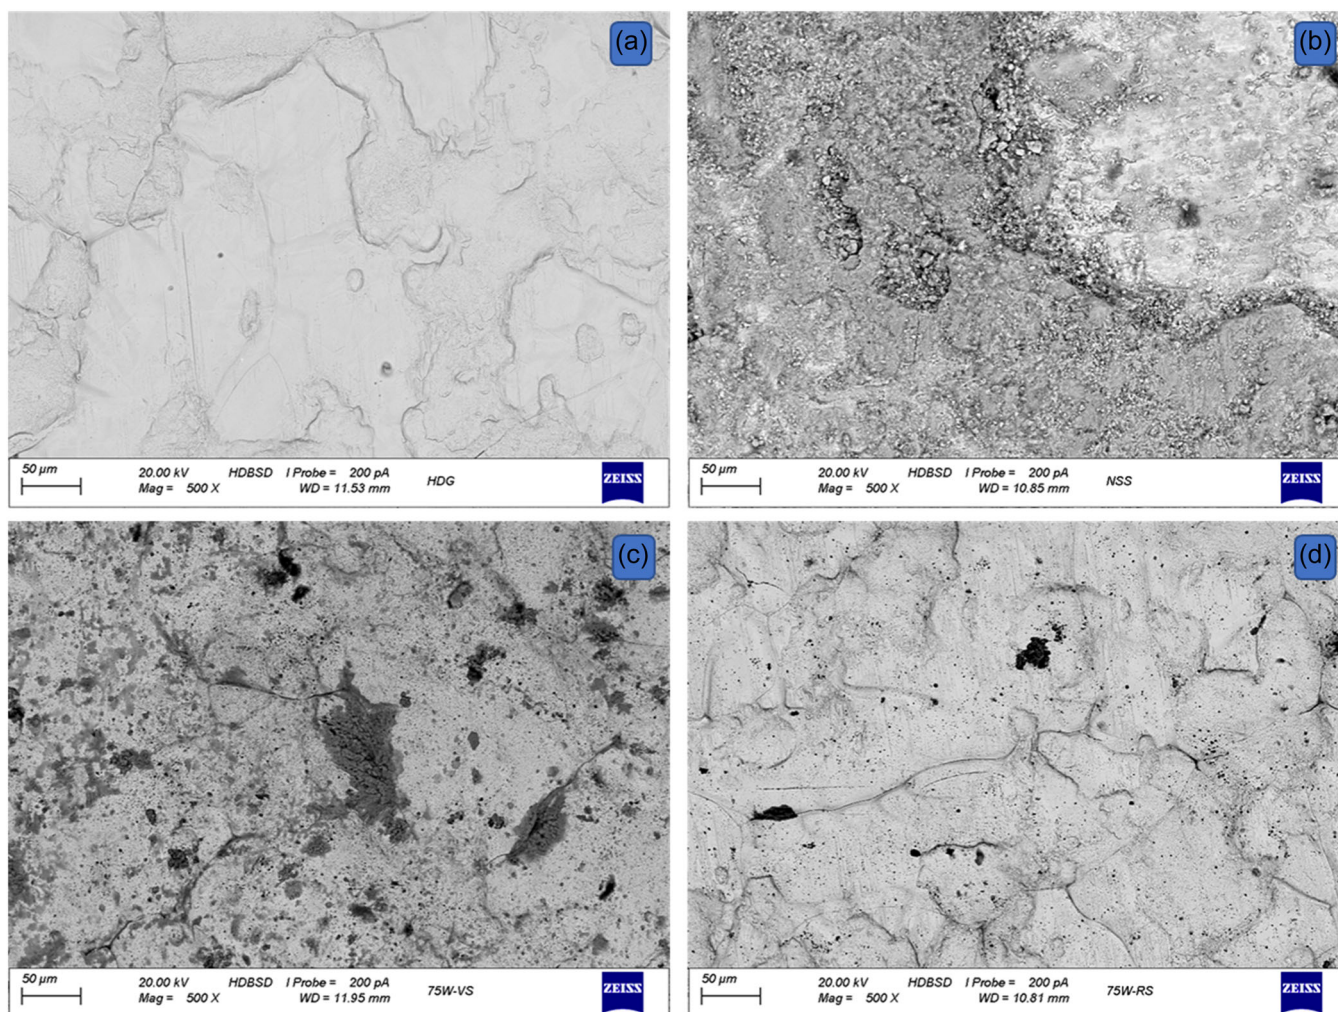
FIGURE 8 Comparative representation of the sample states: (a) HDG original, (b) HDG 7 days NSS, (c) HDG after 75 weeks exposure in C2 atmosphere top side, and (d) bottom side, at $\times 500$ magnification. [Color figure can be viewed at [wileyonlinelibrary.com](https://onlinelibrary.wiley.com/terms-and-conditions)]

The comparative images in BSE mode at $\times 500$ magnification in Figure 8 reveal finer details in the respective sample states. The original state sample appears free from any corrosion products. In contrast, the NSS sample shows edges with apparently loose corrosion products at the boundary of slightly brighter areas, which, according to EDS analyses, are very rich in iron and thus correspond to the heavily dissolved areas where the steel beneath the zinc coating is already providing an EDS signal. In the exposed samples, especially in the areas of grain boundaries, enhanced dissolution or adhering corrosion products are visible. On the top side, these phenomena are more frequent, and the darker areas, identified as zinc corrosion products, are relatively evenly distributed across the surface. On the bottom side of the exposed sample, the distribution of corrosion products is not as uniform. This could be due to the lack of liquid water, which does not have direct access to the bottom side of the samples, preventing an even distribution of corrosion products.

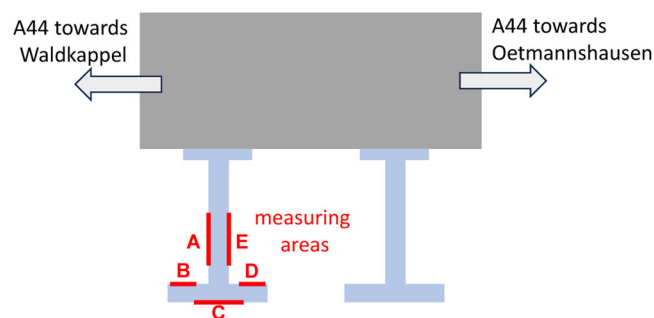
FIGURE 9 Measurement points A to E on a girder of the Waldkappel Motorway Bridge. [Color figure can be viewed at wileyonlinelibrary.com]

varied exposure. This was determined through swipe samples and analysis of the contents of corrosive ion components. Figure 9 schematically shows the measurement points, with A and B being the external surfaces, C the bottom side, and D and E the internal surfaces. This is due to the sheltered exposure against the major air stream at the back side (E and D) of the girder. On the internal surfaces of the girder, pollutants can accumulate

as washing off by rainwater is unlikely. Elevated levels of sulfate ions (320.6 mg/m^2), chloride ions (32.8 mg/m^2), and nitrate ions (24.5 mg/m^2) were found there at the time of measurement. The ions were below the detection threshold on the external surfaces.

The internally located measurement points show varying potential values. At measurement point D, the potential is significantly more negative, but the protective layer resistance is very low at only $6\text{ k}\Omega\text{ cm}^2$. At measurement point E, the average protective layer resistance is comparatively low at $43\text{ k}\Omega\text{ cm}^2$, though the potential is in the range of the external measurement points A and B. The lower protective layer resistances on the internal surfaces correlate with the higher level of corrosive ions found on these surfaces. It can be assumed that these ions have led to the formation of less protective layers. This increases the probability of higher corrosion rates at these points if corrosive conditions are also present.
