Towards predictive maintenance of hydrogen pressure vessels based on multi-sensor data fusion and digital twin modelling

Christos KARAPANAGIOTIS¹, Jan HEIMANN, Eric DUFFNER, Amir CHARMI, Marcus SCHUKAR, Seyedreza HASHEMI, Jens PRAGER

¹Bundesanstalt für Materialforschung und-prüfung, Berlin, Germany
christos.karapanagiotis@bam.de

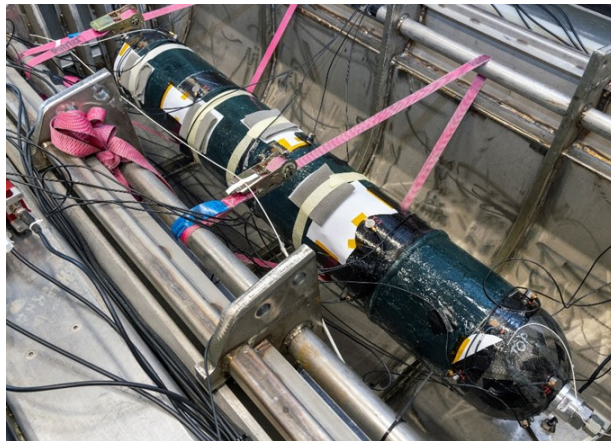
Fig. 1. Photograph of the experimental setup. The COPV is carried via tension belts inside the test rig (PN020) equipped with a hybrid sensor network consisting of AT, DFOS and GW sensors.

For our investigations, we made use of a Type IV COPV manufactured by NPROXX (Heerlen, Netherlands) as can be seen in Fig. 1. Since it is a Type IV COPV, it consists of a plastic liner and overwrapped carbon fiber reinforced polymers. The vessel's outer diameter and total length was 228 mm and 1510 mm, respectively.

Once the SHM sensors were installed, the COPV was placed into a hydraulic internal pressure machine (PN020, Maximator GmbH) for load cycle testing (Fig. 1). This testing involves periodic changes in internal pressure between a predetermined lower and upper pressure level. Initially the lower and upper pressure level was set to 0 bar and 800 bar respectively, while the ambient temperature was set to 50 °C. To accelerate material failure, after 22000 load cycles the ambient temperature and the maximum pressure level were increased to 65 °C and 900 bar, respectively. Finally, the pressure vessel failed after 60000 load cycles. Fig. 4 shows an internal view of the damaged vessel. The damage occurred mostly in the plastic liner, which let the liquid penetrate through the composite material and leave the vessel.

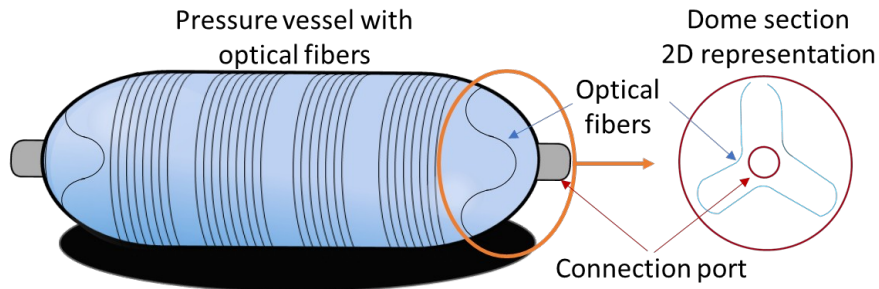
Fig. 2. Schematic illustration of the COPV with hoop layers of surface-applied optical fiber wrapped around the cylindrical part. In the dome areas, optical fibers are positioned as depicted on the right.

To ensure robustness and protect the optical fiber during monitoring the optical fiber wrapping process took place as follows: First, the pre-strained optical fiber was wrapped in a circumferential direction around the vessel's cylindrical part as shown in Fig. 2. The fiber placement at the dome area is slightly more complex. The optical fiber was glued with an epoxy resin-based adhesive. After the curing of the adhesive, a layer of silicone was applied to protect the optical fiber from potential mechanical damage. As can be seen in Fig. 2, on the vessel's cylindrical part there are three sections where no optical fibers are placed. This was done intentionally to ensure safe handling by a crane during the vessel's placement into the pressure machine.

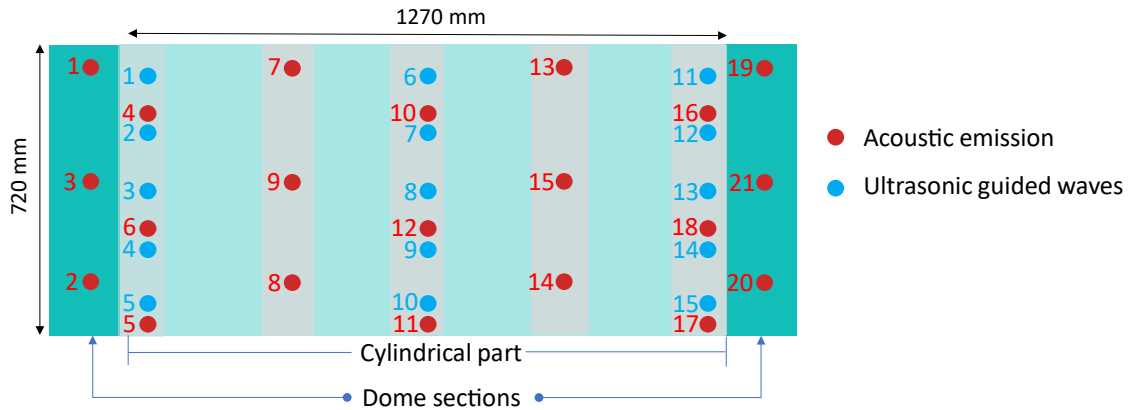
Fig. 3. Schematic 2D illustration of the COPV with the positions of the guided wave (GW) sensors and acoustic emission (AE) sensors marked in blue and red, respectively.

For monitoring and assessing the condition of Type IV COPV with GWs, a sensor network comprising piezoelectric wafers (PZT) was applied to the pressure vessel's cylindrical surface. The sensor network consisted of three rings, each equipped with five PZTs. The PZTs were placed at approximately 72-degree intervals around the circumference with a distance of 610 mm between the single rings so that the total length of the COPV is covered, as shown in Fig. 3. The PZTs used in the setup were DuraAct patch transducers (P 876K025) with a 10 mm circular ceramic embedded in a ductile polymer from PI Ceramics (Lederhose, Germany). The total of fifteen PZTs were bonded to the COPV's surface with a thin layer of two-component epoxy adhesive and then connected to a VantageTM 64 LF system from Verasonics (Kirkland, USA).

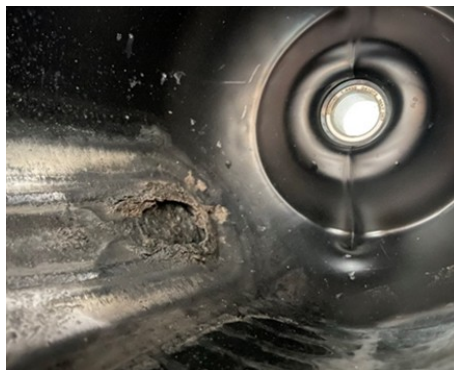
Fig. 4. Internal view of the damaged pressure vessel.

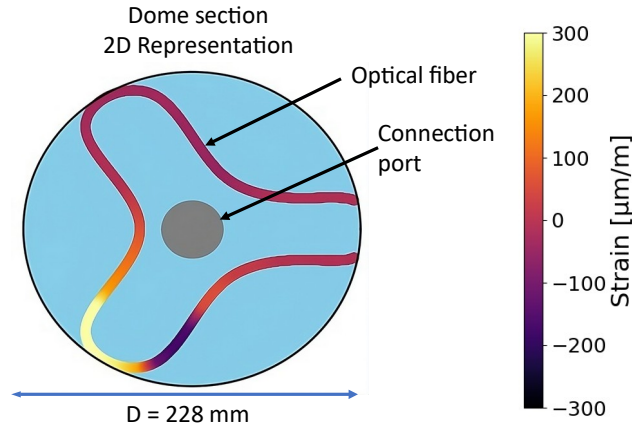
Fig. 5. Distributed fiber optic sensors detect and localize damage precisely at the position where it occurred. The colors indicate the measured strain in the fiber.

Fig. 5 shows a 2D representation of the blind dome area of the COPV with the surface-applied optical fibers. We observe that at the bottom left area close to the vessel's cylindrical section, the strain is significantly increased. This measurement was conducted once the leakage occurred and shows that DFOS managed to detect and precisely locate the damage. The observed slight relaxation, depicted in deep purple, is due to both the structural deformation caused by high strain in neighboring positions (depicted in yellow) and the complex geometry and wrapping angles of the optical fibers within the dome area.

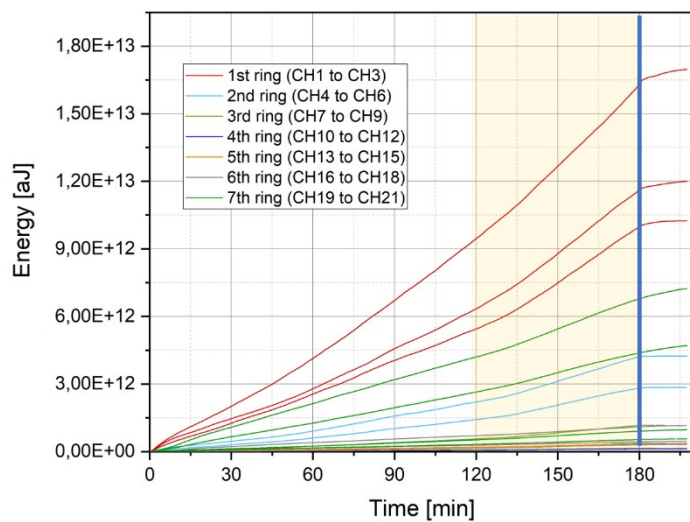
Fig. 7. Accumulated AE energy for the different ring sections (see Fig. 3): progressive energy increase for the last 300 cycles (yellow frame) especially in the dome section (1st ring) indicating upcoming failure. The failure occurred at 180 min (blue vertical line).

Fig. 7. shows the accumulated AE energy recorded from all the ring sections (as depicted in Fig. 3) during the last 900 load cycles. In general, we observe that the channels that are located at the blind dome area, where the vessel failed show a higher AE energy than those sensors placed at the other sections of the vessel. Furthermore, we observe that 300 cycles (60 min) before the vessel's failure, a progressive increase in energy is observed which indicates an upcoming failure.

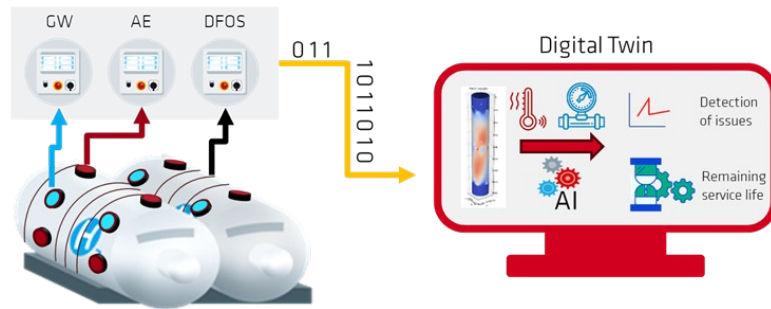
Fig. 8. Digital twin implementation for structural integrity assessment, and remaining service life estimation of the pressure vessel

Our results are very promising for further studies considering that all the applied SHM methods provided useful information for assessing the pressure vessel's structural integrity. In the future, we plan to conduct more lifetime tests and collect data to train a machine learning model using data fusion. A data stream resulting from the three SHM methods will be implemented into a digital signal processing chain and will end up into a digital twin, as shown in Fig. 8. The digital twin will be a digital model of the real pressure vessel depicting its current condition, structural integrity, and operational parameters. Such a quality infrastructure will allow predictive maintenance by analyzing real-time data, warning for potential issues, and estimating remaining service life.
