Distributed fiber optic strain sensing for structural health monitoring of 70 MPa hydrogen vessels

Abstract. We report on the development and testing of 70 MPa hydrogen pressure vessels with integrated fiber optic sensing fibers for automotive use. The paper deals with the condition monitoring of such composite pressure vessels (CPVs) using the optical backscatter reflectometry (OBR) applied for a distributed fiber optic strain sensing along fully integrated polyimide-coated single-mode glass optical fiber (SM-GOF). The sensing fibers were embedded into the vessel structure by wrapping them over the polymer liner during the manufacturing process of the carbon fiber reinforced polymer (CFRP). Detecting local strain events by the integrated fiber optic sensors can be an opportunity for monitoring the material degradation of CPVs under static and cyclic loading.

The work described here stands in context of the European Horizon 2020 research project SH2APED focused on the development of an innovative hydrogen storage system composed of an assembly of nine 70 MPa tubular pressure vessels used as an automotive battery pack.

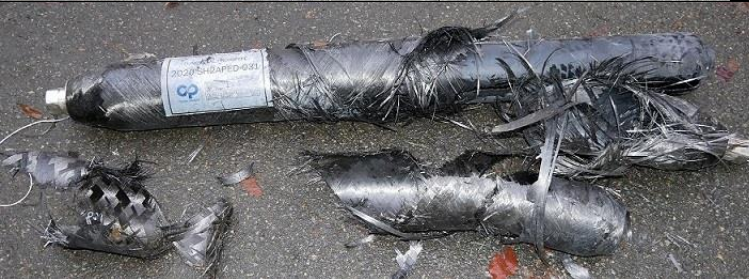
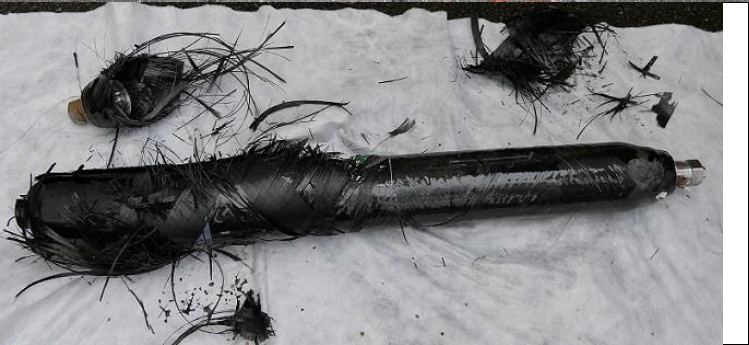
Table 1. Slow burst tests - burst pressure and damage locations

B	1675,1	Cylinder

C	1695,9	Cylinder & dome

The mechanical results of SBT are summarized in Table 1 and show that FOSs integrated into CPVs have no negative impact on the resilience and robustness of the tested vessels. The determined burst pressure exceeds the nominal working pressure by a factor of at least 2.2.

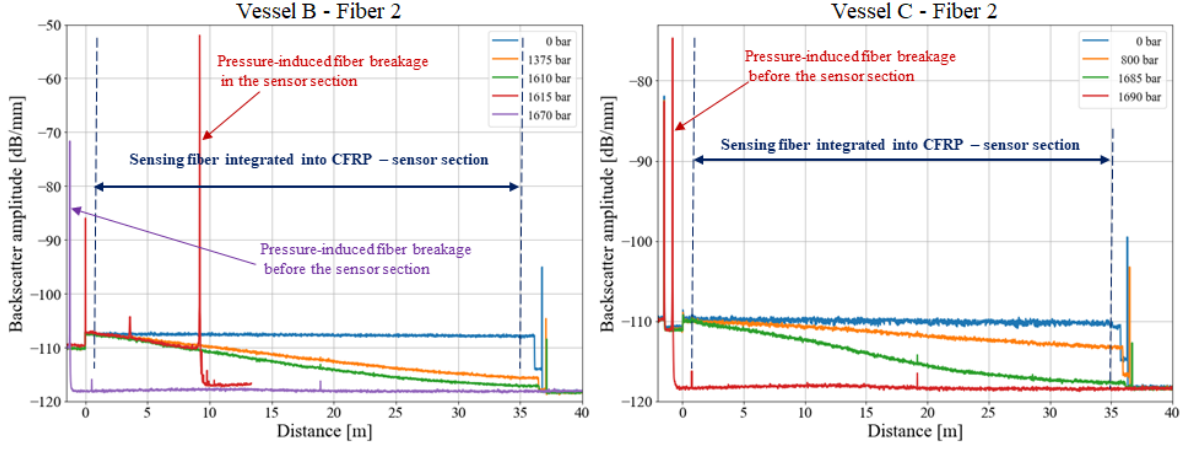
Fig. 2 and Fig. 3 present the development of the backscatter profiles of the sensing fibers integrated both in the circumferential (Fig. 2) and helical (Fig. 3) windings of the not pre-treated vessel B and vessel C. The backscatter profiles generally provide information about optical return losses caused by impurities, imperfections, irregularities, or defects along the tested optical fiber. They can be used to characterize local optical fiber faults due to splicing, bending, connector losses and fiber breaking. The pre-treatment in the ambient cycle test led in case of vessel A to pre-damage in the form of fiber breakage within the fiber section

Fig. 2. Backscatter profiles of the sensing fibers integrated in the circumferential winding of the vessel B (left) and the vessel C (right) changing during the conducted slow burst tests.

The backscatter profiles shown above confirm the robustness of the selected sensing fiber type and the suitability of the investigated concept of FOS integration into CFRP.

The breakage of FOSs, as in case of Fiber 2 in vessel C (see Fig. 2 right) or Fiber 3 in the same vessel (see Fig. 3 right), only occurred when the burst pressure was reached. The remaining two diagrams (Fig. 2 left and Fig. 3. left) prove pressure-induced sensor damage within the sensor section before the burst pressure was applied. The corresponding pressure values of 1615 bar for Fiber 2 in vessel B and 1175 bar for the pre-damaged Fiber 1 in vessel C are far above the nominal working pressure of 70 MPa (700 bar) of the tested CPVs.

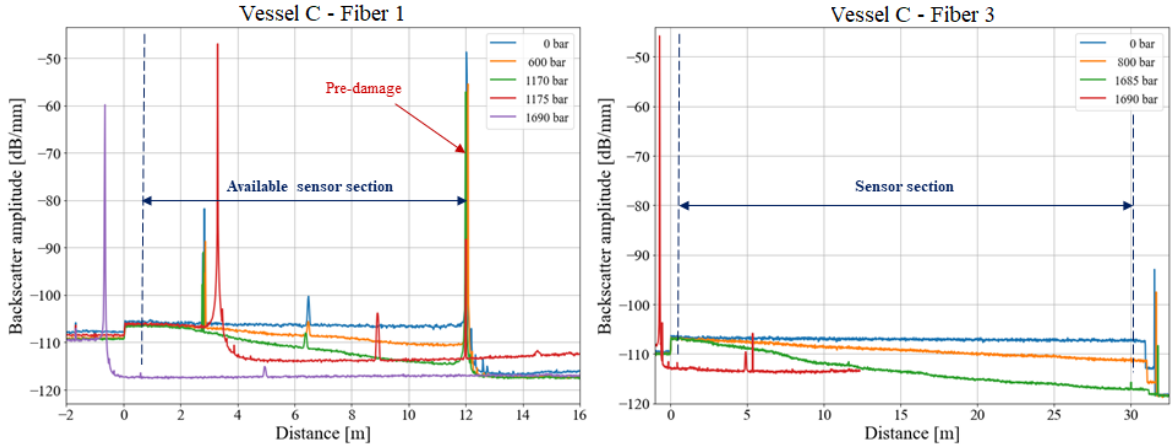
Fig. 3. Backscatter profiles of the sensing fibers integrated in the innermost helical winding (left) and in the penultimate outer helical winding (right) of the vessel C changing during the conducted slow burst tests.

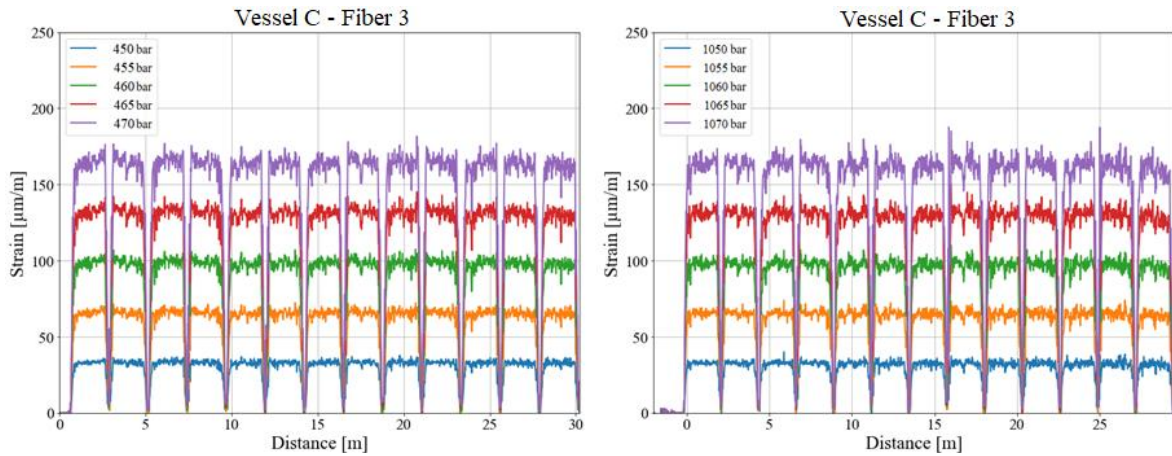
The results of the DSS measurements are represented graphically in Fig. 4 to Fig. 6. The pressure-induced strain gradients are illustrated here with a gradual increase in pressure $\Delta p = 5 \text{ bar}$. The n -th DSS measurement in the diagrams at the pressure p_n ($1 \leq n \leq 5$ in Fig. 4 and Fig. 6 or $1 \leq n \leq 21$ in Fig. 5) relates to a reference measurement at the pressure p_{Ref} . The following therefore applies to p_n :

Fig. 4. Strain profiles of the fiber 3 integrated into the vessel C with increasing pressure.

All DSS measurement results indicate approximately linear strain response to pressure both for circumferential and for helical windings. As shown in Fig. 4 and Fig. 5, there are no strain gradients with increasing pressure in turning areas on both domes in helical windings.

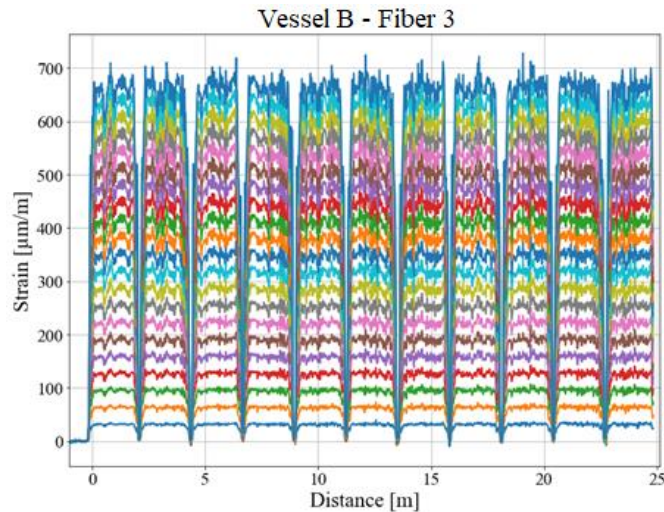
Fig. 5. Strain increase between 1500 bar and 1600 bar along the fiber 3 integrated into the vessel B ($p_{Ref} = 1495 \text{ bar}$; $\Delta p = 5 \text{ bar}$).

Fig. 5 proves the feasibility of the fiber optic DSS at high-pressure values, even at existing pre-damage of the sensing fiber 3 within the sensor section (11 of 13 lengths from dome to dome measurable). Such pre-damages can lead to higher reflections at the fiber breakage deteriorating the signal-to-noise-ratio.
