**The artificial catchment  
'Hühnerwasser' (Chicken Creek):  
Construction and initial properties**

W. Gerwin, W. Schaaf, D. Biemelt, M. Elmer, T. Maurer and A. Schneider

Brandenburg University of Technology Cottbus 2010

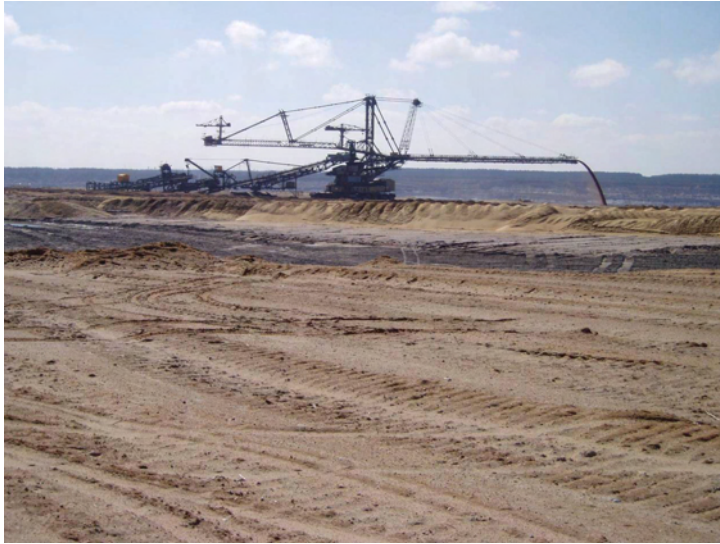
Fig. 8: Technical equipment used in the construction of the artificial catchment: Stacker dumping sandy substrate in Welzow-Süd.

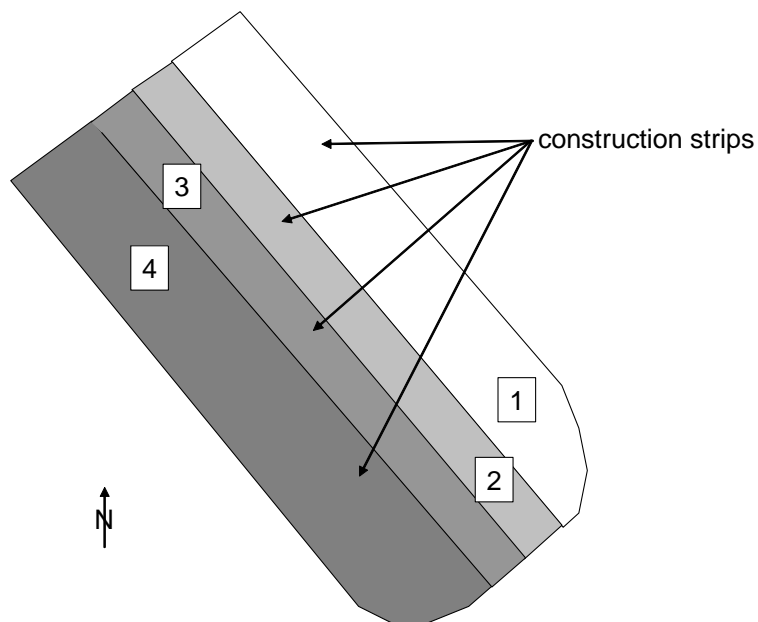
Fig. 9: Schematic illustration of the main construction stages for the Hühnerwasser hillside ('strips' mentioned in Tab. 1) (based on information provided by Beak Consultants GmbH and Vattenfall Europe Mining AG, 2004, modified).

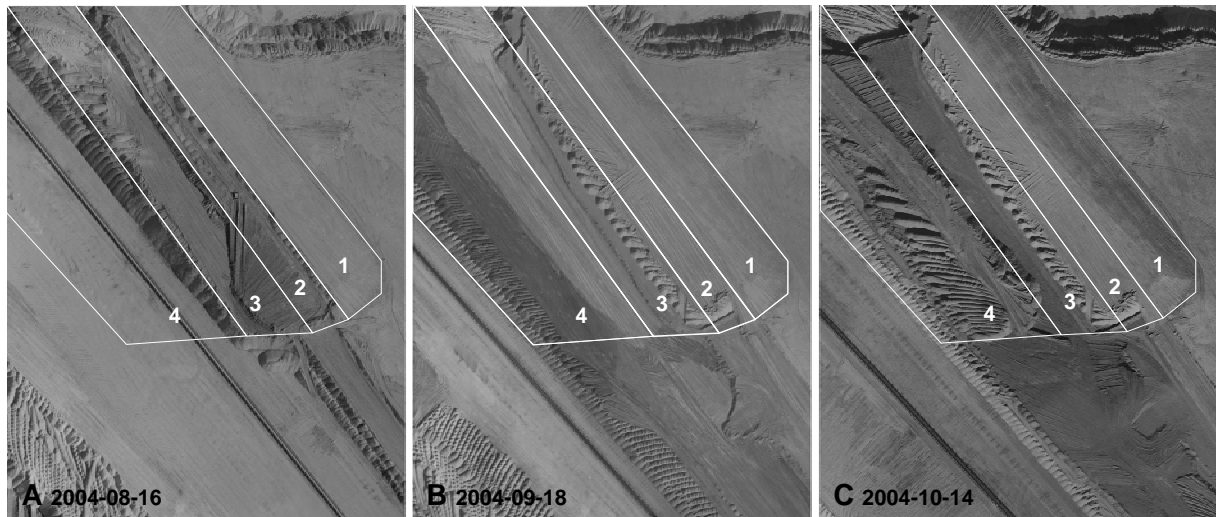
Fig. 10: Strip-wise construction north of the central clay dam can be clearly observed on aerial images (courtesy of Vattenfall Europe Mining AG, 2004).

The catchment was constructed between May 2004 and September 2005 by large mining machinery, including conveyor belt systems involving bucket wheel excavators and coupled stackers (Fig. 8). In general the erection of the catchment was carried out strip-wise, with four major strips able to be distinguished schematically (Figs. 9/10 and Tab. 1). Of these four strips, only the 2nd and 3rd directly cover the area of the watershed and as such are therefore the only ones relevant to the catchment’s behavior and further development. The two other stages of construction mentioned in the scheme were necessary to build the lateral parts of the hillside. These sections lie largely outside the boundaries of the hydrological catchment and are therefore not part of the ongoing ecological investigations. Aerial photographs taken by VEM in 2004 and 2005 illustrate the progress of the construction work (Fig. 11).

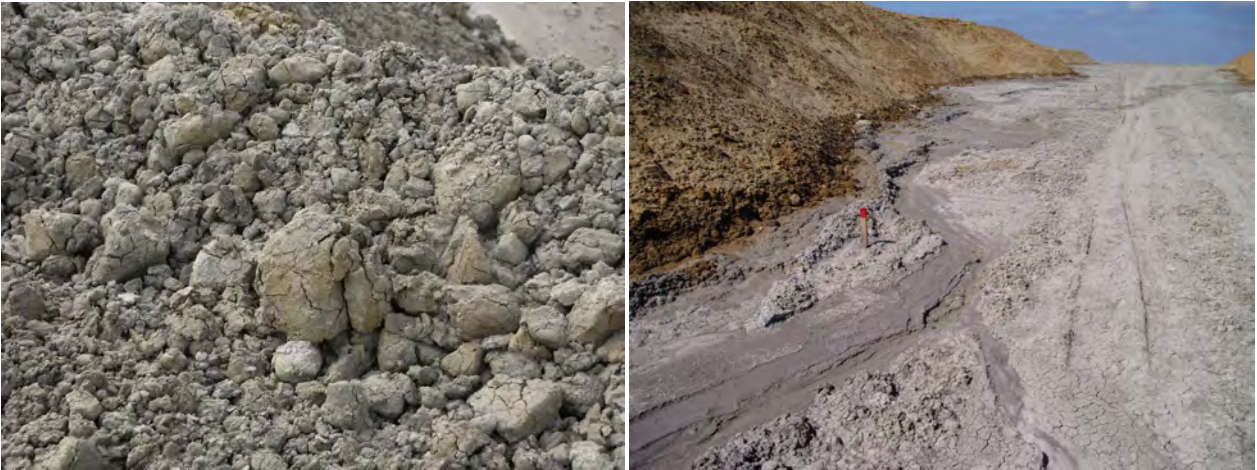
Fig. 13: Freshly dumped clay material with large aggregates resulting from the transport by conveyor belts (left, 2004); clay surface after the occurrence of swelling processes (right, 2005).

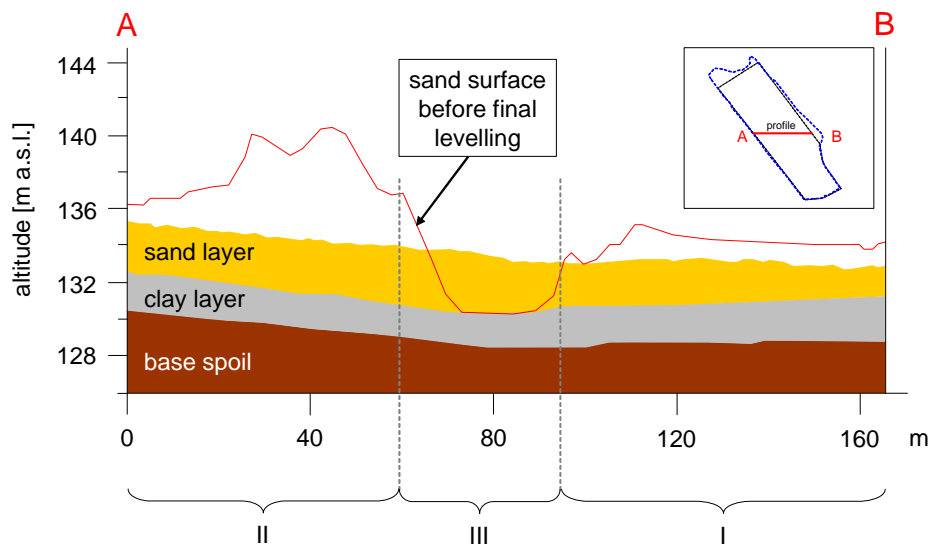
Fig. 15: Cross profiles with the three general construction stages (I - III) showing mass transport during final leveling by bulldozer: (1) red line: surface October 2004; (2) surface of sand layer September 2005 (4x vertical exaggerated, modified after Dominik 2007; based on photogrammetric interpretation of aerial photographs 10/2004 and 09/2005 provided by Vattenfall Europe Mining AG).

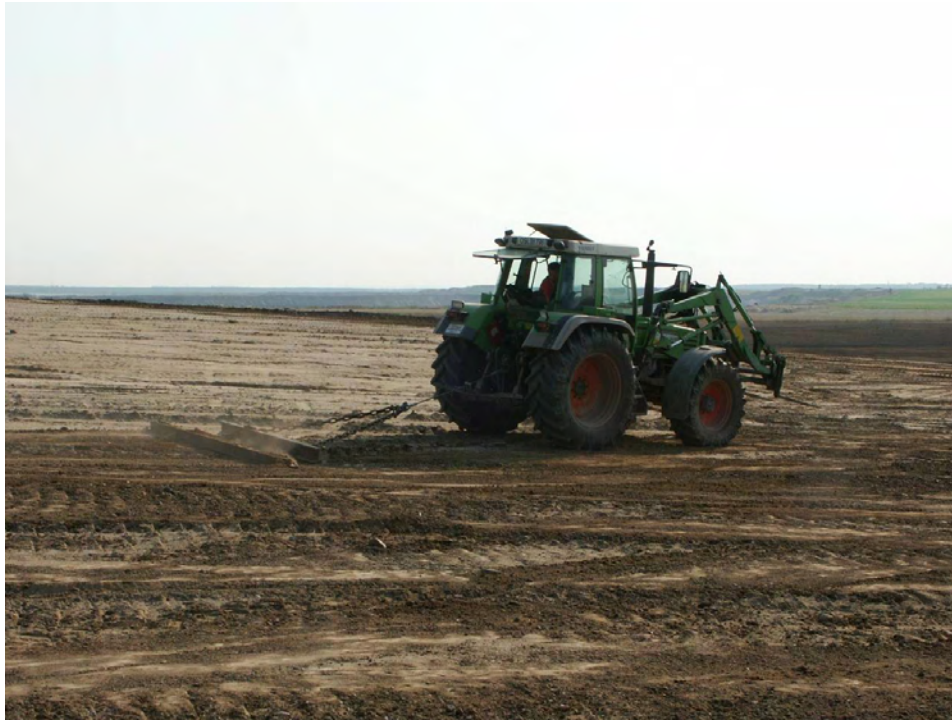
Fig. 16: Final flattening of the sandy surface and elimination of surface structures such as bulldozer tracks (September 2005).

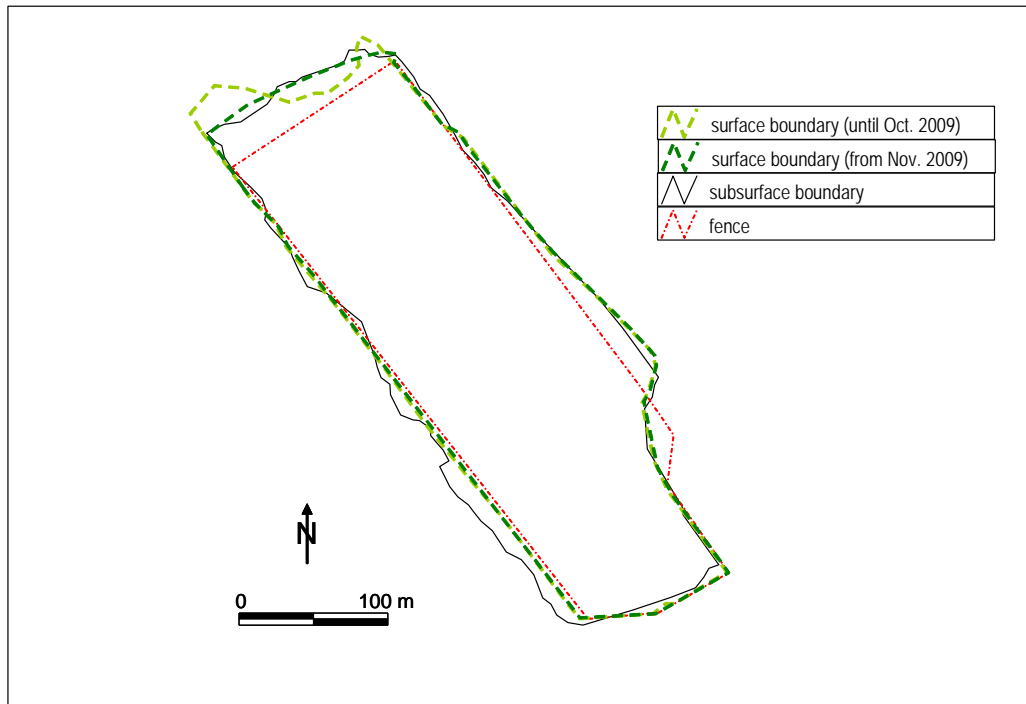
Fig. 17: Catchment borders: (1) surface boundary, (2) subsurface boundary, and (3) outline of the fenced area for comprehensive monitoring of surface structure development.

During construction the boundaries of the catchment were defined according to the working plans by means of specific modeling of site morphology. Both the surface and subsurface catchments were designed as shallow basins, although due to the site being constructed in multiple stages, some slight differences exist between the boundaries of these two catchments, as illustrated in Fig. 17. In addition, in October/November 2009 some modification of the surface boundaries was necessary in the northern part of the catchment due to construction work being undertaken on the adjacent ‘Wolkenberg’ hill. These changes are also highlighted in Fig. 17.

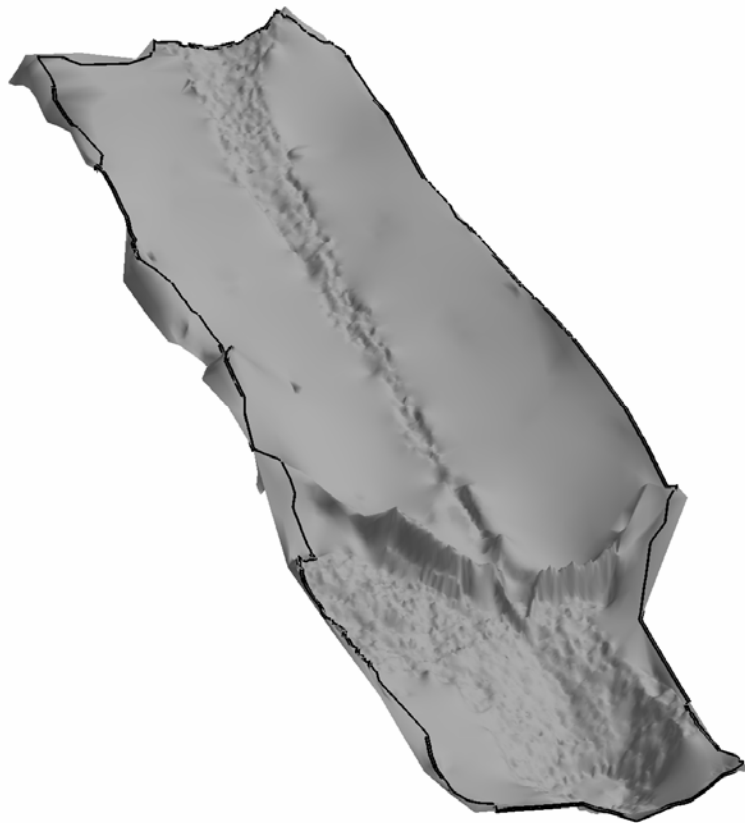
Fig. 18: GOCAD image of the topography of the clay base liner (tenfold vertical exaggeration): The black line marks the subterranean catchment as identified from elevation data using the D8-algorithm in SAGA-GIS. Higher information density is clearly visible in the lower parts of the catchment around the pond as well as along the former ‘central trench’ in the back slope area due to the better availability of data concerning the clay surface (screenshot from the GOCAD model of the catchment, partially based on spatial and elevation data provided by Vattenfall Europe Mining AG).

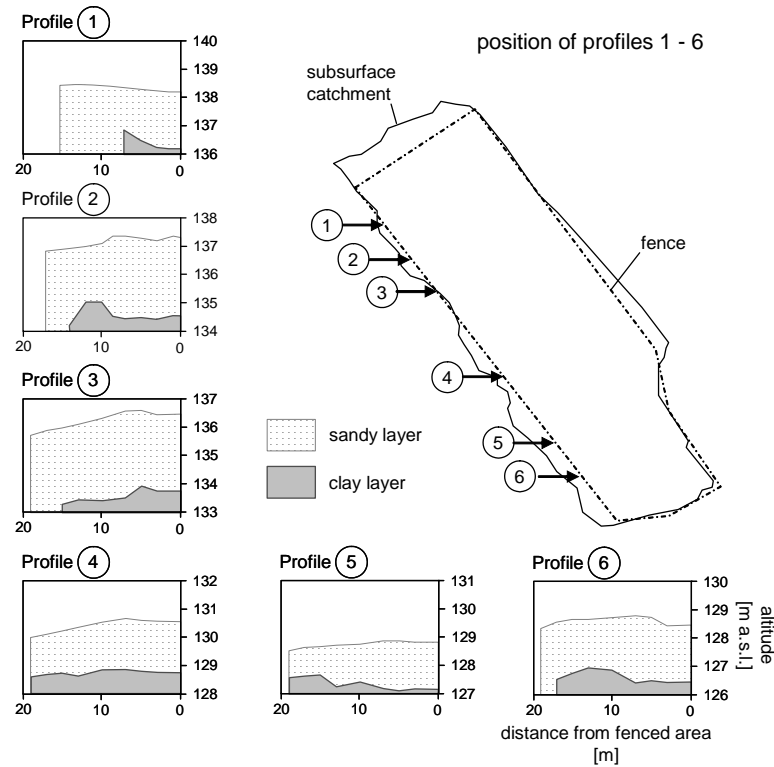
Fig. 20: Sample profiles of the clay border in the western part of the catchment derived from borehole investigations.

The boundary of the subsurface catchment is mainly characterized by small clay dams created during the flattening of the clay surface by bulldozers. Fig. 20 shows sample profiles of the edges of the clay layer in the western part of the catchment revealed by drilling. Obviously, these clay dams have different characteristics in different parts of the site. However despite this limitation, the outline of the underground section of the catchment is generally more clearly defined and understood compared to that of natural watersheds. In future, the edges of models of the clay layer and of the clay dams will be optimized by means of geophysical methods such as Ground Penetrating Radar (GPR).

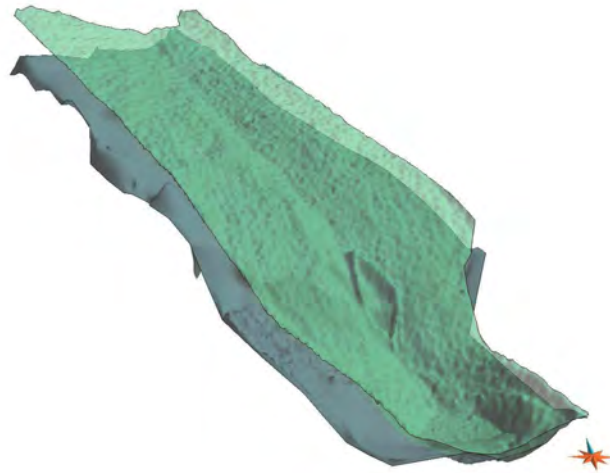
Fig. 21: 3D visualization of the catchment surface in 2005, compared with the surface of the clay layer underground (tenfold vertical exaggeration): screenshot from the GOCAD model of the watershed (partially based on data provided by Vattenfall Europe Mining AG).

Fig. 21 presents a 3D-view of the initial subsurface and surface areas of the Chicken Creek catchment in September 2005, visualized by GOCAD. The data for this 3D-model were obtained from regular surveys carried out by VEM and are based on photogrammetric interpretation of aerial photographs. Both the subsurface clay layer and the surface of the catchment take the form of shallow basins in order to ensure clearly-defined boundary conditions.

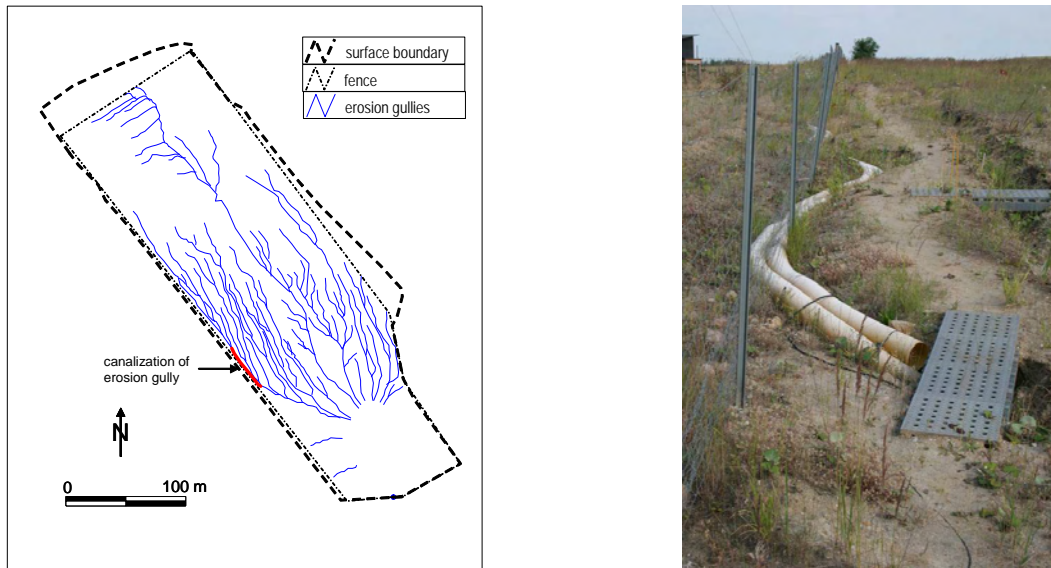
Fig. 22: Canalization of the western erosion gully preventing further incision. Left: location, right: installed flexible pipes (April 2008).

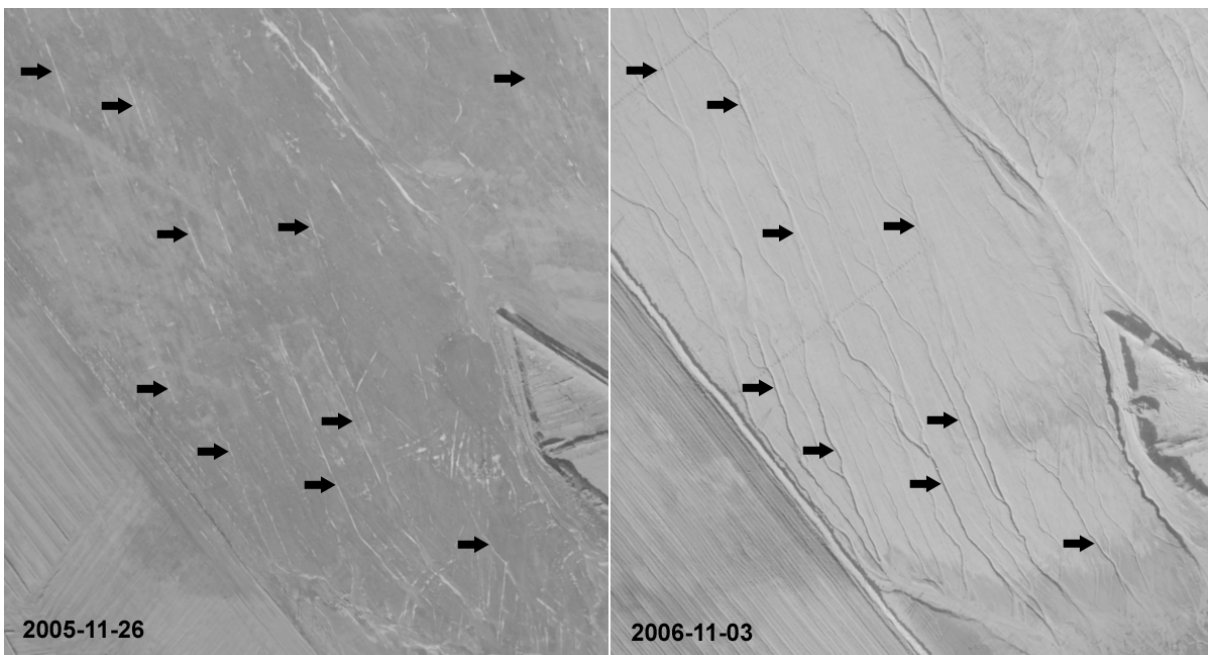
Fig. 24: Initial technogenic surface structures (vehicle tracks) featuring favorable conditions (i.e. small angles with the slope line) were soon transformed into 'gullies' by erosion processes and incorporated in the drainage system (© Photograph by Vattenfall Europe Mining AG, 2005/2006).

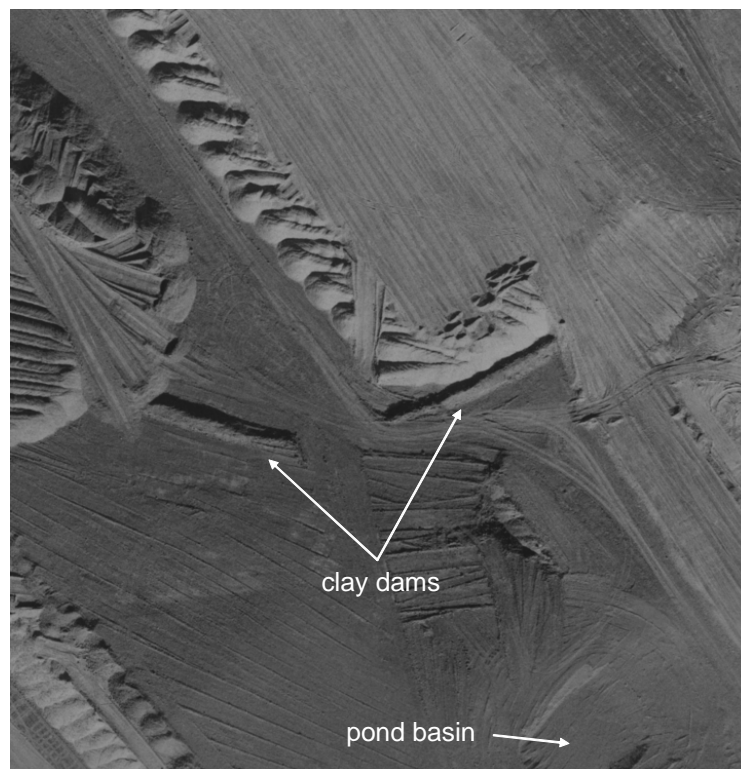
Fig. 25: Subsurface clay dams in the footslope area: Detail of the aerial photograph, October 2004 (© Vattenfall Europe Mining AG).

The clay dams found in the lower part of the site have a complex influence on the groundwater balance of the system. Constructed as a barrier for both potential slides of sandy material and for groundwater, the dams have a height and diameter of around 1 m and are situated on top of the clay layer and embedded into the sandy layer. The location of the clay dams is shown in Fig. 25. In the central area between the western and eastern sections, a section of the impermeable clay dam has been replaced by one made of coarse rubble. This provides groundwater with a defined outlet and also enables measurement of total groundwater discharge from the catchment. A large weir was installed here shortly before the end of construction.

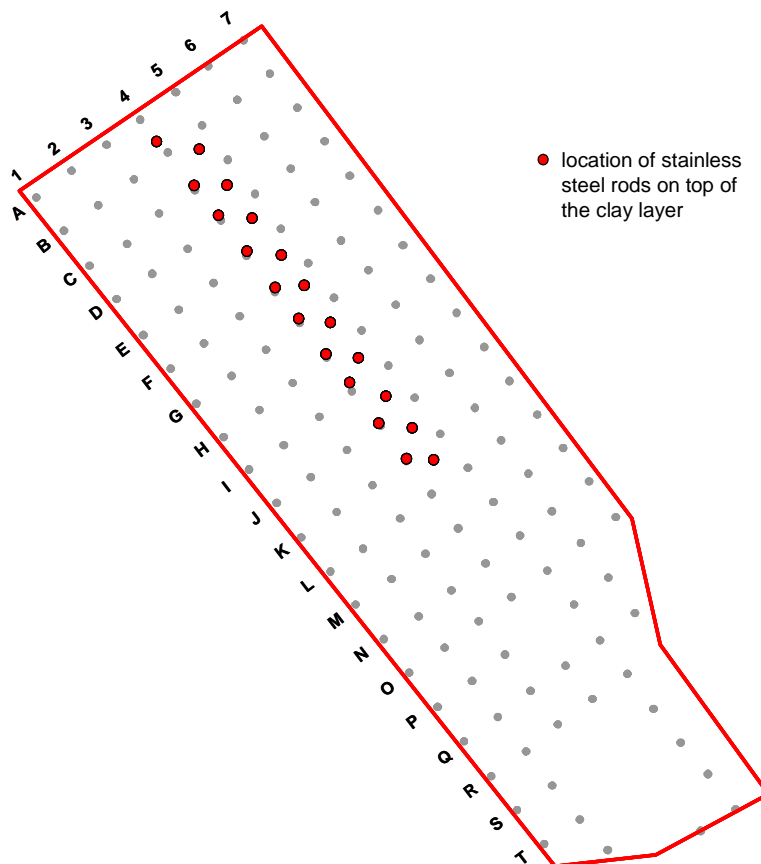
Fig. 26: Position of stainless steel rods on top of the clay layer laid out in March 2005.

In March 2005 with the ‘central trench’ between the two main areas of the catchment still open (see chapter 3.2.2), the opportunity of accessing the clay surface was taken and markers deposited to be used in later geophysical measurements. Short stainless steel rods with a length of 30 cm were laid out in two parallel rows over a distance of 20 m. The rods were placed directly on top of the clay surface and were afterwards covered by sandy material. The precise positions of the rods are given in Fig. 26.

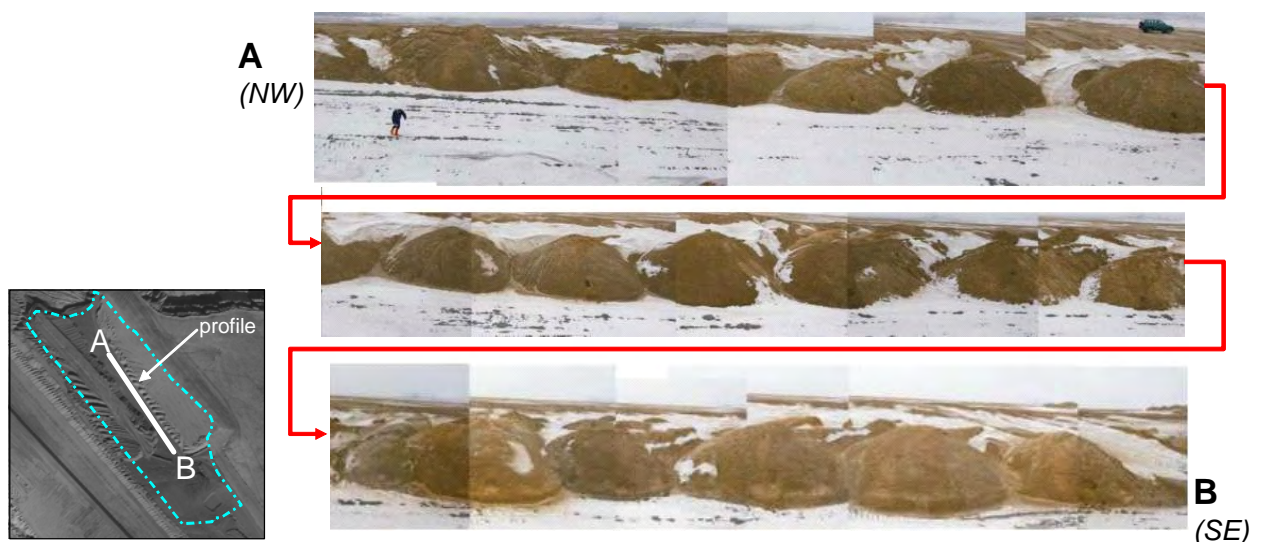
Fig. 27: Longitudinal section across the catchment during the construction phase in March 2005: internal ripple structure.

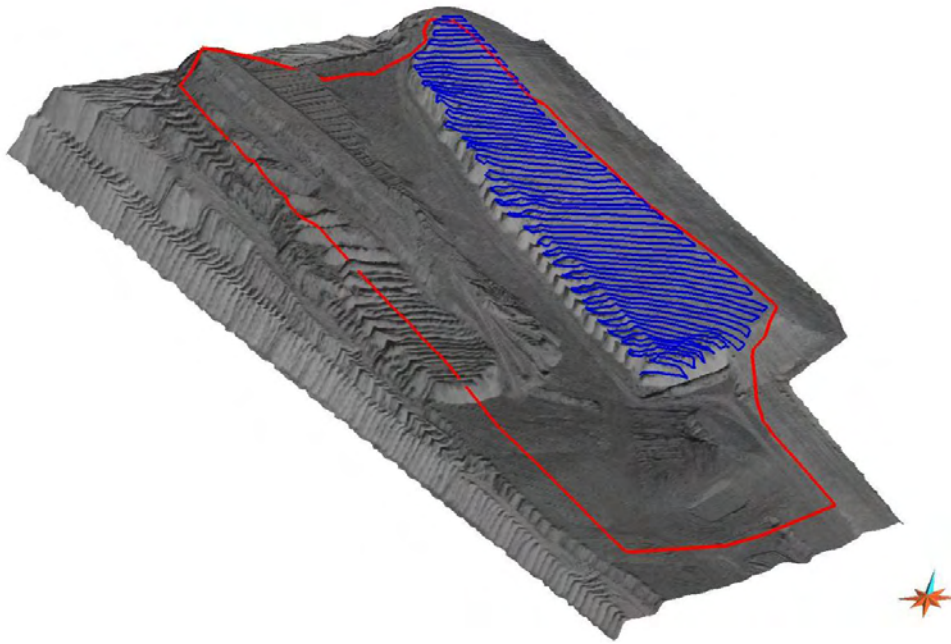
Fig. 29: The course of spoil ridges was derived using a combination of aerial photographs and digital elevation models (GOCAD model; fivefold vertical exaggeration; based on aerial photographs and DTM by Vattenfall Europe Mining AG, October 2004).

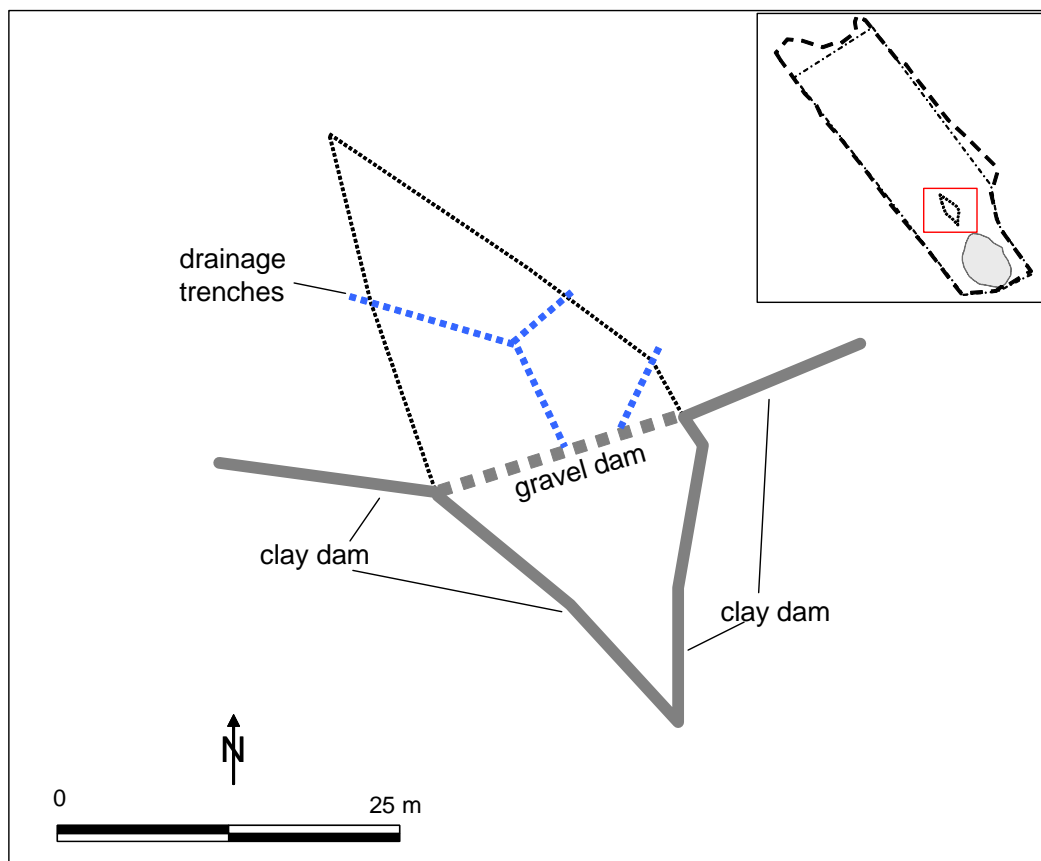
Fig. 31: Position of the drainage trenches in the spring area of the catchment (September 2006).

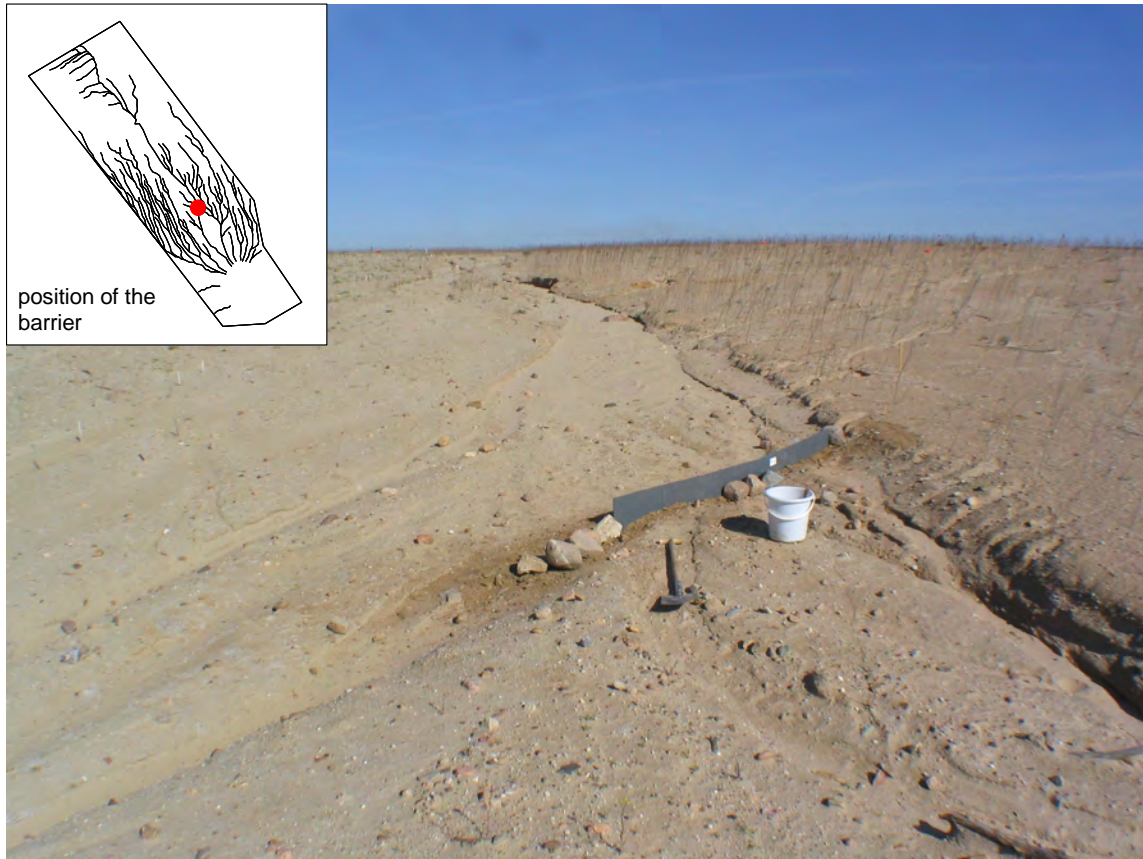
Fig. 34: Temporary barrier at the bifurcation of the central erosion gully close to the central trapezoidal spring area, constructed to direct surface water in the central erosion gully into the western branch of the system (April 2007).

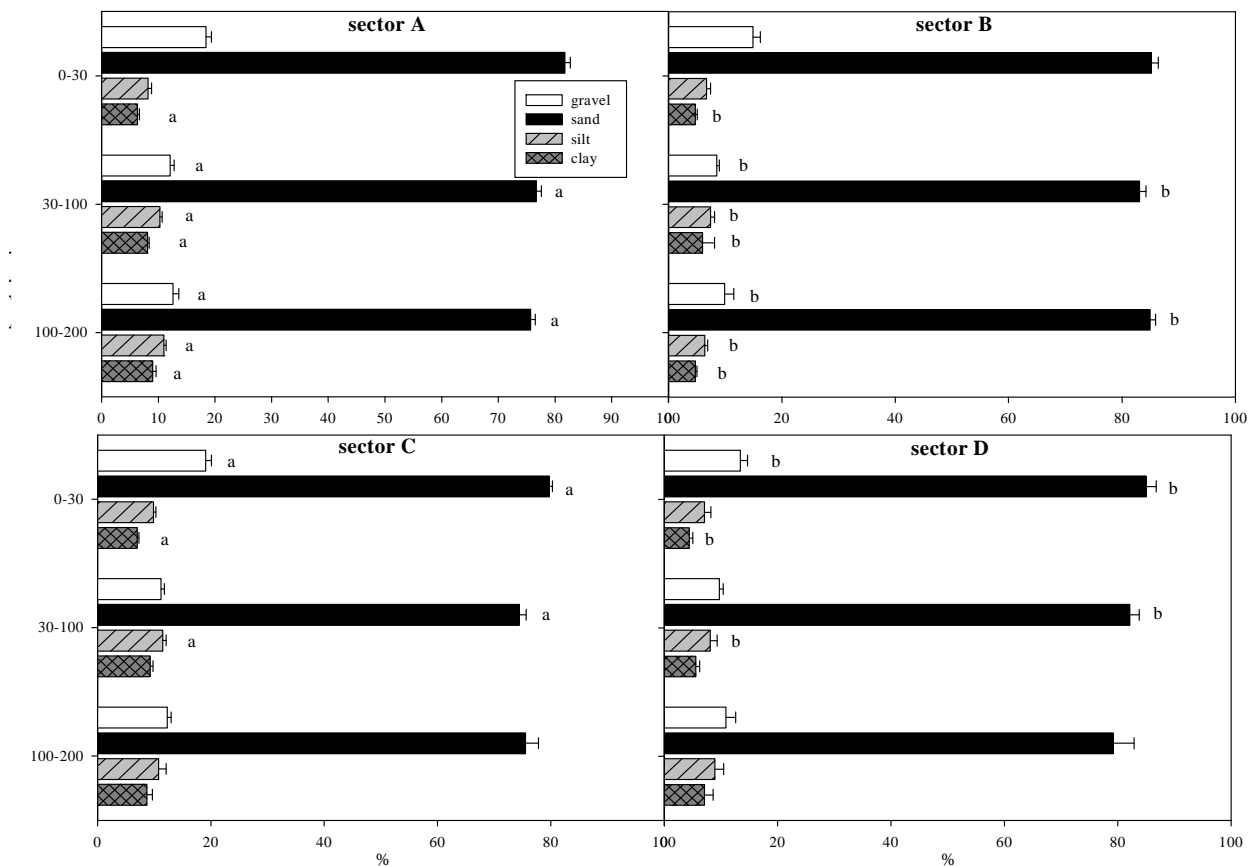
Fig. 35: Soil texture profiles of the four main catchment sectors (mean values and standard error ( $n=18$  for depths 0-30 cm and 30-100 cm,  $n=6$  for 100-200 cm), different letters (a, b) denominate significant differences ( $p<0.01$ ) between the sectors). For the location of sectors A-D see Fig. 7 (Chapter 3.1).

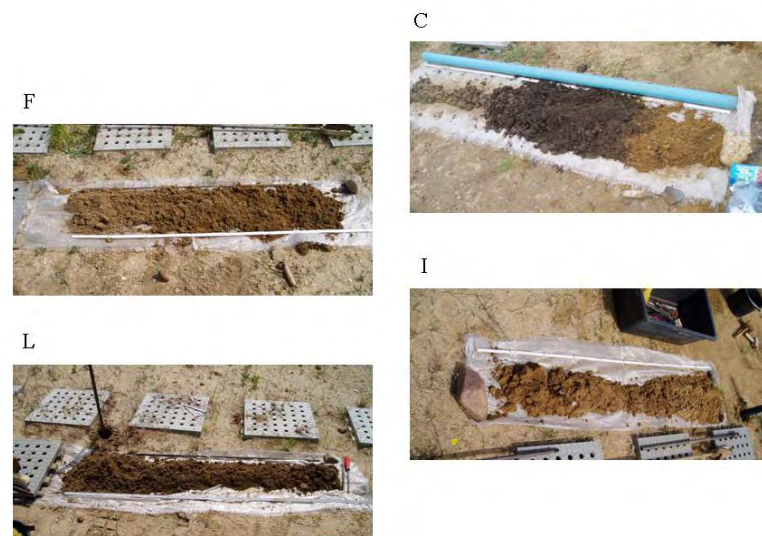
Fig. 44: Sediments from drilling of groundwater level pipe.

Fig. 43 presents the grain-size distribution curves of soil samples taken during drilling for ground water pipes close to the soil pits (see chapter 5.2). At pits F and L loamy sand was found at all depths, while at pits C and I the texture was pure sand. These results correspond with those of grid sampling discussed above and also illustrate the fact that the substrate in the eastern parts of the catchment has a higher sand content than those in the west. Grain-size analysis showed no vertical differences in soil texture at three pits (F, L, I), which correlates with observations made during the installation of the observation pit sensors. While drilling boreholes for the groundwater gauge located close to pit C, vertical layering of different colors (Fig. 44) and textural properties was found.
