# A phenomenological and quantitative view on the degradation of positive electrodes from spent lithium-ion batteries in humid atmosphere

The present study deals with the phenomenological observation of the corrosion of the positive electrode foil of lithium-ion batteries containing  $\text{LiNi}_{0.6}\text{Co}_{0.2}\text{Mn}_{0.2}\text{O}_2$  (NMC) as cathode material. Due to the presence of moisture, localized water accumulation is formed on the NMC surface. The water absorbed by the electrolyte reacts with the NMC under  $\text{Li}^+/\text{H}^+$  exchange and the resulting pH increase leads to dissolution of the carrier foil and characteristic salt-like blooms on the NMC surface. With the increase in the relative area occupied by the holes in the aluminum foil per time, a sufficiently suitable parameter was found with which to quantitatively determine the extent of corrosion. The degree of degradation depends on time and ambient humidity. It was shown that functional recycling with the water jet method is no longer applicable for degraded foils, since the mechanical stability of the foils decreases as corrosion progresses. Lithium, aluminum, sulfur and oxygen were detected in t

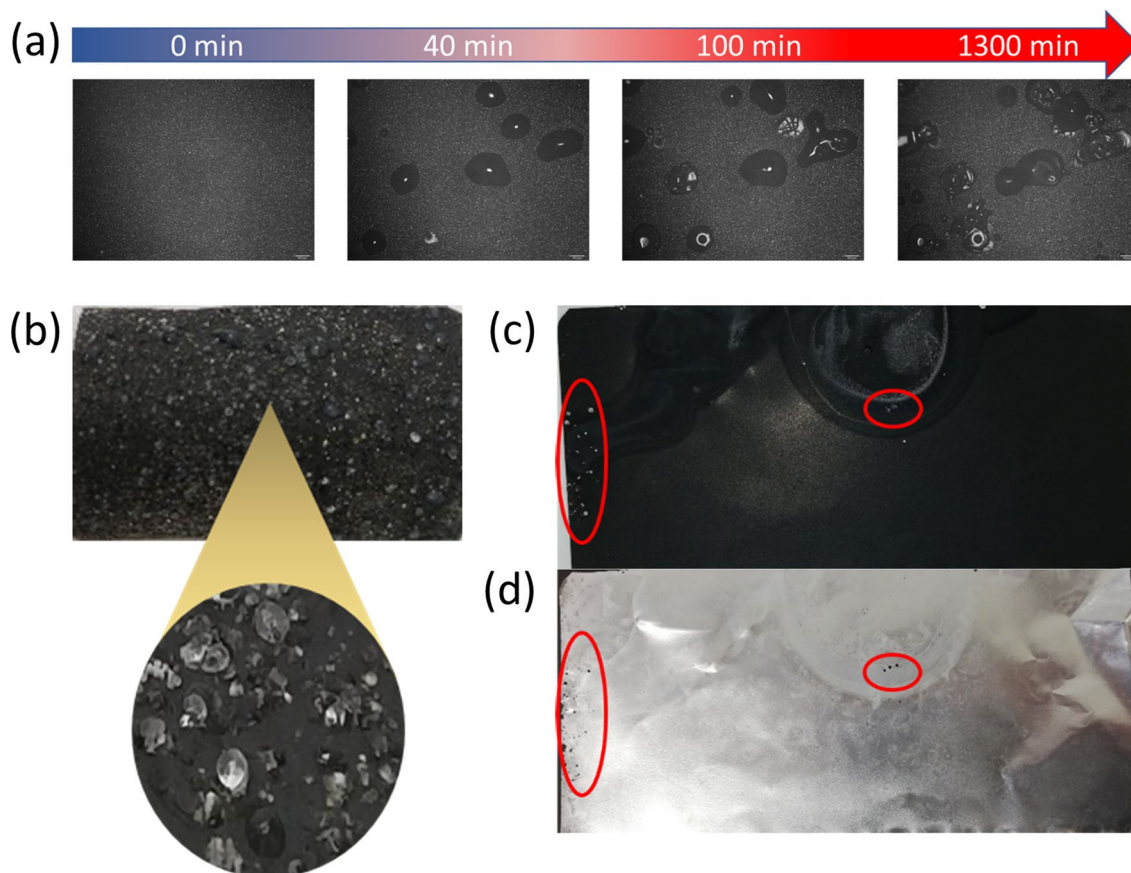
**Figure 1.** (a) Time sequence of the accumulation of moisture on the surface of a positive electrode; humidity of  $\phi = 100\%$ , 2.55 mm  $\times$  1.91 mm; (b) Precipitations on a positive electrode surface (removed from a used LIB) stored in air for 14 days at a humidity  $\phi = 100\%$ , enlarged section with a diameter of  $\varnothing \approx 2.5$  mm; (c) Precipitations on a virgin positive electrode (without any contact with an electrolyte) that has been wetted with an electrolyte only in the areas outlined in red, (d) holes are detectable in the decoated aluminum substrate foil only where the precipitations has been formed as a result of contact with the electrolyte.

Fig. 1a). At the beginning, the fluid accumulations are not visible at this scale, but only by microscopy under strong illumination. In the further course, small droplets become visible on the surface and after a further period of time white dots or larger crystalline blooms. In the following, storage in air will be referred to synonymously as ageing.

Positive electrodes from used LiBs that have been stored in air for several days develop white, salt-like precipitates on the surface of the NMC coating, which can reach typical diameters between 100 and 500  $\mu\text{m}$  (Fig. 1b). If the NMC coating is removed from a positive electrode that is already showing the first salt-like precipitates, a large number of small holes become visible in the exposed aluminum substrate foil. Positive electrodes that have never been in contact with a typical liquid battery electrolyte do not show any of the typical symptoms of aging when stored in air for weeks. If such a virgin positive electrode, which has never been in contact with an electrolyte, is exposed in some spots with a liquid electrolyte taken from a spent cell of the same type, the salt-like precipitates will also develop in the course of a day, and the underlying aluminum foil will show the typical holes at exactly these spots after decoating (Fig. 1c,d).

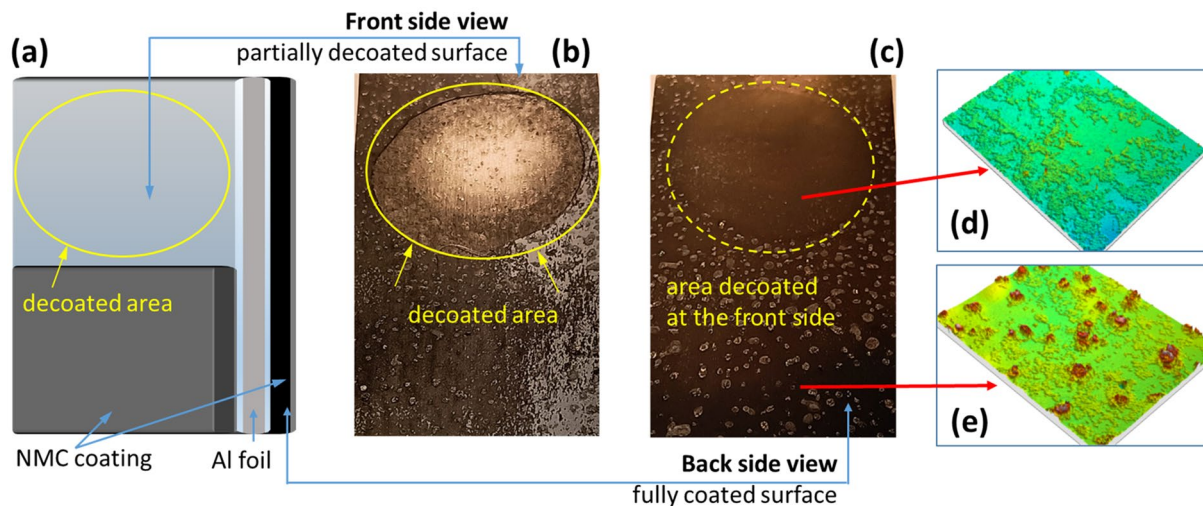
**Figure 2.** (a) Schematic illustration of the partially decoated positive electrode; (b) optical image of the partially decoated front side and of (c) the fully coated back side after aging in air humidity of  $\phi = 97\%$  for 18 h; confocal microscope images electrode surface taken (d) from the apparently non-corroded area with decoating on the surrounding side and (e) the surrounding corroded electrode surface formed in areas with NMC coating on both sides; light–dark patterning seen inside the yellow circle in the optical image (b) and (c) are only due to light reflection.

For a more detailed investigation of the degradation effects, a positive electrode consisting of an aluminum substrate foil (thickness 12  $\mu\text{m}$ ) coated on both sides with approx. 65  $\mu\text{m}$  NMC was partially stripped of the NMC layer on one side by means of an adhesive strip and then stored for about 18 h in an atmosphere with 97% humidity. Figure 2a shows a schematic diagram of the chosen experimental setup. The partially stripped area of the positive electrode foil is formally referred as the front side (Fig. 2b), while the area still fully coated is referred to as the back side (Fig. 2c).

After the aging process had been completed, the following picture emerged: The aluminum substrate foil exposed on the front side shows the previously described fine perforation and also exhibits a large number of white and salt-like precipitates (Fig. 2b). The adjacent, still present NMC coating shows a nearly similar large abundance of these white precipitates (Fig. 2b). Surprising is the image from the back of the positive electrode. The optical image in Fig. 2c illustrates that only the areas with intact NMC coating on both sides show the white, salt-like deposits on the surface. In contrast, the area of the reverse side, which was decoated on one side before storage in air on the front side, shows absolutely no traces of degradation and also no visual nor haptic changes can be detected. This is illustrated in Fig. 2d and e by confocal microscopy images of the surface.

Based on Fig. 2d and e, this different behavior can be quantified using the surface area ratio,  $S_{dr}$ , which covers all features of a surface topography as ratio between the total (folded) surface area,  $A_s$  and the geometric (projected) surface area,  $A_p$ <sup>44–46</sup>. Starting with a common geometric surface area of  $12.4 \text{ mm}^2$  ( $A_p$ ), the positive electrode surface has a folded surface area of  $13.2 \text{ mm}^2$  ( $A_s$ ) resulting in a  $S_{dr}$  of 1.064 when the backside is decoated and the aluminum substrate surface is exposed. In the area with NMC coating on both sides and their clearly visible deposits, almost a doubling of the folded surface is observed measuring  $A_s = 20.1 \text{ mm}^2$  resulting in a  $S_{dr}$  of 1.621. The small irregularities on the surfaces with 5 to 7  $\mu\text{m}$  in height in Fig. 2d and e as well as the whitish haze across the entire positive electrode foil (Fig. 2c) originate from adherent residues of the ceramic coating of the separator foil, which are of no relevance for the present investigations. In addition to the salt-like precipitations, the increasing roughness of the surface of the NMC coating is also attributable to an increase in the volume of the crystallizing salts in the pores of the coating. Only in the case of the single-sided decoated positive electrode the pores of the NMC coating constitute a higher diffusion resistance, so that the salt-containing liquid passes through the holes to the aluminum/air interface with lower transport resistance and crystallizes there. As a result, the surface of the NMC coating shows no salt-like precipitations and also no roughening of the surface, because crystallization and volume increase occur on the decoated side.

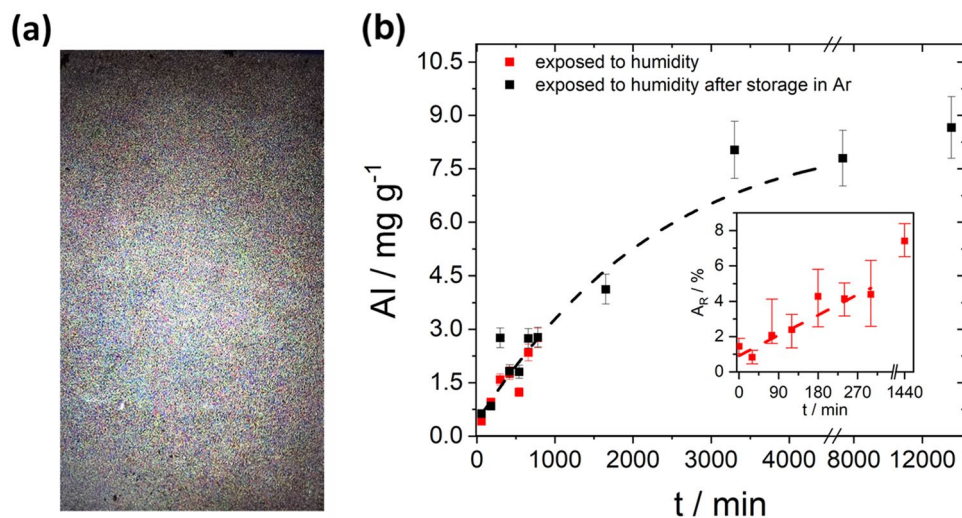
**Figure 3.** (a) after 24 h in air stored, decoated carrier foil (transilluminated); (b) Aluminum content of the cathode material as a function of exposure time at  $\phi \approx 55\%$ , Inset: relative area of the holes of the foils during storage at ambient air humidity of  $\phi \approx 55\%$  as a function of time; the dashed lines are guide-to-the-eyes.

Beginning with the time of contact with ambient air, individual positive electrodes were decoated at defined intervals using a water jet. The positive electrodes, whose volatile electrolyte components evaporated in ambient air, were increasingly difficult to decoat over time (10–300 min), since the adhesion of the positive electrode coating to the substrate foil increases. In parallel, the decoated aluminum substrate foils showed a steady increase in the number of small holes, which was already visually recognizable (Fig. 3a).

The extent to which the formation of holes in an aluminum substrate can reach is shown as an example in Fig. 3a for a positive electrode that was decoated after a treatment time of 24 h at a humidity of  $\phi \approx 55\%$ . To make the resulting holes visible, the aluminum foil was placed on a white luminescent LCD display so that the holes appear as bright dots. It must be emphasized that the holes are evenly distributed over the entire foil; the optical image results in optical aberration, indicating that there are more holes in the center of the foil (at the focus of the camera's optical lens) than at the edges.

The corrosion of the aluminum foil can be clarified on the basis of two investigations. The most reliable statements are those resulting from time-dependent determination of the dissolved aluminum in the active material. Figure 3b shows that the aluminum content in the active material increases continuously without any difference between drying in air or drying in argon as soon as the positive electrodes are exposed to ambient air. After about 3350 min, the aluminum content approaches saturation. Thus, the degradation has a self-limiting character. The fact that the corrosion of the positive electrodes stored under argon proceeds at almost the same rate as the positive electrodes directly exposed to air suggests that it is the non-volatile conductive salt residues that initiate the corrosion of the aluminum through their hygroscopic properties.

The second method of investigation is based on quantifying the area of the holes formed in the aluminum foil. Here, the relative ratio between the area of the holes formed as time progresses and the total area of the aluminum foil ( $A_R$ ) is determined by microscopy. The inset in Fig. 3b shows a linear increase in the relative hole area with considerable dispersion. It should be noted that the quantification of corrosion via the temporal increase in the geometric area of the holes has only limited significance, since the simultaneously occurring process of areal corrosion, which leads to a decrease in the foil thickness, is not taken into account.

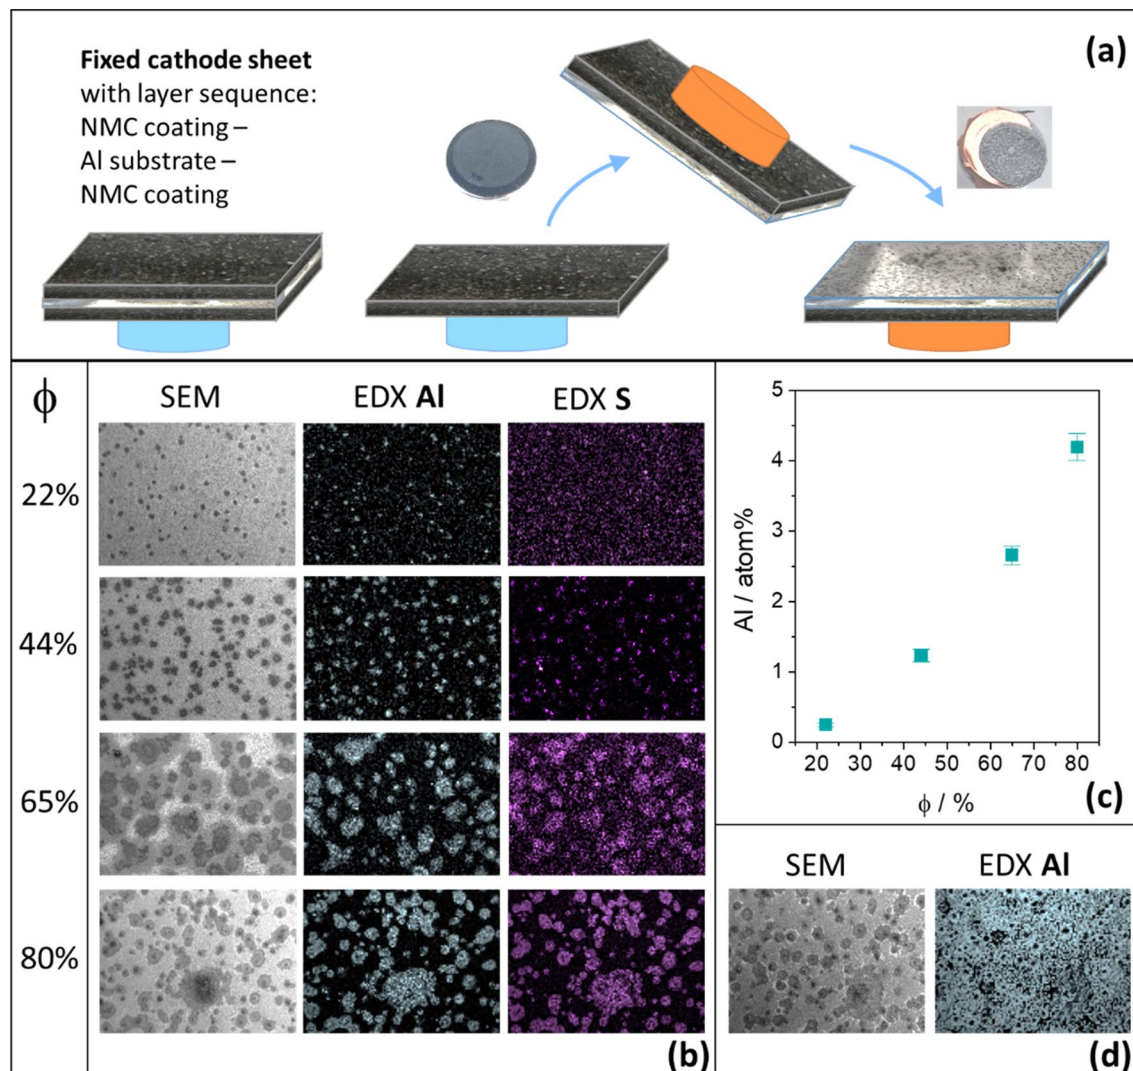
**Figure 4.** (a) Schematic illustration of the separation of the layers of the positive electrode foil in preparation for analysis after ageing; (b) SEM images and SEM–EDX analyses of a fixed section of 5.5 mm × 4 mm on the NMC coating with substrate contact area as a function of air humidity; (c) SEM–EDX analysis of aluminum content on the substrate contact surface of the NMC coating with increasing air humidity; (d) SEM image and SEM–EDX analysis (5.5 mm × 4 mm section) of the decoated aluminum substrate after 18 h at 80% air humidity.

The SEM images as well as the corresponding SEM–EDX mappings in Fig. 4b make clear that the aluminum content in the NMC coating increases more and more with increasing humidity. For a humidity of 97%, it was no longer possible to perform such an analysis, as the degradation of the aluminum foil made it impossible to separate the layers. If one plots the aluminum content determined by SEM–EDX in the examination area as a function of the air humidity (Fig. 4c), a direct, disproportional correlation is found. If one also looks at the exposed aluminum substrate, it becomes clear from the SEM–EDX mapping that at 80% humidity (Fig. 4d) the aluminum foil is interspersed with holes in such a way that the underlying NMC coating becomes recognizable and detectable by means of EDX. Furthermore, it is evident that the aluminum is associated with the sulphur (Fig. 4b). The SEM–EDX analyses show that up to 65% humidity there is an increasing content of fluorine associated with the aluminum and sulphur. At 80% humidity, the fluorine content on the NMC layer is lower and there is no clear association with other elements. The complete SEM–EDX analyses are shown in Supplementary Figure S1 online and Supplementary Table S1 online.

Analogous to the transfer of aluminum to the NMC coating analyzed by SEM–EDX (Fig. 4c), the degradation of the aluminum substrate, measured by the number of holes, also shows a direct correlation with increasing air humidity content (Fig. 5).

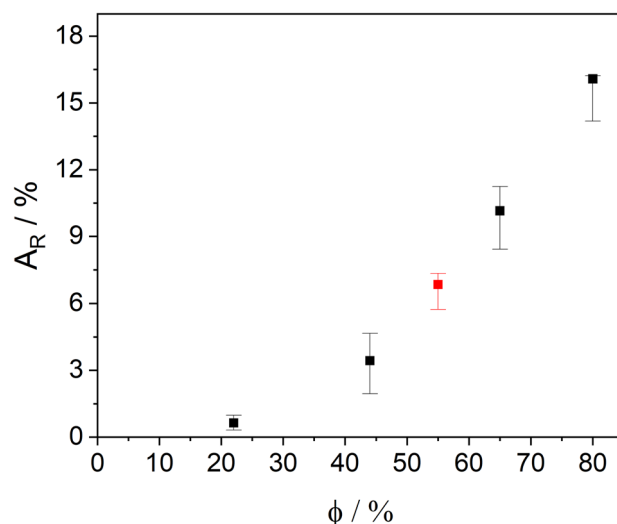
**Figure 5.** Correlation of the relative area of the holes during 18 h storage (black dots) at different degree of humidity, red dot at a humidity of  $\phi = 55\%$  end point from Figure 3b interpolated to 18 h.

Thereby it can be seen that with increasing humidity, a greater extent of degradation in the form of holes can be observed. The end point from Fig. 3b fits into the results of this test seamlessly (Fig. 5, red dot). Furthermore, the delamination deteriorates with increasing exposure to air humidity.

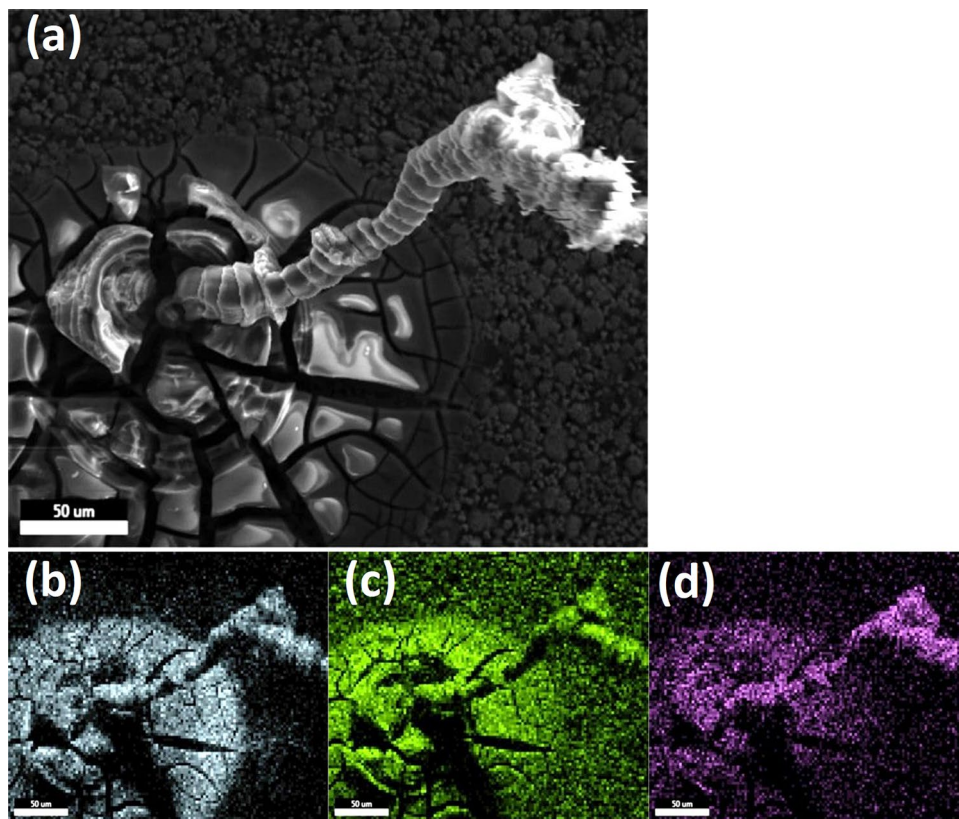
**Figure 6.** (a) SEM image of the stalactite-like crystallite; EDX element mapping for (b) aluminum, (c) oxygen, (d) sulphur of the crystallite; humidity  $\varphi = 80\%$  for  $t = 18$  h.

**Quantitative observations: the salt-like bloom.** The findings suggest that the aluminum foil dissolves in the course of degradation in a locally formed alkaline medium. Dissolved aluminum salts are transported into the NMC layer, and crystallization occurs within and on the NMC coating. Aluminum, sulphur and oxygen were detected in the bloom. A reliable chemical characterization of these precipitates is difficult in the presence of the NMC coating and the aluminum foil. Therefore, an attempt was made to isolate this material. For this purpose, pieces of positive electrodes were placed on top of the humidification apparatus in high humidity of 80% for a period of 18 h. The high humidity ensured that the dissolved salts did not crystallize directly on the surface of the coating, but caused its steady transport by gravity. As a result, stalactite-like crystallizations were obtained on the surface of the NMC coating (Fig. 6a), which could be analyzed by SEM–EDX. The analyses revealed that the crystallite consists predominantly of aluminum (Fig. 6b) and oxygen (Fig. 6c), and it was also found that considerable amounts of sulphur (Fig. 6d) were evenly distributed in the solid.

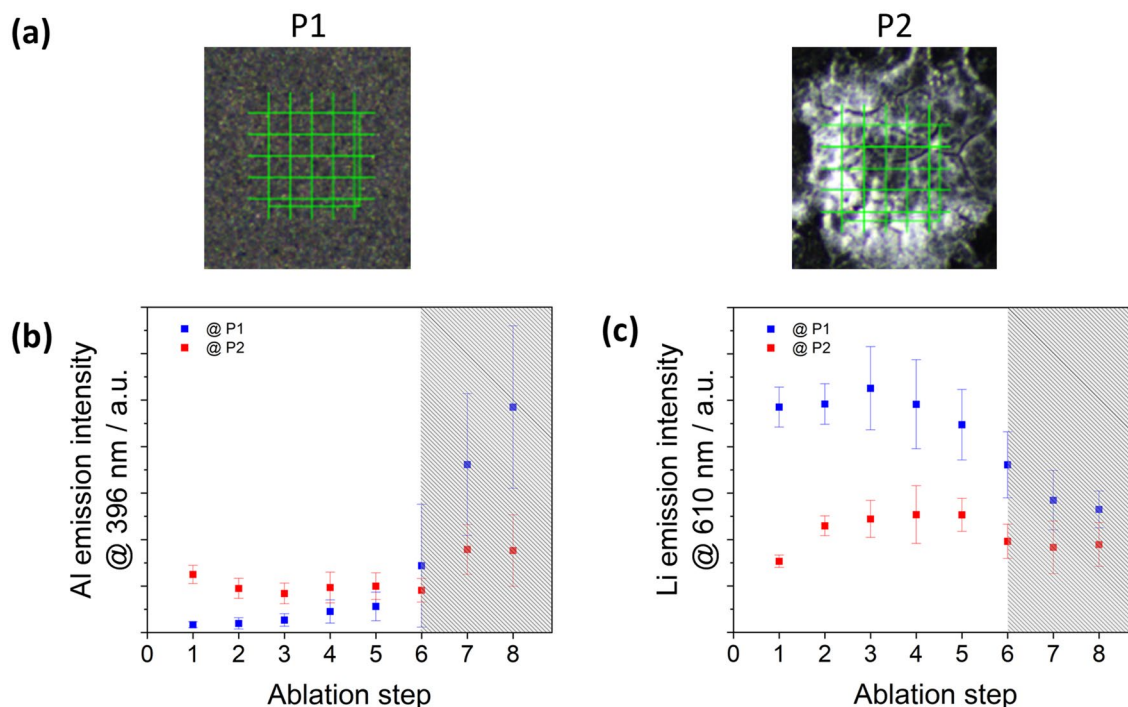
**Figure 7.** (a) P1 non-degraded NMC surface; P2 bloom due to degradation by air humidity of  $\phi = 97\%$  for  $t = 18$  h; (b) emission intensity of the aluminum line at 396.15 nm (hatched: carrier foil); (c) background-corrected emission intensity of the lithium line at 610.36 nm (hatched: carrier foil); points represent the mean values and the error bars the standard deviation.

For the investigation of the crystallite, a positive electrode foil was examined that was stored for 18 h at 97% humidity. Two different areas of the NMC coating were investigated. One where no crystallization or bloom was detected (P1, Fig. 7a) and one with a salt-like bloom on the surface (P2, Fig. 7a). Figure 7b shows the intensity of the emission line of aluminum at 396.15 nm on the two areas P1 and P2 for different ablation steps. For P1 the emission intensities of the ablation steps 1 to 5 merely represent the fluctuation of the background signal, while the intensity increases abruptly from the 6th ablation step until the aluminum substrate is finally detected in the 7th and 8th ablation step (blue squares in Fig. 7b). For P2 already in the first ablation step, a considerably higher aluminum content is detectable, which is almost equally distributed throughout the entire NMC coating up to ablation step 6. With the 7th ablation step, the aluminum foil should be reached, but the emission intensity of aluminum increases only slightly even at depths of  $> 65$   $\mu$ m and does not reach the values achieved for P1 (red squares in Fig. 7b). This loss of intensity indicates a significant destruction of the aluminum foil directly below the salt-like bloom.

Figure 7c compares the intensities of the lithium line as a function of ablation depth on a visually undisturbed area of the NMC coating at P1 and the salt-like bloom at P2. Without exception, the undisturbed NMC coating at P1 shows a significantly higher lithium signal over the entire coating thickness. After the 6th ablation step, the NMC coating at P1 is completely penetrated and the aluminum foil is reached. The lithium emission intensity still present can be attributed here to edge effects of the ablation crater. In parallel, the difference in emission intensities of the measurements of point 1 and point 2 are recorded for nickel (231.60 nm), cobalt (228.62 nm) and manganese (257.61 nm) and also for iron (240.49 nm) and phosphorus (213.62 nm) within the NMC coating. There are no significant differences between the measurements of point 1 and point 2 (Supplementary Figure S3 online). P2, on the other hand, shows significantly lower emission intensity for lithium, indicating that the lithium is deintercalated from the NMC present by the impact of moisture. Of significance, the 1st ablation for the salt-like compound on P2 shows signals only for aluminum and lithium. This supports the hypothesis that the blooms and crystallites contain at least some lithium content that was removed from the NMC of the coating and led to its degradation.

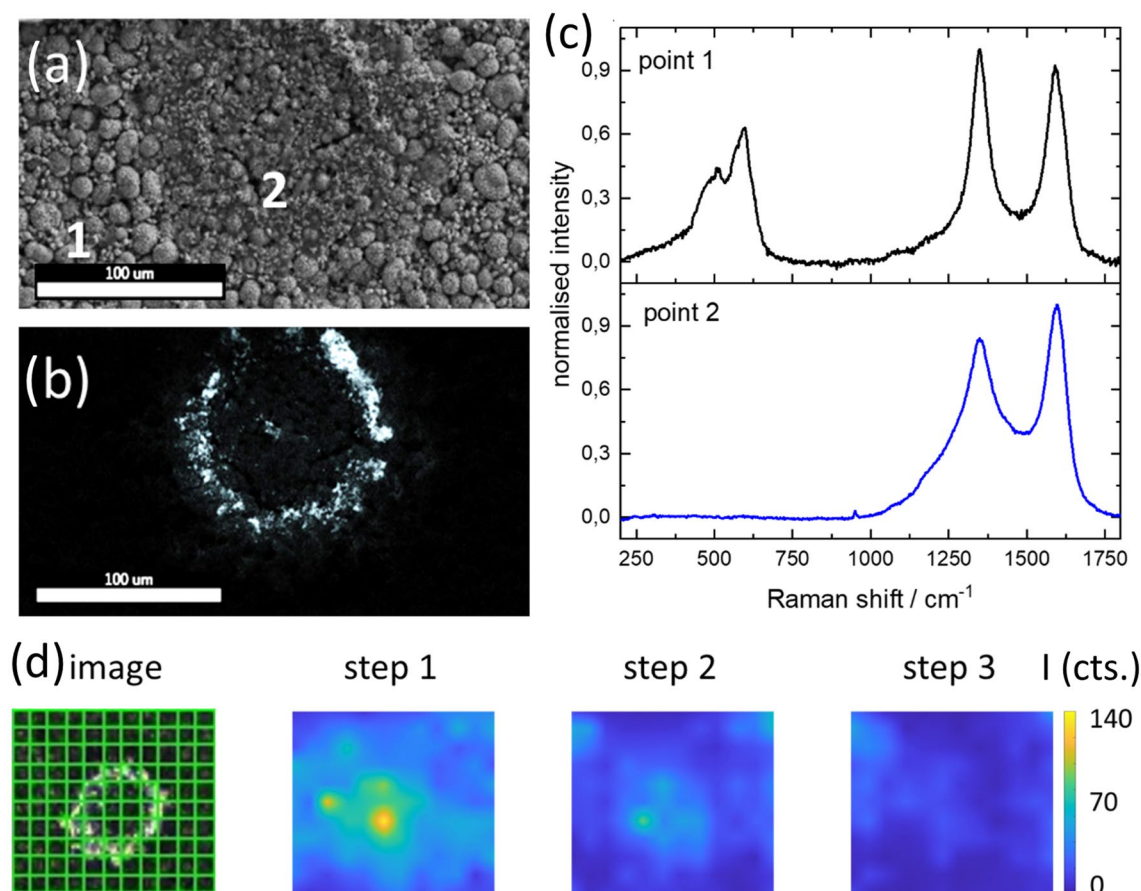
**Figure 8.** (a) SEM image of a local degradation NMC backside (contact surface aluminum-NMC) 1) non-degraded area, 2) degraded area; (b) EDX mapping of aluminum; (c) Raman spectra of point 1 and 2 d) LIBS analysis of a crater of the NMC backside for aluminum @ 396.15 nm, step means ablation step, size of mapped area  $200 \mu\text{m} \times 220 \mu\text{m}$ , the color bar displays the color associated with the absolute intensity (I in cts.)

In the course of the investigations, it was possible to completely separate the contact surface NMC coating—aluminum foil of a positive electrode foil with salt-like blooms by removing it with an adhesive strip. Figure 8a shows the SEM image and Fig. 8b an EDX mapping for aluminum of the NMC coating that was directly on the aluminum foil. A crater-shaped structure can be seen. Inside these craters (Fig. 8a, area 2), the positive electrode material seems to have undergone strong morphological degradation, so that secondary particles are no longer visible. Around the crater (Fig. 8a, area 1), on the other hand, there is no evidence of morphological degradation. What Fig. 8a is not able to show becomes visible in EDX mapping for aluminum or in a light image. The inner area 2 is separated from the outer area 2 by a thin rim of an aluminum-containing deposit.

The Raman microscopic analysis of both areas shows that the degradation in area 2 is not only morphologically but also chemically advanced to a high degree. Thus, the Raman spectra in area 1 without degradation (Fig. 8c, point 1) show vibrations typical for the NMC between 300 and 700  $\text{cm}^{-1}$ <sup>42</sup> and the D and G bands of the conductive graphite (1350  $\text{cm}^{-1}$ , 1590  $\text{cm}^{-1}$ )<sup>49</sup>. Inside the crater, however, the vibrations typical for the NMC are completely absent (Fig. 8a,c, point 2), which indicates the destruction of the layered oxide structure in addition to the proven destruction of the secondary particles.

An example of crystallization containing aluminum that has not yet reached the surface of the positive electrode coating is shown in Fig. 8d. The area shown in Fig. 8d was mapped with LIBS with a step size of 20  $\mu\text{m}$  and the intensity of the aluminum line at 396.15 nm was determined for three consecutive ablation steps. The results show that at different ablation steps (Fig. 8d) a decrease in the aluminum signal is observed with each new ablation step, which most probably correspond to a concentration gradient of aluminum in the NMC coating. Aluminum is considerably enriched at the aluminum/NMC coating interface in the area of the crater and was transported from there through the NMC coating towards the surface. The fact that the aluminum is no longer clearly detectable in the third ablation step suggests that it has not yet reached the surface at this point and thus no bloom has yet occurred on the surface.

As Fig. 8d shows, the measurement grid includes both the circular, aluminum-containing area and its surroundings, in which no aluminum was detected and the NMC coating was obviously not subject to any recognizable degradation. The emission intensities of the transition metals nickel, cobalt and manganese do not show any systematic deviations in the entire area and for each ablation step, which is why these elements can be considered as equally distributed in the measurement area (Supplementary Figure S4 online). Accordingly, the transition metals also exist within the crater of their original distribution and magnitude, but the structure for lithium intercalation is largely destroyed on the basis of the Raman investigations (Fig. 8c) however, no systematic distribution during the individual ablation steps could be detected for lithium.
