# SWBSS 2017

## Fourth International Conference on Salt Weathering of Buildings and Stone Sculptures

# **Proceedings of SWBSS 2017**

**Fourth International Conference on  
Salt Weathering of Buildings and Stone  
Sculptures**

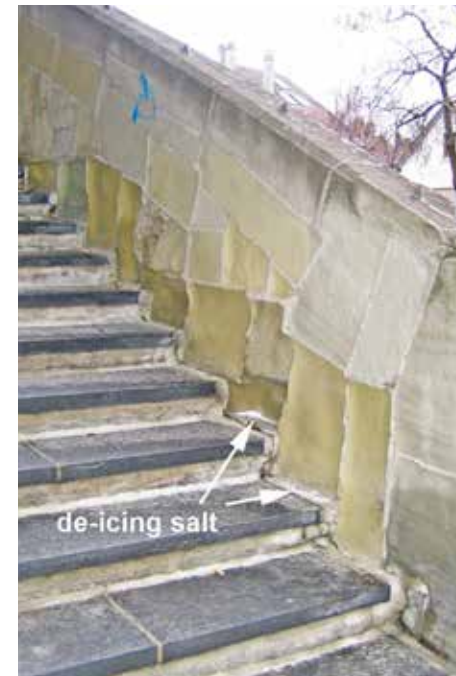
Figure 1: Lausanne (canton de Vaud, CH), Pierre Viret stairs (20.01.2010). Deicing salts are spread lavishly on the practically non-porous gneiss, and the salt and melted snow mixture accumulates at the base of the porous molasse-sandstone bridge wall that promptly powders and disaggregates.

When considering the effect of deicing salts on buildings and constructions the immediate image that comes to mind is the damage at the foot of walls, resulting from the rising damp from the solution of the melted snow and salts, as shown in *Figure 1*.

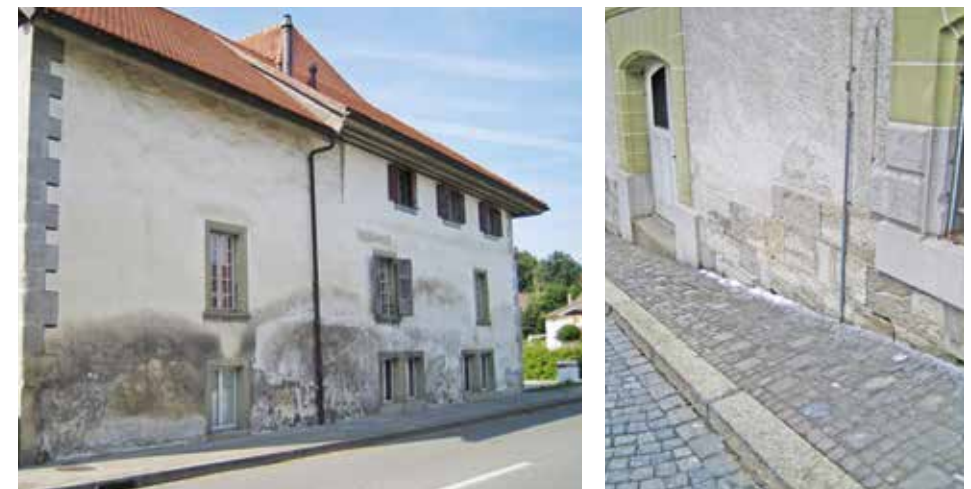
Figure 2: Left: Belfaux (canton de Fribourg, CH), north façade of the Lanthen-Heid manor (1526). The damages that affect the render and the underlying molasse-sandstone are mainly the result of splashing traffic along this street (3.09.2008). Right: Lausanne (canton de Vaud, CH), rue Saint-Etienne (20.01.2010). During dry winter cycles the residues of recrystallized deicing salts can be seen at the foot of façades that can either be mobilized and suspended in the air or enter the material when dissolved in water via hygroscopicity, rain, or more snow.

Experience has shown that to this deterioration mechanism two other direct contamination processes have to be added. The first one occurs in damp winter conditions and affects buildings located along high traffic roads, where topography contributes to accumulate the salt containing melted snow and that vehicular traffic and snow clearance vehicles splash on to the building walls or disperse into the air so that they enter directly at a certain height (*Figure 2* left). The second process occurs during dryer winter periods when the excess deicing salts applied recrystallize and accumulate at the base of buildings (*Figure 2* right).

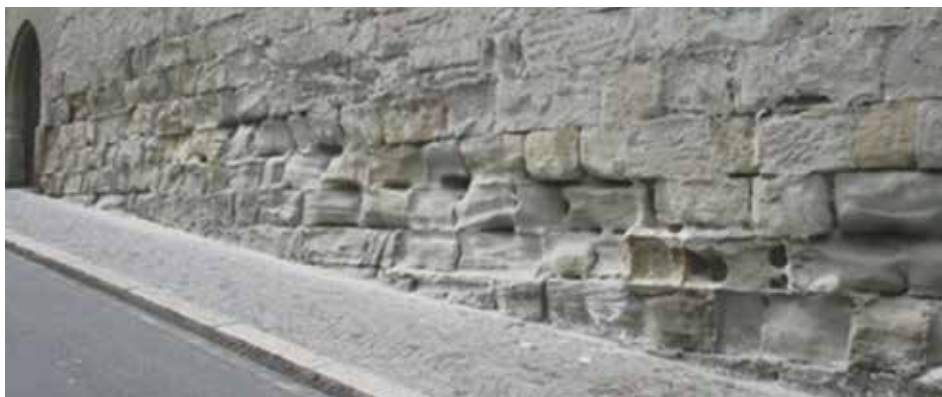
Figure 3: Lausanne (canton de Vaud, CH), rue de la Barre, Château Saint-Maire (10.04.2012). The sanding and disaggregation that affects the base of the building and up to 2 m in some areas is mainly due to the presence of NaCl.

In certain streets, where regular and intense winds are prevalent, the salt grains on the ground can be mobilized and suspended in the air, as well as thrown against the façades by whirl winds. If the building surfaces are moist or rough, the salts will be “attached” to them and deterioration will eventually occur (*Figure 3*).

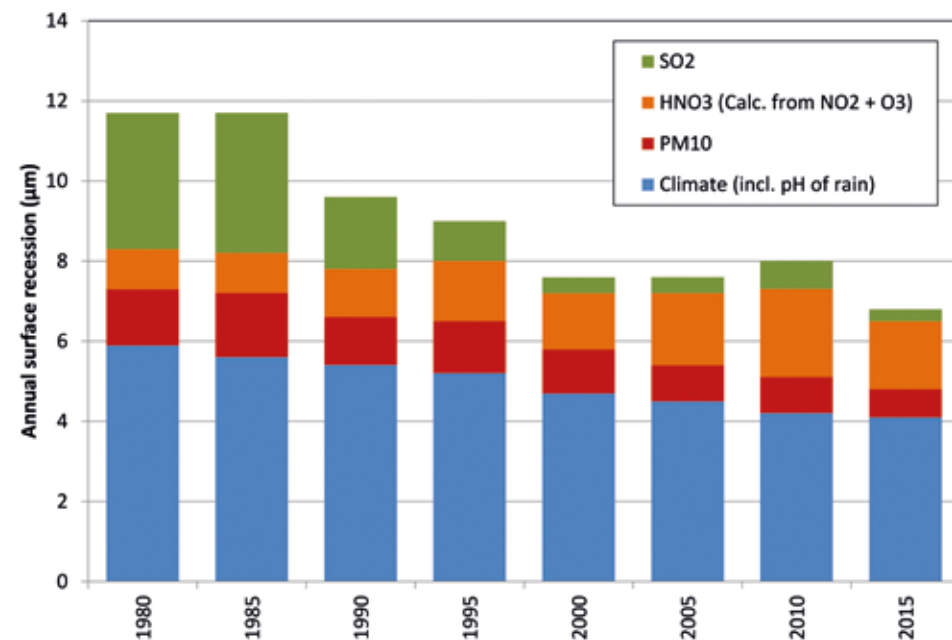
Figure 2: Calculated recession rates of Portland limestone under environmental conditions of the Karlsplatz at Munich during the last 35 years. Modified from<sup>9</sup>

Calculation of recession rates of the reference material Portland limestone via the MULTI ASSESS formulae<sup>5</sup> show a decline of recession caused by the lowering of pollutant concentrations with time. These calculations need an input of data of air pollution (SO<sub>2</sub>, HNO<sub>3</sub>, pH of precipitation) and climate (relative humidity). Missing HNO<sub>3</sub> data are calculated from the concentrations of NO<sub>x</sub> (calculated as NO<sub>2</sub>) and ozone, and relative humidity<sup>5</sup>. By setting one of these factors after another to zero, the influence of the single pollutants on the calculated recession rate can be evaluated. Fig. 2 shows the result of such calculations with environmental and meteorological data from Munich. Although the recession rate decreases continually with time, an increasing impact of HNO<sub>3</sub> (more precisely NO<sub>2</sub> and O<sub>3</sub>) on the weathering of limestone is observed.

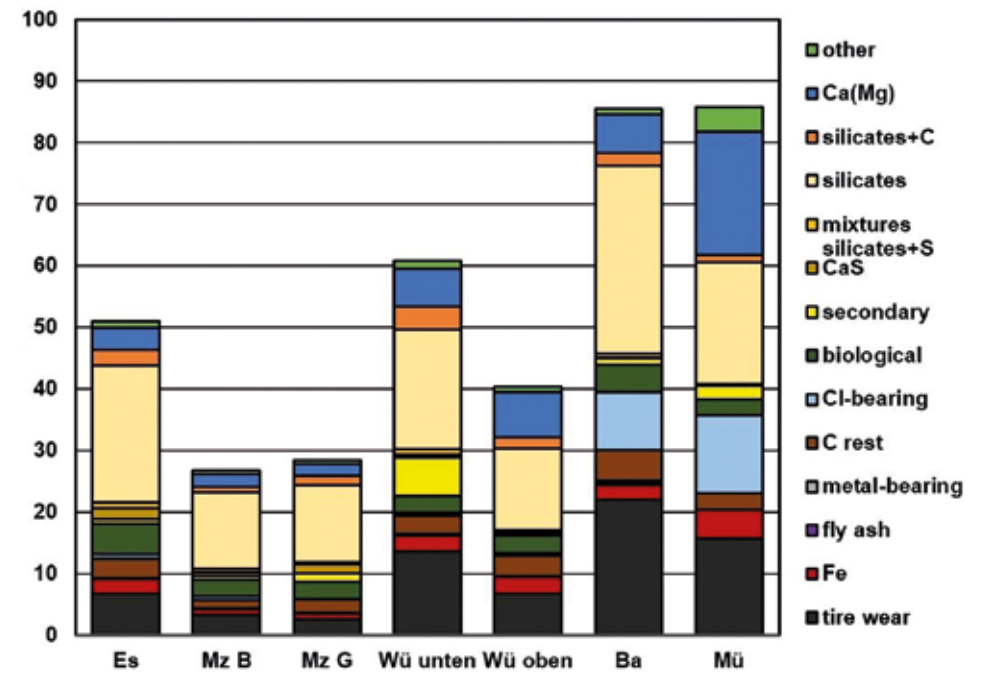
Figure 4: Calculated annual area coverage by particle deposition. From <sup>11</sup>

ce might be covered by chloride particles after one year (Fig. 4). The deposition of redispersed chloride particles predominantly affects the lower parts of buildings, but in two cases it was found also in remarkable height (MZ, low and WU, up). Using surface activated monitors (SAM), the deposition rates are higher for nitrate compared to sulphate. Using however natural stone samples, more sulphate than nitrate is deposited (Fig. 5). It is supposed, that this is caused by the ability of the SAM-samplers to bind nitrogen oxide gaseous substances chemically, while at stone surfaces gaseous substances are only bound physically by weak adhesion forces. So the input on SAM-filters seems to depend on the concentration of NO<sub>x</sub>-gases, while the input on stone samples is assumed to be determined by the formation of HNO<sub>3</sub>.

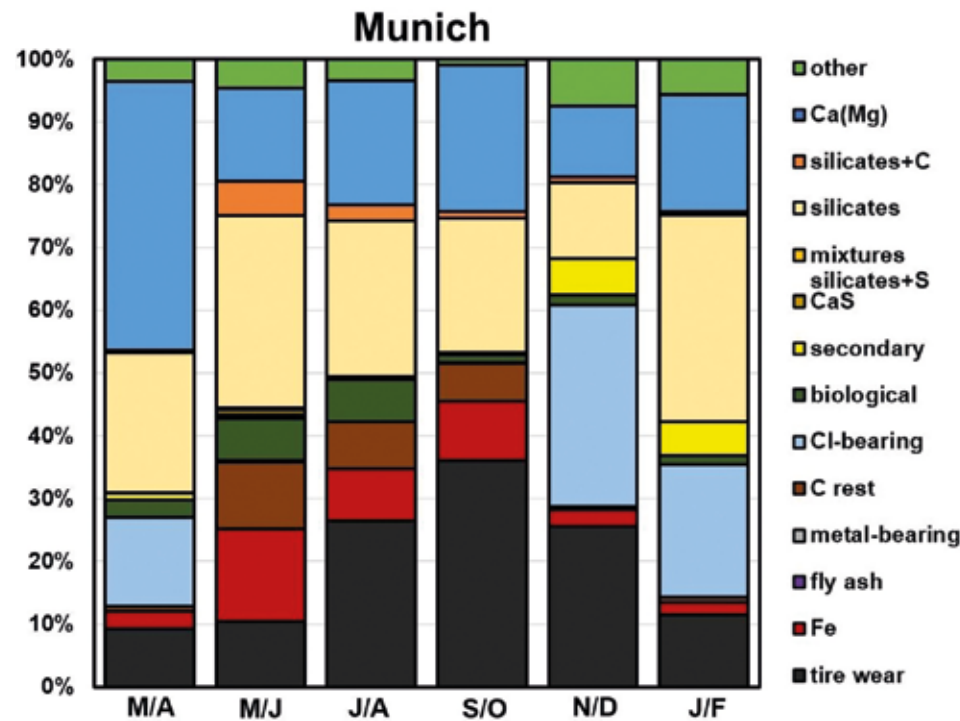
Figure 3: Variation of the composition of deposited particles > 3 µm at Munich (relative surface coverage). Letters on x-axis indicate bi-monthly sampling. From <sup>11</sup>

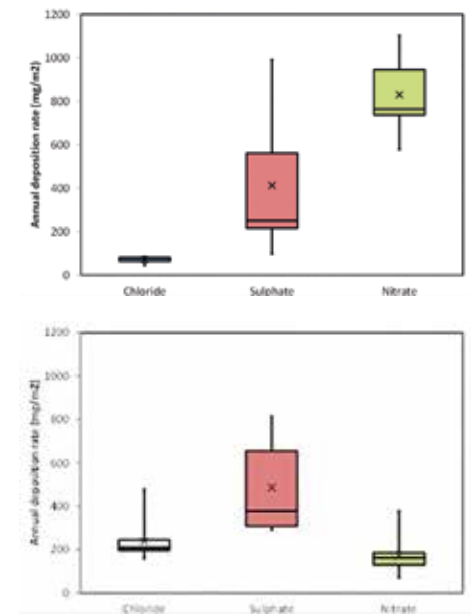
Figure 5: Annual deposition of salts on passive samplers from historic buildings situated at traffic-rich urban main roads. Left: Results for SAM-samplers. Right: Results for stone samples.

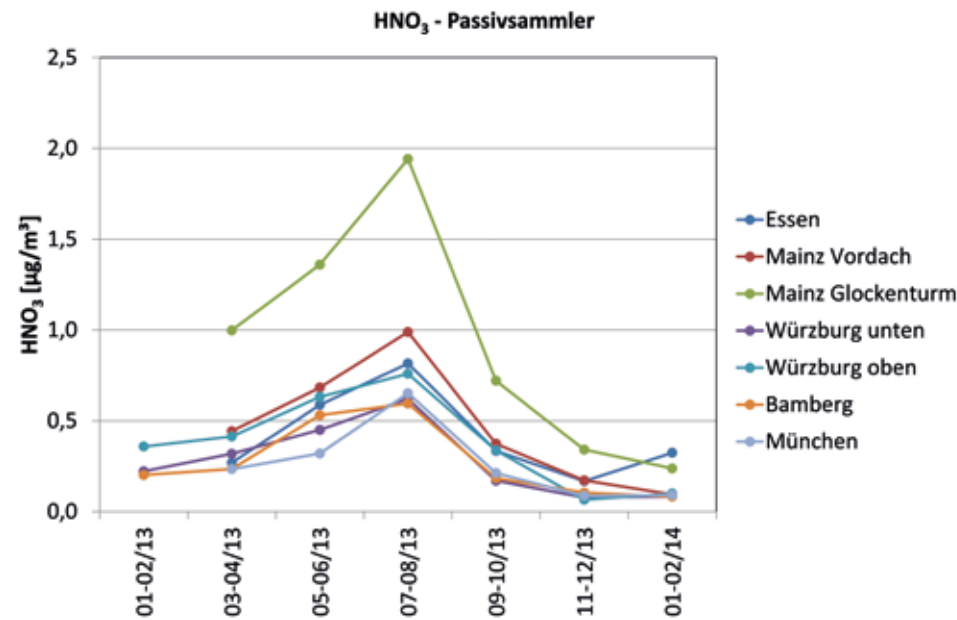
Figure 6: Results from passive sampling of HNO<sub>3</sub> at various facades. Data by courtesy of the Swedish Corrosion Institute, from <sup>12</sup>

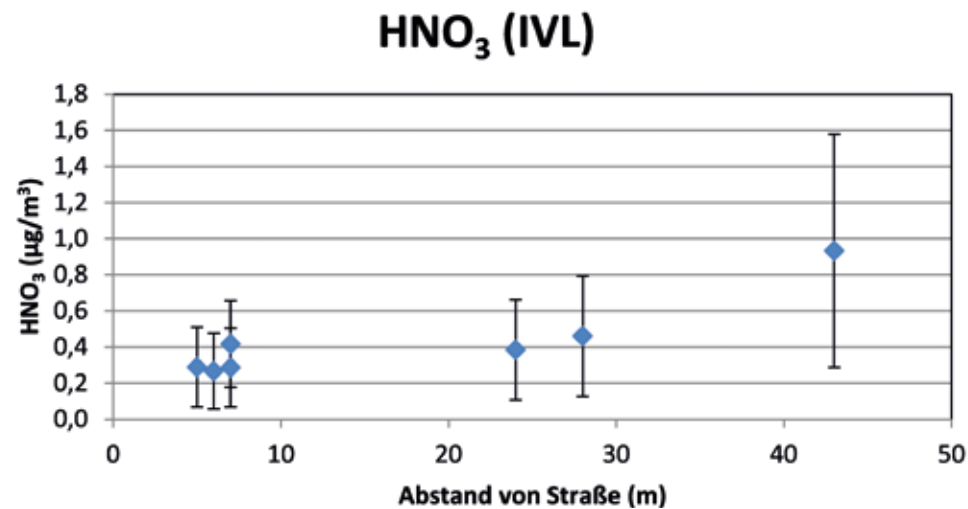
Figure 7: Mean values of the data from figure 6, ordered by the distance from the emission source. Data: see fig. 6

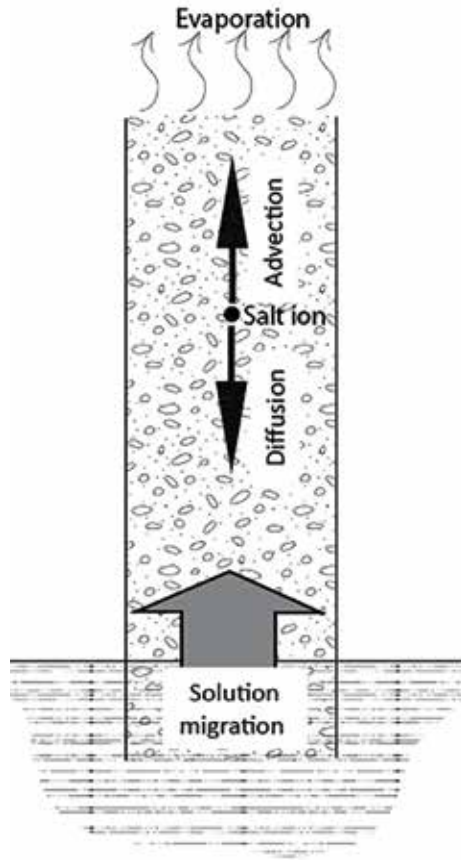
Figure 1: A schematic representation of wick action: one side of an object is absorbing a salt solution, whereas at the same time other side is drying. As a result there will be a continuous flow of ion towards the drying surface.

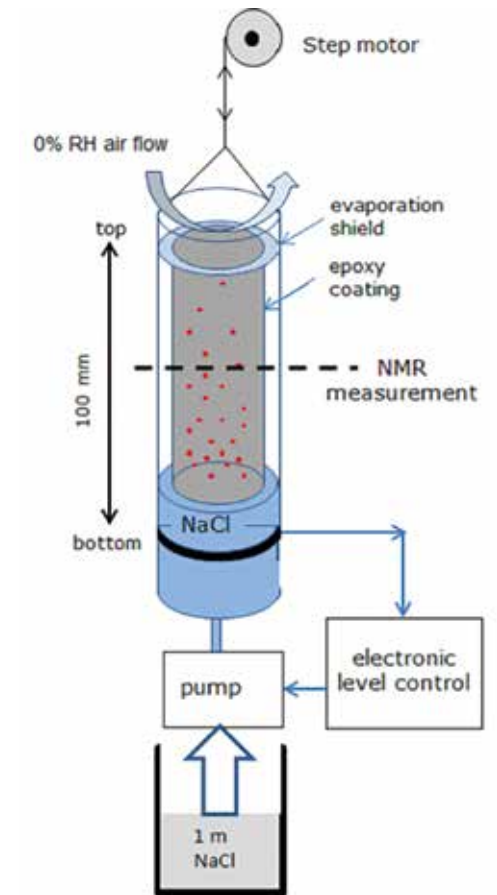
Figure 2: A schematic representation of the setup for measuring the wick action using NMR. With an electronic level control and a pump the reservoir level is kept constant.

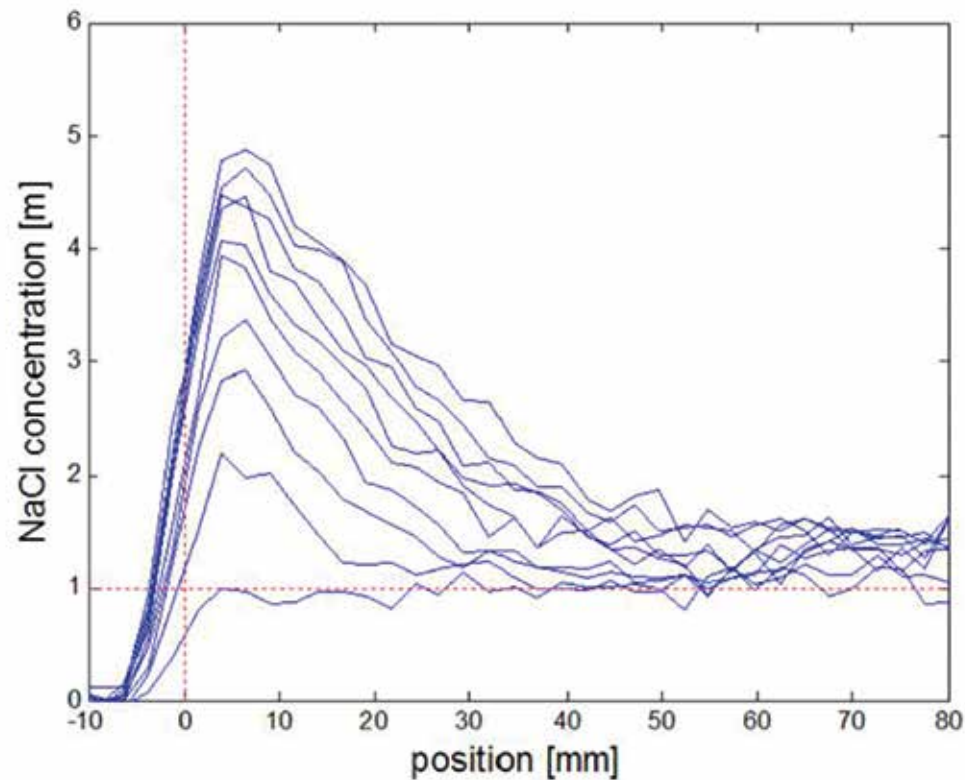
Figure 3: The measured Na-concentration profiles using NMR during wick action of a sample of 100 mm in length and a reservoir of 1m at  $x=100$  mm. The profiles are given for every 4 days for a total time of 40 days.

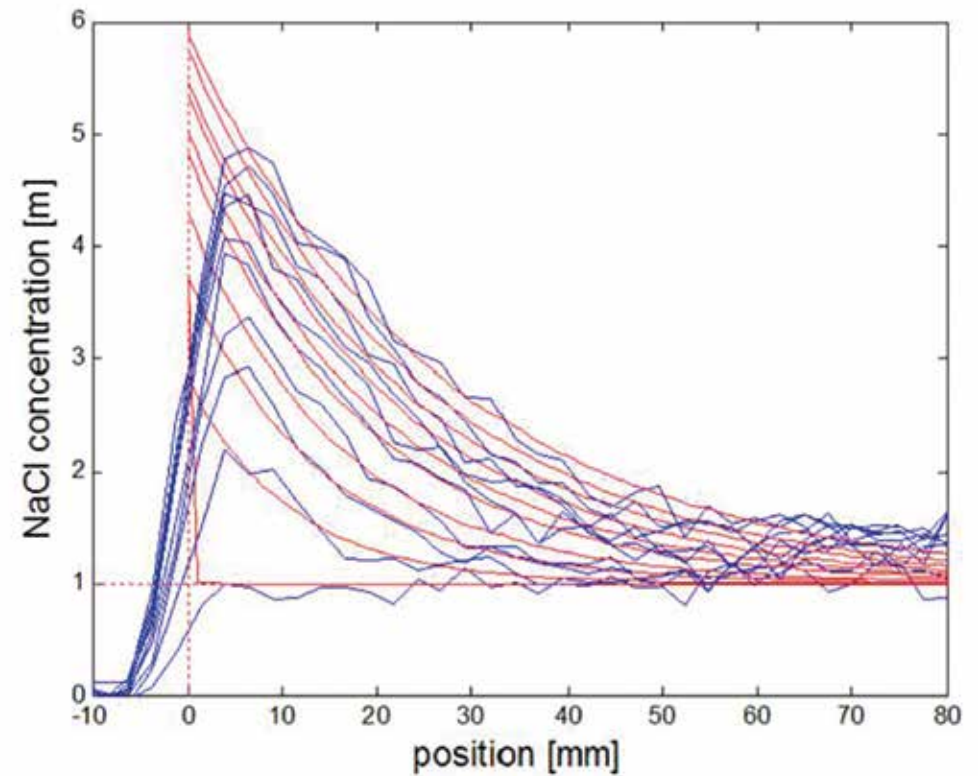
Figure 4: The measured Na-concentration profiles during wick action of a sample of 100 mm in length and a reservoir of 1m. The profiles are given for every 4 days for a total time of 40 days. The smooth curves represent fits of the model to each individual profile.

at the top is slowly increasing with time indicating  $Pe > 1$ , whereas at the bottom of the sample the concentration remains almost constant reflecting the constant concentration of the reservoir.

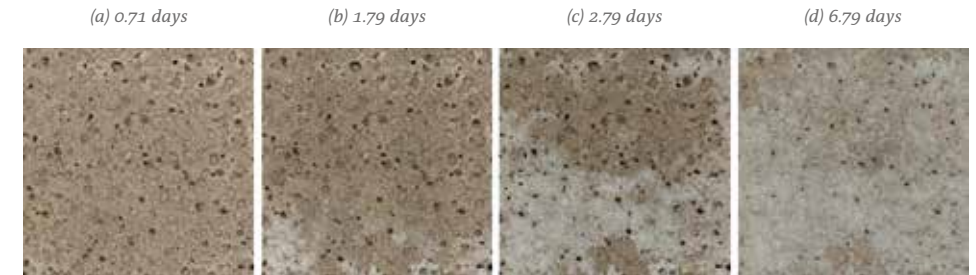
Figure 1: Photographs of the center ( $2.4\text{ cm} \times 2.4\text{ cm}$ ) of the top surface of the specimen taken at the drying stage

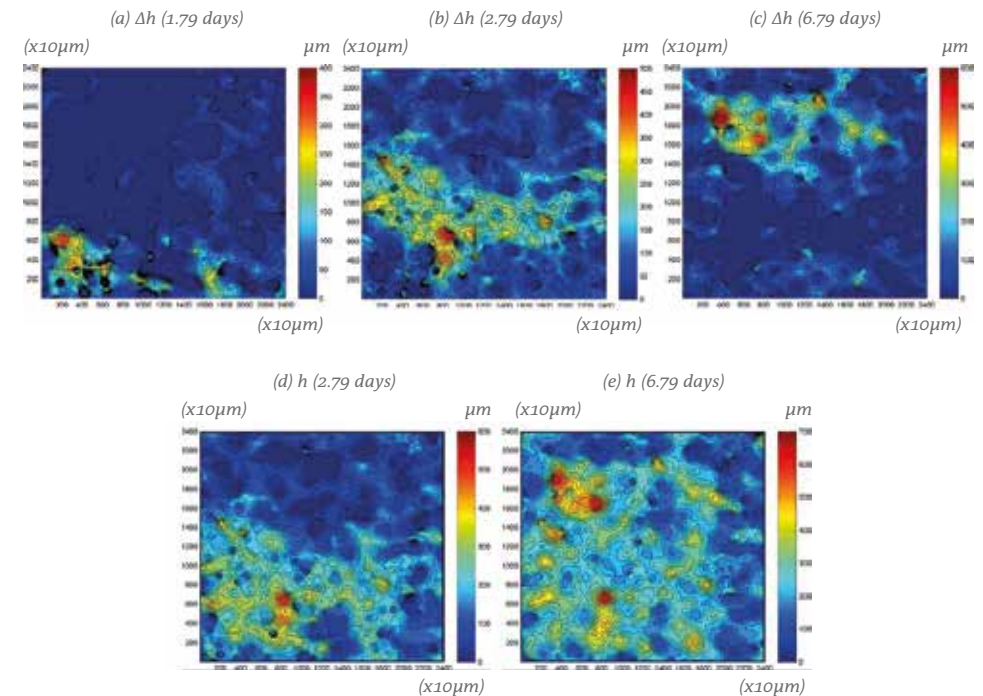
Figure 2: The spatial distribution of (a, b, c) the height change  $\Delta h$  of salt crystallizing on the top surface ( $2.4\text{ cm} \times 2.4\text{ cm}$ ) of the specimen for three consecutive drying periods and (d, e) the height  $h$  at the end of the last two periods (2.79 and 6.79 days). (a)  $\Delta h$  for 26 hours between 0.71 and 1.79 days; (b)  $\Delta h$  for 24 hours between 1.79 and 2.79 days; and (c)  $\Delta h$  for 96 hours between 2.79 and 6.79 days.

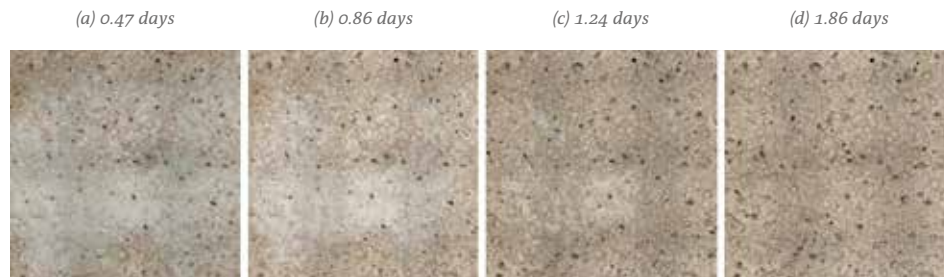
Figure 3: Photographs of the center (2.4 cm x 2.4 cm) of the top surface of the specimen taken at the wetting stage

Photographs of the center of the top surface of the specimen taken at  $t=0.47$ , 0.86, 1.24 and 1.86 days during the wetting stage are given in Figure 3. The decrement  $\Delta h$  of the height  $h$  of salt on the specimen surface at the wetting stage and  $h$  at  $t=0.86$ , 1.24 and 1.86 days are illustrated in Figure 4. Note that  $h$  is equal to 0 at  $t=1.86$  days.

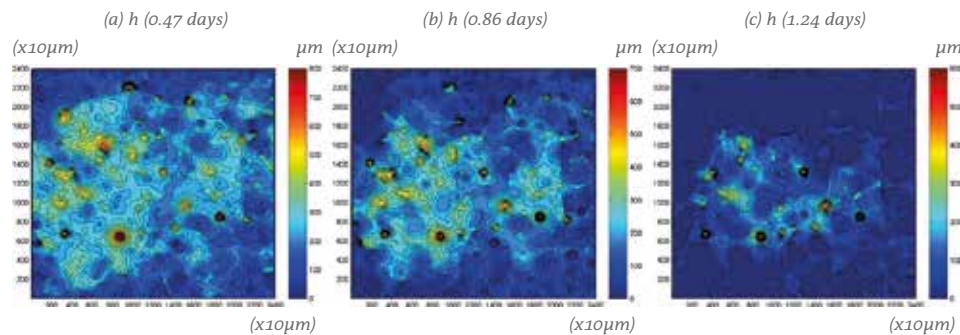
Figure 4: The spatial distribution of the height  $h$  of salt deliquescing on the top surface (2.4 cm x 2.4 cm) of the specimen at  $t = 0.47, 0.86$  and  $1.24$  days of wetting periods.  $h$  is defined to be 0 at 1.86 days.

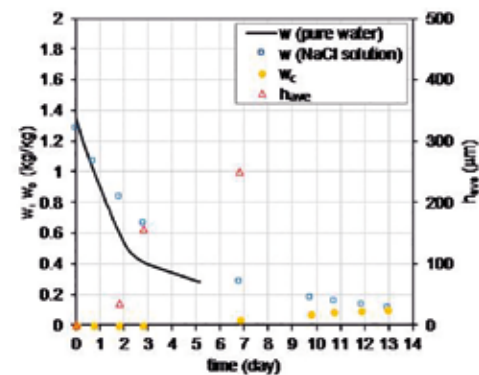
Figure 5: The average moisture content  $w$ , the estimated precipitated salt content  $w_c$  and the average height  $h$  of salt on the specimen surface for the drying process of 13 days. The solid line shows the measurement result of  $w$  for pure water evaporation from the same specimen for 5 days.  $h$  is defined to be 0 at 0 day.

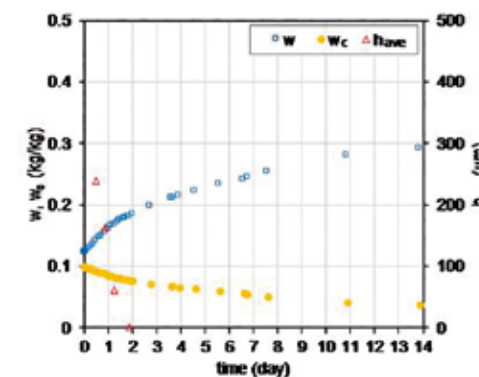
Figure 6: The average moisture content  $w$ , the estimated precipitated salt content  $w_c$  and the average height  $h$  of salt on the specimen surface for the wetting process of 8 days.  $h$  is defined to be 0 at 1.86 days.

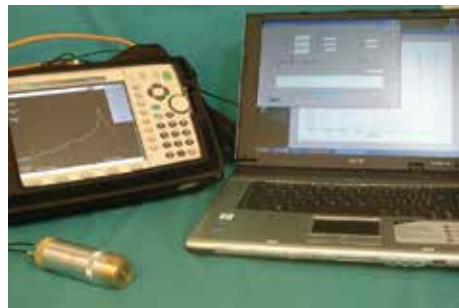
Figure 1: The SUSI<sup>®</sup> system (US Patent Specification 7,560,937 B2)

The SUSI is based on EFD technique that operates in the microwave range. The diagnostics parameters achieved by this instrumentation are the moisture content (MC) and the Salinity Index (SI) related to the presence and amount of salts. A photo of the system is shown in Figure 1. It consists of a two-port resonant probe developed for measurements on solid materials, connected to a scalar network analyser (SNA) for measuring the sensor response (the S21 scattering parameter).<sup>7</sup> The system is completed by a numerical code, running on a PC.

The probe (on the bottom left side) is an open resonant cavity able to check the material without damaging it.<sup>7</sup> Both, the

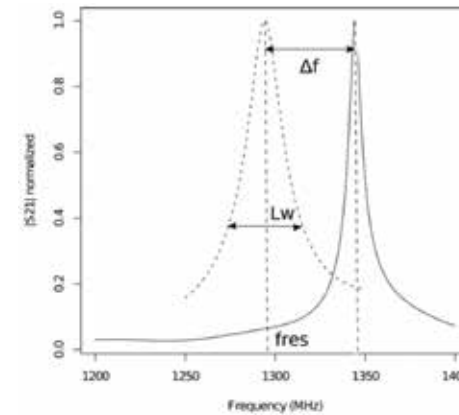
Figure 2: Principle of the SUSI<sup>®</sup> system

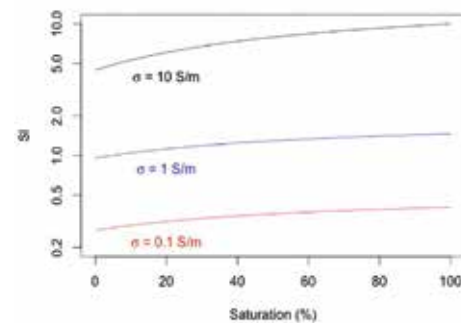
Figure 3: SI versus the saturation degree and the water conductivity

Figure 3 shows the dependence of SI computed by (4), with  $\epsilon'_c$  given by (5), on the saturation degree and on the conductivity of a saline solution filling the solid matrix, for a frequency of 1 GHz and for a porosity  $\phi = 20\%$ . The SI is arbitrarily normalized, choosing a value for the K constant in (4), such as to assume a full-saturation value of 10 for a conductivity of 10 S/m. We observe that the SI slightly depends on the saturation degree, i.e. on

the water content, but SI values relative to different material conductivities are very well separated.

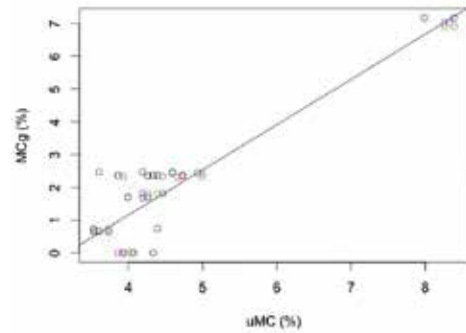
Figure 4: Gravimetric MC (MCg) versus uMC for sample M1

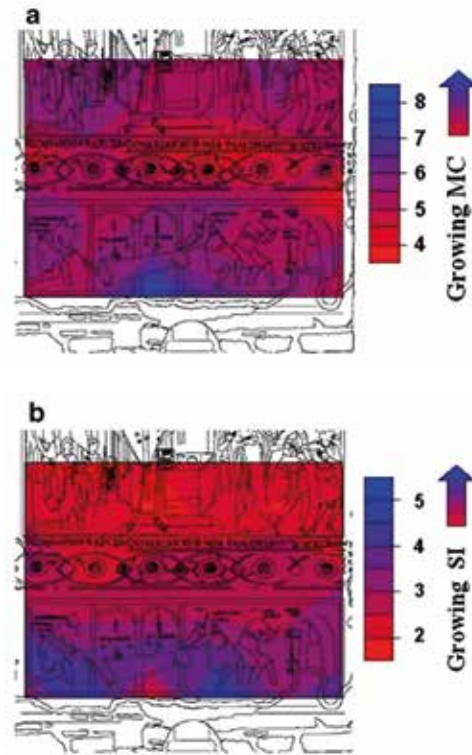
Figure 6: Maps of the distribution of (a) moisture content and (b) of the salinity index

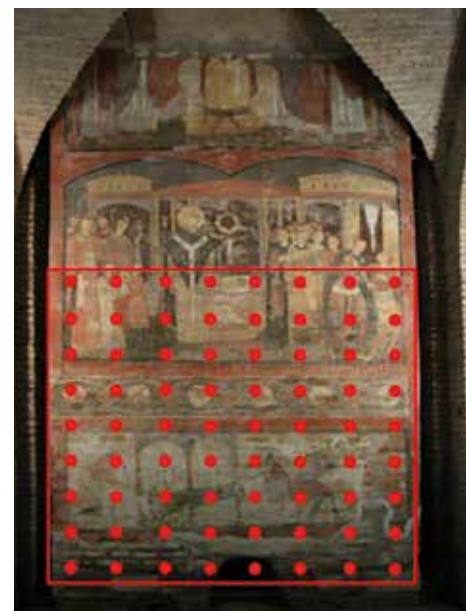
Figure 5: St. Clement at mass and the legend of Sisinnius wall painting. The solid red framework indicates the area investigated by SUSI system and circles represent the points where measurements were performed

22°C), and capillary rise of water from the ground below.<sup>15</sup> On the wall paintings, the typical degradation processes induced by rising damp were present: whitening of the painted layer, salt crystallization, biological microorganism attacks (algae, bacteria, etc.). In particular, on the St. Clement at mass and the legend of Sisinnius, wide areas of salt efflorescence and thick encrustations were present.

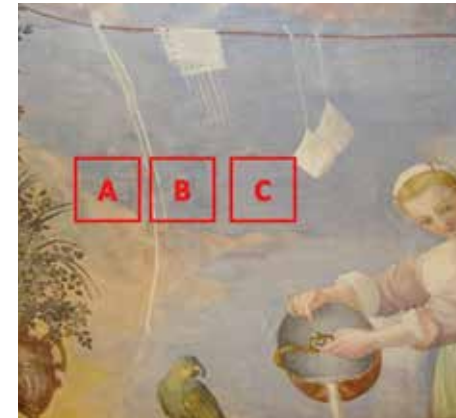
Figure 7: The wall painting of the Allori's small loggia in the Pitti Palace.

Firenze are summarized. Figure 7 shows the portion of the wall painting where the poultrices were applied. On the area labelled with A, a cellulose pulp (bc1000 and bc 200) was applied; on area B the mixing of cellulose pulp, sepiolite clay and sand in different ratios (6 parts of arbolcel bw 40/6 parts of sepiolite clay/6 parts of sand was applied); and, on area C the Cocoon<sup>®</sup> by Westox was applied. The effectiveness of each poultrice was evaluated by SUSI measurements applying the following protocols:

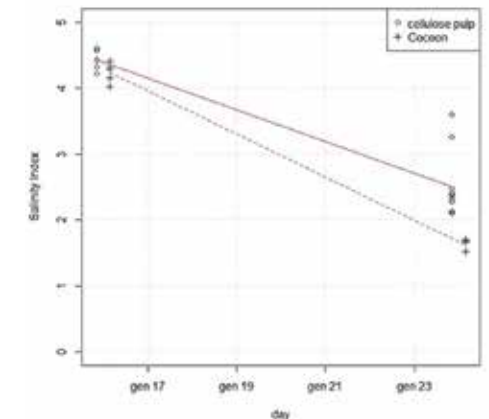
Figure 8: Plots of Salinity Index for two kinds of extractive poultrices

Figure 8 shows the results regarding two kinds of poultrice: cellulose pulp and Cocoon. The Cocoon poultrice demonstrates a better effectiveness after 7 days with respect to the cellulose pulp, while the poultrice made by mixing cellulose pulp and sand didn't provide good results.

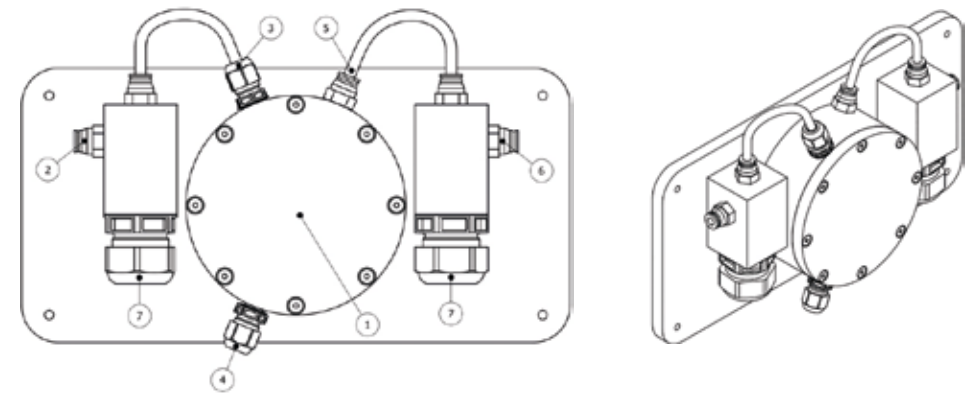
Figure 1: Schematic diagrams of the chamber used for the measurements of moisture flow, showing a front view (left) and a 3D representation (right). Numbers represent (1) cylindrical chamber, (2), (3) inlet and (5), (6) outlet ports for the air flow, (4) external power supply for the ventilating fan and (7) positions for the RH/T sensors at the entrance and the exit of the chamber.

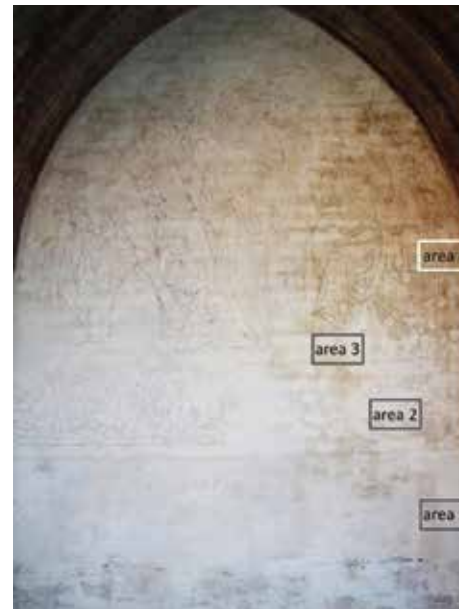
Figure 2: Bay no. 5, cloister of St. Peter Cathedral in Schleswig. Measurement areas 1 to 4 are depicted.

The chamber method was used on different parts of the most affected bay no. 5 which is depicted in Figure 2. The area under the frieze is not pigmented and comprises a fresh and even lime plaster which does not show any visible encrustations (area 1). Within the frieze which is decorated with paintings of ani-

mals (area 2) a patchy yellowish encrustation was clearly visible. The same situation was noted in area 3, while in area 4 on the upper right side of the wall painting a massive and continuous crust was observed. To all these areas the chamber was applied to measure the moisture flow during drying, implemented by passing a dry airflow through the chamber. Two or three replicate measurements were conducted on all areas except area 3.

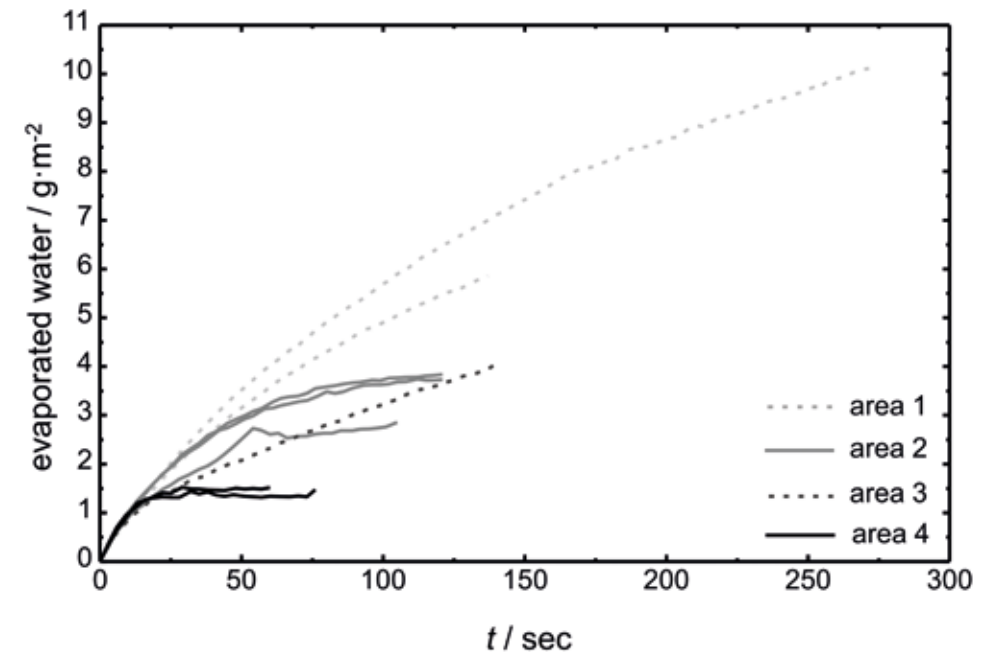
Figure 3: Evaporated water versus time curves for the four areas in bay no. 5 (see Figure 2).

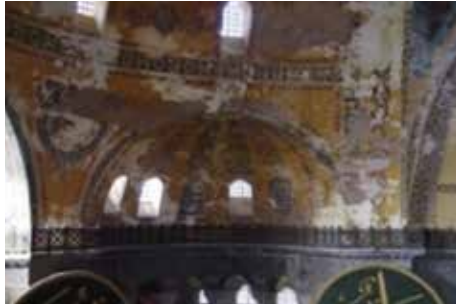
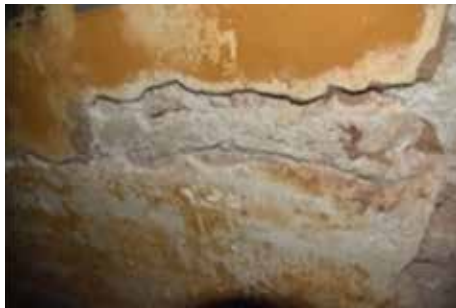
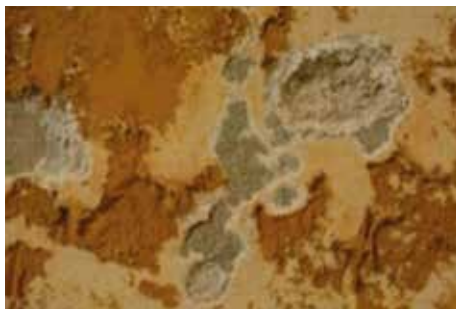
Photo 1: Deterioration of the inner walls due to salt crystallisation at Hagia Sophia, Istanbul, Turkey

Salt weathering is one of the main causes of the deterioration of brick masonry walls, which can be found at the Hagia Sophia (Aya Sophia Museum) in Istanbul (see photo 1). There are many sources of salt in the environment, including ground water, atmospheric deposition, and originally contaminated salts in the materials. In Hagia Sophia, atmospheric deposition and originally contaminated salts in the materials are assumed to be the main sources of salt that cause weathering of the structures.<sup>1</sup> In the Hagia Sophia case, there exist complex humid-dry and wet-dry cycles that complicate the deterioration process that comprises adhesion, dissolution, and infiltration processes that transfer salts from the sources in the environment. Therefore, the process is much more complex than when ground water is the main salt source. The objective of this study was to develop an analytical model of the simultaneous transfer of heat, moisture, and salt and the subsequent crystallisation and dissolution of the salt for reproducing the deterioration mechanism caused by these complex salt deterioration processes.

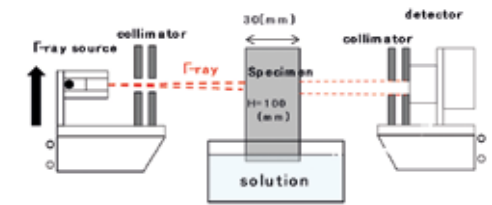
Figure 1: Schematic representation of the measurement set-up

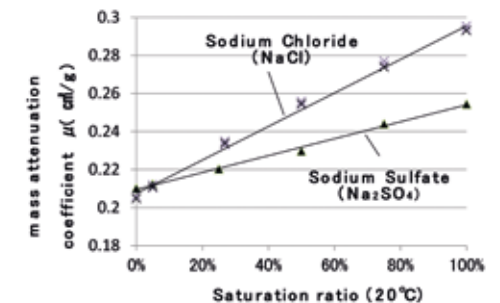
Figure 2: Mass attenuation coefficients of the salt solutions

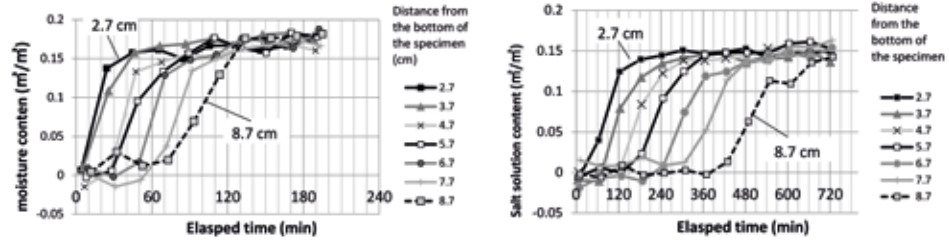
Figure 3: Change in the spatial distribution of the volumetric solution content used in TEST 13 (Left: pure water, Right: NaCl saturation)

Figures 3 and 4 show the change in the spatial distribution of volumetric solution content during TEST 13 (Left: pure water, Right: NaCl saturated solution) and TEST 14 (Left: pure water, Right: Na<sub>2</sub>SO<sub>4</sub> saturated solution), respectively. Since we assumed that the change in the concentration of salt solution would be very little during the solution uptake tests, constant values of the mass attenuation coefficient of the solution for each experimental condition were used to calculate the volumetric solution content. The moisture uptake rate of the specimens was variable. The specimens reached a near steady state in approximately two to three hours after the beginning the absorption of the pure water. The uptake rate of the saturated solutions of both NaCl and Na<sub>2</sub>SO<sub>4</sub> were significantly smaller than that of pure water, as it took approximately 12 hours for saturated solutions to reach a steady state. In addition, the uptake rate of the saturated solutions at upper locations on the specimens (7.7 cm and 8.7 cm from the bottom) became gradually slower. This tendency was assumed to be due to gravity or salt crystallisation within the material during the uptake process. This was significant in case of Na<sub>2</sub>SO<sub>4</sub>. Figure 5 illustrates the change in the spatial distribution of the solution in the specimen that absorbed the Na<sub>2</sub>SO<sub>4</sub> solution with a saturation ratio of 20%. The salt solution uptake rate was twice the rate of pure water, with a decreasing uptake rate at the upper locations of the specimen not seen. Photo 2 shows a comparison of salt crystallisation at the upper surface of the specimen after enough time had passed to allow crystal growth dissipation. In the case of the saturated solution of NaCl, salt precipitation on the surface began during the

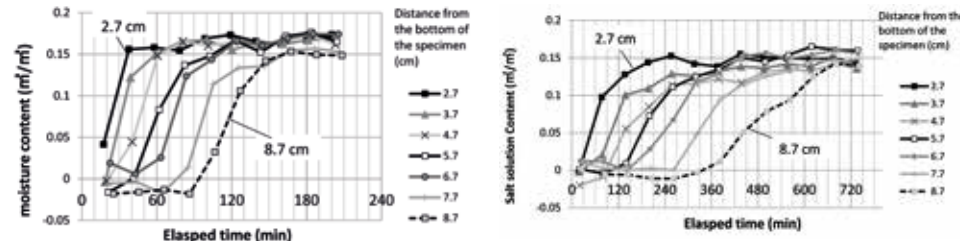
Figure 4: Change in the spatial distribution of the volumetric solution content used in TEST 14 (Left: pure water, Right: Na<sub>2</sub>SO<sub>4</sub> saturation)

solution uptake process and continued approximately 5 days after the solution uptake experiment. On the other hand, in the case of the Na<sub>2</sub>SO<sub>4</sub> saturated solution, efflorescence was not confirmed during nor after the uptake test. Na<sub>2</sub>SO<sub>4</sub> easily crystallised within the specimen because Na<sub>2</sub>SO<sub>4</sub> can change phase at a higher in relative humidity than NaCl. In the case of the Na<sub>2</sub>SO<sub>4</sub> solution with

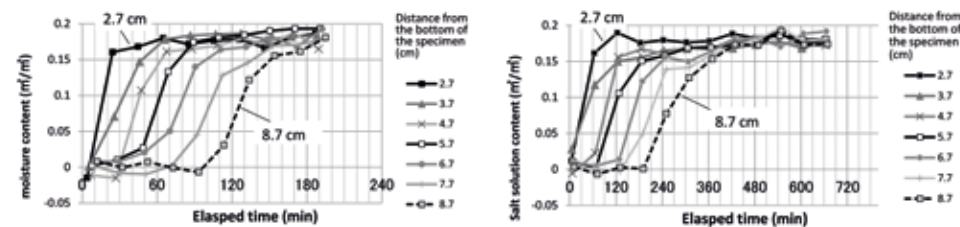
Figure 5: Change in the spatial distribution of the volumetric solution content used in TEST 17 (Left: pure water, Right: Na<sub>2</sub>SO<sub>4</sub> 20%)

the saturation ratio of 20%, salt crystals emerged at the top surface. When we conducted the same experiment at a lower relative humidity (about 25%), the process of crystallisation of the 20% Na<sub>2</sub>SO<sub>4</sub> solution was similar to that observed in the Na<sub>2</sub>SO<sub>4</sub> saturated solution, TEST 14 (see Photo 2). Therefore, a small difference in the concentration of the solution, ambient temperature, or ambient humidity may affect the crystallisation behaviour of Na<sub>2</sub>SO<sub>4</sub>, which may increase the solution uptake rate.

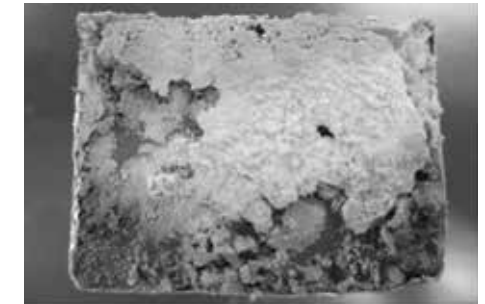
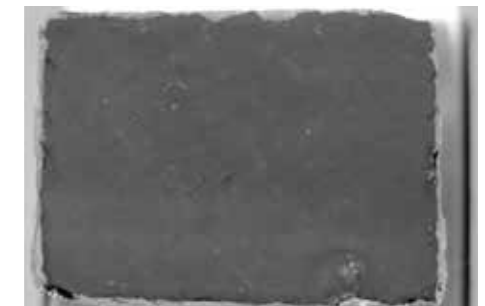
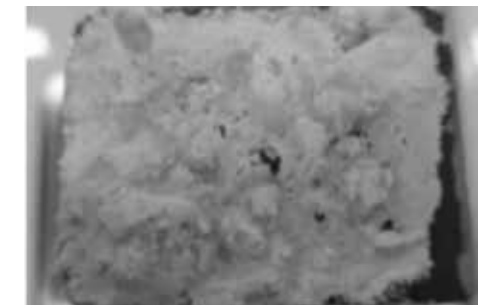
TEST 13 NaCl sat.

TEST 14 Na<sub>2</sub>SO<sub>4</sub> sat.

TEST 17 Na<sub>2</sub>SO<sub>4</sub> 20%

Photo 2: Salt crystallisation at the upper surface of the specimen

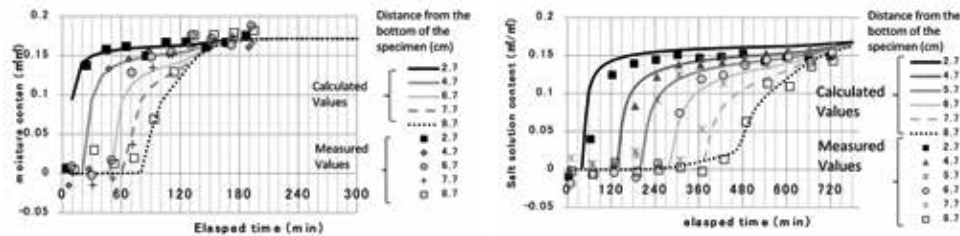
Figure 6: Comparison between the measured and calculated values of the volumetric solution content used in TEST 13 (Left: pure water, Right: NaCl sat)

used to identify the solution diffusivity in the cases of pure water and a saturated solution of NaCl. The calculated values agree with experimental values in both cases. Therefore, we concluded that the solution diffusivity can be found by multiplying the moisture diffusivity of pure water by a constant. Figure 7 illustrates the comparison between the measured values and the calculated values of solution content in the case of the Na<sub>2</sub>SO<sub>4</sub> solution. In the case of a 20% saturated solution, the calculated values of solution diffusivity can be found by multiplying the moisture diffusivity of pure water by a constant. Generally, the results correspond with the measured values (see Figure 7, Right). Alternatively, in the case of the saturated Na<sub>2</sub>SO<sub>4</sub> solution, it was difficult to replicate the measured values by simply changing the solution diffusivity to that of pure water (see Figure 7, Left). This discrepancy is thought to be due to the difference of crystalli-

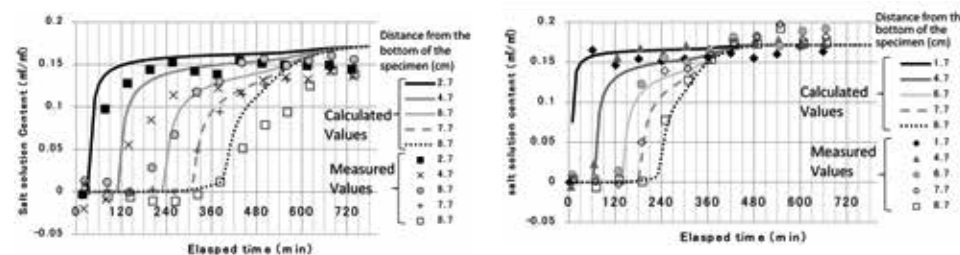
Figure 7: Comparison between the measured and calculated values of the volumetric solution content used in TEST 14 and 17 (Left: Na<sub>2</sub>SO<sub>4</sub> sat, Right: Na<sub>2</sub>SO<sub>4</sub> 20%)

sation behaviour within the specimen. Therefore, the solution diffusion model including a reduction of effective porosity due to salt crystallisation is necessary for reproducing the measured values in the case of the Na<sub>2</sub>SO<sub>4</sub> saturated solution. The Boltzmann data transformed with the Boltzmann variable  $\lambda = x \cdot t^{-1/2}$  obtained from the measured values of the saturated Na<sub>2</sub>SO<sub>4</sub> solution are shown in Figure 8 as a reference to demonstrate that the consideration of in-pore crystallisation

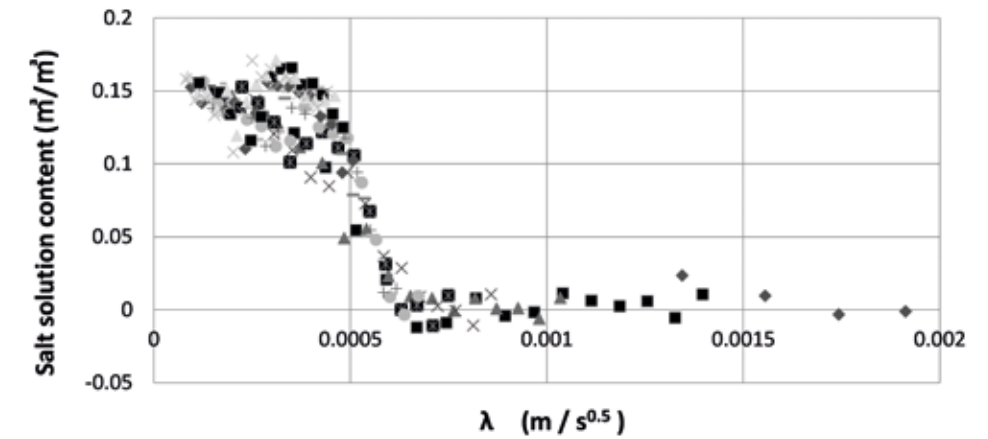
Figure 8: Boltzmann transformation of the measured solution content of the saturated Na<sub>2</sub>SO<sub>4</sub> solution

is required. The relationship of solution content and  $\lambda$  is not able to be formalised as one function because the data scattered, especially at high moisture content. Figure 9 shows the identified solution diffusivity,  $D_{sol}$  as a function of solution content. The influence of salt on solution diffusivity is so large that the value for the saturated solution of NaCl is 0.17 times smaller than that of pure water. In addition, a higher solution concentration causes smaller solution diffusivity. This

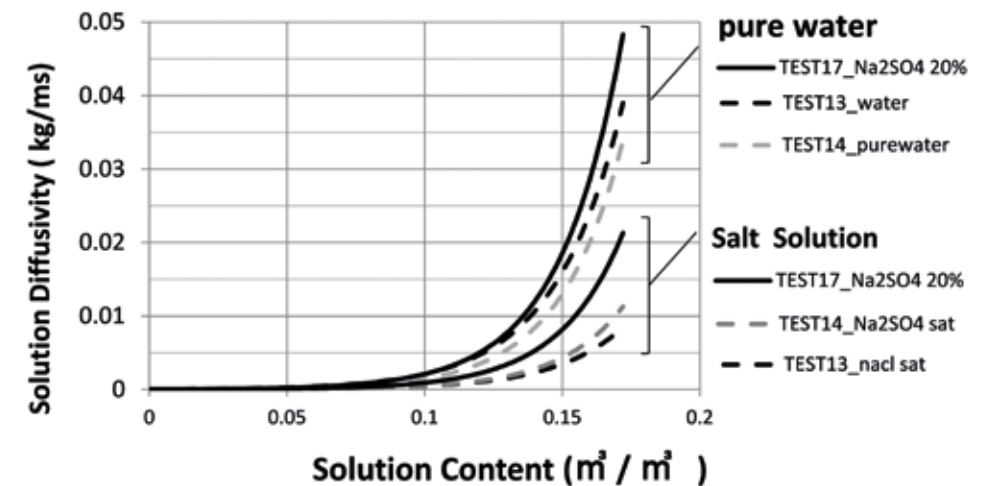
Figure 9: Identified solution diffusivity  $D_{sol}$  as a function of solution content

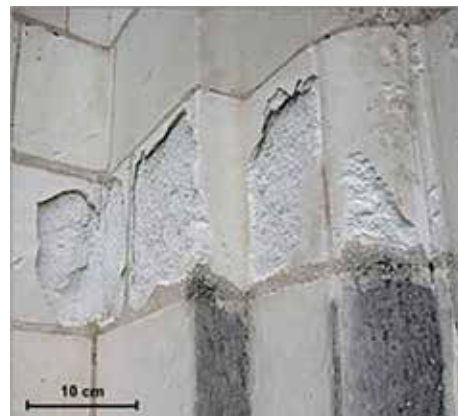
Figure 1: Example of spalling in tuffeau at the "Chateau de Chambord" (France)<sup>3</sup>

Limestones constitute the main construction materials in historical monuments and are affected by several deterioration mechanisms, among which spalling.<sup>1,2</sup> This decay is defined as a detachment of thick plates (1 to 3 cm thick) gradually formed on the surface of the stone (Fig. 1). Once the plate falls off, the resulting stone surface turns to powder. Mineralogical analysis of the degraded stone, throughout its depth, shows the presence of gypsum ( $\text{CaSO}_4 \cdot 2\text{H}_2\text{O}$ ) located mainly within a crack network parallel to the surface at 1 or 2 cm depth.<sup>3</sup> Therefore, the study of the effects of pollution on these stones is one of main aims to understand the physico-chemical mechanism leading to spalling. There is also a consensus on the role of water, which is the source of physical changes and the dissolution/ crystallization of phases. In order to further our knowledge of the reaction of stones with respect to water migration and the effect of pollution,

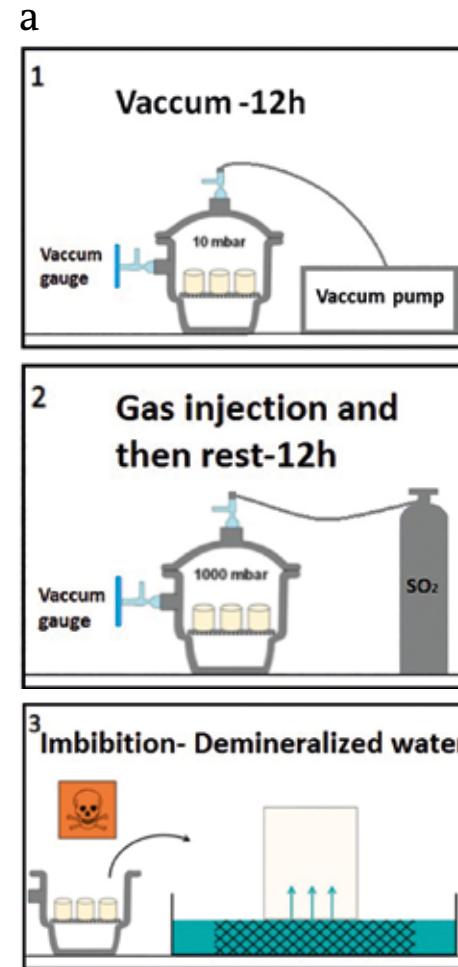
Figure 2: Sample pollution process (a), sample of tuffeau with strain gage rosettes (b)

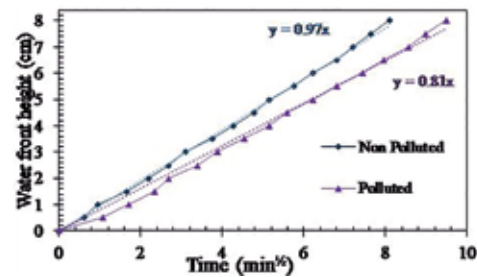
Figure 3: Imbibition curves of polluted and unpolluted tuffeau

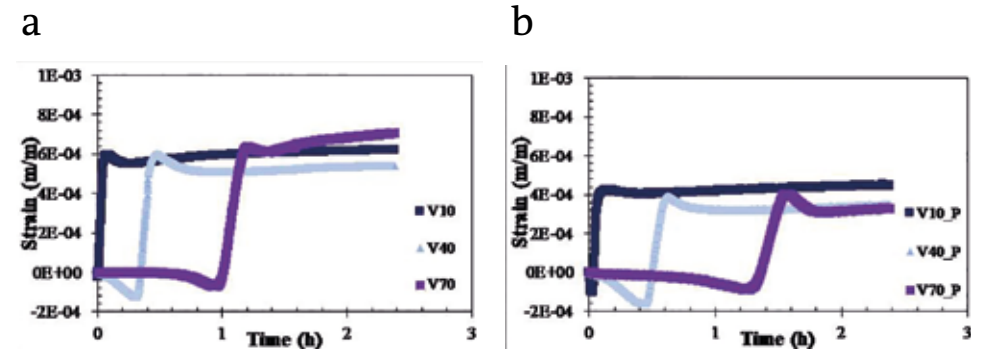
Figure 4: Vertical strains of unpolluted tuffeau (a) and polluted tuffeau (b)

Figures 4.a and 4.b show respectively the results of strain measurements of vertical gages for unpolluted and polluted tuffeau. V10, V40, V70 refer respectively to the vertical strains of gages at 10 mm, 40 mm and 70 mm of height.

While the water penetrates into the stone, local vertical strains change. During the capillary imbibition and depending on the relative location of the water with respect to the rosette, the strain may be a contraction, an exten-

sion, or a stabilization. When the water is below the rosette, the stone is locally contracted. The amplitude is estimated at  $1.6\text{E-}04\text{m/m}$  which represents 28% of total strain. Once the water reaches the rosette height, there is an abrupt extension up to a value of about  $6\text{E-}04\text{m/m}$  for unpolluted tuffeau and around  $3.8\text{E-}04\text{m/m}$  for polluted tuffeau. Then, a small contraction (relative to the amplitude of the extension) is measured, followed by a stabilization step. These stages are present for polluted and unpolluted tuffeau. Two differences were reported between the two states: The magnitude of total vertical strain was higher for unpolluted stone (around  $6\text{E-}04\text{m/m}$  against  $4\text{E-}04\text{m/m}$ ), and the imbibition rate was higher for unpolluted stone. The pollution

by gypsum decreased the total strain by 33%, which is significant.
