# SWBSS 2017

## Fourth International Conference on Salt Weathering of Buildings and Stone Sculptures

# **Proceedings of SWBSS 2017**

**Fourth International Conference on  
Salt Weathering of Buildings and Stone  
Sculptures**

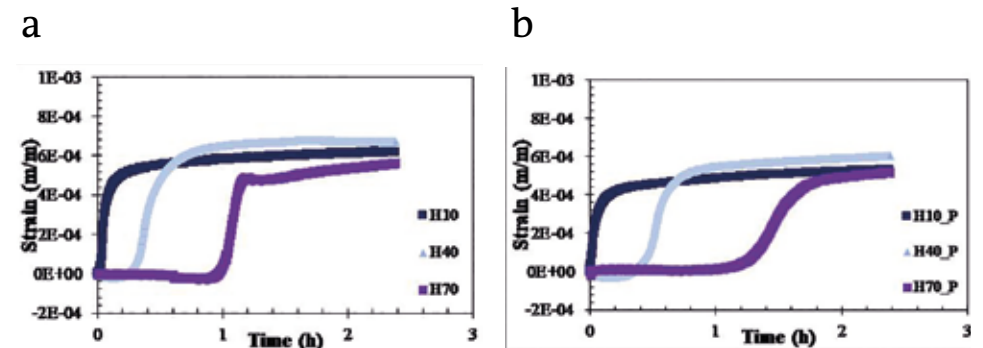
Figure 5: Horizontal strains of unpolluted tuffeau (a) and polluted tuffeau (b)

Figures 5.a and 5.b show respectively the results of strain measurements of horizontal gages for unpolluted and polluted tuffeau. H10, H40, H70 refer respectively to the vertical strains of gages at 10 mm, 40 mm and 70 mm of height. The horizontal strains show monotonous evolution in extension for polluted and unpolluted tuffeau. The same reasoning was adopted for the water front. When the water front is below the rosette, stone extension begins. Then, a sudden extension occurs when the water front reaches the rosette. A second stabilization plateau is obtained when the water front exceeds the rosette. Pollution has no real effect on the total horizontal strain value.

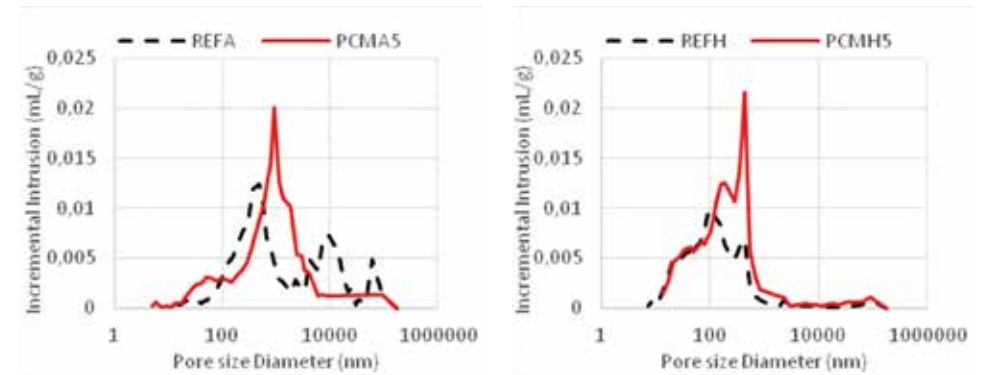
Figure 1: MIP pore size distributions for REFA & PCMA5 (left) and REFH & PCMH5 (right).

relatively higher porosity values can be attributed to the higher water demand of the PCM-enhanced mixtures in order to attain the desired workability<sup>16, 18</sup>; this may, in turn, be associated with the increased volume fraction of solids, the fineness of the microcapsules and the hydrophilic nature of their polymeric wall.

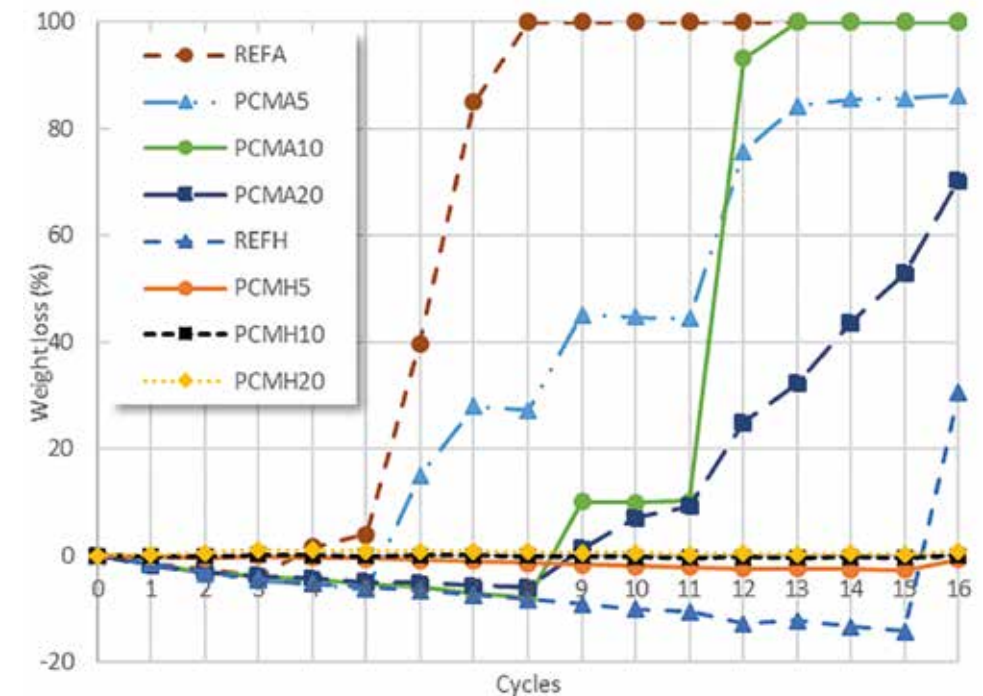
Figure 2: Weight loss of specimens after salt crystallization cycles.

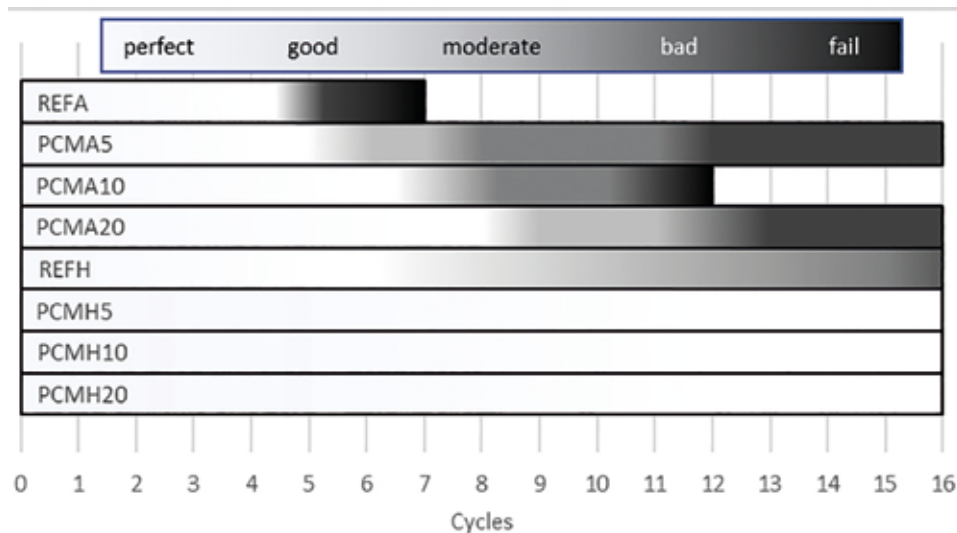
Figure 3: Qualitative evaluation of salt resistance by visual inspection of render mixtures. For explanation on the scale used see Table 2.

The alterations in several physical values (e.g. lower capillary absorption) due to the addition of PCMs led to noticeable changes in the salt crystallization resistance of the mixtures. Better durability results corresponded to the modified composites when compared with the reference mixtures. This is probably due to the reduced amount of salt absorbed owing to the low capillary absorption of the PCM-enhanced composites; a noteworthy increase of the salt crystallization resistance may also be attributed to the hydraulic binder. Visual inspection of the samples studied confirmed the enhanced performance of PCM modified renders.

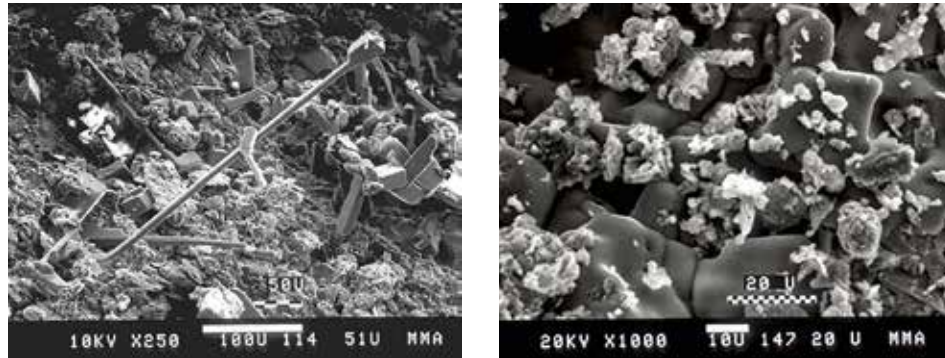
Figure 1: Left: A brick sample collected from the S. Stefano church in Venice and analyzed some years later show the change in crystal growth habit resulting from the changed environmental conditions. Right: Cubic halite crystals growing on brick from the Abbazia da Misericordia in Venice (ca. 1980), where brick powder can be seen being pushed away by the growing crystals.

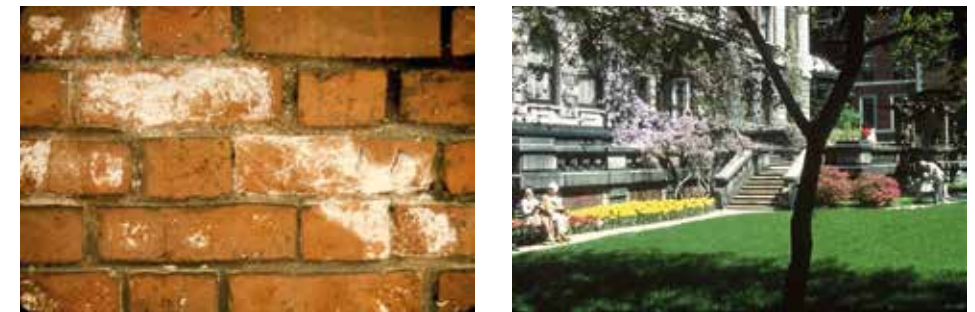
Figure 2: Detail of the brick wall showing the gypsum efflorescence formed on the parallel wall below grade to that seen in the garden at right.

A more prosaic of gypsum efflorescence was found on a brick retaining wall in the garden at the Cowper Hewitt Museum as shown in Figure 2. The gypsum, probably found in the soil of the garden on the other side of the wall, migrates solubilized in water (from watering plants and rain) through it and crystallizes out as a white efflorescence at about the top soil level on the garden side.

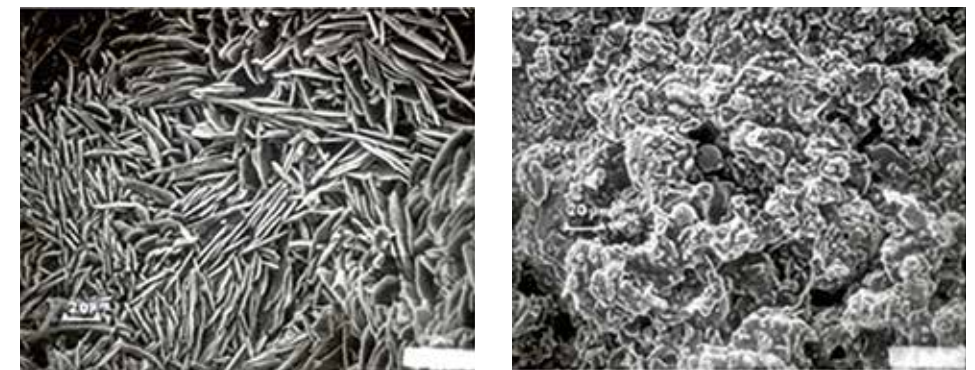
Figure 3: SEM photomicrographs of the gypsum efflorescence on brick, left (see Fig.2 left), and the framboidal growths resulting from air pollution on limestone of the Cowper Hewitt Museum, right.

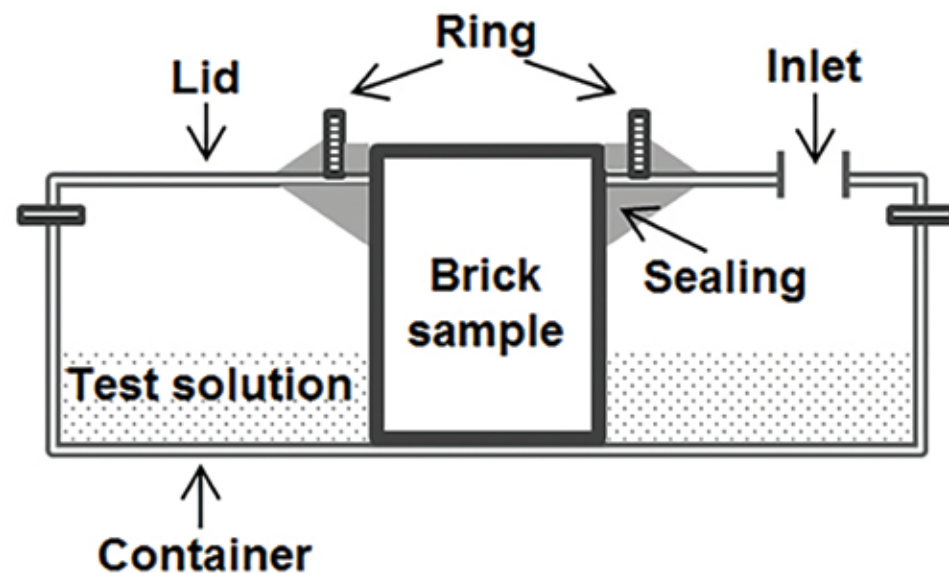
Figure 4: A sketch of the optimized wick-test set up.

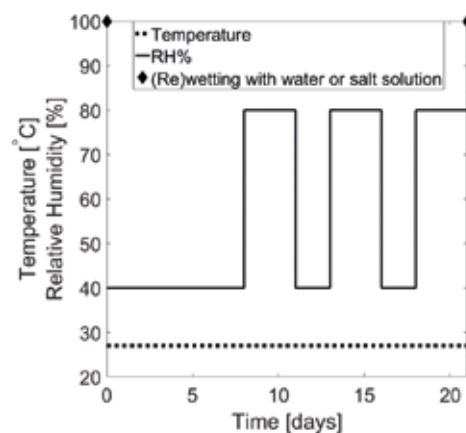
Figure 1: Temperature and RH cycles used in the accelerated salt weathering test. This entire cycle was repeated 5 times (in total 105 days). The diamonds correspond to wetting by capillarity at the start (day 0) or after each 3 week cycle (day 21) at  $22.9^{\circ}C \pm 0.3/29.1RH\% \pm 2.4$ . At day 0 and day 63 salt solution was used, the other times demineralized water.

Before the test, the specimens were contaminated with salt solution via capillary absorption from the bottom. A precise amount of solution was used to ensure contamination with 1 wt% sodium sulfate or 2 wt% sodium chloride with respect to the mortar. In total 3.46 (reference NaCl), 3.91 (ferrocyanide), 1.77 (reference  $Na_2SO_4$ ) or 1.91 (borax) gram salt was added to the specimens during the complete test. These values include the brushed off efflorescences during the test. For each mortar type, 3 replicas were tested.

After each complete cycle, all specimens were rewetted with demineralized water equal to the initial amount used to contaminate the specimens. After 3 cycles (63 days), salt solution (exact amount to obtain again 1 wt% sodium sulfate or 2 wt% sodium chloride) was

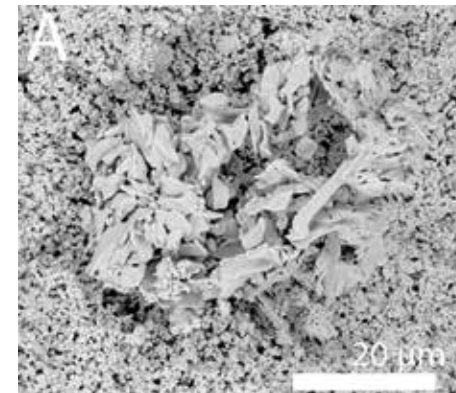
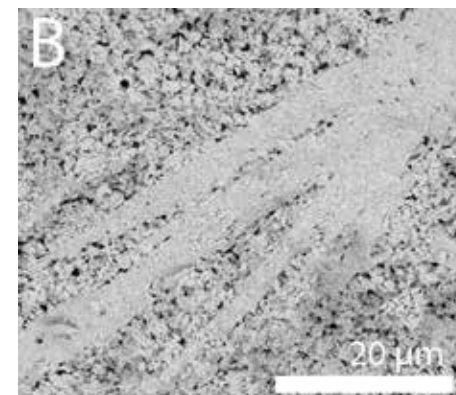
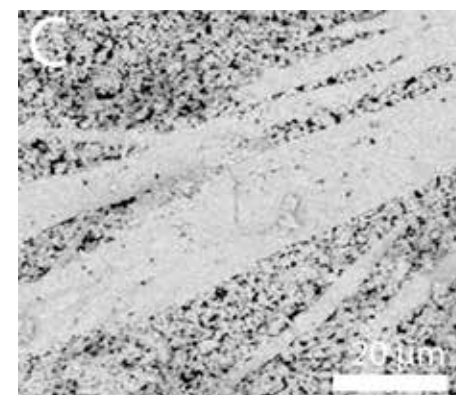
Figure 2: SEM images of lime-only specimens contaminated with sodium sulfate. A: reference specimen; B: specimen with 3.2wt% borax mixed in during preparation (thus before carbonation); C: Specimen additivated with borax after full carbonation of the specimen. A clear difference in crystal habit can be observed between the reference specimen and both specimens with borax. Contrarily, no distinction can be observed between B and C, meaning that the carbonation process has no effect on the borax effectiveness as modifier of sodium sulfate crystallization.

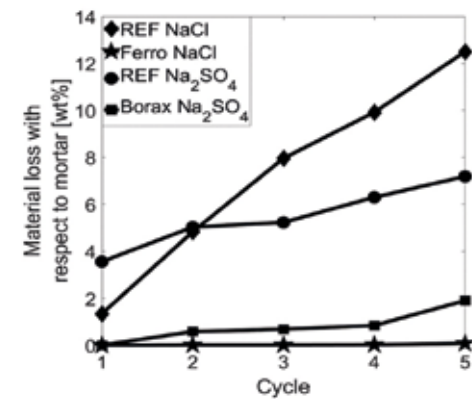
Figure 3: Cumulative material loss, comparison between reference and additivated specimens.

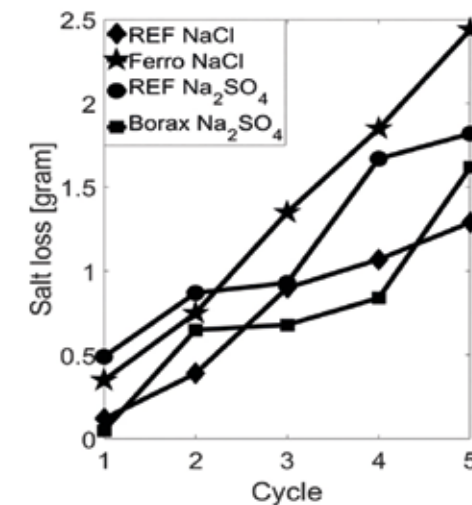
Figure 4: Cumulative salt loss, comparison between reference and additivated specimens.

amount was still present. These values indicate that either the modifiers have leached out (together with the salt efflorescence) or that they are (partially) tightly bound to the mortar structure. Modifier leaching is an important parameter to take into account in future applications, whereas the binding of the modifier could have implications for its effectiveness and working mechanism.

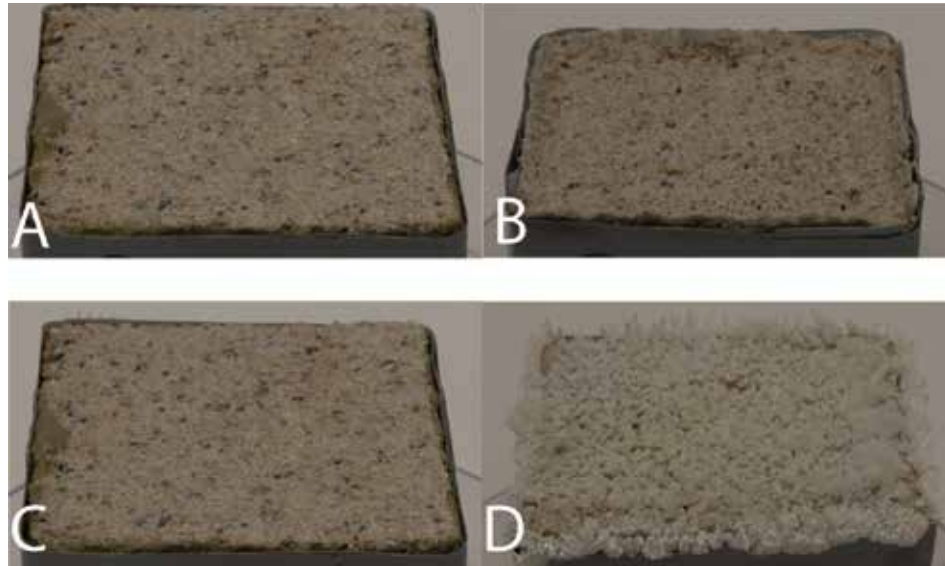
Figure 5: Comparison between reference (A/B) and specimens with mixed-in ferrocyanide (C/D), both contaminated with sodium chloride. A/C show the specimens at the start of the test, B/D show the specimens ~ 15 minutes after brushing after the 5th cycle. The reference specimen (B) shows sanding of the surface. The specimen with ferrocyanide shows no surface damage, only a large amount of efflorescence.

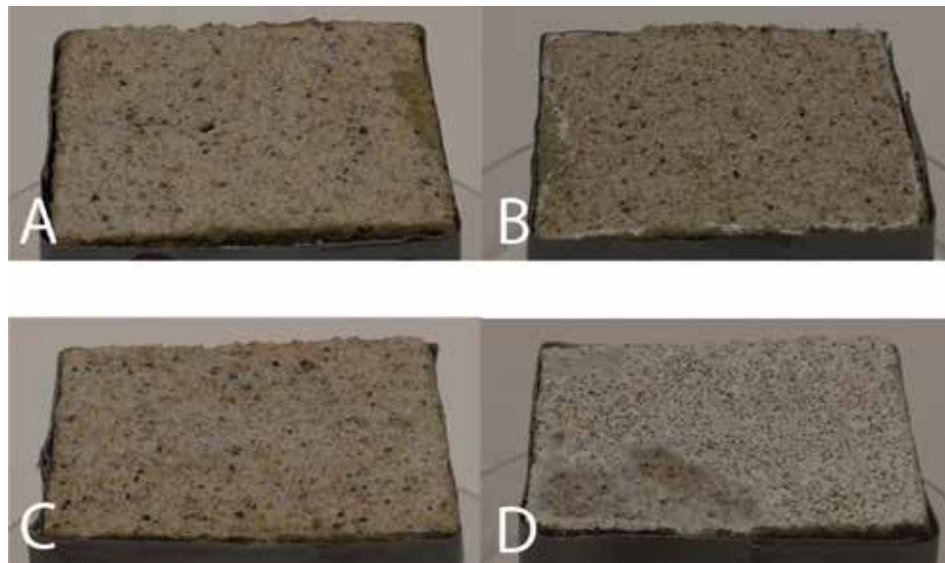
Figure 6: Comparison between reference (A/B) and specimens with mixed-in borax (C/D), both contaminated with sodium sulfate. A/C show the specimens at the start of the test, B/D show the specimens ~ 15 minutes after brushing after the 5th cycle. The reference specimen (B) shows clear damage at the surface. The specimen with borax shows only minor surface damage at the lower left corner (D).

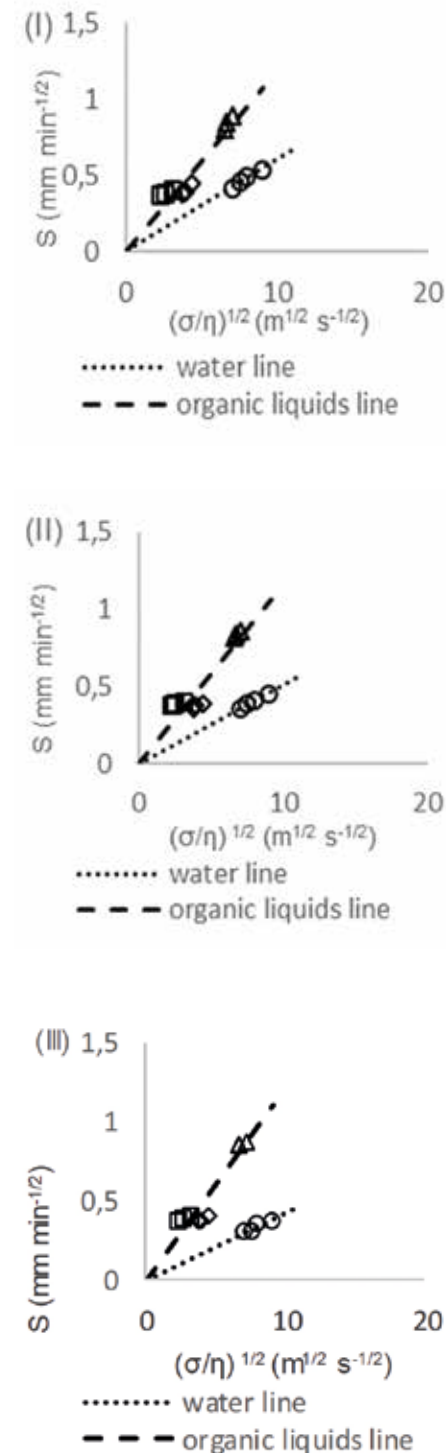
Figure 1: Sorptivity values  $S$  versus  $(\sigma/\eta)^{1/2}$  for the three limestones under study. (I): Agios Theodoros I, (II): Agios Theodoros II, (III): Agios Theodoros III.

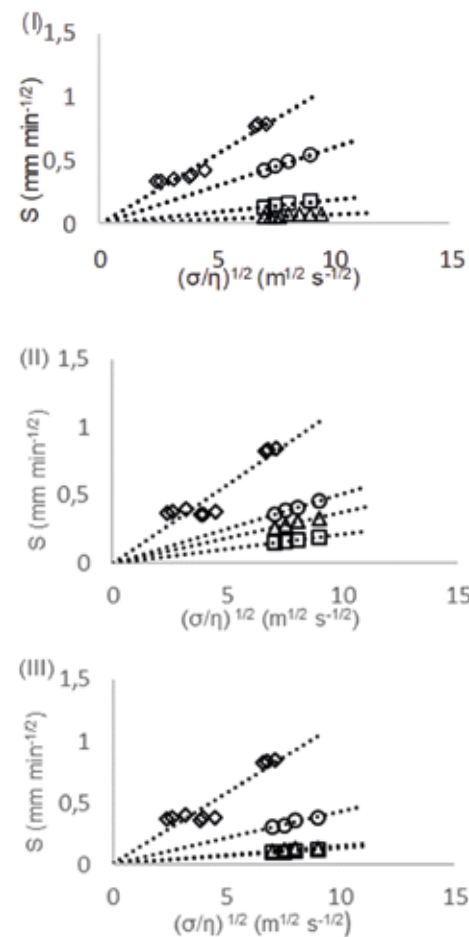
Figure 2: Sorptivity values  $S$  versus  $(\sigma/\eta)^{1/2}$  for water and organic liquids before and after all treatments. (○) water before treatments, (◇) organic liquids before and after all treatments, (△) water after water repellent surface treatments, (□) water after 10 cycles of wetting and drying. (I): Agios Theodoros I, (II): Agios Theodoros II, (III): Agios Theodoros III.

The results of the capillary absorption experiments after the application of the surface treatments are shown in Figure 2 for each specimen. A linear behavior between the sorptivity  $S$  and  $(\sigma/\eta)^{1/2}$  is once again noted. The organic liquids line remains generally unchanged after all treatments (an indication that no significant chemical or structural changes have occurred in the test specimens<sup>14</sup>), whereas the water line has an even lower slope. This, strongly indicates that oleic acid and its by-products adsorb well on the calcite surface of the samples under

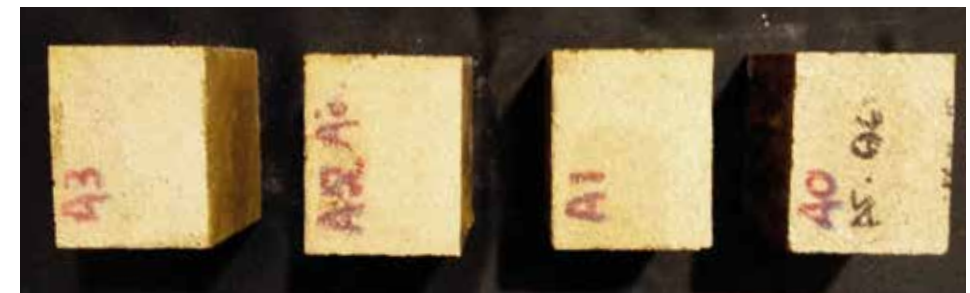
Figure 3: Physical appearance of the stone surfaces before/after each treatment. A0: Untreated stone, A1: Oleic acid treated stone, A2: Sodium oleate treated stone, A3: Calcium oleate treated stone

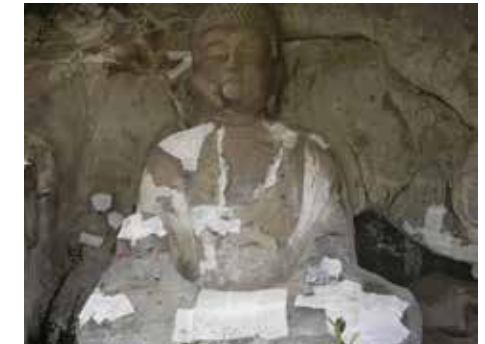
Figure 1: Motomachi stone-cliff Buddha

The Motomachi stone-cliff Buddha is located in Oita prefecture, Japan. It was engraved onto a cliff of soft welded tuff around the 11<sup>th</sup> to 12<sup>th</sup> centuries and was covered by a shelter which was built during in the 20th century (Figure 1 and Figure 2). The entrance of the shelter faces east. Salt crystallisation especially in winter is the most important cause of deterioration. Powdering and scaling occur at the surface of the stone. A previous investigation identified thenardite, mirabilite and gypsum by X-ray diffractometry (XRD).<sup>8,9</sup> Furthermore, a past study showed that sulphate, calcium and sodium ions, that are the origins of thenardite, mirabilite and gypsum, are detected in the groundwater near the site. And the content is higher than in the general groundwater in Japan.<sup>9</sup> Although a drainage tunnel and well were built in order to lower the groundwater levels (Figure 3), an increase in the amount of salt was reported after this construction. A past study also suggested that drop in inside temperature in winter due to door-opening of the shelter and water leaking into the high-water-content stone could be causes of salt crystallisation at the Motomachi stone-cliff Buddha.<sup>9</sup> Therefore, the shelter was improved by setting door closer, double glass windows and boards to reduce ventilation frequency and to block the direct solar radiation to the Buddha in November 2015 by the Oita-city board of education.

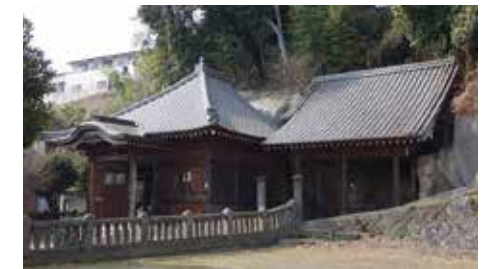
Figure 2: Exterior of the shelter

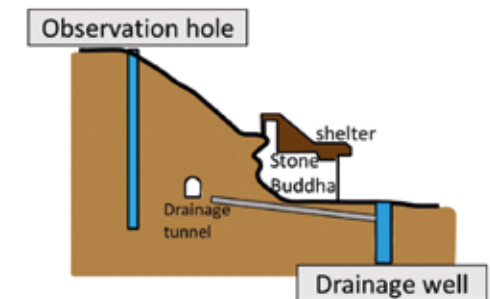
Figure 3: Cross sectional view

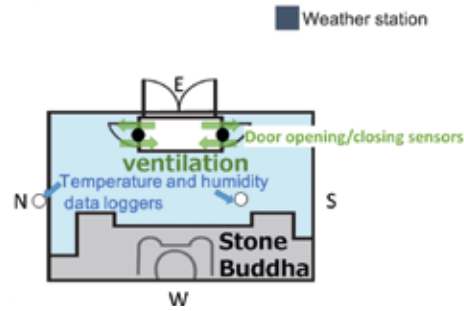
Figure 4: Schematic representation of the inside with location of data loggers

after the shelter improvements. Temperature and relative humidity have been measured inside and outside the shelter with data loggers (HOBO Prov2) from November 2014 (Figure 4). The counts of door-opening/closing have been measured with door-opening/closing sensors (HOBO UX90 State Data Logger) from February 2015 (Figure 4). A weather station was installed in February 2015 which measured local meteorological data (temperature, relative humidity, wind direction, wind speed, solar radiation and pressure). All measurements have been done at 10 minutes intervals and the data were collected roughly once in three months.

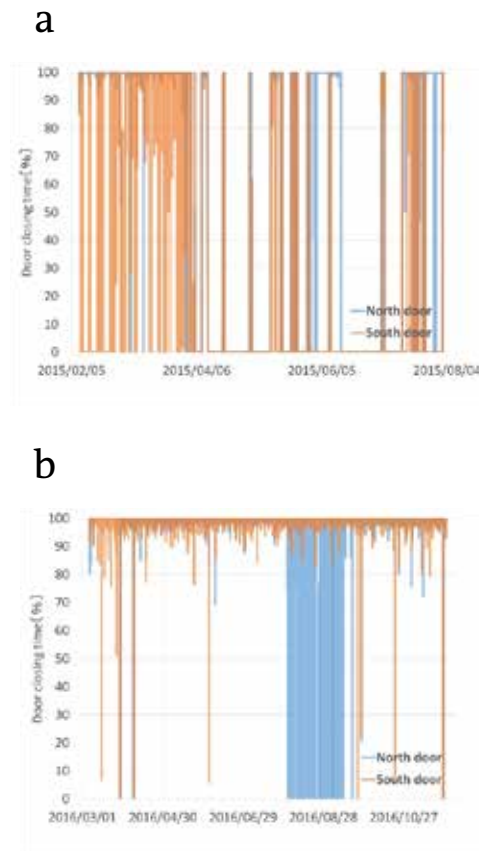
Figure 5: Door closing time a) before the improvements b) after the improvements

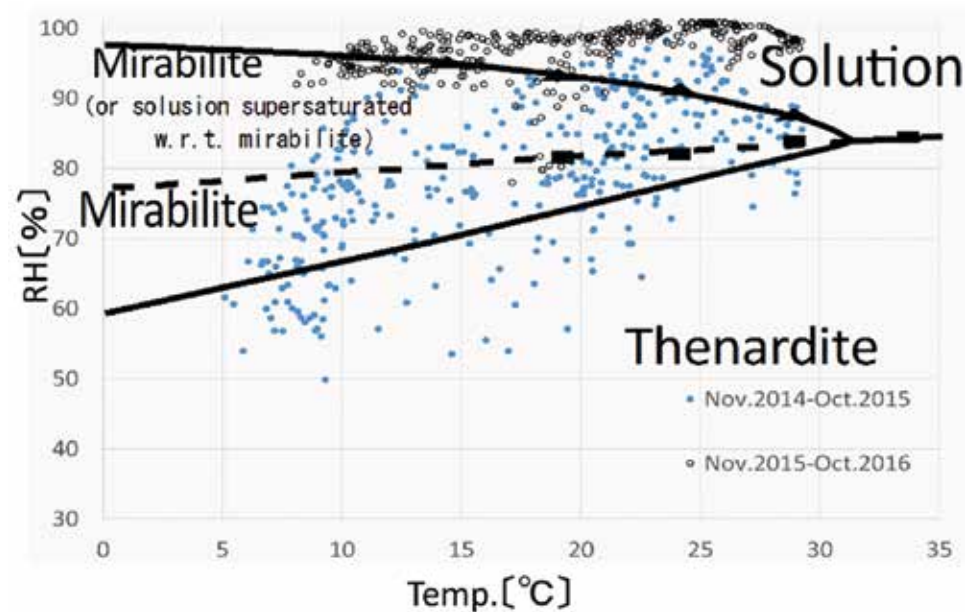
Figure 6: Phase diagram for sodium sulfate and temperature and relative humidity of daily average inside the shelter (based upon data from\*) Blue dots are before improvements Temp. and RH, on the other hand white dots are after improvements.

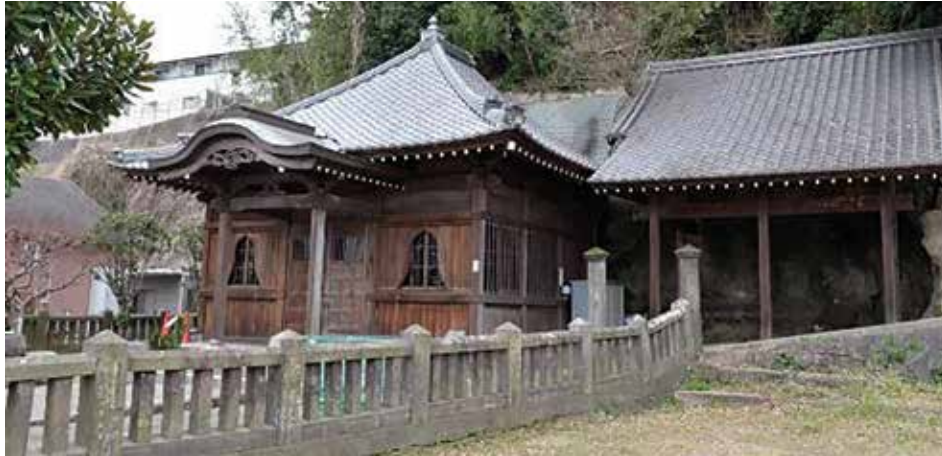
Figure 2: Shelter exterior

dium sulphate, has long been a concern. To prevent these deteriorations, various preservation measures have been undertaken from 1986 to 1996 and again from 2011 onward. These include constructing a shelter (Fig. 2), boring a tunnel behind the statue to reduce groundwater and renovating the shelter. Salt damage by sodium sulphate is considered to be halted as a result of the shelter renovation during November 2015.<sup>2</sup>

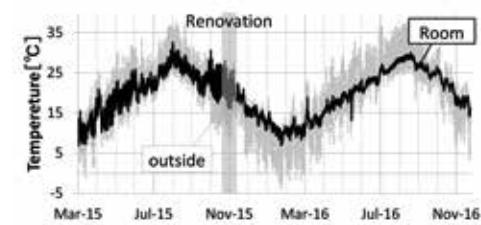
Figure 3: Variation of the measured temperature inside and outside the shelter

4 show the inner and outer temperature and relative humidity from March 2015 to November 2016. After the renovation, the daily fluctuation in room temperature decreased but the relative humidity maintained its high value. We measured the inside and outside concentrations of CO<sub>2</sub> from October 3 to October 4, 2016, and calculated the ventilation rate via the decrease in CO<sub>2</sub> concentration after opening or closing the window. The ventilation rate was 0.21 times per hour when the windows were closed, and it was 9.9 times per hour when they were opened.

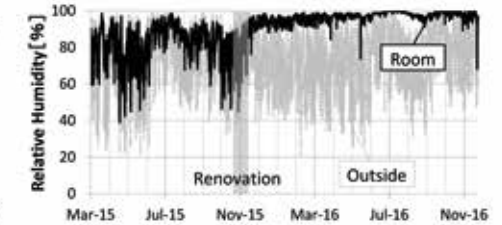
Figure 4: Variation of the measured relative humidity inside and outside the shelter

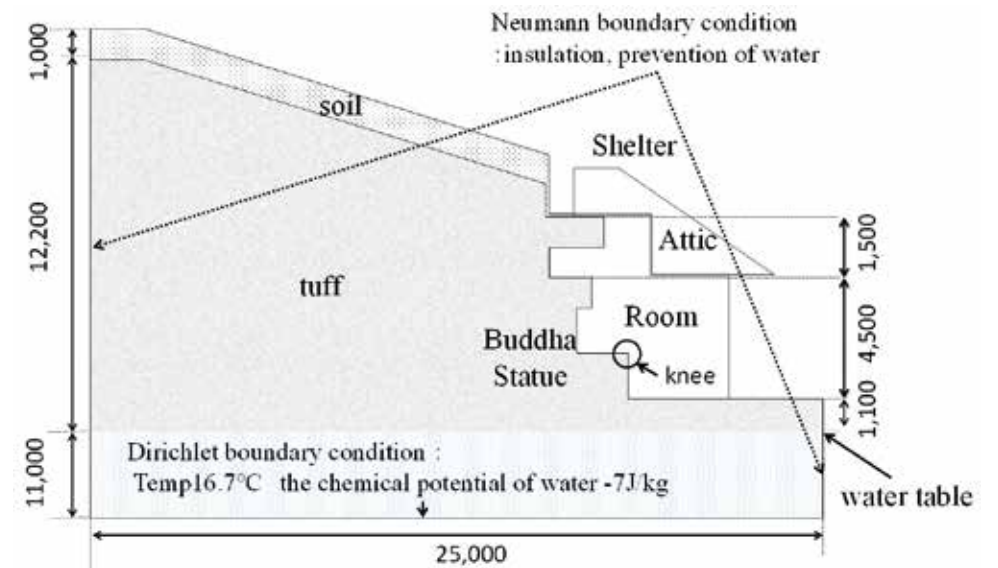
Figure 5: Schematic of the numerical model of the cliff, including the statue

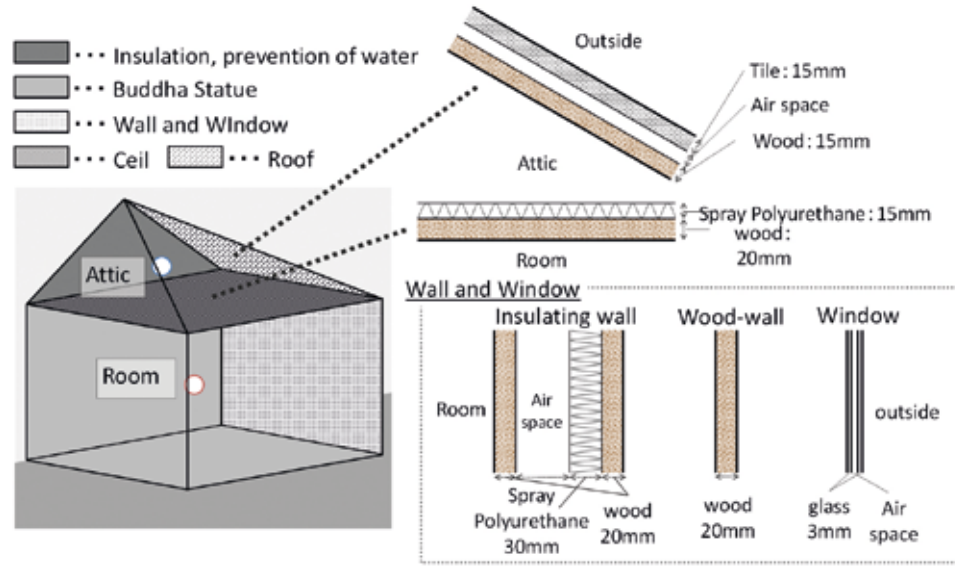
Figure 6: Model for analysing the room environment

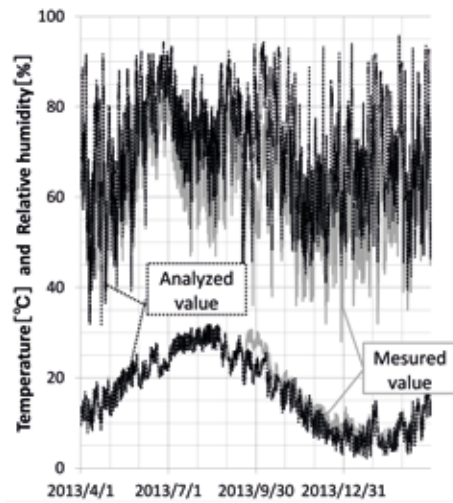
Figure 7: Comparison in Case 0

Fig. 7 and Fig. 8 show the measured and calculated values of the temperature and relative humidity in the room for Case 0 and Case 1. In both cases, the annual fluctuation of the calculated value agrees very well with that of the measu-

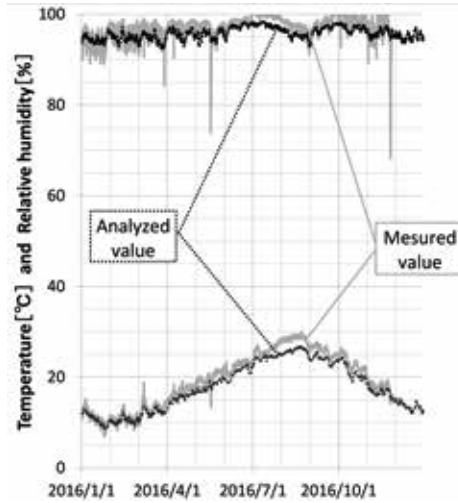
Figure 8: Comparison in Case 0

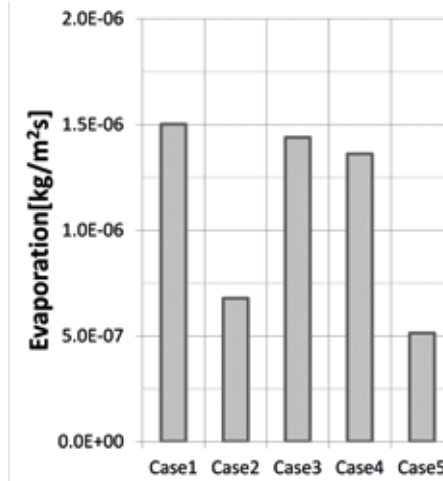
Figure 9: Annual evaporation from the surface of the statue

We examined the trends in salt precipitation for Cases 1–5. Here we assumed that the moisture flux from the surface of the statue is equal to the evaporation in the statue. Figure 9 shows the annual amount of water evaporation in the statue, and Fig. 10 shows the monthly amount of evaporation. Comparing Case 1, before the renovation, to Case 2, it can be seen that water evaporation is suppressed by the decreasing ventilation rate. Similar results are obtained because of the improvement in insulation performance and prevention of solar transmission. These results show that after the renovation, evaporation and salt precipitation was drastically suppressed throughout the year. Here we focus on the effects of each renovation factor. The decreasing ventilation rate suppresses the evaporati-

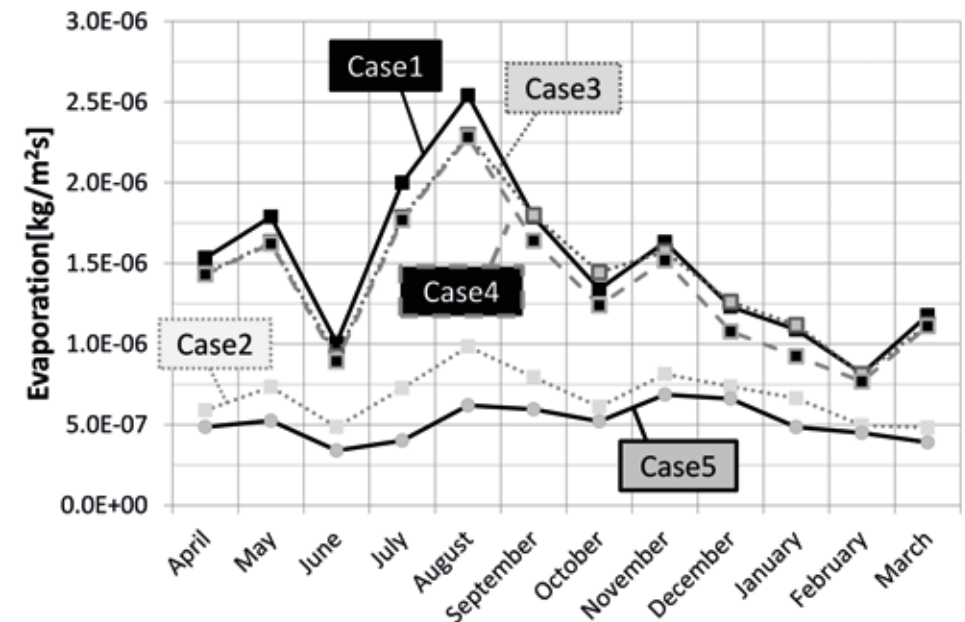
Figure 10: Monthly average evaporation from the surface of the statue

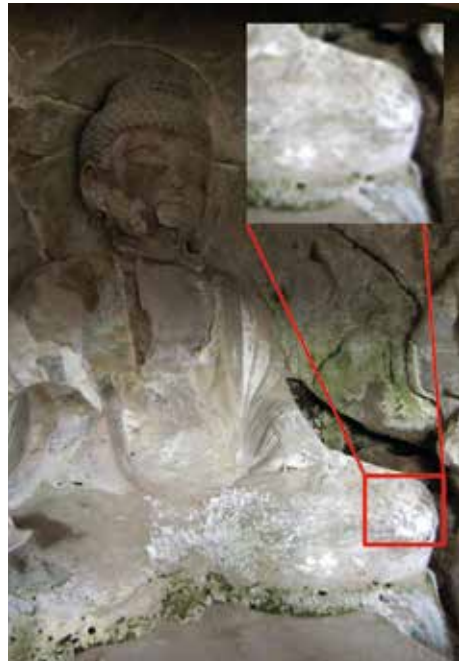
Figure 11: The knee of the statue

At Motomachi Sekibutsu, salt damage can be seen at the knee of the statue (Fig. 11). In this section, we plot the calculated temperature and relative humidity at the surface of the statue on the phase diagram of Na<sub>2</sub>SO<sub>4</sub> and examine the possibility of the resulting salt damage. Figure 12 shows the results of Case 1, Case 3 and Case 4, and Fig. 13 shows that of Case 1, Case 2 and Case 5. In Case 2 and Case 5, which are decreased-ventilation-rate cases, the phase change from Na<sub>2</sub>SO<sub>4</sub> to Na<sub>2</sub>SO<sub>4</sub>·10H<sub>2</sub>O rarely occurs because the

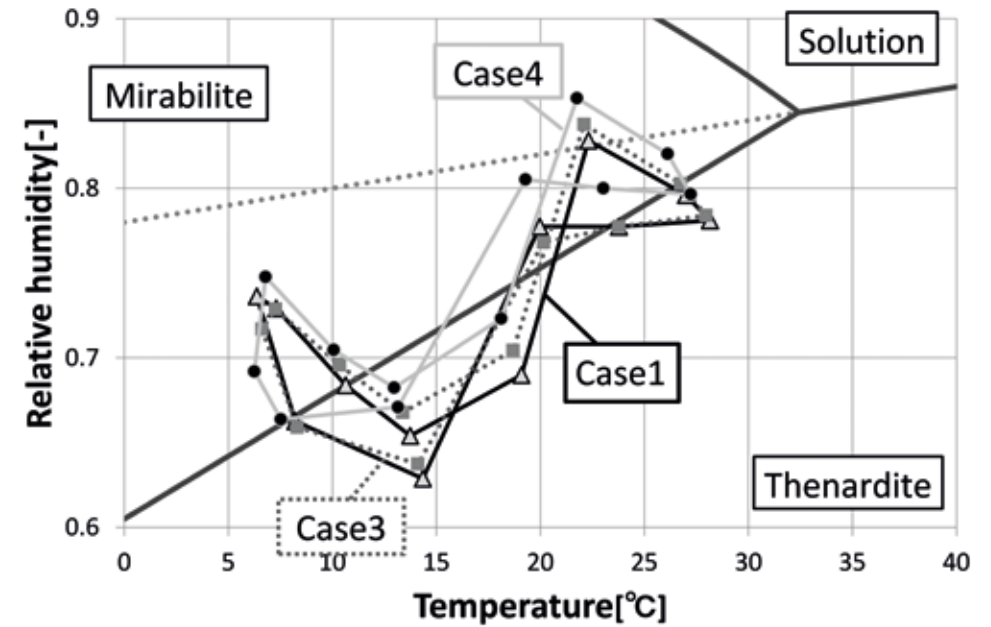
Figure 12: Phase diagrams for Case 1, Case 3 and Case 4

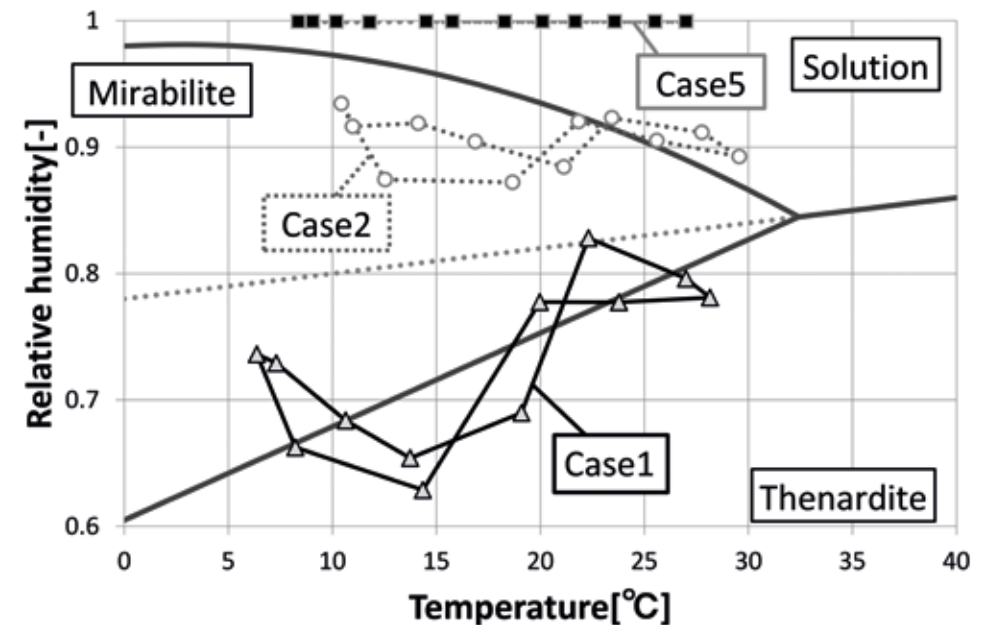
Figure 13: Phase diagrams for Case 1, Case 2 and Case 5

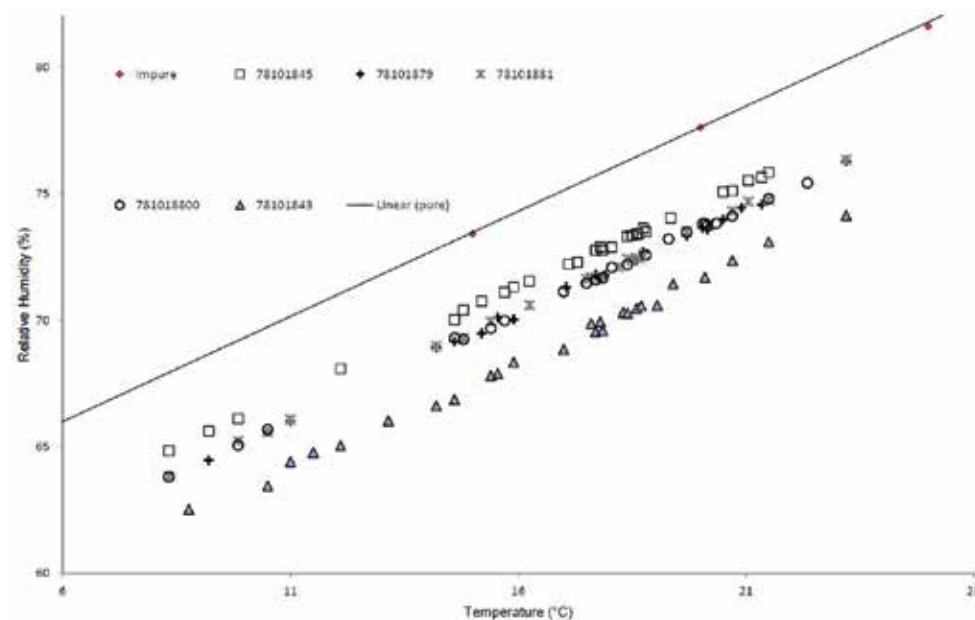
Figure 1: Temperature and RH values at which acoustic emission was observed.

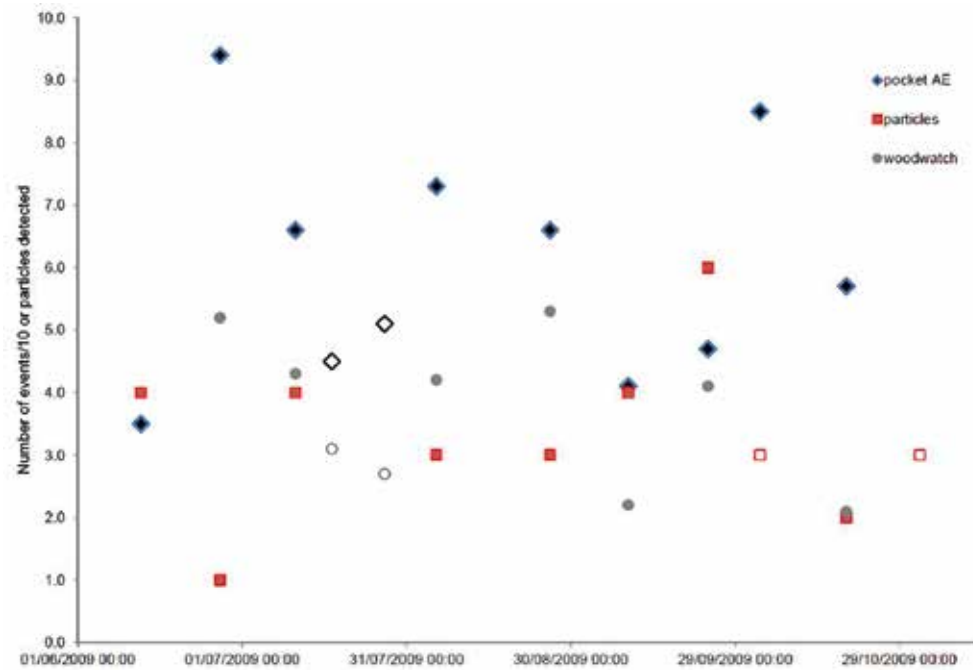
Figure 2: Acoustic emission and particle loss observed from polychrome limestone fragment 78101843

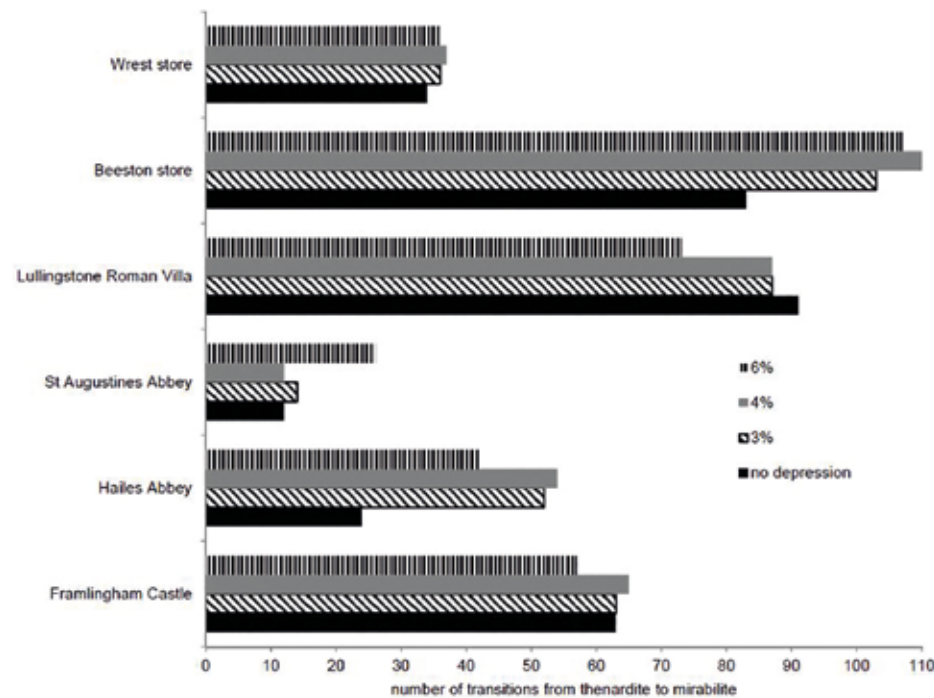
Figure 3: Number of thenardite to mirabilite transitions calculated from environmental data of English Heritage locations with polychrome stone.

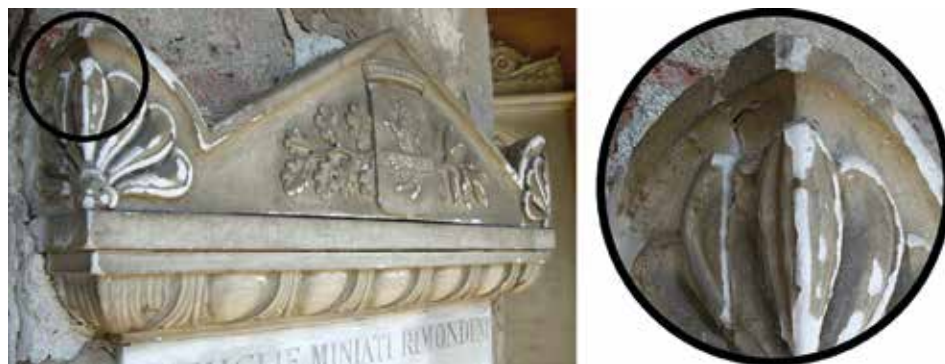
Figure 1: Example of marble decoration affected by sulfation (Monumental Cemetery in Bologna, Italy, XIX century). Beneath the gypsum surface layer (also incorporating some particulate matter), marble exhibits grain disaggregation

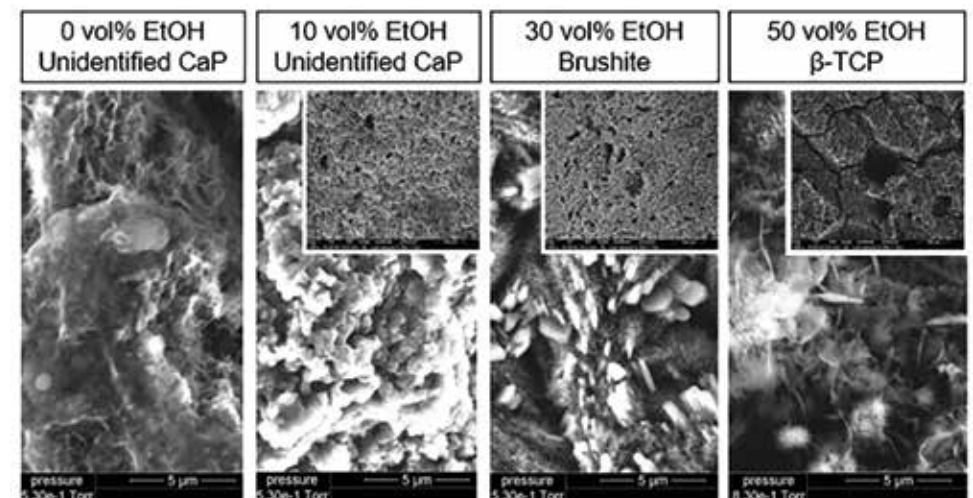
Figure 2: CaP phases formed by reaction with a 0.1 M DAP solution with increasing ethanol content at pH=8

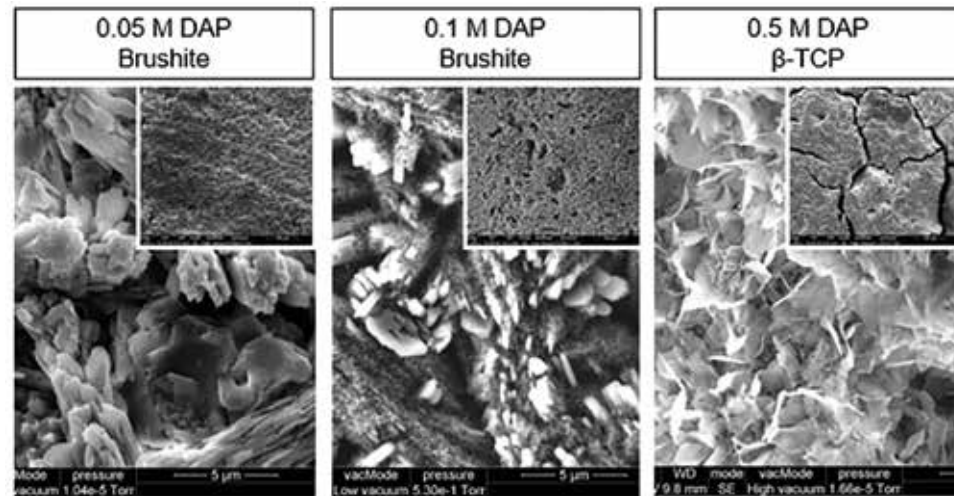
Figure 3: CaP phases formed by reaction with a DAP solution with increasing concentration at fixed 30 vol% ethanol content at pH=8

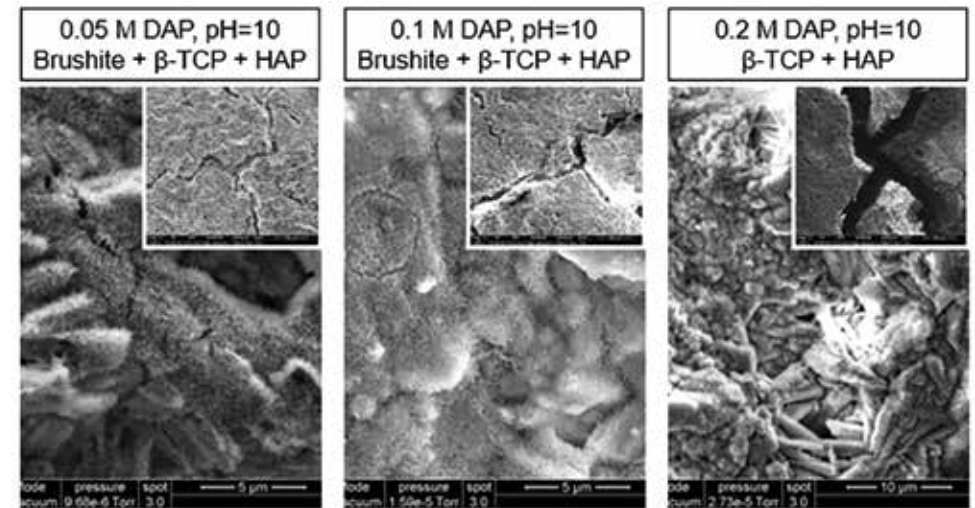
Figure 4: CaP phases formed by reaction with a DAP solution with increasing concentration at fixed 30 vol% ethanol content and pH=10

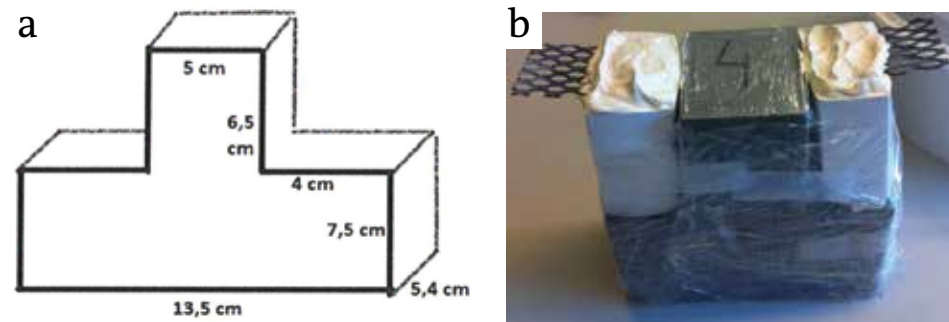
Figure 1: (a) The dimensions of the T-shaped stones and (b) The stone with electrodes.

Electrode compartments as seen in *figure 1b*. A frame was folded in thin plastic and jointed with tape to fit the horizontal part of the stone at each side of the attribute. The frames were filled with poultice; a mixture of kaolinite and CaCO<sub>3</sub><sup>3</sup> with an initial water content of 54%. Inert platinum coated electrode meshes were placed at the top of each electrode compartment. The sandstone

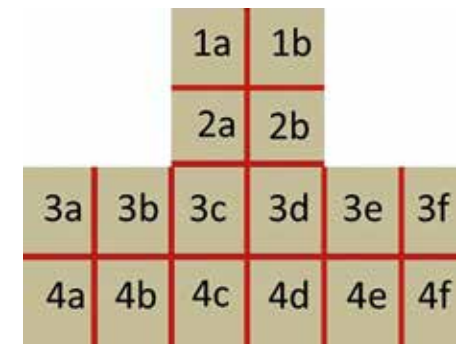
Figure 2: Segmentation and numbers after REF and ED experiments

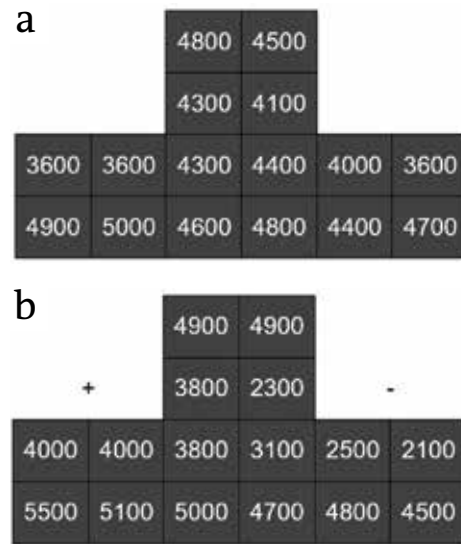
Figure 3: Chloride concentrations in the segment of the (a) REF stone and (b) and in the segment of the ED1 experiment after 7 days [mg/kg]
