# SWBSS 2017

## Fourth International Conference on Salt Weathering of Buildings and Stone Sculptures

# **Proceedings of SWBSS 2017**

**Fourth International Conference on  
Salt Weathering of Buildings and Stone  
Sculptures**

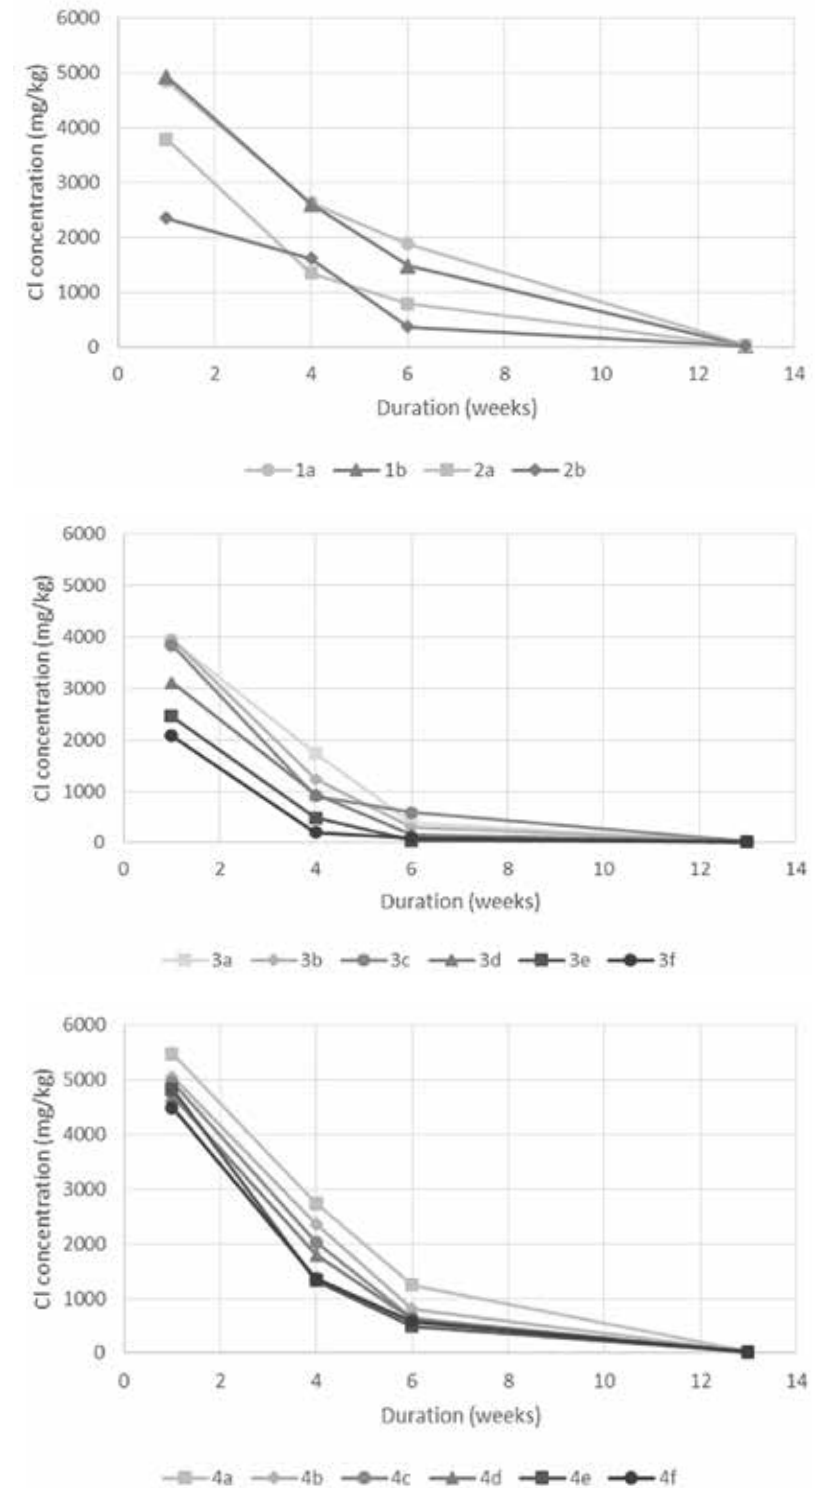
Figure 4: Cl concentration in the different stone segments as function of ED duration: (a) in the attribute, segments in row 1 and 2 (b) segments in row 3 and (c) segments in row 4.

The removal rate differed in the different segments. Figure 4a show that the Cl removal was faster in the segments in row 2 than in row 1, i.e. the desalination occurred from the row closest to the electrodes first and later to the upper row. The same pattern is seen when comparing the desalination of row 3 (figure 4b) and row 4 (4c) when e.g. comparing the Cl concentrations after 6 weeks in the two figures. In row 3 the concentrations were less than about 500 mg/kg and in row 4, the concentrations were all higher than 500 mg/kg. That row 3 is desalinated before row 4 confirms the pattern found for ED of bricks in<sup>3</sup>, when the electrodes were placed at the same side of the bricks. Further, it is evident that the Cl concentration decreased fastest from the end of the stone closest to the cathode (figures 4a and b), e.g. 3f and 4f had.

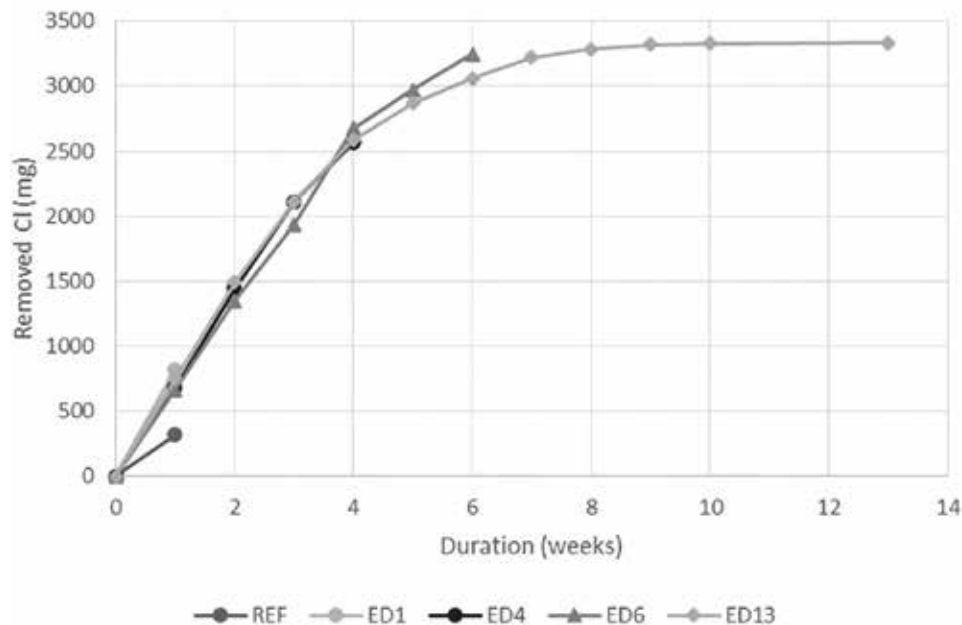
Figure 5: Accumulated Cl amount removed into the anode poultice during the REF and ED experiments.

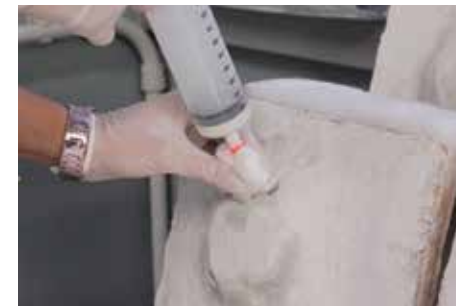
Figure 1: Injection of grout PLM25-75 into the replica of delaminated plaster

water : 75% ethanol solution for grouts PLM25-75, LEDAN25-75 and C25-75). Measurements of MC and SI were performed with SUSI® immediately after pre-wetting. Injection of the grout was then performed, one grout in each replica (Fig. 1).

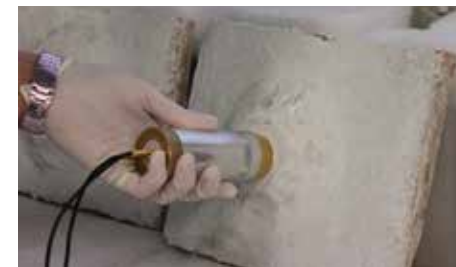
Figure 2: SUSI® measurements on a replica after 48 hours from the injection

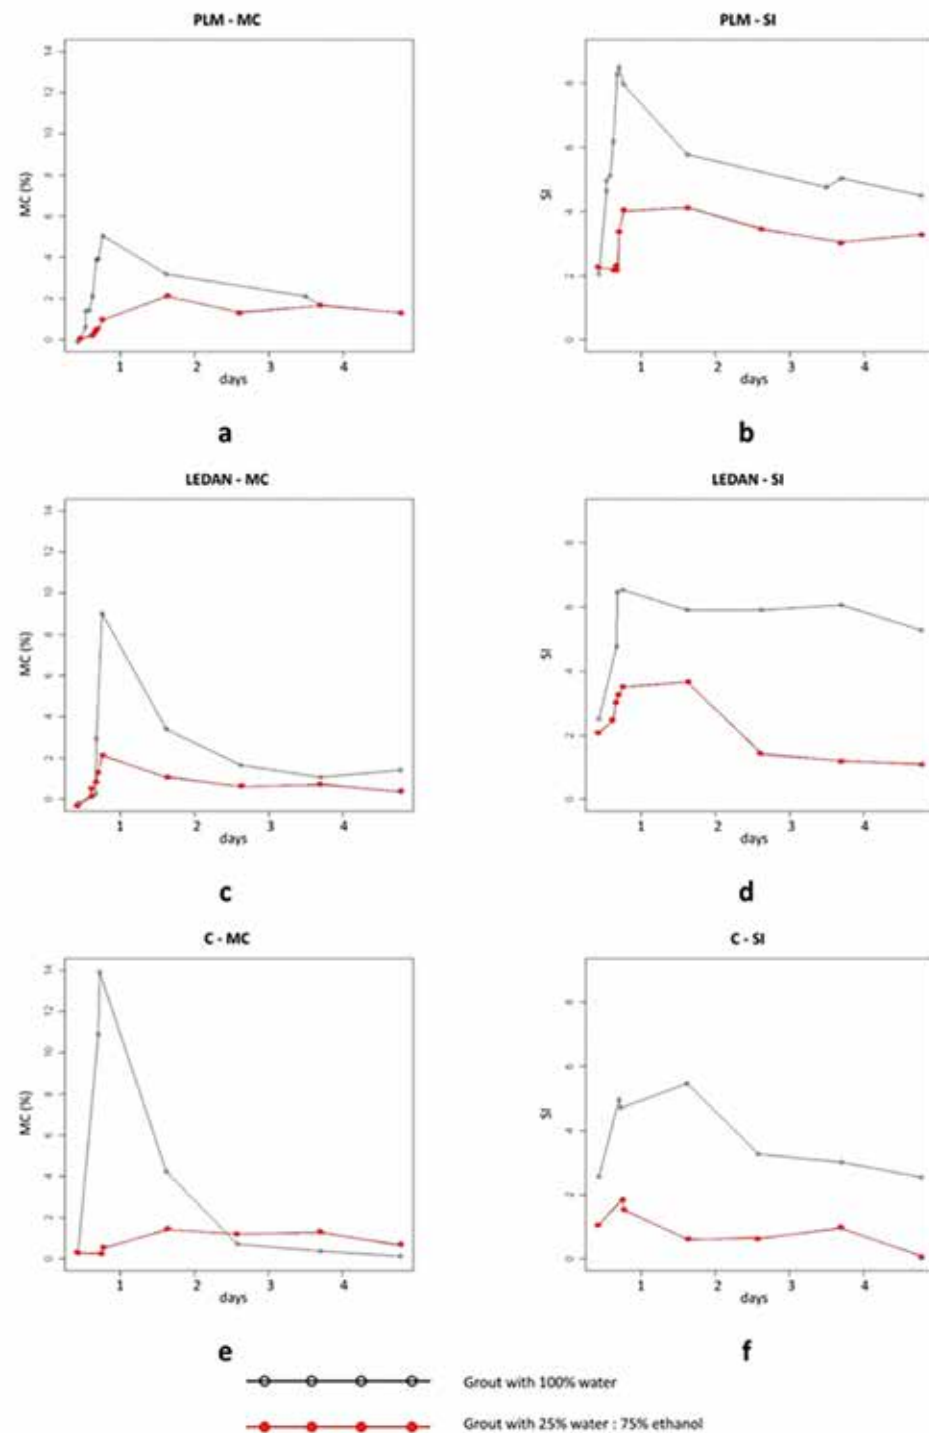
Figure 3: Graphs showing MC (3a PLM, 3c LEDAN, 3e grout C) and SI (3b PLM, 3d LEDAN, 3f grout C) over time, from to (dry replica) to 72 hours after the injection. The first point of measure on the graph is performed on the dry replica, the second point immediately after pre-wetting, the third point immediately after the grout injection; measures are then taken at 10 minutes interval within the first hour, after 2, 3 and 4 hours, after 24, 48 and 72 hours

The maximum value of SI after the injection of PLM25-75 is less than half compared to the maximum value after the injection of the control (PLM100-0). The maximum value of SI after the injection of LEDAN25-75 is about 2/5 lower compared to the maximum value after the injection of the control (LEDAN100-0). Values referred to grout C25-75 are particularly low (maximum value of SI 1.8): the maximum value measured for C25-75 is about 1/3 of the maximum value measured for the control (C100-0).

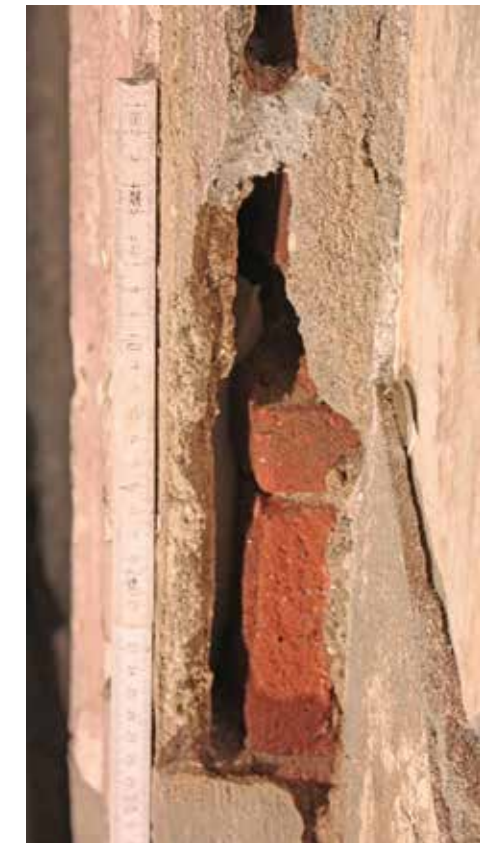
Figure 4: Delaminated pilaster in San Vincenzo Oratory, north wall

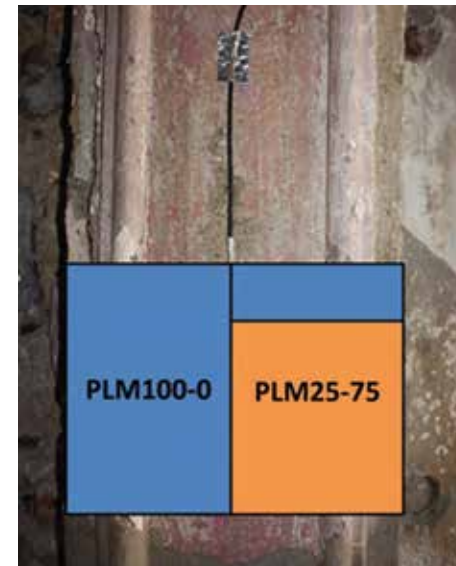
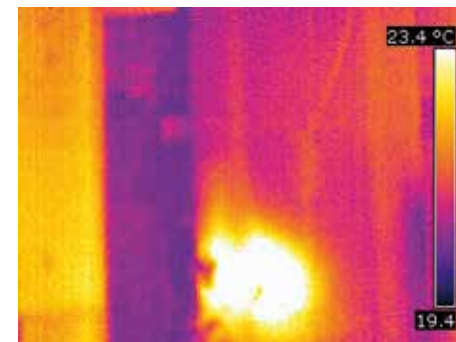
Figure 6a: Thermoimage after the injection of PLM100-0

ter the injection over time to follow the grouts setting (every 5 minutes for the first hour; 2, 3, 4 hours after the injection; 24 and 48 hours after the injection). In order to better assess the positioning of the grouts in the delamination (Fig. 6), the grouts were both slightly heated in a water bath prior to injection. In Fig. 6a PLM100-0 is more clearly visible compared to PLM25-75 (Fig. 6b) because it was possible to heat it longer (PLM25-75 is ethanol-based: it could not be heated long because its suspension medium is more volatile than water). It was verified that the positioning of two grouts injected in the delamination was kept separate by the foam rubber, as planned.

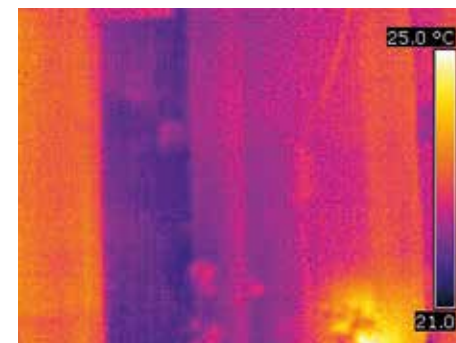
Figure 6b: Thermoimage after the injection of PLM25-75

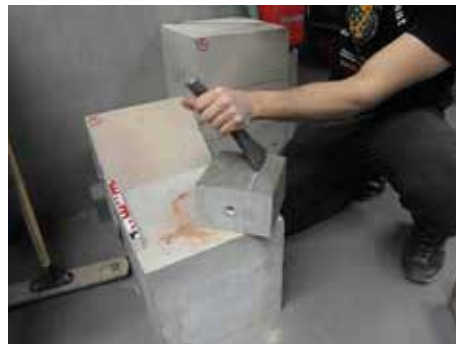
Figure 1: Chopping of the block

te of the system was visually inspected, the poultrice removed for visual inspection, moisture and salt determination, and the substrate block gravimetrically inspected, drill powder sampled in 12 stages of 1cm depth and analysed for moisture content<sup>6</sup> and salt content by electrical conductivity. Finally the block was chopped in stone masons fashion for further visual inspection of the ink drop.

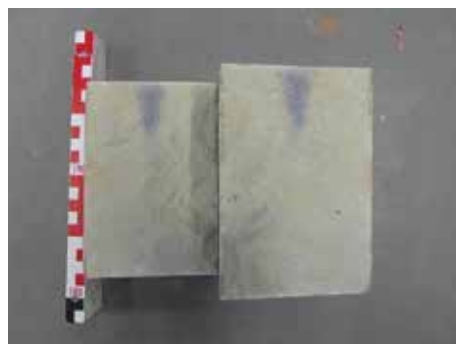
Figure 2: Ingress of ink drop

cally invisible in the brick, showed a cone in Postaer sandstone. In Cottaer sandstone it was hardly visible but tended to be vanished on the top and was most intensive in about 2 cm depth. Also in the poultice material the ink was solely visible in the pure cellulose material AC. However, we recommend to use much more than 50 µl ink for contamination for possible future experiments.

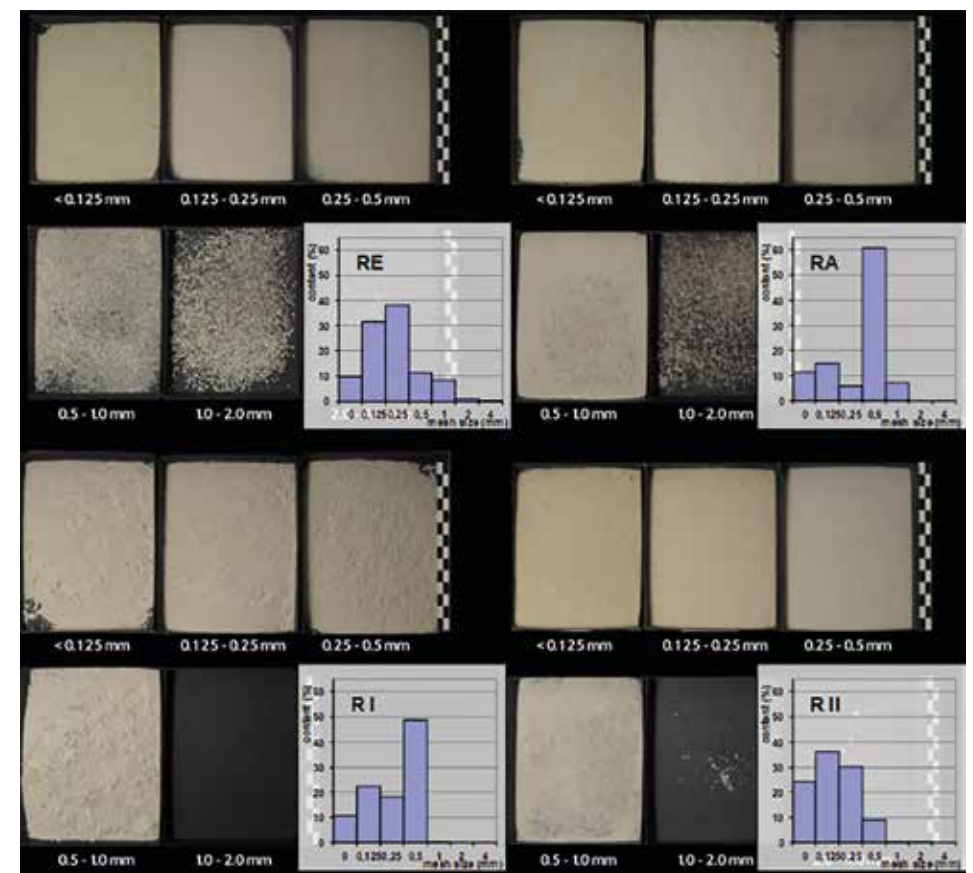
Figure 3: Size fractionated poultrice materials (A – cellulose not displayed)

Obviously there are major differences in the poultrice performances due to divers material compositions. Figure 3 shows their size fractions with standard sieves. When it comes to the creation of specific pore sizes for effective desalination as recommended by<sup>7</sup> we suggest to define adapted mesh combinations for the future. Of course the cellulose content in all mixtures hampers the sieving. For displaying the results (diagramms in Figure 3) giving the sieve fraction in mass could be misleading due to different densities e.g. sand and foam glass. Reference to volume lead to other difficulties.

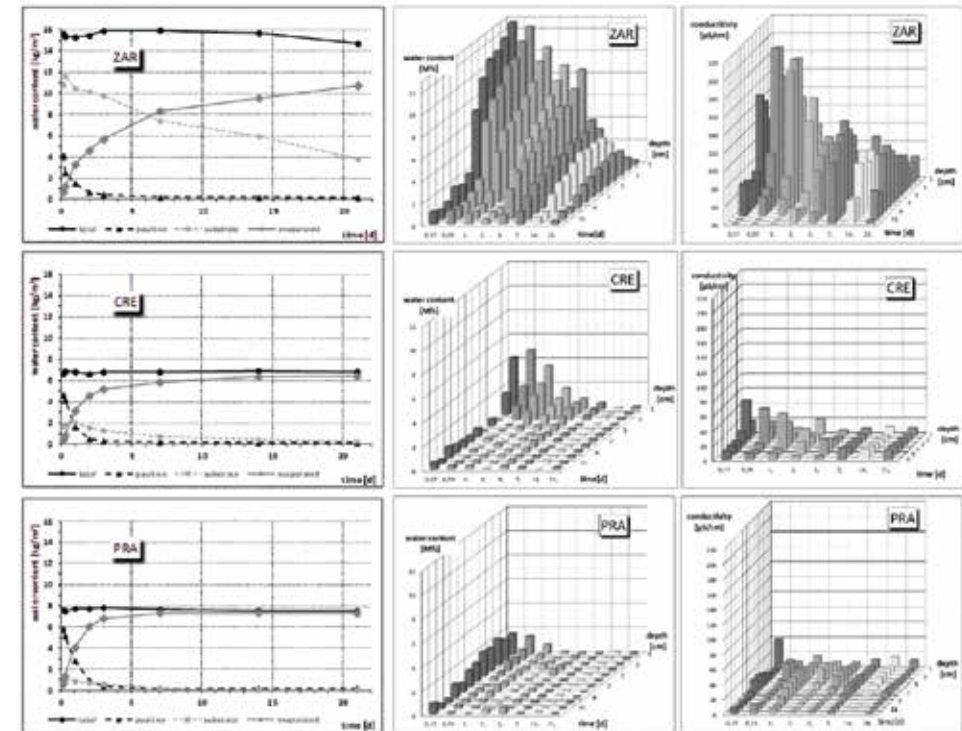
Figure 5: 1<sup>st</sup> column: water contents in experiment: total, poultrice, substrate and mount evaporated vs time; 2<sup>nd</sup>: depth resolved water content; 3<sup>rd</sup>: conductivity results

When the poultrice gets dryer than the substrate the general water movement is returned at least mathematically. Nevertheless in parallel the water front in the substrate moves on. That is to be seen in Figure 5 2<sup>nd</sup> column, where the water con-

tent in the substrate is shown in all depth at all investigated time stages. In brick material most poultrices affect a depth about 4 to 5 cm. In Postaer sandstone RE an RA reach about 7 cm while RI and R II on the other hand affect 4 cm which partially can be explained by a problematic performance during the application.

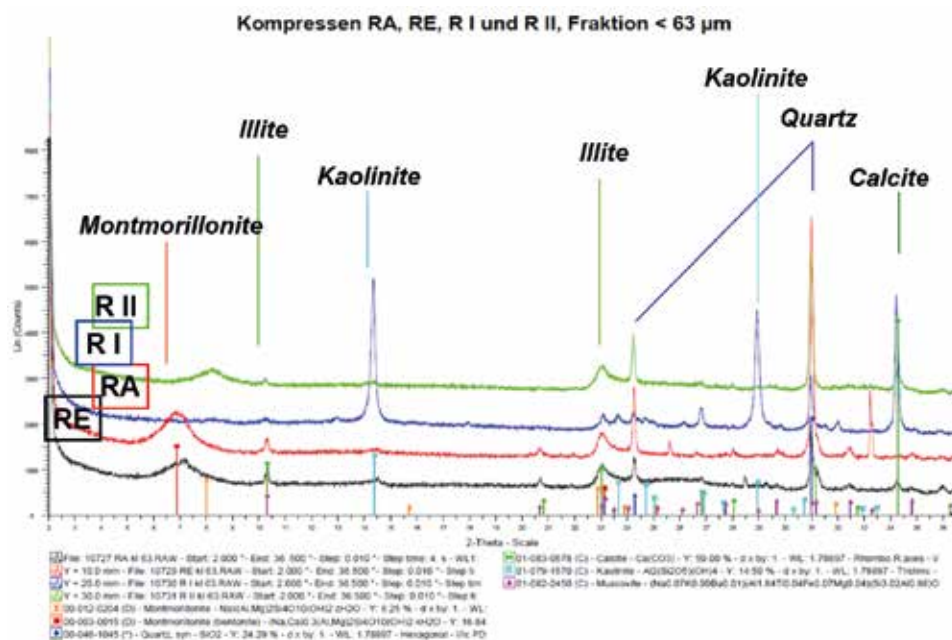
Figure 4: XRD pattern of four poultrice materials, smallest mesh fraction

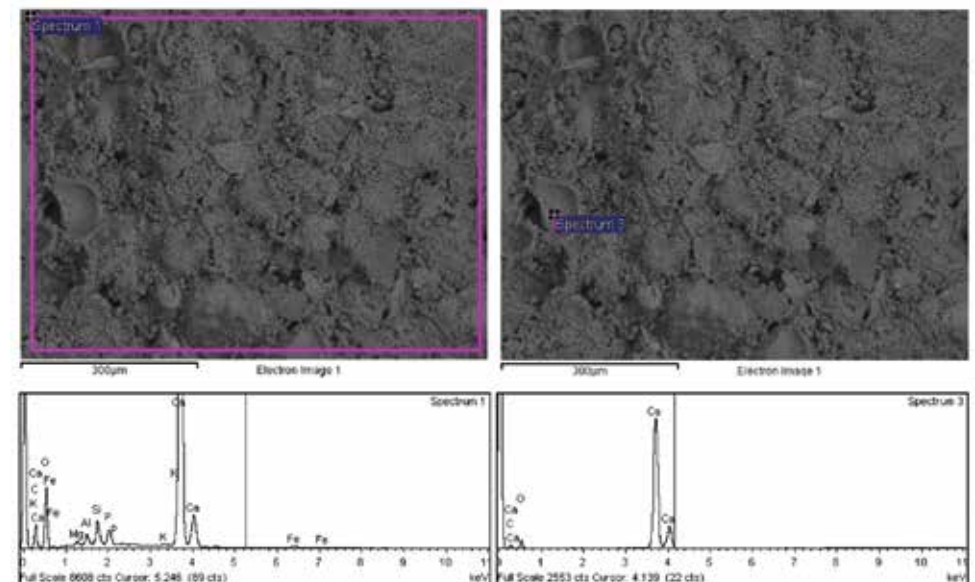
Figure 1: SEM images and EDS spectra of untreated Lecce Stone

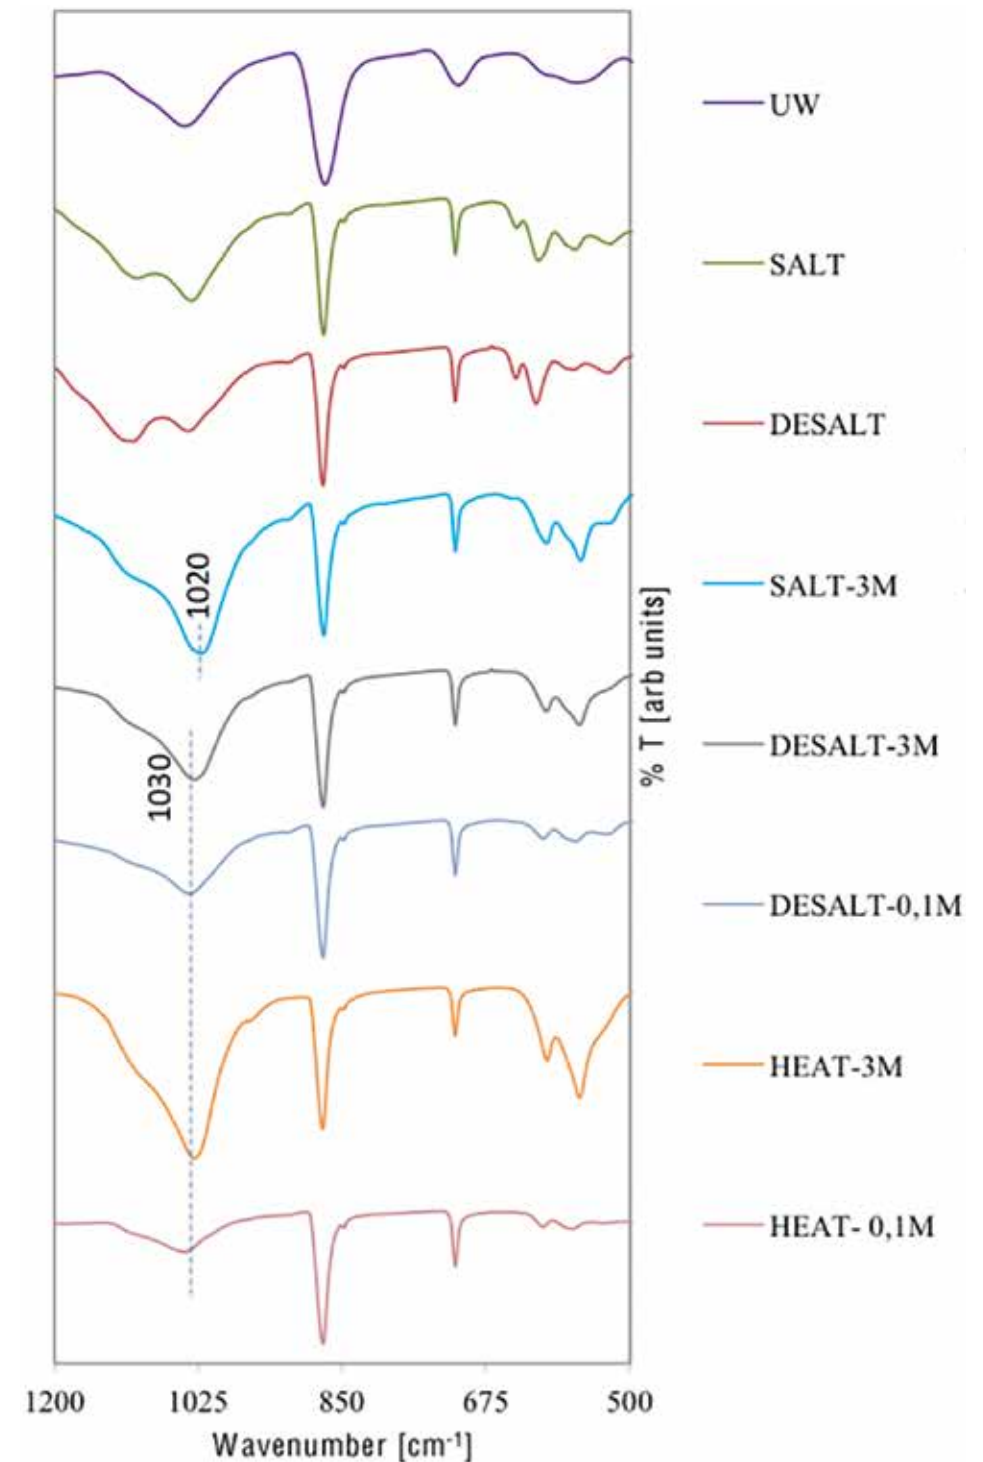
Figure 2: FT-IR spectra on untreated and treated specimens, for different levels of salt contamination

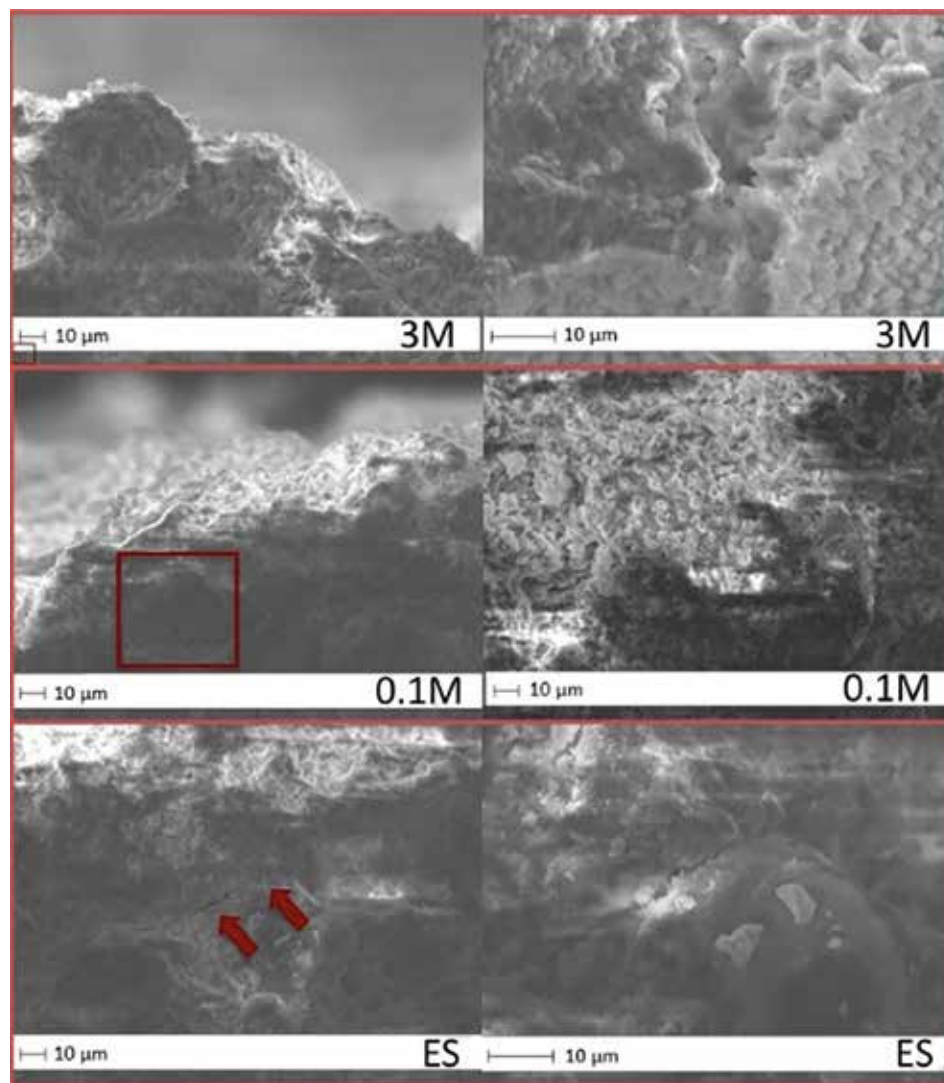
Figure 3: SEM images of treated samples' cross sections. In figure, the red square indicates significant formation of phosphate phases in correspondence of one shell, the arrows indicate a crack that remains unsealed after ethyl silicate treatment.

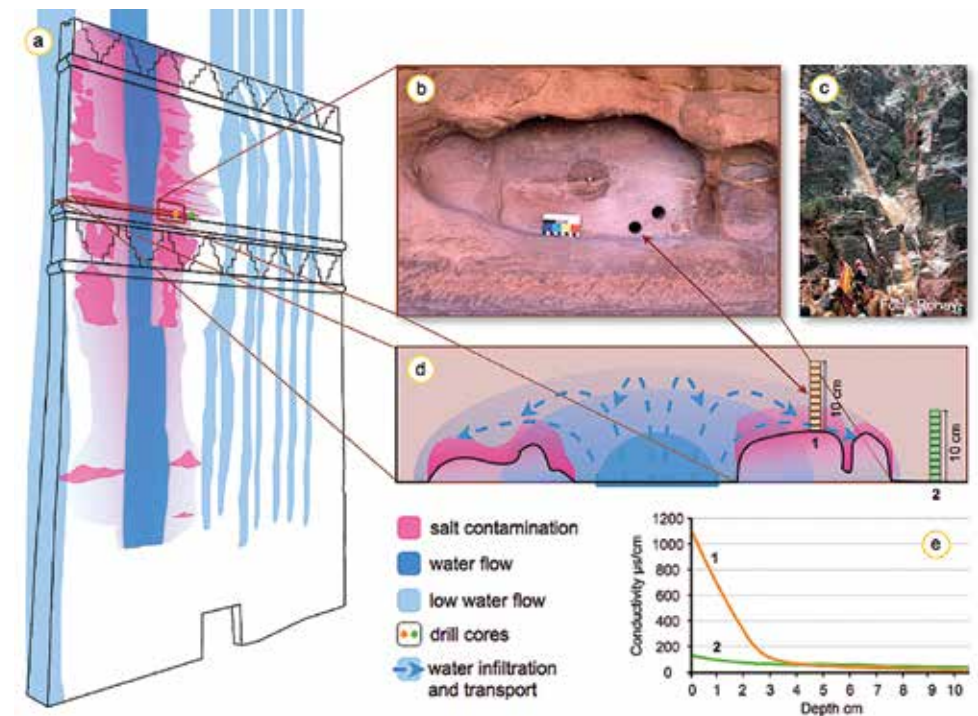
Figure 1: a) Distribution of alveolar weathering and traces where the rainwater drains at façade no. 826. b) Tafoni 3 with sampling point of the crust and drill core holes. c) Cascade-like water stains after a rainfall. d) Idealized cross section of the sampling area. e) Electrical conductivity at depth in the drill core samples.

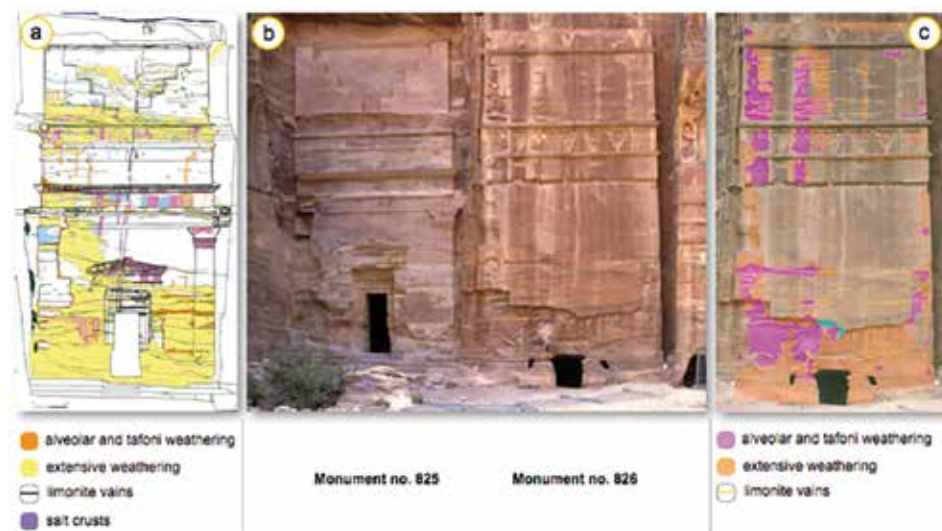
Figure 2: The treated monuments. a) Mapping by the CARCIP team. b) Monument no. 825 and 826 and c) mapping of monument no. 826.

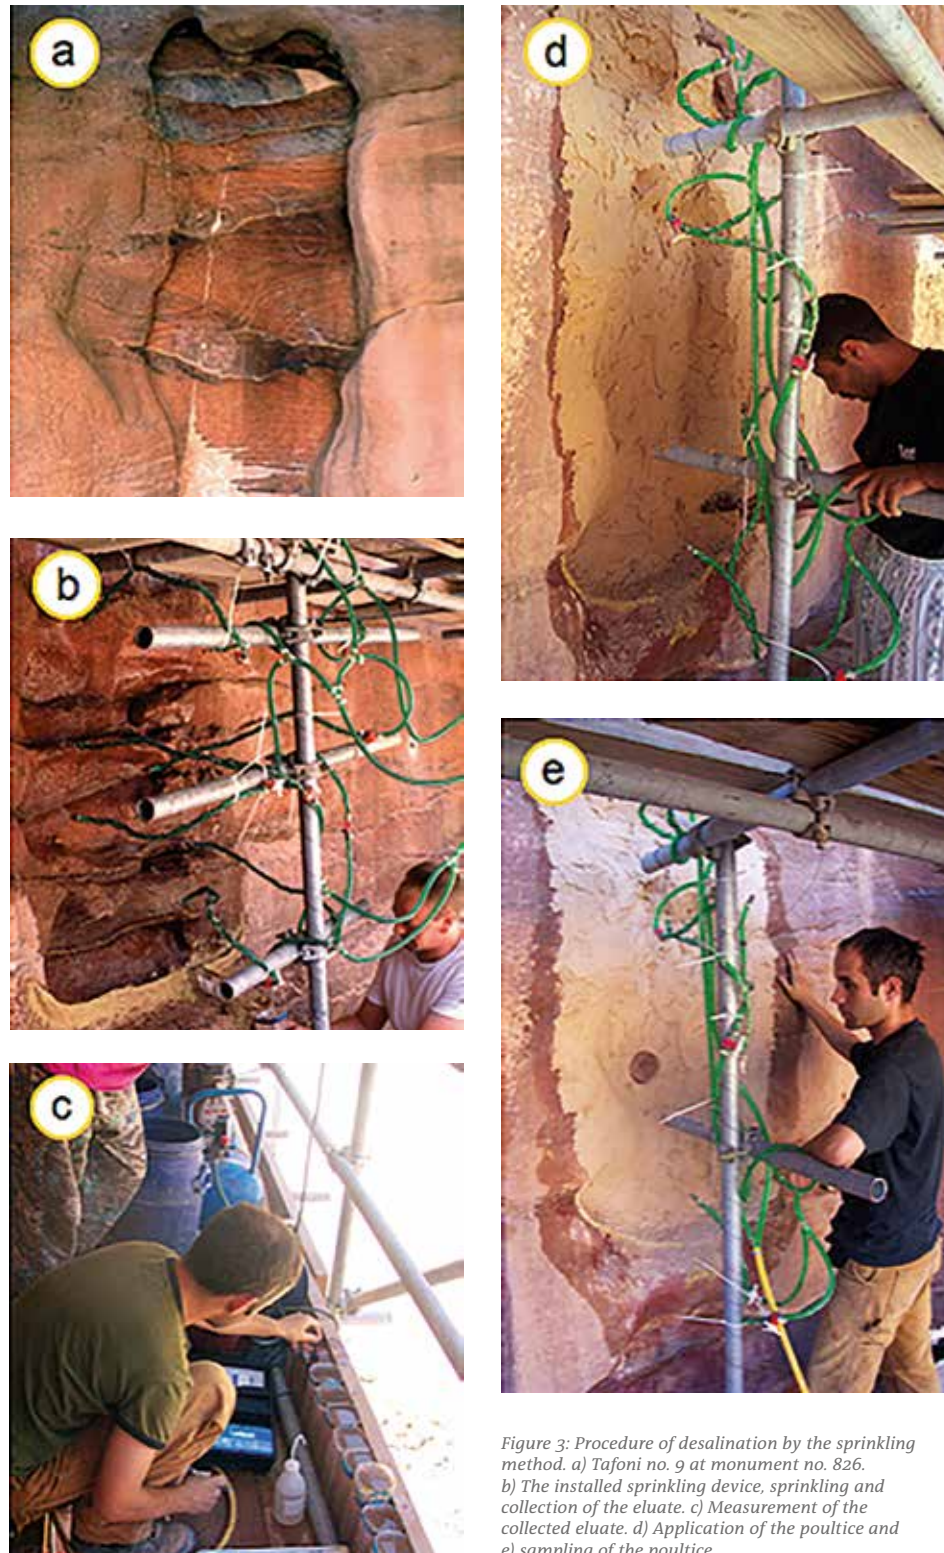
Figure 3: Procedure of desalination by the sprinkling method. a) Tafoni no. 9 at monument no. 826. b) The installed sprinkling device, sprinkling and collection of the eluate. c) Measurement of the collected eluate. d) Application of the poultice and e) sampling of the poultice.

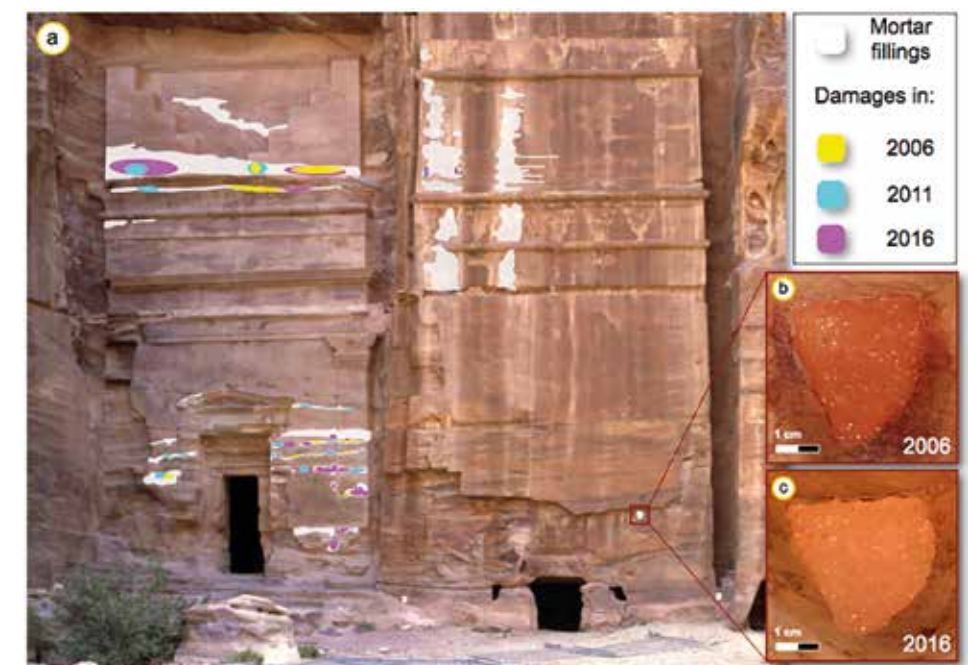
Figure 4: a) Ongoing damage progress of restored areas treated with silica-sol mortars during a period of 15 years on monument 825. b) Sample of a dry-slaked lime mortar just after application in 2006 and c) after 10 years.

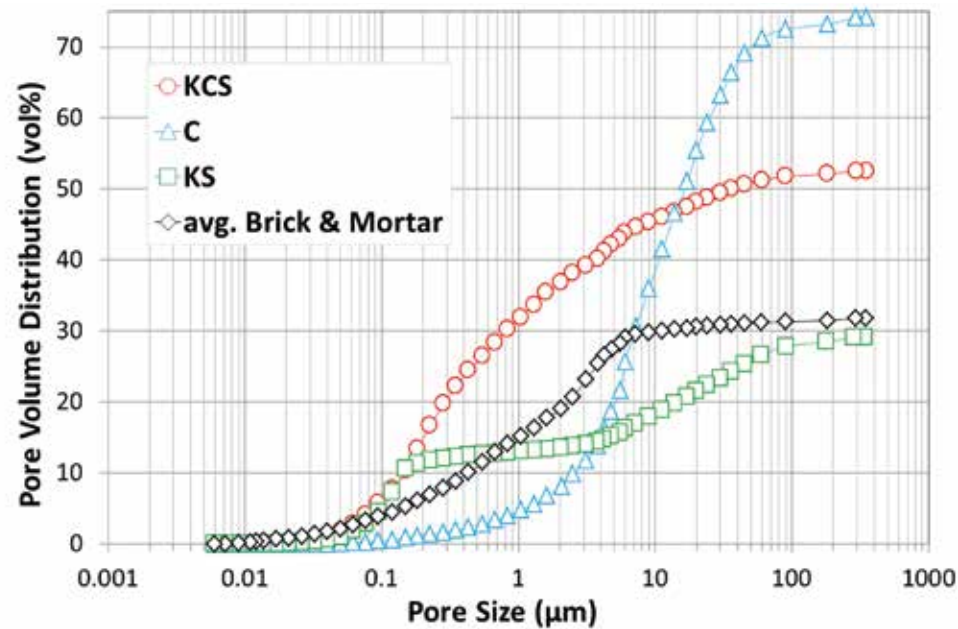
Figure 1: Cumulative pore volume distribution (vol%) of the dried poultice materials KCS (o), C (Δ) and KS (◻) compared to the avg. pore volume distribution of the brick and mortar from 7 locations (◊).

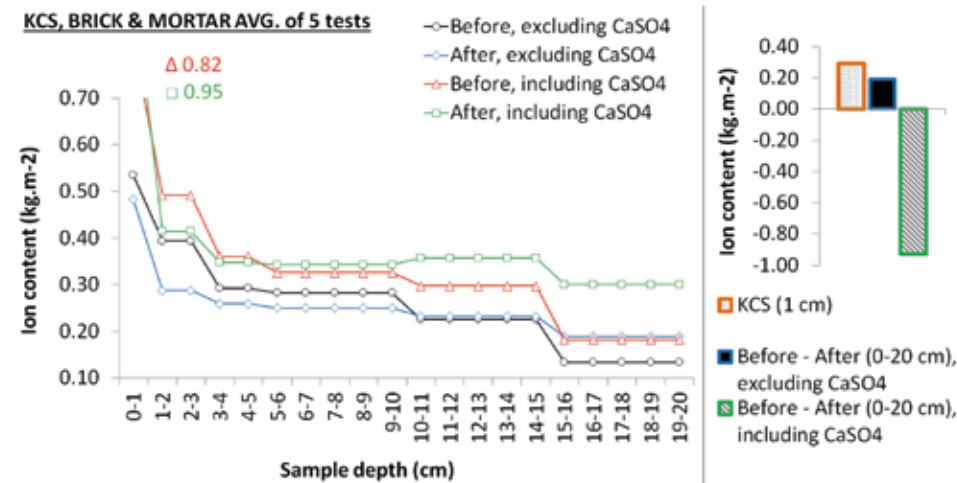
Figure 2: Poultice KCS, avg. of 5 locations (1-5). Left: Results of the avg. ion concentration ( $\text{kg}\cdot\text{m}^{-2}$ , per cm), detected in the masonry, while taking the respective surface areas of the brick and mortar into account: before (o, black line) and after (o, blue line) excl.  $\text{CaSO}_4$ , and again before ( $\Delta$ , red line) and after ( $\square$ , green line) incl.  $\text{CaSO}_4$ . The vertical bars on the right show respectively the avg. amount of salts deposited in the poultice (dotted and orange column,  $\text{kg}\cdot\text{m}^{-2}$ ) and the avg. amount of salts, excl.  $\text{CaSO}_4$  that have disappeared from the substrate (full and blue column,  $\text{kg}\cdot\text{m}^{-2}$ , total of sampled depth 0-20 cm) and idem, incl.  $\text{CaSO}_4$  (striped and green column). For the latter the negative value indicates an average increase of the salt content over the sampled volume.

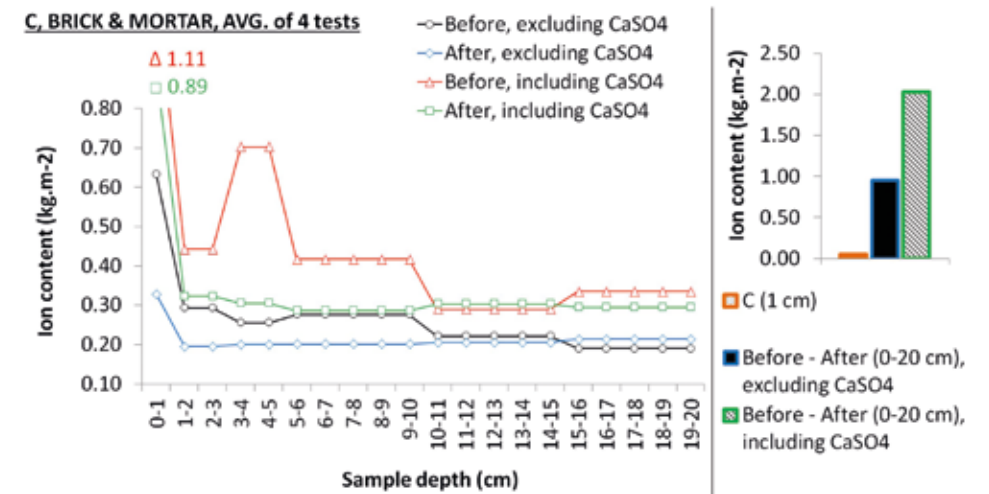
Figure 3: Poultice C, avg. of 4 locations (6-9). Left: Results of the avg. ion concentration ( $\text{kg}\cdot\text{m}^{-2}$ , per cm), detected in the masonry, while taking the respective surface areas of the brick and mortar into account: before (o, black line) and after (o, blue line) excl.  $\text{CaSO}_4$ , and again before ( $\Delta$ , red line) and after ( $\square$ , green line) incl.  $\text{CaSO}_4$ . The vertical bars on the right show respectively the avg. amount of salts deposited in the poultice (dotted and orange outlined column,  $\text{kg}\cdot\text{m}^{-2}$ , total thickness of the poultice: 1 cm) and the avg. amount of salts, excl.  $\text{CaSO}_4$  that have disappeared from the substrate (full and blue outlined column,  $\text{kg}\cdot\text{m}^{-2}$ , total of sampled depth 0-20 cm) and idem, incl.  $\text{CaSO}_4$  (striped and green outlined column,  $\text{kg}\cdot\text{m}^{-2}$ , total of sampled depth 0-20 cm).

The average results of the four experiments with poultice C are shown in figure 3. The amount of salts, either excluding or including gypsum, that has disapp-

ared from the masonry (0-20 cm) after the poultice application is respectively 18 and 24%, while the amount of salts that migrated towards the poultice is in both cases only 1% of the total salt content before application. When considering the first cm of the substrate (0-1 cm) the results would indicate an efficiency of 8 and 5%. Although the efficiency concerning the extraction is slightly lower compared to poultice KCS, the salt content in the substrate, excluding gypsum, has decreased significantly further from the surface up to a depth of 15 cm. While practically none of these salts have migrated to the poultice, approximately 17% of them have disappeared, and therefore most likely migrated to lesser salt contaminated areas and into the depth (beyond 20 cm) of the substrate.

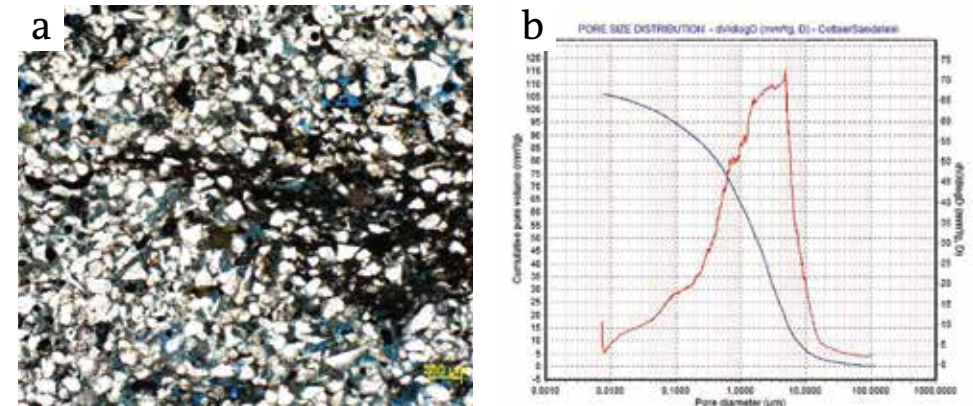
Figure 1: Thin section image of Cotta type sandstone (Nicols II) with pores coloured by blue dye (a) and typical pore size distribution obtained by MIP (b)

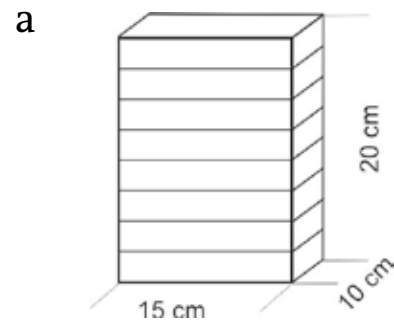
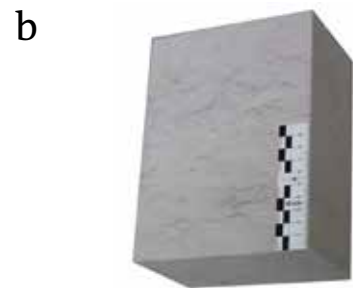
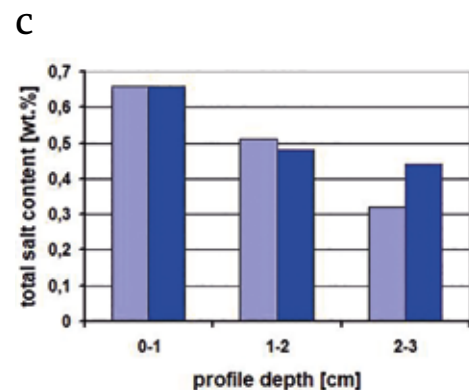
Figure 2: Dimension of the stone specimens used for desalination experiments (a, b) and analytical control of the salt distribution on two random samples (c)

Cotta type sandstone in the dimension of 15x20x10 cm with the largest areas cut perpendicular to the bedding were prepared (Figure 2a, b). After sealing the specimens at the 4 smaller sides with epoxy resin, they were loaded with 3% sodium sulphate solution by capillary suction parallel to bedding over 7 days. After

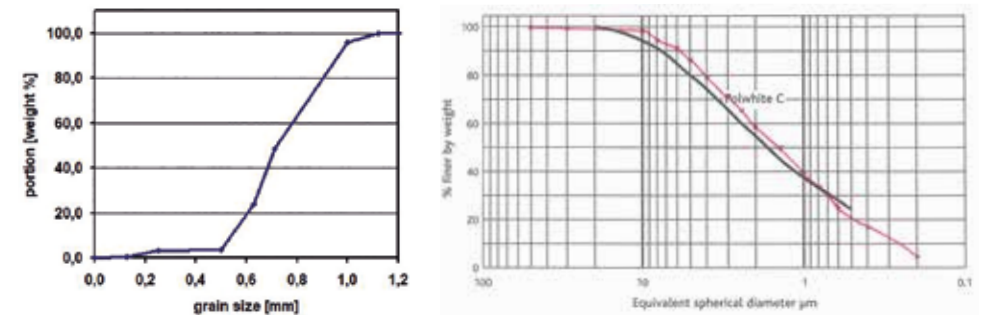
Figure 3: Grain size distribution of the used sand (a) and kaolin (b) components (red line = kaoline Caminau, black line kaoline Polwhite™ C for comparance)

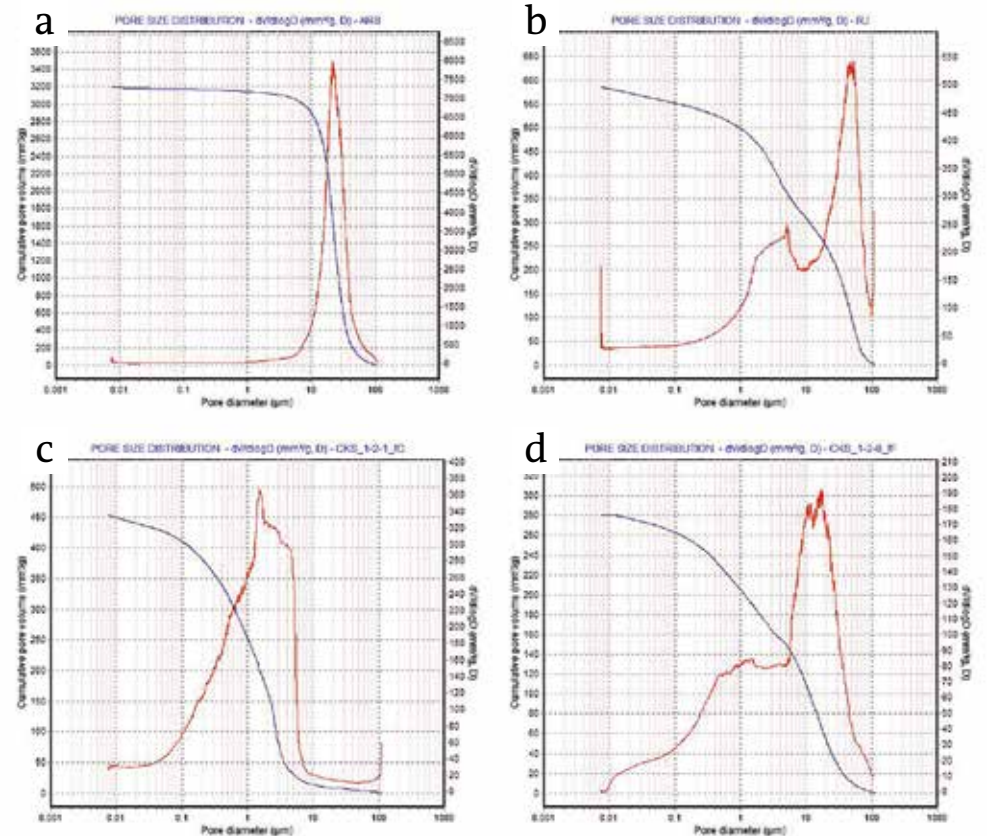
Figure 4: MIP diagrams of the applied poultices: a) pure Arbocel® poultice, b) Rajasil ready-made mixture, c) cellulose-kaolinite-sand 1:2:1 mixture (CKS\_121), d) cellulose-kaolinite-sand 1:2:8 mixture (CKS\_128)

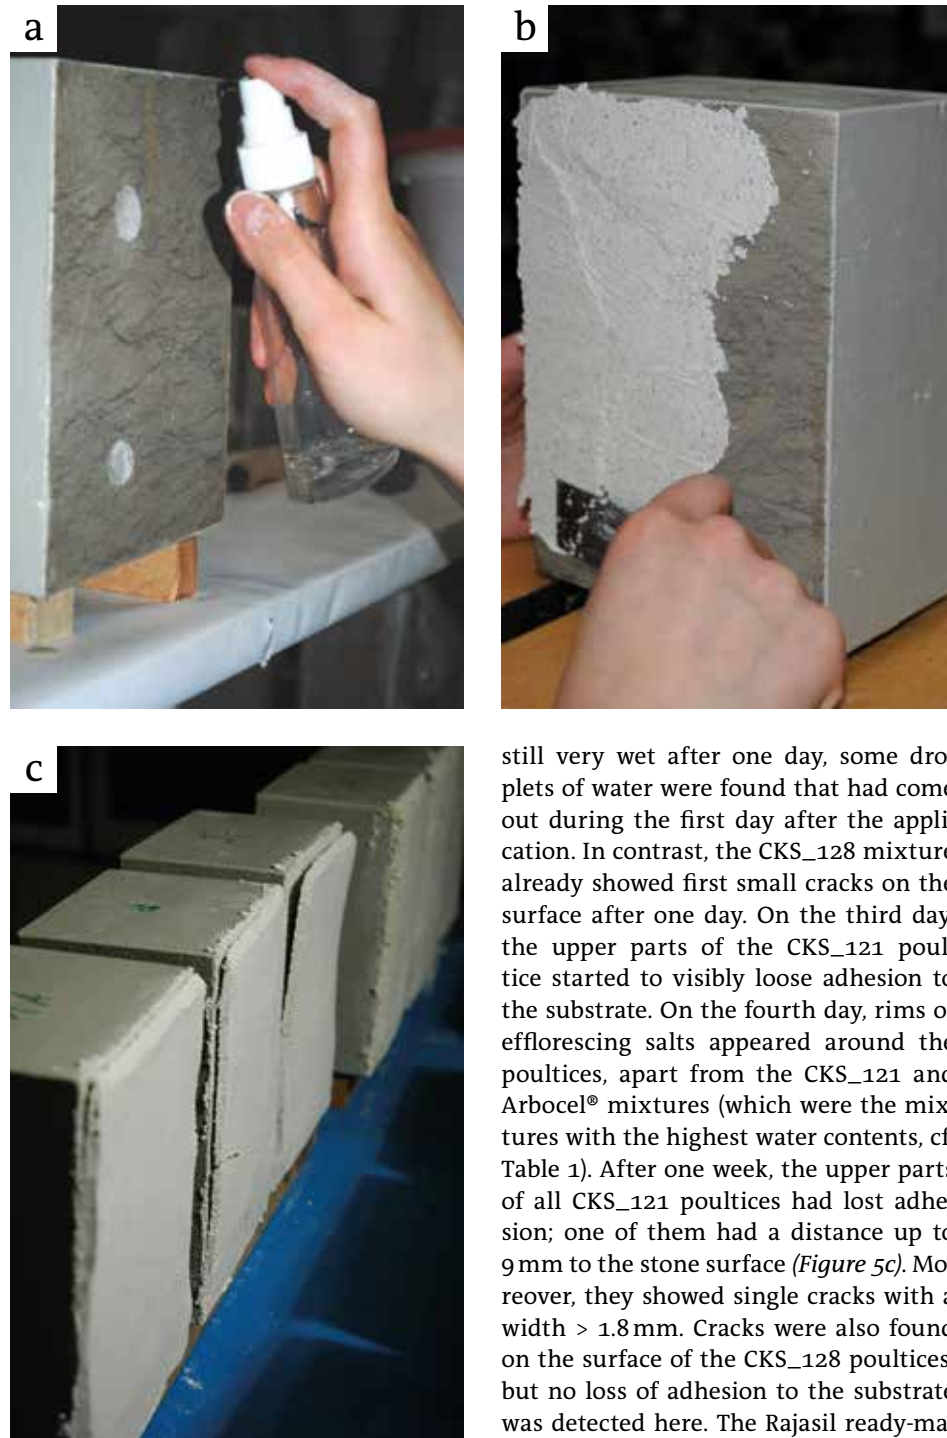
Figure 5: a) Pre-wetting of the stone surface, b) application of the CKS\_121 poultice on the pre-wetted stone specimen, c) loss of adhesion on the CKS\_121 mixtures one week after application

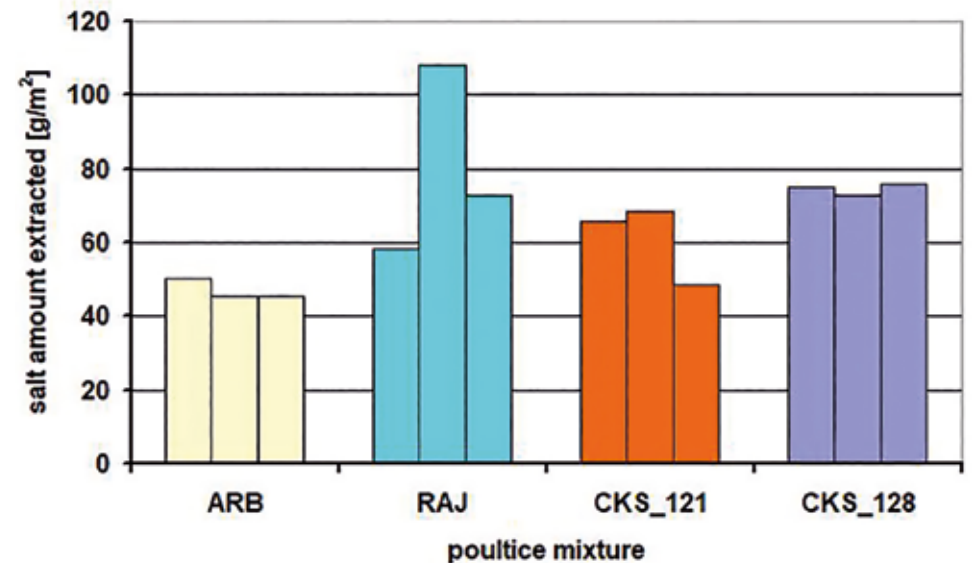
Figure 6: Salt amounts extracted from the salt-loaded Cotta type sandstone specimens with different poultice mixtures during a 3 week's desalination cycle

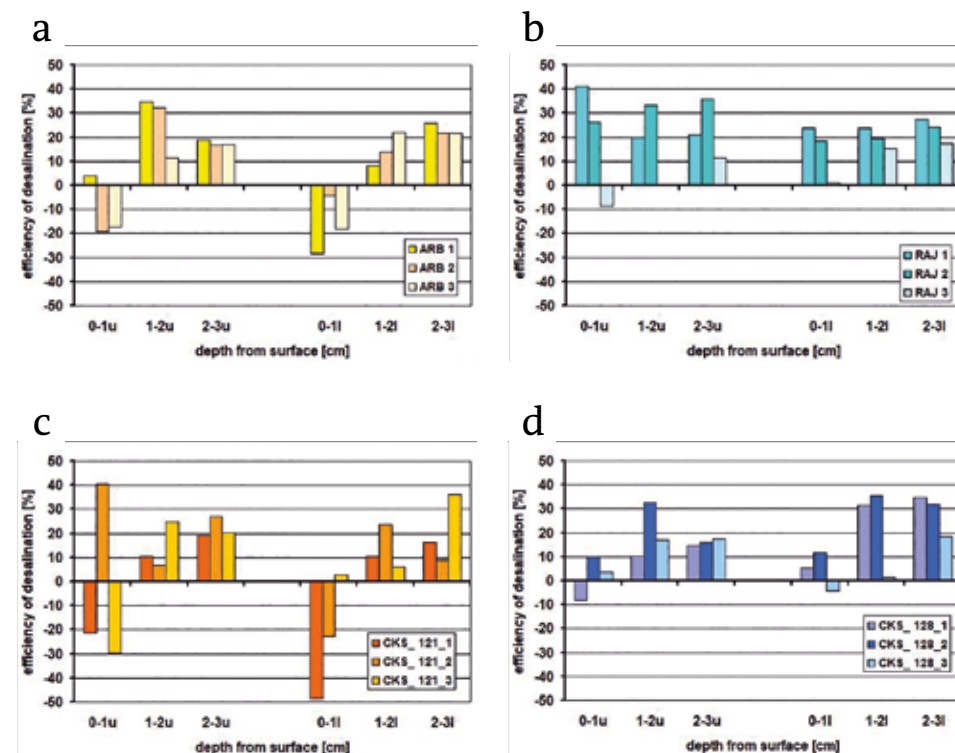
Figure 7: Efficiency of desalination displayed for different profile depths in each of the three sandstone specimens for a) Arbocel® mixture, b) Rajasil ready-made mixture, c) CKS\_121 mixture and d) CKS\_128 mixture. Positive values indicate salt reduction, negative ones increase of salt content after desalination, related to the original salt content in every specimen (u = upper part, l = lower part of the stone specimen)

tely dried to moisture equilibrium with the surrounding air might lead to concentration of the activated salts near the stone surface (*cf. Figure 7 c*), which could be dangerous to the stone substrate. Alternatively, more frequently repeated short application periods of only a few days (until adhesion gets lost) with the CKS\_121 mixture could be tested. This might save time but will increase costs for material and personnel. More practical experiments are needed to work out strategies balanced between appropriate poultice materials, workability and costs.
