# SWBSS 2017

## Fourth International Conference on Salt Weathering of Buildings and Stone Sculptures

# **Proceedings of SWBSS 2017**

**Fourth International Conference on  
Salt Weathering of Buildings and Stone  
Sculptures**

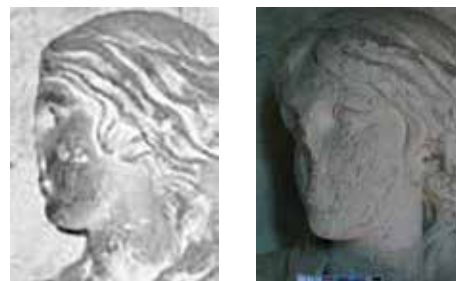
Figure 2: Face of the statue Esperance: blackening in 1998 (detail of figure 1), scaling and granular disintegration in 2012.

on and salt efflorescence were noticed on Charity and Esperance sculptures (Figure 2). This led Irène Jourd'heuil, the curator responsible for their preservation to ask for a condition survey, aiming at understanding the reasons for their quick degradation, and at setting up a conservation project.

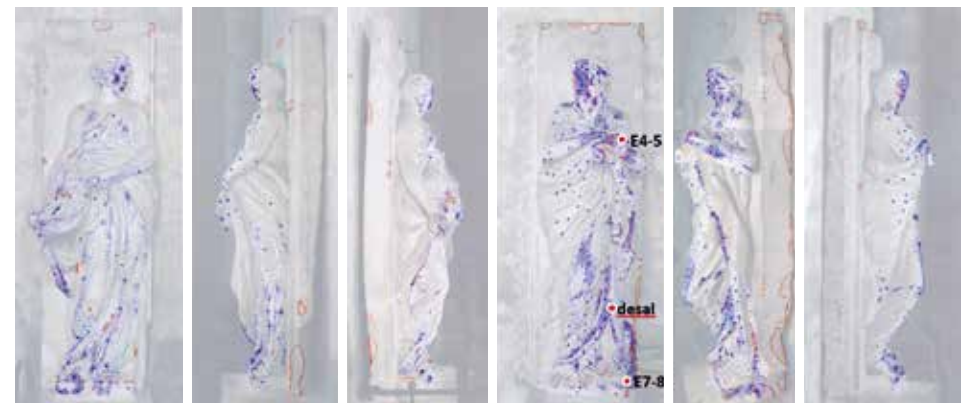
Figure 3: Charity (three images on the left) and Esperance (three images on the right): distribution of stone losses due to granular disintegration + scaling (blue spots), and to mechanical impacts (red lines). Sampling locations are shown as red spots.

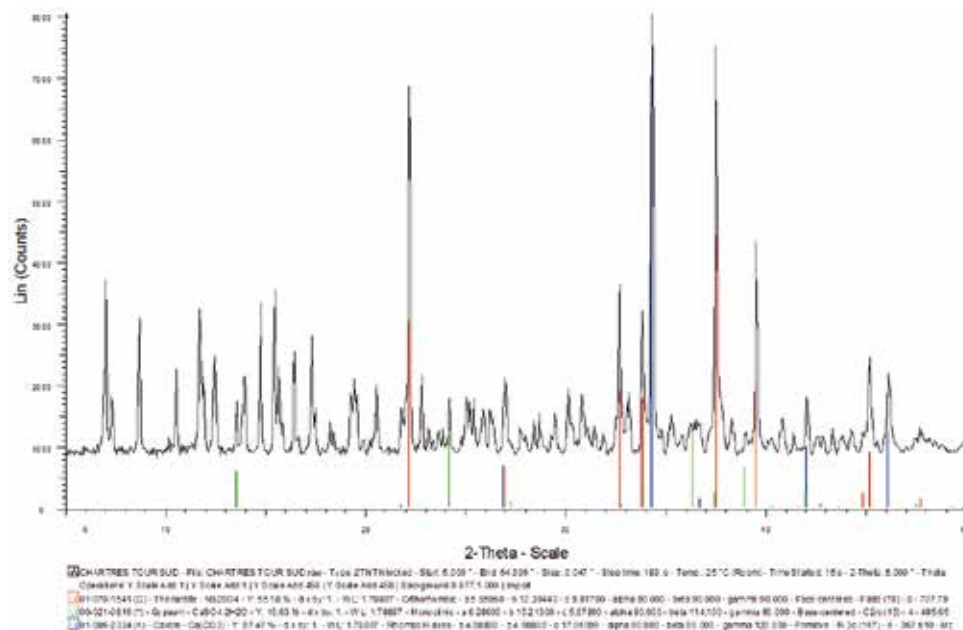
Figure 4: Diffractogram of a typical efflorescence sample collected on the sculpture Esperance. Thenardite (red), gypsum (green) and calcite (blue) are present; most peaks cannot be attributed to an identified mineral phase.

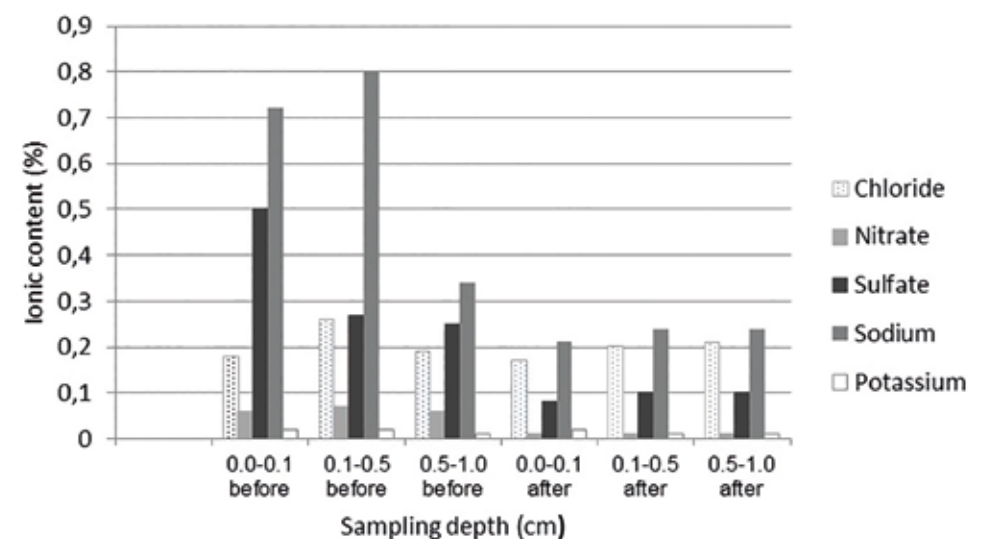
Figure 5: Results of the soluble salts quantification on the sculpture "Esperance". Location of sampling to be found on Figure 3 (ref. "desal")

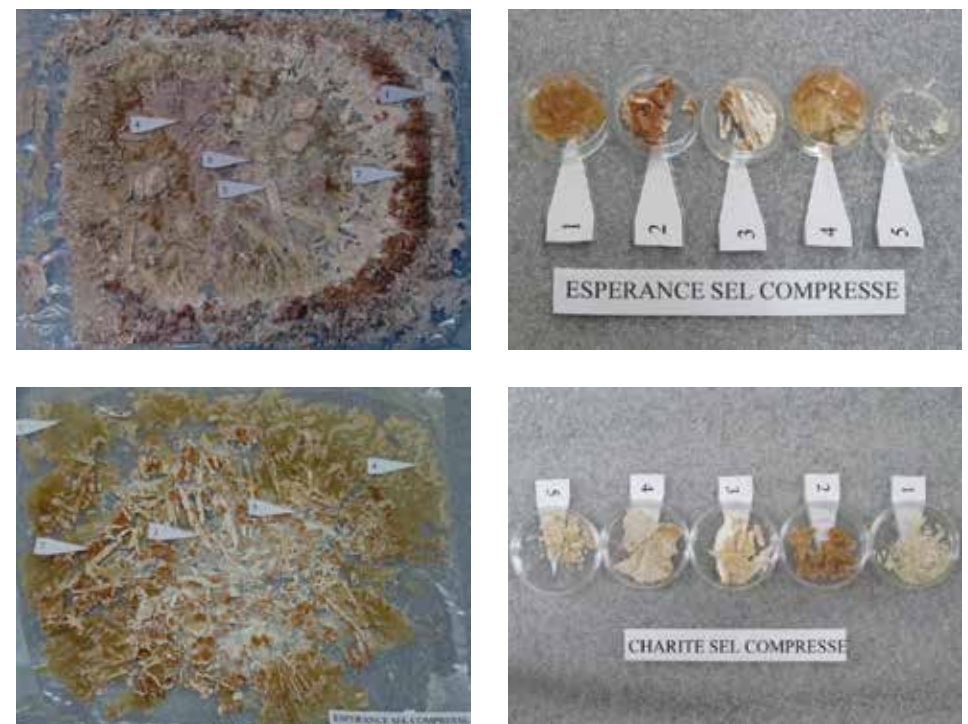
Figure 6: General aspect of the evaporates, and overview of the sampling.

The salts extracted from the two sculptures looked pretty much the same (Figure 6): a light brown colour, and a ring shape sequence of crystals. Samples collected from the outer to the inner ring were characterized by X-ray diffraction (Table 2).

The evaporates contain mainly thenardite. The other major phase is an unidentified phase (ref “unident phase b”), different from the unidentified phase (ref unident phase “a”) found on surface samples collected on the sculptures before the desalination intervention. Three other phases are locally abundant: gypsum and halite, and the unidentified phase “a”. Calcic EDTA is found in four samples. Interestingly, the sample containing the higher amount of calcic EDTA also contains high amounts of the two unidentified phases. The sample Charity 3 was collected on big flat quadrangular white crystals visible in the two evaporates, suggesting that they are thenardite (or rather mirabilite dehydrated into

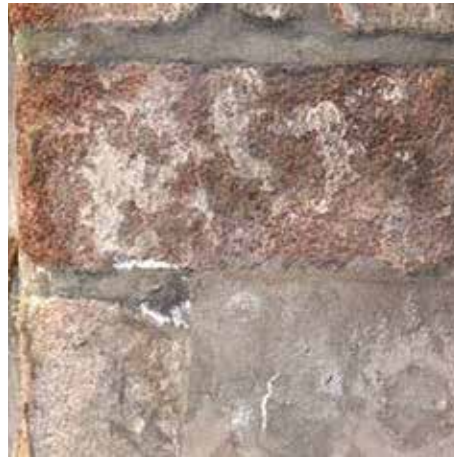
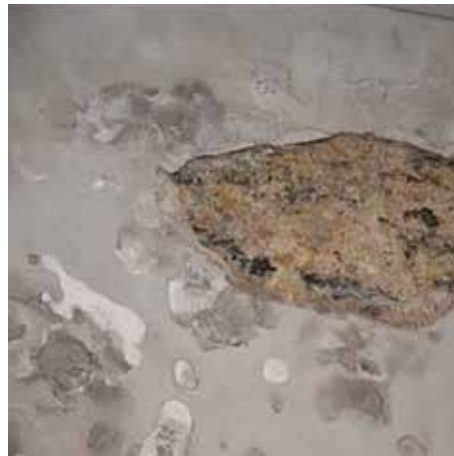
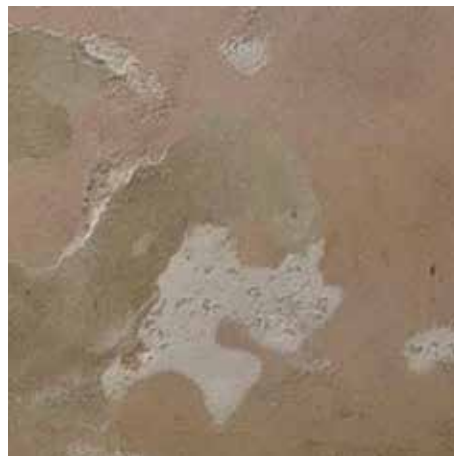
Figure 1: Overviews and details of salt efflorescences and moisture areas on granite and cement plaster covering the schist masonry

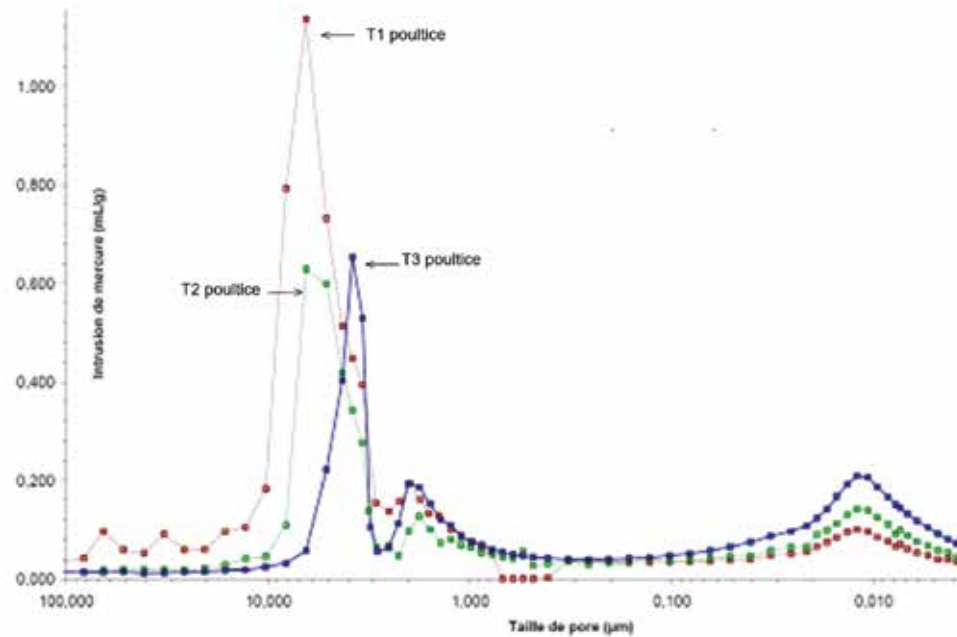
Figure 4: Pore size distribution curves of poultices formulations

We can conclude that, the 3 poultice formulations may permit advective extraction on these granite and schist stones. According to the proportion of volume of the different pore categories, T2 formulation poultice is the most suitable for the granite pore size distribution while T3 formulation poultice is the most suitable for the schist in place.

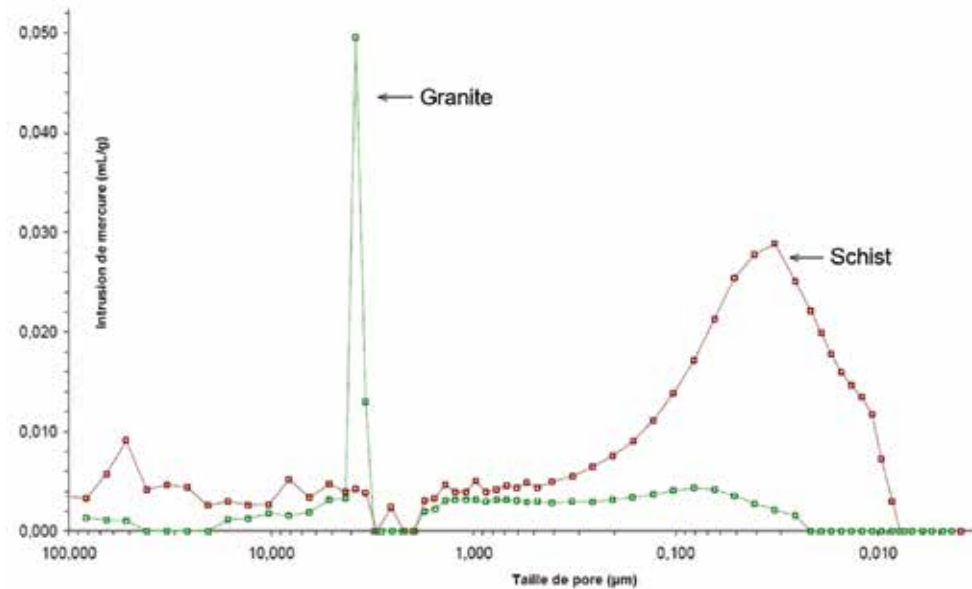
Figure 5: Pore size distribution curves of granite and schist

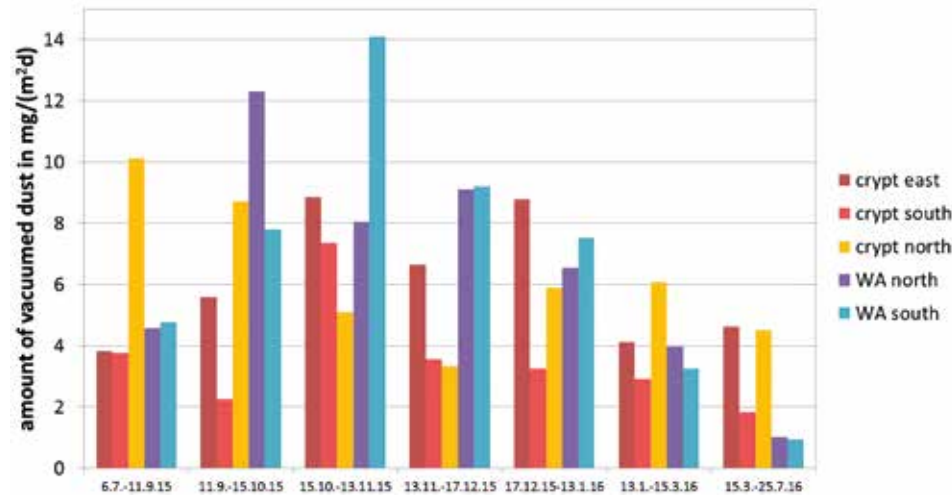
Figure 1: Dust accumulation of the main series in crypt (window sills) and nave (west apsis arcade windows sills).

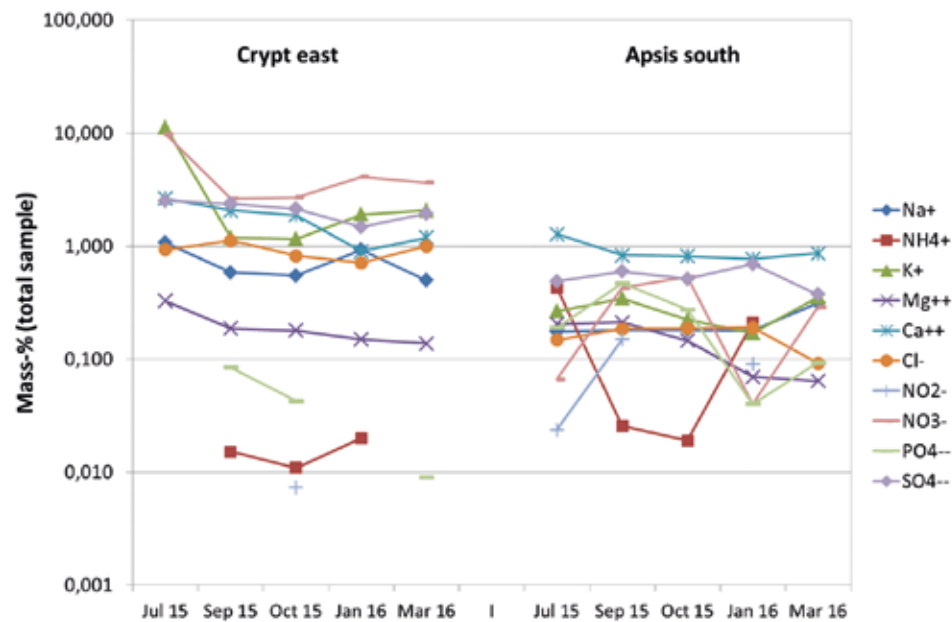
Figure 2: Salt analyses by ion chromatography of the two main series of dust collection.

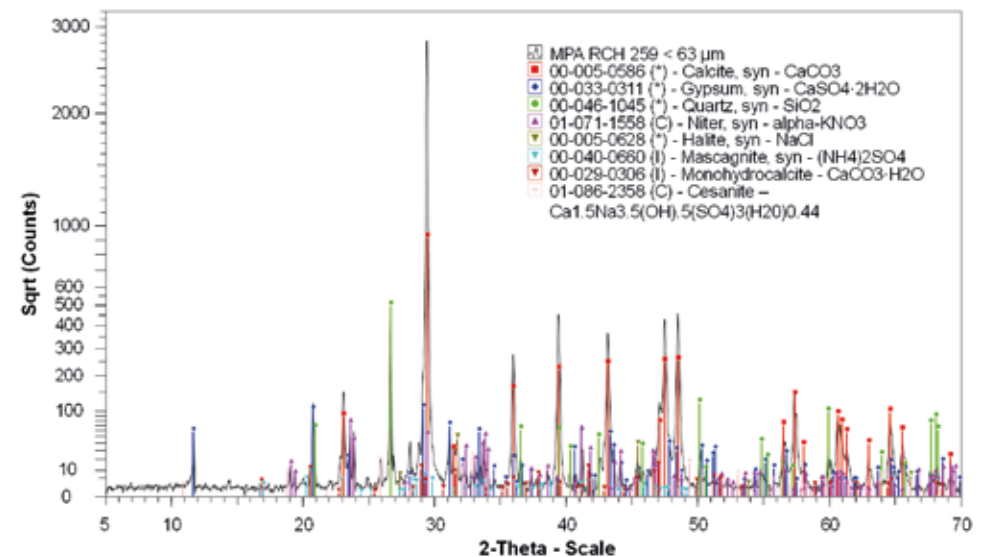
Figure 3: X-ray diffractometry of a dust sample from the crypt east window sill.

Some dust samples from crypt and apsis were analysed by x-ray diffraction. As expected calcite, gypsum and quartz occurred in both samples and some unspecific mixed crystals. Figure 3 shows an

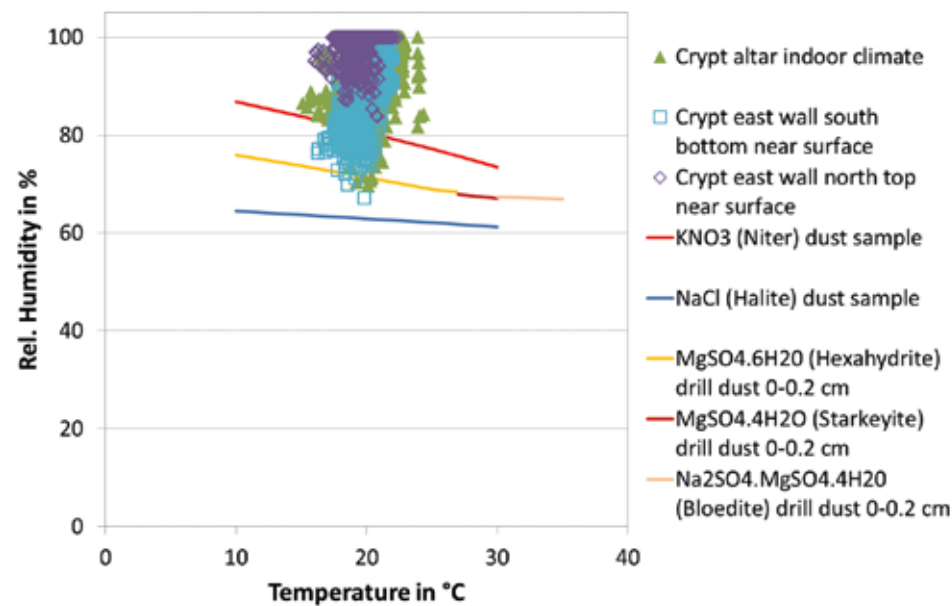
Figure 4: Comparison of simulated deliquescence humidities with climate data of the dust sampling period (6<sup>th</sup> July 2015 to 11<sup>th</sup> September 2015) in the crypt.

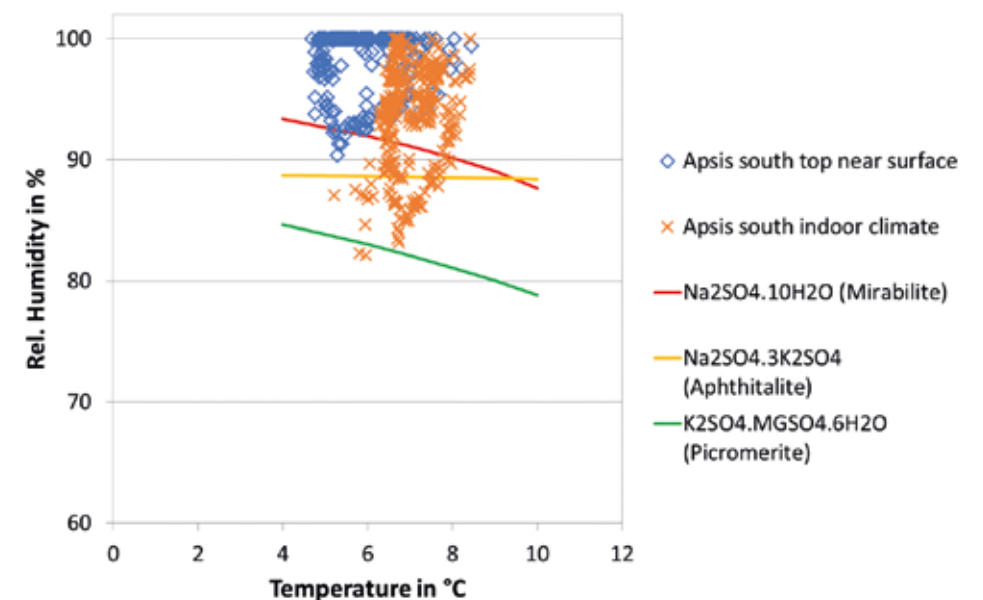
Figure 5: Comparison of simulated deliquescence humidities with climate data of the dust sampling period (17<sup>th</sup> December 2015 to 13<sup>th</sup> January 2016) in the apsis.

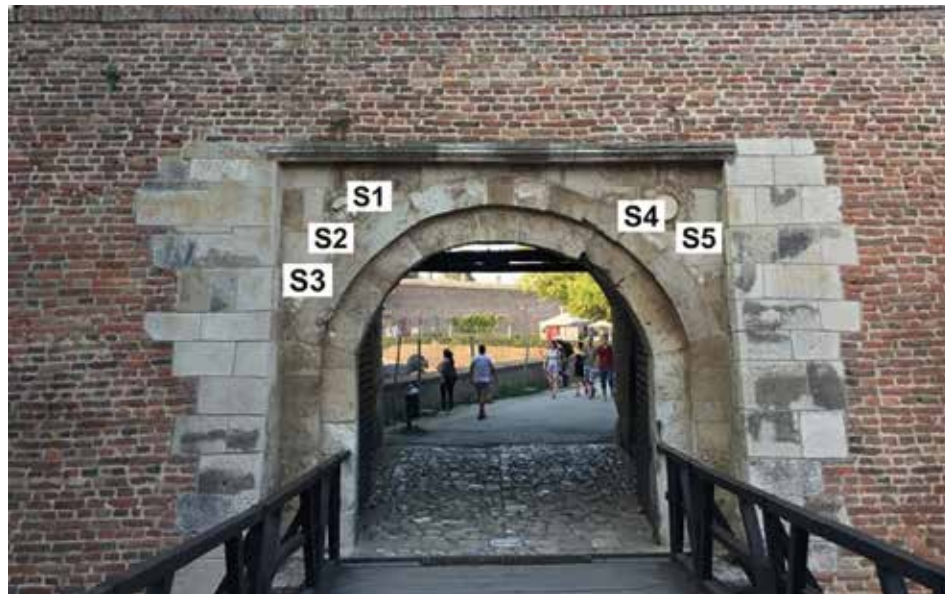
Figure 1: The view of the Karadjordje's Gate in Belgrade (Serbia) and position of the taken salt samples

The gate consists of frontal (south) facade (investigated area in this paper), central aisle with two side rooms for guards and north facades built of bricks and stone. Frontal facade consists of double stone arches and it is finished with decorative cornice (*Fig. 1*). Facade is built entirely of limestone blocks with simple decorations representing two symmetrical rosettes. The gate was subject to the restoration campaign carried out in 2007. The cleaning was done by water jet and restoration of damaged stone blocks was carried out, without prior consolidation of the stone, with so called „artificial stone“. Joints were restored with Portland cement mortar.

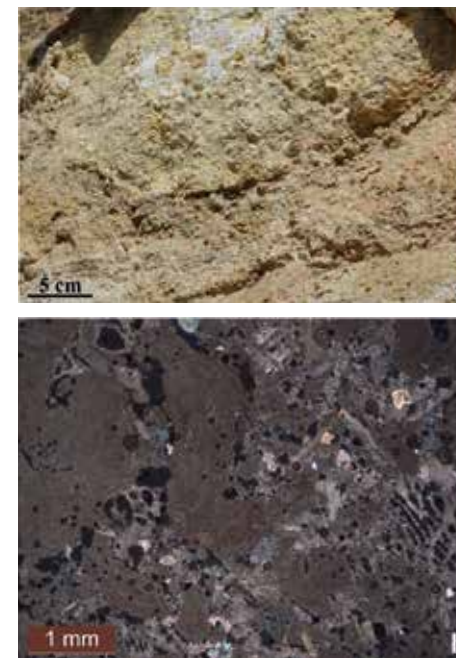
Figure 2: The macroscopic appearance (a) and photomicrograph (XPL) of built Algal rudstone from the Karadjordje's Gate

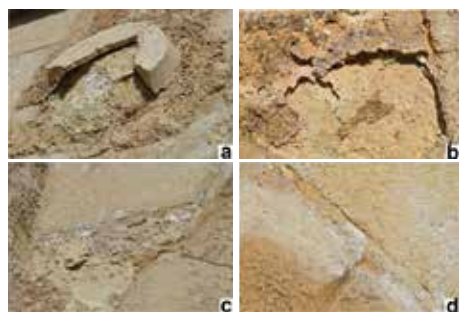
Figure 3: The damage forms on stone blocks. a) detachment of "artificial stone"; b) scaling and disaggregation of the original stone blocks; c-d) efflorescence on mortar joints and surface of artificial stone

Mapping of the Gate's façades and registration of decay forms of stone degradation after the restoration was carried out. Damage occurs on the stone blocks at the upper part of the south façade. The most dominant decay forms are scaling and disaggregation of the original stone blocks, as well as detachment of “artificial stone” used for restoration from the rosettes (Fig. 3a, b). Salts deposits occur around the joints on the stone blocks

in the upper part of the gate, as well as beneath the broken parts of rosette or beneath the scales on the original stone (Fig. 3c, d).

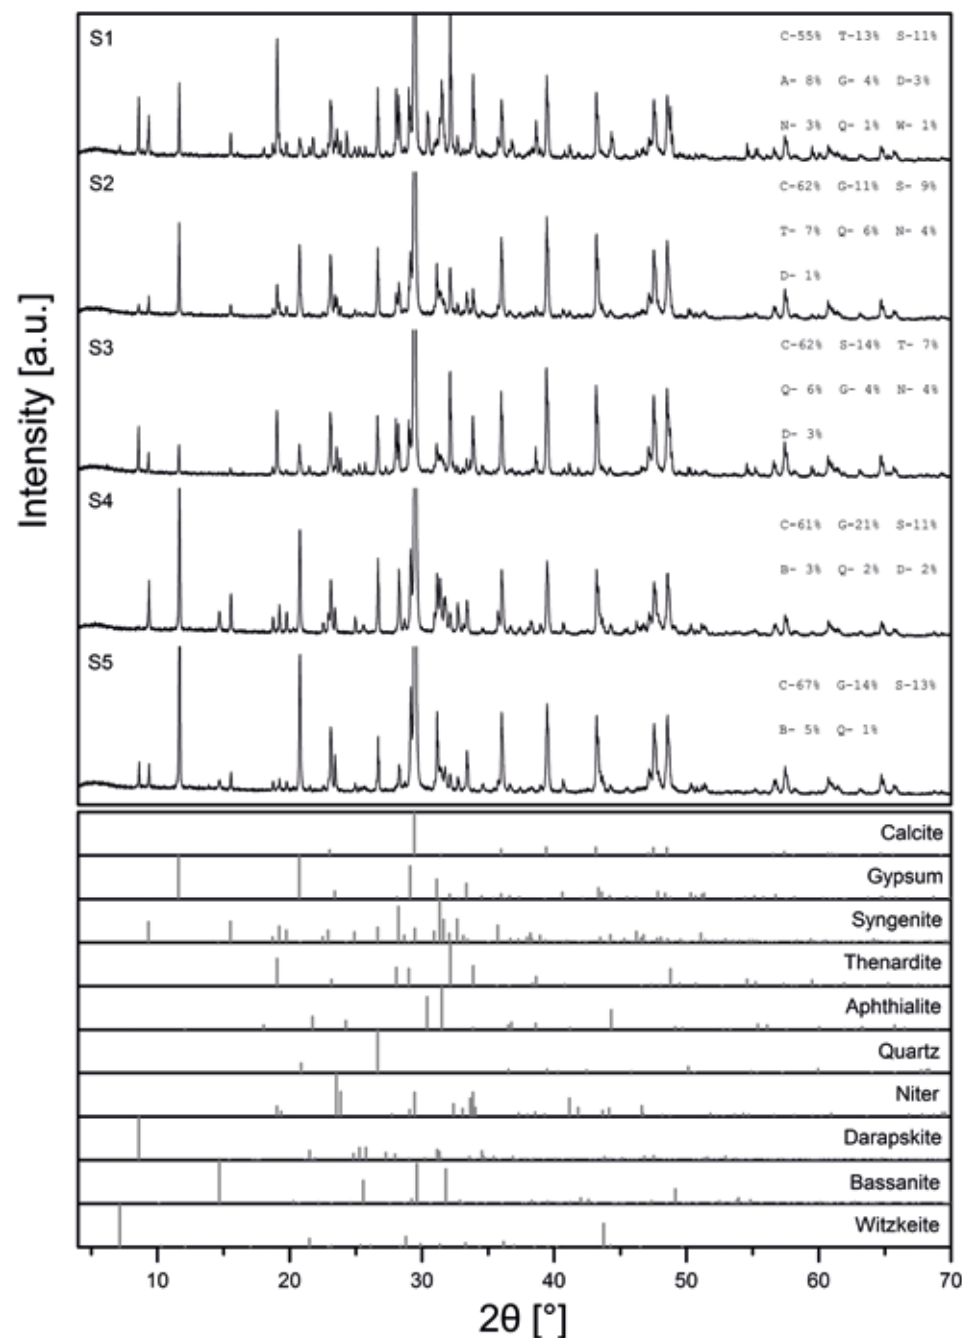
Figure 4: X-ray diffraction patterns of the salts formed on built limestones of Karadjordje's Gate with respective semi quantitative analyses results

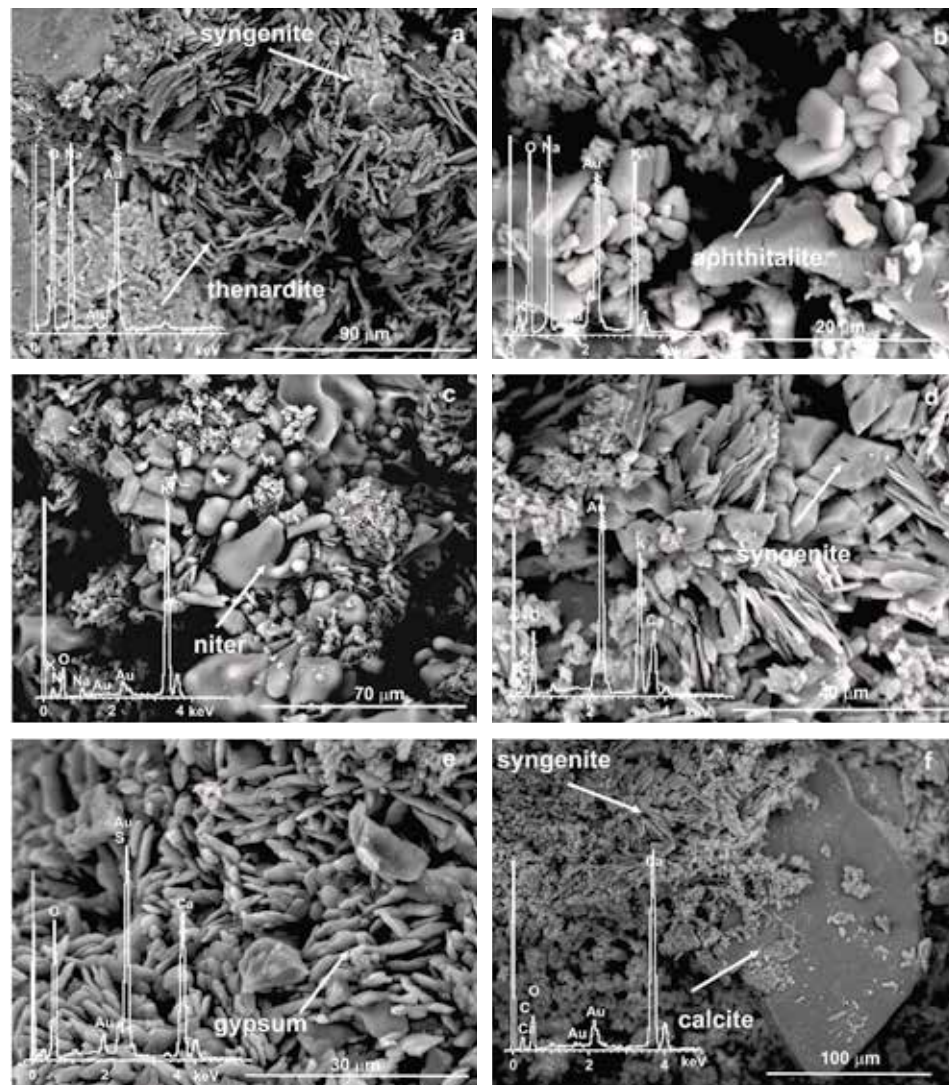
Figure 5: SEI images with EDS spectrums of salts from the analyzed samples S1-S5

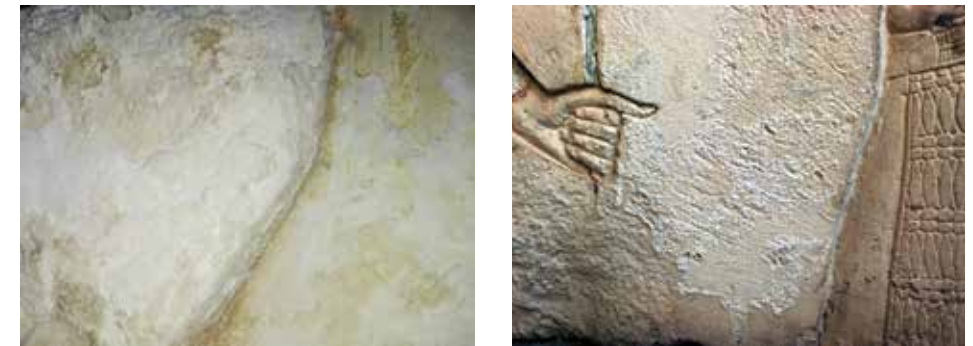
Figure 3: [left image] Crystallized salts in the upper area of the Ramesses II's side, [right image] Crystallized salts in the lower area of the same side.

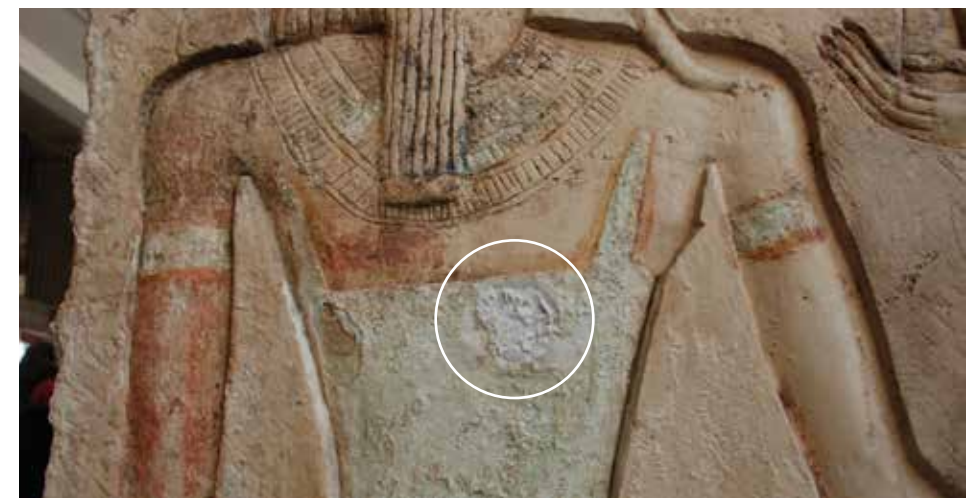
Figure 4: The circle shows the area where Microballoons filler was used to complete the missing parts of the pigment layer. This intervention should be reduced in order to become more discreet and suitable for the rest of the surface.

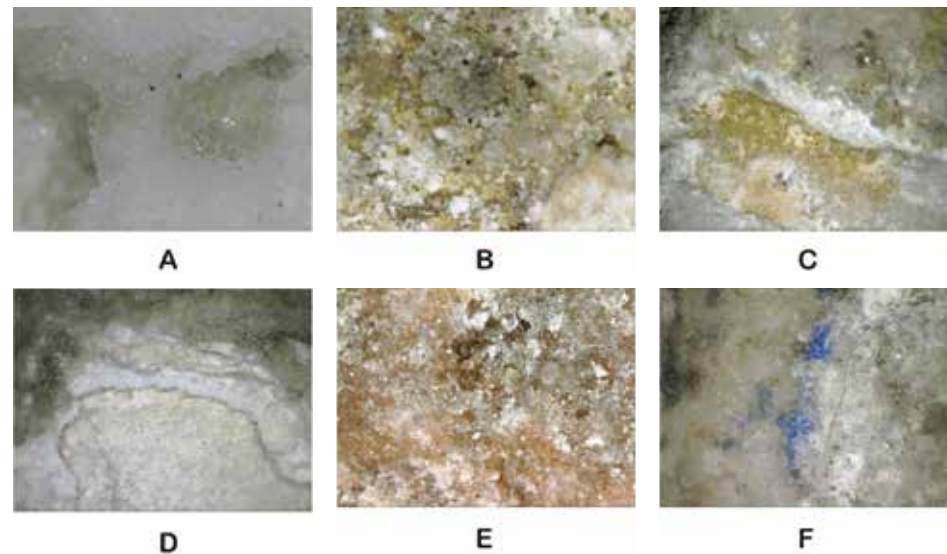
Figure 6: Digital light microscope images on Ramesses II's side of the slab. Images A and B show the crystallized salts on the surface of the relief. C and D show the crystallized salts above and below the pigments, which already led to the fall of some parts of the colour's layer. On image E the crystallized salts are captured inside the red colour, while F consists in a photograph of the crystallized salts above the blue colour. [A, B, E] 250x; [C, D, F] 50x.

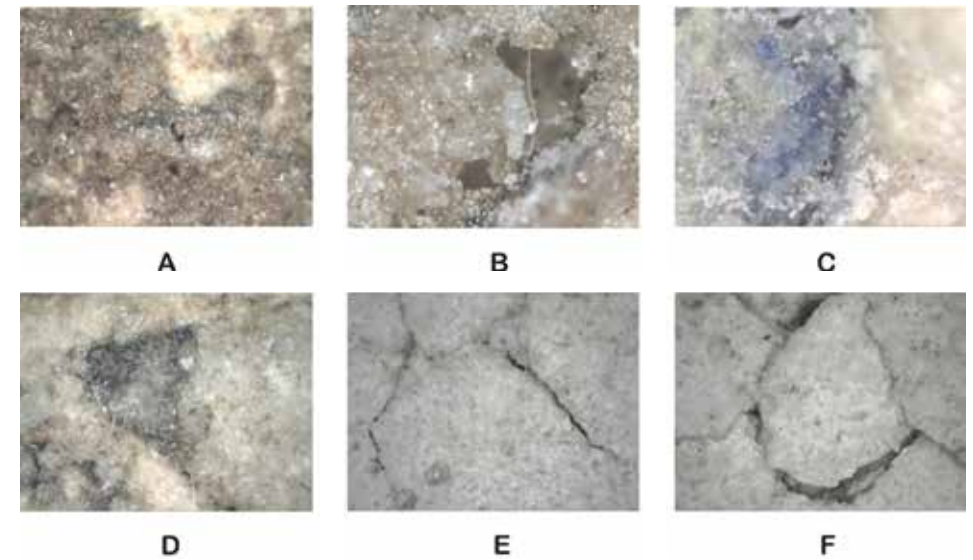
Figure 8: Digital light microscope images taken on the Thutmose II's side. A shows the crystallized salts inside the red colour; B shows the crystallized salts above and below the pigments, which led to the fall of some parts of the colour's layer; on that photograph, we can see the flaking between the painted layer and the original surface. The crystallized salts inside the blue colour are visible on image C, while on D are shown the crystallized salts inside the eye of the figure of the king. E and F show the cracks and the micro-cracks on the surface of the relief. [A, C, D, E, F] 50x; [B] 250x.

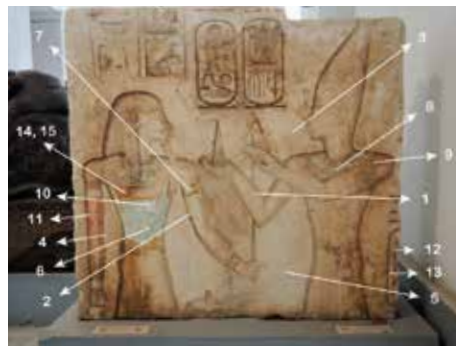
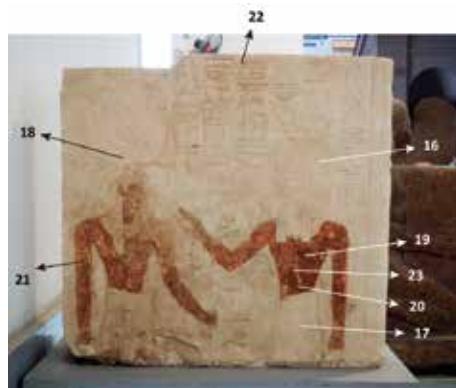
Figures 9 and 10: Slab JE 100014, with numbers showing the areas where PXRF analysis was carried out – face 1 [Fig. 9] (offering scene of Ramesses II) and face 2 [Fig. 10] (offering scene of Thutmose II).

SN 177), which we used to determine the specific elements that are present within the pigments and in the stone block itself (including the salts).

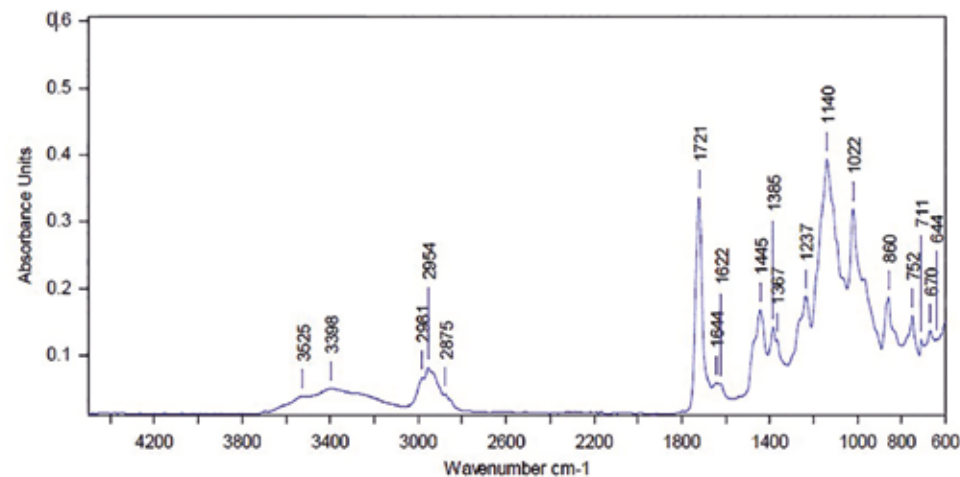
Figure 11: Spectrum FTIR of the sample of red pigment

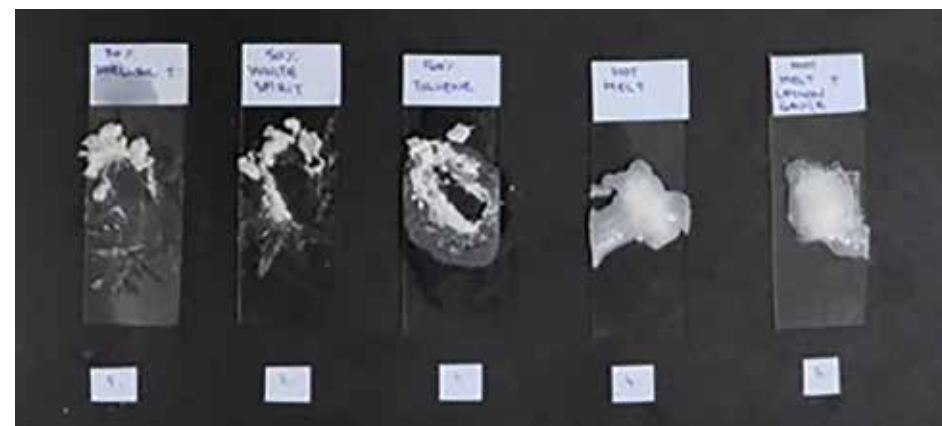
Figure 2: Glass slides with Seget powder and different types of application of CDD after fingernail scratching test (from left to right: 50% solution of CDD in Shellsol T; 50% solution of CDD in white spirit; 50% solution of CDD in toluene; hot melted CDD; hot melted CDD with cotton gauze)

After a fingernail scratching test (after 24 hours) it was possible to conclude that the powder treated with hot melted CDD (in both cases, glass slide 4-5 with hot melted CDD and hot melted CDD with cotton gauze, Fig. 2) was stable and still packed. Powder treated with CDD dissolved in the solution (glass slide 1-3, Fig. 2) after the

test was unstable, and the consolidation effect was less effective.

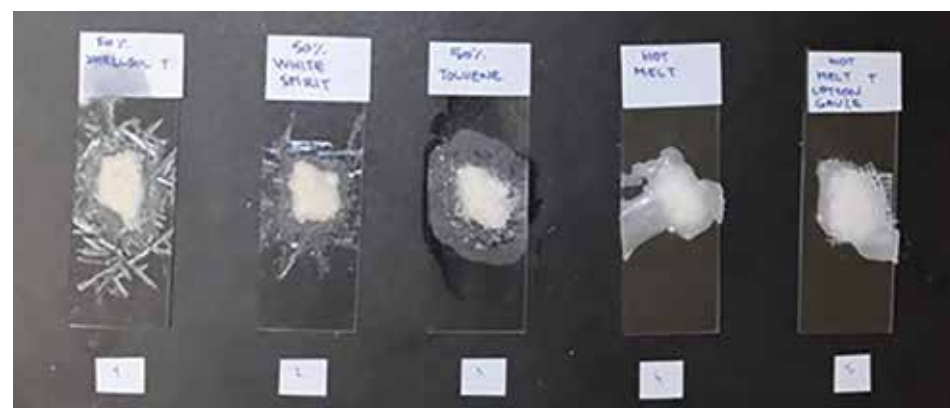
Figure 1: Glass slides with Seget powder and different types of application of CDD (from left to right: 50% solution of CDD in Shellsol T; 50% solution of CDD in white spirit; 50% solution of CDD in toluene; hot melted CDD; hot melted CDD with cotton gauze)

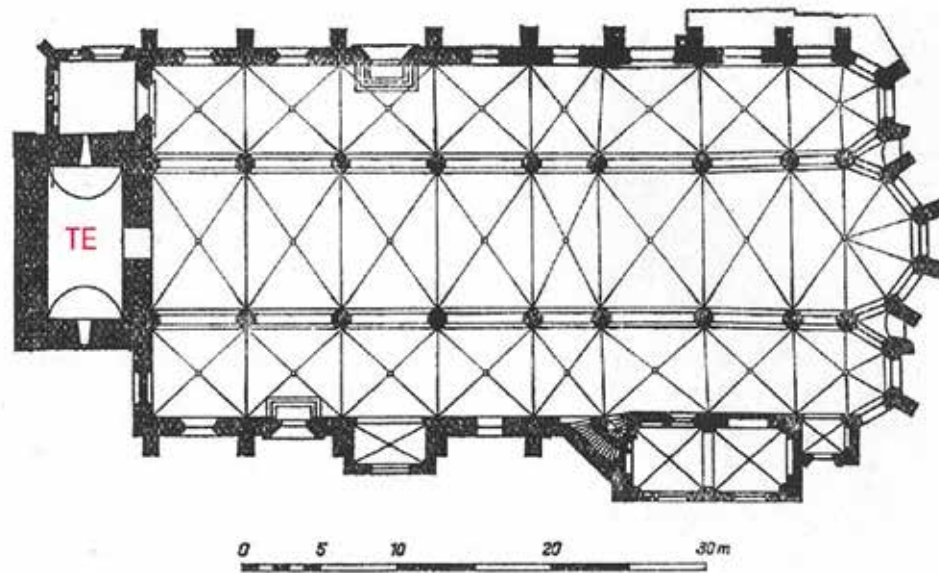
Figure 2: Ground map of St. Johannis 1 containing the ground floor of the steeple (TE)

with a floor area of 9,20m x 4,20m and a height of 4,82m in the zenith of the barrel-vault. Today, the ground floor can only be reached through a wooden door from the nave (Fig. 2). The masonry of the ground floor consists of 1,50m – 1,80m thick walls made of bricks and mortar that today, contain only one window to the south leading to a moist and dark room. The walls were plastered with a lime mortar that is now partly damaged by moisture and salts.

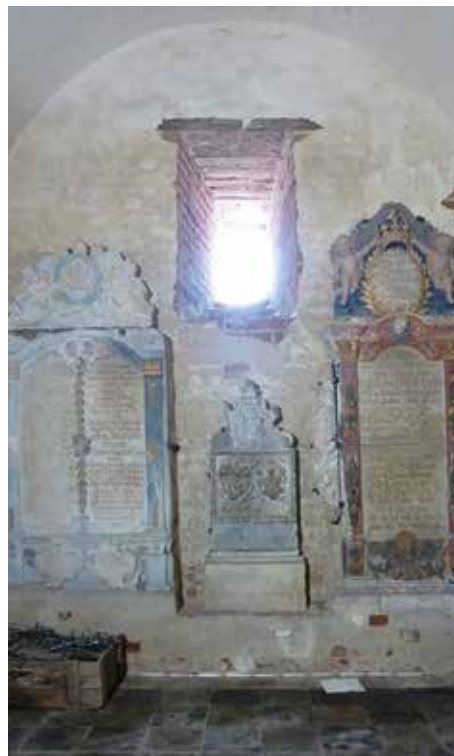
Figure 3: polychrome epitaphs at the southern wall and the only window in the ground floor, in the middle the epitaph of Leonhardt Kämpfe

Today, each epitaph stands on a ca. 40 cm high pedestal made of bricks that are plastered (Fig. 3). The epitaphs are fixated by iron anchors to the back. Additionally, bricks with mortars were applied irregularly to support the backward connection of the epitaphs to the walls. Probably later grey cement mortars were used to reinforce the connection of the epitaphs to the back.

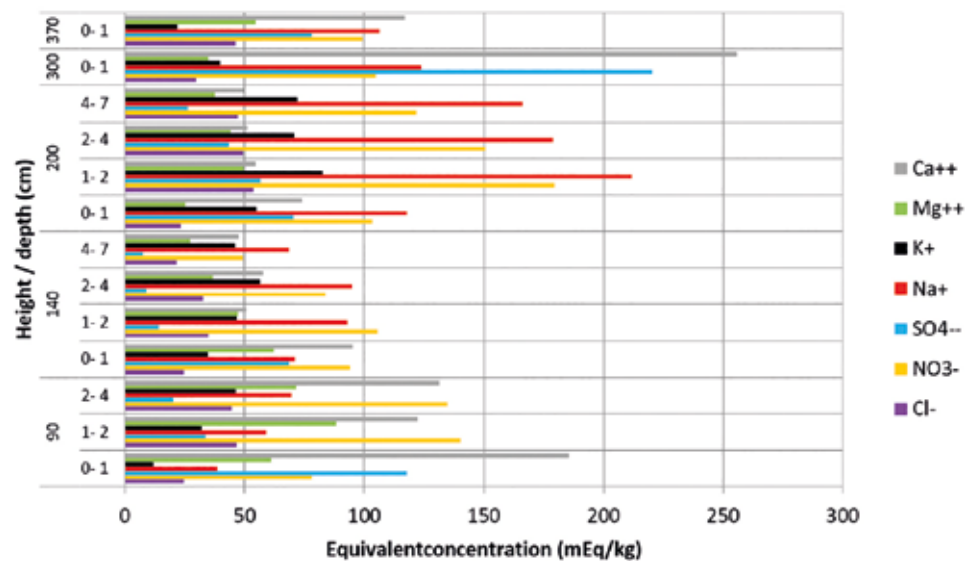
Figure 4: Salt ion distribution in the western wall expressed in Equivalent concentration (mEq/kg)

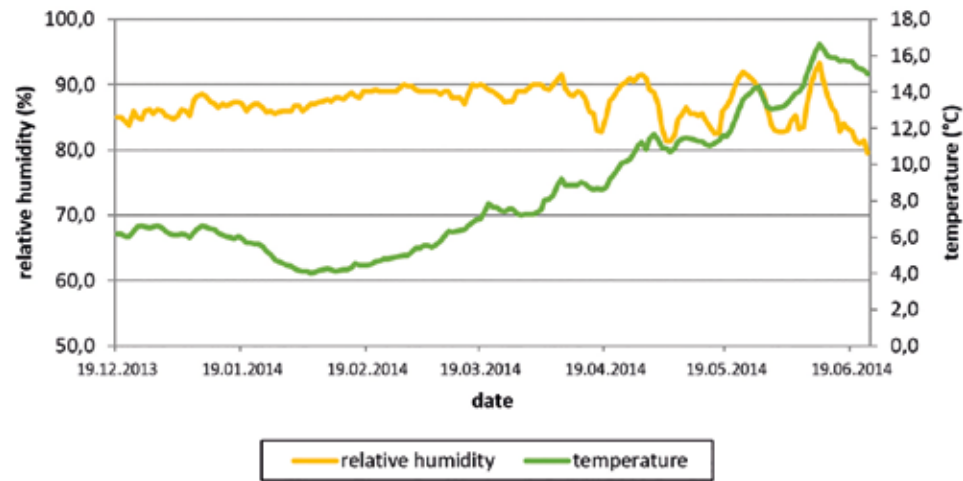
Figure 5: Daily average values of room temperatures (scale right) and relative humidity (scale left) in the ground floor

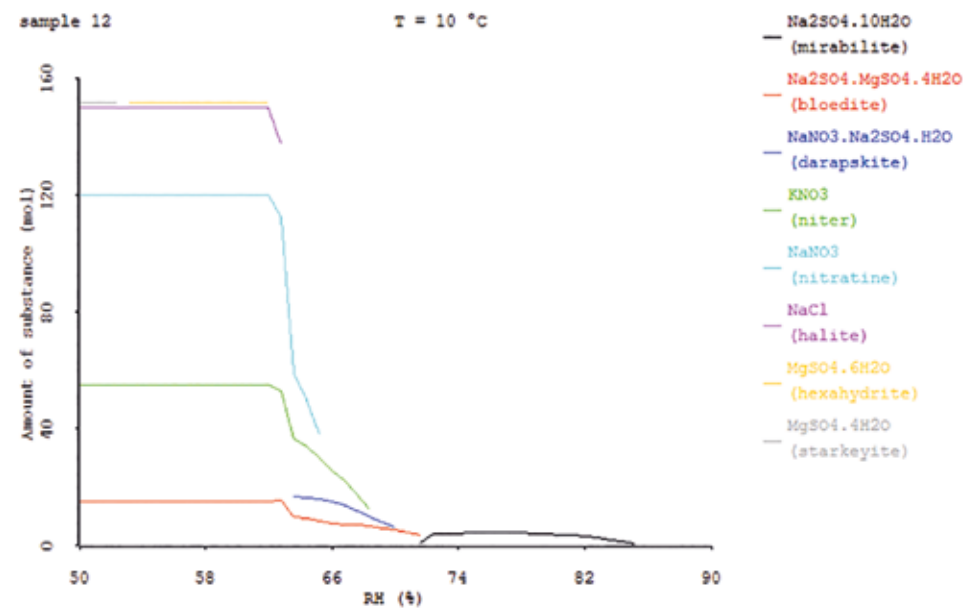
Figure 6: Image of ECOS/RUNSALT after calculation of sample 12 at 10°C showing the crystallized salt phases between 50% and 90% of relative humidity

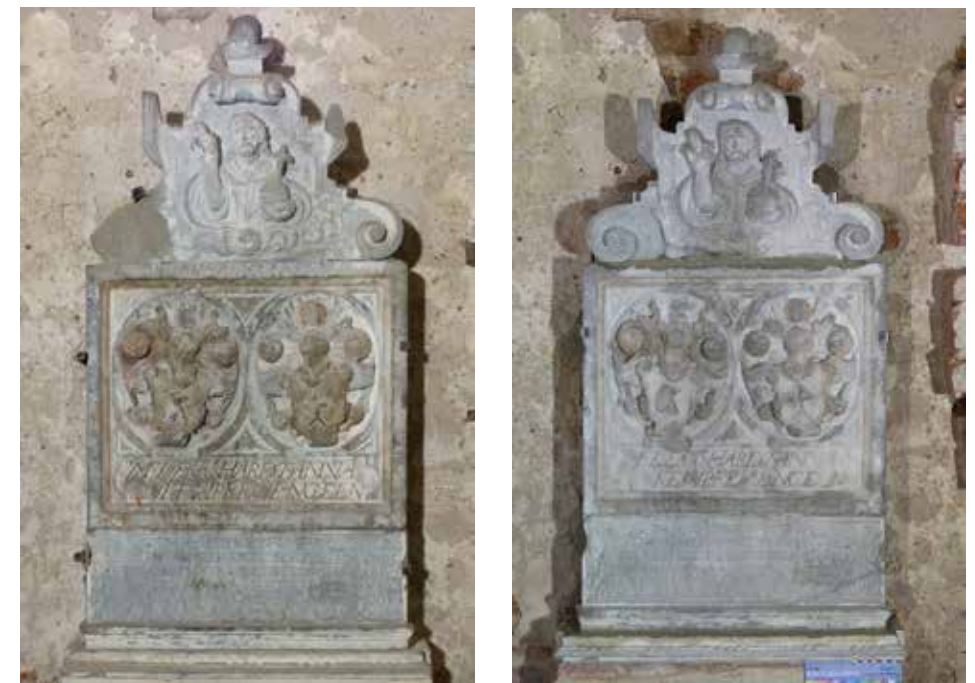
Figure 7: Epitaph of Leonhardt Kämpfe in Werben before (left) and after conservation (right)

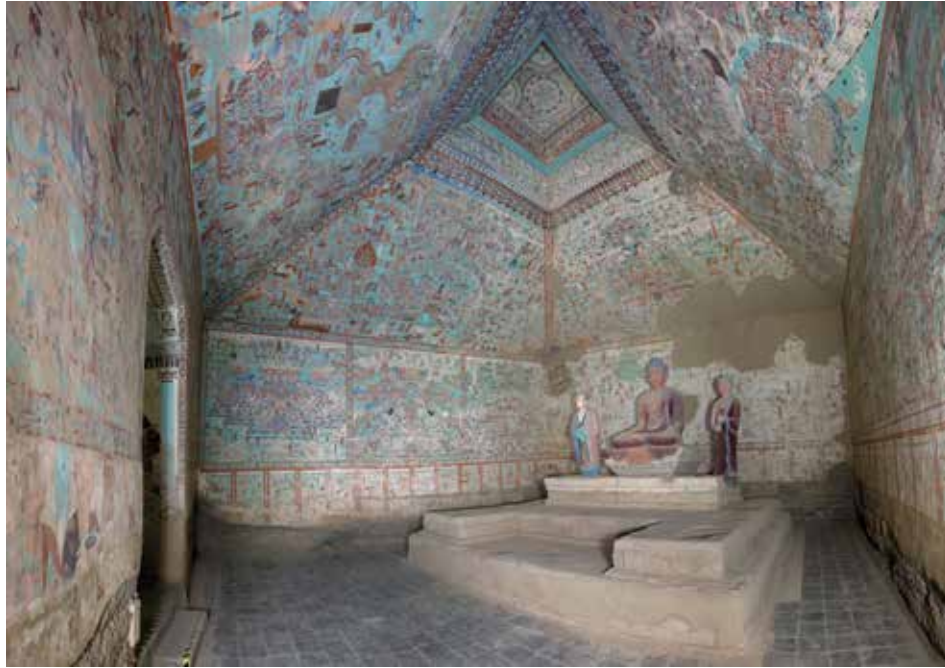
Figure 1: Cave 85, one of the 492 painted Buddhist cave temples at the Mogao Grottoes, was selected as the test cave for this project. Its wall paintings which date from the ninth century suffer from salt-induced flaking.

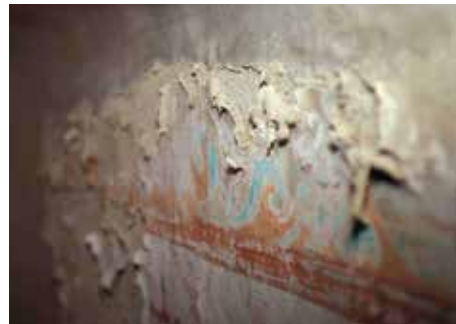
Figure 2: Salt-induced flaking or exfoliation of the wall paintings in Cave 85

and paint flaking, known as exfoliation (Figure 2). Repeat cycles of treatment in past decades have played a role in causing and exacerbating the deterioration phenomena, resulting in significant loss of the cave wall paintings. A joint research project to study this problem was undertaken as part of a collaboration between the Getty Conservation Institute (GCI) and the Dunhuang Academy (DA) under China's State Administration for Cultural Heritage (SACH) with the aim of developing and implementing improved treatment methods as well as measures to prevent this condition from recurring. Improvements in documentation and condition monitoring methods were also undertaken to better assess when changes to the wall paintings are occurring.

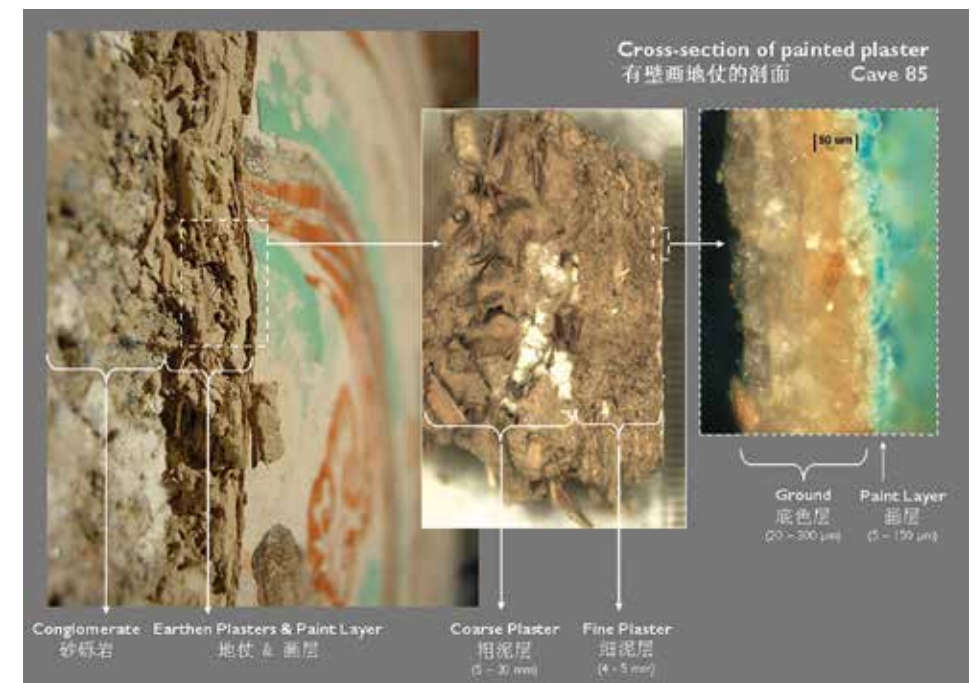
Figure 3: Stratigraphy of the painted plaster in Cave 85.

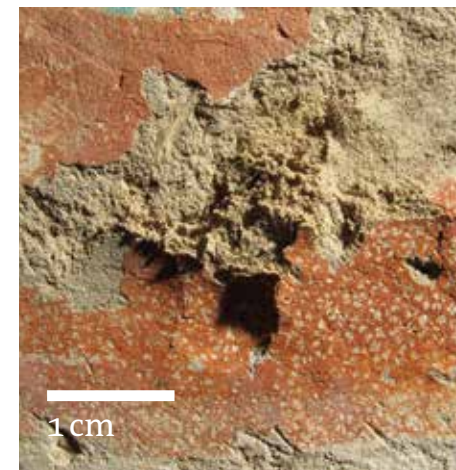
Figure 4: Powdering and decohesion of the plaster and punctate losses, visible in the red paint layer, are both forms of salt deterioration.

Conditions related to salt deterioration included plaster disruption which exhibits itself as powdering plaster caused by repeat cycles of salt activity (Figure 4); salt efflorescence seen as salt crystals on the painted surface; and, punctate loss, tiny, rounded losses, less than 1mm in diameter, in the paint, ground and/or fine plaster layer. Salt efflorescence and punctate loss are related conditions: individual salt crystals push through to the surface creating tiny losses in the paint layer. Over time, this gradually leads to complete loss of the paint layer in areas where salt problems are concentrated.

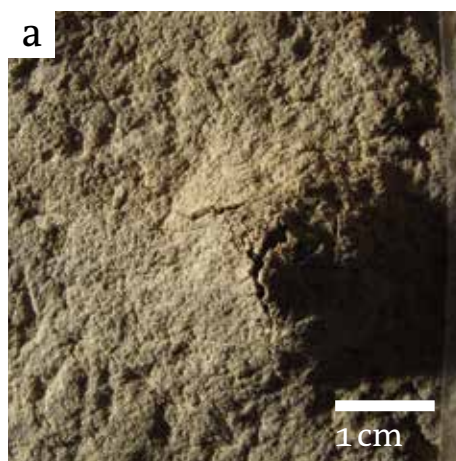
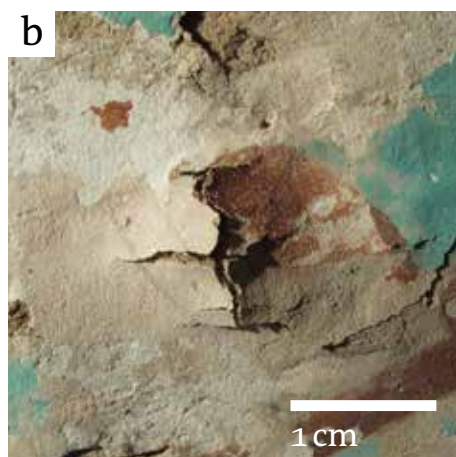
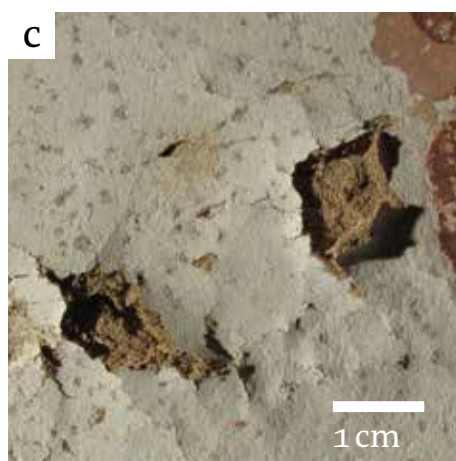
Figure 5a-c: The three stages of progression of exfoliation.

- 1) Decohesion of the plaster due to salt activity causing volume expansion that pushes out the layers above leading to bulging and tenting of the paint, ground and some fine plaster layers. In some cases the protruding area can have associated cracking but otherwise the surface is still closed (Figure 5a).
- 2) The protruding layers of paint, ground and some fine plaster breaks open along cracks and begins to lift further (Figure 5b).
- 3) The breakage and opening of protruding areas progresses further to a point where loss of original material occurs (Figure 5c).
