# SWBSS 2017

## Fourth International Conference on Salt Weathering of Buildings and Stone Sculptures

# **Proceedings of SWBSS 2017**

**Fourth International Conference on  
Salt Weathering of Buildings and Stone  
Sculptures**

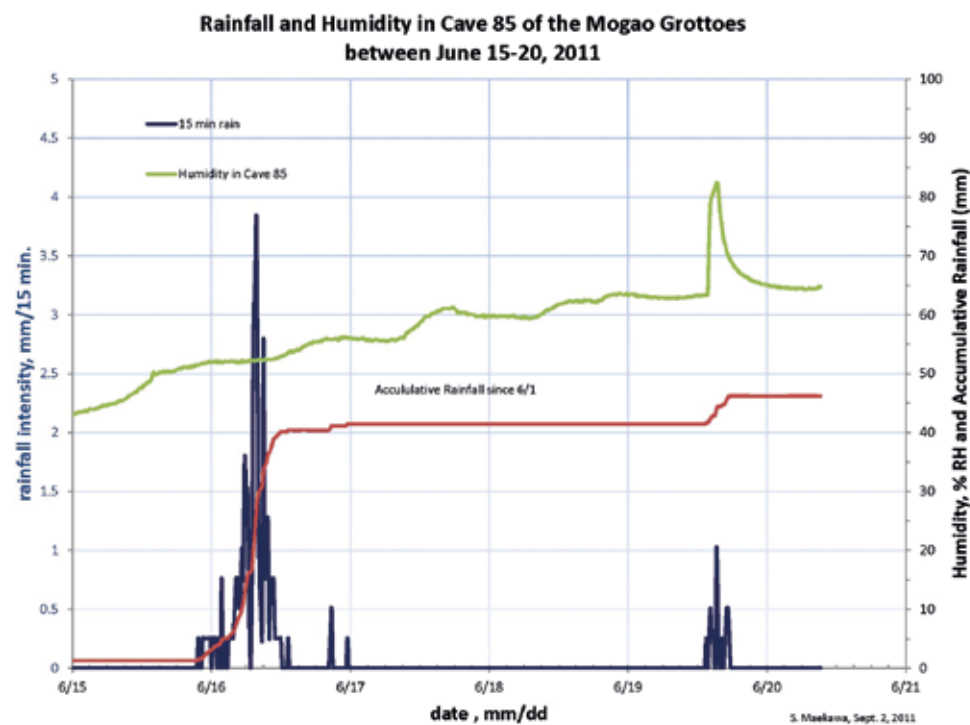
Figure 6: The humidity in Cave 85 rises even with the cave door closed after a prolonged period of rainfall on 6/16. The sharp peak in humidity that occurs between 6/19 and 6/20 is when the door is opened. In 2011, the RH exceeded 75% several times throughout the summer months.

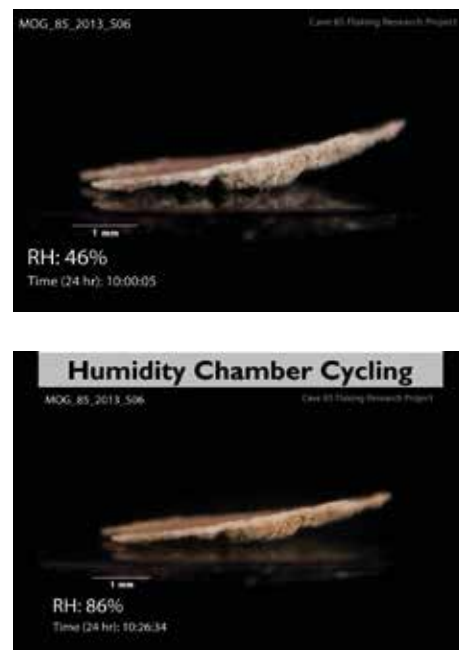
Figure 7: A sample from Cave 85 placed in an environmental chamber contracted at 46% RH (left) and relaxed at 86% RH (right) in response to changing humidity. Movement in the sample was observed around 60% RH.

In order to understand the impact of fluctuating humidity on the surface and subsurface layers treated with PVA and PVAc, samples taken from exfoliated areas were placed in an environmental chamber to assess their response to changes in RH (possible moisture uptake and contraction) (*Figure 7*). The RH in the chamber ranged from approximately 38–86%. A selection of samples were subjected to RH fluctuation and a few showed movement beginning around 60%, indi-

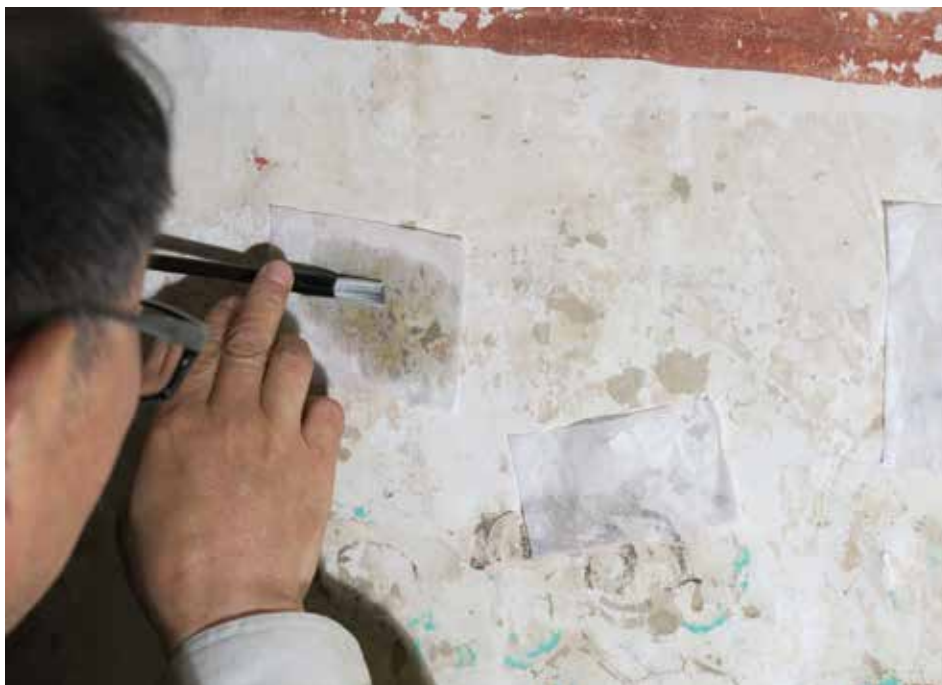
Figure 8: Relaying of exfoliated areas was undertaken with water and water: ethanol mixes applied with brushes through paper tissue.

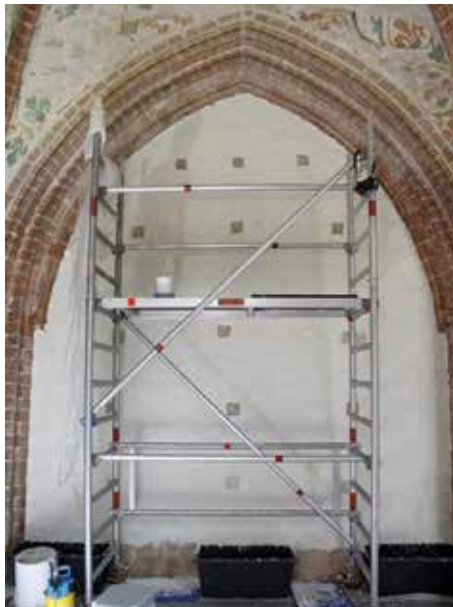
Figure 2: Application of desalination poultices

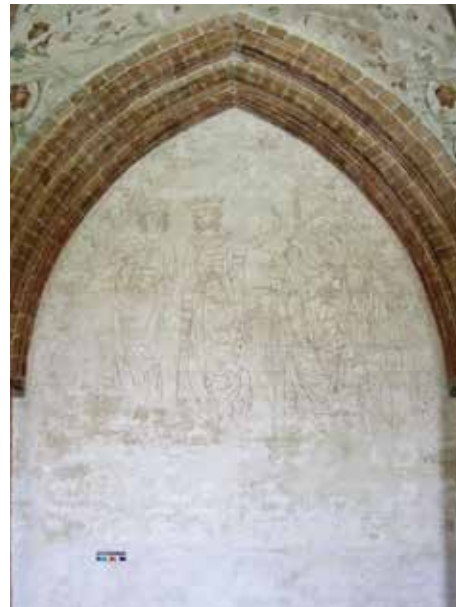
Figure 3: After the application of desalination poultices

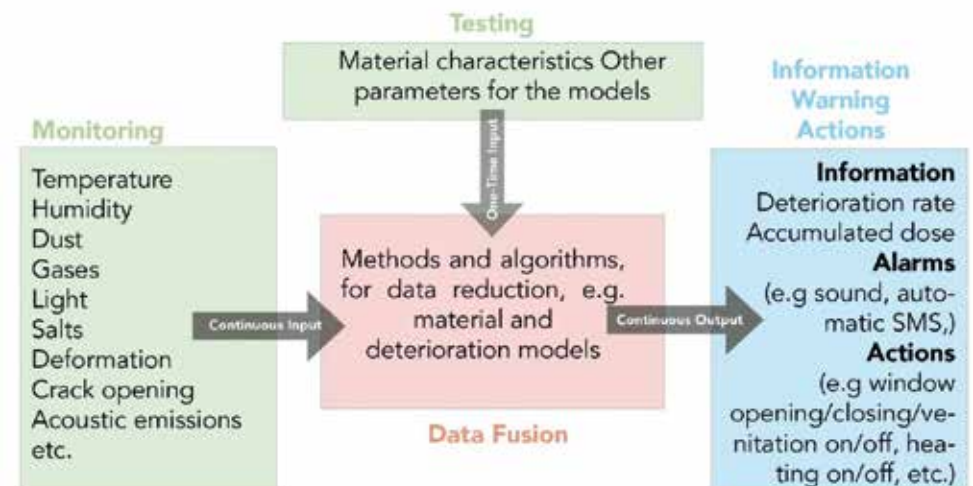
Figure 4: Principle sketch of intelligent monitoring and its integration in cultural heritage maintenance, based on [1]

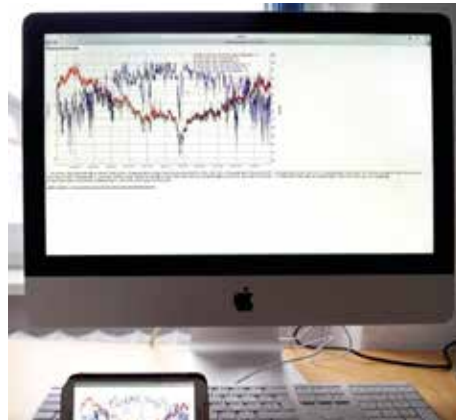
Figure 5: Read the climate data from the Schwahl, via Mobilephone and PC.

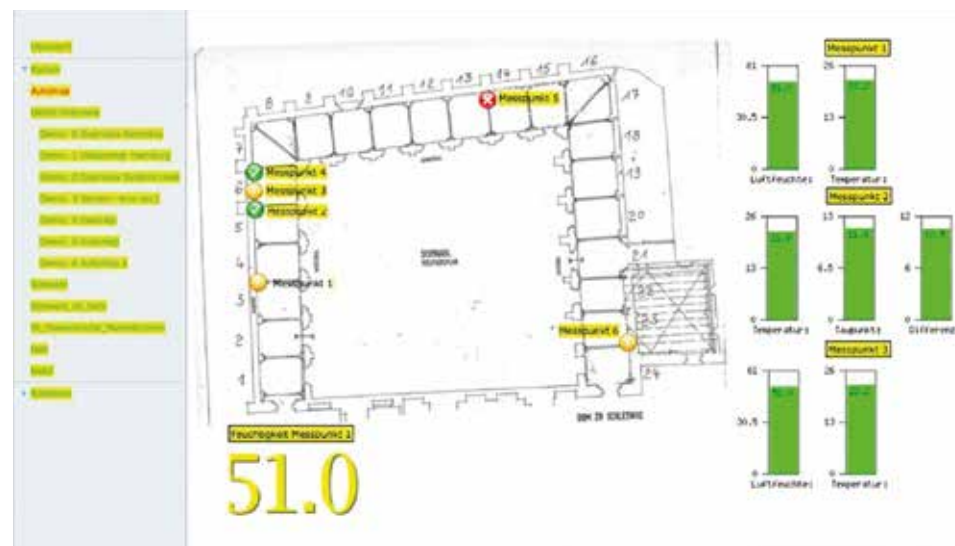
Figure 6: Visualization of the measuring points on site, defective devices are displayed in real time (measuring point 5).
