**On the risks of transporting
liquid and gaseous fuels in pipelines**

Research report 289

Berlin 2009

BAM Federal Institute for Materials Research and Testing

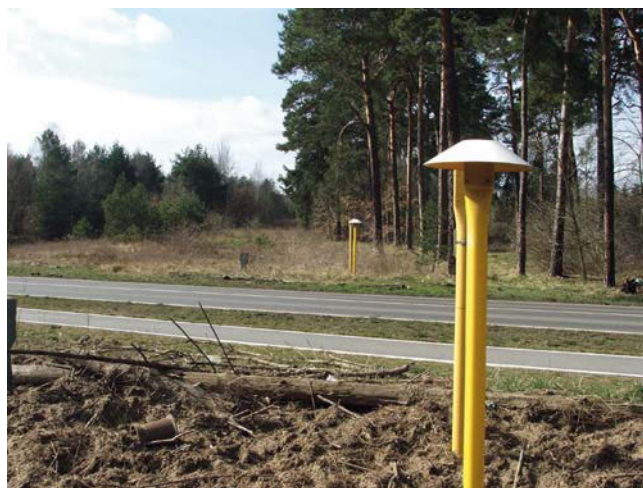
Figure 1: Route marking of a natural gas pipeline passing under a road.

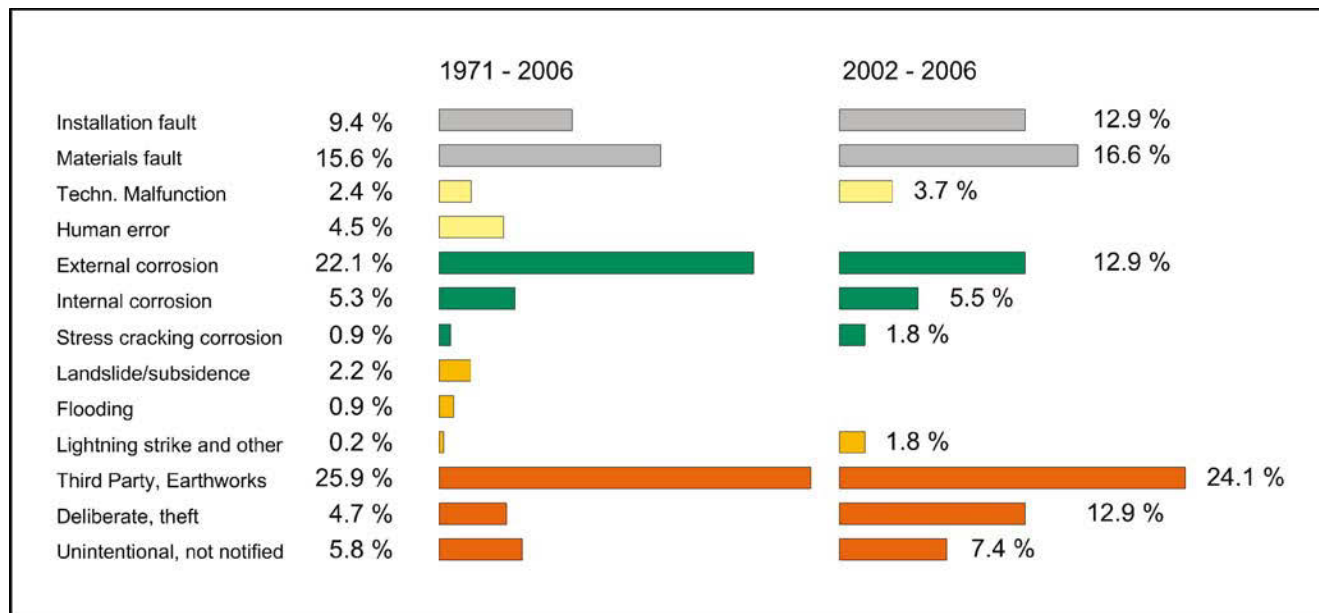
It can clearly be seen that the operators of oil pipelines are mainly confronted with two problems, external influences and corrosion. Damage and leaks caused by corrosion have many causes. Sometimes the cause is related to the substance (i.e. “coming from inside”) and sometimes the cause is related to the environment, i.e. the result of external influences. Detailed explanations of these problems are dealt with in Chapter 5.

Figure 3: percentage distribution of causes of leaks in oil pipelines 1971 to 2006 and 2002-2006

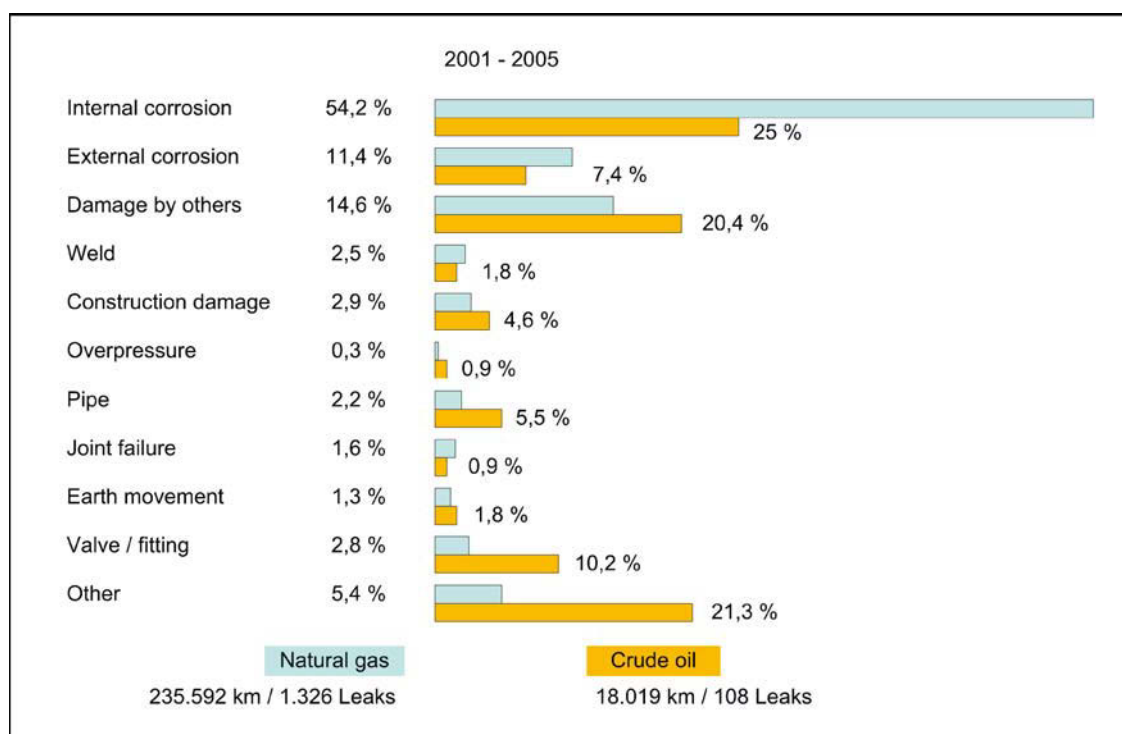
Figure 4: Causes of pipeline leaks in the Province of Alberta/Canada (according to [7])

It is easy to see from these damage statistics that with regard to natural gas pipelines, more than 50% of the damage/leaks are caused by internal corrosion.

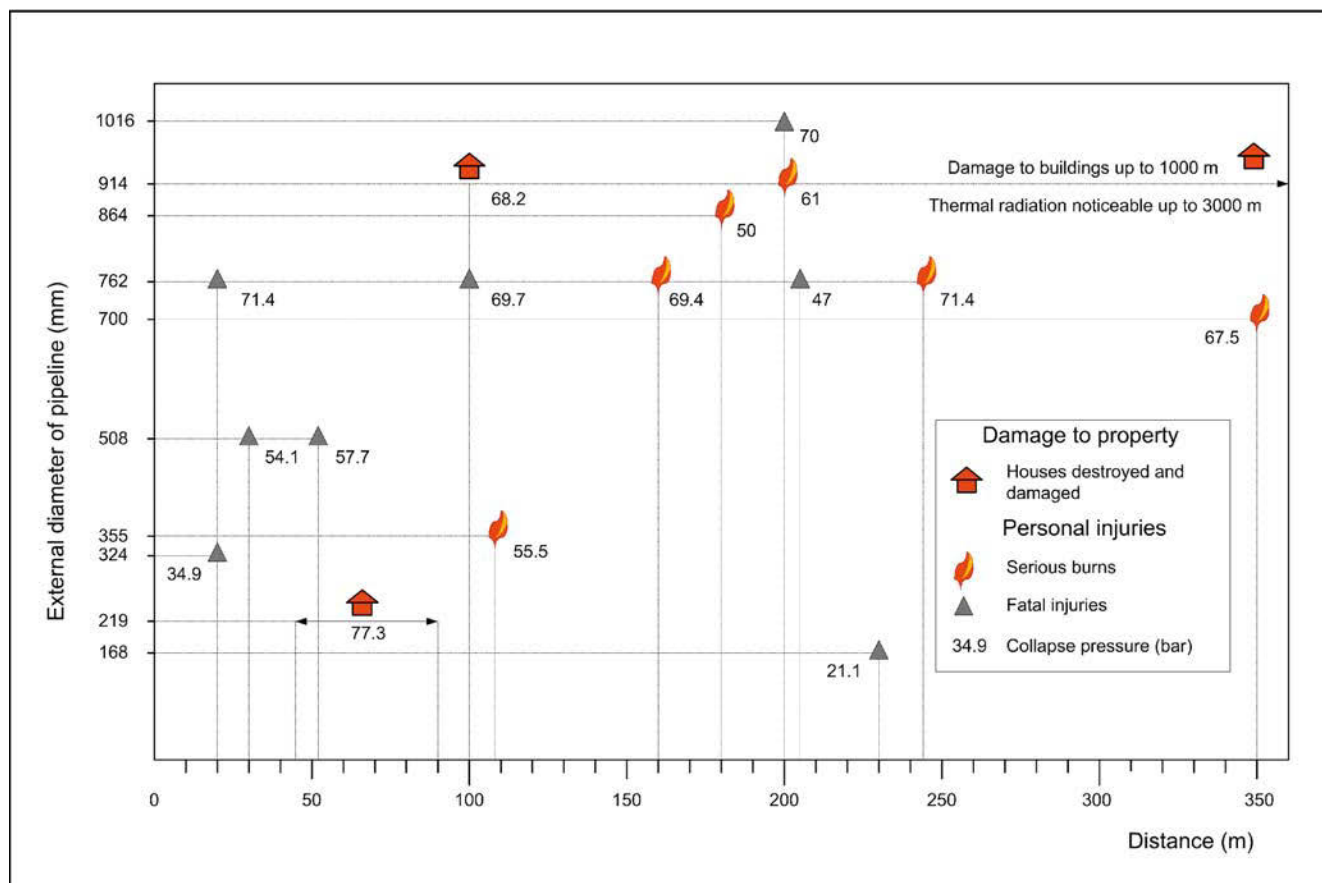
Figure 5: Documented hazard radiuses resulting from thermal radiation in natural gas pipeline failures

It can be seen from *figure 5* that there is a correlation between the diameter of the pipeline, i.e. the mass flow rate, the collapse pressures and the hazard radiuses. In some cases, damage resulting from thermal radiation has occurred at distances of 350 to 1000 m. As a result of the height of the burning flare stacks, which can be as high as 150 m, there have been reports in individual cases of the thermal radiation being clearly felt over even greater distances.

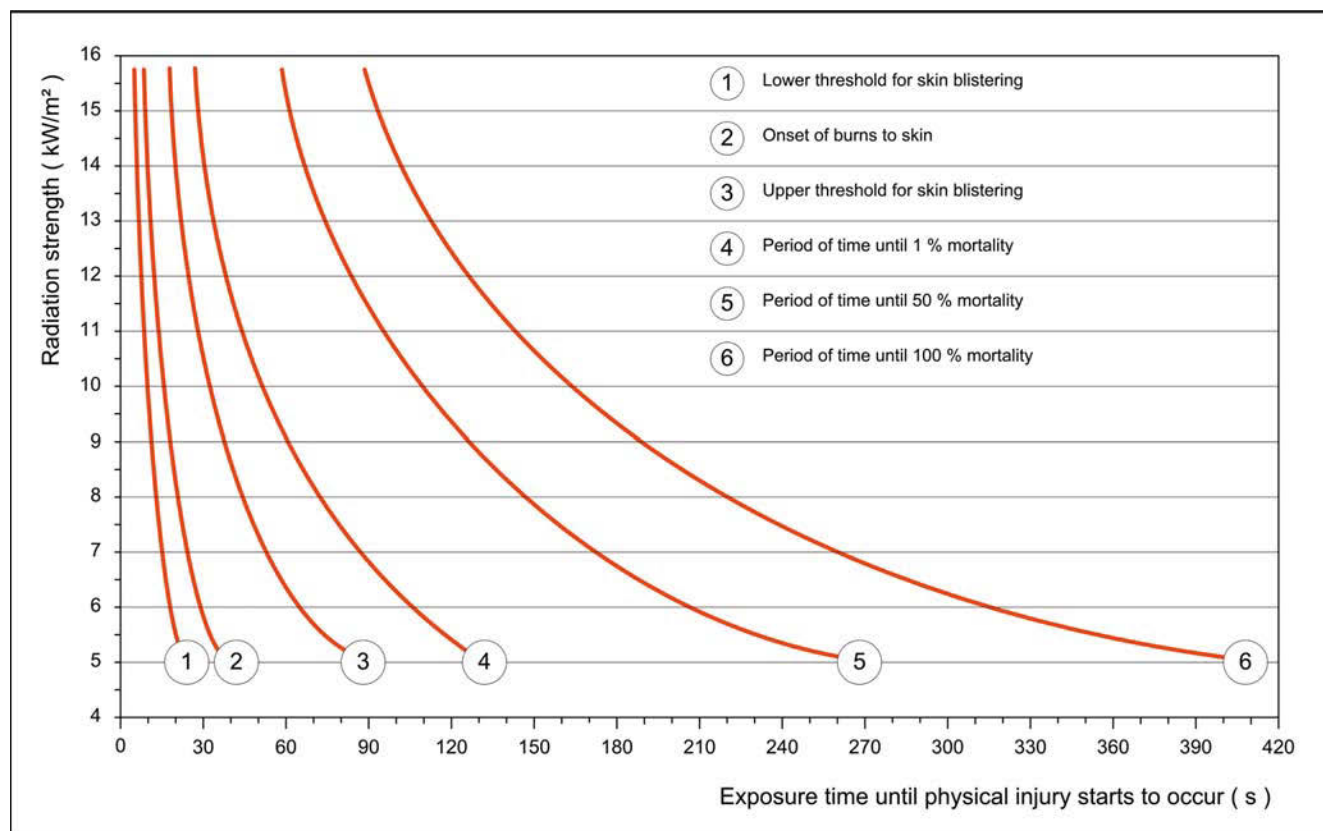
At a radiation strength of 5 kW/m² and ~ 20 seconds exposure time, the first blisters form on the skin; after a further 20 seconds, more serious skin damage, i.e. burns, must be anticipated. From an exposure time of around 130 seconds, the threshold to potentially fatal burns is reached. This is one reason why in many gas cloud explosions, there is virtually no chance of surviving within a damage radius of around 100 m, and also because as a result of the pressure wave, physical injuries are often caused which again make it difficult to save oneself.

Figure 6: Effect of radiation strength plotted against exposure time (from [15])

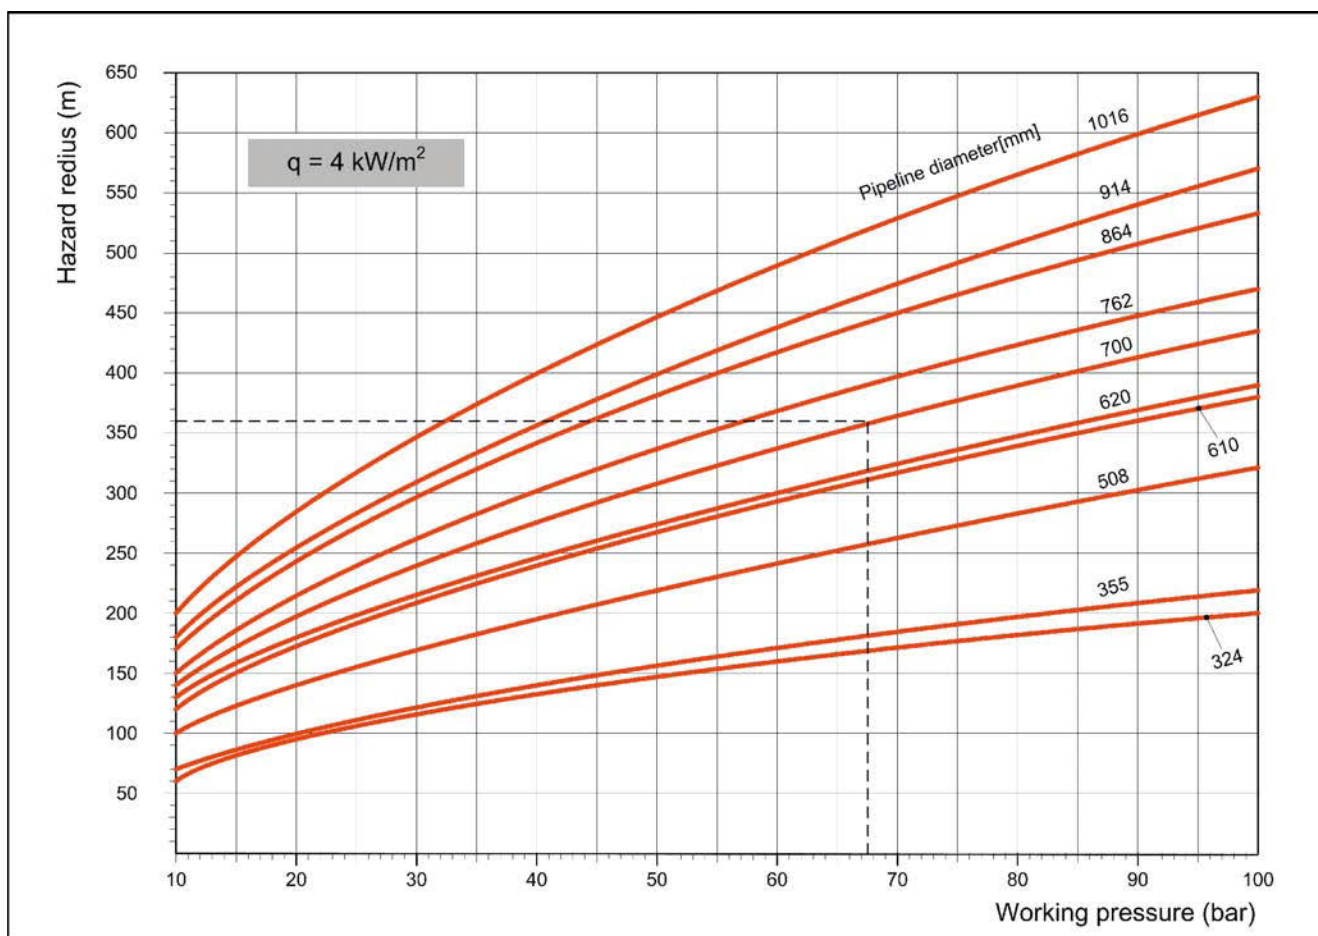
Figure 9: Hazard radiuses for a critical radiation strength of 4 kW/m²

Figure 9 illustrates the explosion of a 700 mm natural gas pipeline (67.5 bar) on 25 March 1984 in Erlangen (Germany). At the time, it was noted that the heat of radiation from the burning gas cloud could still be clearly felt at a distance of 350 m.

Assuming that the radiation intensity needed for this is around 4 kW/m² (see Table 7), figure 9 indicates a hazard radius of around 350 – 360 m.

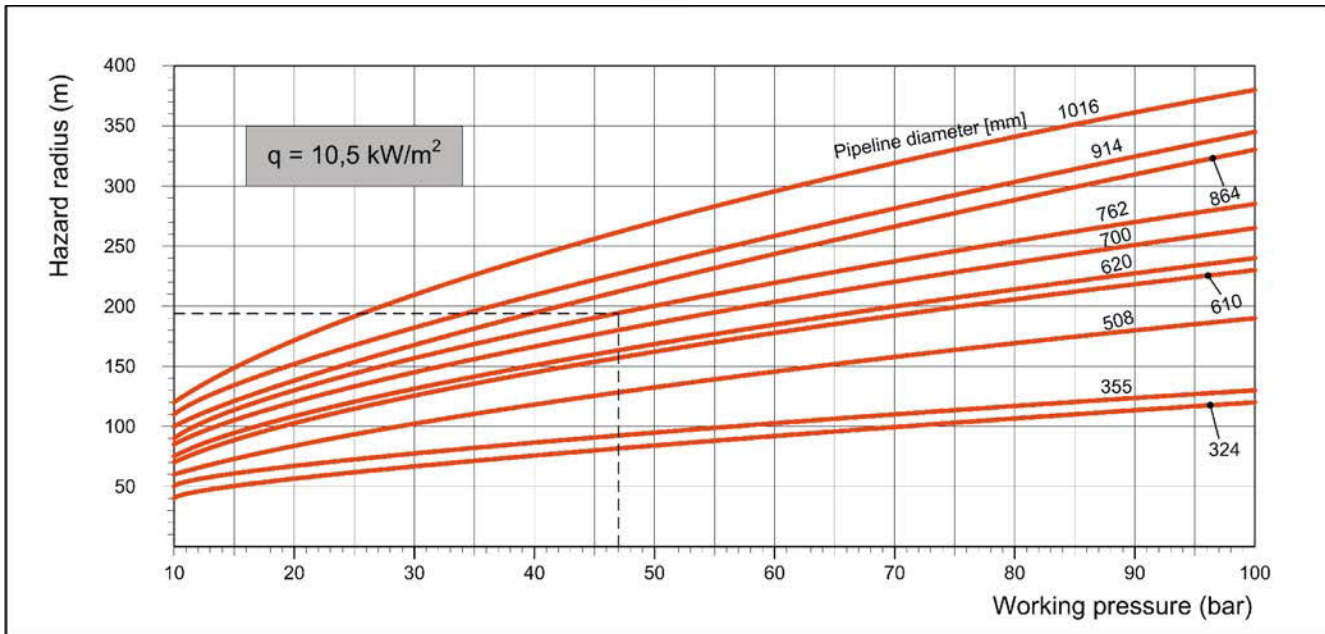
In the “guillotine-type” pipeline failure that occurred on 19 August 2000 in Carlsbad, 12 people were fatally injured by the thermal radiation 205 m away from the explosion crater.

Taking as a basis a critical radiation strength of 10.5 kW/m², a diameter of 762 mm and a collapse pressure of 47 bar, figure 10 indicates a hazard radius of 190 to 200 m.

Figure 10: Hazard radiuses for a critical radiation strength of 10.5 kW/m²

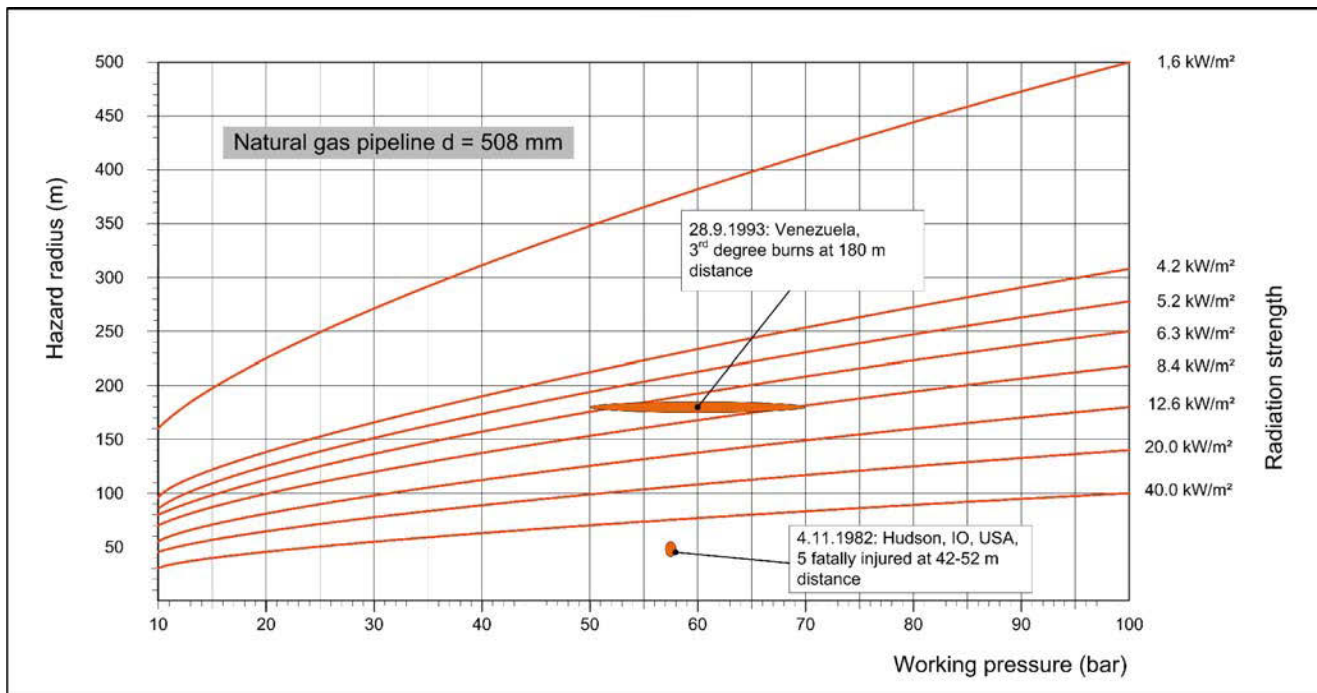
For a natural gas pipeline with a diameter of 508 mm, two cases with documented damage radiuses are known, figure 11.

- On 4 November 1982, a 508 mm natural gas pipeline was damaged in the course of earthworks. The gas cloud ignited immediately. At a distance of 42 to 52 m, people with fatal injuries were recovered. From figure 11, it can be seen that these people were exposed to thermal radiation of > 40 kW/m², so in fact, the accident could not be survived.
- Another case occurred on 28 September 1993 in Venezuela. In this case, a natural gas pipeline was also damaged by earthworks. It was noted that at a distance of around 180 m, 3rd degree burns to skin occurred. At an estimated working pressure of between 50 and 70 bar, the thermal radiation was

Figure 11: Hazard radiuses resulting from thermal radiation for a natural gas pipeline of d = 508 mm

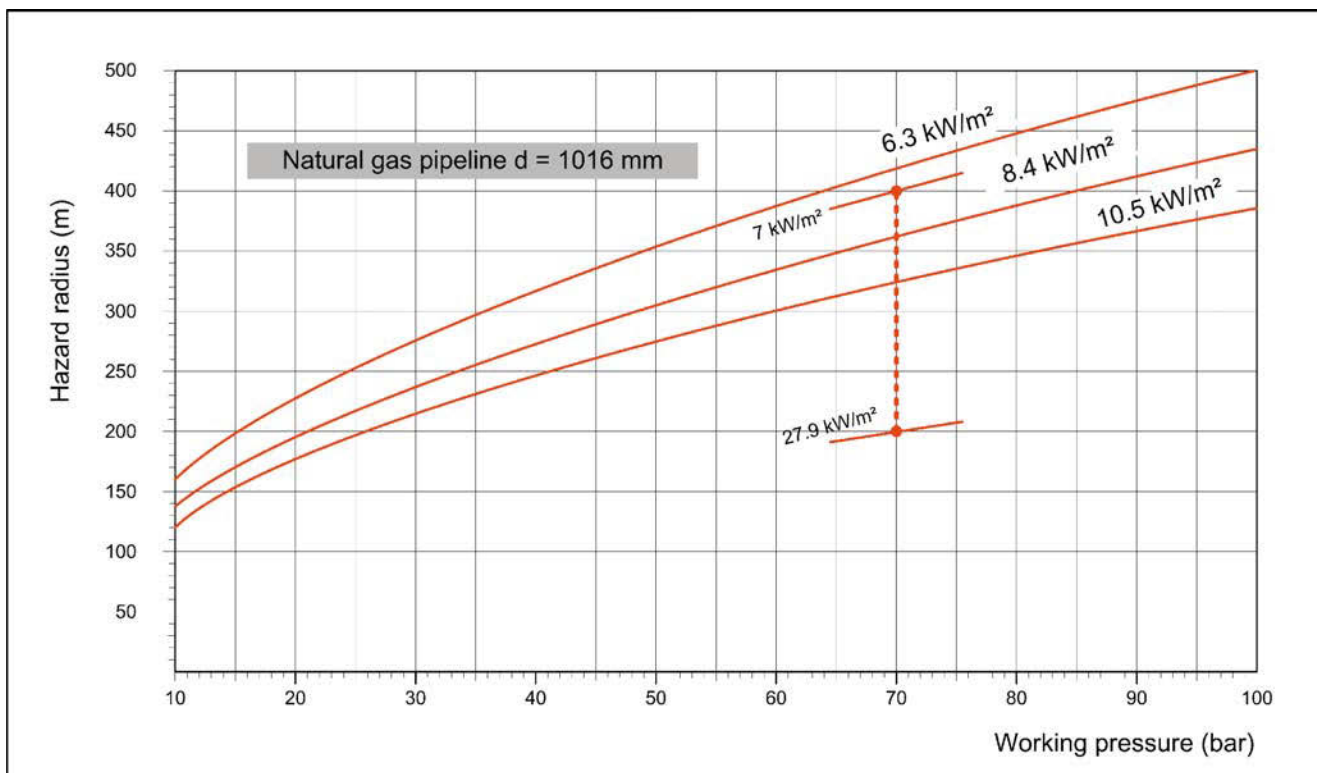
The subsequent calculation of the hazard radiuses for a natural gas pipeline with a diameter of 1,016 mm, which exploded in Belgium on 30 July 2004, gives the following results, figure 12.

The subsequent calculation of these distance data using formula 5 produces a radiation intensity of 7 to 27.9 kW/m².

Figure 12: Hazard radiuses resulting from heat radiation for a natural gas pipeline of d = 1,016 mm.

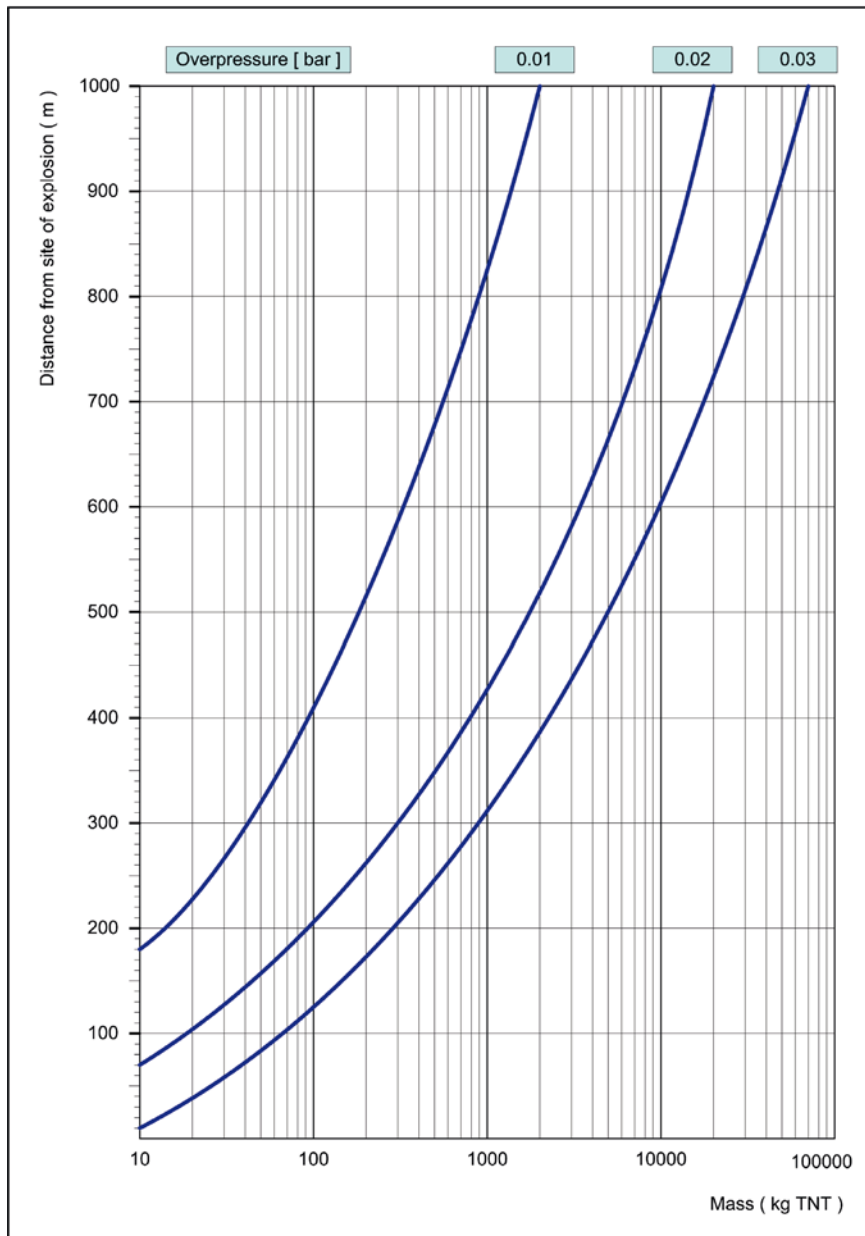
Figure 13: Correlation between peak overpressure, equivalent mass of flammable substance and impact radiuses, calculated using formula (F 6).

Figure 13 shows some characteristic peak overpressures as a function of the equivalent mass and the distance to the centre of the explosion.

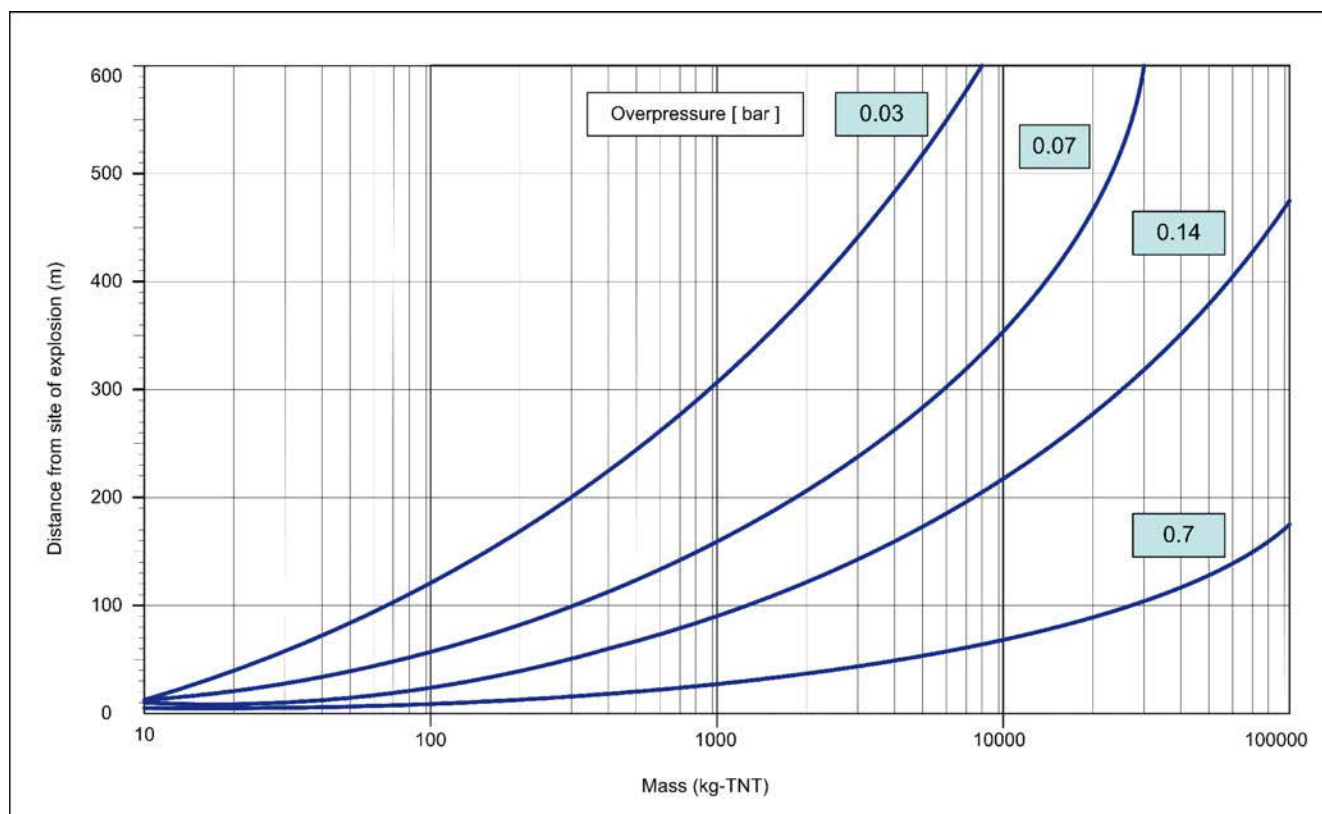
The impact radiuses of higher peak overpressures resulting from explosions are shown in figure 14 for the thresholds:

- 0.03 bar – 50 % destruction of window panes, onset of slight structural damage to buildings,
- 0.07 bar – Buckling of sheet steel, onset of severe damage,
- 0.14 bar – Formation of cracks in reinforced concrete walls and
- 0.70 bar – Onset of total destruction of buildings.

Figure 14: Correlation between peak overpressure, equivalent mass of flammable substance and impact radiuses (from [17])

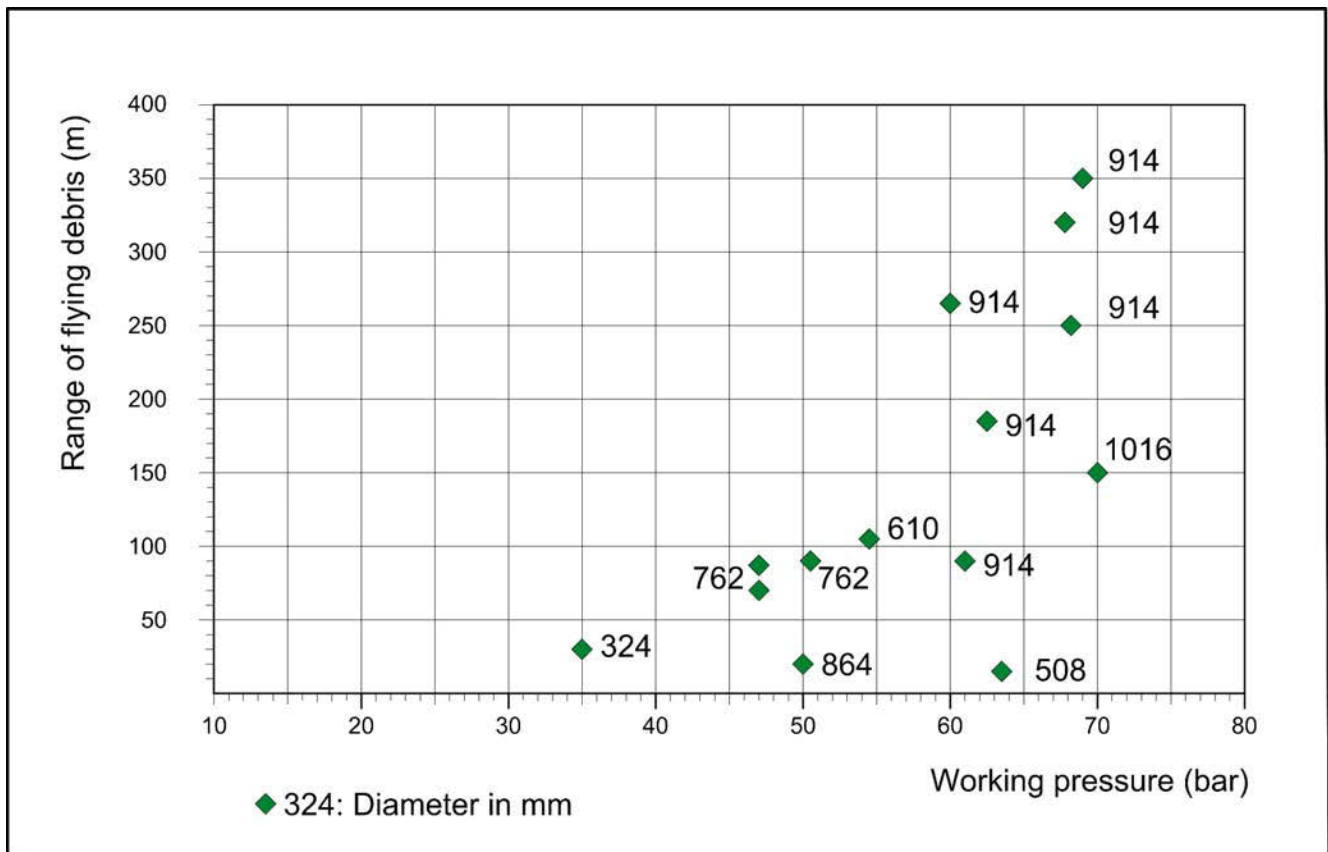
In addition to the hazards of thermal radiation and pressure waves, damage may also result from flying debris from pipeline segments, pieces of equipment or soil that is thrown up (stones, boulders). The chart in figure 15 shows a summary of all the incidents considered.

only possible to analyse 14 incidents with documented ranges of flying debris. In addition, it cannot be ruled out that the trajectory ranges might increase as a result of the effects of ricocheting. On the basis of the current level of data, it is also impossible to make any precise statement with regard to the probability of certain zones around a hypothetical pipeline rupture being reached.

Figure 15: Documented ranges of flying debris for natural gas pipelines
