## **Quantitative comparison of different non-destructive techniques for the detection of artificial defects in GFRP**

### **Abstract**

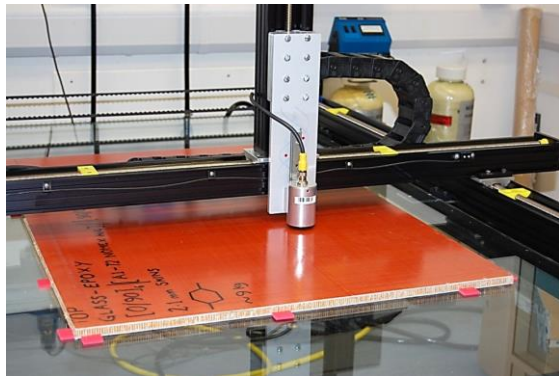
Figure 1. Evisive microwave inspection system, here shown with another sample (orange)

Microwave inspections were conducted using an Evisive Inc. microwave flat-bed scanning system. Here, the microwave transducer is fixed to a scanning system to enable the inspection of larger surfaces. The equipment is shown in figure 1; note, the sample shown in this figure is a GFRP-Nomex® sandwich panel and not the RDA inspected in this study. The transducer includes two separate sensor diodes to record the complex reflection signal. For these investigations a probe frequency of 34 GHz was selected corresponding to a wavelength in the order of 9 mm. Conducting the scan with an increment of only 0.5 mm, a good spatial resolution, certainly below the wavelength, could be obtained as can be seen in figure 2. This image is only the intensity distribution from one sensor diode. Most of the artificial delaminations can clearly be recognised. More details about the setup and data processing are described in (5).

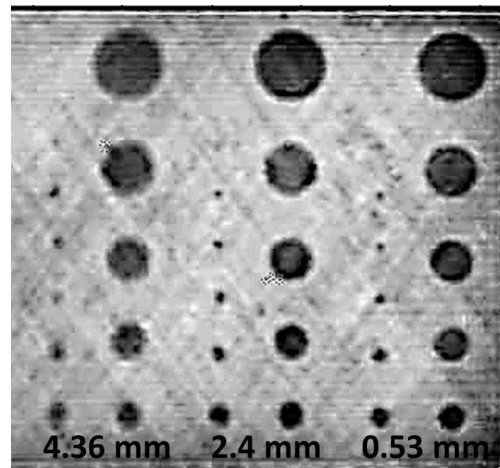
Figure 2. Inspection result of a GFRP specimen with artificial delaminations from channel B output, the frequency was 34 GHz and the scanning increment 0.5 mm

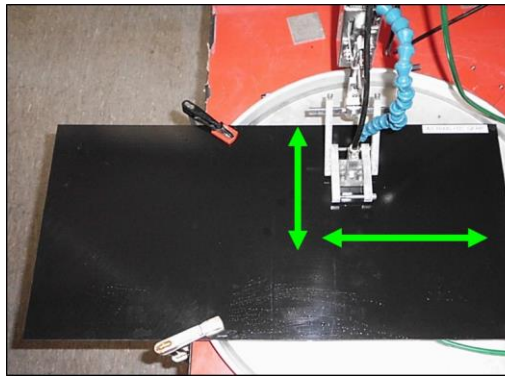
**Figure 3.** GFRP specimen and the scanning unit with US matrix array, the arrows show the scanning directions

Ultrasonic investigations were realised in contact technique in reflection configuration. A matrix array of 10x6 elements with 1.3 mm pitch is mounted on a scanning unit. The

scanning was carried out with 0.5 mm or 1 mm increment in both directions with variable focus point. The ultrasonic frequency of the elements was 2.25 MHz. Figure 3 shows the used setup and figure 4 contains a compilation of three different scans of the GFRP specimen including all investigated defects. At a first glance it can be seen that, besides the designed defects, a number of unintentional defects also occur. A detailed discussion of these results follows below in the *Experimental results* section.

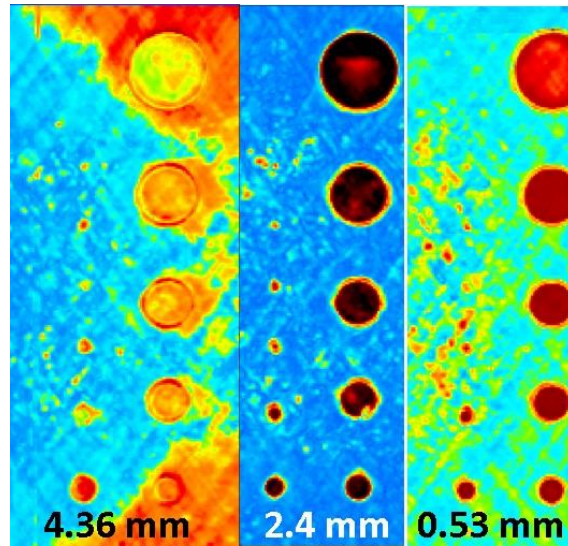
**Figure 4.** Compilation of three different US images obtained at the GFRP specimen, the numbers indicate the intended depth of the respective delaminations

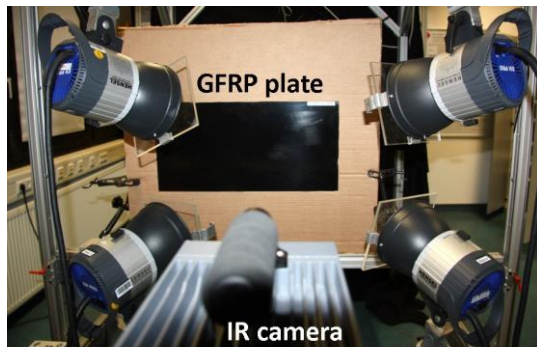
Figure 5. Thermography setup with four flash lamps and the GFRP specimen (from a view point at the IR camera), the GFRP is black due to black pigments within the material

Thermographic inspections were realised with an array of 4 flash lamps and a cooled IR camera with an InSb detector of 640 x 512 pixels, both located at the same side of the specimen i.e. in reflection configuration. The lamps had 45 cm distance to the specimen surface generating an energy density of about 0.5 Ws/cm<sup>2</sup> at the surface. The arrangement of lamps, IR camera and specimen is illustrated in figure 5. The spatial resolution was about 0.5 mm per pixel. The thermal resolution characterised by the NETD (noise equivalent temperature difference) at 30°C is about 25 mK. Here, thermal sequences of 3100 frames were recorded with a frame rate of 50 Hz, including some frames before the flash heating and at least 60 s during cooling down.

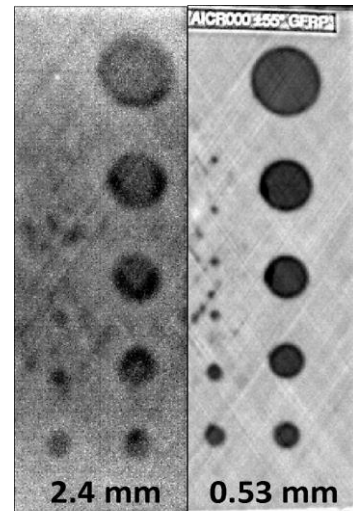
Figure 6. Compilation of two different phase images obtained at the GFRP specimen, the numbers indicate the intended depth of the respective delaminations, the delaminations at 4.36 mm depth could not be detected

In order to reduce influences from inhomogeneous heating and to enhance the depth range phase images at suited frequencies were considered. Here, standard tools integrated in the camera manufacturer's software were used. Figure 6 contains phase images with respect to 20 mHz (2.4 mm part) and 100 mHz (0.53 mm part) frequency. Both phase images indicate, as well as the ultrasonic results, smaller unintended defects. Much more details about experimental results and data analysis will be published soon (6).

The next figure shows the data obtained at the delaminations in 2.4 mm depth. It is a magnified part of the phase image in figure 6 (rotated by 90°).

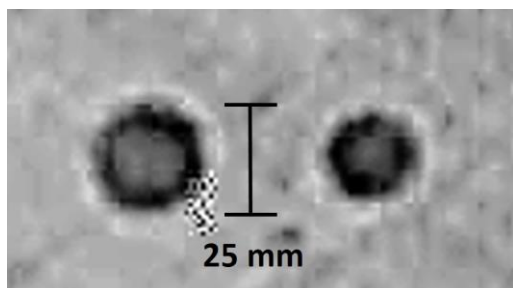
Figure 7. Intensity image obtained by single channel microwave reflection at artificial delaminations of 25 mm size (left) and 20mm size (right) in an intended depth of 2.4 mm in GFRP (clear result)

In the presented case the single channel signal was sufficient to detect most of the artificial delaminations. The following figures show the data obtained at delaminations of 25 mm and 20 mm diameter in 2.4 mm depth (clear result) and at 3, 4 and 5 mm diameter in 4.36 mm depth. The cause of the chequered pattern at 5 o' clock position from the left delamination is still unknown. The detection limit is reached at 4 mm, probably caused by material inhomogenities. Please note the appearance of the surface which results from the orientation of the plies in the  $\pm 55^\circ$  lay-up.

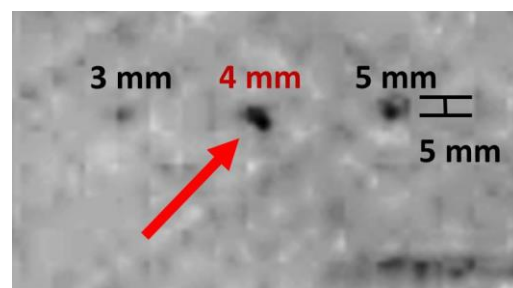
Figure 8. Intensity image obtained by single channel microwave reflection at artificial delaminations of different sizes in an intended depth of 4.36 mm in CFRP, the detection limit is 4 mm

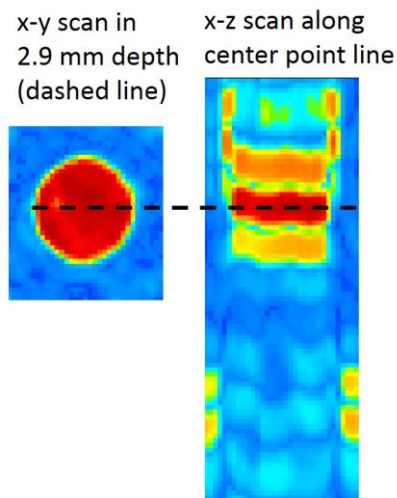
**Figure 9.** Ultrasonic scan result obtained with a matrix array at an artificial delamination of 25 mm size in an intended depth of 2.4 mm in GFRP (clear result)

The following figures show the data obtained at a delamination of 25 mm diameter in 2.4 mm depth (clear result) and at 3 mm diameter in 4.36 mm depth. A sound velocity of 3600 m/s was determined in a range without known failure based on the known thickness. Comparing the estimated thickness values with the intended depths of the delaminations an offset of about 0.5 mm occurred.

In figure 9 the shown image of the x-z-scan includes also part of the back-wall signals. Here, the reflections are shielded in the range below the delaminations. That means there are two indications for inner delaminations. However, this effect could not be observed in case of small delaminations (x-z scan in figure 10)

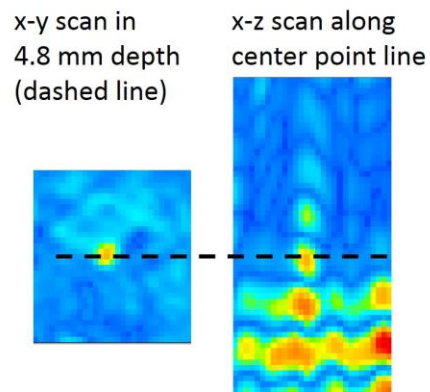
**Figure 10.** Ultrasonic scan results obtained with a matrix array at an artificial delamination of 3 mm size in an intended depth of 4.26 mm in GFRP (detection limit)

The x-y-scan indicates the 3 mm small delamination in 4.25 mm depth clearly. However, further signals with similar magnitude, probably caused by unintended manufacturing defects, were also recorded (not shown here). Thus, the used specimen is not suitable for evaluating even lower detection limits.

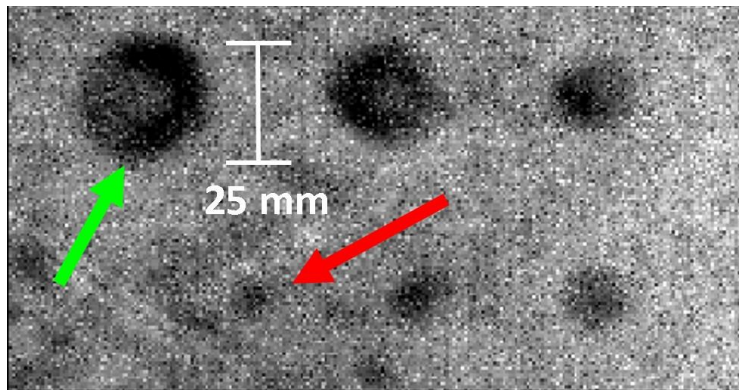
**Figure 11. Phase image obtained after flash excitation at 20 mHz, clear result: delamination of 25 mm size in an intended depth of 2.4 mm in GFRP (green arrow)  
Detection limit: delamination of 6 mm size in an intended depth of 2.4 mm in CFRP (red arrow)**

Similar to the other methods, the evaluation of the detection limit is affected by further unintended manufacturing defects. In addition, it had to be established that the deep delaminations in 4.36 mm depth could not be detected for no diameter at all.
