Evolution of Creep Damage of 316L Produced by Laser Powder Bed Fusion

The damage mechanisms of metallic components produced by process laser powder bed fusion differ significantly from those typically observed in conventionally manufactured variants of the same alloy. This is due to the unique microstructures of additively manufactured materials. Herein, the focus is on the study of the evolution of creep damage in stainless steel 316L specimens produced by laser powder bed fusion. X-ray computed tomography is used to unravel the influence of the process-specific microstructure from the influence of the initial void distribution on creep damage mechanisms. The void distribution of two specimens tested at 600 °C and 650 °C is analyzed before a creep test, after an interruption, and after fracture. The results indicate that the formation of damage is not connected to the initial void distribution. Instead, damage accumulation at grain boundaries resulting from intergranular cracking is observed.

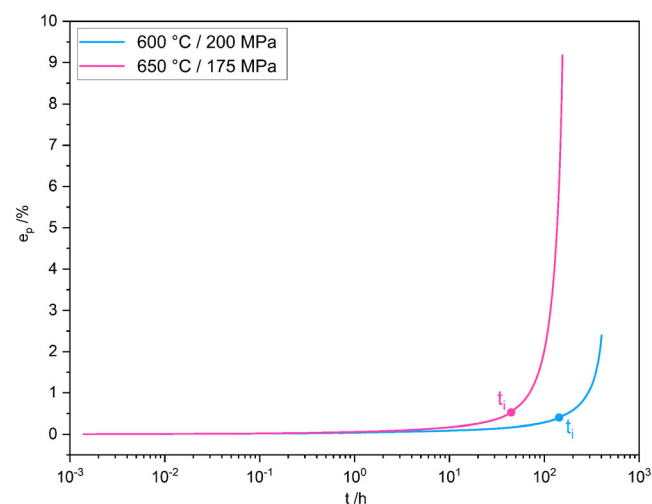
Figure 1. Creep curves e_p versus t of the two tested specimens including the interruption time t_i .

Creep testing was performed in-house according to DIN EN ISO 204:2019-04, i.e., with constant force until rupture (see Ávila et al. for further details of the mechanical test).^[11,21] The loading direction of the creep tests coincided with the build direction of the creep specimens. Two PBF-LB/M/316L creep specimens were tested under different test conditions: One specimen was tested at 600 °C/200 MPa and the other at 650 °C/175 MPa. The creep tests were interrupted to enable XCT inspection at a specific time for each specimen approx. at the first quarter of the tertiary creep phase. To interrupt the tests, the specimens were cooled down to room temperature and unloaded afterward. The time of interruption t_i is marked in the creep curves given in **Figure 1** and in **Table 1**. Besides, Table 1 shows that the percentage plastic extension e_p of both specimens consists only of the percentage creep extension e_f . The total plastic strains at the point of interruption were 0.39% for the 600 °C/200 MPa creep specimen and 0.53% for the 650 °C/175 MPa creep specimen. Most of the percentage plastic/creep extension was developed during the test period after the interruption, as visible in **Figure 1**. The

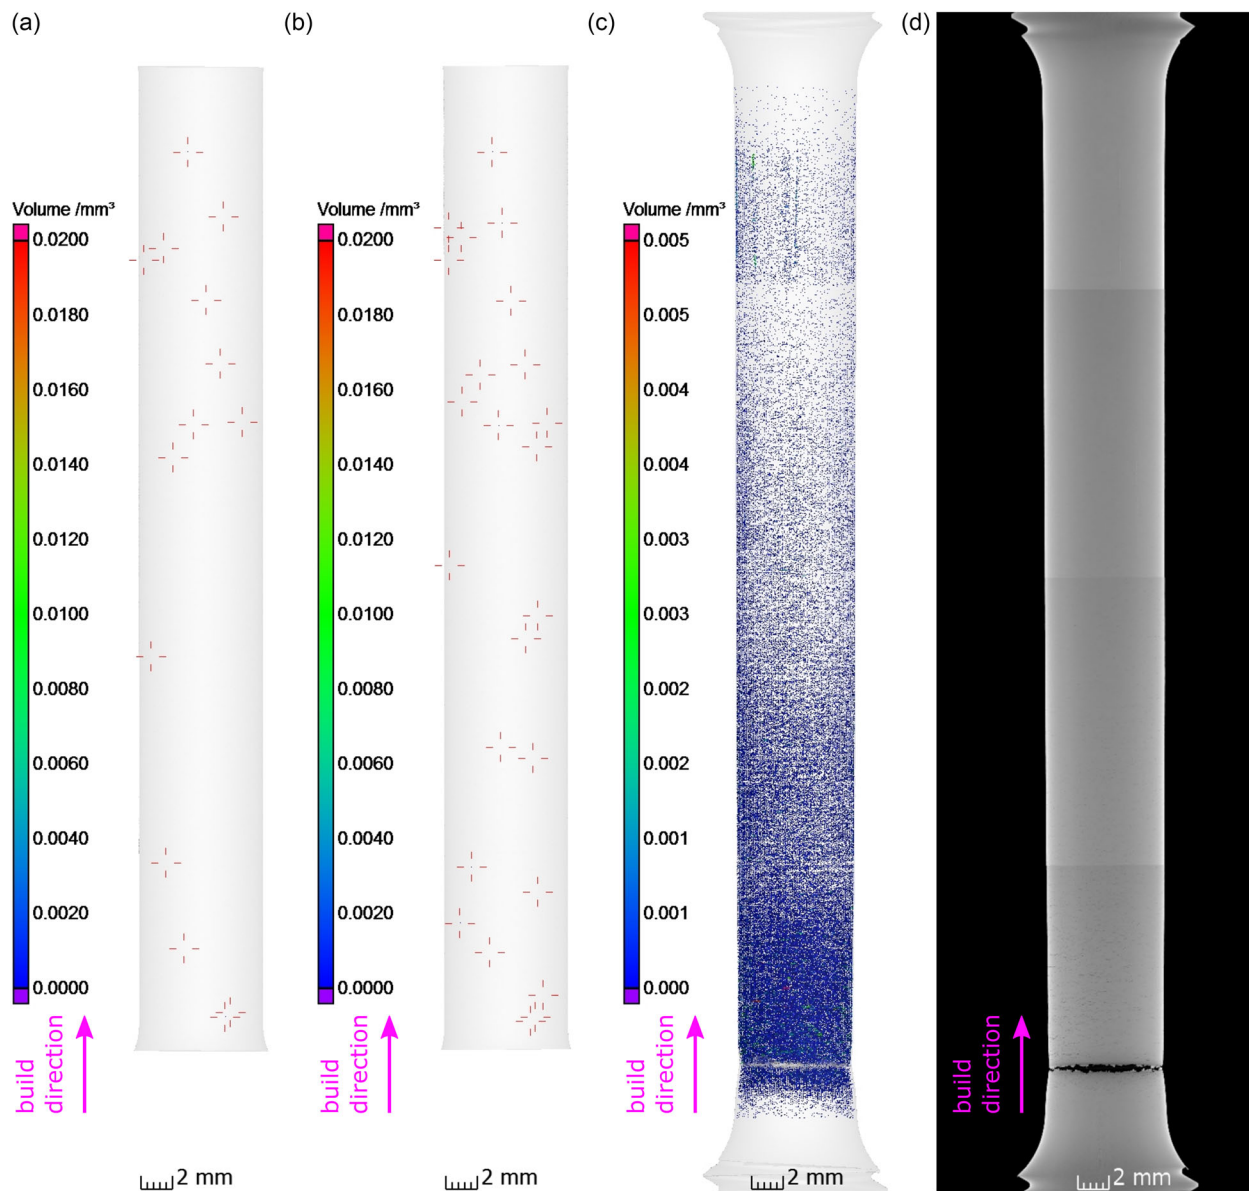
Figure 3. XCT reconstruction of the 650 °C/175 MPa specimen at different stages of the creep test: a) Void distribution before the creep test; b) void distribution after test interruption; c) void distribution after rupture; d) virtual cut at the maximum specimen vertical cross section.

The initial porosity of the two creep specimens was very low ($<0.01\%$). This was in agreement to previous studies of the same material produced by PBF-LB/M/316L.^[21] In the two specimens a sparse population of spherical voids was found (see Figure 2a and 3a). Their average equivalent diameter was 29 μm .

A large increase in the number of detected voids was observed along the whole length of both specimens after rupture. In both specimens, the highest density of voids was detected near the rupture surface. Due to the slight gray level variation in the 3D reconstructed volumes, some artefacts were observed at the locations of the stitches. These stitching artefacts influence the quality of the segmentation of voids. Therefore, the void distribution in Figure 2c and 3c could be analyzed in a qualitative fashion.

The XCT data of both broken specimens revealed a network of voids (see Figure 2 and 3). The spatial distribution of these voids was arranged in a grid. Its shape and size resemble the grain morphology of the PBF-LB/M/316L material. Due to the amount of creep-induced damage (overlapping myriad of further defects) and the elongation of the specimens, it was not possible to retrace the location of the individual initial voids in the broken specimens. In the 650 °C/175 MPa creep specimen (Figure 3), creep-induced voids occur throughout the whole specimen's length. Their spatial density increases toward the location of the rupture.

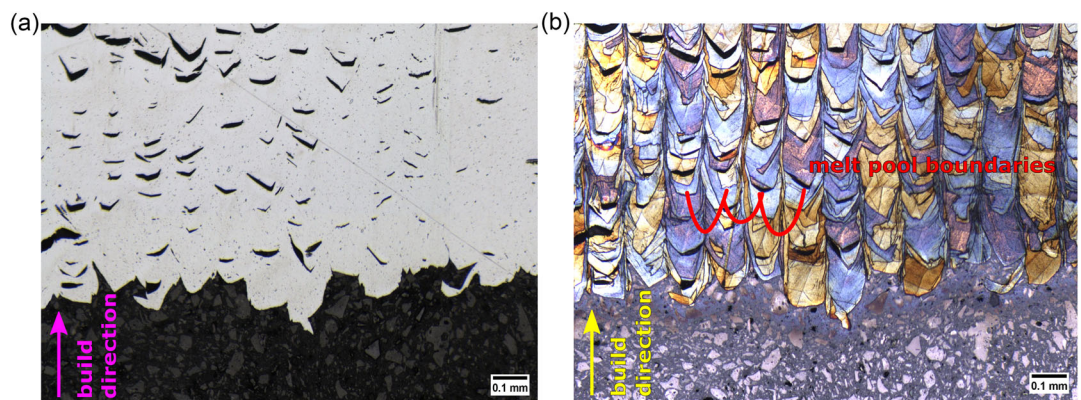
Figure 6. Optical microscopy images of a cut section of the 650 °C/175 MPa specimen. The longer upper part of the broken specimen was cut along the build direction: a) Before etching and b) the very same section after etching. Three melt pool boundaries are highlighted in red.

For completeness, Figure 6 shows optical microscopy images of the damage characteristics. The micrograph before etching,

Figure 6a, is shown as reference. There, the melt pool boundaries are not visible. The etched surface (see figure 6b), which reveals both the grain boundaries and, in less strong contrast, the melt pool boundaries, shows that the micro-cracks form at the horizontal grain boundaries. The figure also reveals that the rupture surface is formed by a network of micro-cracks along those grain boundaries. Additionally, three melt pool boundaries are highlighted in red to emphasize the fact that micro cracks form along horizontal grain boundaries rather than along melt pool boundaries. An inspection of the rupture surfaces revealed a checkerboard-like structure, which matches the spatial distribution of the voids found in the two specimens (see Figure 7).

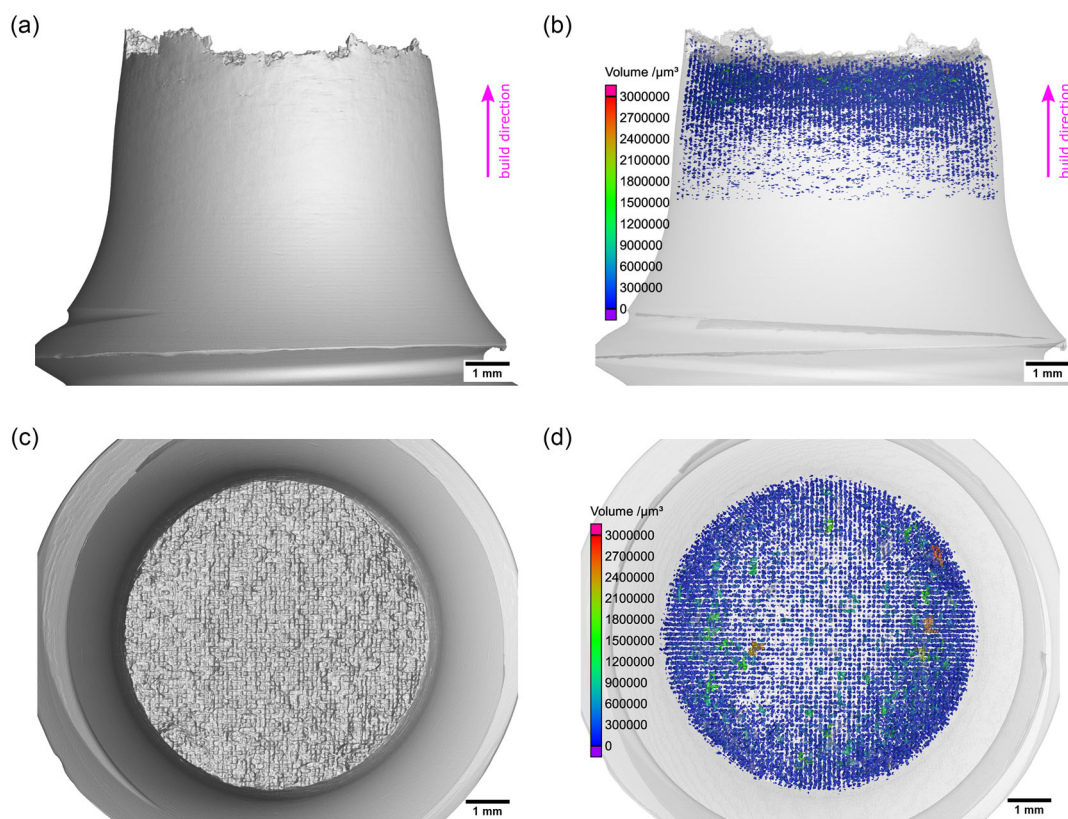
Figure 7. 3D rendering of the bottom part's top view of the 650 °C/175 MPa specimen: a) rendering of the rupture surface—side view; b) rendering of the void distribution—side view; c) rendering of the rupture surface—top view; d) rendering of the void distribution—top view.

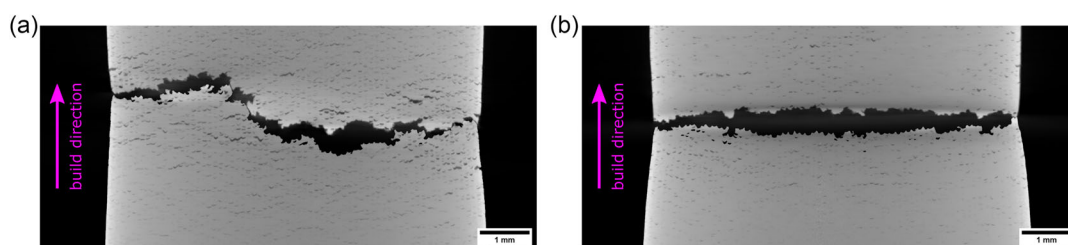
Figure 8. Gap between the centers of the two broken parts after combination: a) 600 °C/200 MPa specimen; b) 650 °C/175 MPa specimen.

The broken parts of each of the two specimens were virtually matched in VG Studio MAX in such a way that the outer circumferences of both parts were matched without leaving a gap. However, a small gap in the center between the two parts was observed (see Figure 8).
