10th World Conference on Neutron Radiography 5-10 October 2014

Measuring hydrogen distributions in iron and steel using neutrons

A. Griesche^{a,*}, E. Dabah^a, T. Kannengiesser^a, A. Hilger^b, N. Kardjilov^b, I. Manke^b, B. Schillinger^c

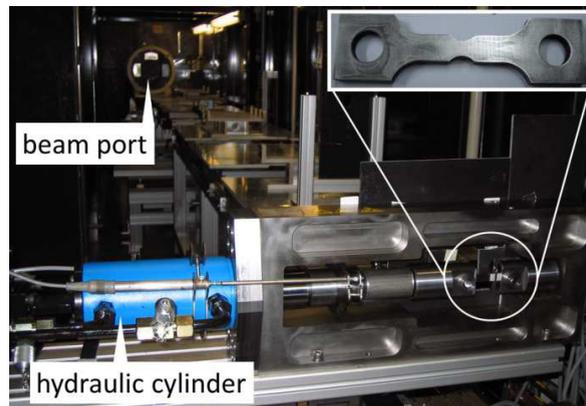
Fig. 1. Picture of the tensile rig mounted at the CONRAD experimental station. The direction of view is towards the cold neutron source. The insert shows a typical tensile test sample.

load with subsequent rupture of the sample. This investigation targeted on the prerequisites necessary to initiate HAC. The sample was processed in a self-made hydraulic tensile rig (see Fig. 1) mounted in front of the detector. The mechanical load curve applied to the tensile test sample is shown in Fig. 2. The ruptured sample was rearranged for tomography and after reconstruction the tomographic data set was binned $3 \times 3 \times 3$ and median filtered $3 \times 3 \times 3$ in order to reduce noise. The results are presented in chapter 3.2.

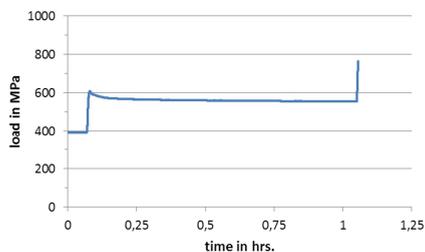
Fig. 2. Load profile of a tensile test with supermartensitic steel at room temperature. Neutron radiographs were recorded all the time with an exposure time of 10 s. The elasticity limit of non-hydrogenous supermartensitic steel is 600 MPa. Data on mechanical properties for hydrogenated material are not available in literature. The sample ruptured before the theoretical tensile strength of non-hydrogenous material of 900 MPa has been reached.

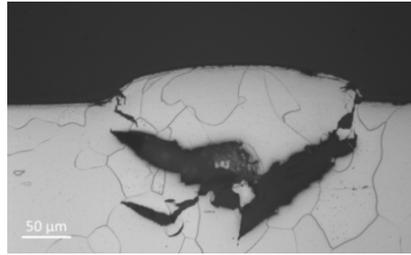
Fig. 3. Light microscopic image of a cross sectional cut of a blister in technical iron.

HAC already occurred during the charging of samples visible as blisters on the surface. Fig. 3 shows a metallographic specimen with blister.

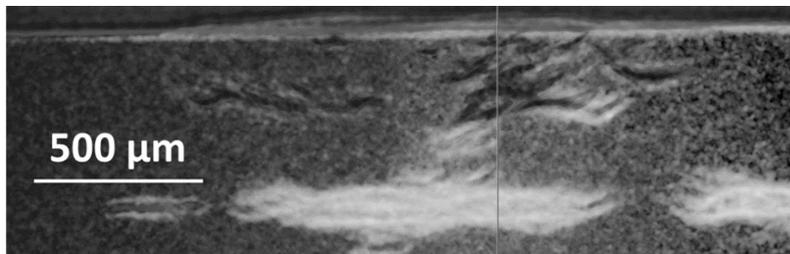
Fig. 4. Slice of a reconstructed model from a neutron tomography of a blister in an iron sample. The white color indicates the presence of hydrogen. Some cracks are filled with hydrogen gas whereas others that are located closer to the blister at the surface are not.

The use of neutron imaging gave a new insight in such degradation phenomena with subsequent cracking and blistering. We investigated blistered samples by using white beam neutron tomography and Fig. 4 shows a view into a blister (Griesche et al. (2014)). Fig. 5 presents a series of slices of the whole sample taken from the reconstructed model.

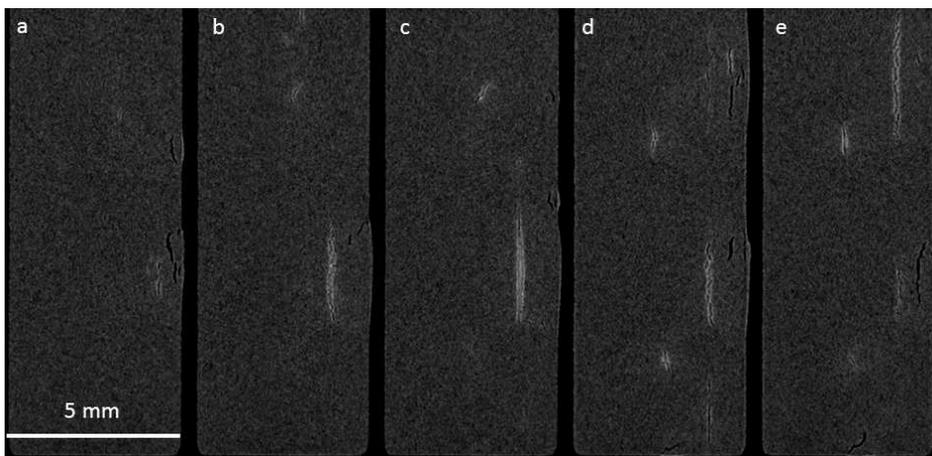
Fig. 5. Slices taken from the reconstructed model of a neutron tomography of a hydrogen-charged and blistered iron sample. The distance between each slice (a)-(e) is approx. 250 μm . The white color indicates the presence of hydrogen. Some cracks are filled with hydrogen gas whereas others that are located closer to the surface are not. The cracking direction correlates with the rolling direction.

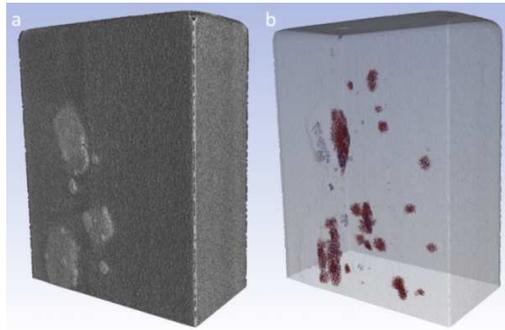
Fig. 6. Inclined view on the reconstructed 3-D model of a hydrogen charged iron sample. The rendered surface with blisters is shown in (a). Both the cracks (blue) and hydrogen (red) distribution are shown in (b). Most of the cracks are filled with hydrogen except some of the cracks closer to the surface. The latter cracks are mostly located underneath blister.

The 3-D model allows for a detailed analysis of both the crack and hydrogen distribution. For the first time it was possible to detect and visualize hydrogen accumulations around cracks and hydrogen gas inside cracks. Also for the first time the local hydrogen content could be determined by Griesche et al. (2014). The hydrogen accumulated to 100-200 wt.ppm in a small region of $\sim 50 \mu\text{m}$ around the cracks. The concentration of the hydrogen gas in the crack's volume corresponds to a pressure of 5-15 MPa, which is an order of magnitude smaller than the yield strength of non-hydrogenous rolled iron. For more details regarding the quantification procedure of the intensity distribution in tomograms, we refer to the contribution of Kardjilov et al. in this issue of Physics Procedia. Finally, Fig. 6 gives a nice view on both the rendered surface of the reconstructed 3-D model and the interior of the sample.

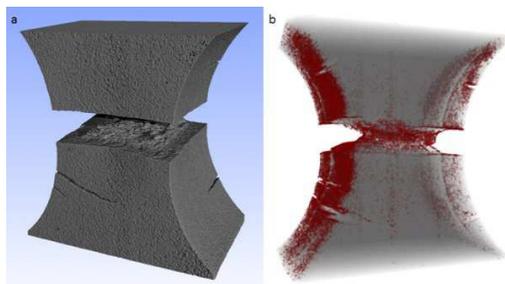
Fig. 7. Inclined view on the reconstructed 3-D model of a part of a hydrogen-charged supermartensitic tensile sample. The rendered surface of the notched area is shown in (a). The hydrogen distribution (red) is shown in (b).

The tensile sample ruptured at a load of $2/3$ of the theoretical tensile strength value for non-hydrogenous material. This indicates that a degradation of the mechanical material property had happened. The fractured surface, presented in Fig. 7a in form of the rendered surface of the 3-D model, shows the typical topology of HAC. A brittle outer fracture surface surrounds a honeycomb-like inner fracture surface of plastically deformed material. Interestingly, the observed hydrogen distribution shown in Fig. 7b corresponds to the regions in the sample where increased stress appeared. These regions were the surface of the notch base and the heavily plastically deformed inner part of the sample. This preliminary analysis does not allow for a full reconstruction of the history of hydrogen diffusion and HAC. Nevertheless, for the first time the crack topology and hydrogen distributions have been visualized *in situ* together in one sample. The analysis of the radiographic image series before rupture of the sample will give more insight in the chronological sequence of all steps of HAC.
