Energy Procedia 114 (2017) 5219 - 5228

# 13th International Conference on Greenhouse Gas Control Technologies, GHGT-13, 14-18 November 2016, Lausanne, Switzerland

# Corrosion fatigue of 1.4542 exposed to a laboratory saline aquifer water CCS-environment

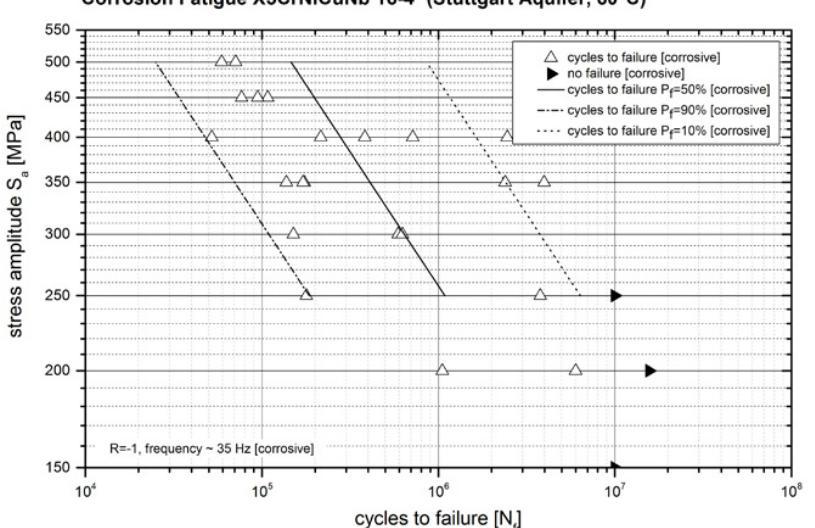
Corrosion Fatigue X5CrNiCuNb 16-4 (Stuttgart Aquifer, 60°C)

Fig. 1. S-N-curve and sample of 1.4542 exposed to flowing saline aquifer [20] and CO2 at 60 °C [34].

The S-N-curve did not show typical fatigue strength (Fig. 1). The coefficient of correlation r2 = 0.33 is very small indicating a non-linear relationship of the considered variables. In addition, the scattering range TN = 1:34.4 was disproportionately large. The corrosion fatigue strength of X5CrNiCuNb16-4 is 60% below the endurance limit

measured in air (620 MPa). Maximum number of cycles (10 x 107) was reached at a stress amplitude of 150 MPa. The decrease of the fatigue limit line with increasing number of cycles (Wöhler-exponent of k = 3.59) is much larger in corrosive environment than in air. [15]

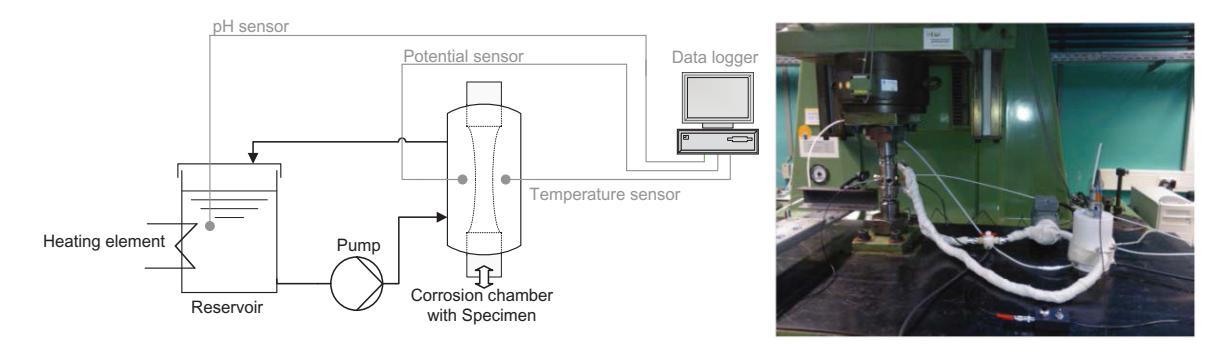
Fig. 2. Schematic set-up of operating corrosion chamber for in-situ corrosion fatigue testing [15].

The objective was to simulate in-situ conditions (temperature 60 °C, corrosive environment) of a material exposed to dynamic mechanical stress and corrosive gas- saturated saline aquifer environment. The corrosion chamber is fixed directly onto the sample leaving the resonant testing machine unaffected (Fig. 2). During mechanical stress-strain tests a magnetically driven gear pump constantly pumps the corrosive media from the reservoir to the corrosion- and temperature-resistant corrosion chamber. The specimen is during the complete test surrounded of the corrosions medium. Heating is realized by a heating element which is placed at the reservoir. The ratio of sample surface to volume of the corrosive media after DIN 50905 Part 1 (10 ml/cm<sup>2</sup>) is greater than required. The connecting of the chamber onto the specimen via clamping collar creates a force-fit process ensuring enough force to the corrosion chamber at high frequencies to keep it firmly on the test specimen. The corrosion chamber is sealed by O-rings made of Viton in the area of restraint. In order not to impede the change in length of the sample during the experiment, a membrane is applied to the corrosion chamber as a motion-compensating element.[15]

The corrosion chamber is also equipped with measurement technique to obtain electrochemical data during the mechanical tests. There are sensors to measure the temperature, the pH and the electrochemical potential. For measurement of the electrochemical potential a special is used. The silver-silver chloride electrode is shock resistant and hence optimized for use inside the corrosion chamber under cyclically load. The silver wire is fixed in a channel made of Teflon. To simulate non-static operation a resonant testing machine has been used at 30 - 40 Hz where samples of both steels were tested in stress-strain mode under CCS aquifer environment. In addition technical CO<sub>2</sub> was introduced into the closed system at a rate close to 9 L/h to keep stable environmental conditions.

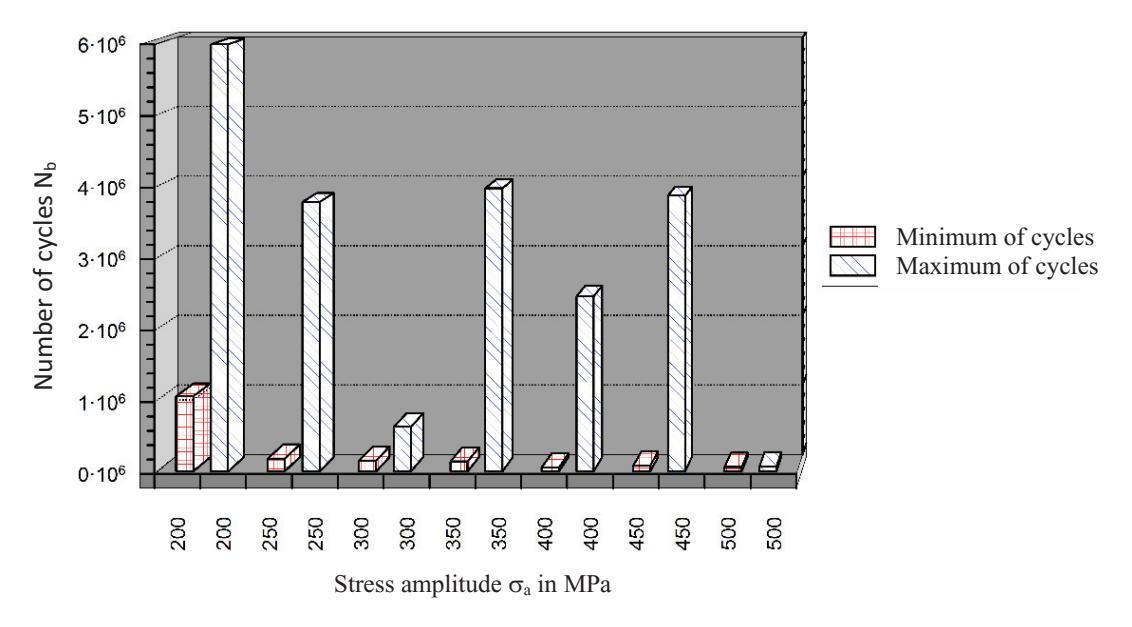
Fig. 3. Scatter range of number of cycles at certain stress amplitudes after fatigue testing.

To explain the unusual high scatter range TN = 1:34 (figure 3) and differing results in corrosion fatigue tests extended analysis was performed selecting four specimens two that failed after maximum/minimum of cycles at low stress amplitude (250 MPa) and two that failed after maximum/minimum of cycles at high stress amplitude (450 MPa). Figure 3 demonstrates that at certain stress amplitudes the number of cycles differ by a factor of 50.

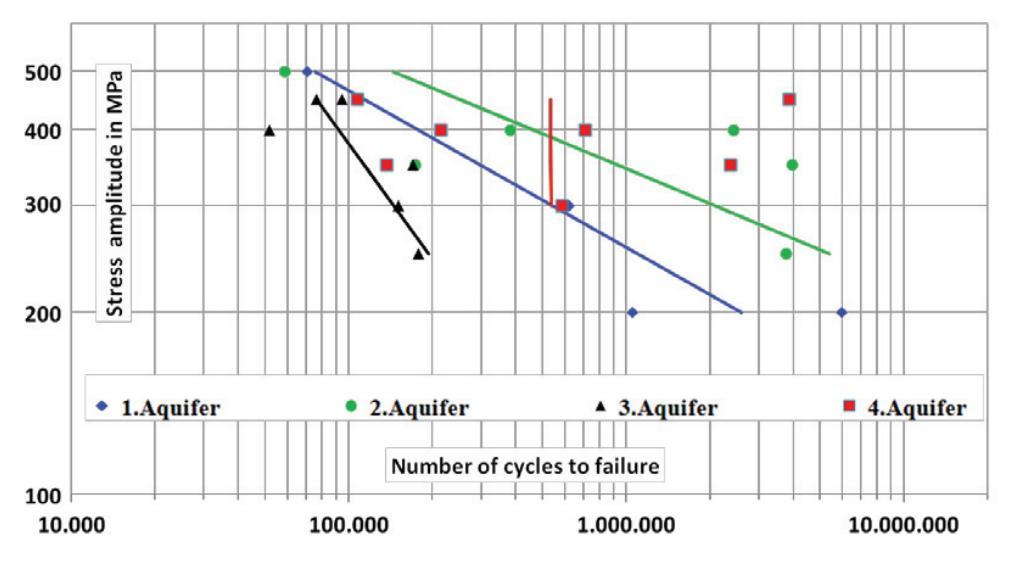
Fig. 4. Microstructure of X5CrNiCuNb16-4.

Ordering the numbers of failure within the S-N-plot results in three data sets as demonstrated by different types of lines in Fig. 4. These may be related to the charge of synthesized aquifer water.

The large scatter range, the possibility of three charges and the very small coefficient of correlation r2 = 0.33 indicate a non-linear relationship of the considered variables giving only a 24% chance of linear relationship. The overall scatter range is TN=1:34 while Fig. 5 shows estimated scatter ranges for the different aquifer charges as follows: 1. Aquifer: TN=1:9,4, 2. Aquifer: TN=1:43,2, 3. Aquifer: TN=1:2,6 4. Aquifer: TN=1:48,4. Even here the differences between the charges are unusually high. Still, each of the 4 charges has been synthesized in a strictly orderly way following the same protocol to guarantee high quality and therefore reliability of the fatigue tests. Chemical analysis indicates no significant difference in composition or pH. It is highly doubtful, that even if Fig. 5 may assume otherwise the charge of Aquifer water is reason for this fatigue behavior.

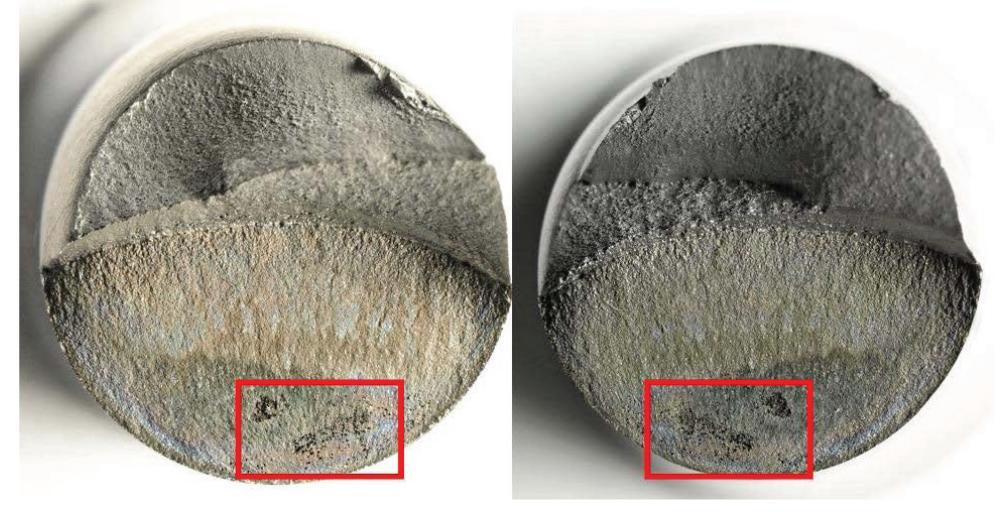
Fig. 5. Crack surfaces after fatigue failure. Samples reveal impurities with no influence on endurance limit.

All specimens were thoroughly visually analyzed at their crack surfaces to determine differences on the crack surface that may be related to high or low number of cycles to failure at certain stress amplitudes (Fig.5). Fig. 6 clearly points out that the surfaces of the cracks show darker areas related to impurities. But, these impurities were found on various surfaces with no significant correlation to the endurance limit. Note, the specimen in Fig. 5 was tested a high number of cycles prior to failure.

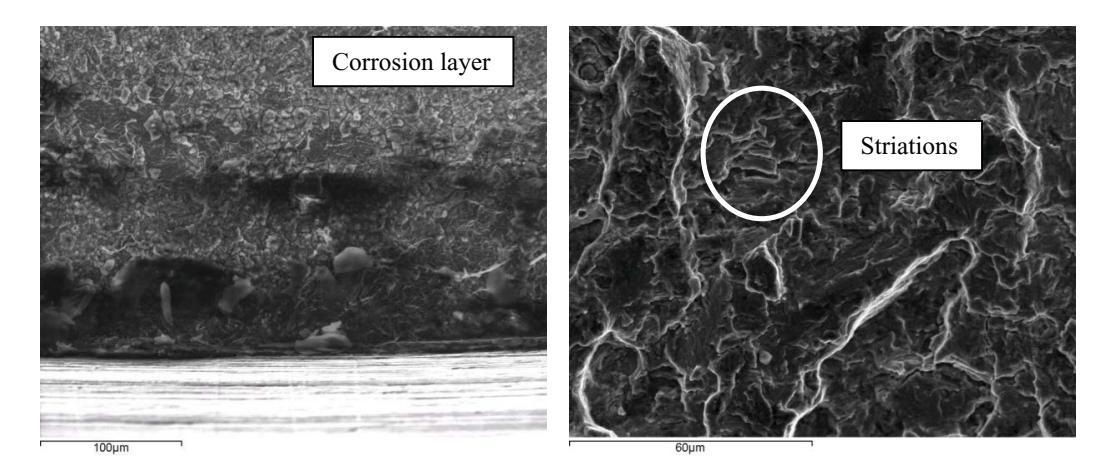
Fig. 6. Crack surfaces after fatigue failure. Samples reveal impurities with no influence on endurance limit.

Additionally, all specimens revealed corrosion layers on the fatigue surface. These corrosion layers are mainly composed of iron carbonate (siderite,  $FeCO_3$ ) and iron hydroxide ( $Fe(OH)_2$ ) (Fig. 6, left). Once the crack opens the crack-flank surfaces corrode continuously during cyclic load leading to crack propagation perpendicular to the direction of load. Localized corrosion (pits: 0.1 mm deep and 0.2 mm diameter) is accompanied with cracks, but not necessarily identified as the cause of crack initiation and failure under mechanical load [15]. Both, the presence and the thickness of the corrosion layer could not be related to early failure. Concurrently all samples exposed striations

indicating the opening and closing of the initial crack during cyclic load (Fig. 6, right). The number of striations was also not a matter of early or late failure

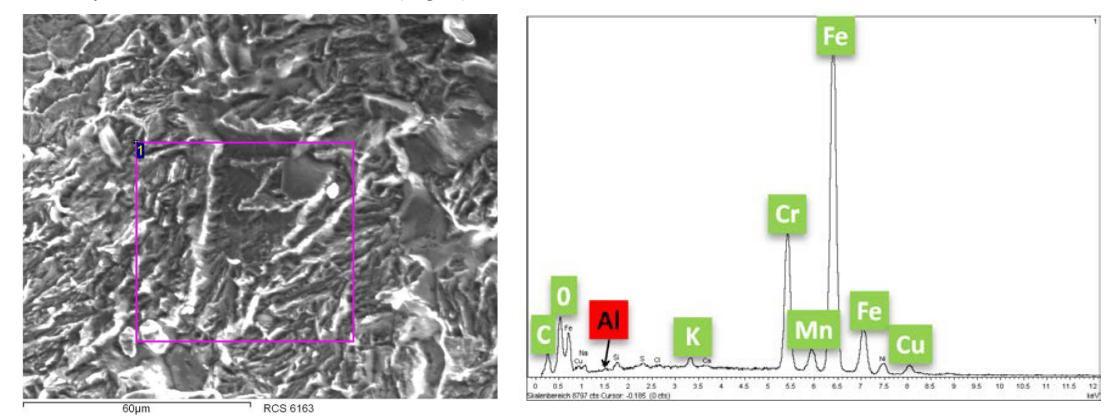
Fig. 7. Surface image (left) of corrosion layer on crack flank and main elements indicating Al as impurity (right).

The analysis of the surface corrosion layers revealed multiple elements from the alloy, but in 50% of the corrosion layers aluminium was detected (Fig. 7).

Because aluminium is not constituent of the alloy the chemical composition was double checked displaying aluminium also in the base material of all specimens. The presence of aluminium in the corrosion layer was correlated to samples with short number of cycles to failure and therefore is the only evidence for reason of lower endurance limits so far. In steels aluminium is added to obtain a fine grain microstructure. It also minimizes the decrease of mechanical properties related to aging processes and precipitates to aluminium nitrides in the presence of nitrogen promoting hardness (precipitation hardening) [27]. But, there is no information on the influence of aluminium on the corrosion fatigue behavior of steels. It is most likely that all of the aluminium analyzed is located in the base material and not in the corrosions layer. This excludes impurities from the aquifer water, the corrosion chamber or the test system.

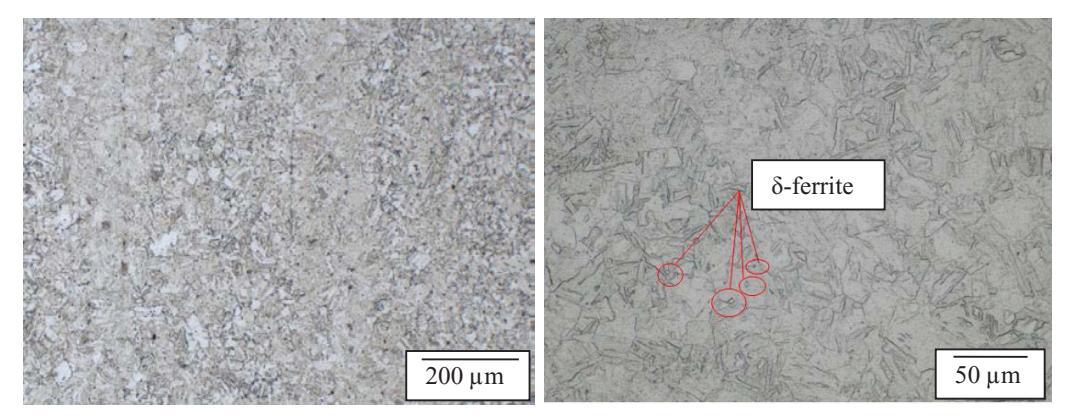
Fig. 8. Microstructure of X5CrNiCuNb16-4.

After hardening and annealing the microstructure of X5CrNiCuNb16-4 reveals the typical needle-structure of martensite with embedded  $\delta$ -ferrite (Fig. 8). White areas and darker spots that may be related to non metallic precipitations do not influence the mechanical properties because of their rather small diameter (5-10 µm). Samples with low number of cycles to failure revealed non-metallic inclusions that were distributed discontinuously lamellar within the alloy. But, these findings were also found in samples with high number of cycles to failure. It may be assumed that, impurities present in the base material consolidate during cyclic loading within the corrosive environment and then lead to unpredictable early failure. Perhaps some specimens contained more inclusions at the rupture cross section than other specimens explaining early failure. Possibly the endurance limit is dependent on the number of impurities within the alloy, but, because this is a statistic process no significant correlation may be given for microstructural appearance and endurance limit. Crack formation is correlated with local corrosion phenomena (pitting) resulting in inter crystalline corrosion. It may also be possible that these impurities lead to local corrosion phenomena, but again failure is not necessary a consequence of local corrosion.
