Energy Procedia 114 (2017) 5337 - 5345

13th International Conference on Greenhouse Gas Control Technologies, GHGT-13, 14-18 November 2016, Lausanne, Switzerland

Investigation of Corrosion Fatigue of Duplex Steel X2CrNiMoN22-5 3 Exposed to a Geothermal Environment under Different Electrochemical Conditions and Load Types

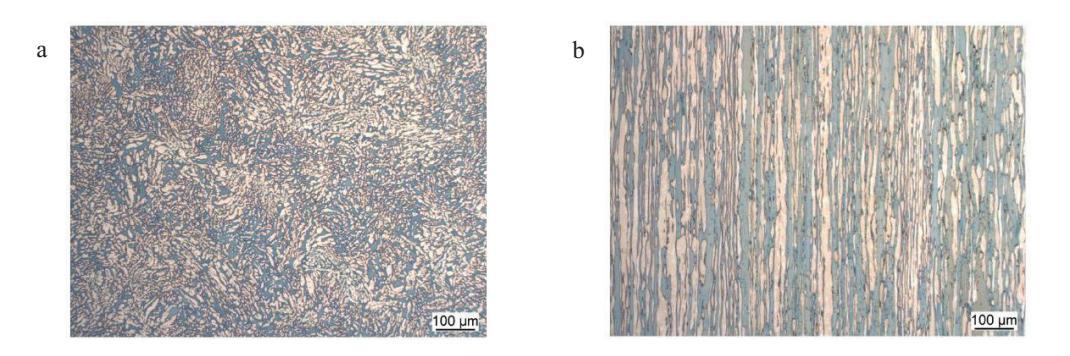
Fig. 1 Microstructure of experimental alloy prior to testing; (a) transversal and (b) longitudinal sections respecting the casting direction [18]. Etching: Beraha II

Table 2 shows the major mechanical properties of the alloy. The high strength values result from the material's fabrication process, its dual balanced microstructure and of the additional alloying elements, in particular nitrogen [19, 20]. Fig. 1 depicts the alloy's microstructure obtained via etching prior to fatigue testing.

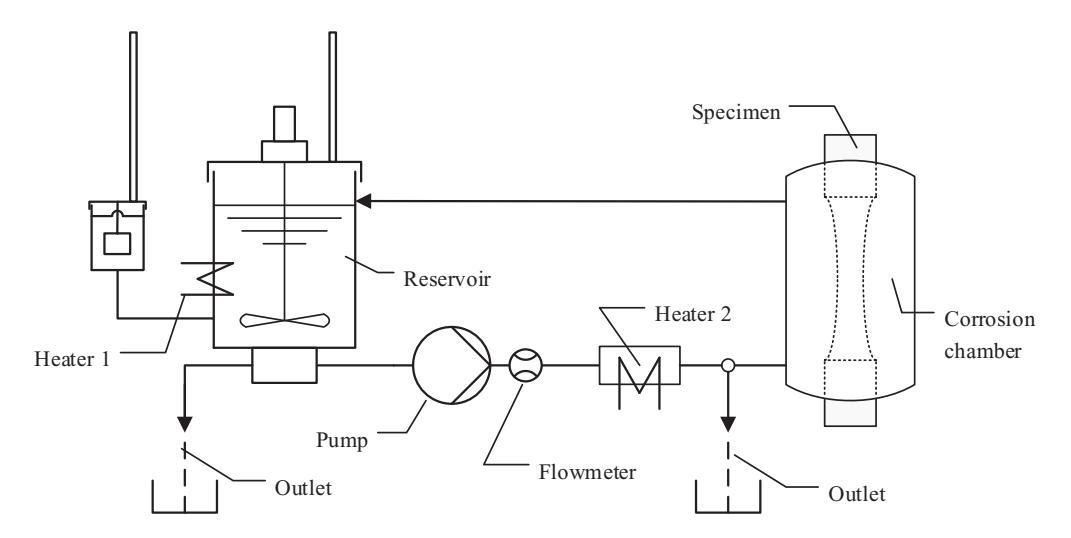
Fig. 2 Experimental setup for the geothermal in situ fatigue testing; schematic representation.

In order to investigate the influence of the load type on the CF alloy's behaviour, the two major experimental series, namely push/pull and rotating bending series, were accomplished. Due to the distinct nature of the mechanical load applied, the experiments were performed employing two different corrosion chambers. The chambers were developed, manufactured and tested specifically for the following CF tests. The push/pull experimental series were carried out on the horizontal fatigue testing machine Schenk-Erlinger Puls PPV. The experimental setup is shown in Figure 2.

The rotating bending experimental series were completed on the in-house designed rotating bending fatigue testing machine. On account of comparability the boundary conditions as well as the measuring devices applied were identical in both experimental series. Taking into account the rotation of the specimen, a modified OCP measuring setup was applied. Additionally to the Ag/AgCl wire electrode a brush was installed to establish direct contact with the shouldered section of the specimen Figure 2 shows the major components of experimental setup for the fatigue tests.

The design of both corrosion chambers allowed for advantageous installation of sensors and additional components in immediate proximity to the critical cross-section of a specimen. The volumetric constant flow of the corrosion medium, which was provided by the internally developed gear type pump, accounted to $\dot{v} = 2.5 \times 10^{-6} \text{ m}^3/\text{s}$. The theoretical flow velocity of the electrolyte at specimen's critical cross-section was therefore $\omega_0 = 1.7 \times 10^{-3} \text{ m/s}$. The electrolyte underwent preheating within the main electrolyte reservoir and was held at a constant temperature of 369 K via control unit and additional heater, which was installed directly prior to the corrosion chamber entry. The resulting temperature fluctuation did not exceed ± 0.3 K. The mean frequency of cyclic load applied accounted to 30-33 Hz. The open-circuit potential of the specimen was recorded by the shock proof Ag/AgCl wire electrode.

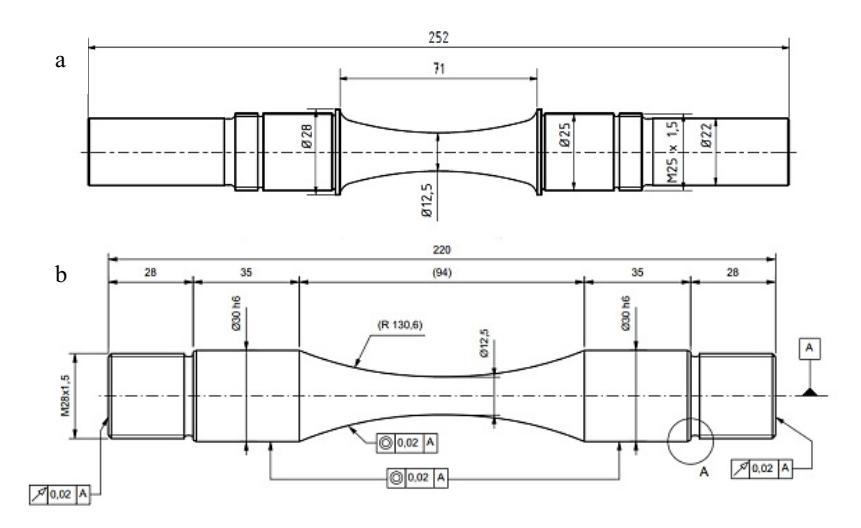
Fig. 3 Specimens for (a) rotation bending and (b) push/pull CF tests

The shape and dimensions of hourglass specimens were selected in accordance to the standard DIN EN ISO 11782-1 and to the recommendations of the FKM Research Issue 217 [22]. The critical cross-section of both specimen types is 12.5 mm in diameter; the total contact surface area did not undergo 25 cm² in order to minimize the influence of irregularities [23]. The schematic drawing of specimens for push/pull and rotating bending fatigue experiments are exhibited in Figure 3.

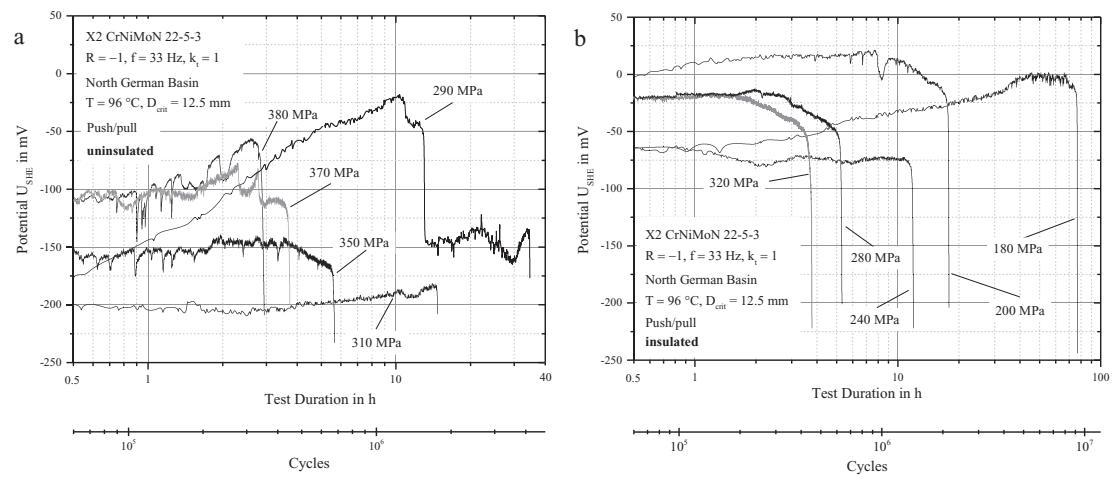
Fig. 4 Effect of electric insulation of fatigue testing machine (a) OCP behaviour of uninsulated and (b) insulated setup

The additional electric insulation of the otherwise electrically grounded fatigue testing machine lead to a decrease of OCP fluctuations and to a general stabilisation of OCP values (Fig. 4). The initial OCP values shifted towards more noble magnitude in response to insulation. Moreover, the range of initial values decreased from U_{SHE} (-110 to -200) to (-5 to -65 mV) applying the insulated test setup.

The remarkable drop of the OCP values was observed during the ending phase of each test independently from the electric insulation and other variable parameters applied. The potential fall began approximately 10 minutes prior to the final mechanical failure of a specimen and became thereby an earliest termination indicator. The potential drop can be explained by the formation of cracks, the passive layer is destroyed and the newly formed crack surface comes into contact with the corrosive medium [24]. An analogous behaviour of the OCP was observed in earlier studies [8, 25]. Considering the observed effect of electric insulation, the following experimental series, i.e. the comparison of the surface finish influence as well as the rotating bending experimental series were accomplished on the setups employing distinct electric insulation.

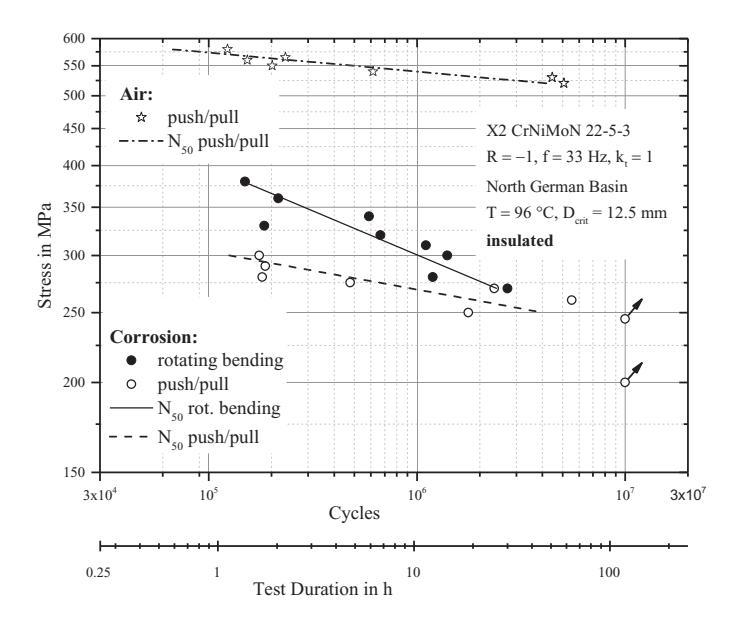
Fig. 5 Rotation bending vs. push/pull cyclic load in situ geothermal NGB conditions; 50% probability S-N curves

The reference fatigue tests in air appointed an endurance limit of 485 MPa for X2 CrNiMoN 22-5-3 considering 10^7 cycles as threshold reference. Figure 5 summarises the experimental data combined with the corresponding 50% probability S-N curves for both load types. The slope factors of rotating bending and push/pull experimental series accounted to k=8.2 and k=19 respectively. The higher slope coefficient value in case of rotation bending load was significant in the cycle range 10^5 to 10^6 and decreased with the increasing number of cycles. The S-N 50% probability diagrams converged at approximately 3.5×10^6 cycles or 30 experimental hours, eliminating the advantage of the rotation bending load.

The fatigue experiments in air show a lower decline of the rotating bending for the entire experimental cycle span including the endurance limit section, i.e. convergence or overlapping of push/pull and rotation bending S-N curves diagrams is nonexistent. The advantage of rotating bending load over the push/pull purely alternating load in case of steel alloys loaded in air could be approximated by the factor 1.11-1.25, which correlates well with the results obtained in the initial experimental period [26]. A more negative slope factor of the rotation bending experimental series can be explained with the dominant influence of corrosion degradation caused by corrosion.

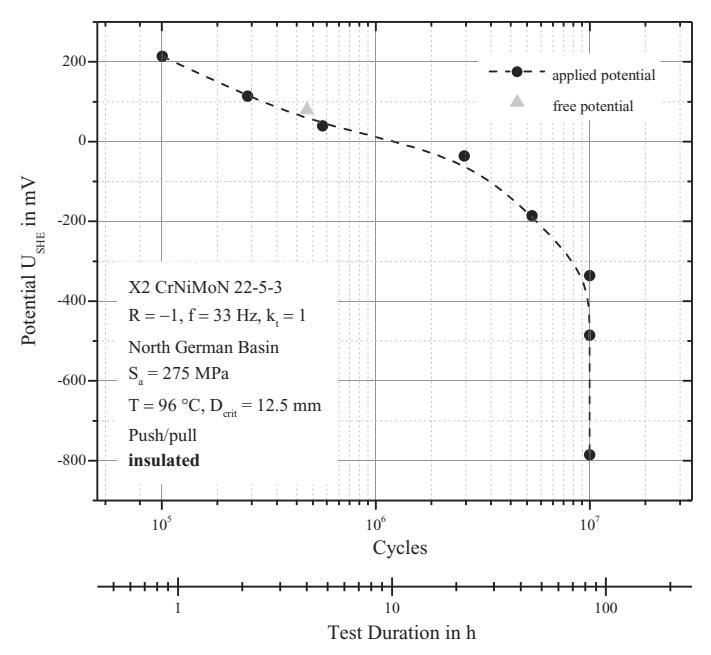
Fig. 6 Influence of applied potential on CF life expectancy of X2 CrNiMoN 22-5-3; polished surface finish, push/pull load

The applied potentials ranged from $U_{SHE} = -900$ to +100 mV and covered partially anodic and cathodic domains. The result obtained are summarised in Figure 6. The specimens loaded in an anodic potential domain exhibited the reduction of the CF life expectancy. The velocity of deterioration correlated with the value of potential applied, i.e. the increasing potential led to the decrease of the alloy's CF life expectancy. The potentials of the cathodic range led to a significant increase of cycles to failure. The advantage of cathodic potential and the related increase of cycles corresponded to the decreasing value of potentials applied. The specimens loaded within the potentials $U_{SHE} = -450$ to -900 mV reached a preset threshold of 10^7 cycles without indicating mechanical failure and were declared as runouts. Furthermore, the cathodic potential range led to an explicit discharge of hydrogen from the specimen's surface. The results obtained show that the manifestation of pitting corrosion, which was assumed as a notch-based

initiation zone of fatigue crack propagation, can be successfully hindered via application of an appropriate cathodic potential.

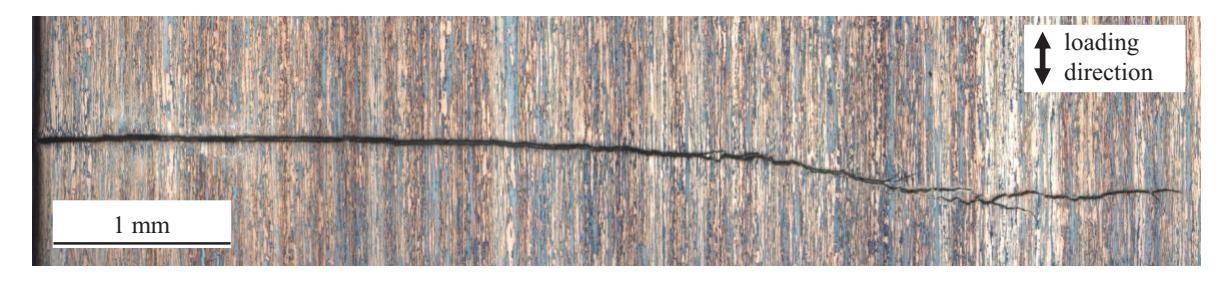
Fig. 7 Microsection through a major fatigue crack; precisely turned surface, push/pull load

The evaluation of the CF damage was accomplished by means of both optical and scanning electron microscopy (SEM). The direct contrasting juxtaposition of the damage observed was advantageous in terms of understanding the influence of load type on the formation of CF cracks. The investigated fatigue cracks were divided into major and secondary cracks. The major cracks, which lead to failure, were characterised by a well pronounced residual opening and macro dimensions. The major fatigue cracks occurred predominantly in immediate proximity to the specimen's critical cross-section and were responsible for the final mechanical failure of a specimen. The secondary fatigue cracks, on the contrary, exhibited micro dimensions and did not possesses noticeable residual opening. The latter cracks could therefore only be observed via sufficient magnification. Figure 7 shows an etched microsection of a major fatigue crack. The crack's propagation path lay predominantly perpendicularly to the direction of load applied and crosses both phases of the alloy without indicating a preferable propagation phase. The termination region showed moderate branching within the partially curved propagation path.

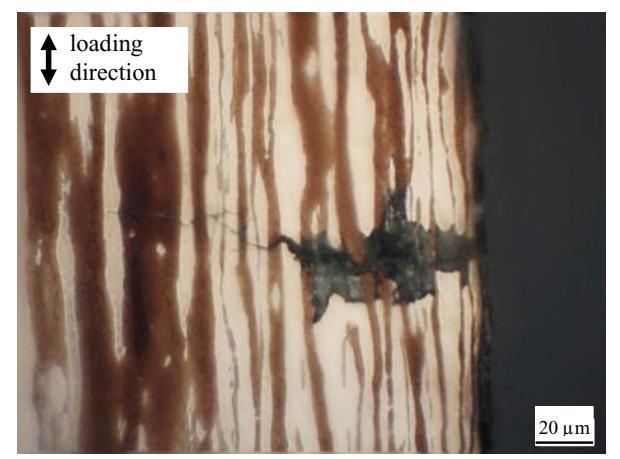
Fig.9 Microsection through secondary crack; precisely turned surface finish, push/pull load. Etching: Beraha II

Figure. 9 demonstrates a microsection through corrosion pit, which was associated with a secondary crack. The distinct horizontal grain attack with an enhanced deterioration within the boundary surface was registered in the pit cavity. The latter may indicate potential proneness of the alloy to intergranular attack in NGB environment. The remaining ferritic lamellae in the pit's cavity (dark) indicate preferable deterioration of the austenitic phase (bright). The propagation of a fatigue microcrack, which initiated in the base of the pit's cavity possessed an arbitrary path and no residual opening, emphasising relatively young age of this specific crack. This type of micro corrosion pits were identified due to the presence of corrosion stains in their immediate proximity. - It is supposed that under given experimental conditions, corrosion pit initiation has primary character. Initiated corrosion pits first grow in dimension reaching a critical size, being then followed by formation of a fatigue crack due to a notch effect.
