FATIGUE LOADING OF SANDWICH SHELL TEST SPECIMENS WITH SIMULATED PRODUCTION IMPERFECTIONS AND IN-SITU NDT

Keywords: fatigue of sandwich shell structures, non-destructive testing, wind turbine blades

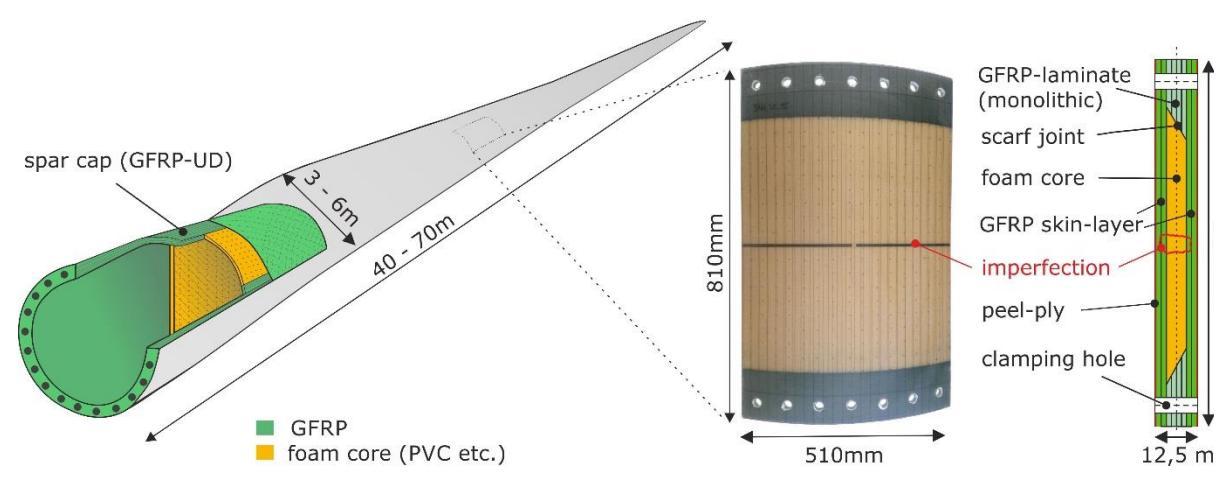
Figure 1: Structural design of rotor blades (left) and design of representative sandwich shell specimen (right).

Wind turbine rotor blades are produced using fiber reinforced plastics (FRP). Except the root section and the spar caps, the majority of the blade is a sandwich shell structure. Rotor blades typically have a length of 40m - 70m and a width of 3m - 6m (see Figure 1). The typical width of technical textiles used for fiber reinforcement is a maximum of 2.5m. Foam plates used in the structure core have dimensions of approximately 1.2m x 2.5m. Hence, ply overlaps and gaps between the foam plates are sometimes inevitably brought in to the structure during production. Additionally, the number of outer layers covering the length of the blade decrease toward the blade tip according to the bending moment, and thus lead to ply drops. Ultimately, these imperfections are unavoidable and design rules must be incorporated to make their impact on the in-service strength as low as possible. This task was subsequently addressed in the course of this project.

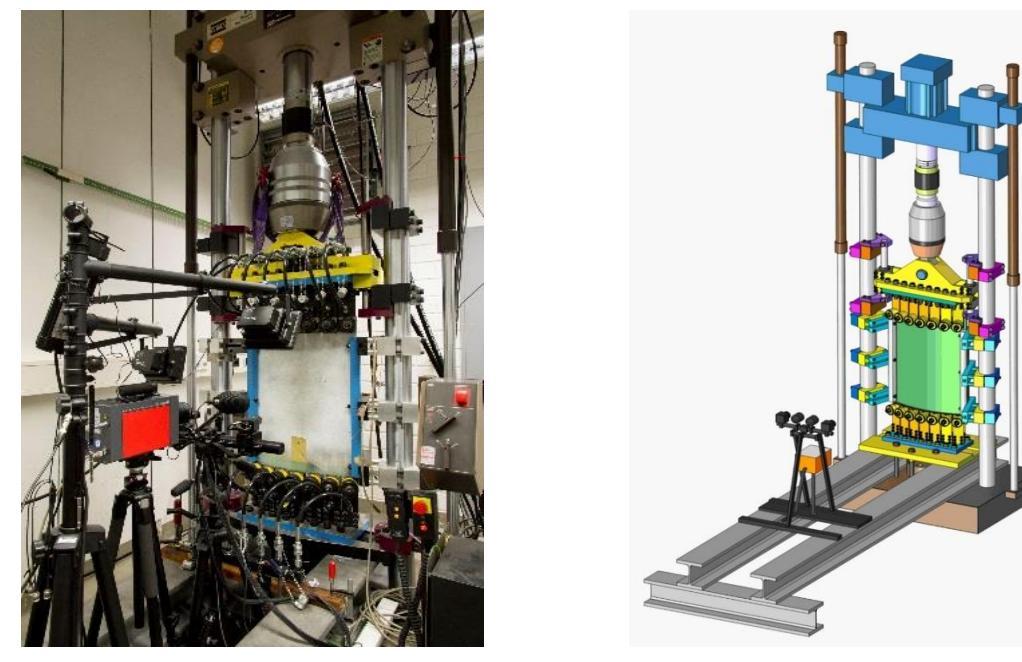
Figure 2: Shell test bench with infrared thermography camera (red) and field strain measurement system

A shell test bench developed at the BAM 5.3 allows for static and fatigue testing of curved fiber-reinforced plastic (FRP) structures. The experimental set up was integrated into a 500kN MTS 810 axial test machine (see Figure 2) to simulate typical operational loads. The load is transferred by each of the seven grips at the top and bottom of the specimen, and a hollow piston cylinder applies a maximum clamping force of 125kN on each grip. Finally, a maximum load per unit length of 1kN/mm can be applied to the shell specimen. This unique, intentional construction of the test bench allows for a guaranteed homogeneous load transfer to the test specimens (see Figure 3 - tensile load 50kN, tensile strain $\varepsilon_y = 0.31 + 0.02$ %). A combined GOM ARAMIS 5M field strain and Infratec IR8300 thermography camera system is used to non-destructively detect defects as well as their evolution. With these systems, the development of defects can be followed in-situ during the fatigue testing.

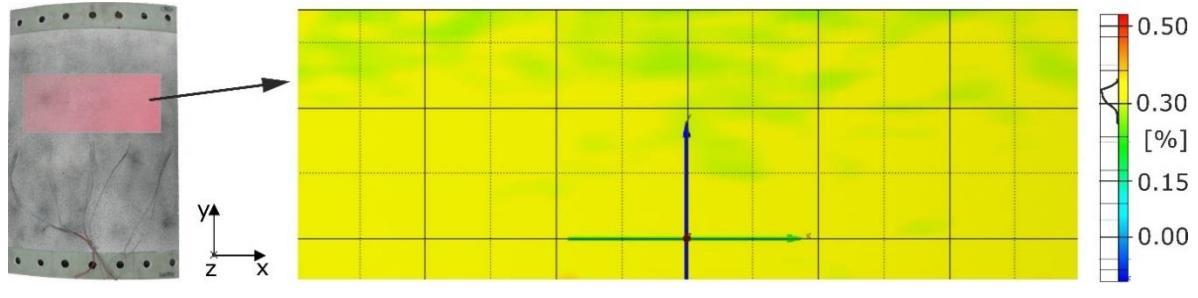
Figure 3: Field strain measurement on a defect-free shell specimen. Tensile load 50kN, strain ϵ_y = 0.31 +/- 0.02%

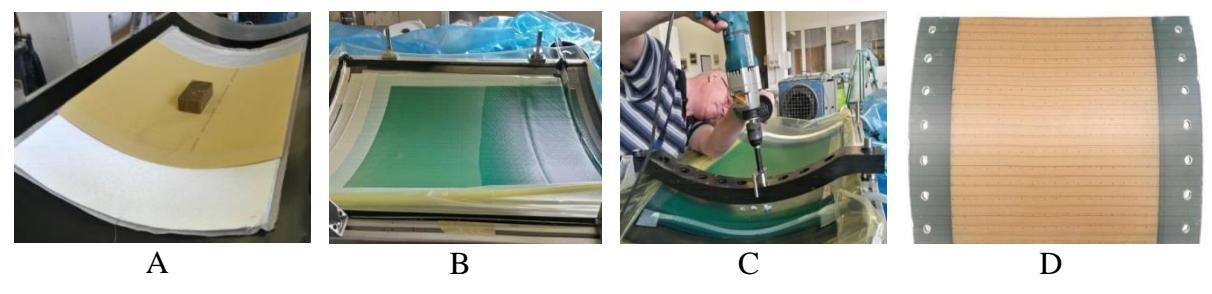
Figure 4: SCRIMP production process of the sandwich shell specimens.

ply (Seemann Composites Resin Infusion Molding Process), which is one of the most common resin infusion techniques (see Figure 4, A-D). First, the tailored dry glass fiber textile and the foam plate are positioned in the mold (Fig.4, A). The 10mm thick PVC-foam has lengthwise slits, allowing for easier laying into the curved mold and acting as channels for resin flow during. Next, the preform is covered with a vacuum foil and sealed to the mold (Fig.4, B). The preform is subsequently evacuated, and the resin infusion begins. The specimen is then tempered after production for 15 hours at 80°C. Finally, holes for clamping were drilled in the specimen (Fig.4, C) and the edges were tailored to allow for comfortable fit into the shell test bench (Fig.4, D).

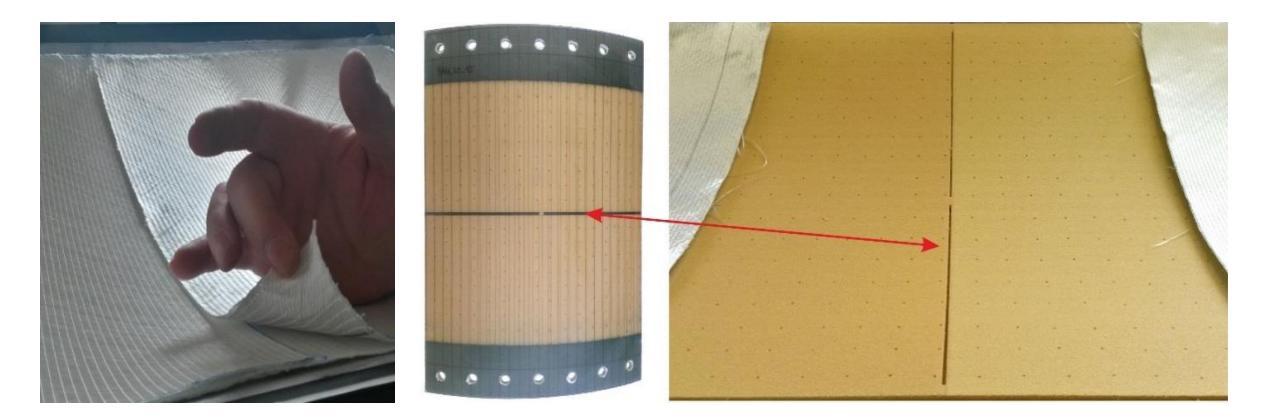
Figure 5: Typical manufacturing of imperfections often seen in blade production. Ply overlap (left), and foam gap (middle und right).

The outer layers each consist of two biaxial $+/-45^{\circ}$ non-crimp fabrics of $810g/m^2$ weight with an effective total thickness of 1.3mm. The10mm thick AIREX C70.55 PVC-foam core had a density of $60kg/m^2$, and the epoxy matrix system used was RIM R135/ RIM H137. In the clamping section, the foam core was replaced by 0°-glass-fiber non-crimp fabric to enhance the compressive strength, and a scarf joint was performed for a smooth load transfer from complete laminate to the sandwich portion (see Figure 1, right). The following typical imperfections were incorporated into the above-described fabrication of the defect-free specimen (see Figure 5):

- Foam gap, with an epoxy filled gap of 3mm, 5mm, 7mm
- Single-ply overlap
- Double-ply overlap

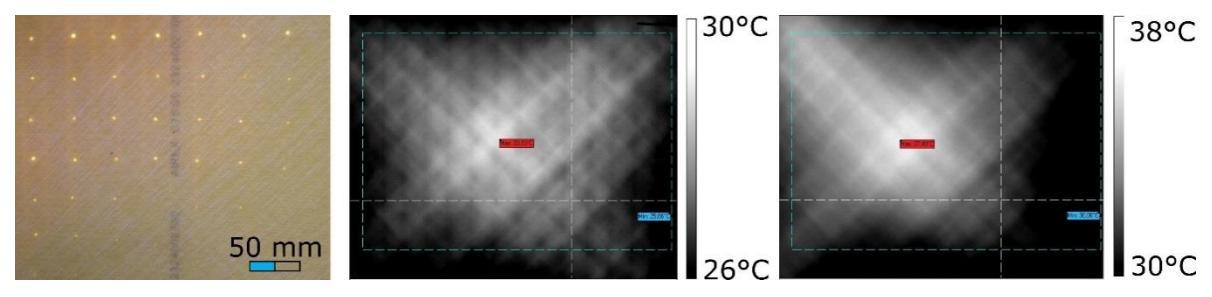
Figure 6.: Test specimen SI_2. Tensile strain 2 ‰. After 8.2 million load cycles. Photo of rear side of specimen with inter-fiber failure cracks (left). The contrast is (middle). With frame rate 8 Hz, in-situ fatigue test (right).

The self-heating of the shell specimens is used for the passive thermography. Figure 6 shows a shell specimen without artificial imperfection after 8.2 million load cycles at +/-35kN. Microcracks are clearly visible on the rear side of the specimen (Figure 6, left). Depending on the frame rate, the thermal contrast maps only the surface cracks (8Hz, right) or additionally the foam core (80Hz, middle). Furthermore, it is advantageous to stop the test, let the specimen cool down, and then restart the cyclic loading and take the thermogram in the warm-up phase. This procedure was automated by means of the test bench computer control.

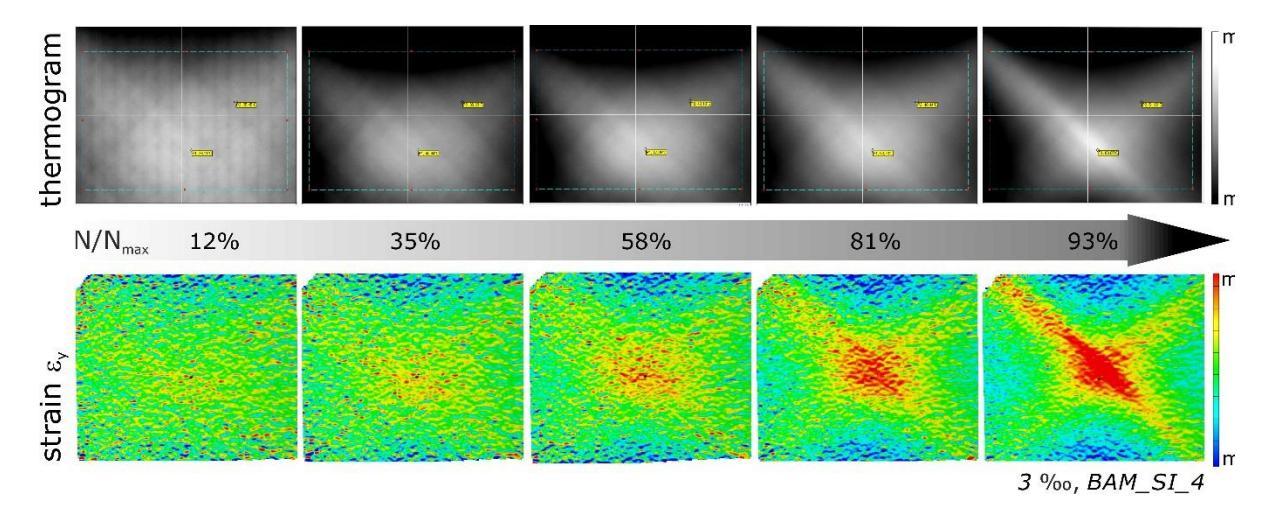
Figure 7: Test specimen SI_4. Tensile strain 0.3%. Strain field measurement (ARAMIS) and passive thermography showing damage evolution.

The front side of the specimen was coated with a white color and black speckles for the strain field measurement. This coating is transparent for the thermal contrast. Figure 7 compares the tensile strain field and the thermogram for different damage states. The specimen did not have any incorporated imperfection, and was subjected to cyclic loaded with a load amplitude of +/-49kN. Both techniques image the developing micro-cracking in the middle of the specimen until a cleavage fracture occurs. The temperature range of all thermograms was adjusted to be equal. Thus, the severe damaged region emerges in the thermal contrast, and the outer region becomes less visible. The damage was found to begin in the middle of the specimen, and was not affected from the free edge or clamping region. This result was the first proof of concept concerning the design of the specimens and the test bench.

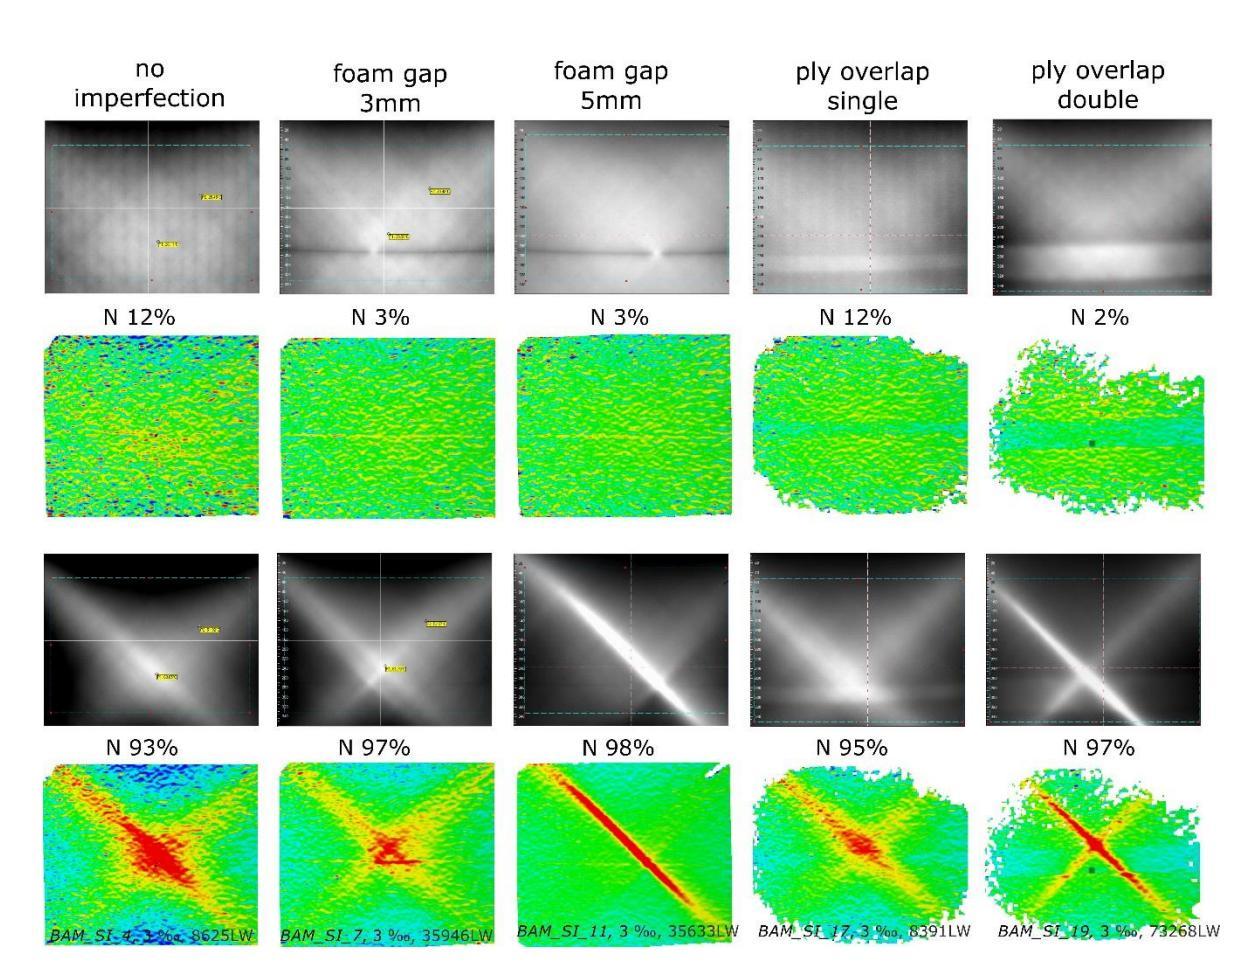
Figure 8: Strain field and thermogram in undamaged (top) and damaged state (bottom) for specimens without (left) and with different imperfections.

The shell specimens with typical imperfections were investigated in the second stage (see Figure 8). Again, all specimens began to fail in the middle region, regardless of the imperfection type. The foam gap and ply overlay can be imaged clearly with passive thermography (see Figure 8, top). However, the strain field measurement is not as sensitive. The increased local stiffness causes a decrease in local strain. The foam gaps are hardly visible in the tensile strain image. On the contrary, the ply overlaps are clearly imaged, but the contrast has a lower quality compared to the thermography. In the damaged state, both techniques indicate the location of the initial defect and the progression until the final failure. The initial damage always begins at the imperfection. In the case of the ply overlays, the position of the initial failure is at the edge of the ending ply. Again, the temperature range was equally adjusted for all experiments. Thus, the contrast in the thermograms emphasizes the position of the cleavage fracture.
