Distributed Fiber Optics Sensing and Coda Wave Interferometry Techniques for Damage Monitoring in Concrete Structures

Abstract: The assessment of Coda Wave Interferometry (CWI) and Distributed Fiber Optics Sensing (DFOS) techniques for the detection of damages in a laboratory size reinforced concrete beam is presented in this paper. The sensitivity of these two novel techniques to micro cracks is discussed and compared to standard traditional sensors. Moreover, the capacity of a DFOS technique to localize cracks and quantify crack openings is also assessed. The results show that the implementation of CWI and DFOS techniques allow the detection of early subtle changes in reinforced concrete structures until crack formation. With their ability to quantify the crack opening, following early detection and localization, DFOS techniques can achieve more effective monitoring of reinforced concrete structures. Contrary to discrete sensors, CWI and DFOS techniques cover larger areas and thus provide more efficient infrastructures asset management and maintenance operations throughout the lifetime of the structure.

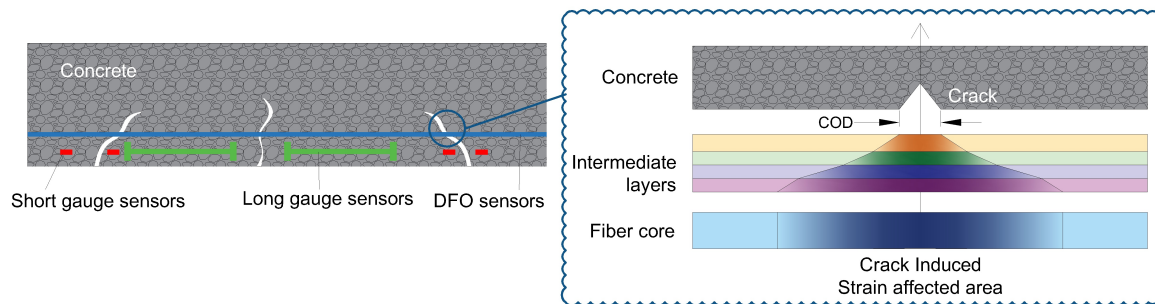
Figure 1. Crack detection using Distributed Fiber Optics Sensing (DFOS) techniques.

As mentioned in the previous paragraph, DFOS techniques provide spatially distributed strain measurements. Thus, as shown in Figure 1, direct damage detection and localization can be achieved

contrary to short gauge and long gauge sensors where sophisticated algorithms are required [18]. Previous works [19–23] have already demonstrated the ability of DOFS to detect and localize cracks in concrete structures. However, the quantification of crack opening assessment from this kind of measurements remains a challenge that this paper aims to tackle. For civil structures applications, optical fibers are usually surrounded by protective layers or adhesives in order to prevent fiber breakage and to glue the fiber on the surface of the structure [24]. As shown in Figure 1, it was found that the deformation discontinuity due to the crack formation is transferred to the optical fiber, through the intermediate layers, and in the form of a localized strain distribution covering an important length (several centimeters) of the optical cable [22].

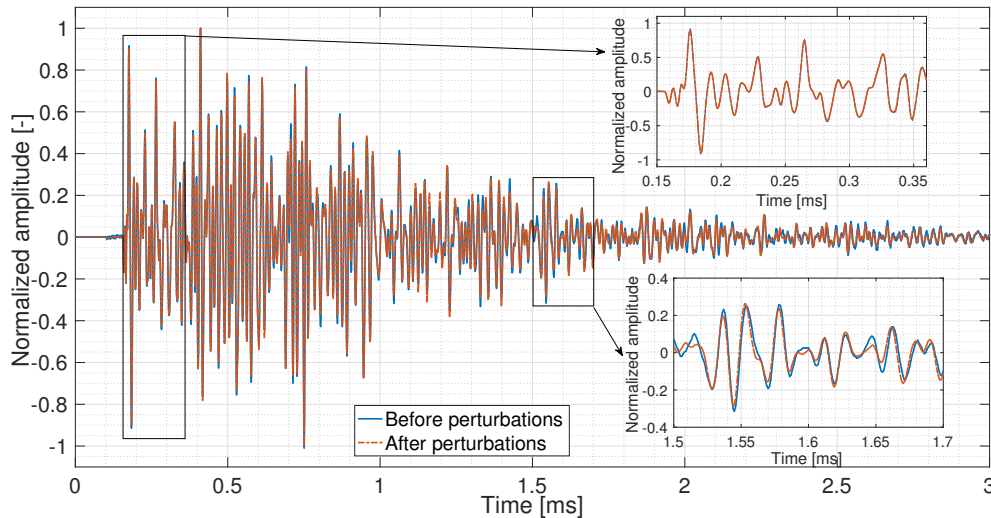
Figure 2. Signals recorded before and after perturbation in the medium [31].

The principle of CWI is to compare the coda waves recorded in two different states to monitor weak velocity variations and waveform modifications. As shown in Figure 2, two signals are

recorded before and after a perturbation. The first arrivals of the signals are almost the same (i.e., [0.16 ms, 0.35 ms]), while the coda wave (i.e., [1.5 ms, 1.7 ms]) shows a significant difference. For this reason, CWI is more sensitive to weak perturbation in the medium.

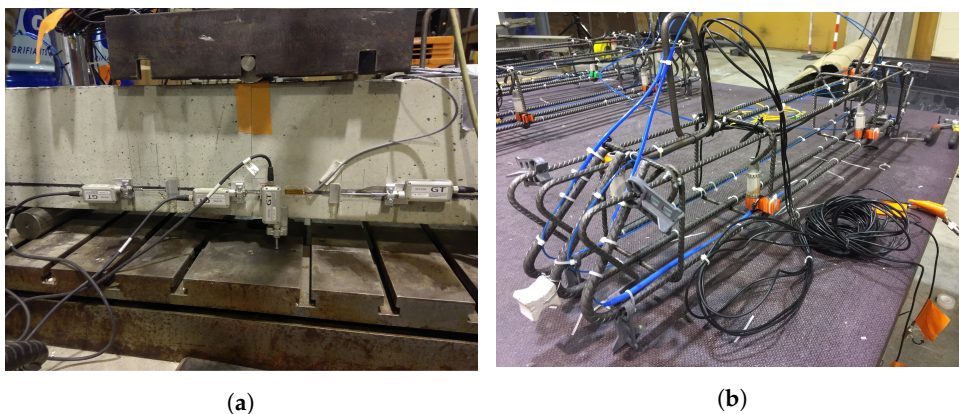
Figure 3. (a) front view of the loading arrangement and the beam instrumented with sensors before testing; (b) Ultra Sonics (US) and Distributed Fiber optics (DFO) sensors attached to the rebars before casting of concrete.

A $20 \times 20 \times 100$ cm reinforced concrete beam was tested under continuous three-point loading with a loading speed of 1 kN/min (Figure 3a). As shown in Figure 4a, the beam was reinforced with three $\phi 10$ longitudinal reinforcement bars (rebars) in the tension area and three $\phi 6$ rebars in the compression area, attached together by four $\phi 6$ stirrups. The beam was instrumented with SG (green color), LVDT (grey color), Ultra Sonic US (red color) and DFO (blue color) sensors. Before casting of concrete, four US sensors were attached to the stirrups while one optical cable was fixed over the length of four rebars (Figure 3b). After casting, the same optical cable was bonded to the surface of the beam by making a groove in the concrete at the same level of rebars and gluing the optical cable using a two components epoxy adhesive.

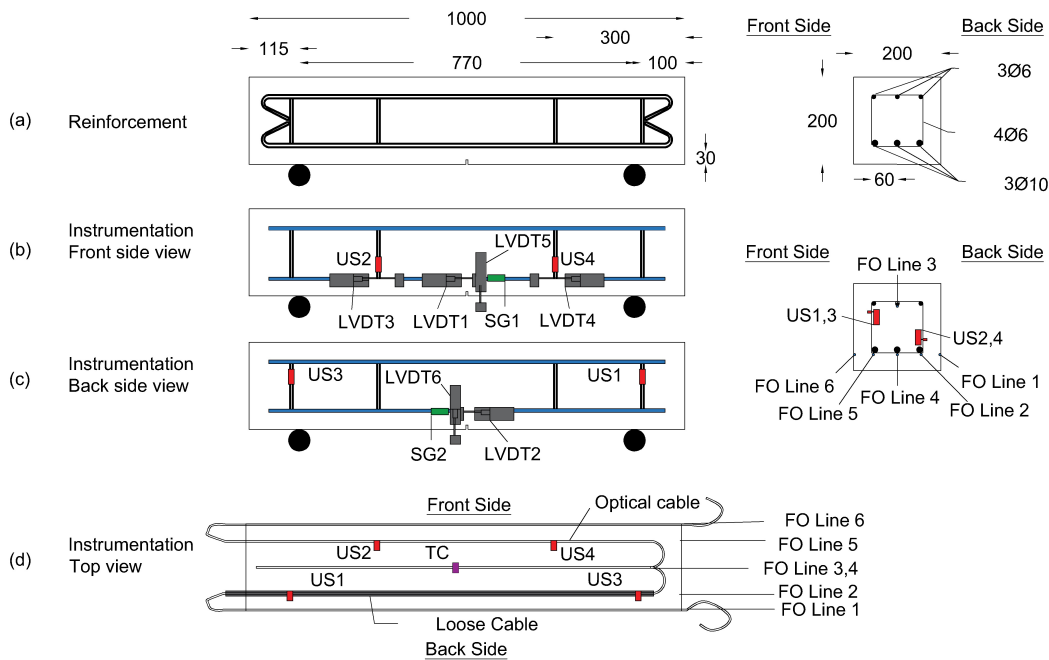
Figure 4. (a) dimensions of the beam and different rebars positions; (b) front view of sensors positions; (c) back view of sensors positions; (d) top view of sensors positions.

Figure 4 shows the top view of the optical cable trajectory while respectively:

- Glued on the front surface (Line 1).
- Attached to the front bottom rebar (Line 2). This line was surrounded by a tube to create a loose part for temperature compensation.
- Attached to the mid top rebar (Line 3).
- Attached to the mid bottom rebar (Line 4).
- Attached to the back bottom rebar (Line 5).
- Glued on the back surface (Line 6).

In addition, two LVDT sensors (one from each side) were measuring deflection at the center of the beam, while four other sensors were fixed at the level of rebars for displacement monitoring at specific locations as shown in Figure 4b,c. Moreover, two SG sensors (one from each side) were fixed 6 cm away from the central part of the beam. A thermocouple (purple color), fixed in the central part of the beam, followed low temperature variations (in the order of ± 0.1 °C) during the test in accordance with those measured all over Line 2 (Figure 4d).

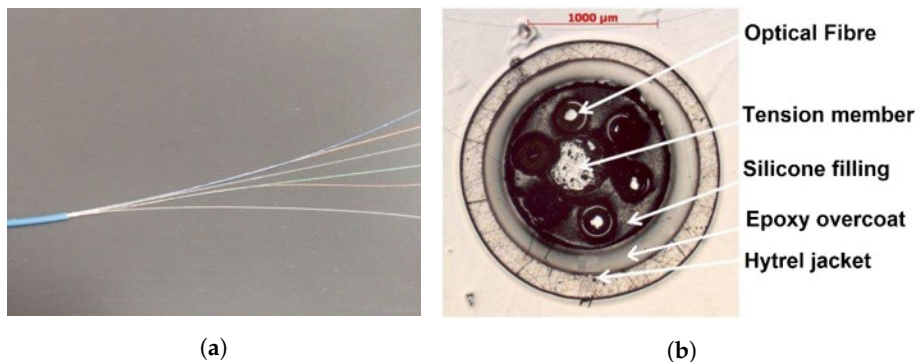
Figure 5. (a) Photo of the optical cable. (b) Micrograph of different constitutive layers of the optical cable [22].

ODISI-B interrogator (manufactured by Luna, Blacksburg, VA, United States) was chosen for this experiment. Based on Optical Backscattering Reflectometry (OBR) technique, this interrogator can reach a spatial resolution of 5.2 mm with a maximum strain repeatability of $\pm 10 \mu\text{m}/\text{m}$ and a strain accuracy of $\pm 25 \mu\text{m}/\text{m}$. Figure 5 shows the AFL optical cable (from Sensornet, Hertfordshire, United Kingdom) used as a sensor. As shown in Figure 5b, the cable holds six fibers wrapped around a central rod and embedded in a soft polymer matrix. One of the optical fibers was connected to the interrogator and used for performing the measurements.

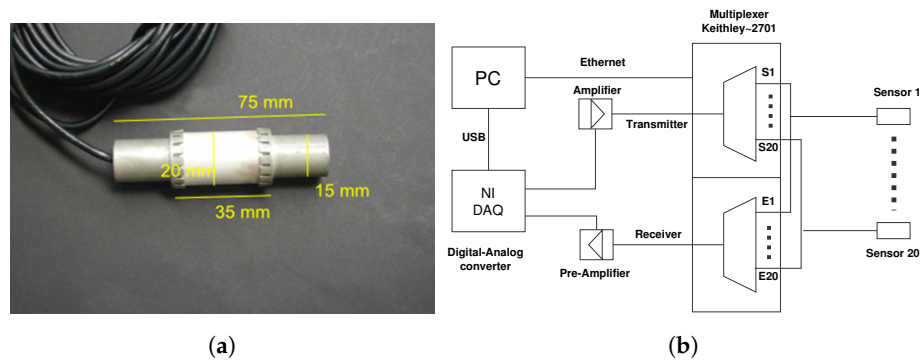
Figure 6. (a) dimensions of “SO807” [34]; (b) diagram of the data acquisition system.

A new embedded ultrasonic transducer “SO807” was used for this experiment. It was designed by Acoustic Control Systems ACS (Sarrebuck, Germany) in cooperation with and exclusively for BAM [34]. The main part of SO807 is a hollow piezo ceramic cylinder (Figure 6a) that can be both transmitter and receiver, and can be installed easily during the construction. The central frequency of this transducer is around 62 kHz. Contrary to classic ultrasonic sensors glued on the structure surface, SO807 is embedded inside the concrete material and thus records fewer surface waves

and is less influenced by near-surface changes (e.g., temperature influence). As shown in Figure 6b, a Keithley 2701 multiplexer (manufactured by Linktronix, Thalwil, Switzerland) was used to switch between different combinations S-E (transmitter-receiver) during the test. This data acquisition system allows autonomous continuous monitoring of the structure with a sampling frequency of 1 MHz.

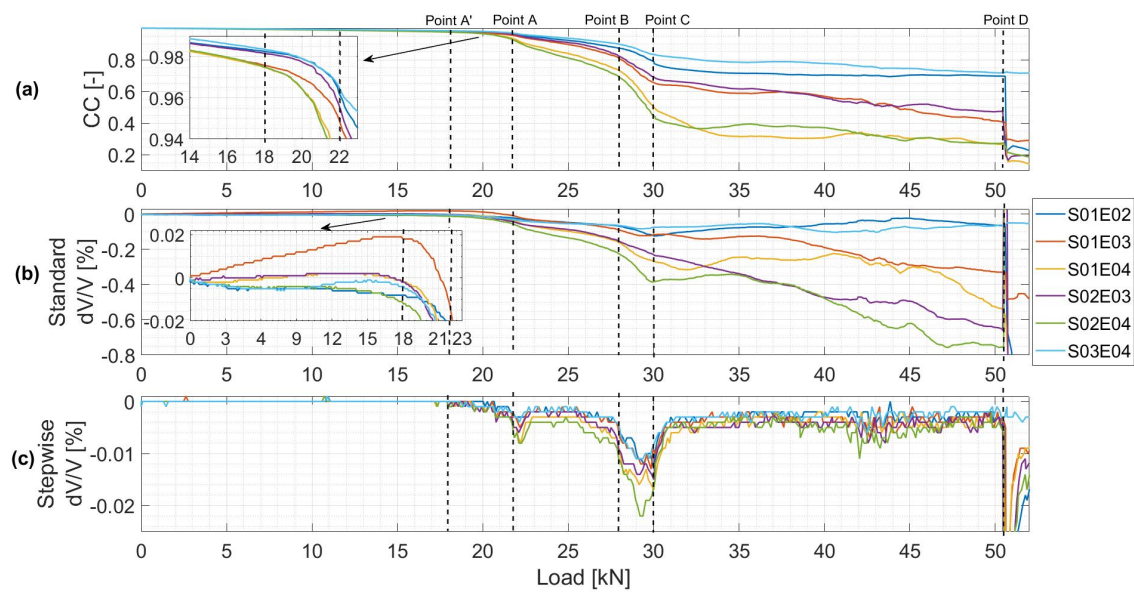
Figure 9. (a) CC plots for each $S_{xx}E_{yy}$ combination. (b) dV/V plots for each $S_{xx}E_{yy}$ combination. (c) Stepwise dV/V plots for each $S_{xx}E_{yy}$ combination.

The CC and dV/V values, calculated by standard and stepwise CWI for all different combinations of sensors $S_{xx}E_{yy}$ (transmitter xx and receiver yy), are plotted in Figure 9. A reference signal was chosen for standard CWI calculations before any load was applied. The CC values for all different combinations decrease as the load increases continuously during the test (Figure 9a). CC and deflection plots took a similar trend as they are related to the stiffness of the reinforced concrete beam. As micro cracks propagate over the height of the beam, the similarity between the ultrasonic signals reduces and is accompanied by a rapid decrease in CC values. Similarly, standard dV/V values decrease during the test depending on stress changes and positions of the sensors (Figure 9b). During the linear elastic state, these values vary between 0.02% and -0.01% for S01E03 and S02E04 combinations where the two sensors were positioned, respectively, in the upper and bottom part of the beam. While dV/V decreases for combination S02E04, S01E03 dV/V increases linearly with the increase in compression stresses in the upper part of the beam. Indeed, the stress–velocity variation coefficient changes between different combinations depending on the location and the distance between the two transducers [34]. Local velocity changes compared with the previous signal are observed clearly from stepwise dV/V (Figure 9c). The changes in stepwise dV/V plots help distinguishing four main remarkable load levels similar to those observed in the deflection plots. CWI results and their relation to damage propagation will be discussed and compared with other sensors in Section 5.1.3.

The formation of crack 1 is first detected by US and DFO sensors. When the load exceeded 18 kN, a first variation in velocity for S02E04 combination is observed from stepwise dV/V plot (Figure 9c). This decrease in dV/V followed shortly by other combinations is due to the propagation of the micro crack. The standard dV/V plots show that this fall in dV/V value is the highest between the two closest transducers located on the bottom part of the beam (combination S02E04). On the other hand, the smallest variations are observed for combinations S01E02 and S03E04 as the direct waves between these transducers do not bridge through the crack. CC plots follow a similar trend as dV/V plots.

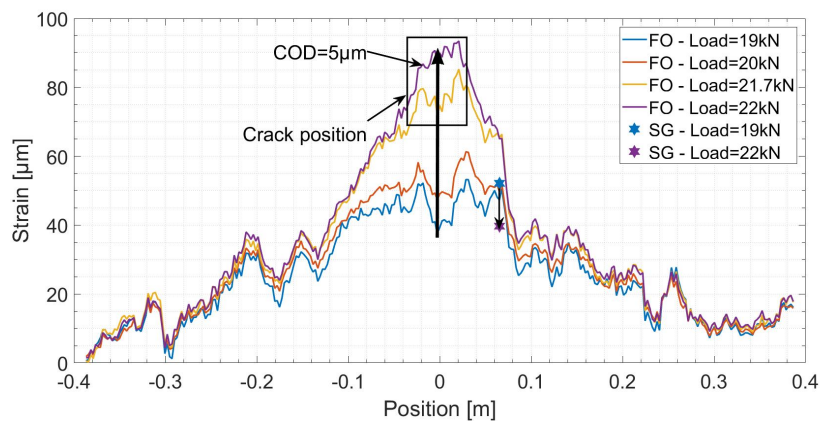
Figure 10. Spatial strain distribution over the length of Fiber Optics (FO) Line 1 before and after the creation of the first micro crack.

Figure 10 shows the measured strain versus the position for different load levels. For the specific (cable, glue, concrete) combination used in this experimentation, a crack opening of $5\ \mu\text{m}$ resulted in an increase to 200% in the strain measured near the location of the crack. On the other hand, the strain measured by SG sensors decreased to 80% at 6 cm far from the crack location. If the crack location were closer to the SG sensors, a bigger rate of strain decrease would have been detected. However, if the crack bridged through the SG sensor, high strain values would have been measured. Since these two cases are rare when instrumenting real scale structures, crack detection using SG sensors is in most cases an indirect detection.

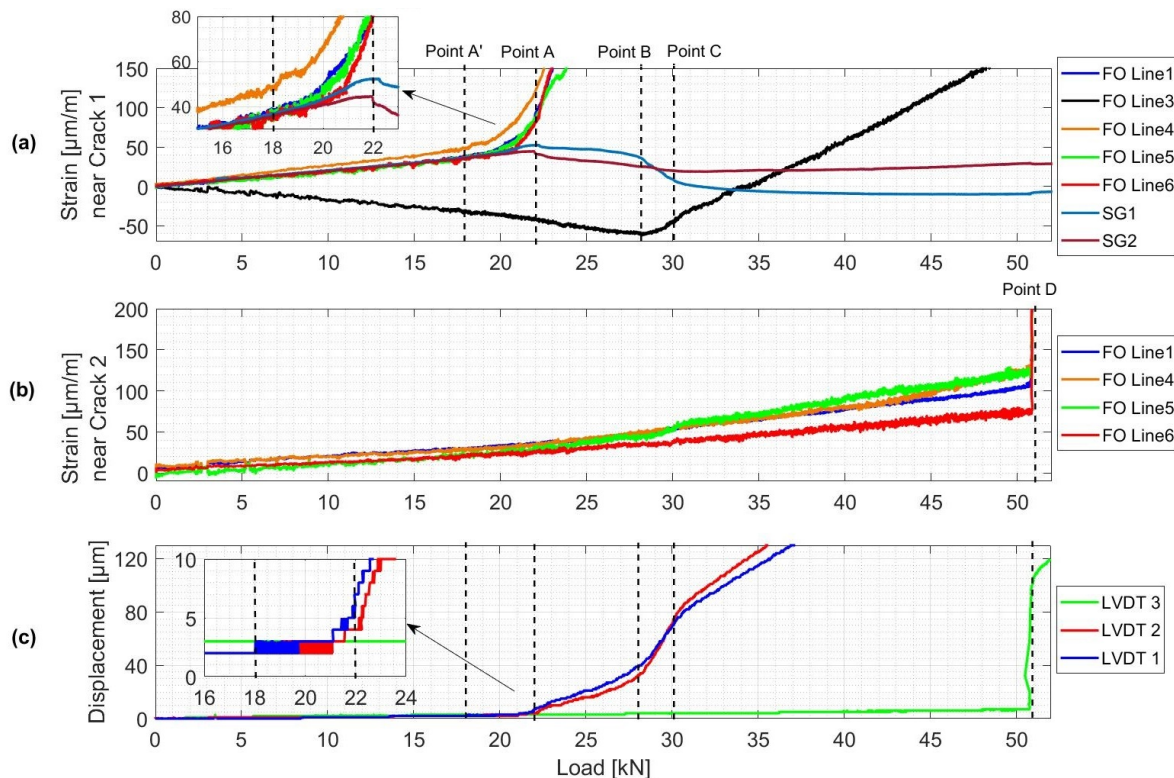
Figure 11. (a) Strain variations measured by FO lines and SG sensors near Crack 1. (b) Strain variations measured by FO lines near Crack 2. (c) Horizontal displacements measured by LVDT sensors.

While Figure 9 presents the results of CC and dV/V calculated from US sensors measurements, Figure 11 shows the DFO strain measurements at the location of cracks 1 and 2 compared to displacements (crack openings) and strains measured respectively by LVDT (1, 2, 3) and SG (1, 2). Cracks 1 and 2 refer to the first crack detected at the center of the beam and the second one 20 cm away from the center (monitored by LVDT 3).

Likewise, FO Line 1 and 4 present first an increase in strain variation near 18 kN, followed shortly by Line 5 and 6 near 20 kN (Figure 11a). However, the change in LVDT 1 and LVDT 2 measurements due to the crack opening occurred when the load reached 21 kN with higher values on the front side of the beam (Figure 11c). The creation of Crack 1 was the reason behind a strain release in concrete. This decrease in strain was detected by SG (1, 2) 6 cm from the crack location near 22 kN (Figure 11a). Finally, LVDT 3 did not show any change in measured displacement.

18 kN and 28 kN. When Crack 1 approaches top rebars, a high dV/V and CC changing rates are observed signaling a rapid crack propagation between the top rebars level and the top of the beam until the load reached 30 kN. The beam is then divided into two parts and therefore dV/V values started increasing for combinations $S01E02$ and $S03E04$ (Figure 9b). The fact that the top rebars started working in tension near the crack introduced a sort of asymmetrical damage propagation in the beam. This can be observed from LVDT (1, 2) and SG (1, 2) measurement plots where the CODs and strains measured on the back side of the beam reached higher values than those on the front side between 28 kN and 31 kN (Figure 11c).

When load reached 51 kN, Crack 2 suddenly appeared at 20 cm from the center of the beam. The fact that the crack reached instantaneously a COD of 100 μm led to high variations in strain measured by FO Line (1, 4, 5, 6) (Figure 11b). For US measurement, the CC and dV/V for all combinations, except $S03E04$, changed significantly (Figure 9). Indeed, transducers (03, 04) are located on the other side of the beam and direct waves do not pass through the second crack. Another piece of compelling evidence is that the beam was separated into two parts.
